## BS5837:2012 TREE SURVEY / Arboricultural Impact Assessment

Customer No: MBHDE05  
Document No: 800717  
26/01/2022

Site Address:  
FS408 MFG RUSHOLME SERVICE STATION  
10 WILMSLOW ROAD  
MANCHESTER. M14 5TQ

Version 2 Jan 2022

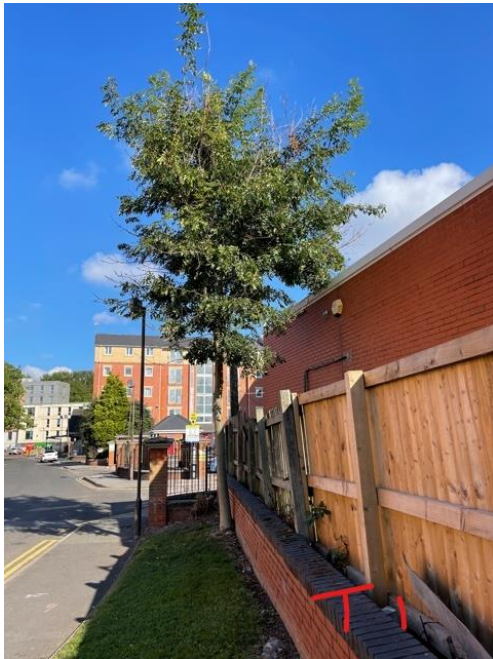
### Tree 1: Ash

Off site Ash tree, Semi mature,  
Height approx. 10m.  
Stem diameter at 1.5m: 175mm.  
Crown spread approx. 2.5m radius.

Condition: Early indications of Ash Dieback (*Hymenoscyphus fraxineus*) a fungal disease of recent distribution in the UK, causing leaf and stem dieback, leading to death of the tree.

The tree is also against the boundary wall of the Fuel Filling Station. If allowed to grow unchecked (and if it survives Ash Dieback) is likely to damage the wall.

5837:2012 Category U with less than 10 years expected safe useful life remaining.

Impact on the Proposed Design?  
None

No works are proposed to T1 or T2.

No storage of materials, or vehicles should be allowed to the grass area around T1 and T2

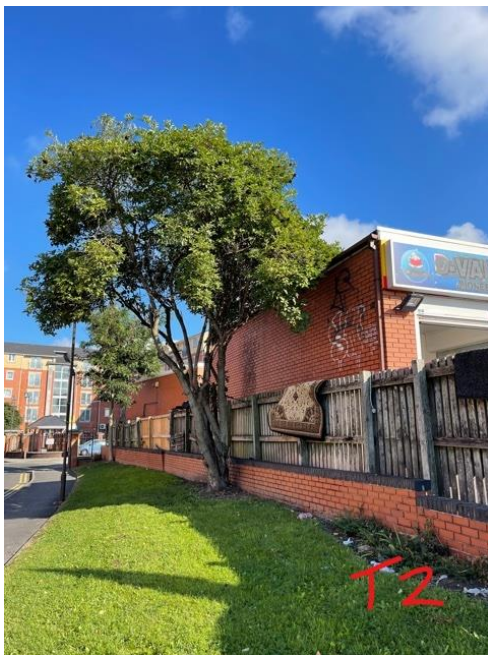
### Tree 2: Elderberry

Off site Elderberry, Mature,  
Height approx. 8m.  
Stem diameter at 1.5m: 6 stems of average diameter 120mm.  
Crown spread approx. 3.5m radius.

Condition: Mature, Fair condition, Surgery, crown raising and removal of dead wood has been carried out in the past. The fence appears to have a rotten base and is tied to the tree for support.

While the tree is against the boundary wall of the Fuel Filling Station, it is unlikely to cause significant damage to the wall. The roots are unlikely to be significantly under the wall foundations given the relatively soft and fibrous nature of Elderberry roots.

5837:2012 Category C with possibly around 10 years expected safe useful life remaining.

There is no impact on the Proposed Design. The current Car Wash is around 4.5m tall, the crown is impacting against the top corner of the wall. The proposed design calls for demolition of the Car Wash and installation of an a new Jet Wash Bay to be located in the same place.

The Jet Wash Bay requires minimal foundations and is much lower in height than the current Car Wash.

Protection is required adjacent to T2. While it is presumed that the fence may be replaced, it or an alternative screen to replace it should be left in place during demolition and construction of the New Jet Wash Bay.

Note that the new Jet Wash Bay is smaller than the current Car Wash Building, there no disturbance to T2 anticipated.

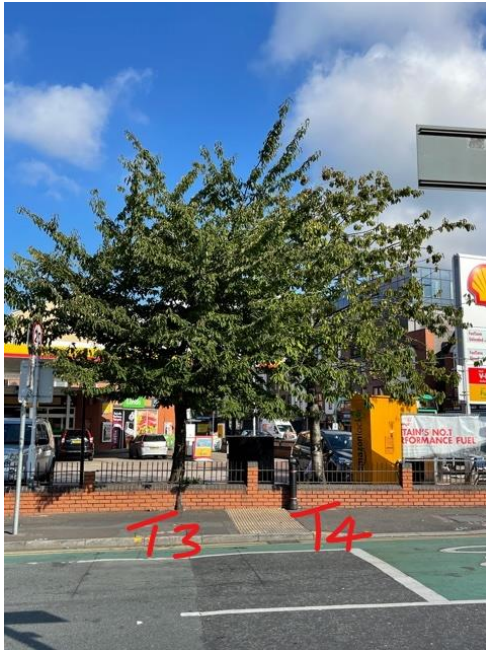
### Tree 3 and 4: Cherry

On site Cherries, Mature,  
T3 Height approx. 7.5m.  
Stem diameter at 1.5m: 270mm  
Crown spread N 2.75m, E 2.9m, S 4.8m, W 4m radius.

Condition: Good. Crown height is just below statutory height over the pavement and tips just over the road, below the 5m height requirement. One main root has grown through the wall expansion gap and down to the pavement, protruding a little over the edge of the pavement. At present there appears to be no damage to the wall or obstruction / danger to the pavement and its users.

T4 Height approx. 6m.  
Stem diameter at 1.5m: 245mm  
Crown spread N 3.6m, E 4m, S 3m, W 3m radius.

Condition: Fair. Crown canopy density is a little sparse. Crown height over the road is as T3. Exudate marks on the trunk hint at a potentially compromised vascular system. Longer term there is likely to be limited safe useful life with

the tree potentially being in a state of decline.

5837:2012 Category C for both T3 and T4 with potentially 10 to 20 years expected safe useful life remaining.

There is an impact on the T3 from the Proposed Design. Please see proposed works below for the details.

It is anticipated that the hard surfacing below T4 will not be disturbed.

If for some reason the surface has to be lifted. Hand tools and toothless bucket should be used to remove the top layer within the RPA to avoid damage to the roots below. A new surface can then be laid, preferably avoiding disturbance of the sub surface layers.

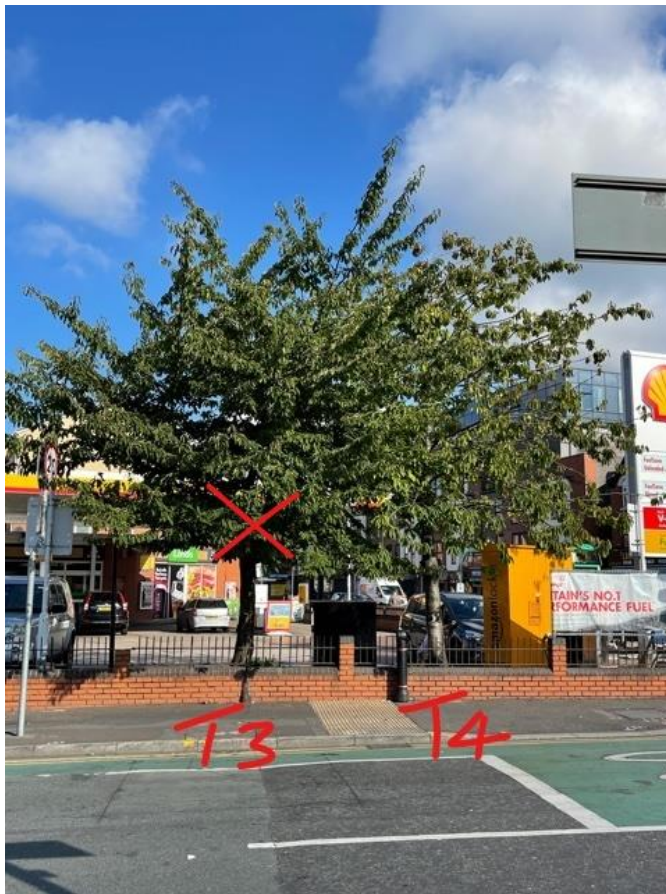
## Works to T3 and T4

T3 as previously noted has a main root that is forcing its way between the wall in the wall joint and through to the pavement. Removing the tree will also therefore prevent the incursion of the root expansion into the pavement.

T3 must be removed to allow for the EV Charging bays and Canopy installation.

Works are required are to ensure the statutory requirement that the crown is lifted to 2.4m over the pavement and tipped back to avoid overhang to the roadway below 5m

Also it is anticipated that where the crowns of T3 and T4 interfaced, some minor reshaping may be required. And minor lifting of the crown to clear the EV Charging Bay Canopy.

Tree Protection is recommended for T4 while the construction works are carried out.
