# **HISTORIC BUILDING RECORDING (LEVEL 3)**

**BELLE VUE STADIUM  
GORTON, MANCHESTER**

**PREPARED BY LANPRO SERVICES  
ON BEHALF OF  
COUNTRYSIDE PROPERTIES AND  
SCP INVESTMENTS**

March 2022

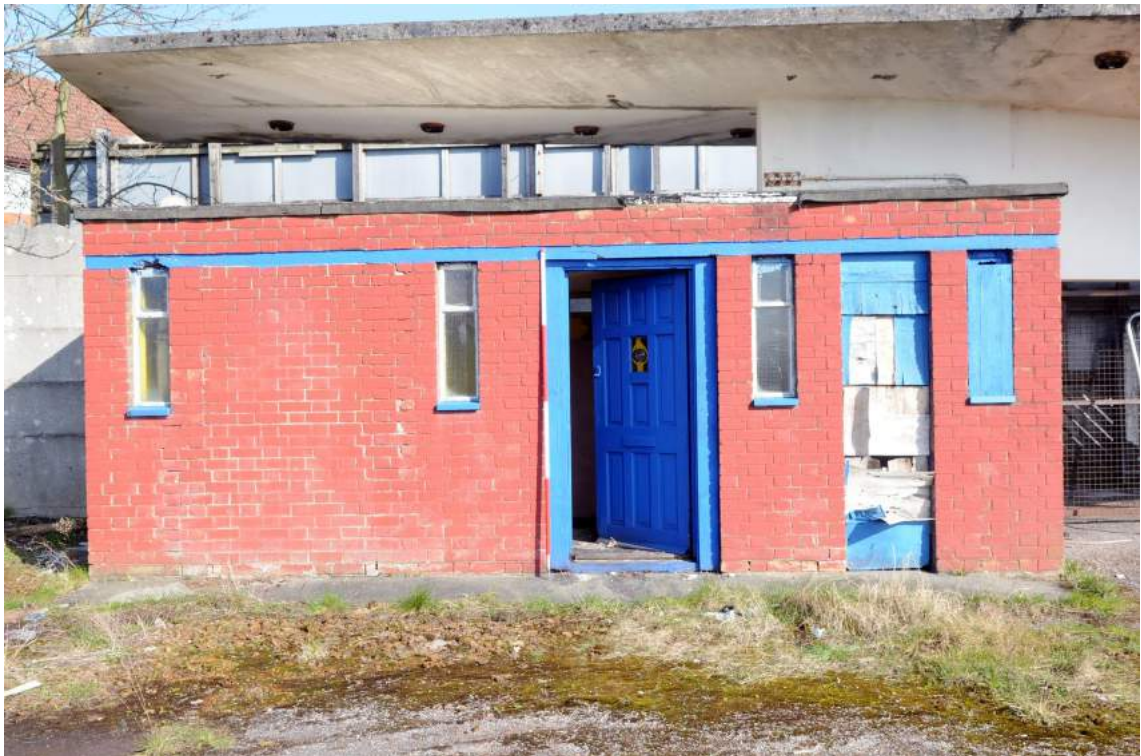
- 8.20 The south-west elevation windows of the west booth were original two-light, top-hung Crittal-type iron window frames. The door is a modern replacement. The horizontal blue painted band is the cast concrete roof that presumably leaked because a later felted roof was constructed over the low parapet. The wall face was painted red (Plate 3). The door gave access to a single room (right) of uncertain function (Plate 4). The right (east) room was boarded up and could not be accessed.

Plate 3. Structure A, west booth, south-west elevation (facing north-east)

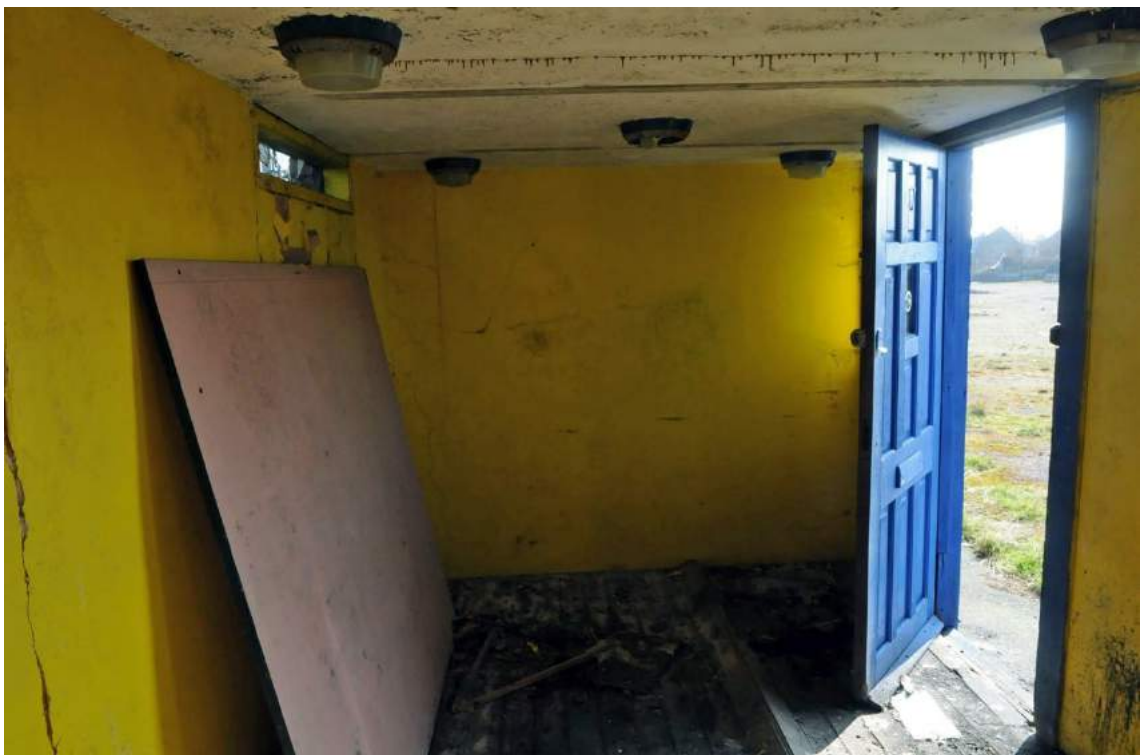
Plate 4. Structure A, interior of the west booth (facing east)

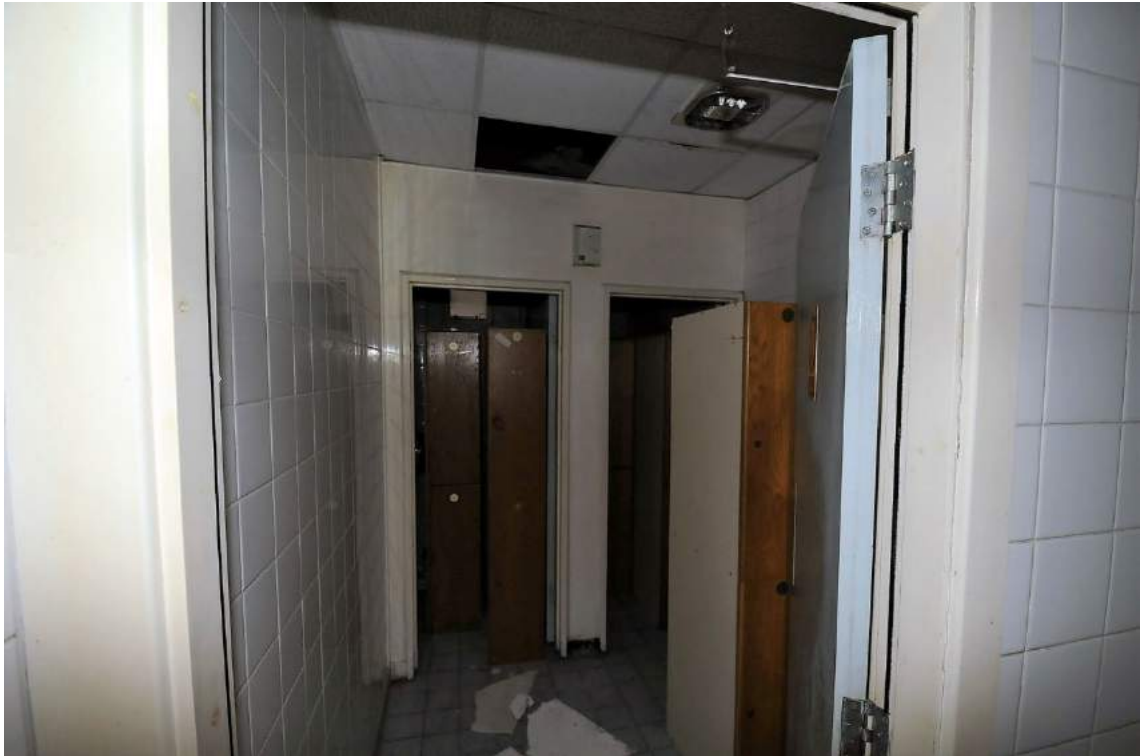
- 8.34 This part of the building was a large commercial kitchen with associated storerooms and also coincided with the Phase II extension built 1963-1968. There was clear evidence for the phasing and the demolition and replacement of a building shown on the 1935 Ordnance Survey rather than its adaptation.
- 8.35 Within the kitchen area, to the rear of the south wall was a void providing insight to the underlying steel frame of the building (Plate 56), which comprised an upright I-beam and brace supporting the Bison beam. Off the main kitchen area, there was a small staff room at its west end (Plate 21), with stores (Plates 22 and 23) and WC facilities (Plate 24) along the north side of the kitchen within the Phase IV extension.

Plate 24. Structure B west end Phase IV WC facilities (facing west)

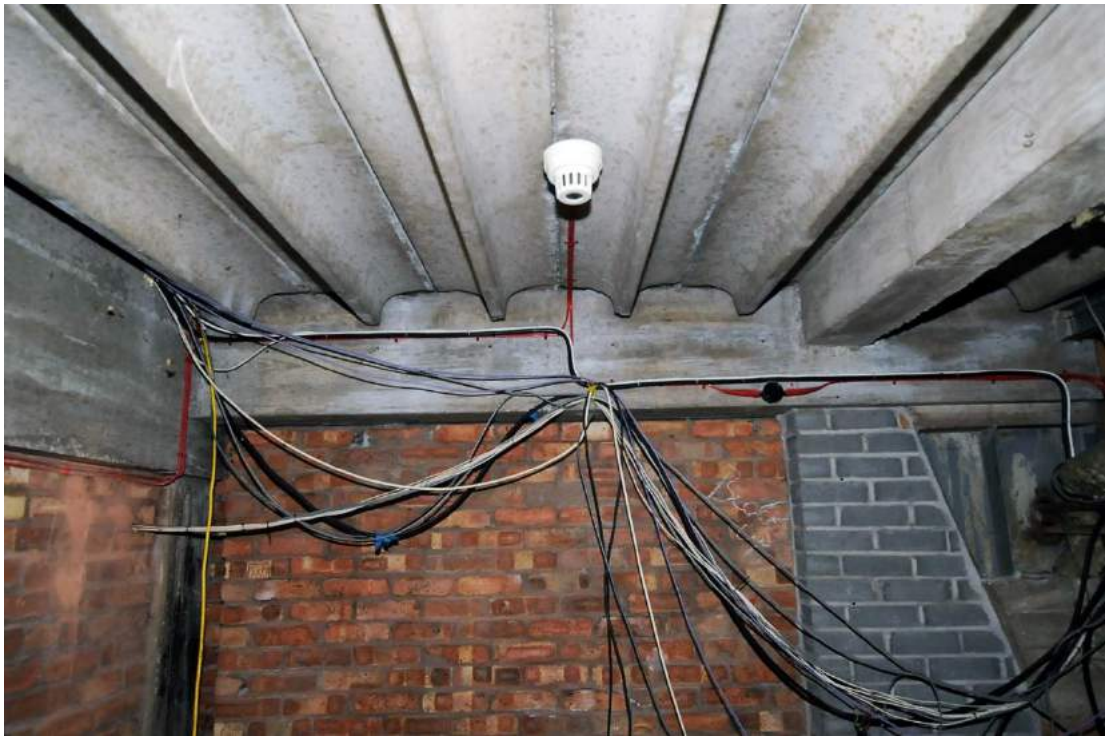
- 8.48 The building was extended to the west between 1963-1968 based on Ordnance Survey mapping and was characterised by triangulated roof trusses constructed from rolled steel joists (RSJs) and a 'Bison beam and block' first floor (a type of precast concrete T-beam and block floor). Bison Precast was founded as Concrete Ltd in 1919 by two Royal Engineers who had created fortifications in the Great War (Forterra Building Products 2022). The beams used in the Phase II element are typical of 1950s precast flooring. (Plates 54, 55 and 56). Hollow core concrete flooring was developed as early as 1935 with the invention of the 'pneumatic core' and further developed after 1945 with the introduction of pre-stressing and in the early 1950s the 'Bison Preferred Dimension frame was introduced (Forterra Building Products 2022).

Plate 54. Structure B, Bison beam and block floor in the main kitchen area

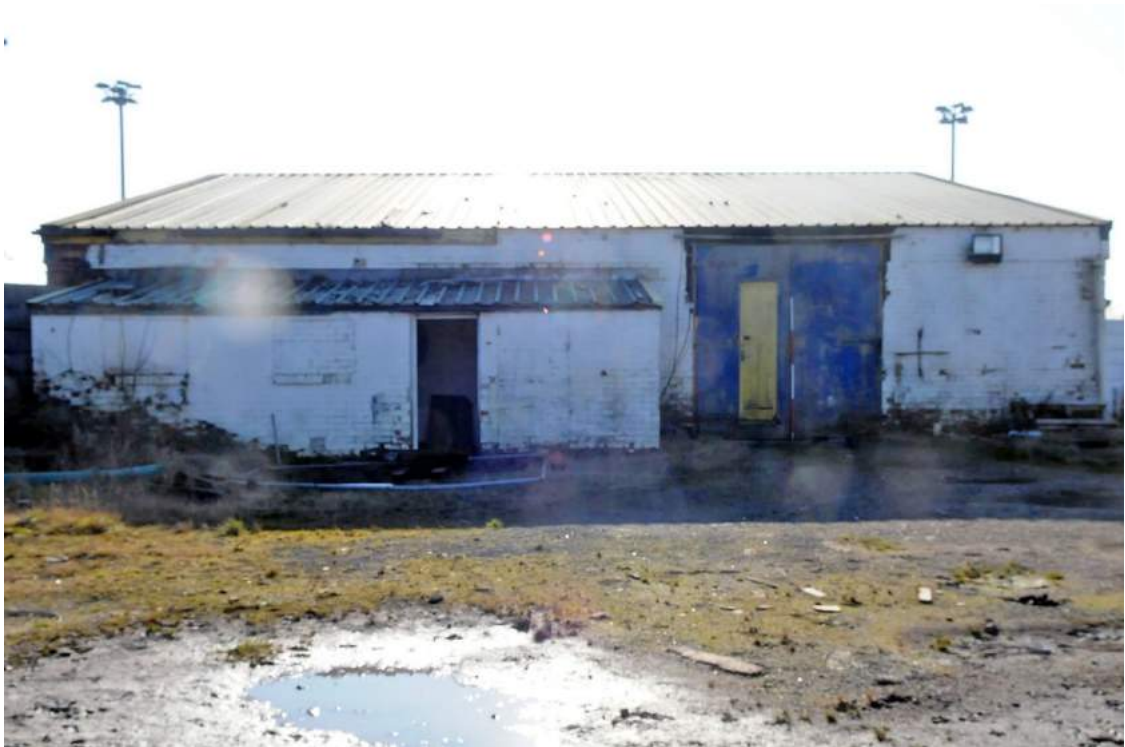
- 8.68 The north-east elevation has been significantly changed (Plate 66). It was not possible to establish exactly when this occurred but, in all likelihood, it was after 1952. The changes comprised narrowing the lean-to section and reducing its length. The entire northeast elevation of the lean-to is thus post 1952. The large double door opening to the right was original, but the doors were modern plywood replacements of what would almost certainly have been framed and braced boarded doors.

Plate 66. Structure D, north-east elevation (facing south-west)

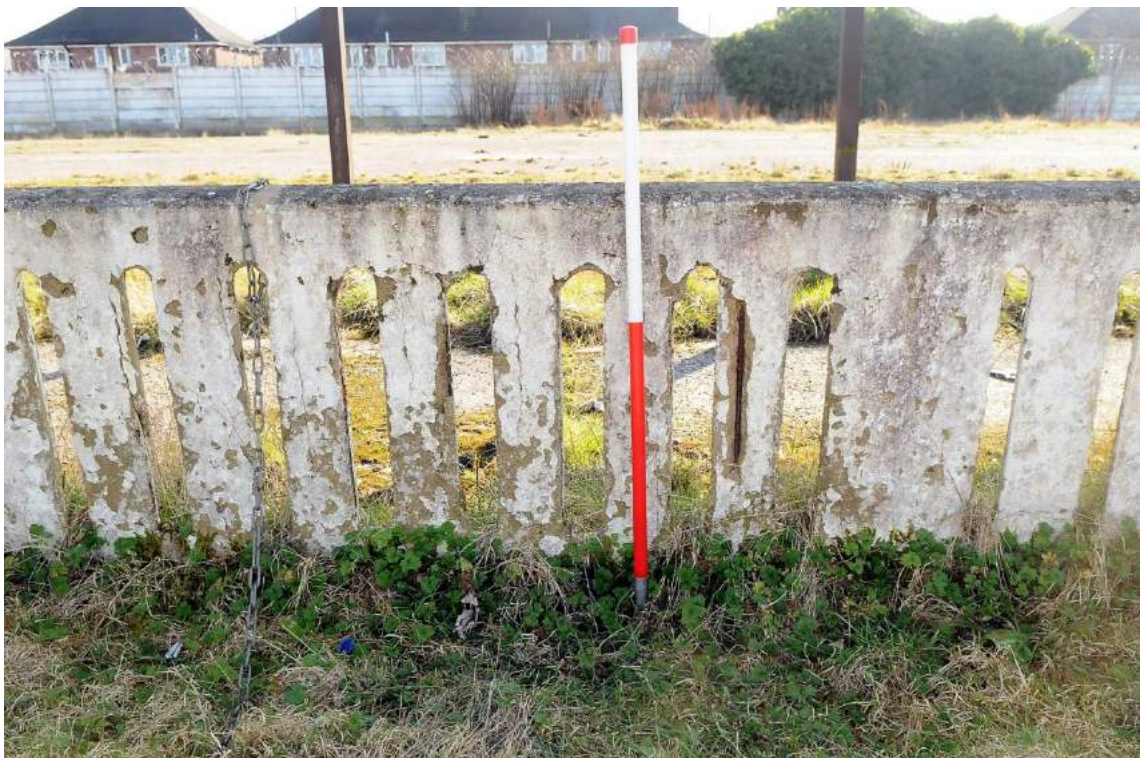
- 8.10 The covered south stands overlooked the greyhound track that was defined by several fences of differing ages. The earliest was of cast sectional concrete with later repairs and more modern tubular steel sections.

Plate 78. Structure I, inner face of the trackside fence exhibiting a semi-trowelled finish (facing south)

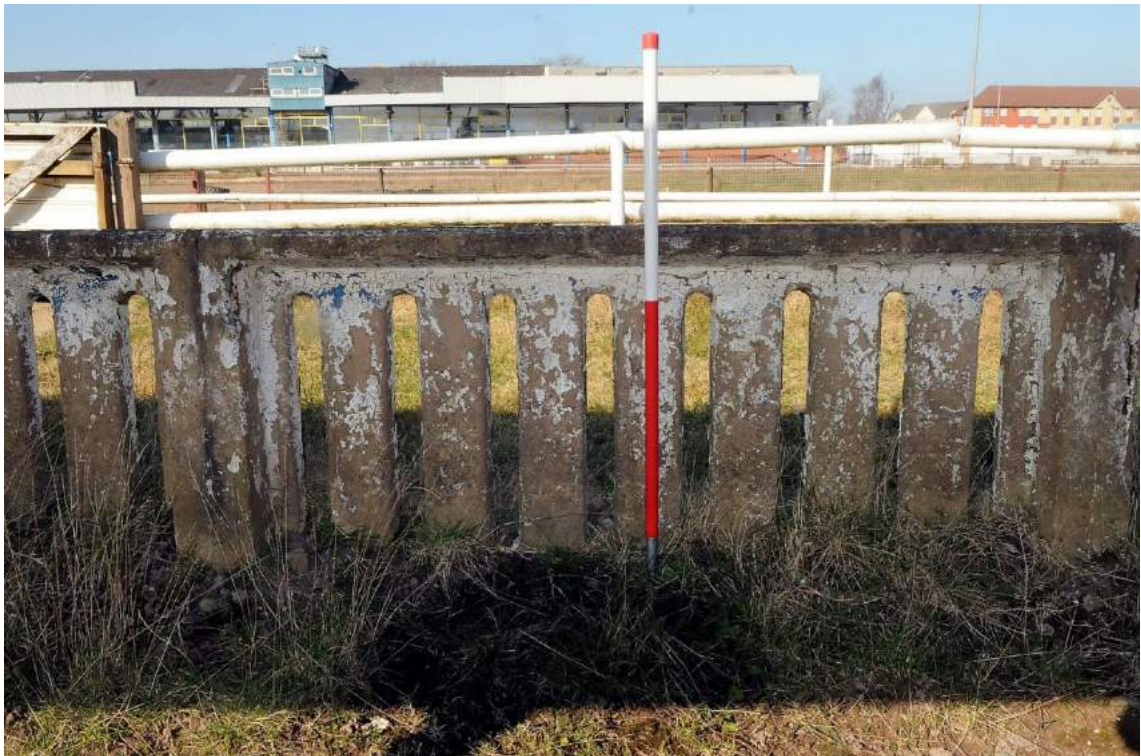
Plate 79. Structure I, outer face of the trackside fence (facing north)
