# GEOSHIELD Verification Report

GEO101021

McAlear & Rushe

Visqueen Geoseal Ultimate

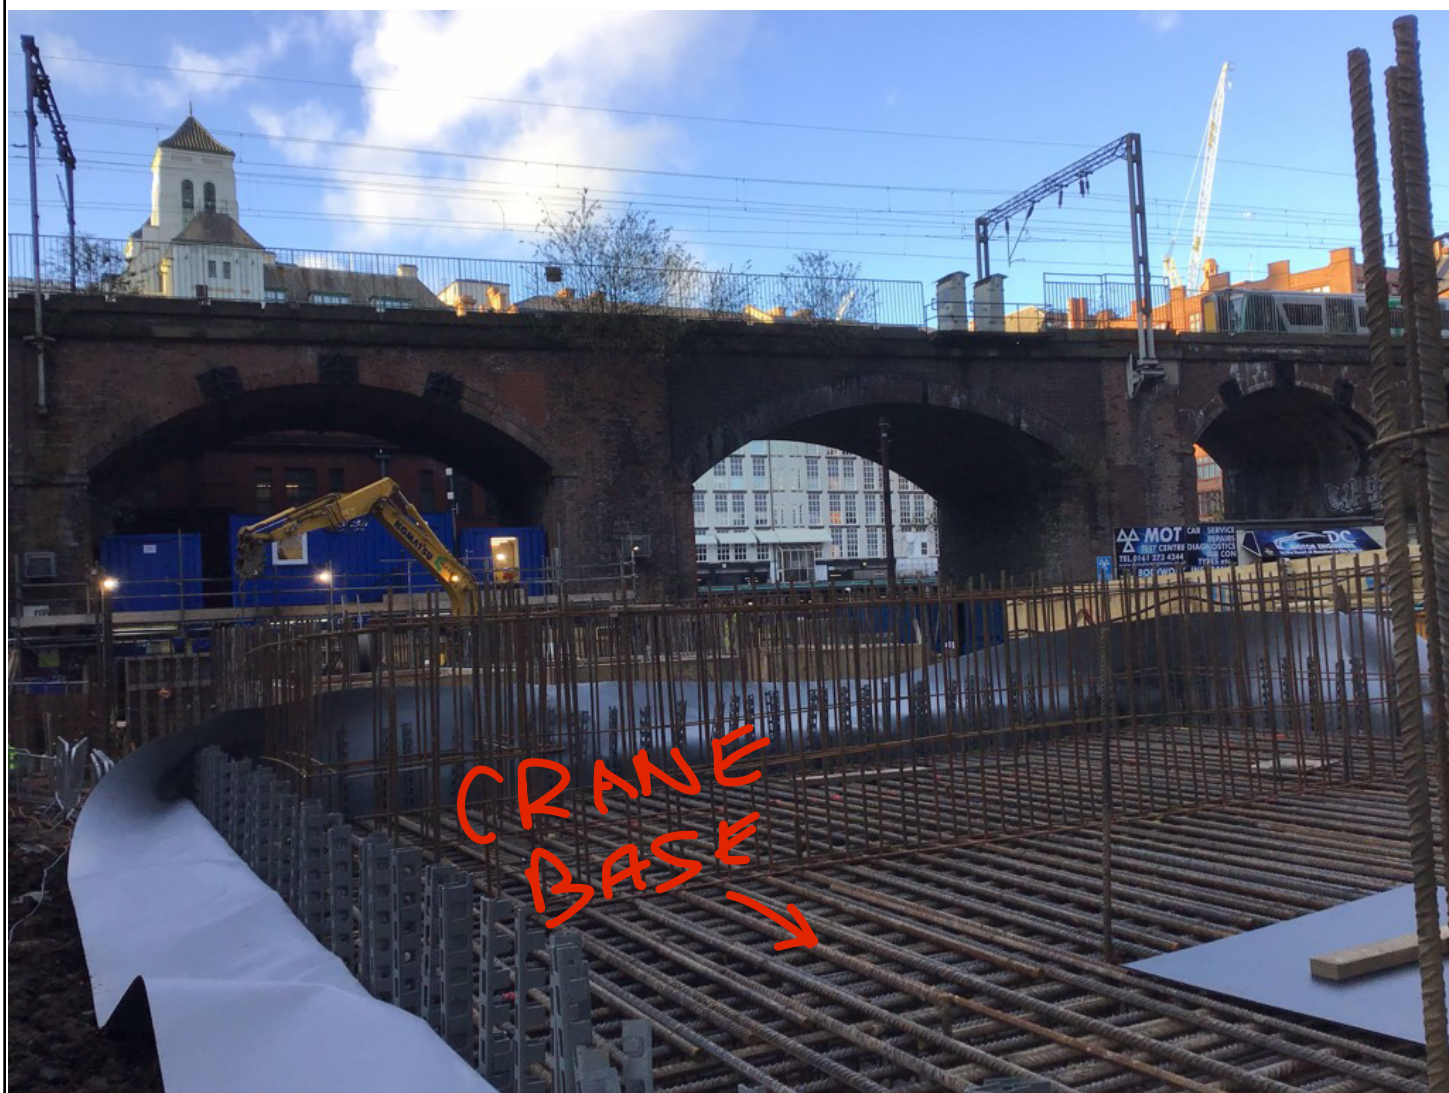
Overview of site. Crane Base steel rebar already installed on arrival.

Visqueen Geoseal Ultimate wrapped around the edges and sealed

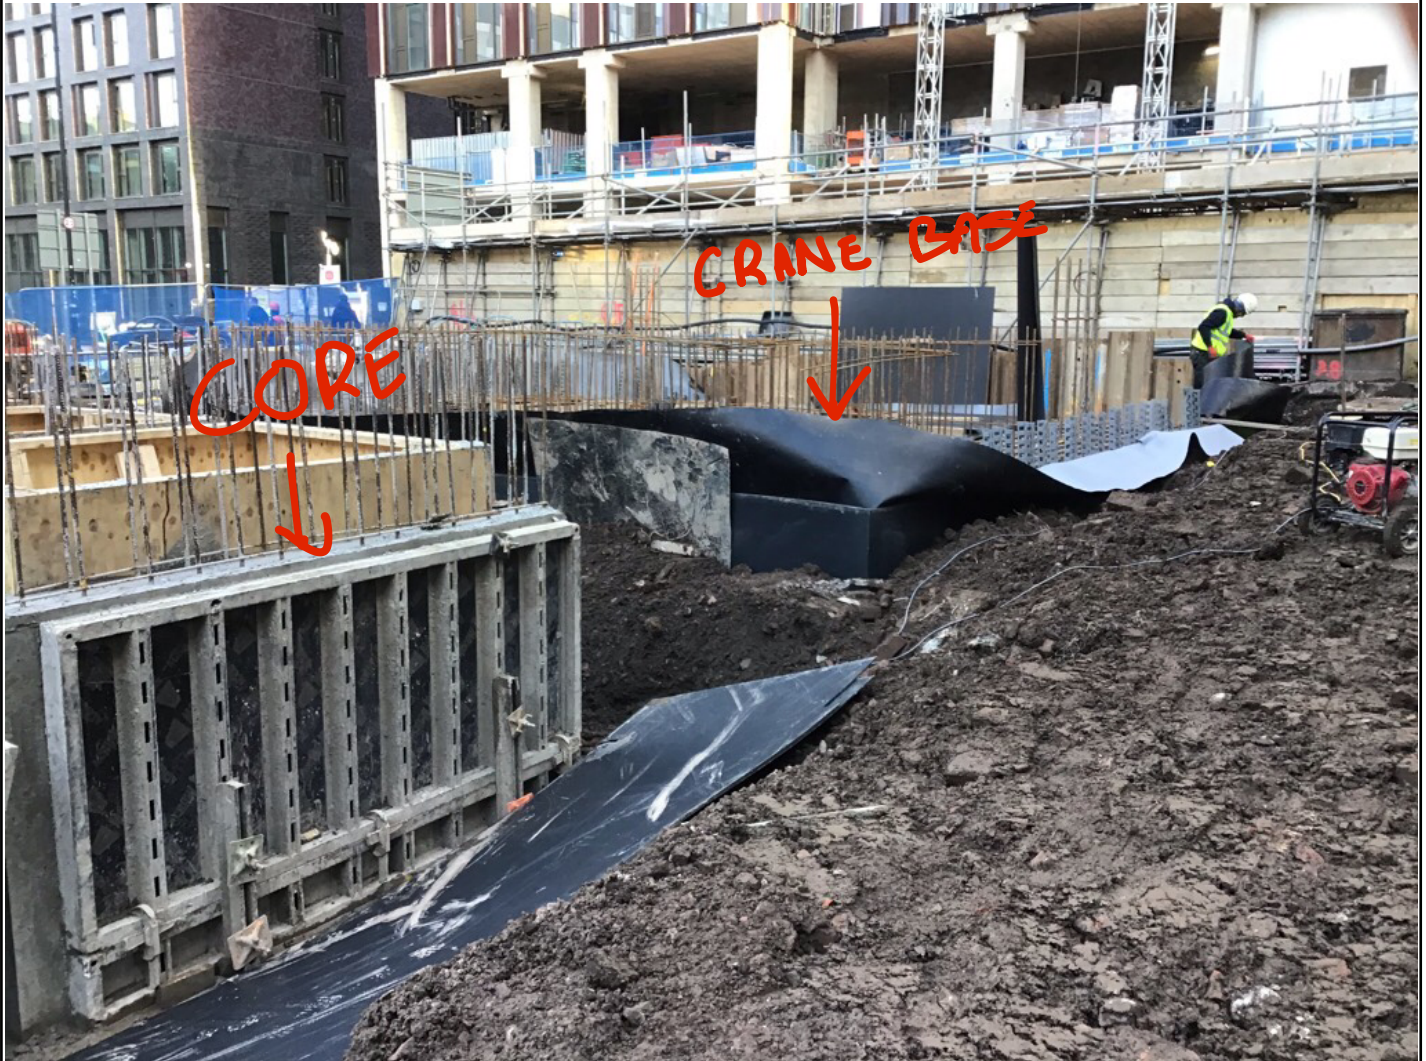
Overview of Core and a Crane Base

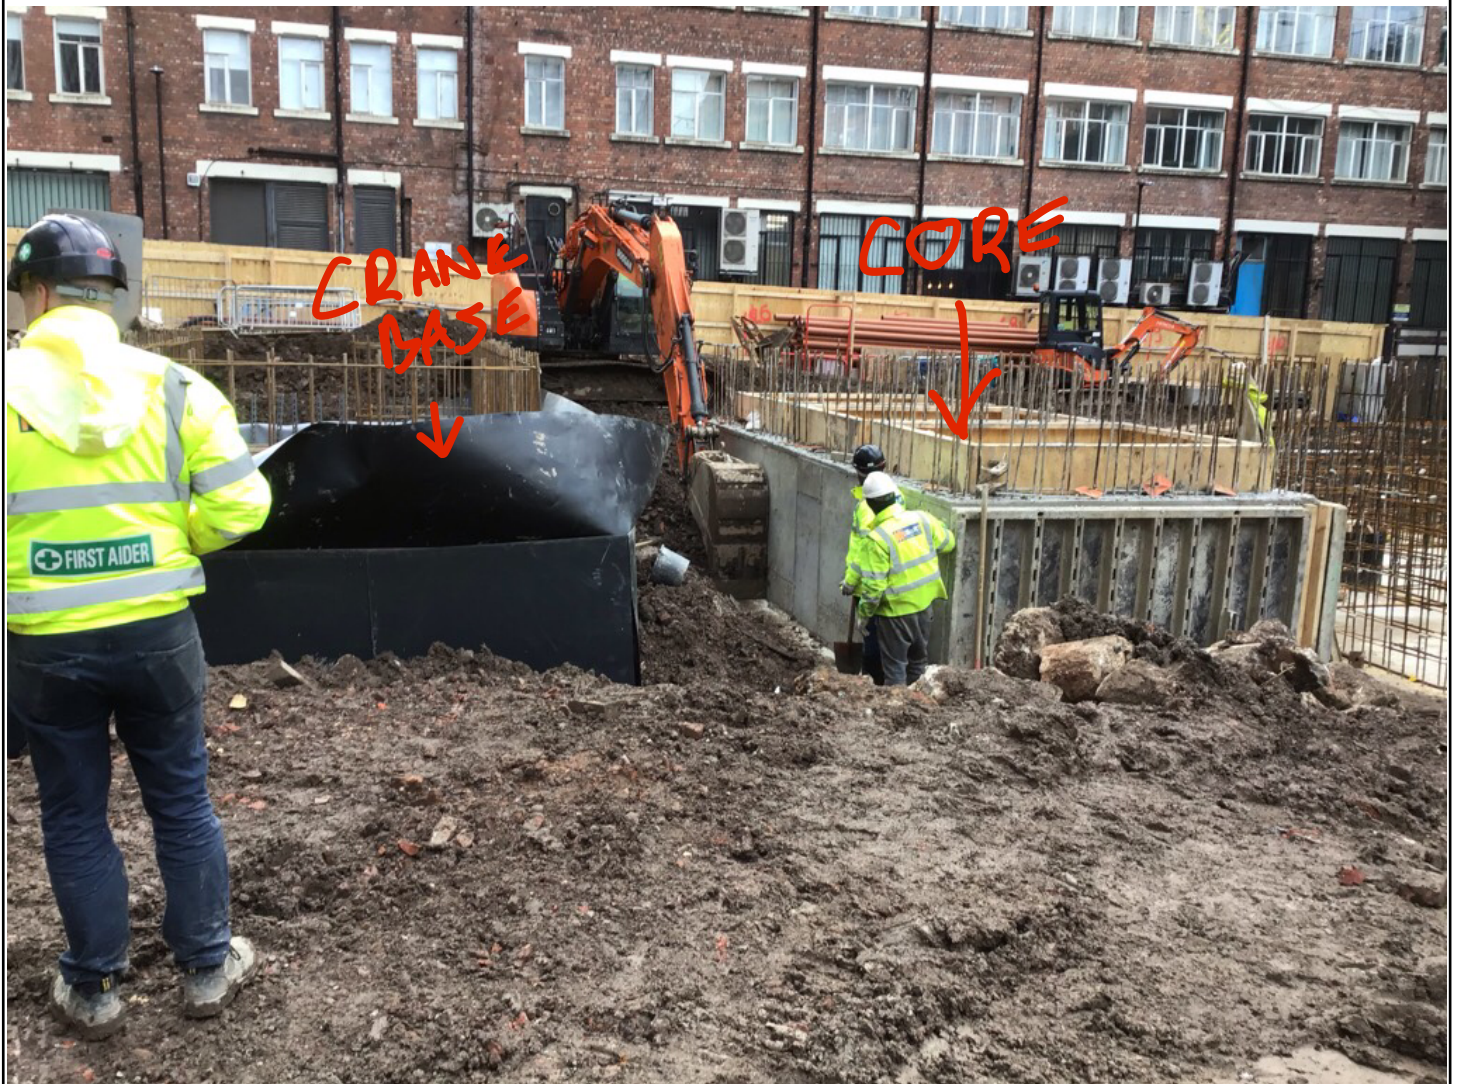
Overview of Core and a Crane Base

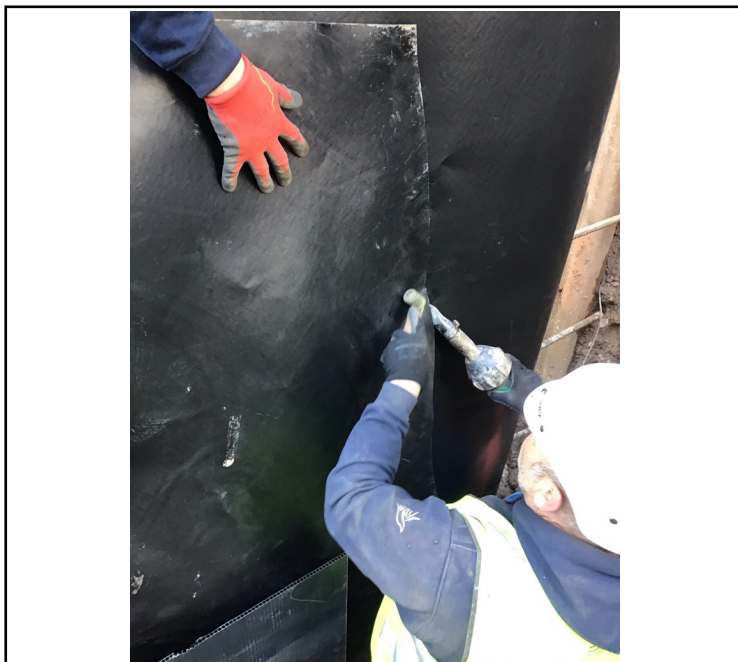
NOTES: Visqueen Geoseal Ultimate installed with minimum 150mm

return beneath the rebar. Long rolls used to minimise the number of joints required.

Joints sealed with hot weld before being extrusion welded. Visual inspection and

pick and probe test carried out.

1. Joints hot welded shut.

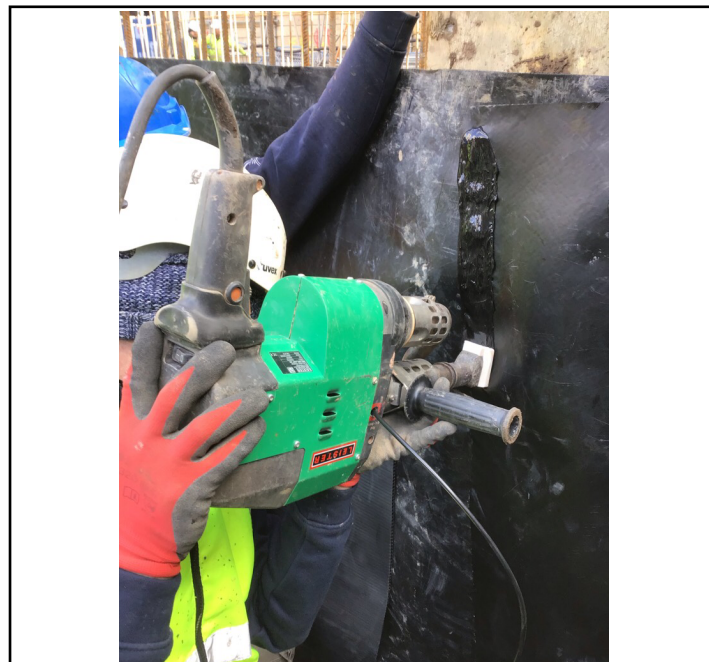
2. Joints reinforced and sealed with extrusion weld.

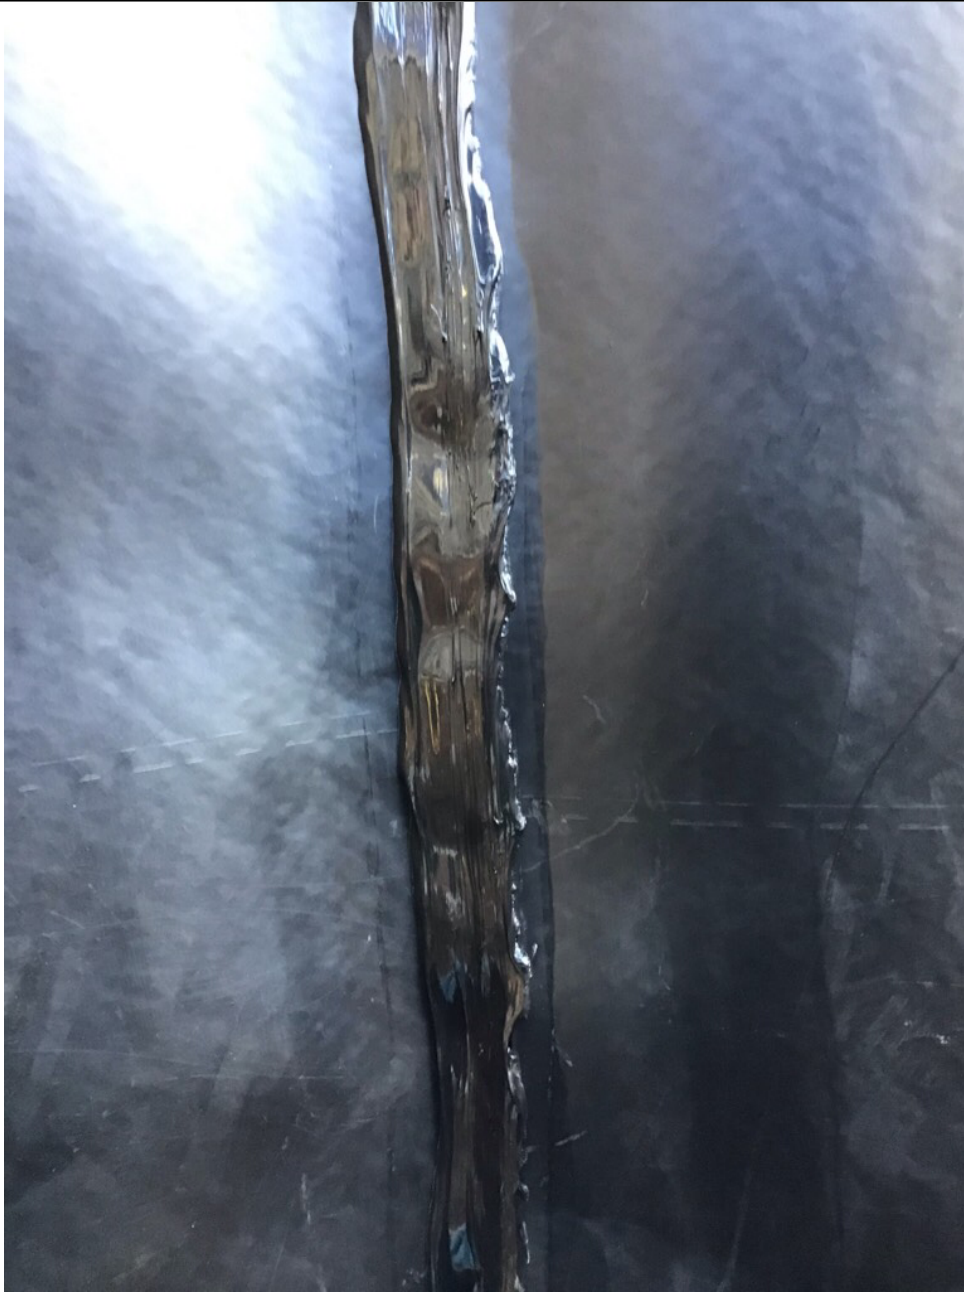
3. Joint sealed with hot weld and extrusion weld.

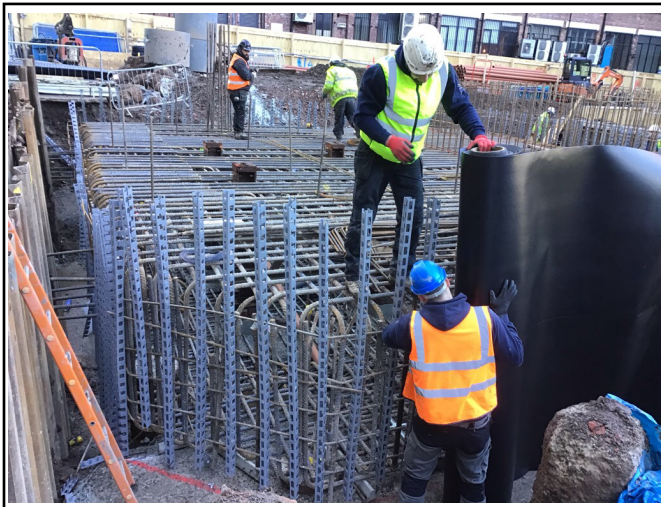
NOTES: Visqueen Ultimate Geoseal installed around the edges

of the crane base. Installation method and verified. Good number of spacers attached

to rebar and pegs installed through Visqueen to embed in concrete sealed with

GR SAM.

1. Good number of spacers attached to rebar.

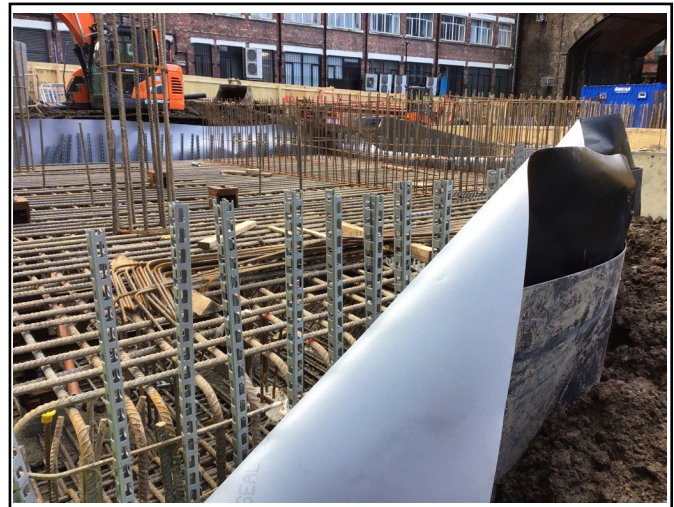
2. Membrane kept minimum 50mm from rebar.

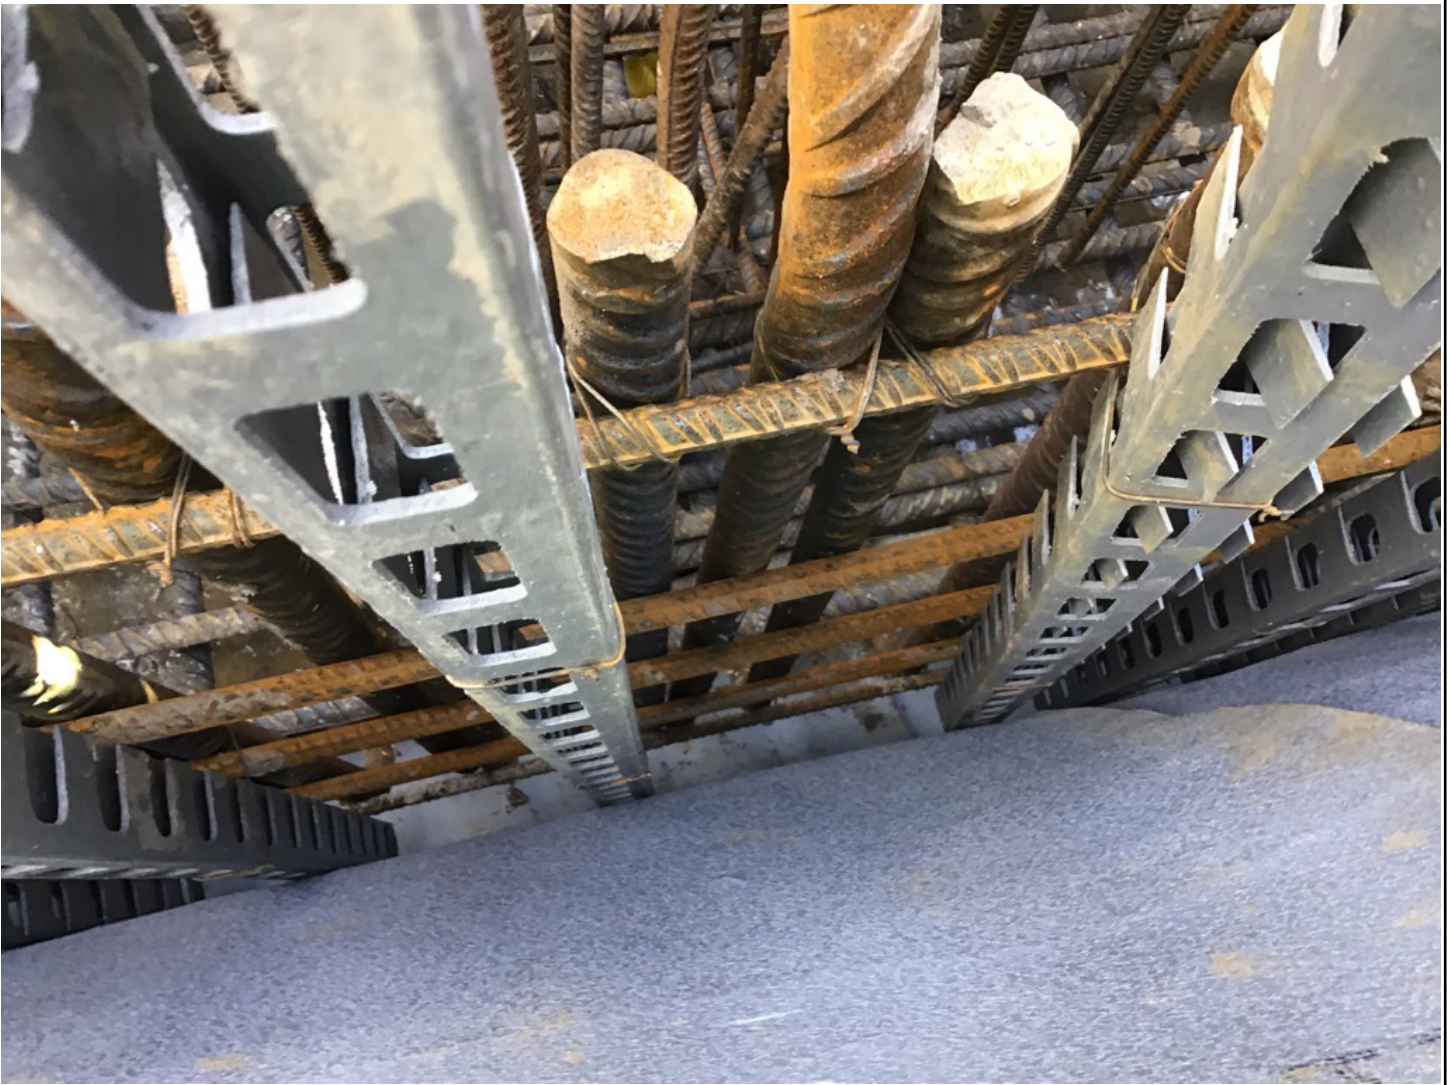
3. Minimum 150mm lap beneath steel rebar.

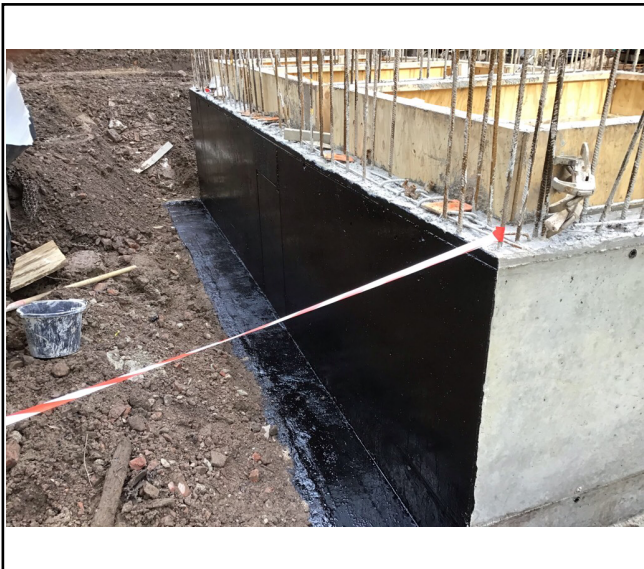
NOTES: Core wall primed with HP Tanking Primer and left

overnight to go off. Visqueen GR SAM installed the following day once primer

ready. GR SAM then protected with Visqueen Protective Board before being backfilled.

1. HP Tanking Primer applied to face of core

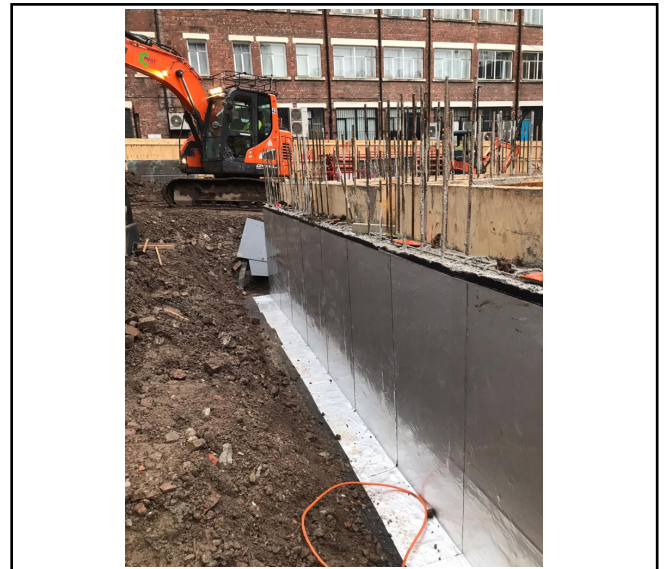
2. GR SAM applied to face of Core

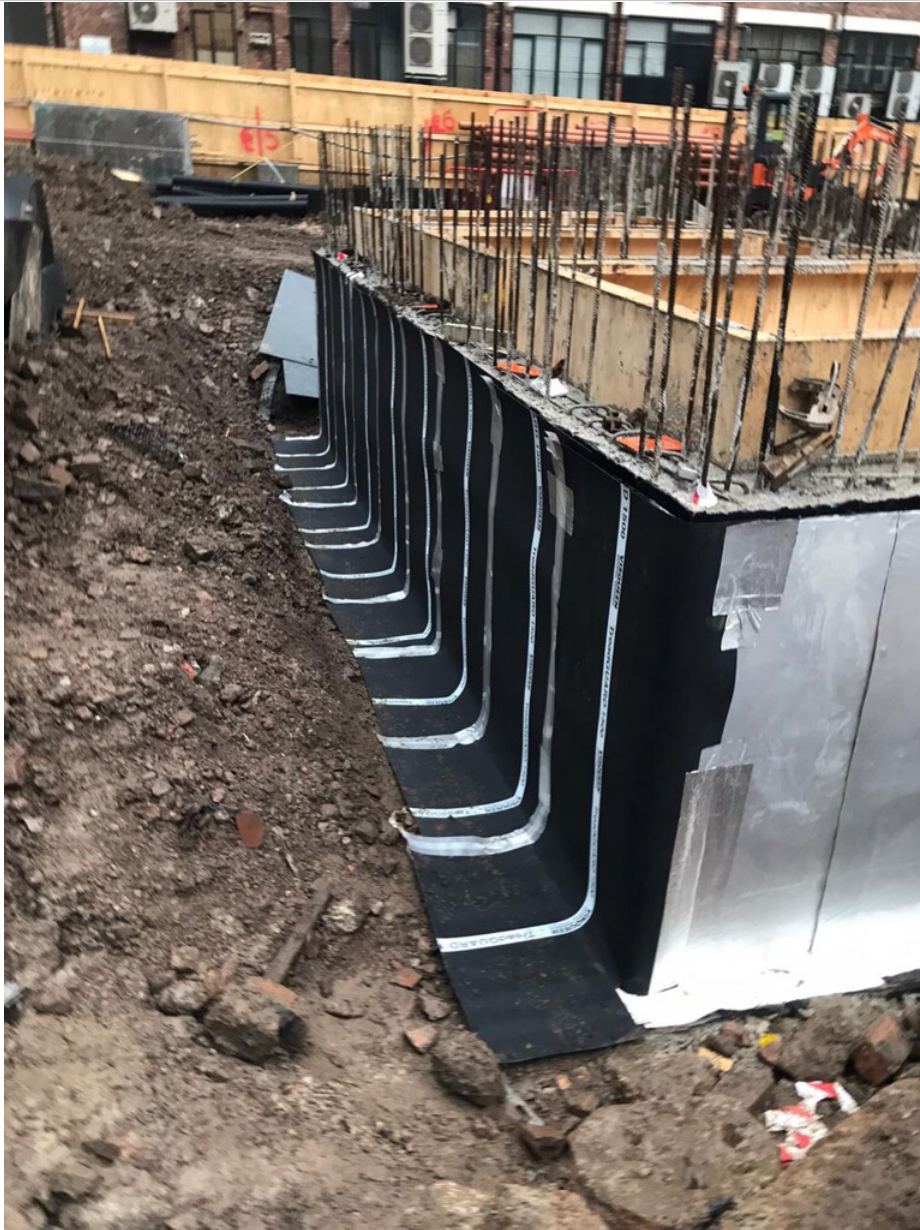
3. GR SAM protected with Protective Boarding before being backfilled.

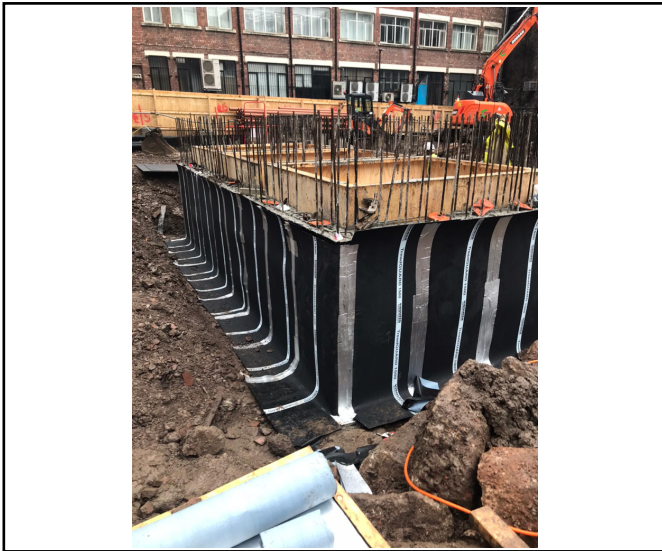
Core protected with protective boarding

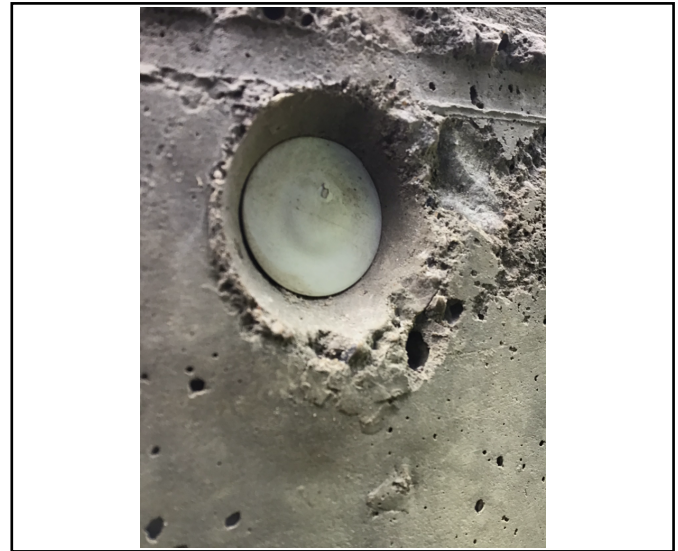
Dividag holes plugged with rubber

plugs before being primed

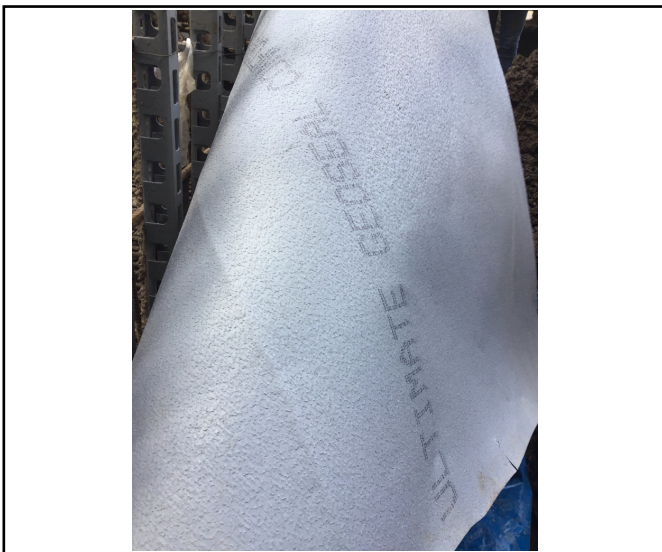
Visqueen Geoseal Ultimate used

around crane base

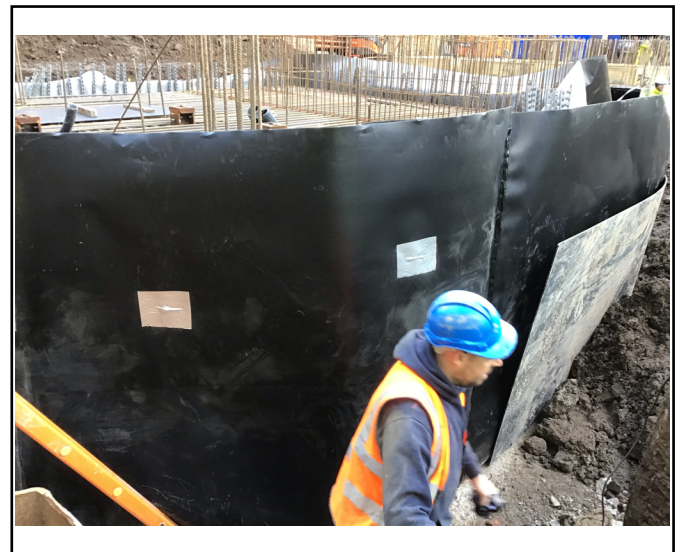
Pegs to bed in concrete sealed

with GR SAM

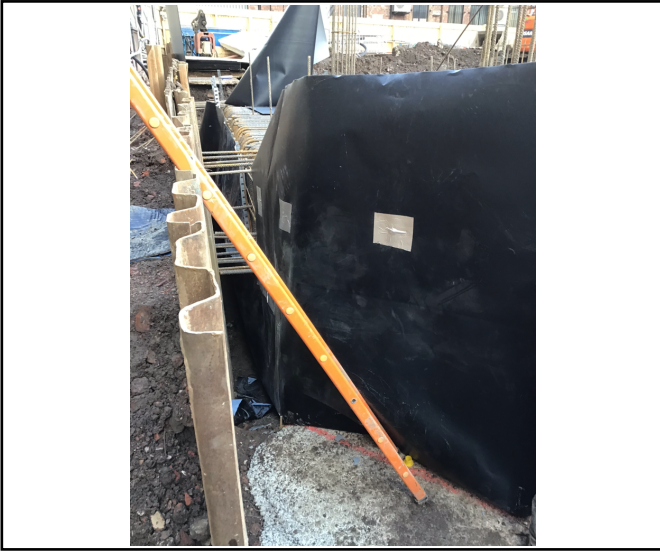
Peg sealed

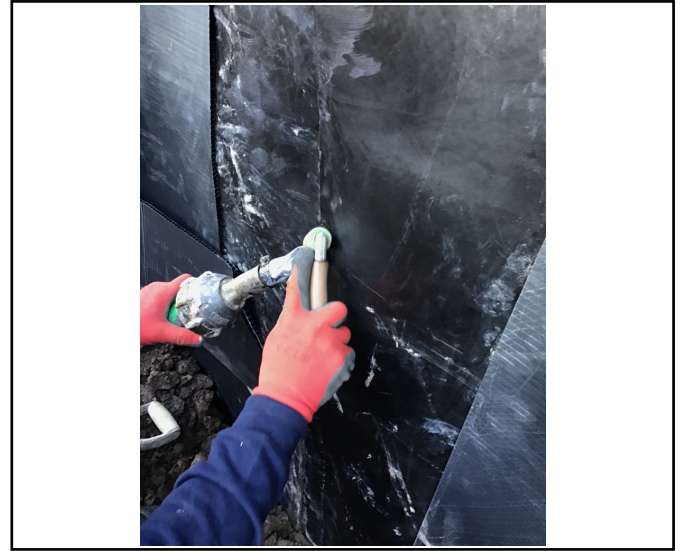
Hot weld in before extrusion

weld witnessed

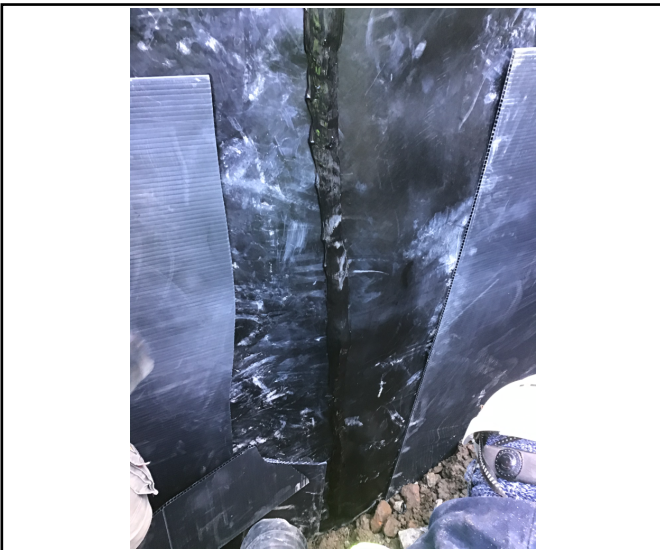
Extrusion weld on complete

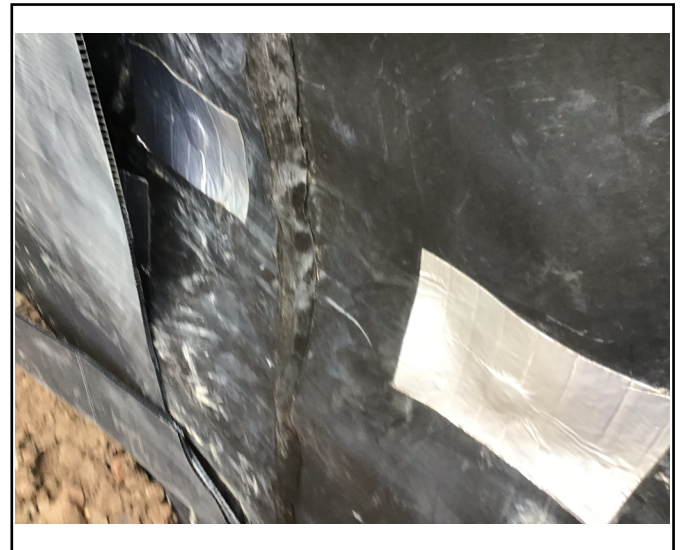
Pegs installed either side of

extrusion weld and sealed

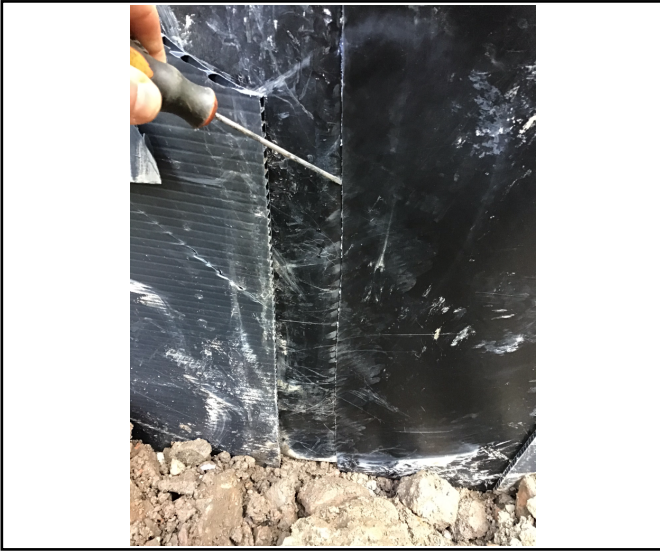
Pick and probe on hot weld before

extrusion welded

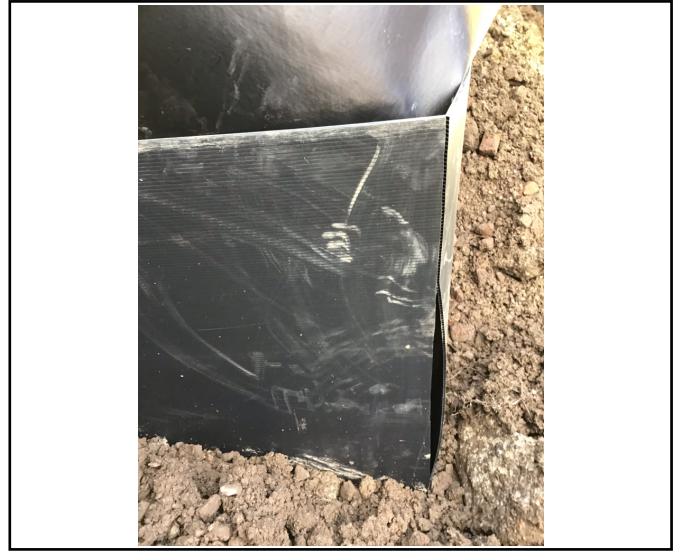
Protection board applied to

base of crane

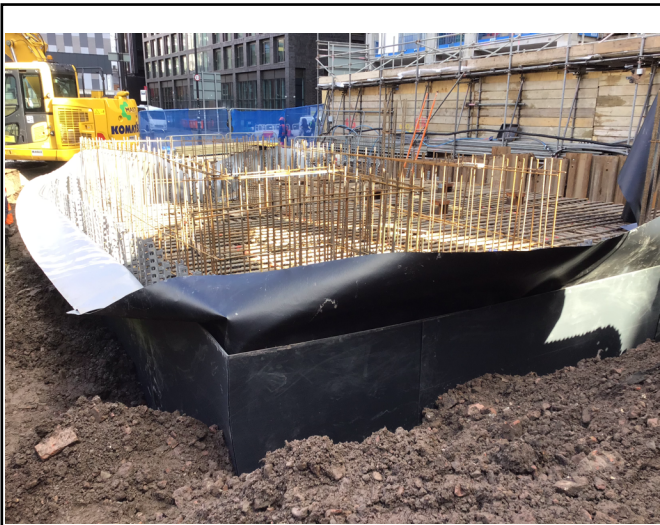
Protection board to base of crane

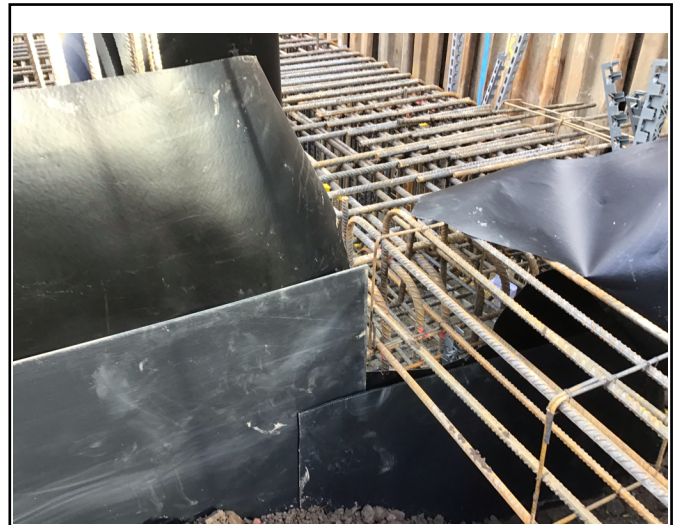
Membrane cut around ring beam

to be connected to base
