## Asbestos Demolition Survey

**Block D8 Boiler House No1  
North Manchester General Hospital  
Delaunays Road  
Crumpsall  
Manchester  
M8 5RB**

**Manchester Foundation Trust**

| Project Number: | Survey Date: | Issue Date: |
|---|---|---|
| B-31336s2 | 26 May 2021 | 21 October 2021 |

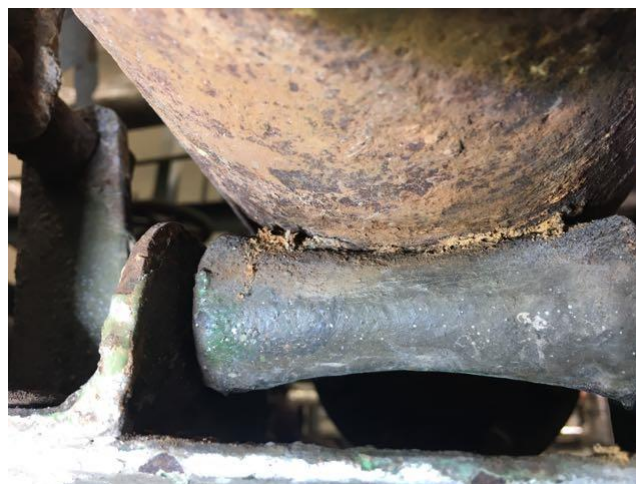
| Quantity | 70 Lin M |

| Analysis Result | Amosite, Chrysotile | 2 |
| Condition | High Damage | 3 |

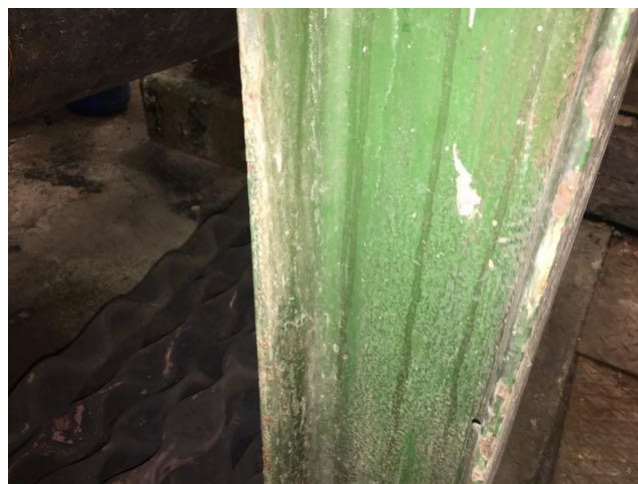
| <b>Quantity</b> | 20 Lin M |

| <b>Analysis Result</b> | Chrysotile, Amosite, Crocidolite | 3 |
| <b>Condition</b> | High Damage | 3 |

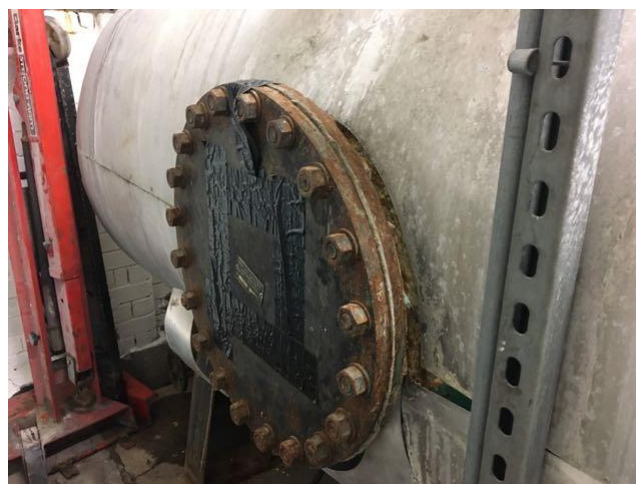
| Quantity | <1 m <sup>2</sup> |

| Analysis Result | Chrysotile | 1 |
| Condition | Good Condition | 0 |

The asbestos containing material should be encapsulated with a suitable sealant. Once encapsulated, a system of ongoing management should be implemented which includes routine condition inspections. Although not a legal requirement, labelling the material as asbestos should be considered to reduce the risk of accidental disturbance.

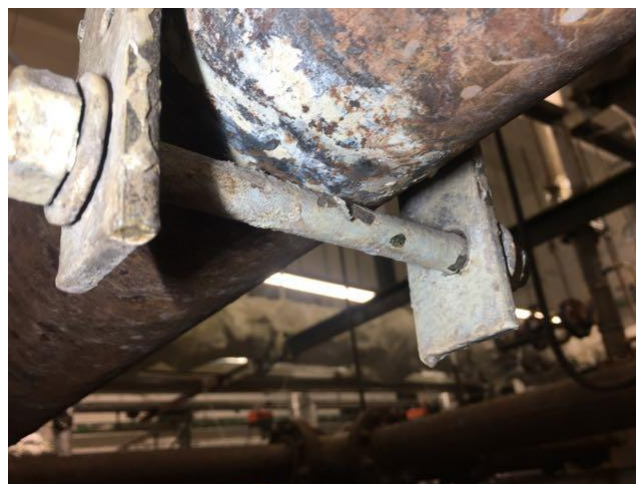
| Quantity | 70 Lin M |

| Analysis Result | Amosite, Chrysotile | 2 |
| Condition | High Damage | 3 |

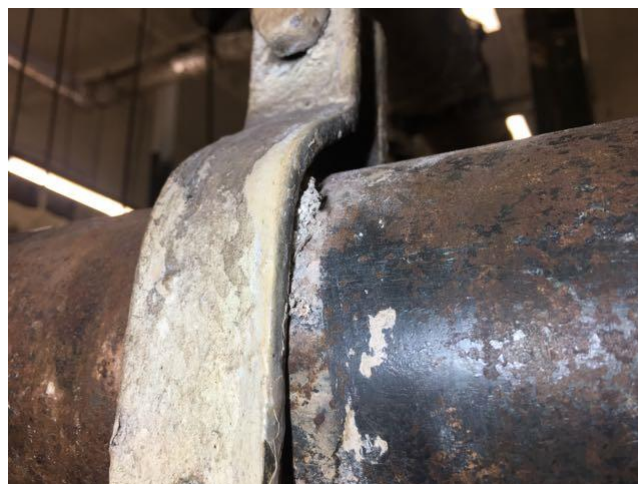
| <b>Quantity</b> | 70 Lin M |

| <b>Analysis Result</b> | Amosite, Chrysotile | 2 |
| <b>Condition</b> | High Damage | 3 |

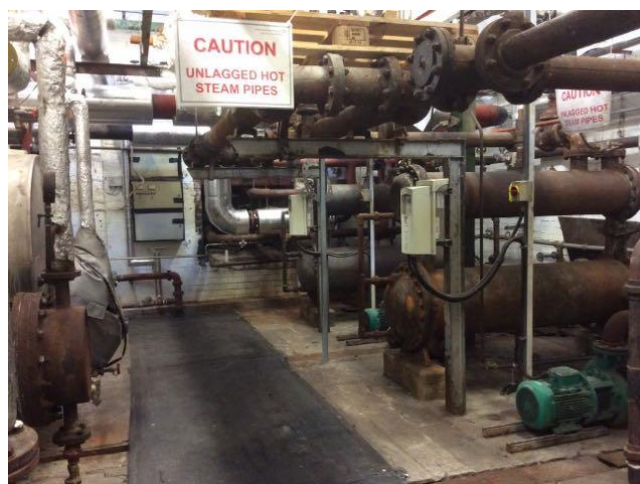
| Quantity | 70 m <sup>2</sup> |

| Analysis Result | Chrysotile, Amosite, Crocidolite | 3 |
| Condition | High Damage | 3 |

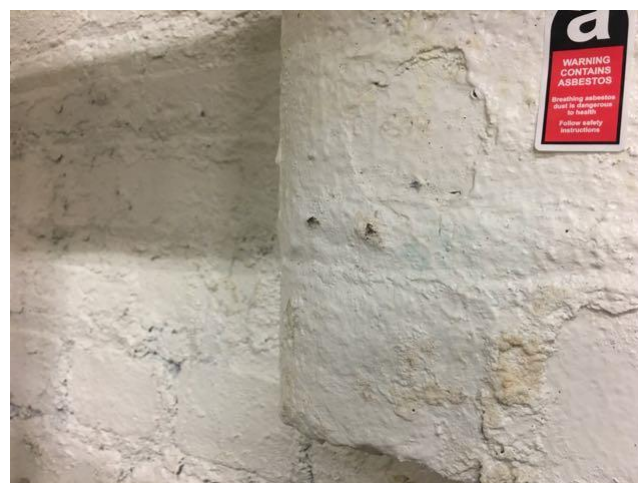
| Quantity | 70 m <sup>2</sup> |

| Analysis Result | Chrysotile, Amosite, Crocidolite | 3 |
| Condition | Low Damage | 1 |

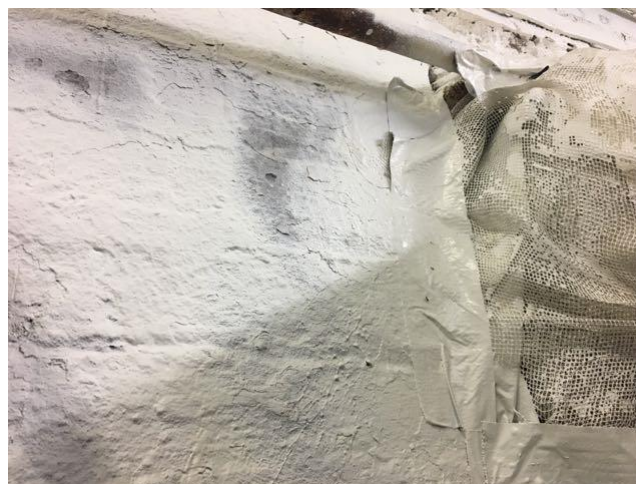
| Quantity | 70 m <sup>2</sup> |

| Analysis Result | Chrysotile, Amosite, Crocidolite | 3 |
| Condition | Low Damage | 1 |

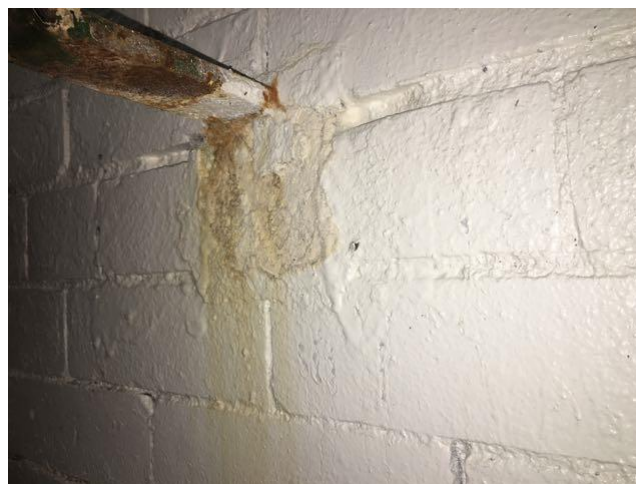
| Quantity | 70 m <sup>2</sup> |

| Analysis Result | Amosite, Chrysotile | 2 |
| Condition | Low Damage | 1 |

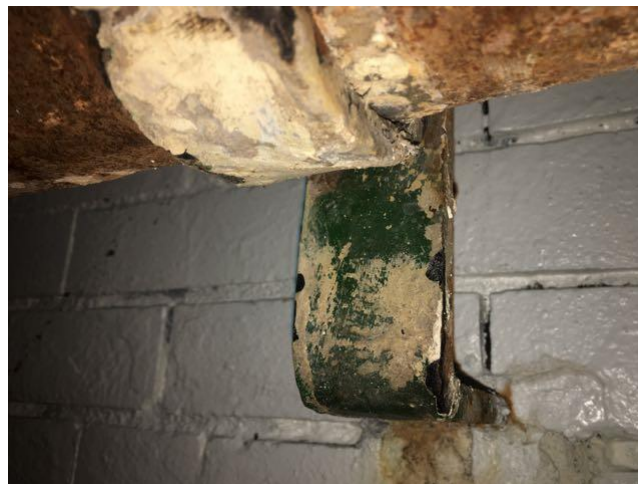
| <b>Quantity</b> | 70 Lin M |

| <b>Analysis Result</b> | Chrysotile, Crocidolite | 3 |
| <b>Condition</b> | High Damage | 3 |

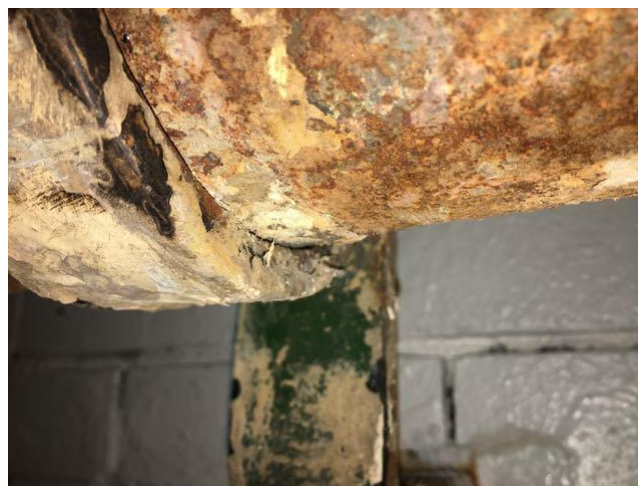
| Quantity | 40 Lin M |

| Analysis Result | Chrysotile, Crocidolite | 3 |
| Condition | High Damage | 3 |

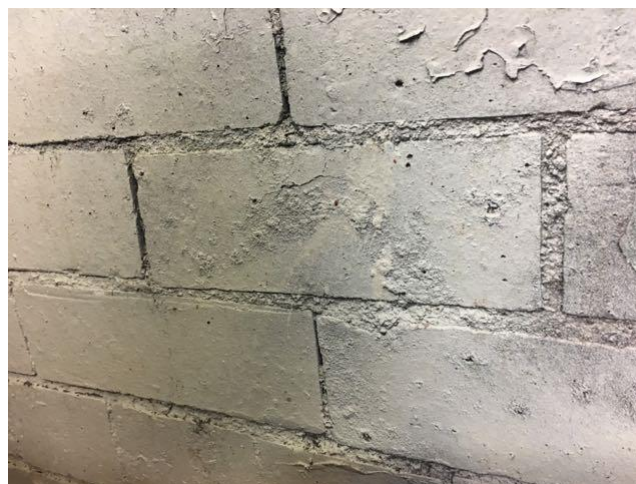
| <b>Quantity</b> | 70 m <sup>2</sup> |

| <b>Analysis Result</b> | Chrysotile, Amosite, Crocidolite | 3 |
| <b>Condition</b> | Low Damage | 1 |

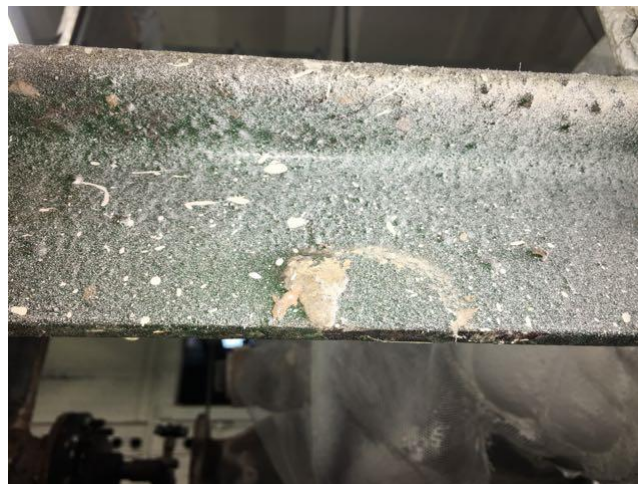
| <b>Quantity</b> | 70 Lin M |

| <b>Analysis Result</b> | Chrysotile, Amosite, Crocidolite | 3 |
| <b>Condition</b> | High Damage | 3 |

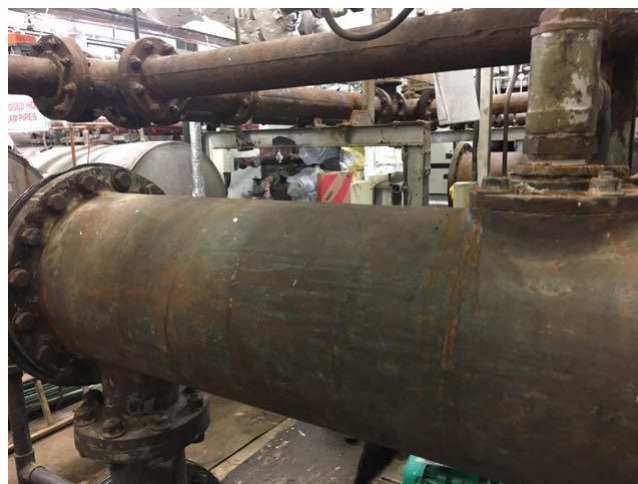
| Quantity | 18 m <sup>2</sup> |

| Analysis Result | Chrysotile | 1 |
| Condition | High Damage | 3 |

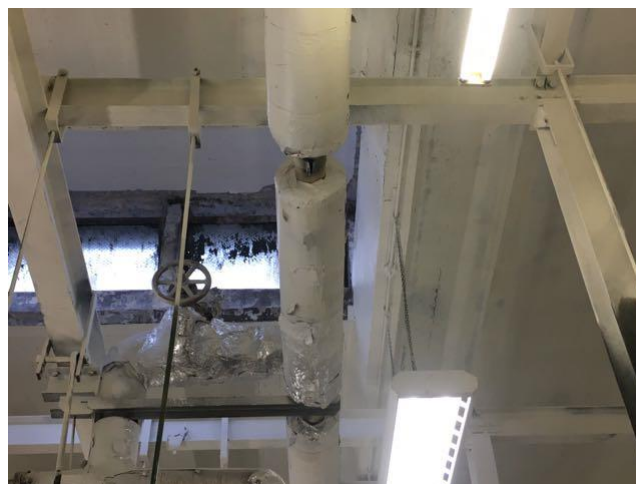
| Quantity | 70 Lin M |

| Analysis Result | Amosite, Chrysotile | 2 |
| Condition | Low Damage | 1 |

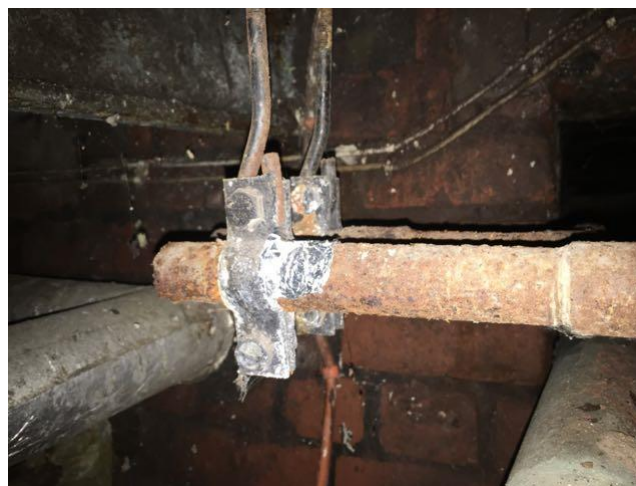
| Quantity | 60 m <sup>2</sup> |

| Analysis Result | Chrysotile, Amosite, Crocidolite | 3 |
| Condition | High Damage | 3 |

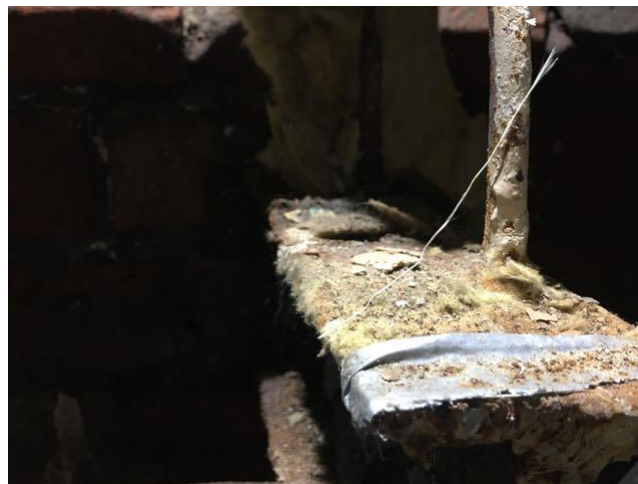
| <b>Quantity</b> | 60 m <sup>2</sup> |

| <b>Analysis Result</b> | Chrysotile, Amosite, Crocidolite | 3 |
| <b>Condition</b> | High Damage | 3 |

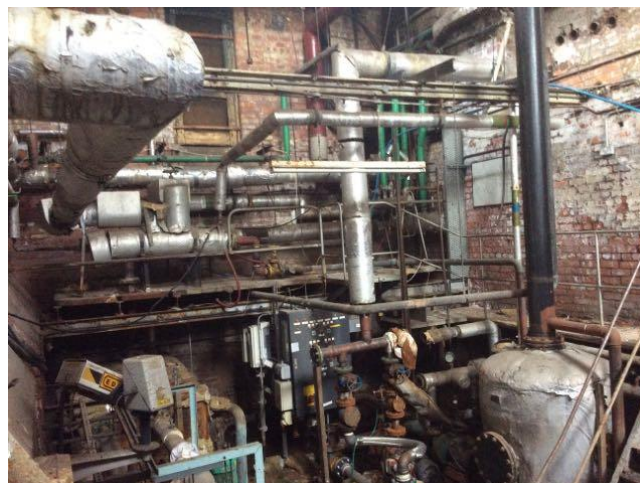
| Quantity | 60 m <sup>2</sup> |

| Analysis Result | Chrysotile, Amosite, Crocidolite | 3 |
| Condition | High Damage | 3 |

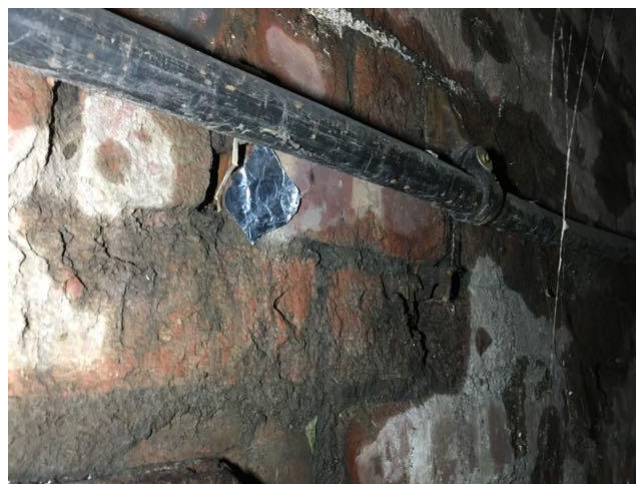
| Quantity | 60 m <sup>2</sup> |

| Analysis Result | Amosite | 2 |
| Condition | High Damage | 3 |

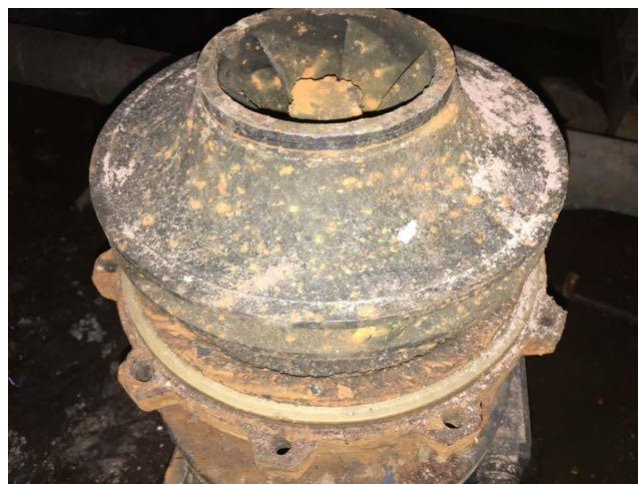
| <b>Quantity</b> | <1 m <sup>2</sup> |

| <b>Analysis Result</b> | Chrysotile | 1 |
| <b>Condition</b> | High Damage | 3 |

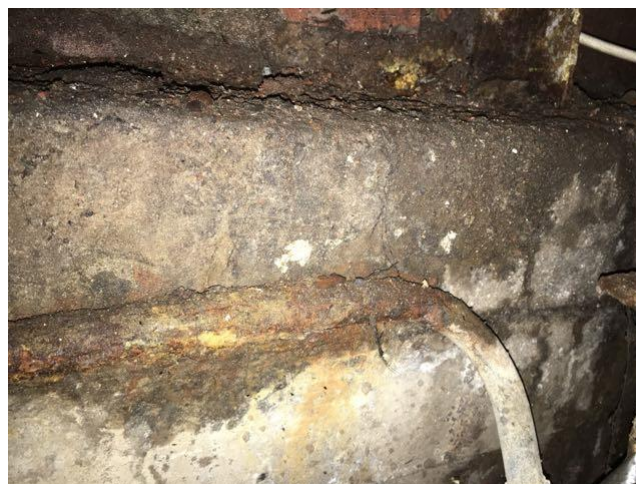
| <b>Quantity</b> | 60 m <sup>2</sup> |

| <b>Analysis Result</b> | Amosite, Chrysotile | 2 |
| <b>Condition</b> | High Damage | 3 |

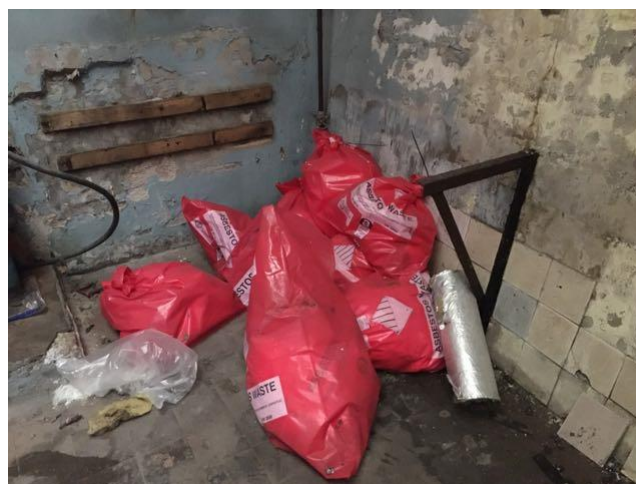
| Quantity | 8 Units |

| Analysis Result | Chrysotile, Amosite, Crocidolite | 3 |
| Condition | High Damage | 3 |

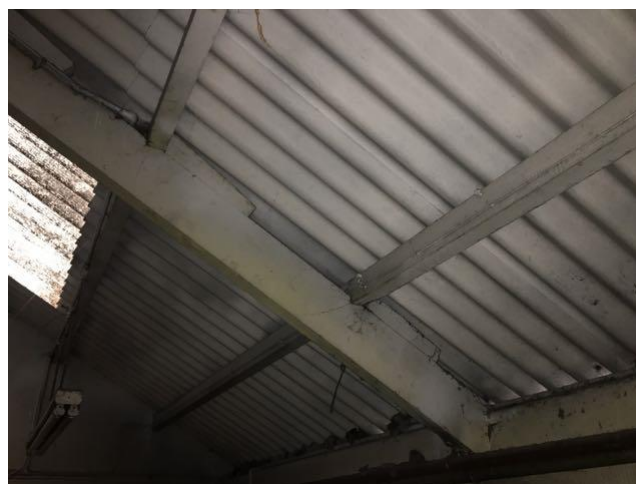
| <b>Quantity</b> | 20 m <sup>2</sup> |

| <b>Analysis Result</b> | Chrysotile | 1 |
| <b>Condition</b> | Low Damage | 1 |

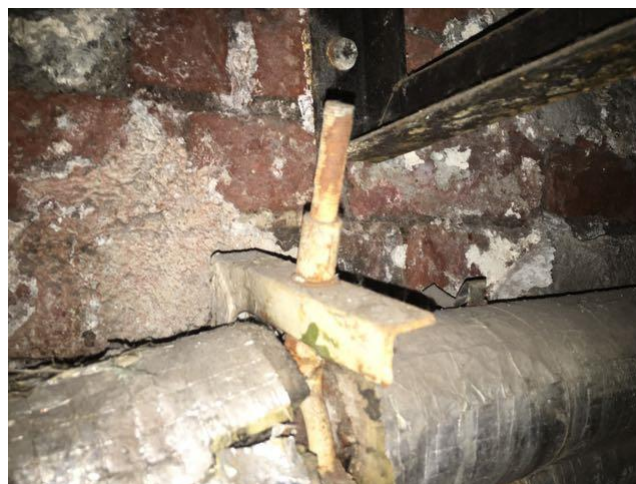
| Quantity | 180 Lin M |

| Analysis Result | Amosite | 2 |
| Condition | High Damage | 3 |

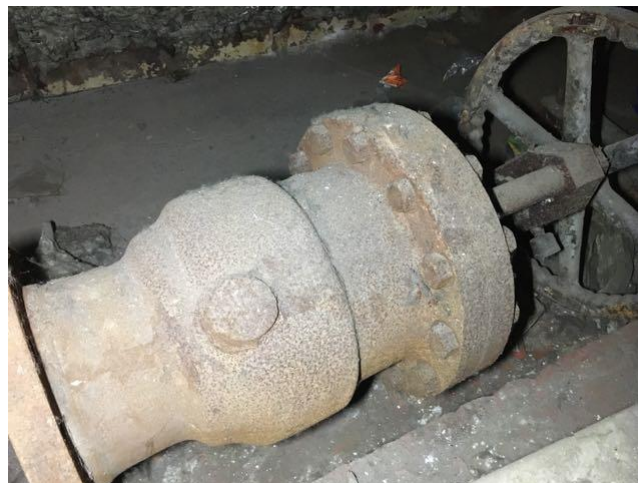
| <b>Quantity</b> | <1 m <sup>2</sup> |

| <b>Analysis Result</b> | Chrysotile | 1 |
| <b>Condition</b> | High Damage | 3 |

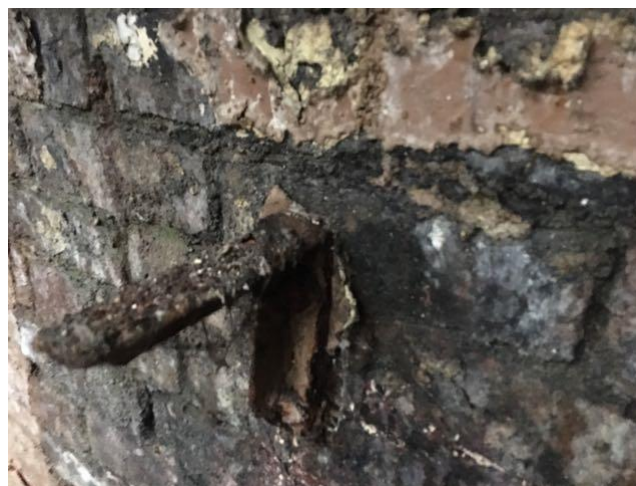
| <b>Quantity</b> | 180 m <sup>2</sup> |

| <b>Analysis Result</b> | Amosite, Chrysotile | 2 |
| <b>Condition</b> | High Damage | 3 |

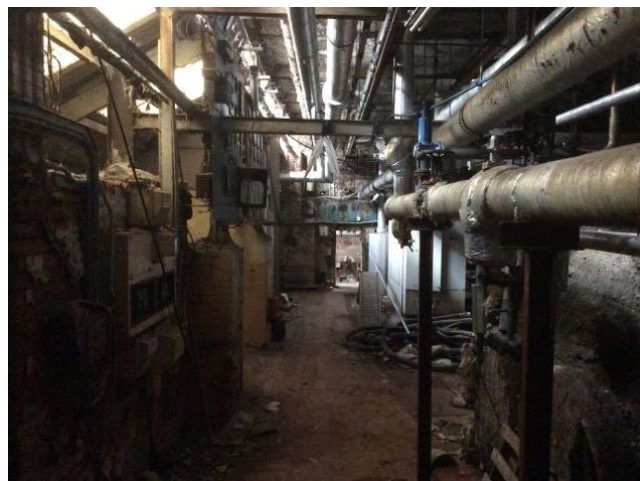
| Quantity | 180 m <sup>2</sup> |

| Analysis Result | Chrysotile, Amosite, Crocidolite | 3 |
| Condition | High Damage | 3 |

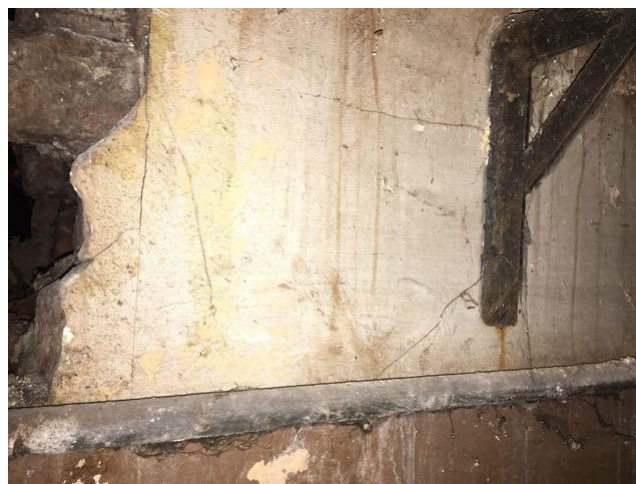
| <b>Quantity</b> | 180 m <sup>2</sup> |

| <b>Analysis Result</b> | Amosite, Chrysotile | 2 |
| <b>Condition</b> | High Damage | 3 |

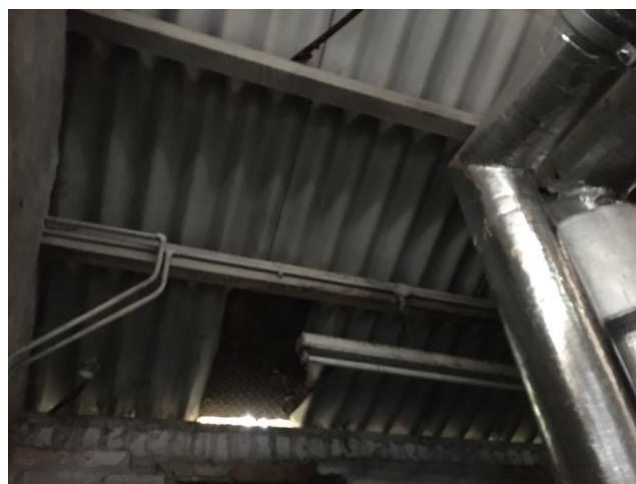
| <b>Quantity</b> | 15 m <sup>2</sup> |

| <b>Analysis Result</b> | Chrysotile | 1 |
| <b>Condition</b> | Low Damage | 1 |

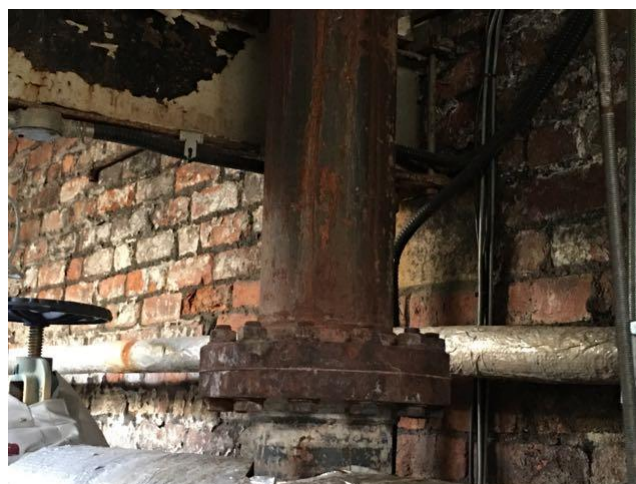
| Quantity | <1 m <sup>2</sup> |

| Analysis Result | Chrysotile | 1 |
| Condition | Low Damage | 1 |

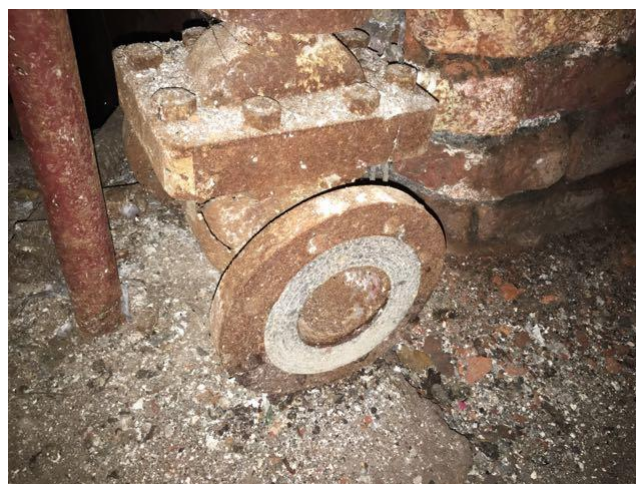
| Quantity | <1 m <sup>2</sup> |

| Analysis Result | Chrysotile | 1 |
| Condition | Low Damage | 1 |

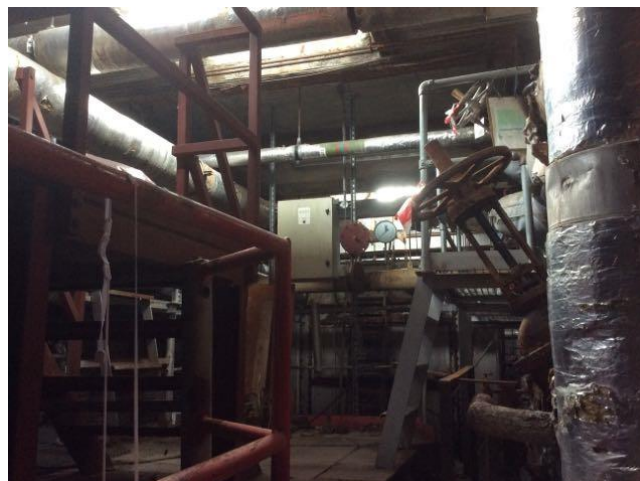
| Quantity | 80 m <sup>2</sup> |

| Analysis Result | Chrysotile, Amosite, Crocidolite | 3 |
| Condition | High Damage | 3 |

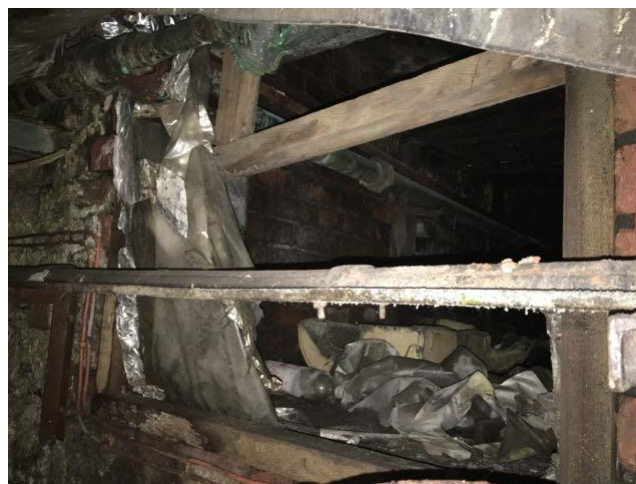
| Quantity | 12 m <sup>2</sup> |

| Analysis Result | Chrysotile, Amosite, Crocidolite | 3 |
| Condition | High Damage | 3 |

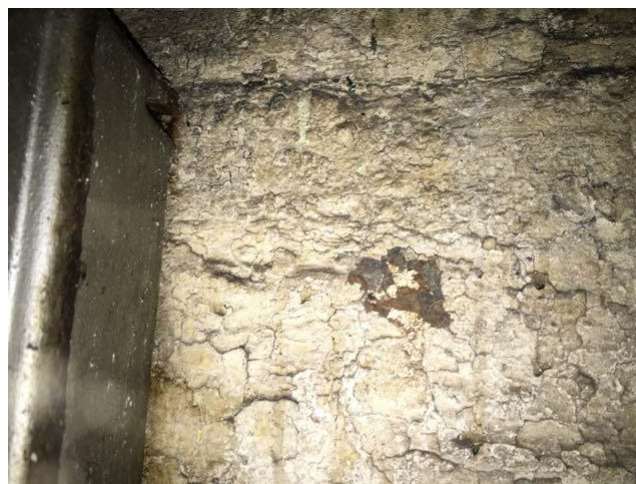
| <b>Quantity</b> | 50 m <sup>2</sup> |

| <b>Analysis Result</b> | Amosite | 2 |
| <b>Condition</b> | High Damage | 3 |

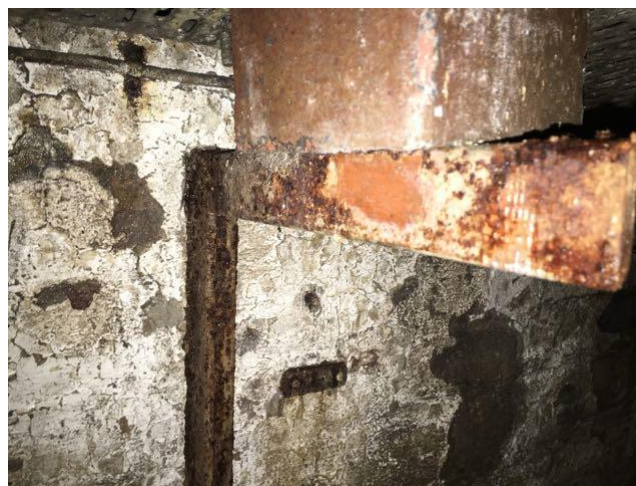
| Quantity | 50 Lin M |

| Analysis Result | Chrysotile | 1 |
| Condition | High Damage | 3 |

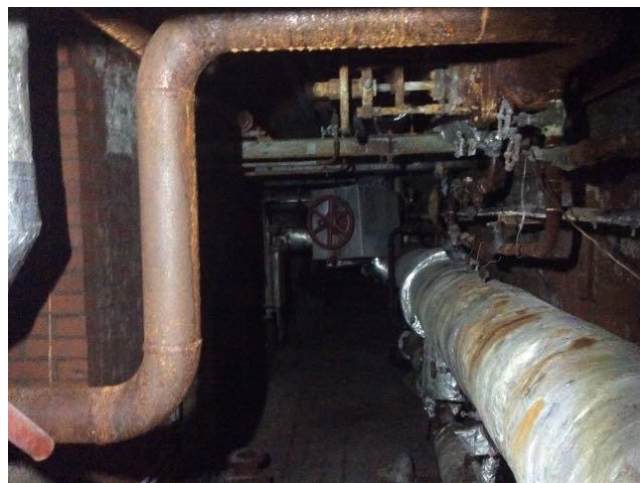
| Quantity | 50 m <sup>2</sup> |

| Analysis Result | Amosite | 2 |
| Condition | High Damage | 3 |

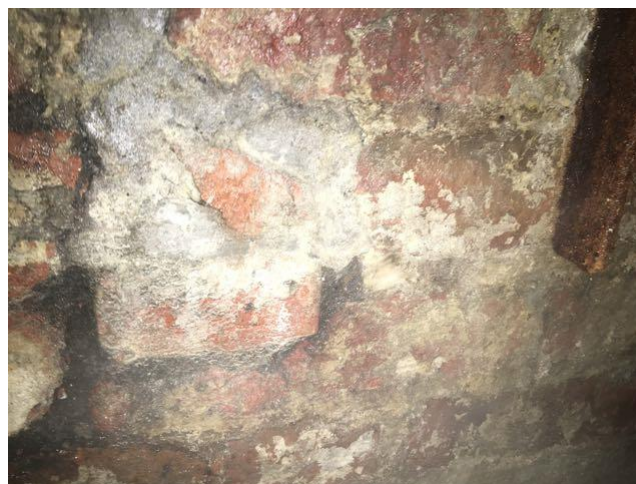
| <b>Quantity</b> | 50 m <sup>2</sup> |

| <b>Analysis Result</b> | Amosite | 2 |
| <b>Condition</b> | High Damage | 3 |

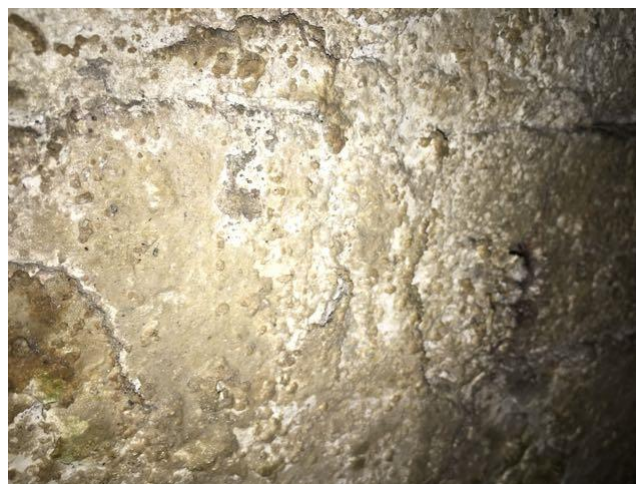
| Quantity | 50 m <sup>2</sup> |

| Analysis Result | Amosite, Chrysotile | 2 |
| Condition | High Damage | 3 |

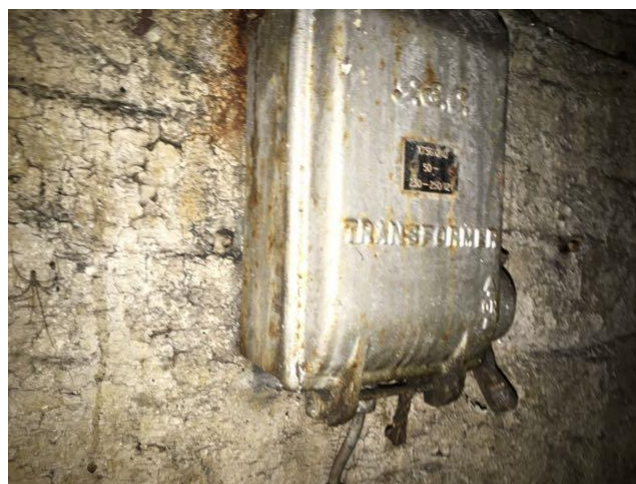
| <b>Quantity</b> | <1 Lin M |

| <b>Analysis Result</b> | Chrysotile | 1 |
| <b>Condition</b> | Low Damage | 1 |

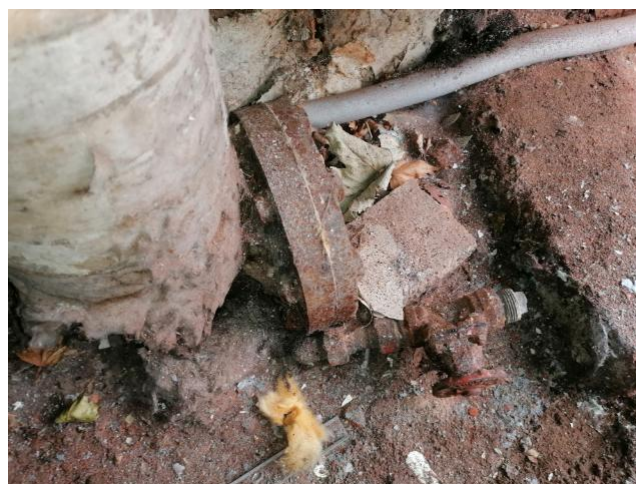
| <b>Quantity</b> | 25 m <sup>2</sup> |

| <b>Analysis Result</b> | Chrysotile | 1 |
| <b>Condition</b> | Low Damage | 1 |

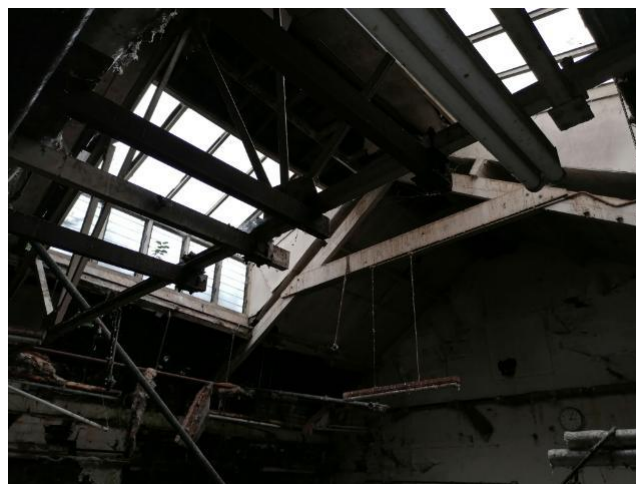
| Quantity | 10 m <sup>2</sup> |

| Analysis Result | Chrysotile | 1 |
| Condition | Good Condition | 0 |

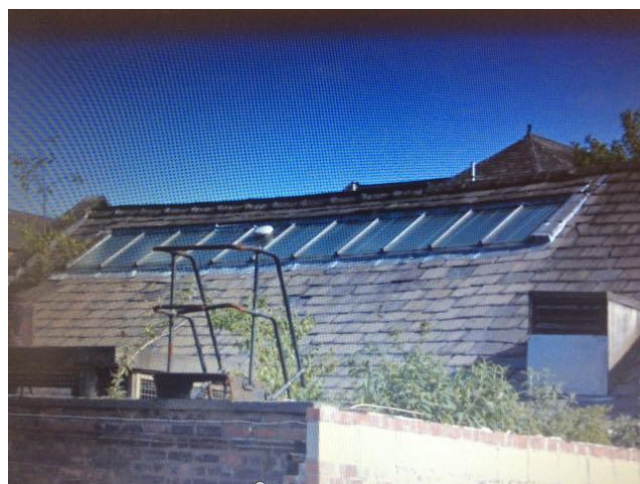
| <b>Quantity</b> | 40 m <sup>2</sup> |

| <b>Analysis Result</b> | Chrysotile | 1 |

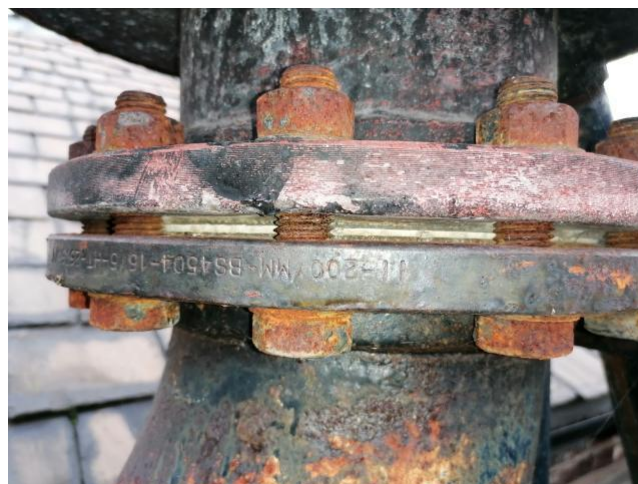
| Quantity | 1 m <sup>2</sup> |

| Analysis Result | Chrysotile | 1 |
