**Project Name:** 27593 Cheltenham Green Civ Manchester 10 02 22 win

**Project Description:** WinCan Import in Miraculix Standard

**Project Date:** 15/02/2022

**Company:** NRC WWS Ltd  
**Contact:** DEREK KEARNS  
**Department:** SALES MANAGER  
**Street:** UNIT D, RUSSELL ROAD  
**Town or City:** ROCK FERRY, BIRKENHEAD  
**County:** WIRRAL  
**Post Code:** CH42 1LU  
**Phone:** 0151 643 0800  
**Mobile:** 07557 231 879  
**Email:** dkearns@nrcc.com

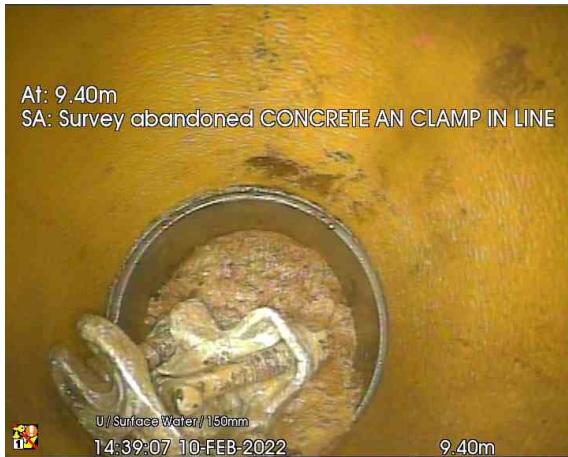
SW1 US RE6\_9-40m\_143907.jpg, 00:00:35, 9.40 m  
Survey abandoned, CONCRETE AN CLAMP IN LINE
