## **PHOTOGRAPHS**

**Heaton Park Farm Centre, Middleton Road, Manchester, M25 2SW**

**Re-roofing and External Repairs**

**Ref: AMP44649**

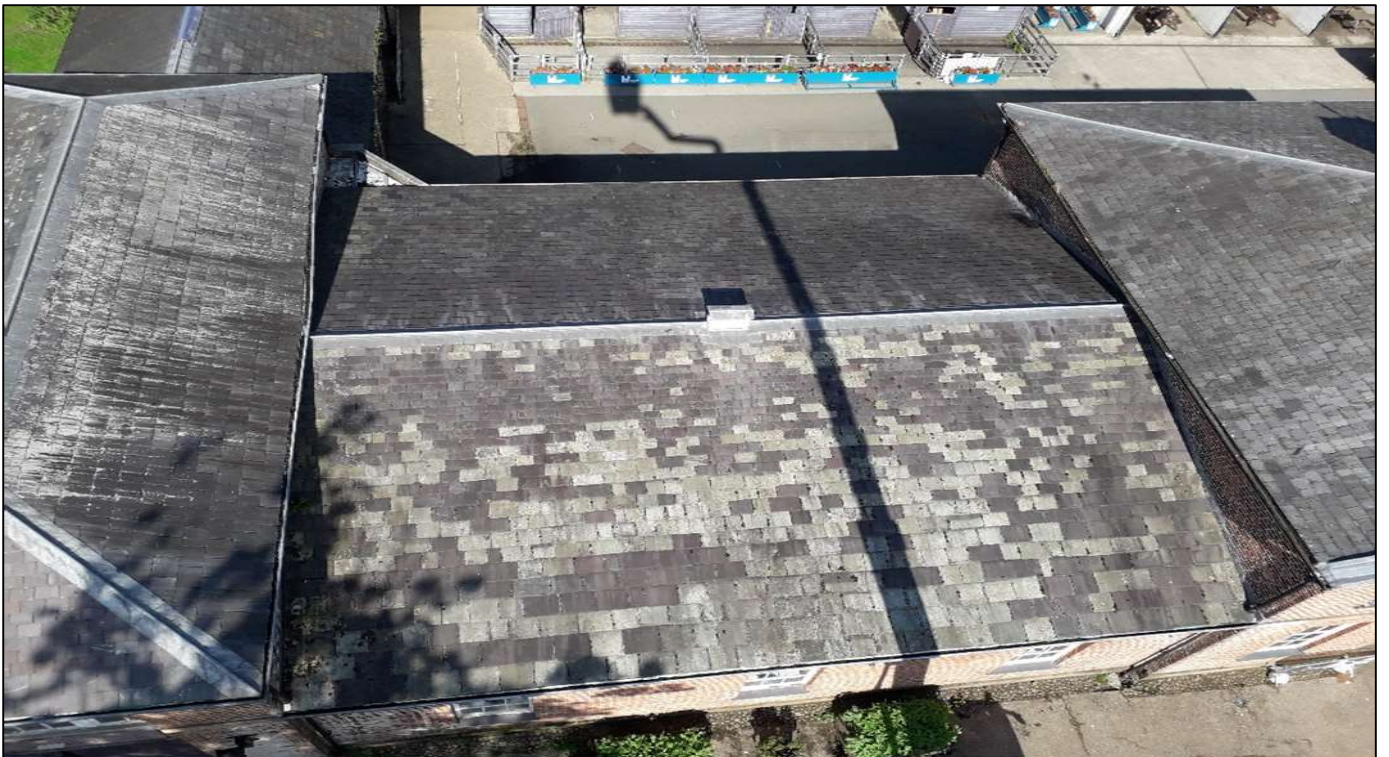
Figure 2: Aerial View of Roof Area 2 – Proposed Re-roofing

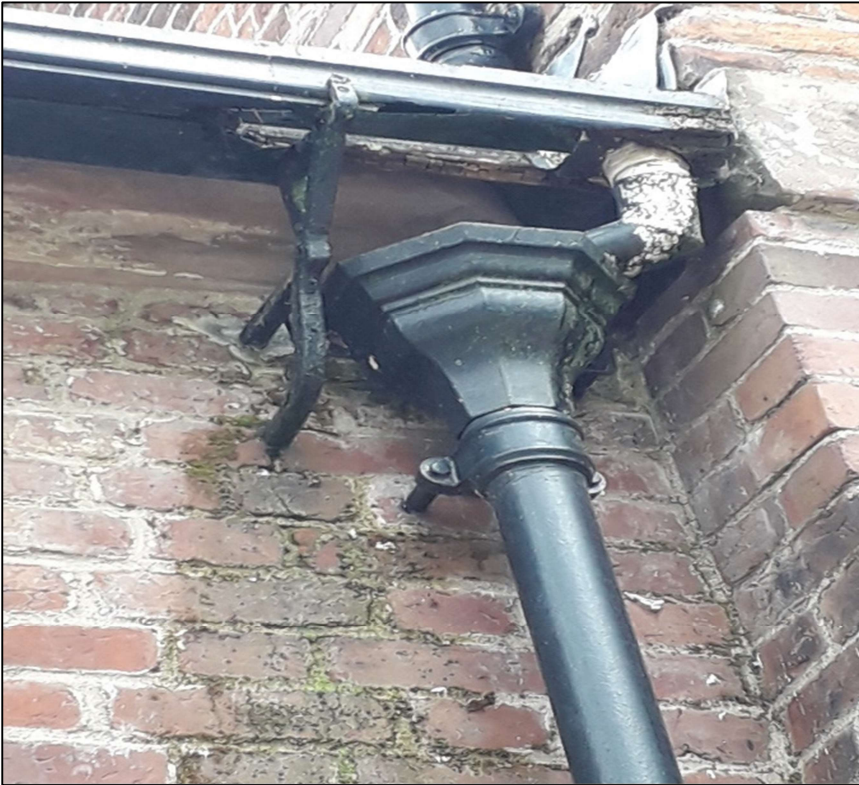
Figure 3: View of Existing Timber Guttering. Completely Rotted Through & Leaking.

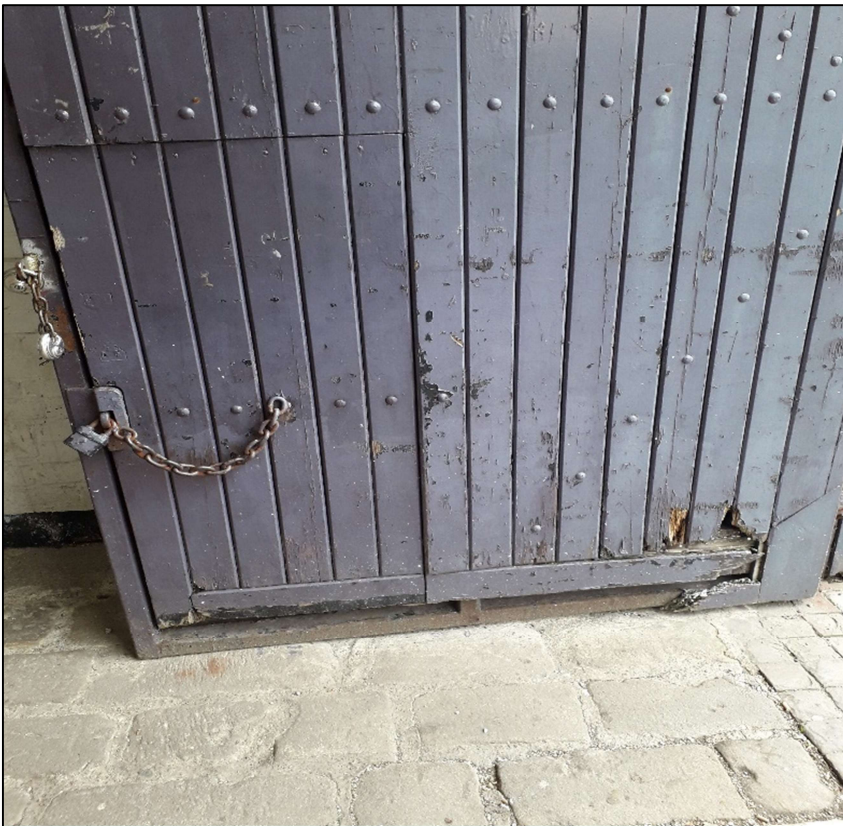
Figure 4: View of Rotted / Missing Boarding to Courtyard Entrance Doors.

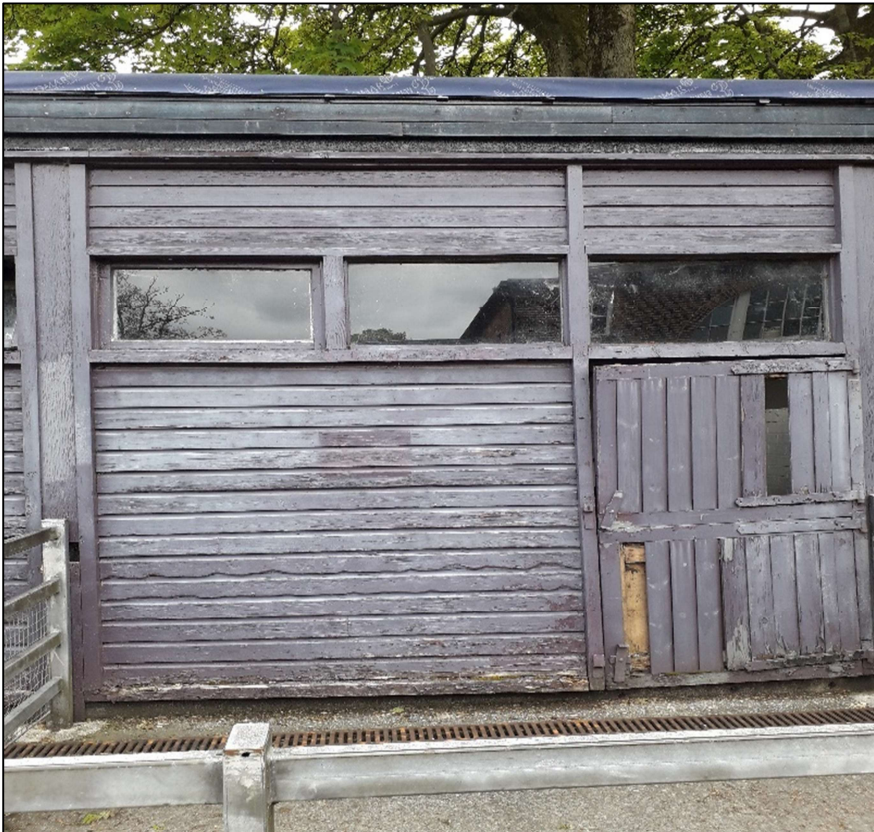
Figure 5: View of Rotted / Missing Boarding to Stable Block in Courtyard Area.

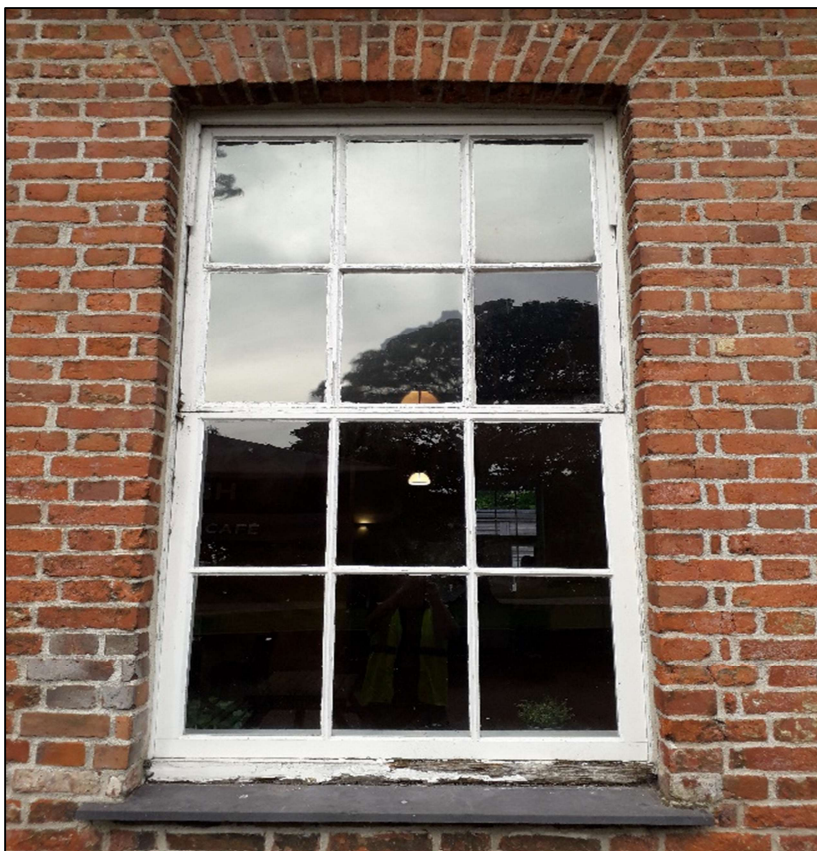
Figure 6: View of Rotted Timberwork to Cill of Vertically Sliding Sash Window.

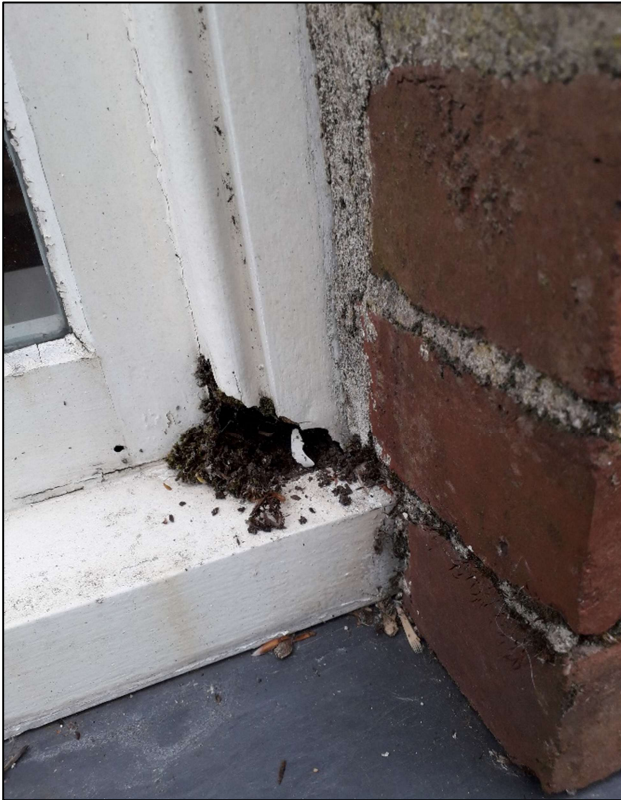
Figure 7: View of Rot to Window.

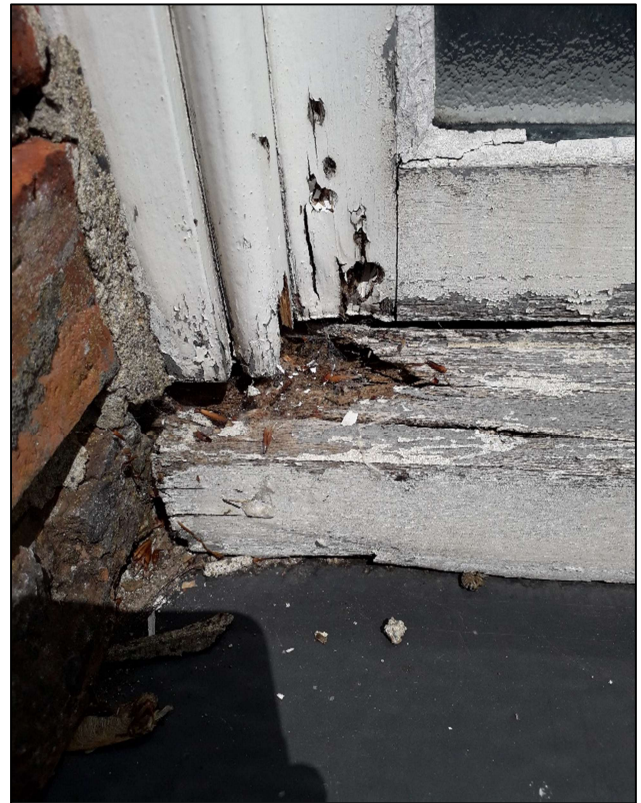
Figure 8: View of Rot to Window Cill & Sash
