# GEOSHIELD

## Verification Report

McAlear & Rushe

101 Charles Street

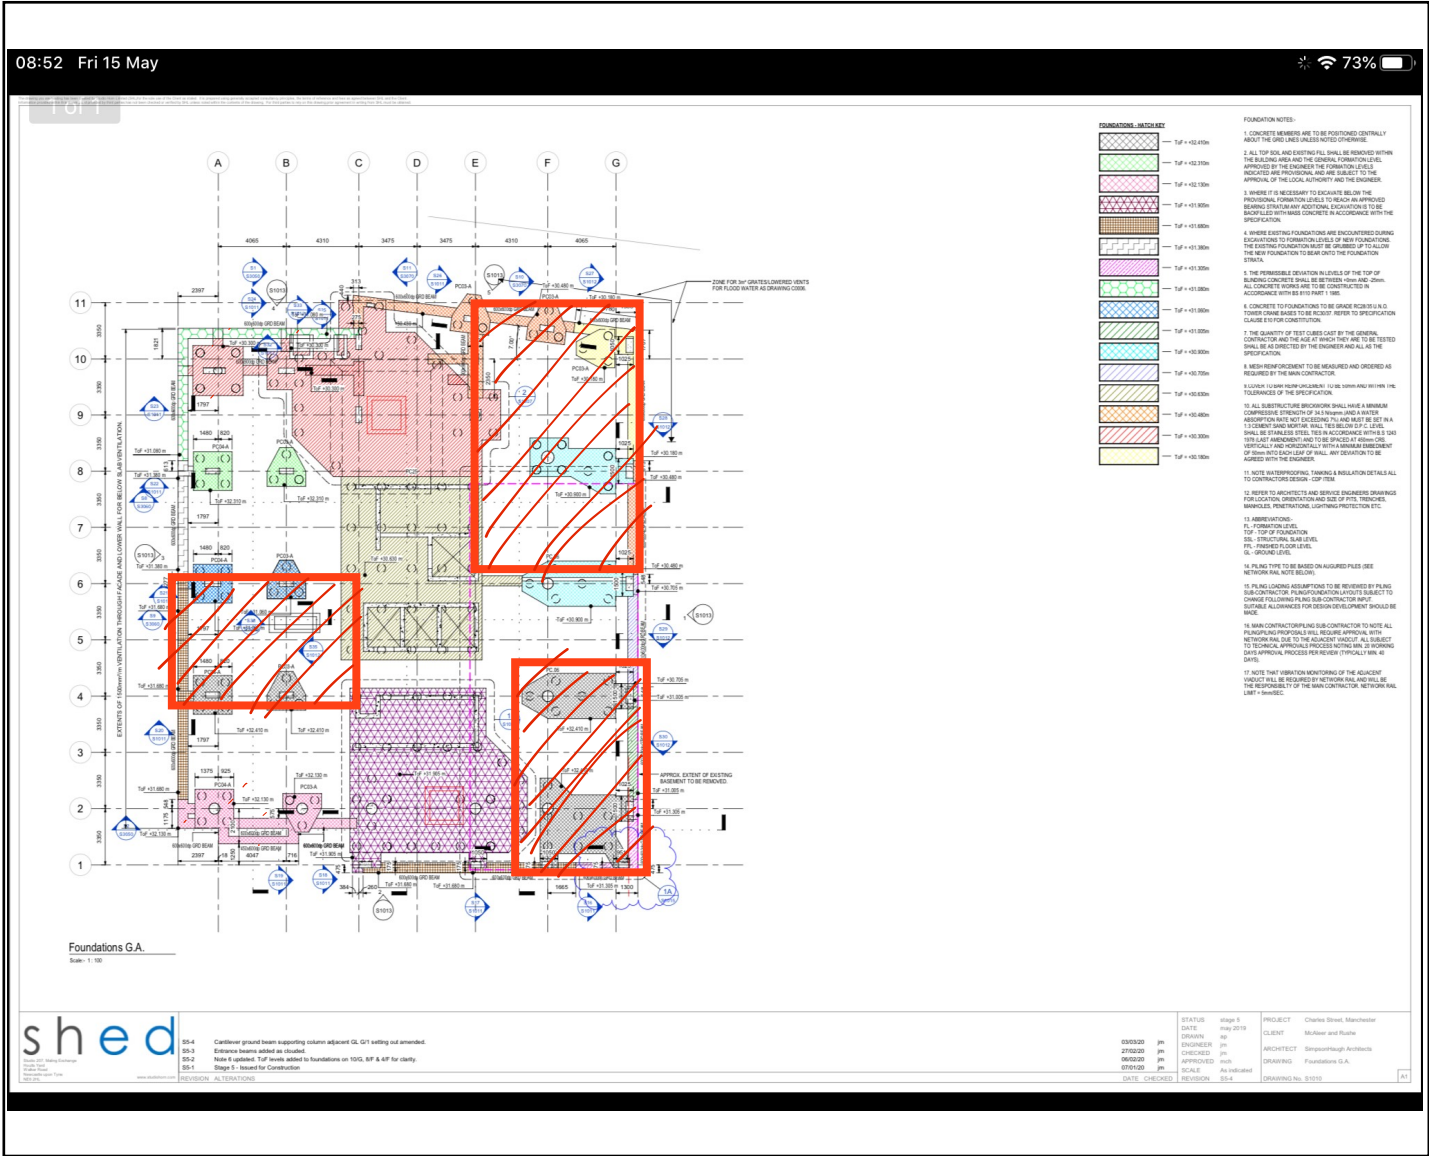
Gridlines 11/6:E/G, Gridlines 6/4:A/C and ring beams to 3/1:E/G

Verified in this report as highlighted above

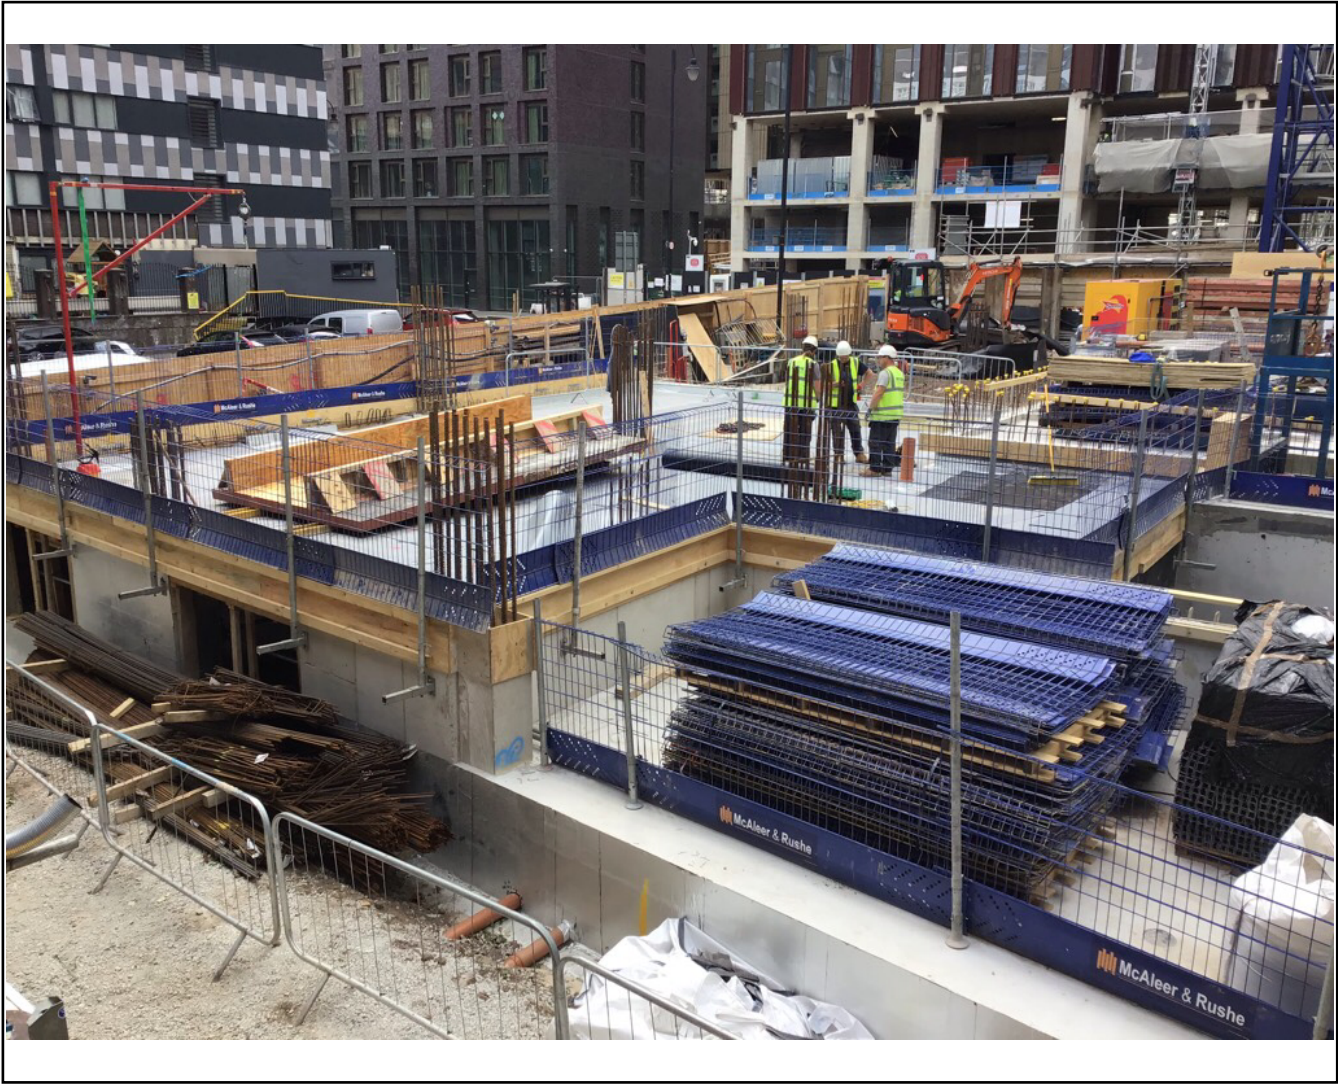
Overview of Site

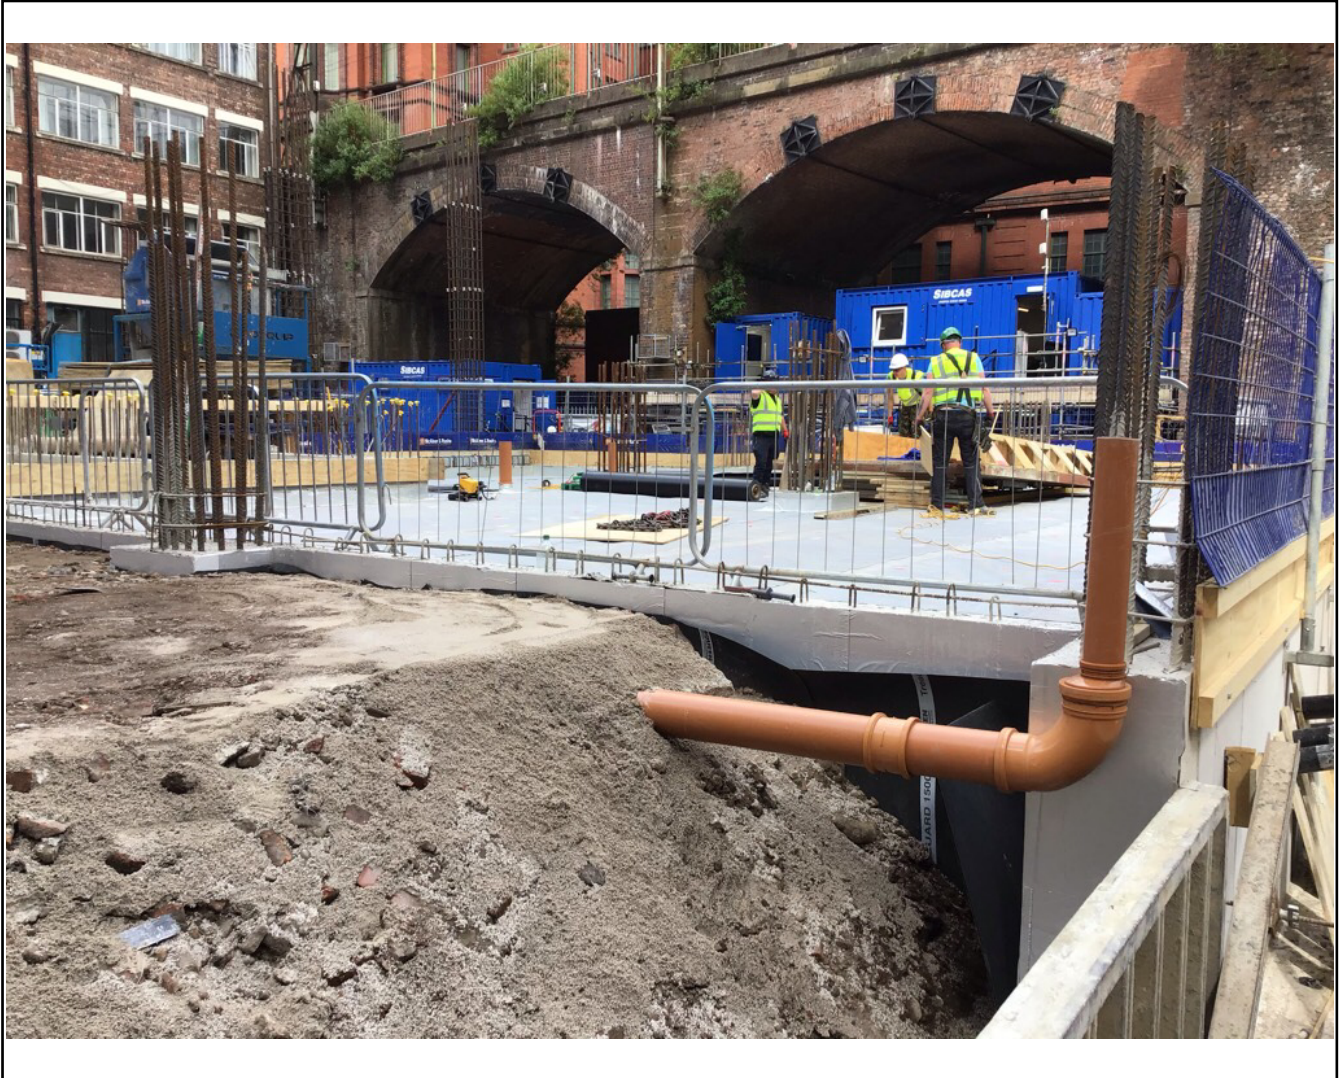
Overview of Gridlines 11/6:E/G

Membrane installed beneath suspended slab

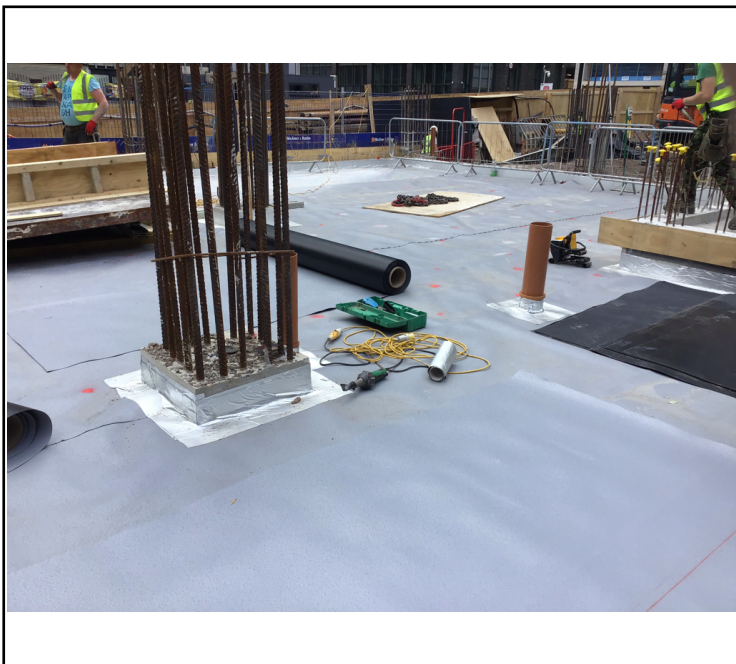
NOTES: Visqueen Ultimate Geoseal installed with Pro Demtech

Welded joints. Location of hooks marked on the membrane, extrusion welder to be used to installed hooks to support the membrane from steel re bar with in the slab. Hooks to be installed but strength will be tested on next visit.

1. Overview of Gridlines 11/6:E/G

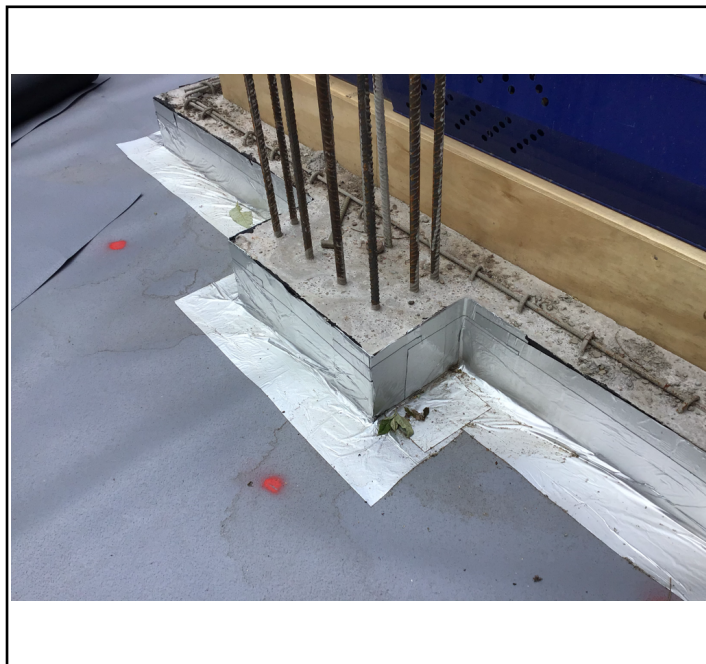
2. Perimeter details sealed with Visqueen GR SAM

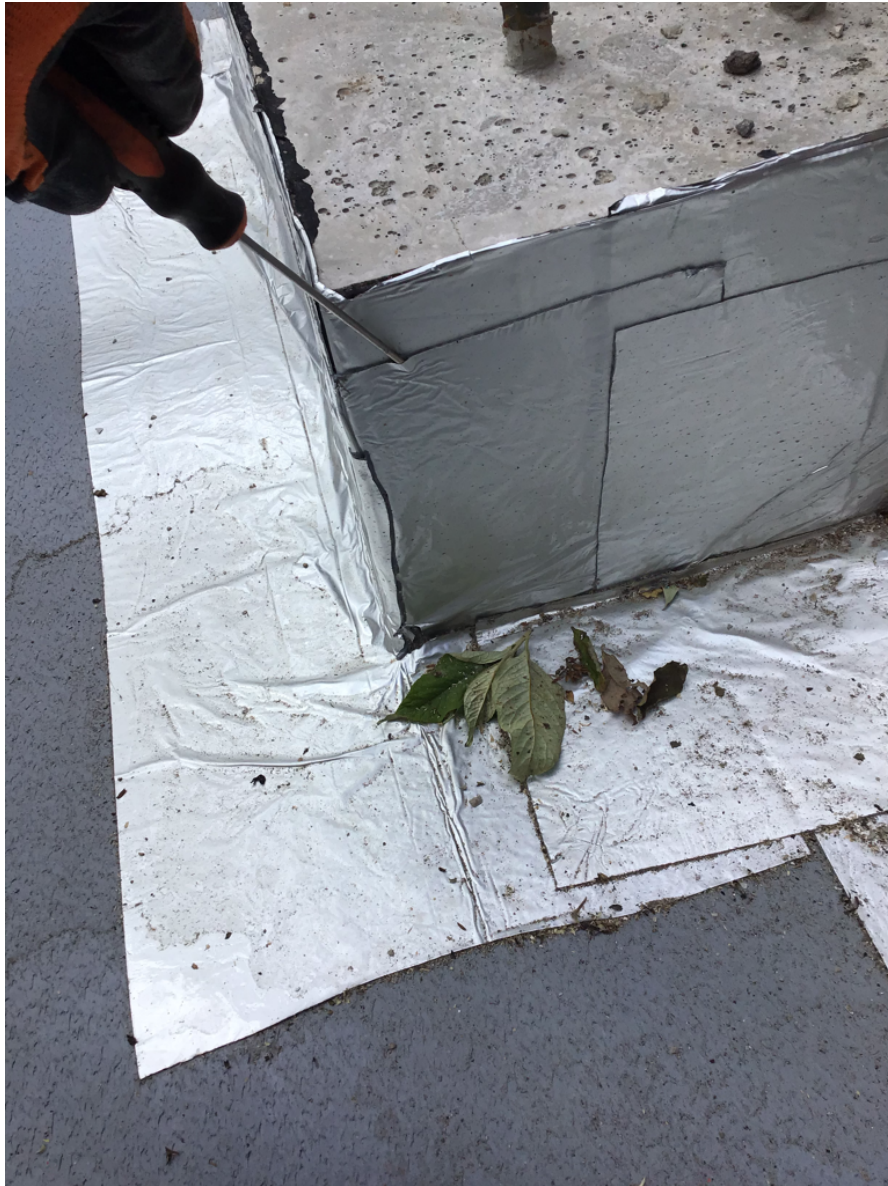
3. Pick and probe test carried out to ensure good bond achieved. Bitumen primer

applied to face of concrete. Good installation, passed and verified.

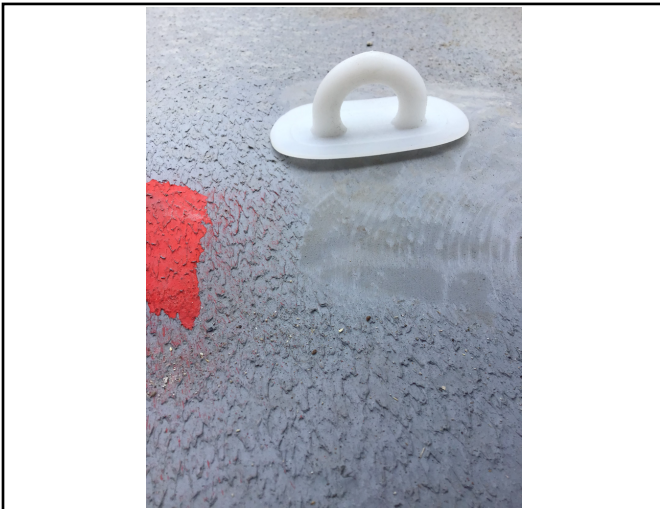
1. Hook which will be sealed to membrane to support installation. Membrane should also bond to concrete during the pour. Once cured temporary formwork beneath the slab to be stripped.

NOTES: Location of hooks marked. Method of installation

discussed on site. Hooks to be sealed to membrane with extrusion weld and

insulation to be installed around before hooks attached to re bar. Installation to

be verified next visit.

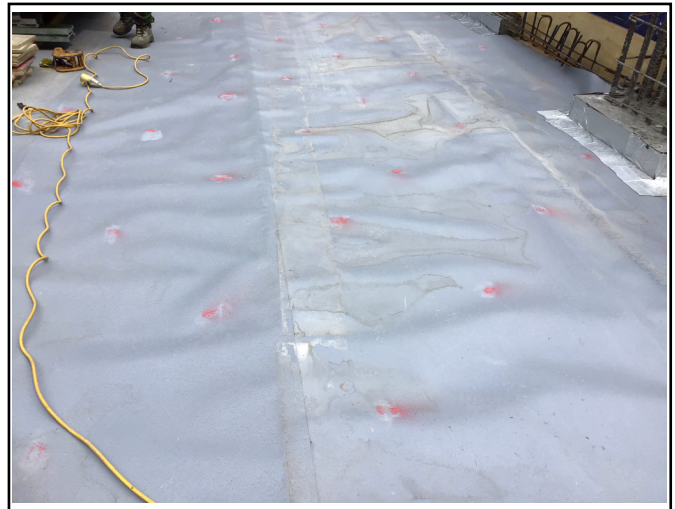
2. Location of hooks marked on the membrane.

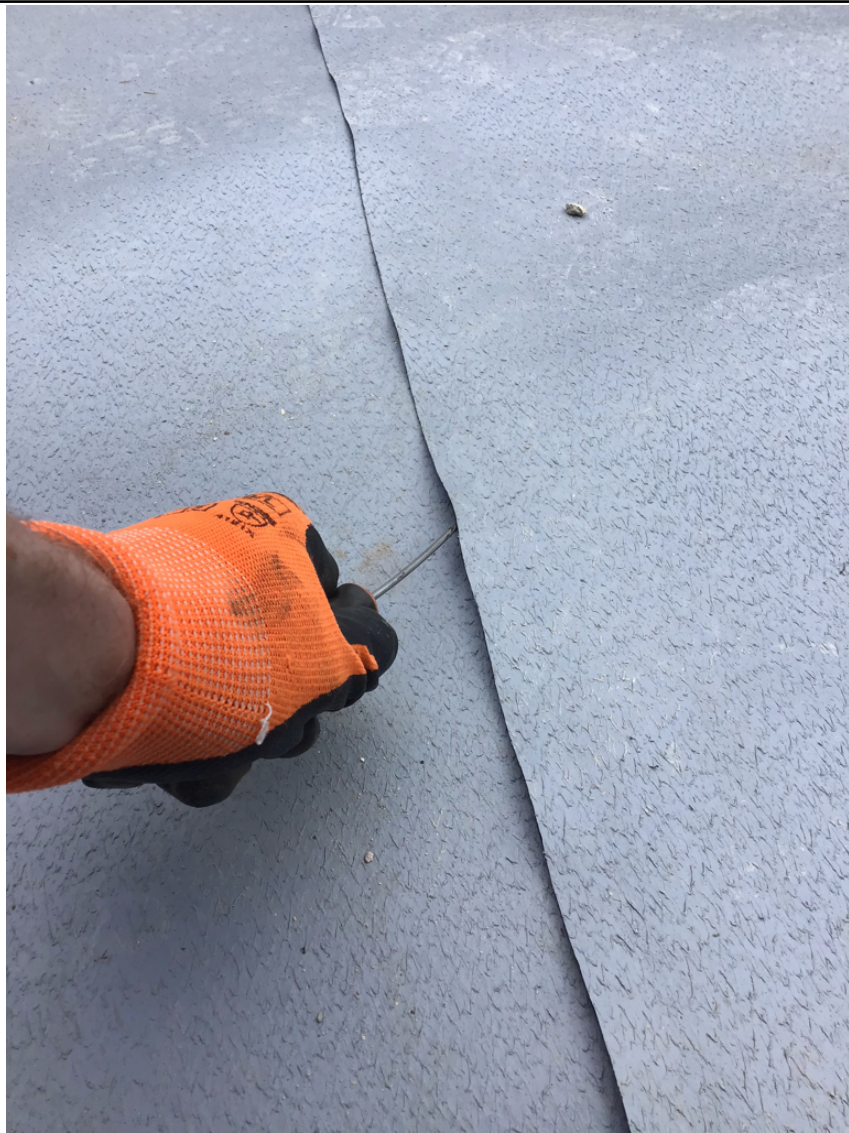
3. Pick and probe test carried out to all Pro Demtech Welded joints.

Excellent seal achieved throughout.

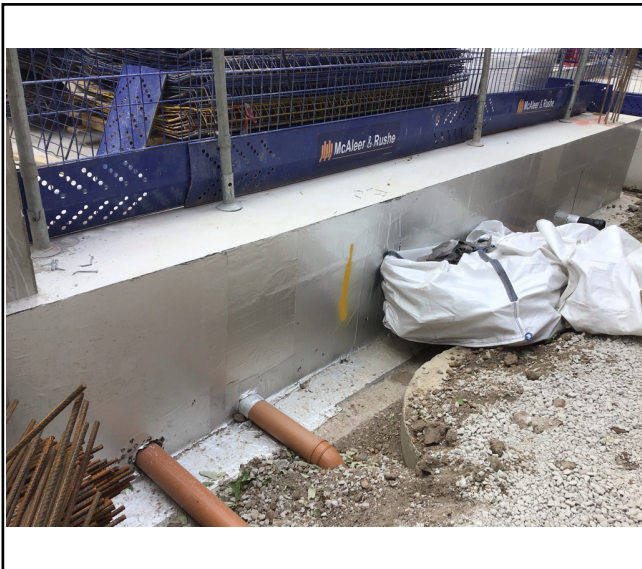
NOTES: Visqueen GR SAM installed to the perimeter details

to a bitumen primer concrete base. Works visually inspected and tested with pick and probe. Pipe penetrations sealed to a good standard. Works on going but complete works installed to a good standard with no faults found.

1. Overview of perimeter detail

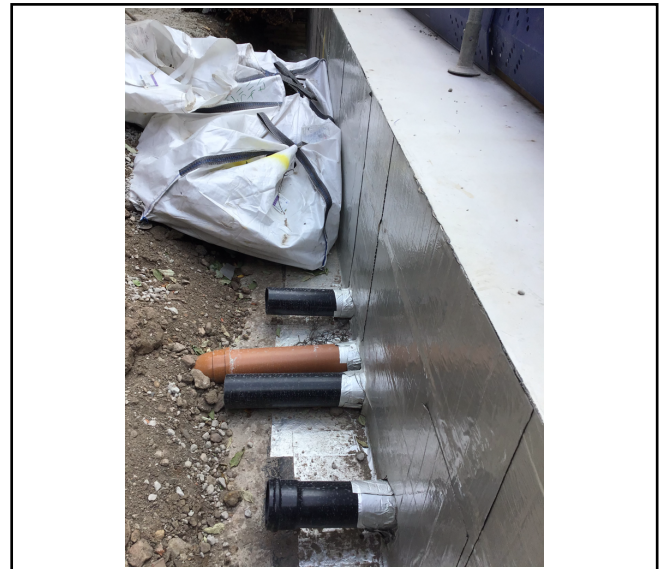
2. Pipe penetrations sealed to a good standard as per NVQ Level 2.

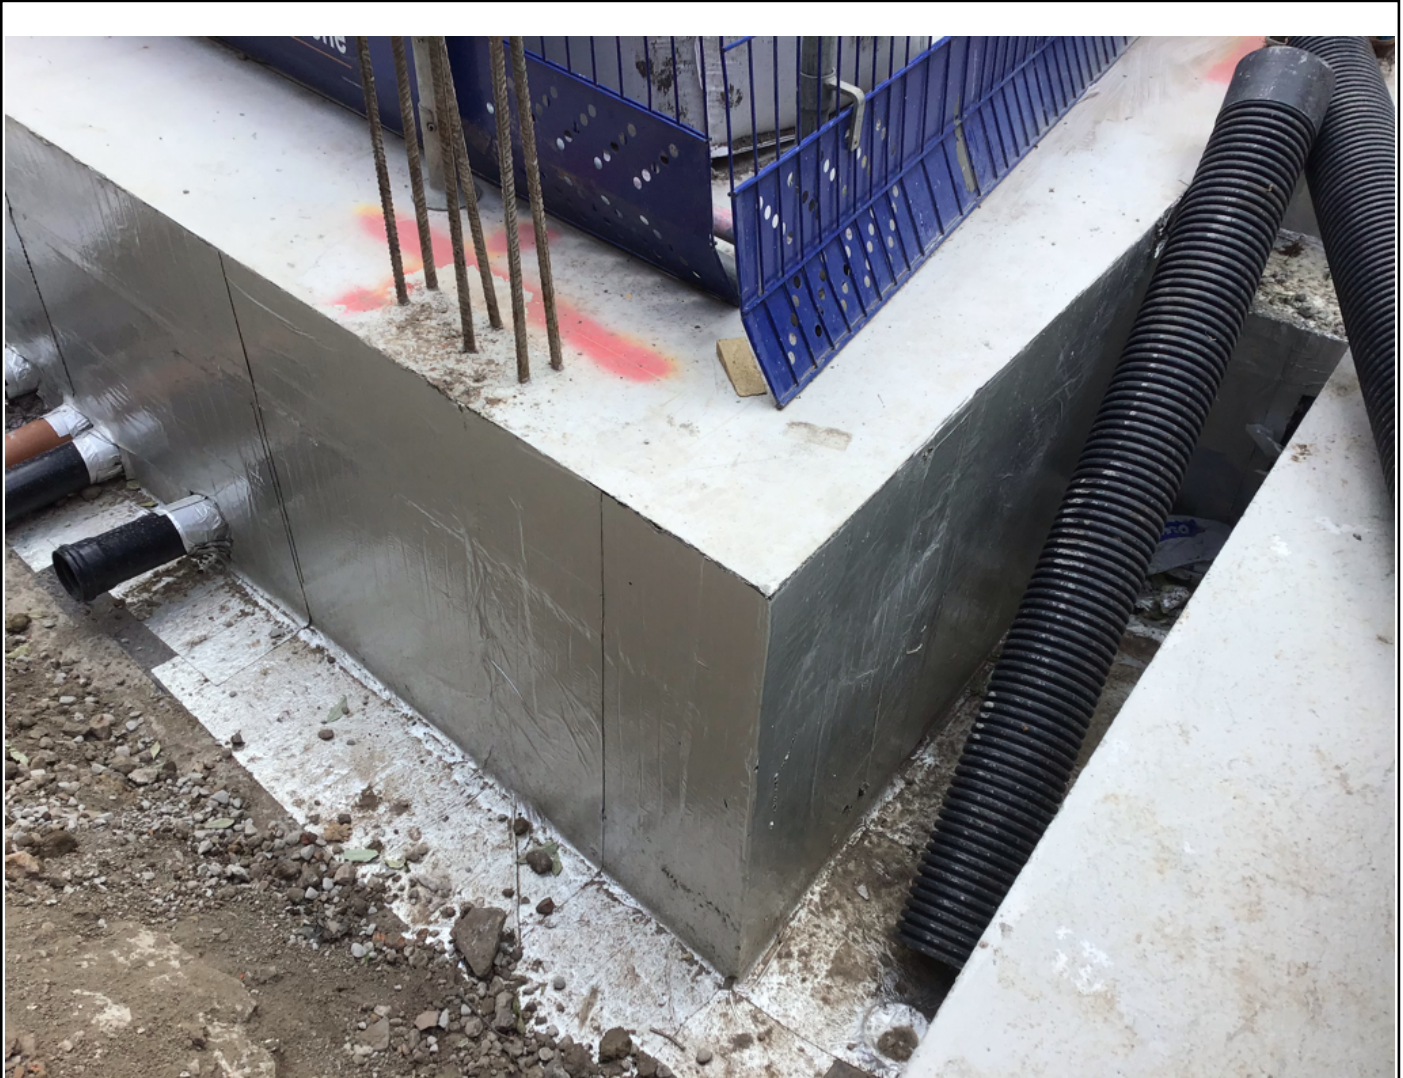
3. Overview of perimeter detail sealed to a good standard. No faults found.

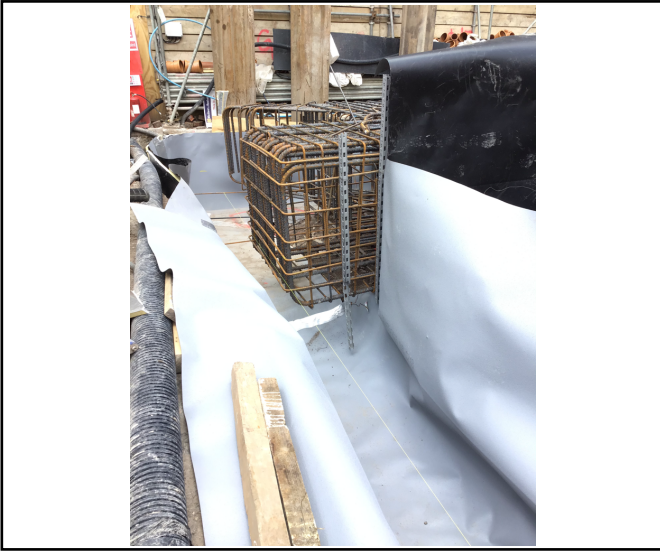
Visqueen Geoseal beneath ring beam

to 3/1:E/G

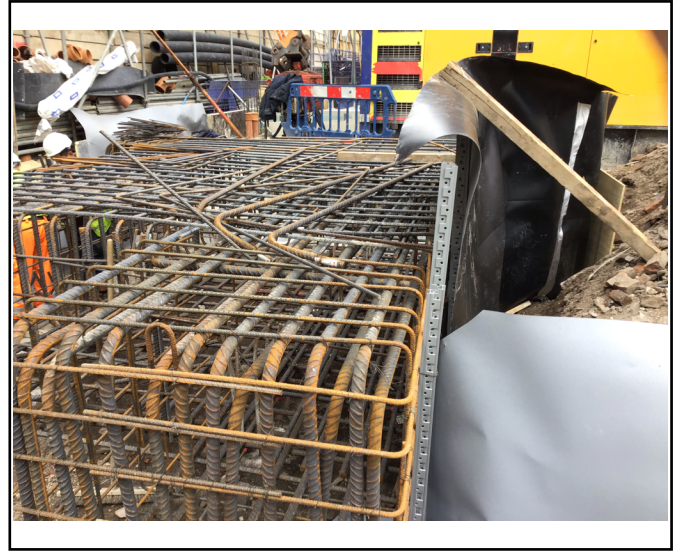
Visqueen Geoseal beneath

steel rebar 300mm as design detail

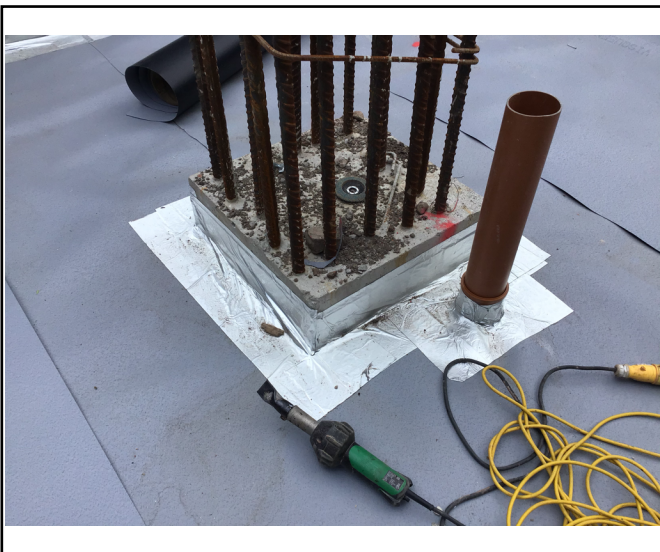
Penetrations in Gridlines 11/6:E/G

sealed to a good standard

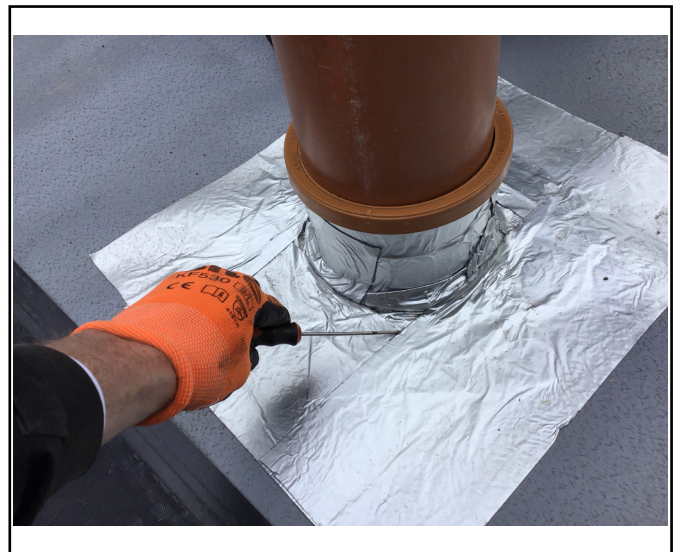
Penetrations in Gridlines 11/6:E/G

sealed to a good standard

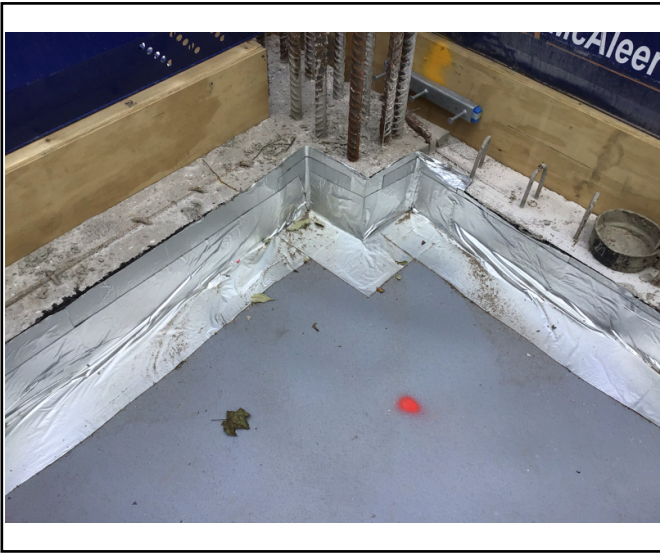
Perimeter to Gridlines 11/6:E/G

sealed to a good standard

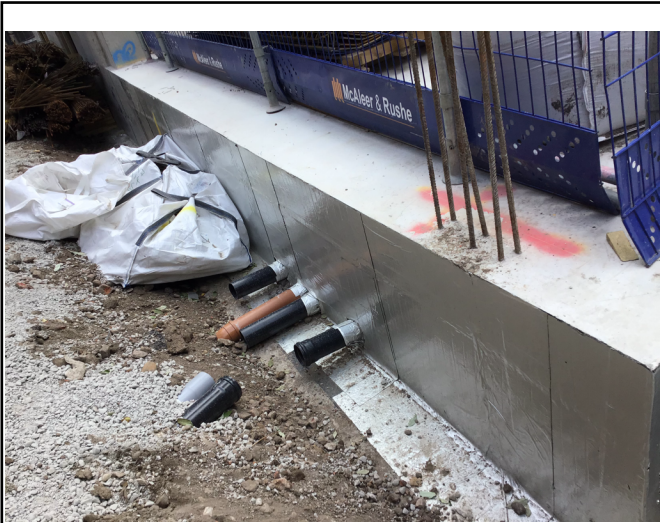
Perimeter detail sealed with no

faults found

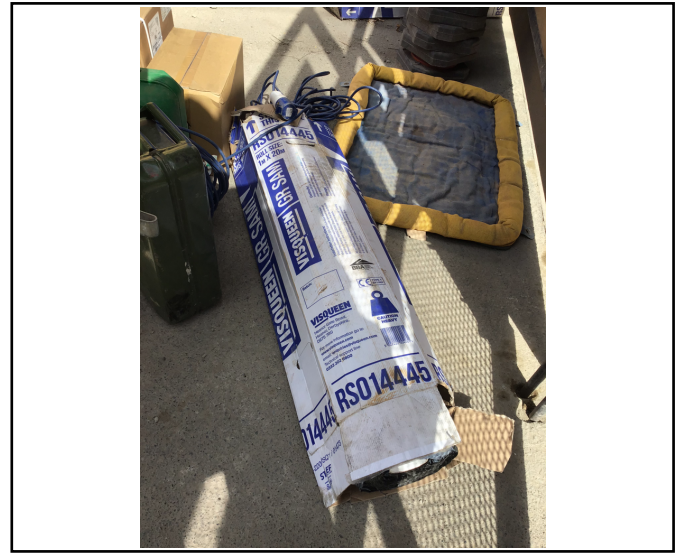
Visqueen GR SAM used throughout

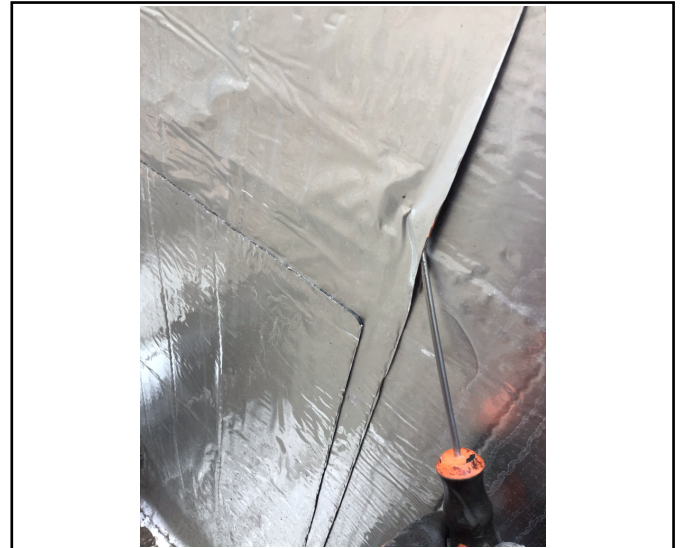
Pick and probe test to perimeter

detail. Good bond and overlaps
