# GEOSHIELD

## Verification Report

McAlear & Rushe

101 Charles Street

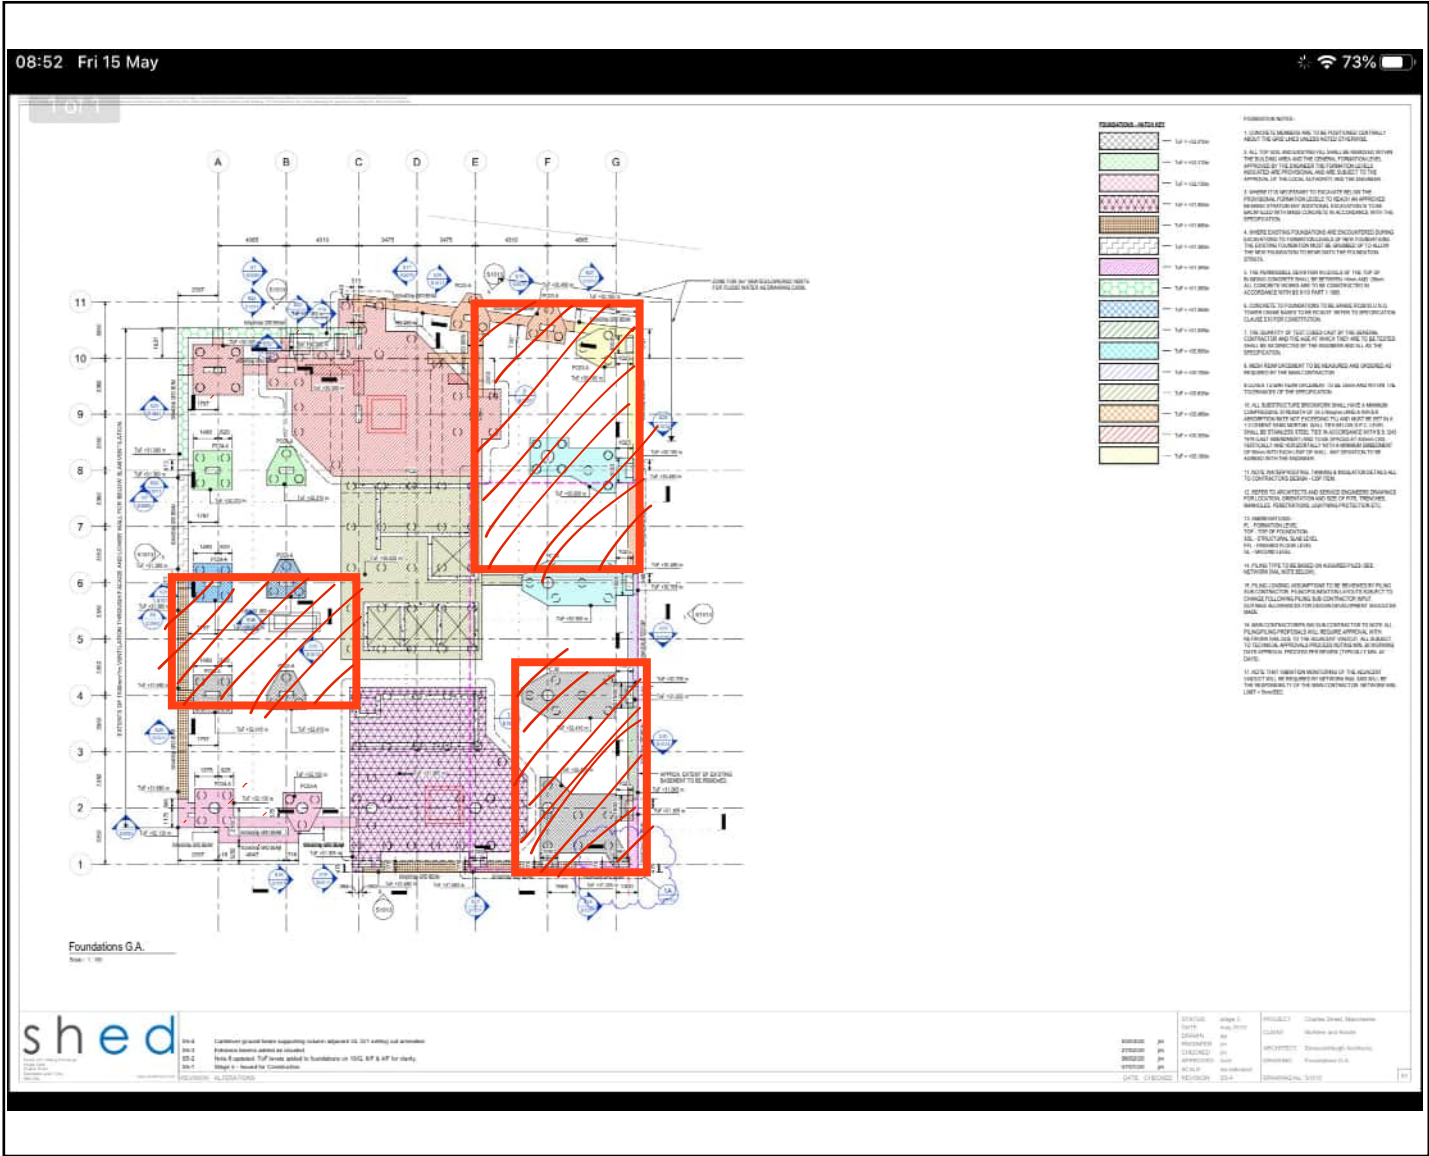
Gridlines 11/6:E/G, Gridlines 6/4:A/C and ring beams to 3/1:E/G

Verified in this report as highlighted above

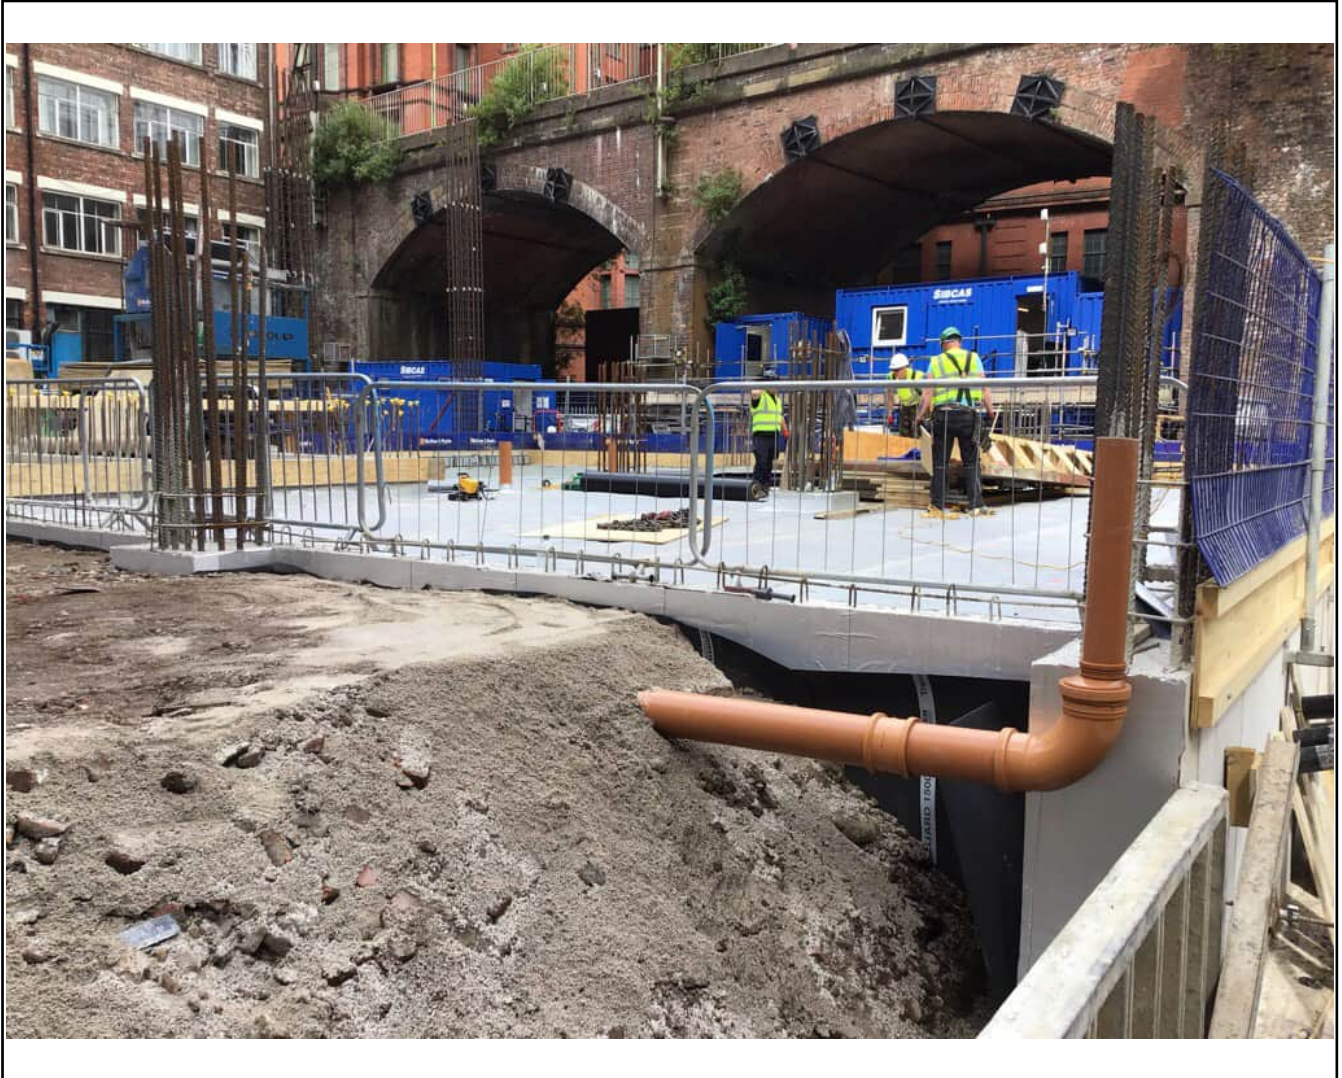
Overview of Gridlines 11/6:E/G

Membrane installed beneath suspended slab

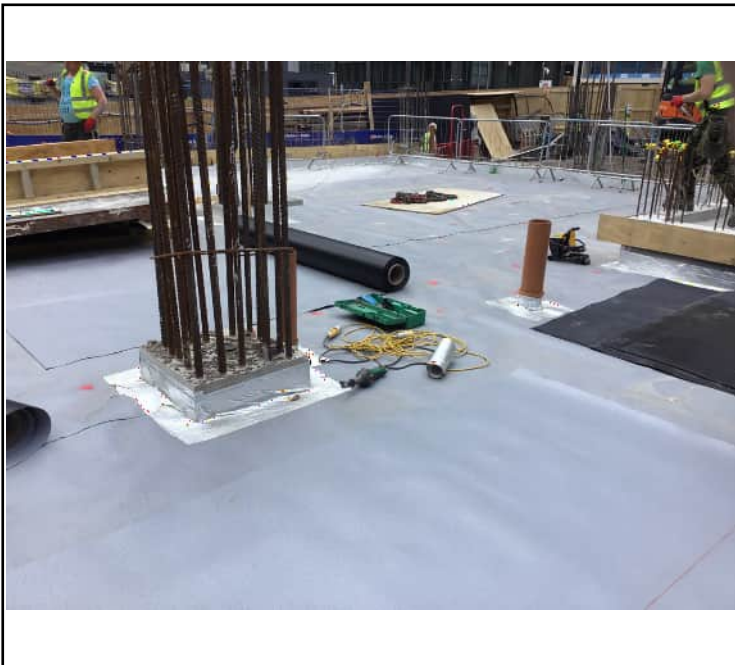
NOTES: Visqueen Ultimate Geoseal installed with Pro Demtech

Welded joints. Location of hooks marked on the membrane, extrusion welder to be used to installed hooks to support the membrane from steel re bar with in the slab. Hooks to be installed but strength will be tested on next visit.

1. Overview of Gridlines 11/6:E/G

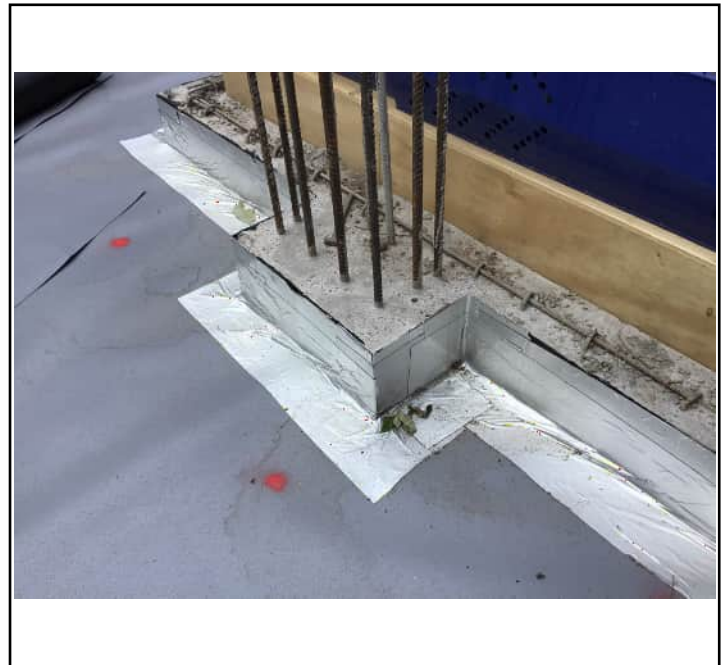
2. Perimeter details sealed with Visqueen GR SAM

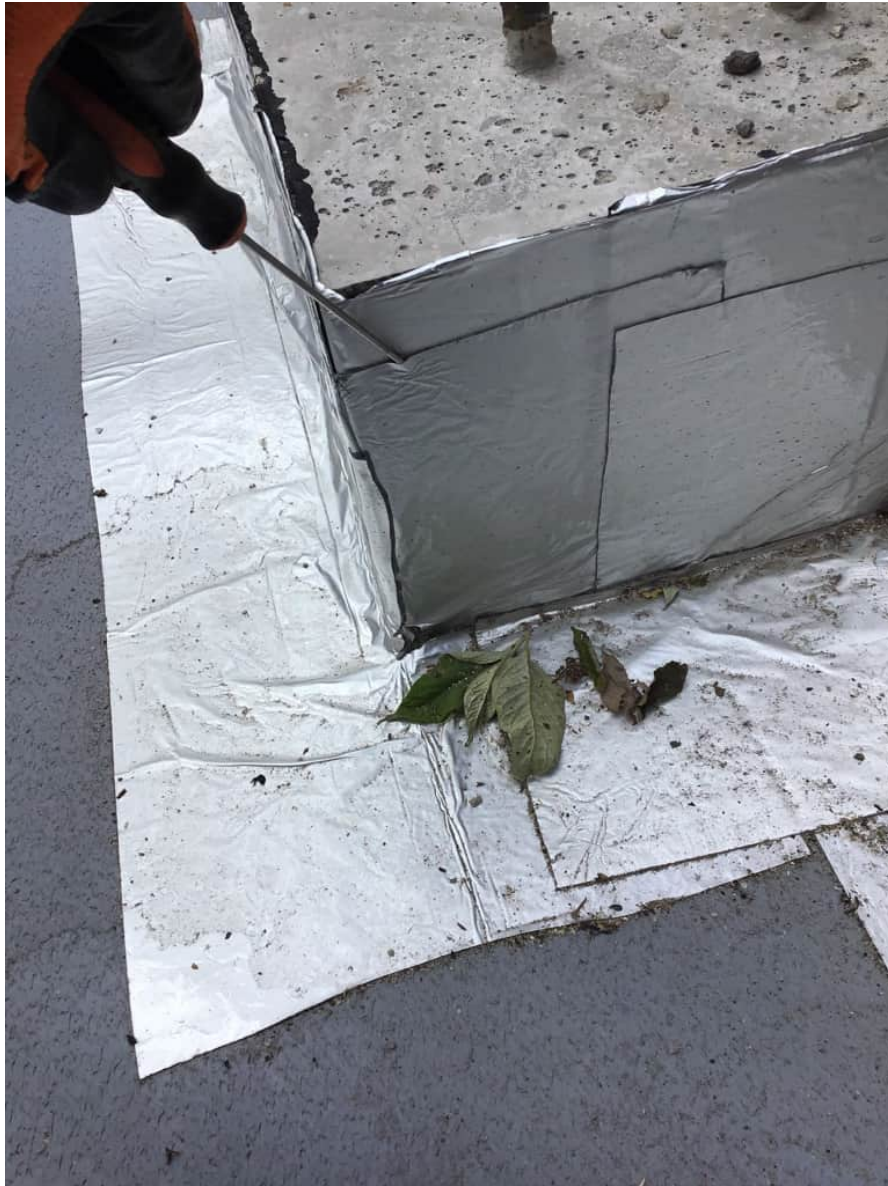
3. Pick and probe test carried out to ensure good bond achieved. Bitumen primer applied to face of concrete. Good installation, passed and verified.

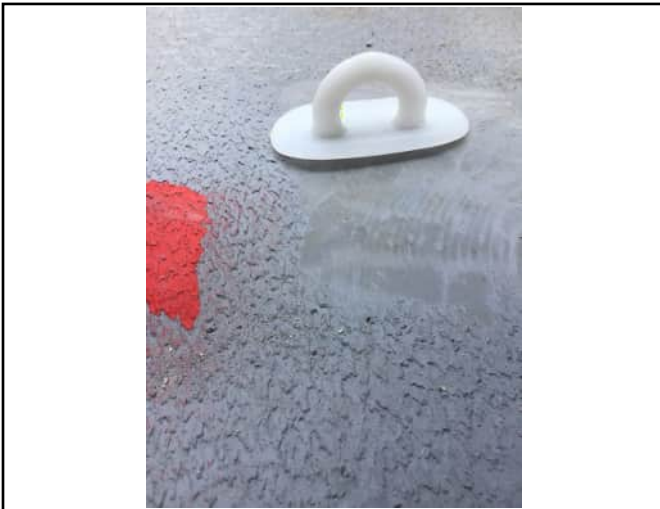
NOTES: Location of hooks marked. Method of installation

discussed on site. Hooks to be sealed to membrane with extrusion weld and

insulation to be installed around before hooks attached to re bar. Installation to

be verified next visit.

1. Hook which will be sealed to membrane to support installation. Membrane should also bond to concrete during the pour. Once cured temporary formwork beneath the slab to be stripped.

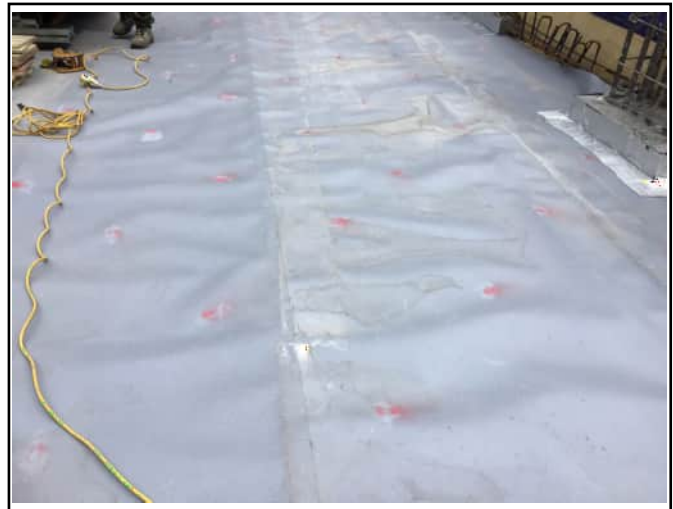
2. Location of hooks marked on the membrane.

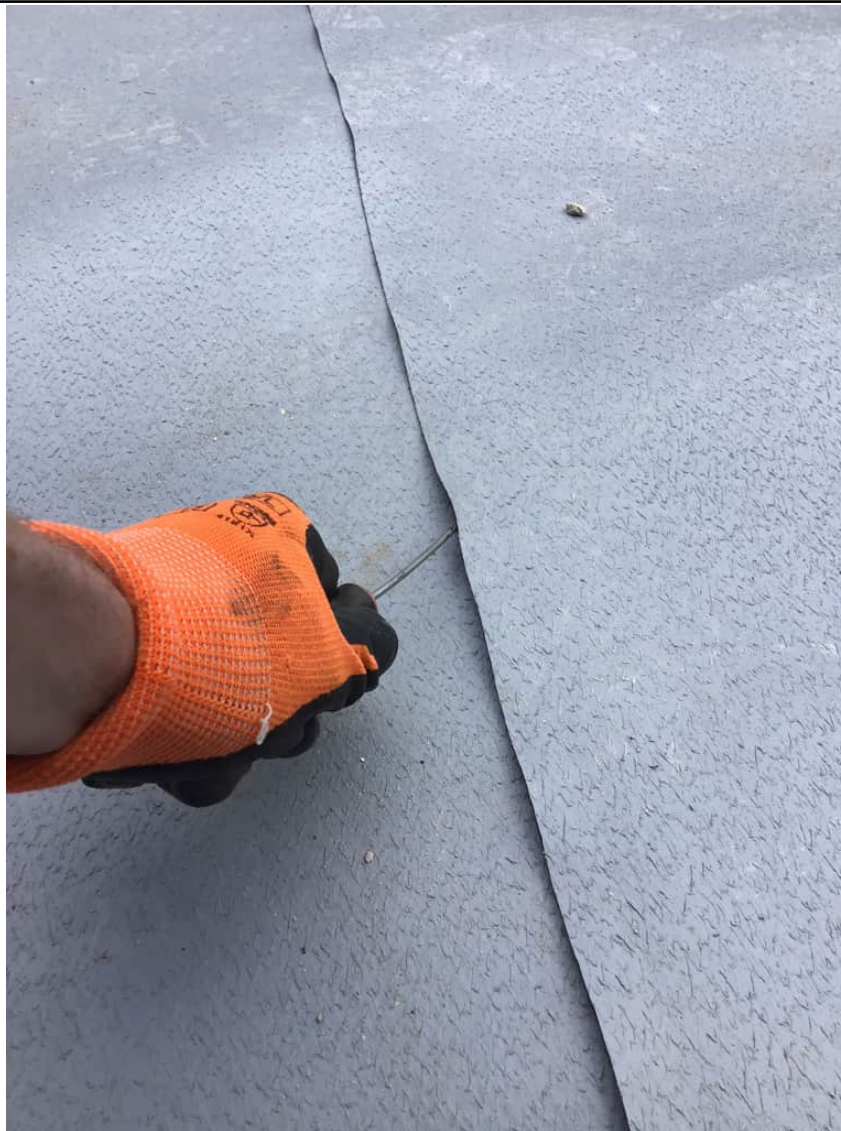
3. Pick and probe test carried out to all Pro Demtech Welded joints.

Excellent seal achieved throughout.

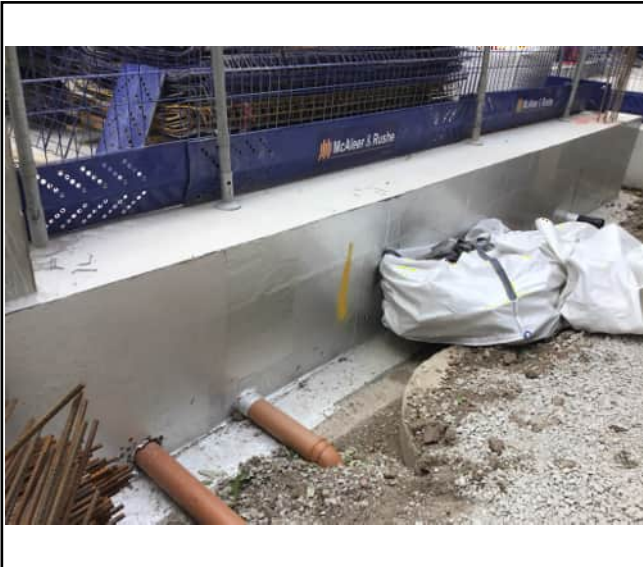
NOTES: Visqueen GR SAM installed to the perimeter details

to a bitumen primer concrete base. Works visually inspected and tested with pick and probe. Pipe penetrations sealed to a good standard. Works on going but complete works installed to a good standard with no faults found.

1. Overview of perimeter detail

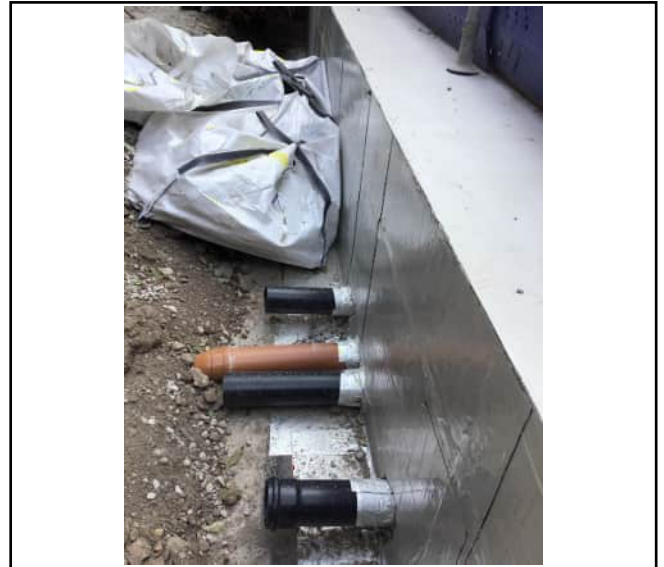
2. Pipe penetrations sealed to a good standard as per NVQ Level 2.

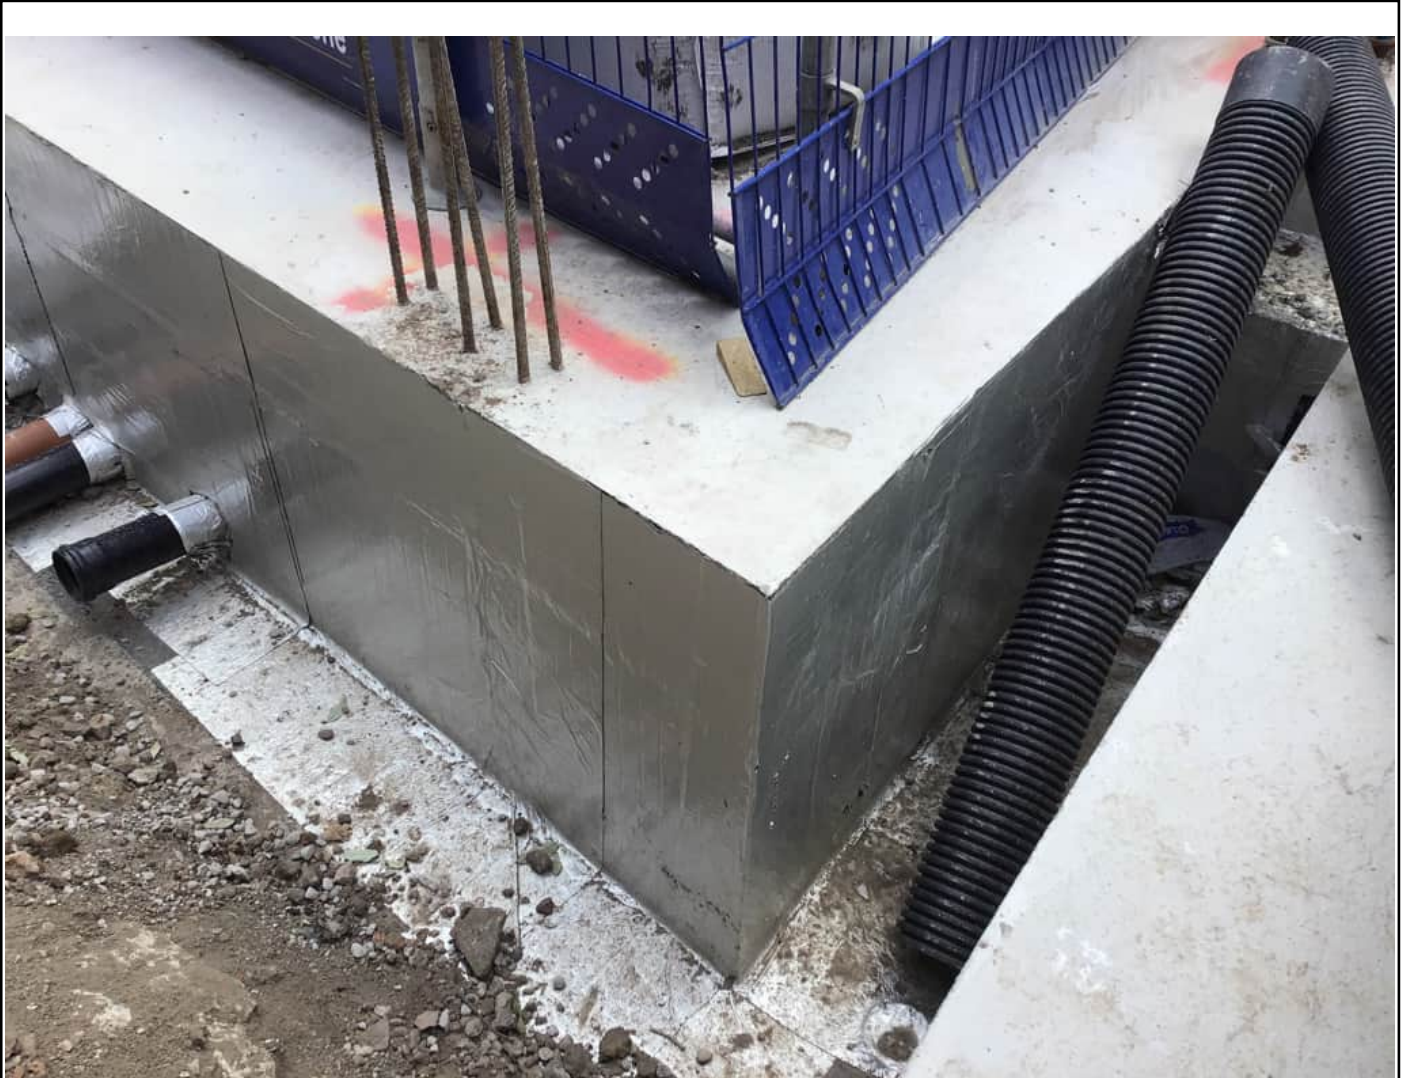
3. Overview of perimeter detail sealed to a good standard. No faults found.

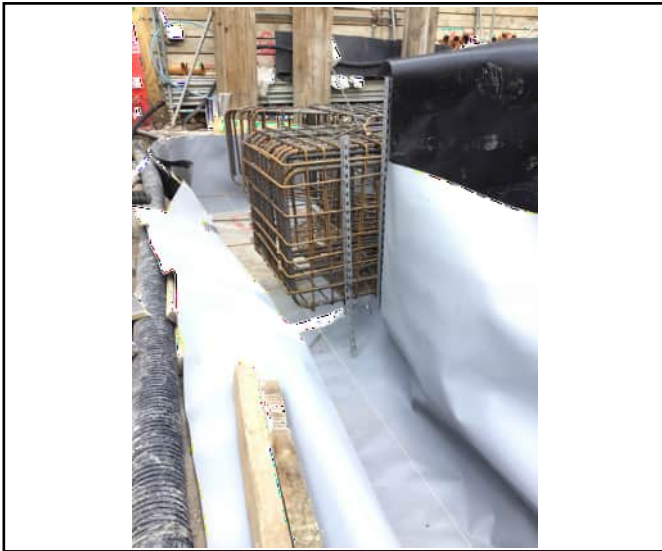
Visqueen Geoseal beneath ring beam

to 3/1:E/G

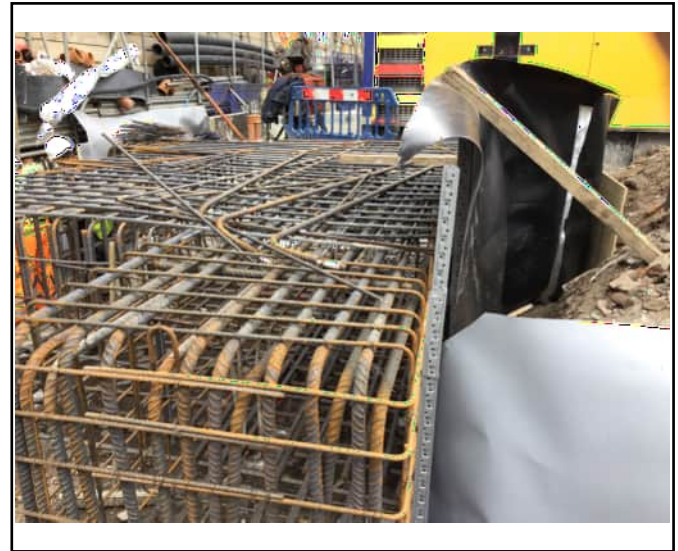
Visqueen Geoseal beneath

steel rebar 300mm as design detail

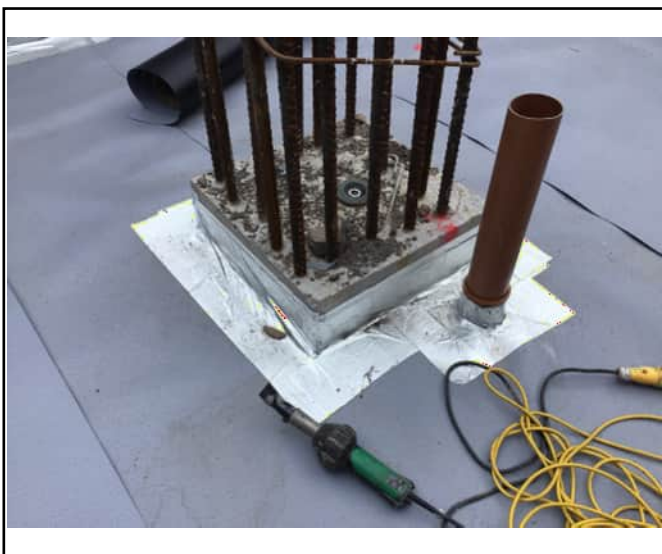
Penetrations in Gridlines 11/6:E/G

sealed to a good standard

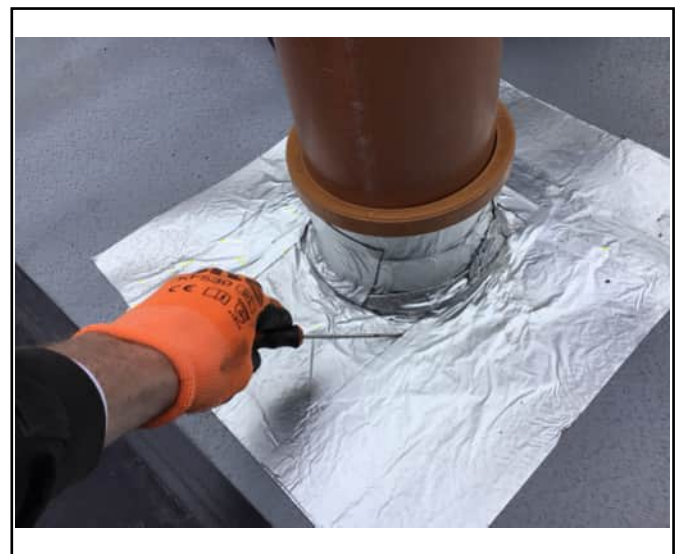
Penetrations in Gridlines 11/6:E/G

sealed to a good standard

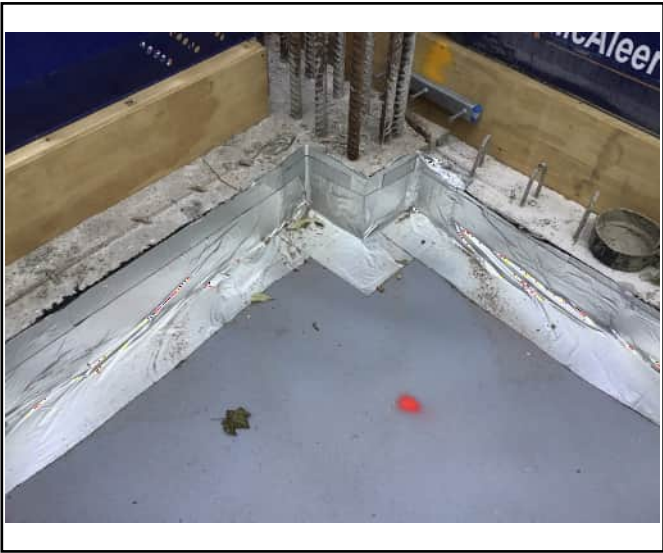
Perimeter to Gridlines 11/6:E/G

sealed to a good standard

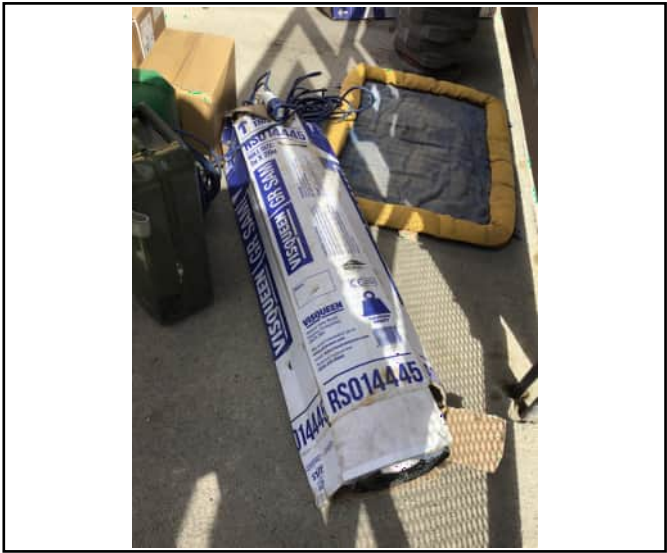
Visqueen GR SAM used throughout

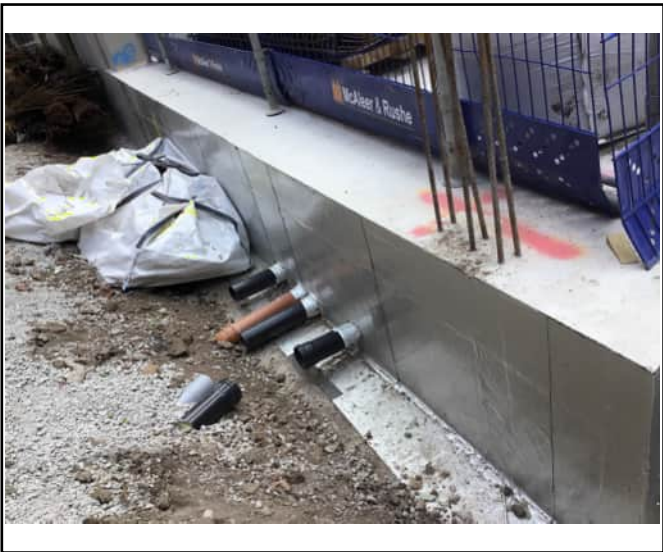
Perimeter detail sealed with no

faults found

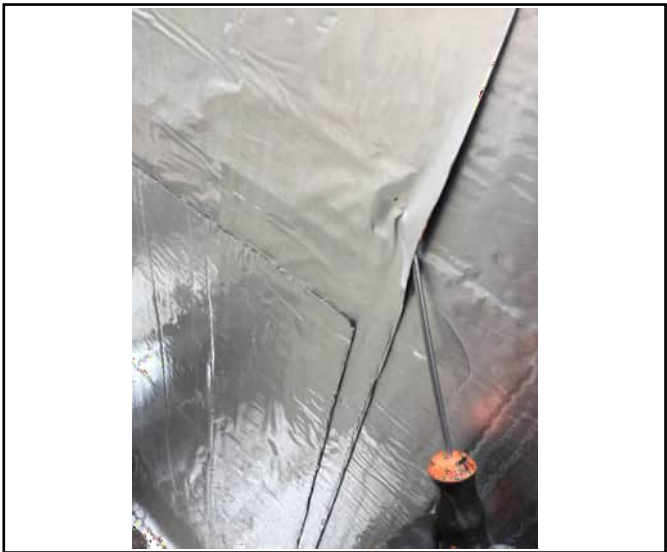
Pick and probe test to perimeter

detail. Good bond and overlaps
