CONSERVATION ENGINEERING

| Rev | Description | Issued | Checked | Date |
|---|---|---|---|---|
| 00 | Technical Note Issue | D.W. | D.W. | 2 <sup>nd</sup> December 2021 |

PROJECT: 807 WILMSLOW ROAD, MANCR.

TITLE: STRUCTURAL REPLACEMENT OF DEFECTIVE ARCHED OPENING

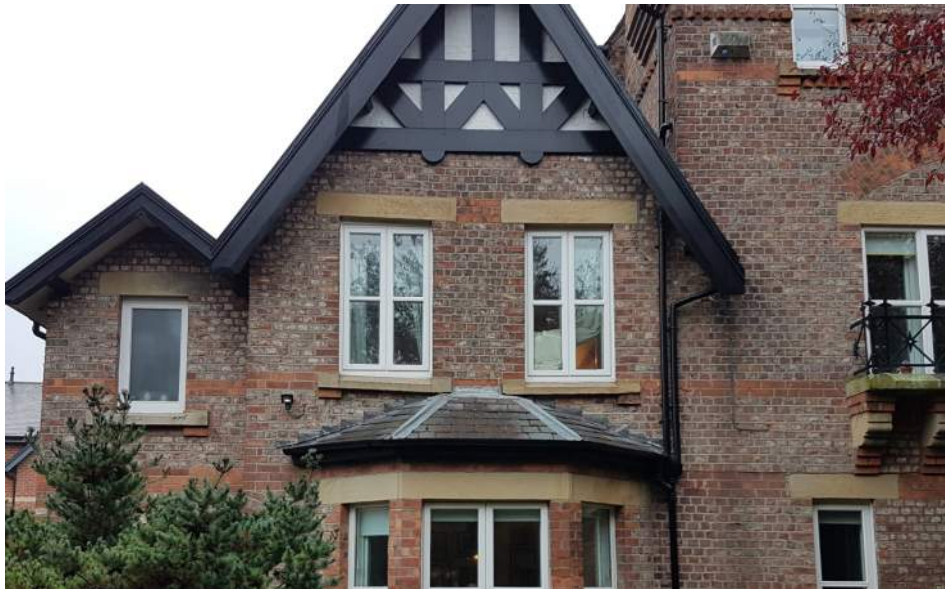
Figure 1: G.A. view on W gable showing position of projecting bay window and area of structural activity overhead.

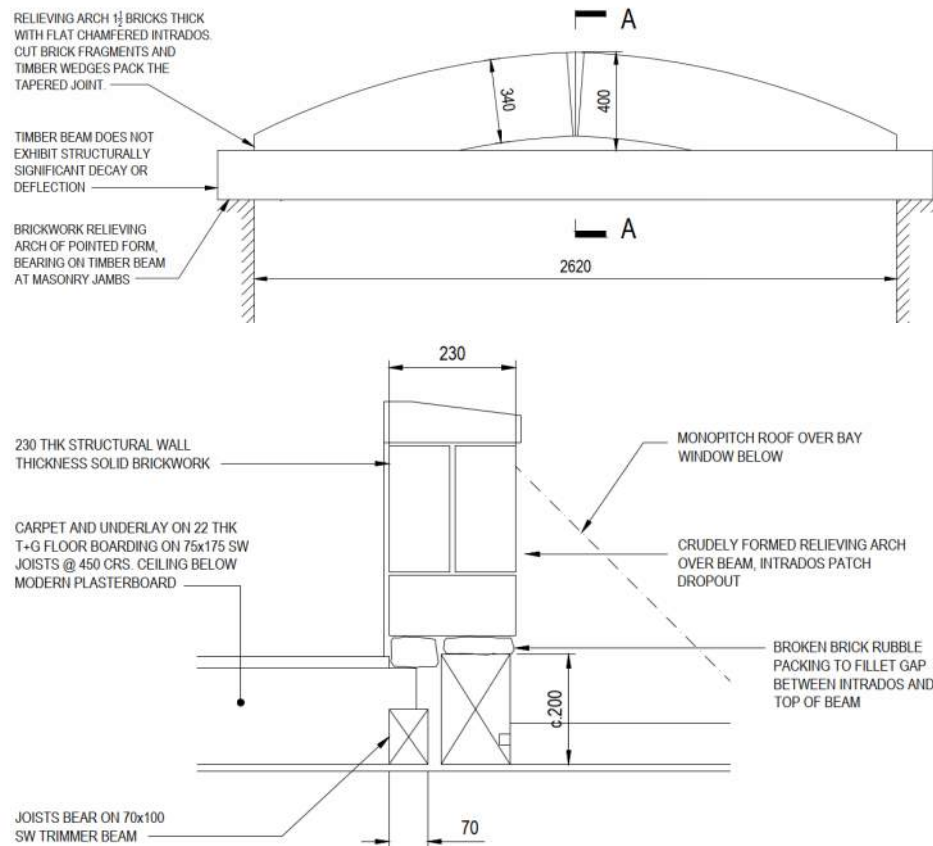
Figure 2: Form and composition of opening through W wall into bay window at midfloor (Extract from DR-S-100)

- 3.2 Intrusive determination of the structural composition of the opening informs that the floor is carried by an under-sized timber trimmer joist, which does not seem to attract load from the wall above (Fig. 2; see DR-S-100, Appendix A). Indeed, owing to its compact section, it is insufficiently strong or stiff enough to offer a meaningful contribution to the support of the structure overhead.

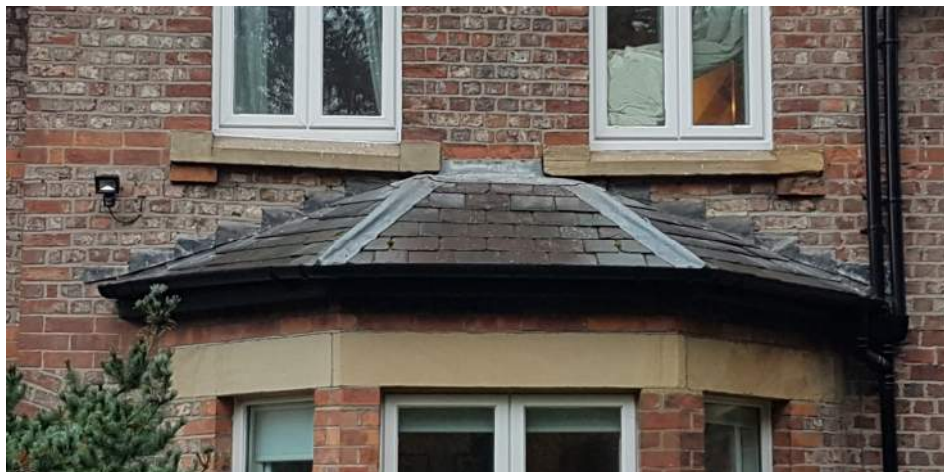
- 3.1 The pattern of structural activity presented showing cranked geometry of the upper masonry tending down to the beamed opening, apparently level floor, square shape of the opening below (no significant deformation in the ceiling) and square / level geometry of the bay window structure itself is not consistent with differential settlement of foundations or ground subsidence (i.e. it does not fit a bottom-up deterioration mechanism diagnosis). Rather, the evidence points towards an issue at height within the superstructure, roughly at the level of the opening through the west gable to form the bay window (Figs. 3, 4).

Figure 3: External view on significantly cranked geometry of the masonry skeleton (central pier translated downwards)

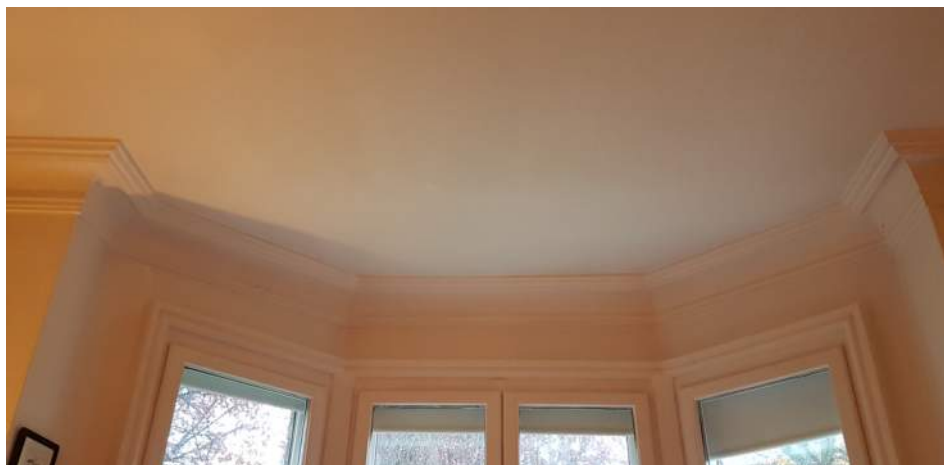
Figure 4: Internal view on opening through W gable wall into bay window showing patent lack of distress.

- 3.6 The relieving arch has been crudely made, with timber wedges in awkward-shaped joints as the arch tapers towards either end. This awkward packing arrangement appears to have squashed and progressively slipped (Fig. 5).
- 3.7 No evidence of spreading of the jambs was observed (Figs. 3, 4) and indeed constructive care has been taken to buttress the outer corner of the jamb proper.
- 3.8 This slipping / disruption of the tapered ends of the shallow relieving arch seems to be the root cause of the drop in the crown, i.e. abutment spread in a very localised sense, manifesting in downward translation of the pier over without symptoms of distress being witnessed further below.

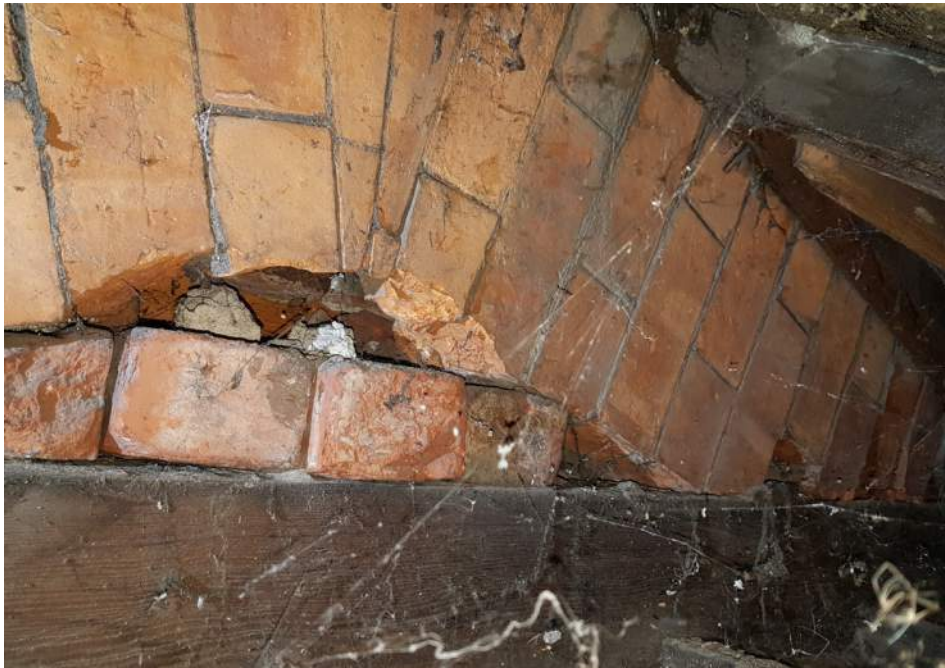
- 3.5 Reconciling the absence of structurally significant deflection and/or decay affecting the timber floor, trimmer and bressummer beam with the significant deformation manifested in the masonry informs that the masonry superstructure is carried by the relieving arch, not the timber beams. This suggests that the timber beam has simply been a construction former on which to build the relieving arch. There is of course composite interaction at the bearings, where the vertical force component at each springing compresses the embedded timber beam ends.

Figure 5: Crudely formed relieving arch spreading on abutments owing to broken brick and timber packers to awkwardly tapering joint either side (see Fig. 6)

- 3.11 Our recommendation will be for Option B, as the height of the spandrel is dictated by the window cill height at first floor level, and in practical terms the construction of a new arch of new shape within these constraints would be very difficult and practically infeasible to achieve an effective repair which did not further deflect on load uptake.

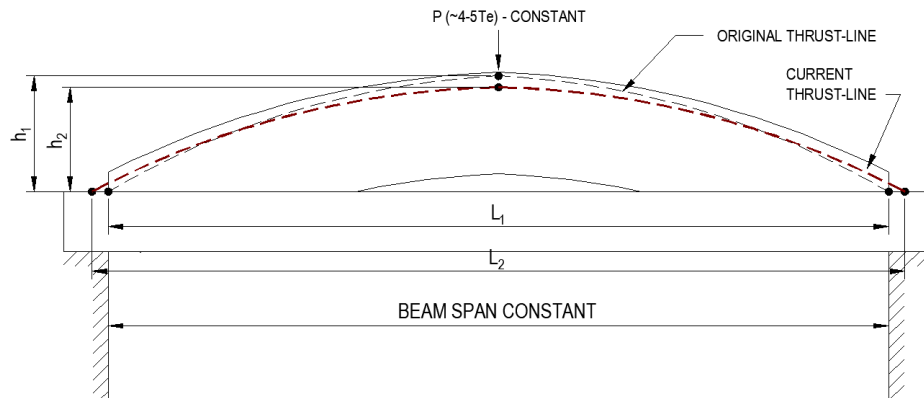
- 3.9 The time taken for this inherent construction defect to manifest itself is highly unusual, and the reason(s) are not entirely clear. We suspect an initially long, slow continuous squashing of the timber packers, and as the leverage reduces (slight drop in crown hinge) the magnitude of thrust increases (a function of load and leverage), creating a progressive feedback loop which we are now seeing the acute latter stages of (Fig. 6).

Figure 6: Possible 'feedback loop' structural deterioration process of increasing thrust and vertical slumping.

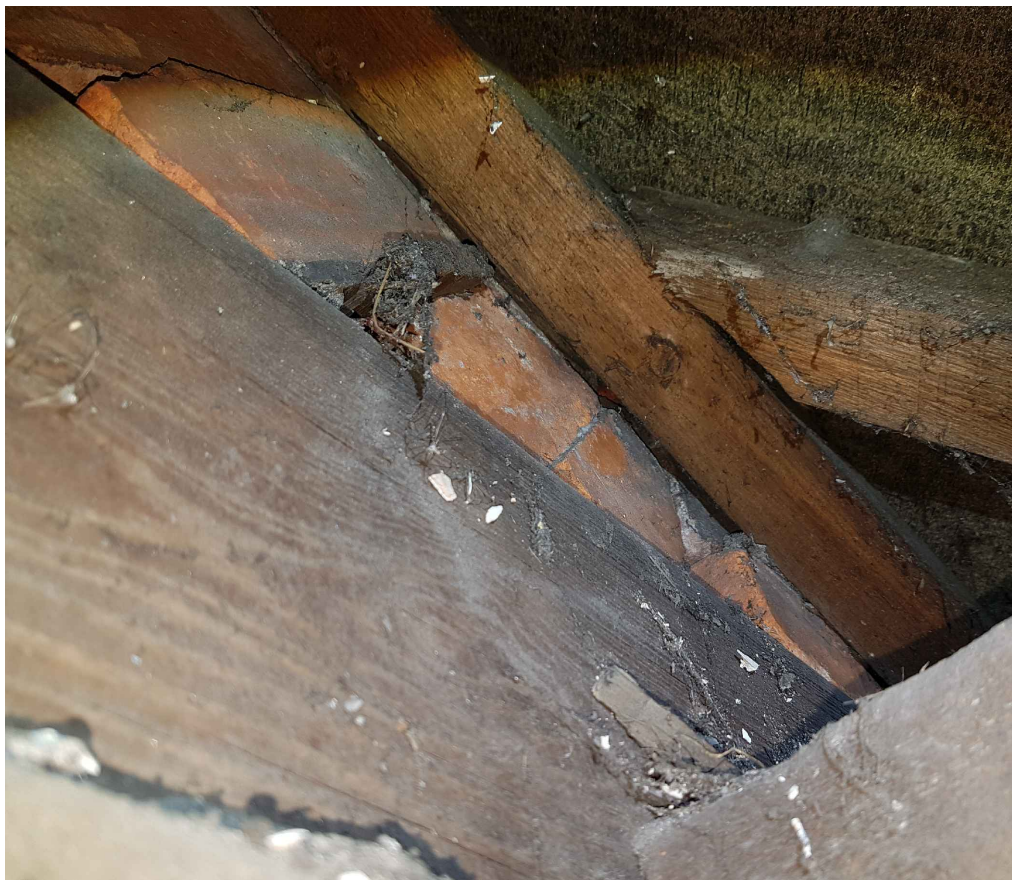
IMAGE 03: VIEW OF RIGHT-HAND BEARING (AS VIEWED EXTERNALLY. SEE IMAGE 01) SHOWING TIMBER WEDGES AND CUT BRICK PACKERS TO AWKWARD TAPERED END OF RELIEVING ARCH. NOTE LOOSE CHARACTER OF CUT BRICK UNITS AS ARCH SLIDES ALONG BEAM.

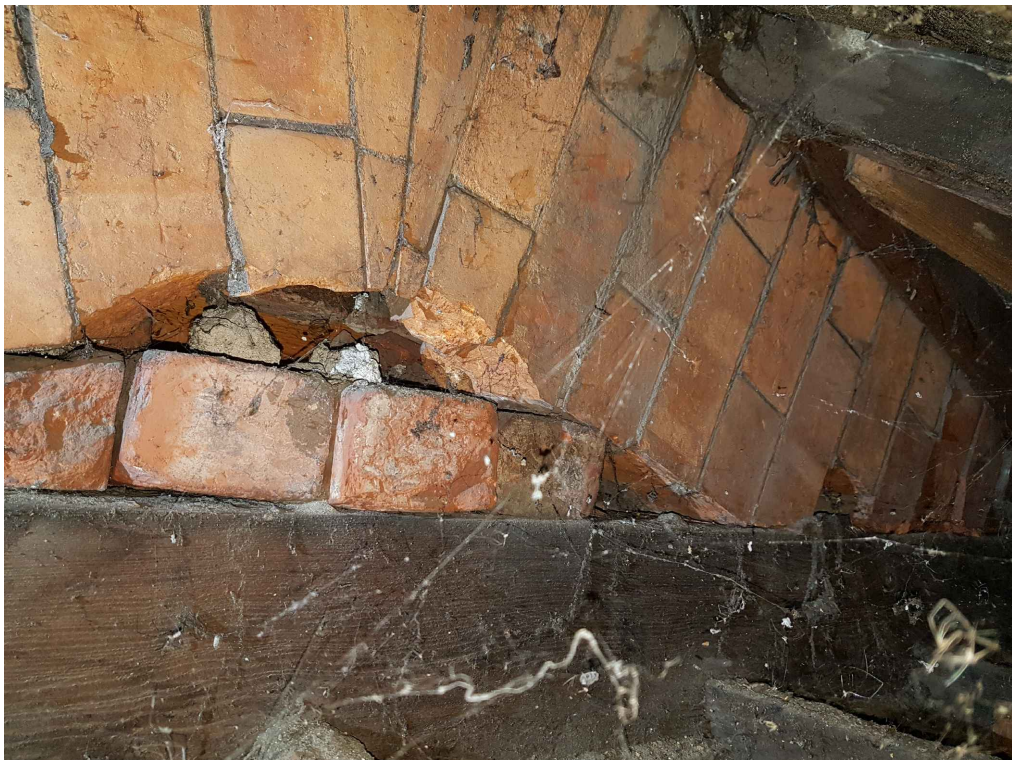
IMAGE 02: EXTERNAL VIEW OF RELIEVING ARCH OVER TIMBER BEAM SHOWING AWKWARD FLAT CHAMFER OF INTRADOS. DROP-OUT OF INTRADOS AND PACKING UNITS BELOW CROWN.

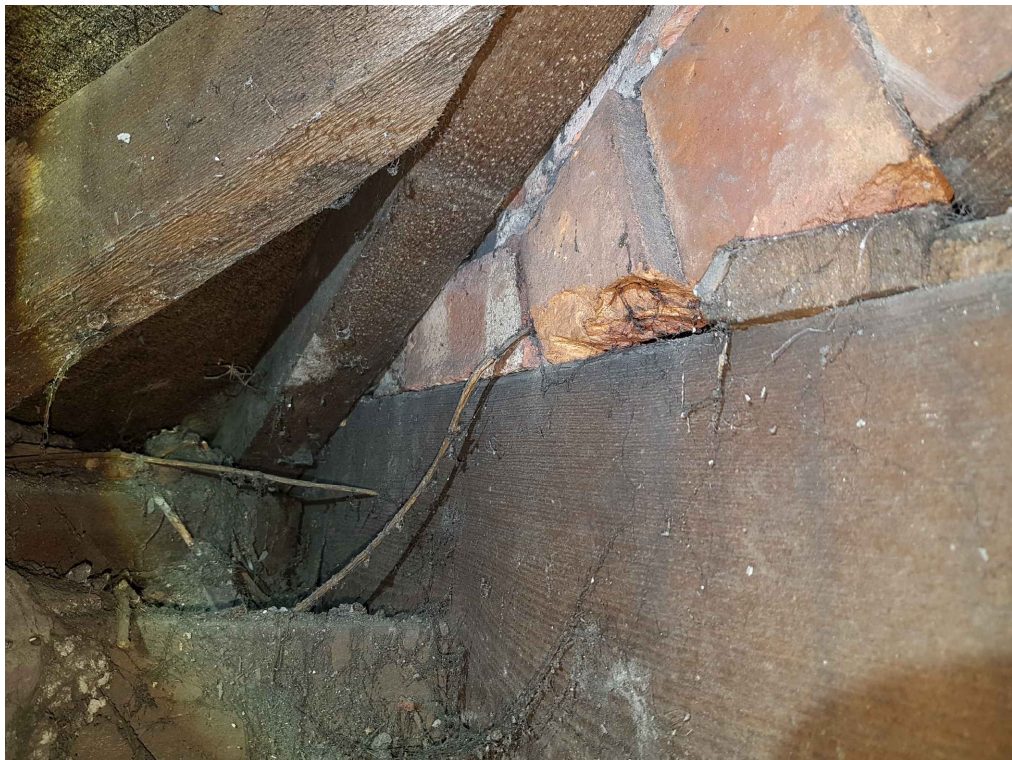
IMAGE 04: VIEW OF LEFT-HAND BEARING (AS VIEWED EXTERNALLY. SEE IMAGE 01) SHOWING TIMBER WEDGES AND CUT BRICK PACKERS TO AWKWARD TAPERED END OF RELIEVING ARCH, SIMILAR TO OPPOSITE BEARING (IMAGE 03). TIMBER BEAM APPEARS IN SOUND TIMBER CONDITION.
