**2020 6679**

**481-485 Wilmslow Road**

# **Structural Investigation Report**

Date of Report: 06/04/2022

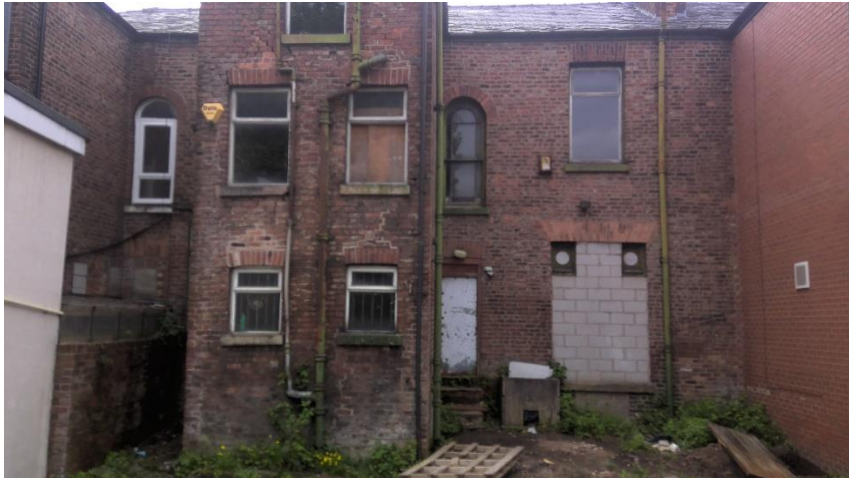
| <b>Description</b> | <p>General view of rear elevation and rear outrigger.</p> <p>The outrigger is in poor condition with evidence of foundation and lateral movement affecting the structure.</p> <p>The movement to the outrigger has resulted in settlement and deformation in a number of the brick arch lintels.</p> <p>The proposed scheme includes demolition of the outrigger and re-modelling of the rear elevation changes to existing openings.</p> |

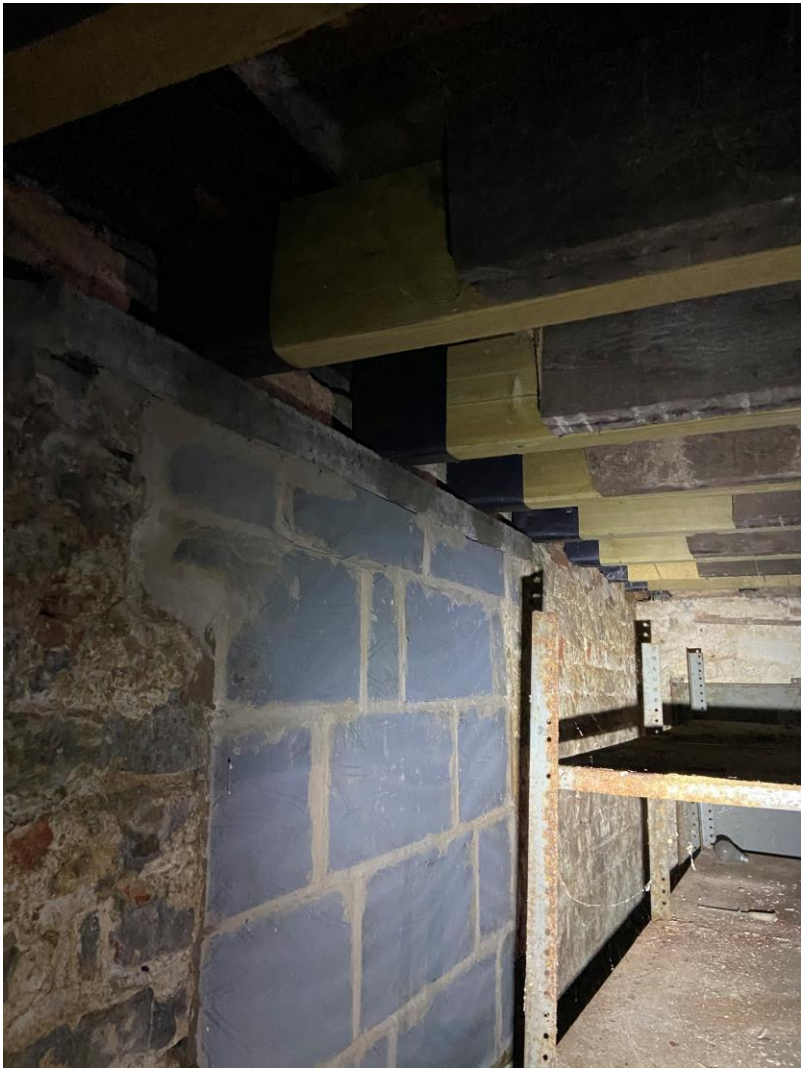
| <b>No</b> | 6.2 |

| <b>Description</b> | The existing original timber floor joists at ground floor have been affected by rot in the past and new sections of floor joists have been spliced onto the existing. |

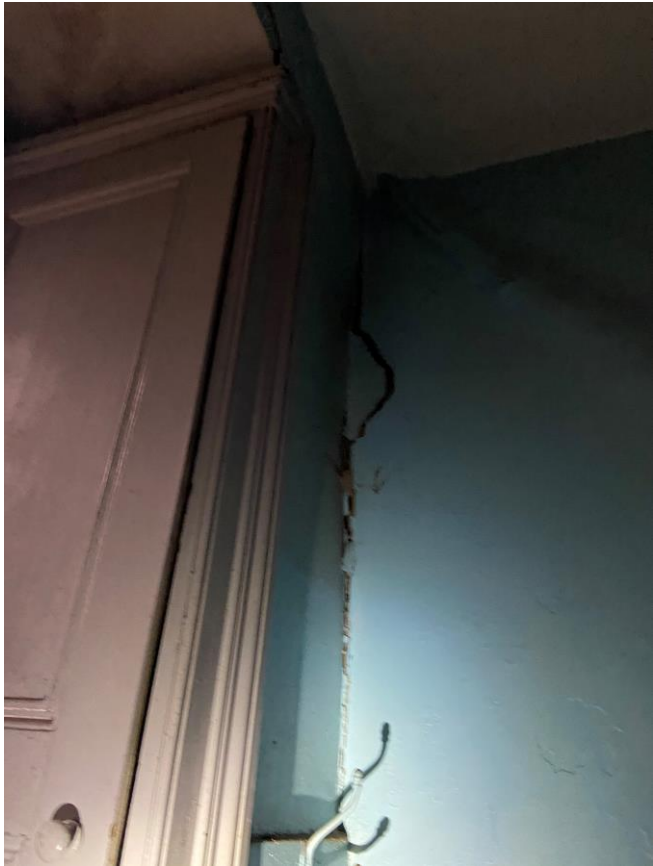
| <b>No</b> | 6.3 |

| <b>Description</b> | <p>The outrigger has subsided and rotated away from the remainder of the building resulting in the rear elevation moving laterally and causing cracking at the intersection of the outrigger and the main building.</p> <p>The cracking present is significant in magnitude.</p> |

The rear elevation of the building and rear outrigger are both in poor condition with significant downwards foundation movement and lateral movement evident within the structure.

Given therefore the condition of the rear wall, outrigger, internal walls, ground and upper floors and roof it would be safer and more practical to demolish these elements and re-construct them.

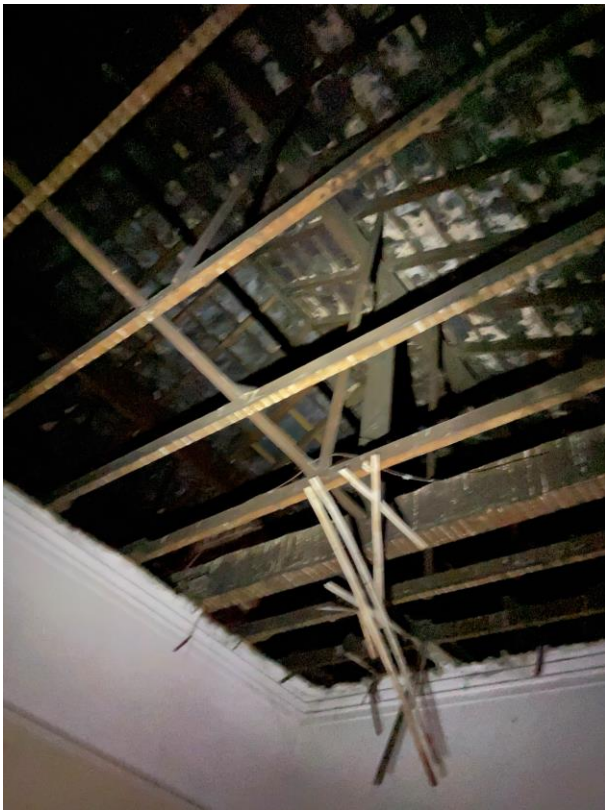
| <b>Description</b> | <p>The roof structure consists of traditional timber purlins supporting timber rafters.</p> <p>The proposed scheme involves conversion of the loft space</p> <p>The existing roof appears to leak and water ingress and rot is likely to be an issue in respect of the condition of the roof timbers.</p> <p>The conversion of the roof space will increase the load to the roof structure due to the addition of insulation and finishes.</p> <p>The existing timbers are not adequate to accommodate the new loading and strengthening or replacement will be required.</p> |
