# GEOSHIELD

## Verification Report

McAlear & Rushe

101 Charles Street

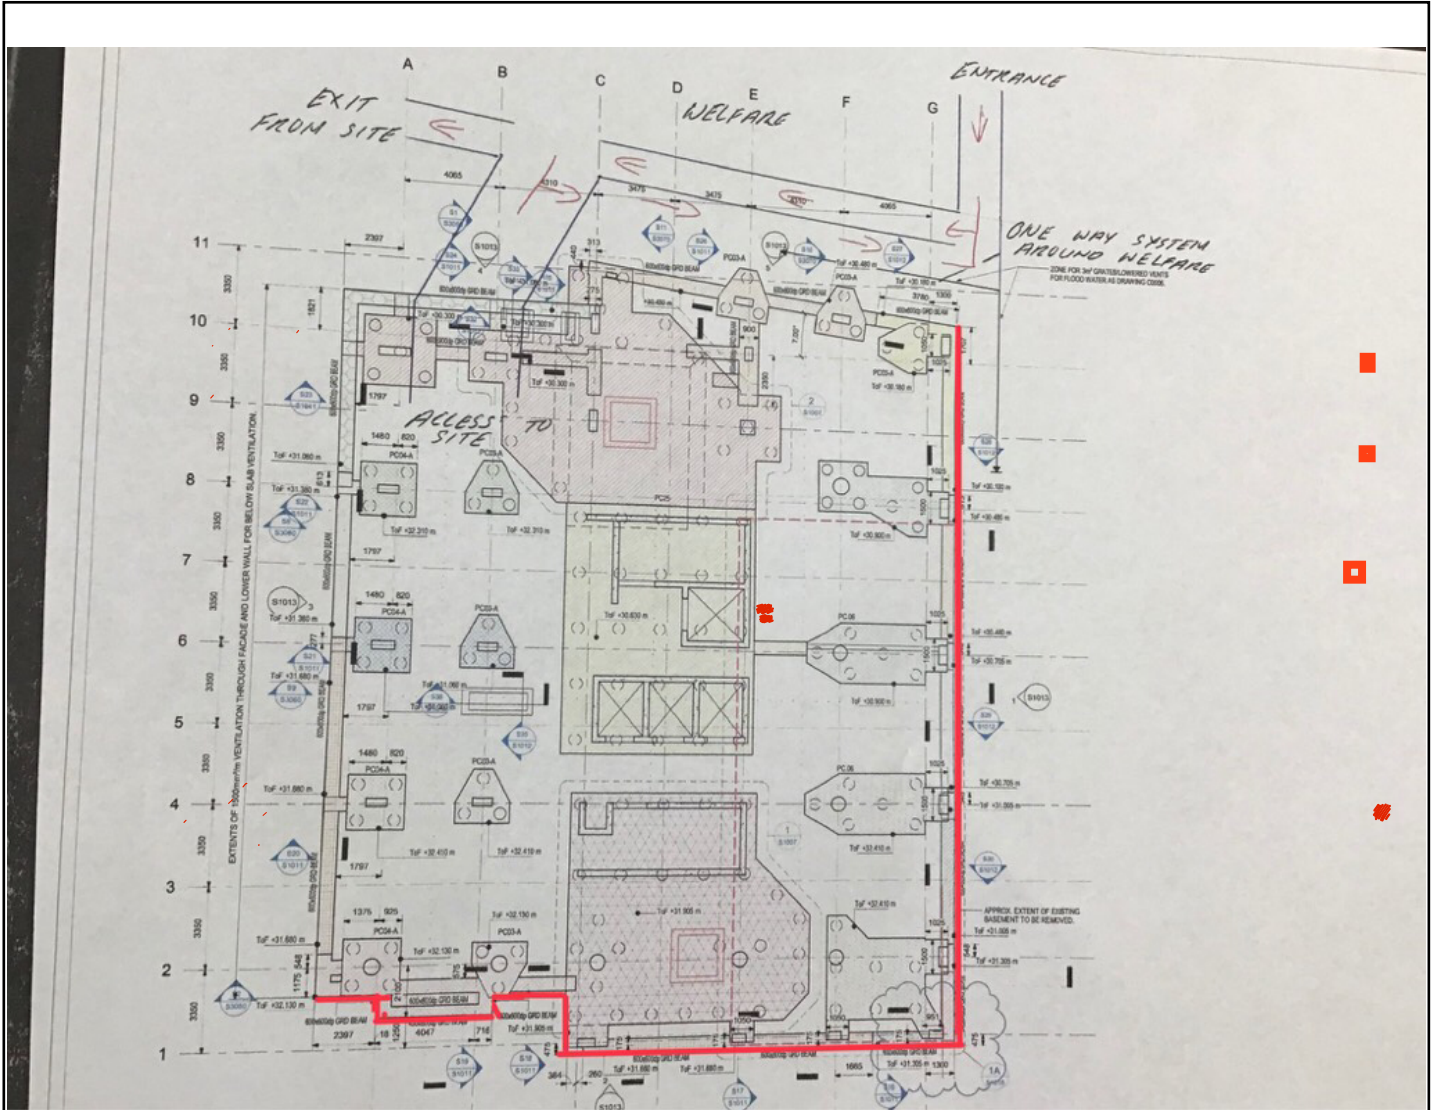
Area highlighted East and South Toe Detail

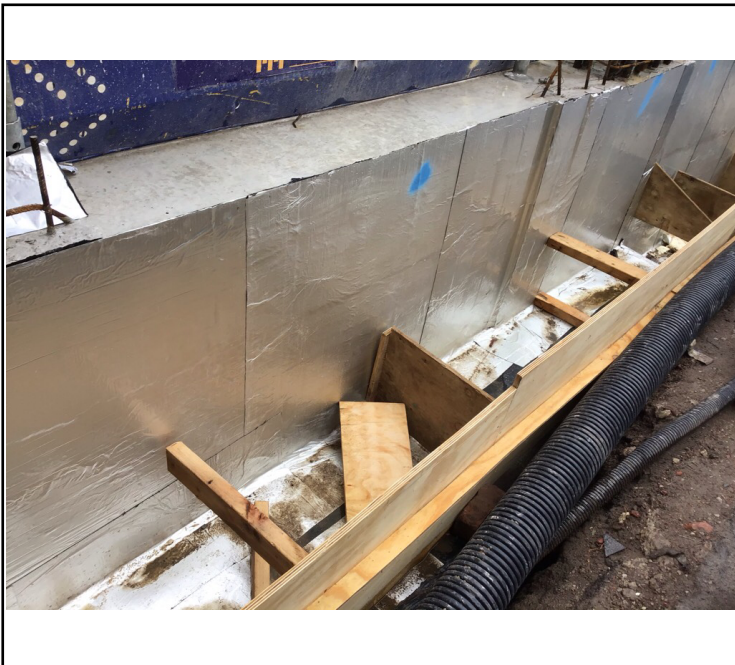
Down both the East and South toes, large rolls of Gas Resistant Self Adhesive Membrane has been applied. The toe has first been primed and left to dry, then the GR SAM has been had heat applied and then installed onto the toe.

Left photo) overview of East Toe Detail

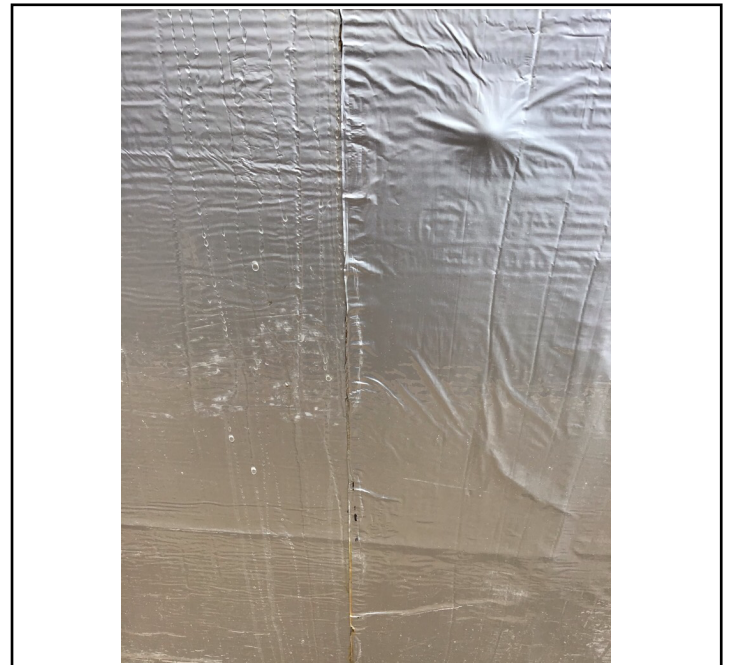
Right photo) this shows an overlap of the GR SAM

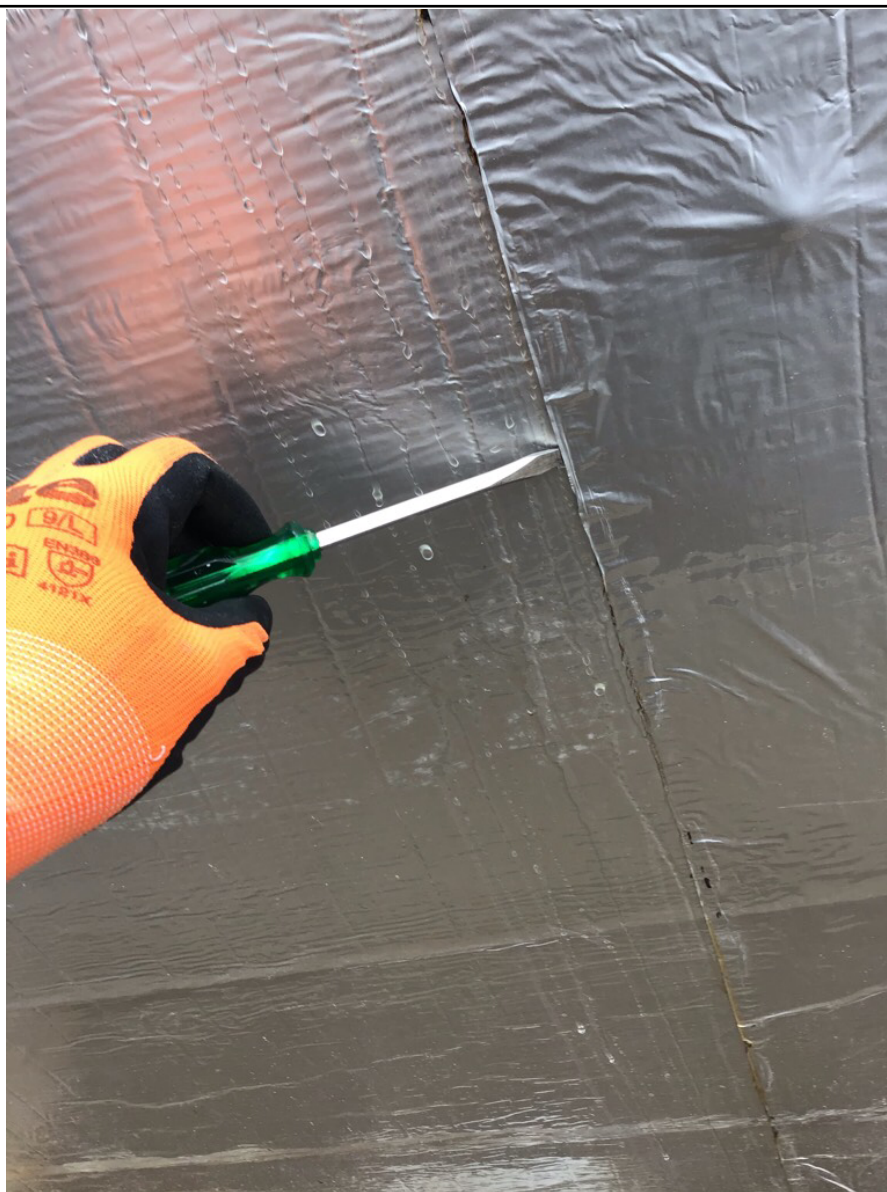
Above photo) a pick and probe test was carried out on the vertically applied GR SAM on the East and South Toes. A good seal has been created between the GR SAM and the primed concrete underneath.

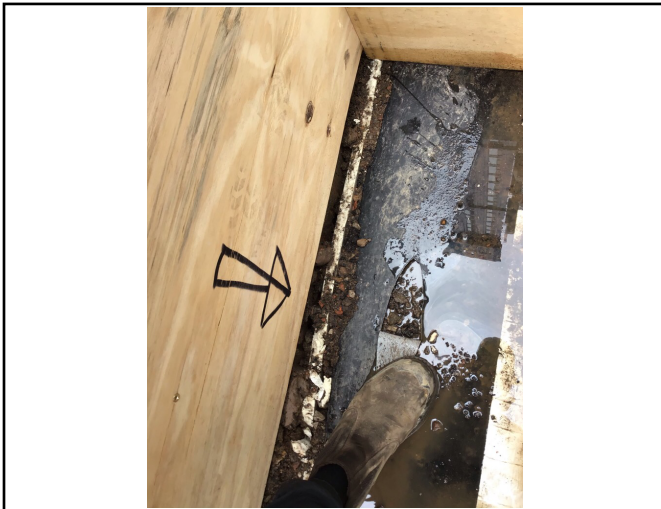
During the visit a visual inspection was carried out, a large hole was found in the DPC where the GR SAM is lapped down onto it. Installers remediated the hole during the visit using a patch of GR SAM.

Left photo) this shows the large hole in the DPC found during the visual inspection of the verified area.

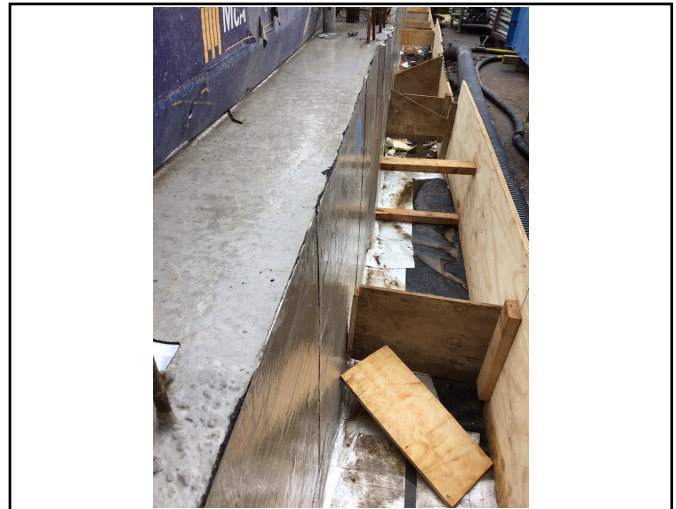
Right photo) reverse angle overview of where the hole was found

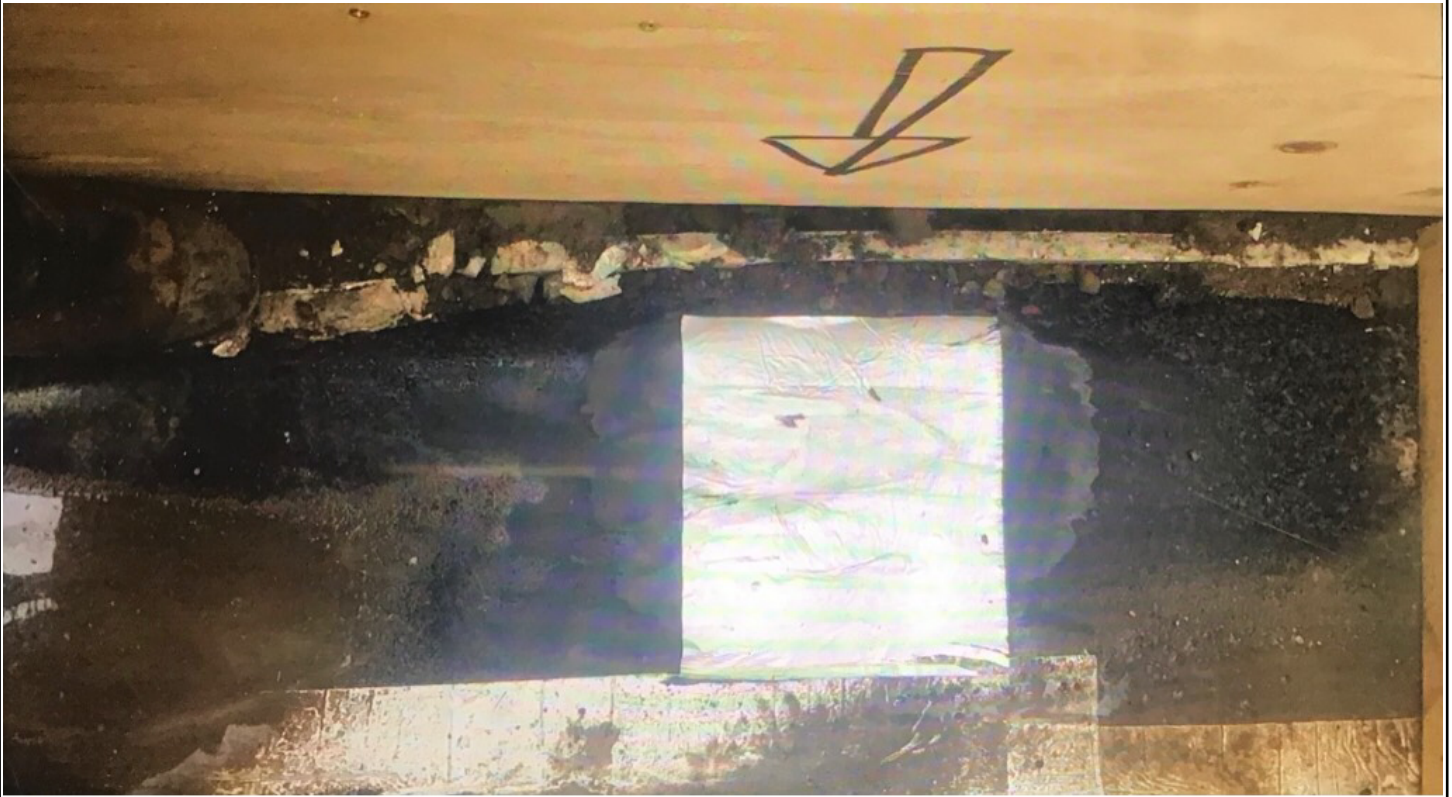
Above photo) this shows the patch of GR SAM that was applied to the hole found

during the visual inspection. Heat was applied to the patch using a leister, the DPC

was then dried and cleaned and the patch was applied.

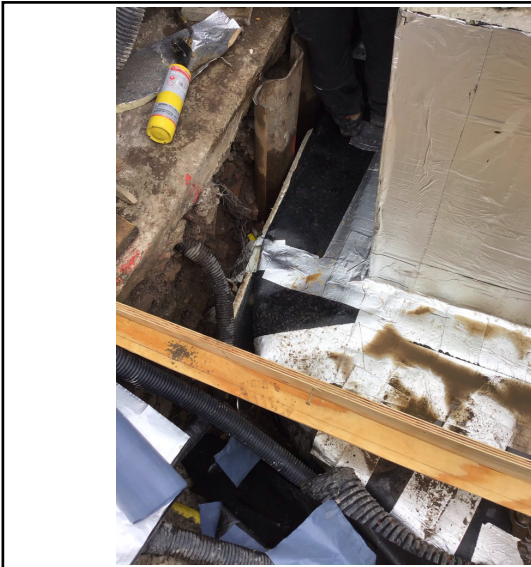
Gas resistant self adhesive membrane has been applied to the DPC where joints have needed to be sealed. Pick and probe test were carried out to ensure a good bond has been created.

Left photo) this shows the corner of the East and South Toe Detail, the GR SAM has been applied vertically down and lapped onto the DPC. The DPC has then been sealed using GR SAM.

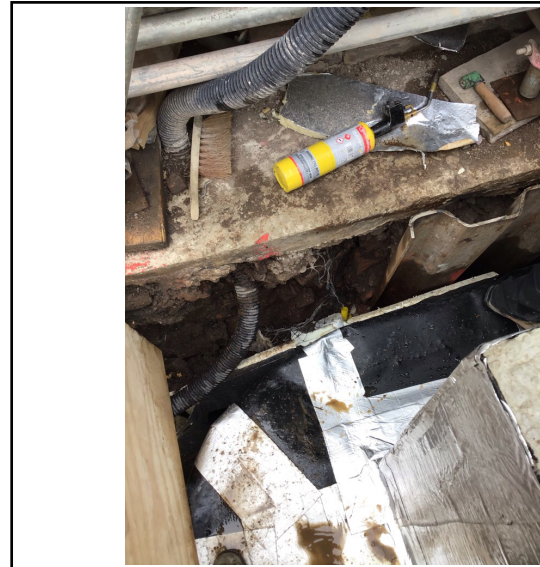
Right photo) overview of the corner and DPC

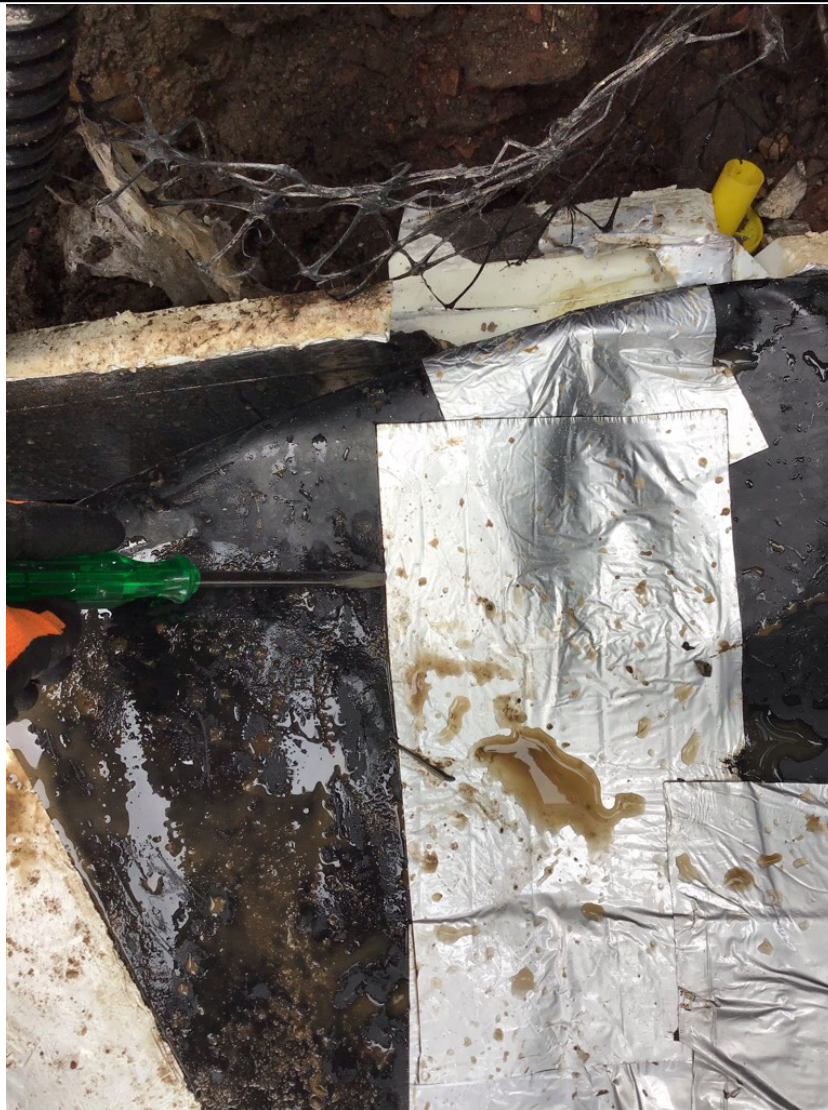
Above photo) a pick and probe test was carried out on the GR SAM which has been applied to the DPC, to ensure that a good seal has been created.

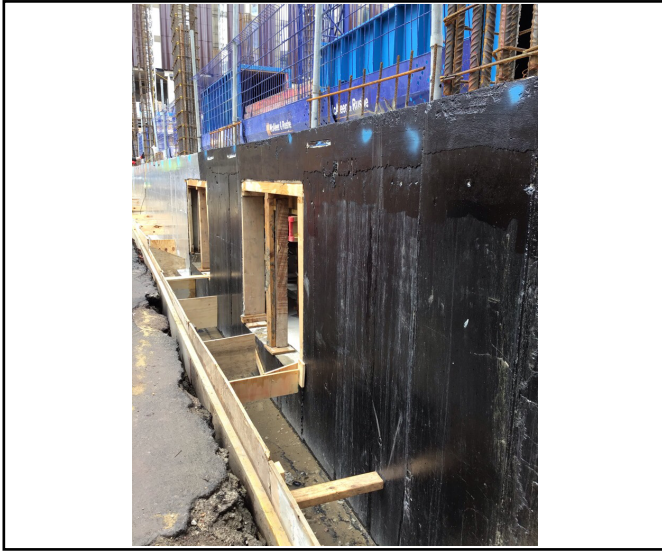
Primed concrete wall on

Eastern Toe

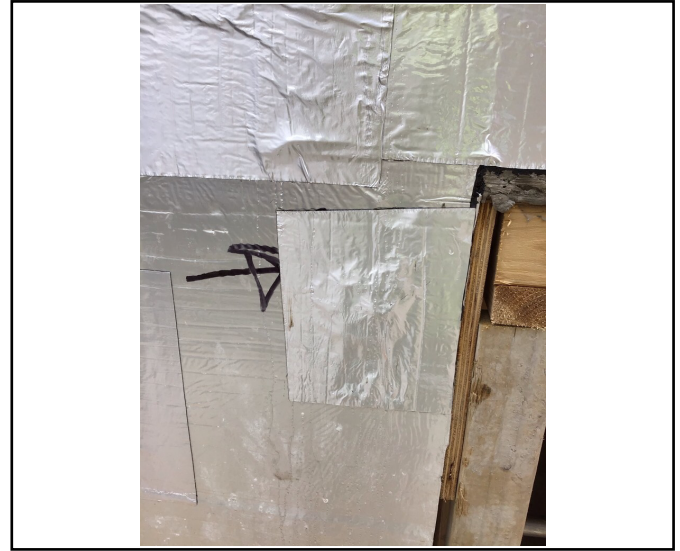
GR SAM patched applied to

hole

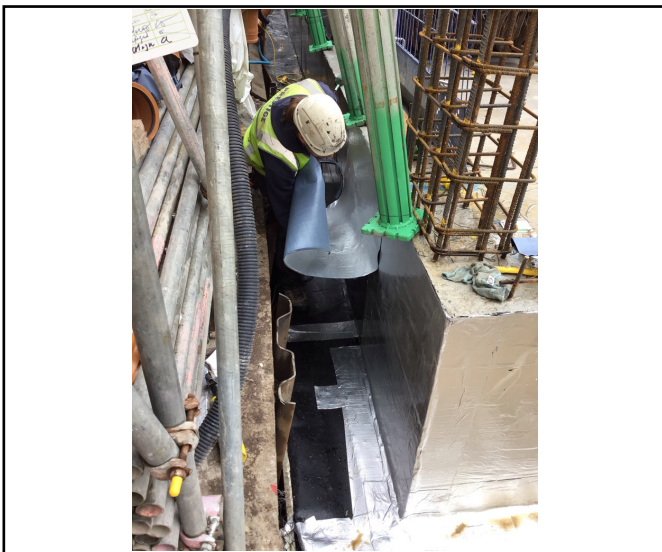
GR SAM applied to southern toe

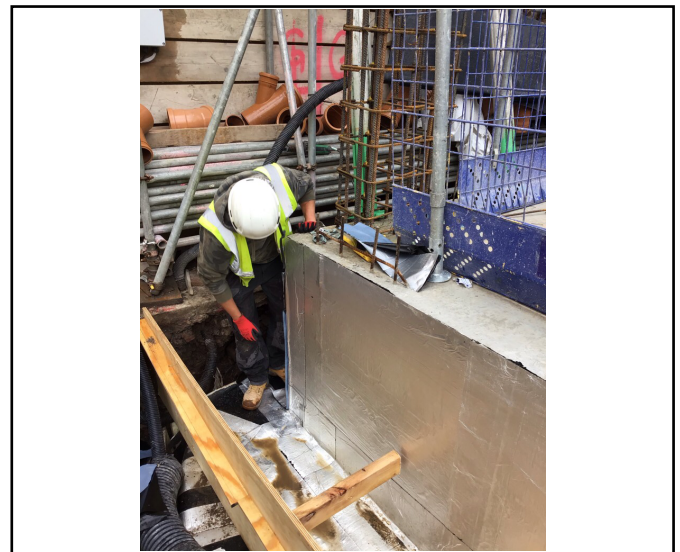
Installer applying GR SAM to South

toe
