The Royal Exchange  
Manchester

PPM Proposal Year 1

High Access

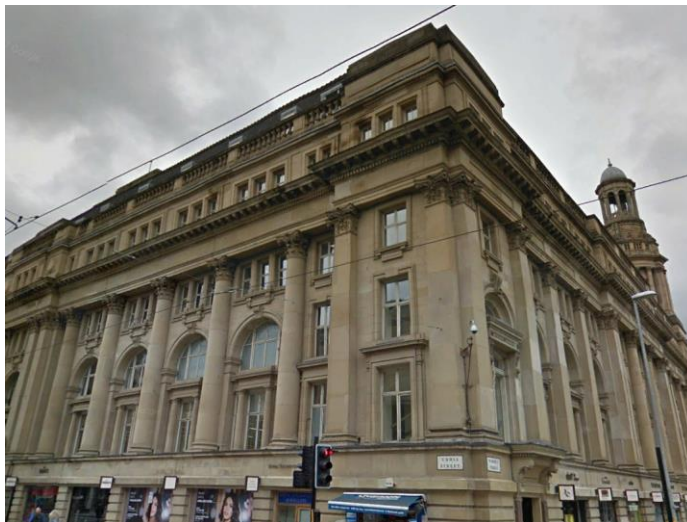
| Line Ref. | Main Element / Location Type | Main Element / Location | Element | Defect (Existing or Anticipated) | Brief Details of Work Item | High Access Quote |
|---|---|---|---|---|---|---|
| 8 | Full Façade | All elevations | Inspection and condition report | Annual Inspection | Inspect condition of stone work, lead work, windows and frames and all fixtures and | £14,500.00 |

- Operatives to complete inspection via MEWP
- Inspection of stone features, façade and cornice details.
- Inspection of window frames, sills and supporting features.
- Inspection of gutters, glazing and remaining wall mounted fixtures and fittings.
- Including flag poles, light fittings and other associated fixtures.
- Removal and make safe any loose or dangerous material.
- Measure up any defective stone spalling, broken glass or framework.
- Provision of condition report including all above features.
- Report broken down into elevations – client to provide blueprint drawings for operatives to use during inspection.

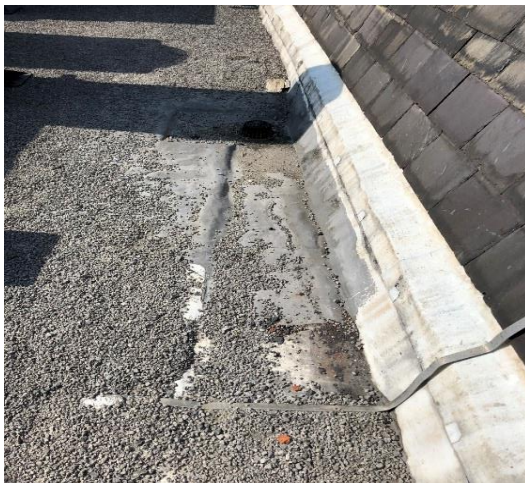
| Line Ref. | Main Element / Location Type | Main Element / Location | Element | Defect (Existing or Anticipated) | Brief Details of Work Item | High Access Quote |
|---|---|---|---|---|---|---|
| 53 | Roofs | Gullies main roof | Drainage Gullies | Silted gullies; vegetation growth | Clear gullies and remove vegetation | £560.00 |
| 54 | Roofs | Gullies main roof | Drainage Gullies | Missing grills | Supply and fit grills as required | £370.00 |

#### 53 - Cleaning of gullies:

Access to be gained via access internal methods.

Operatives using soft sweeping brushes to sweep through the gullies.

All waste is to be picked up using small shovels and placed in to waste sacks.

Once all are complete the waste sacks are to be taken to the high access van for disposal.

#### 54 - Supply and fit grills:

Supply and install new grills as required to outlets.

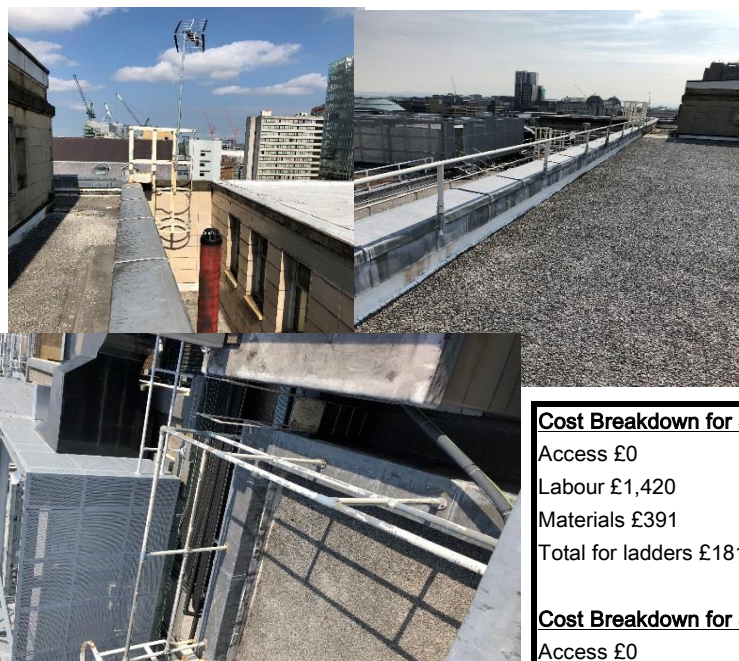
| Line Ref. | Main Element / Location Type | Main Element / Location | Element | Defect (Existing or Anticipated) | Brief Details of Work Item | High Access Quote |
|---|---|---|---|---|---|---|
| 58 | Roofs | Hand rails main roof | Paint finishes to hand rails | Peeling paint and corrosion | Redecorate hand rails | £3,198.00 |
| 59 | Roofs | Fixed ladders main roof | Paint finishes to ladders | Peeling paint and corrosion | Redecorate ladders | £1,811.00 |

Painting of hand rails, fix ladders:

A sample of the current paint will be taken, and colour matched from our supplier.

All rails will be hand sanded back to a firm feathered edge.

Any areas of exposed steel work will be treated using red oxide primer.

A primer will then be applied to the full rail.

Using the colour matched paint 2 x of weather shield paint will be applied.

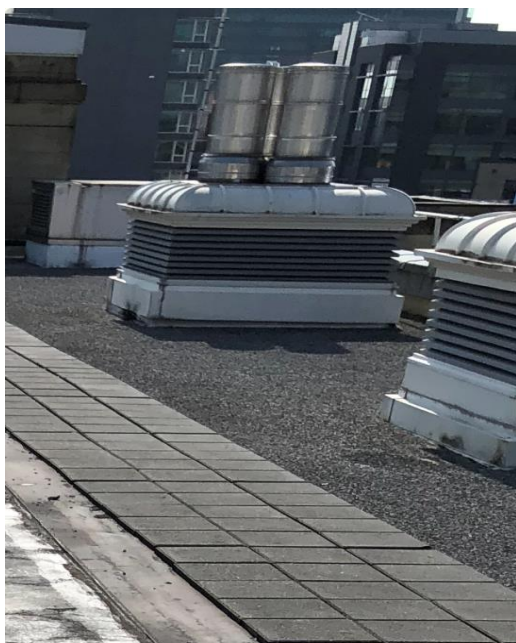
| Line Ref. | Main Element / Location Type | Main Element / Location | Element | Defect (Existing or Anticipated) | Brief Details of Work Item | High Access Quote |
|---|---|---|---|---|---|---|
| 62 | Roofs | Flue enclosures main roof | paint finishes to flue enclosures | peeling paint | Redecorate | £723.00 |

Painting of flue enclosures:

A sample of the current paint will be taken, and colour matched from our supplier.

All wooden doors and louvres to be scrapped back of loose paint.

They will then be sanded back to a firm feathered edge.

They will then be undercoated with 1 x coat.

Using the colour matched paint 2 x coats of exterior gloss will be applied.

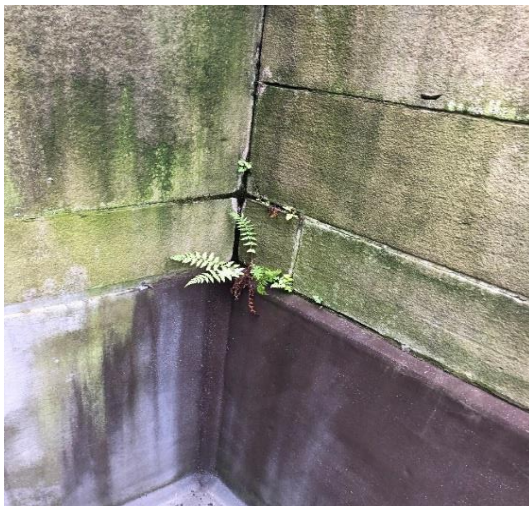
| Line Ref. | Main Element / Location Type | Main Element / Location | Element | Defect (Existing or Anticipated) | Brief Details of Work Item | High Access Quote |
|---|---|---|---|---|---|---|
| 67 | Roofs | 4th floor balconies generally | Drainage gullies | Silted gullies vegetation growth | Clear gullies and remove vegetation | £685.00 |
| 68 | Roofs | 4th floor balconies generally | Drainage gullies | Missing grills | Supply and fit grills | £370.00 |

Cleaning of gullies:

Access to be gained via access window on the 4th floor.

Operatives using soft sweeping brushes to sweep through the gullies.

All waste is to be picked up using small shovels and placed in to waste sacks.

Once all are complete the waste sacks are to be taken to the high access van for disposal.

Supply and install new grills to outlets where required

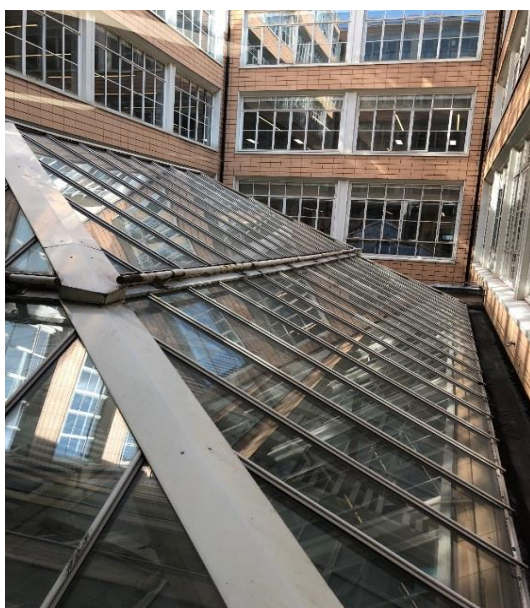
| Line Ref. | Main Element / Location Type | Main Element / Location | Element | Defect (Existing or Anticipated) | Brief Details of Work Item | High Access Quote |
|---|---|---|---|---|---|---|
| 130 | Lightwells | Glazed roof | Glazed roof section at base of central lightwell | Surface corrosion to metal | Remove corrosion treat surface and repaint | £2,587.00 |
| 131 | Lightwells | Glazed roof | Allowance for access to carry out repairs | Surface corrosion | Remove corrosion treat surface and repaint | £2,587.00 |

Using easi dec gantries access is to be gained to the atrium.  
A sample of paint is to be taken and colour matched from our supplier  
The metal support rails are to be hand sanded back to a firm feathered edge.  
Red oxide primer is to be applied to any areas of exposed steel.  
Using the colour matched paint 2 x coats of weather shield paint to be applied

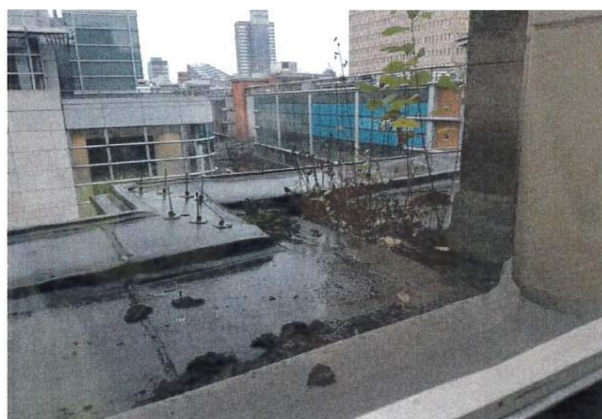
| Line Ref. | Main Element / Location Type | Main Element / Location | Element | Defect (Existing or Anticipated) | Brief Details of Work Item | High Access Quote |
|---|---|---|---|---|---|---|
| 18 & 31 | Roofs | 3rd floor cornice south & West | Drainage Gullies | Silted gullies; vegetation growth | Clear gullies and fit grilles as required | £885.00 |
| 43 | Roofs | 3rd floor cornice east | Asphalt covering | Splits failed historic repairs | Patch repairs | £1,210.00 |

Access to be gained via access window on the 4th floor.  
 Operatives using soft sweeping brushes to sweep through the gullies.  
 All waste is to be picked up using small shovels and placed in to waste sacks.  
 Once all are complete the waste sacks are to be taken to the high access van for disposal.  
 Supply and install new grilles as required to outlets.

Area to be swept clean of all loose material and waste it is then to be bagged in to waste sacks and removed from site.  
 All old failing repairs are to be removed.  
 Using grey mineral felt patches are to be cut to the required size and installed over the defective areas.

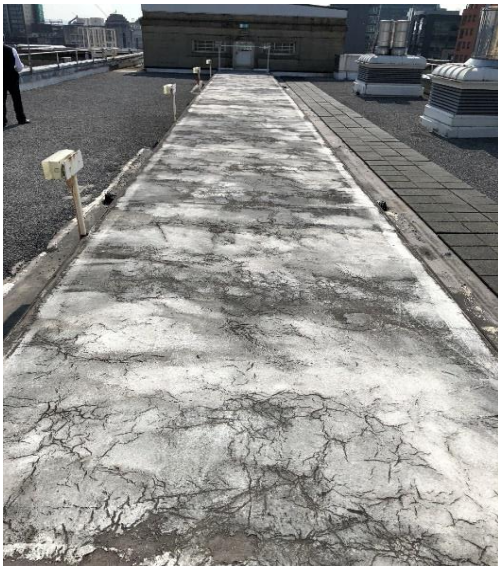
| Line Ref. | Main Element / Location Type | Main Element / Location | Element | Defect (Existing or Anticipated) | Brief Details of Work Item | High Access Quote |
|---|---|---|---|---|---|---|
| 55 | Roofs | Asphalt roof main roof | Reflective coatings | Flaking and degraded paint | Renew reflective paint | £2,051.00 |

Asphalt roof repairs:

Area to be swept clean of all loose material and waste it is to be then bagged in to waste sacks and removed from site.

The area is to be then thoroughly cleaned and allowed to dry

The reflective coating is then to be applied using 2 x coats roller applied ensuring a good coverage of 53microns per coat.

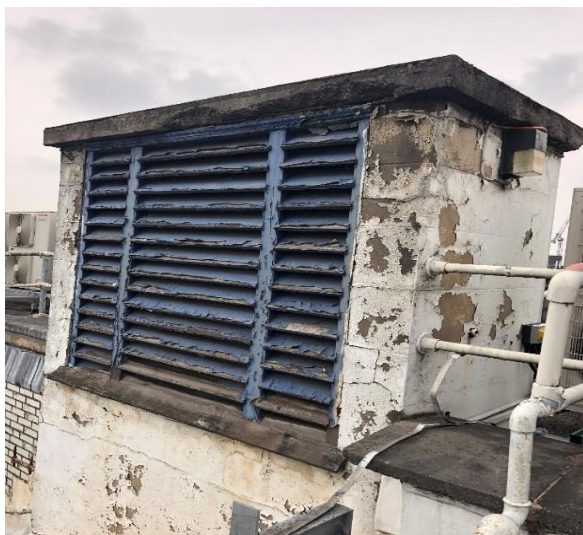
| Line Ref. | Main Element / Location Type | Main Element / Location | Element | Defect (Existing or Anticipated) | Brief Details of Work Item | High Access Quote |
|---|---|---|---|---|---|---|
| 60 | Roofs | External doors main roof | paint finishes to doors and frames | peeling paint | Redecorate | £900.00 |
| 61 | Roofs | Louvres main roof | Paint finishes to louvre | Peeling paint | Redecorate | £443.00 |

Painting of external doors, louvres main roof:

A sample of the current paint will be taken, and colour matched from our supplier.

All wooden doors and louvres to be scrapped back of loose paint.

They will then be sanded back to a firm feathered edge.

They will then be undercoated with 1 x coat.

Using the colour matched paint 2 x coats of exterior gloss will be applied.

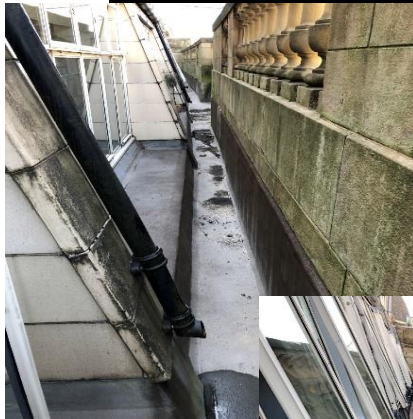
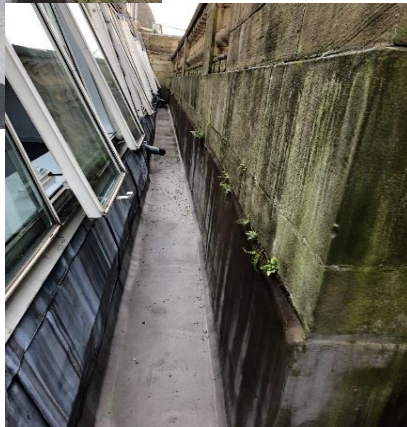
| Line Ref. | Main Element / Location Type | Main Element / Location | Element | Defect (Existing or Anticipated) | Brief Details of Work Item | High Access Quote |
|---|---|---|---|---|---|---|
| 65 | Roofs | 4 <sup>th</sup> floor balcony NE corner | Asphalt covering | Incomplete covering | Patch repairs to asphalt | £1,375.00 |
| 66 | Roofs | 4th floor balcony NE corner | Parapet walls | Vegetation growth and open joints to masonry | Remove vegetation and repoint | £965.00 |

#### Repairs to Asphalt:

Area to be swept clean of all loose material and waste it is then to be bagged in to waste sacks and removed from site.

All old failing repairs are to be removed.

Using grey mineral felt patches are to be cut to the required size and installed over the defective areas.

#### Vegetation removal and re pointing:

All vegetation to be removed and bagged in waste sacks for removal.

Weed killing to be sprayed to the areas and allowed to dry.

Using sand and cement mix with stone colouring all areas of damaged mortar to be re pointed

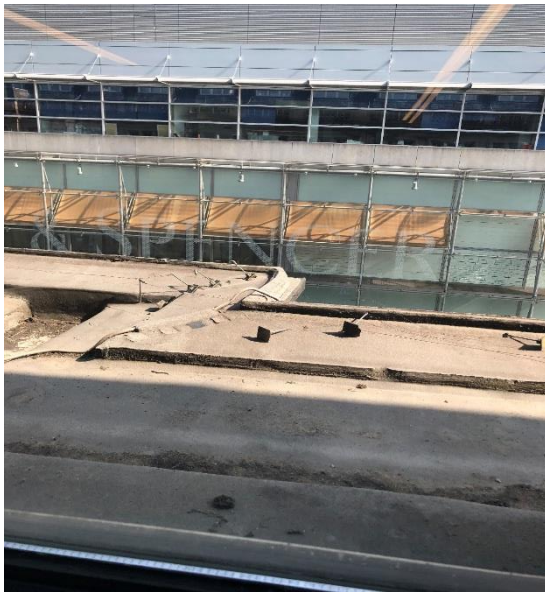
| Line Ref. | Main Element / Location Type | Main Element / Location | Element | Defect (Existing or Anticipated) | Brief Details of Work Item | High Access Quote |
|---|---|---|---|---|---|---|
| 69 | Roofs | 4th floor balconies generally | Anti-bird wires | Broken and detached | Repair | £1,500.00 |

The bird wire is still in place however the mounting posts have become dislodged.

Clean the base of the mounting posts of all old silicone and wipe with isopropyl cleaner.

Clean the surface where the mounts are to be positioned on the stone work using hot water.

Apply a small amount of clear low modulus silicone adhesive.

Once the mount is securely stuck back in to its original position the original bird wire is to be fed back through the mounting posts.

Once the wire is through the final fixing post it is to be crimped with a copper crimp.

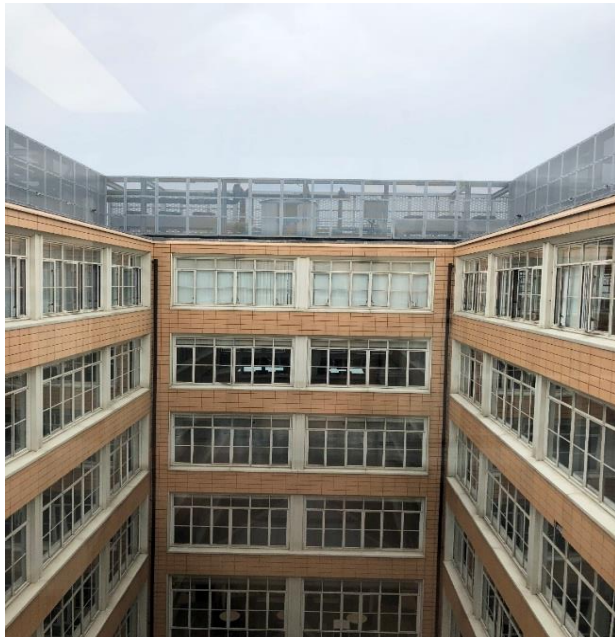
| Line Ref. | Main Element / Location Type | Main Element / Location | Element | Defect (Existing or Anticipated) | Brief Details of Work Item | High Access Quote |
|---|---|---|---|---|---|---|
| 132 | Lightwells | Lightwell elevations | Decorative tiles to lightwells | Isolated slipped missing tiles | Isolated slipped missing tiles | £1,010.00 |
| 133 | Lightwells | Lightwell elevations | Decorative tiles to lightwells | Isolated slipped missing tiles | Isolated slipped missing tiles | £1,010.00 |

Inspecting and replacing cladding tiles:

Access via abseiling

Inspect tiled facades and ensure no tiles are loose or damaged

Supply and install new replacement tiles where required (tiles will need to be sourced due to age of building this might be a problem any O&Ms manual would be helpful)
