## BS5837:2012 TREE SURVEY / Arboricultural Impact Assessment

Document No: 800711

Version 2, 03/04/2022

Site Address:  
FS304 Levenshulme Service Station  
Stockport Road, Manchester M19 2RE

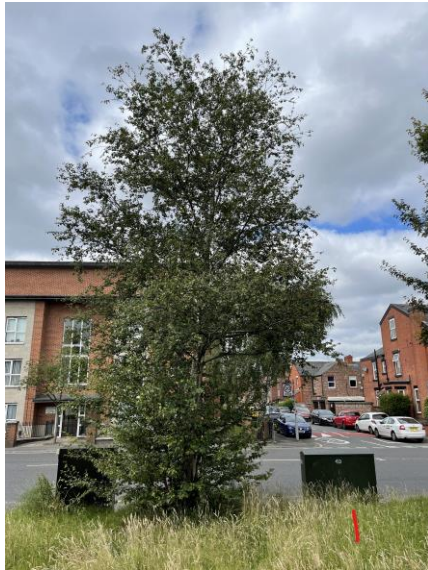
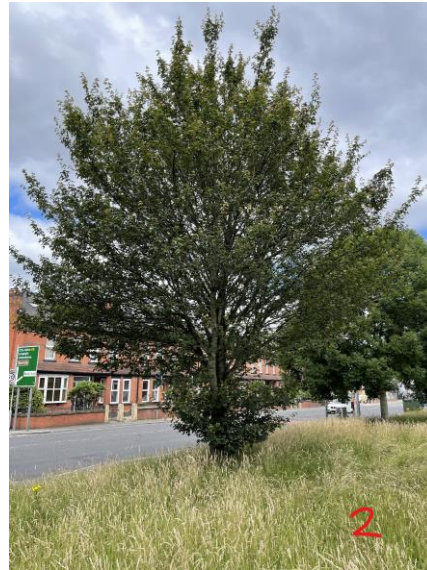
Trees 1 Birch and 2 Field  
Maple to be retained

| Tree ID | Common Name | Latin Name | Maturity | Likely Bat Habitat | Height (m) | Height of first significant branch (m) | Number of Stems | Stem 1 (mm) | Spread - N E S W (m) | CH (m) | Crown | Stem | Basal Area | Cat | Life Expectancy | Subcategories | Phys Condition | Comment |
|---|---|---|---|---|---|---|---|---|---|---|---|---|---|---|---|---|---|---|
| 1 | Silver Birch | Betula pendula | Semi-mature | No | 9.5 | 2 | 1 | 240 | 2.8 | 2.5 | Fair | Fair | Fair | C | 20 to 40 yrs | 2 Landscape Values | Fair | Mediocre tree of limited value |
| 2 | Field Maple | Acer campestre | Semi-mature | No | 10 | 2.4 | 1 | 280 | 4 | 2.4 | Good | Fair | Good | C | 20 to 40 yrs | 2 Landscape Values | Fair | Mediocre tree, Steel mesh guard embedded in the trunk |

| Tree Removal, Retention (and Treeworks Required) | | |
|---|---|---|
| T1 Birch | | Retain |
| T2 Field Maple | | Retain |

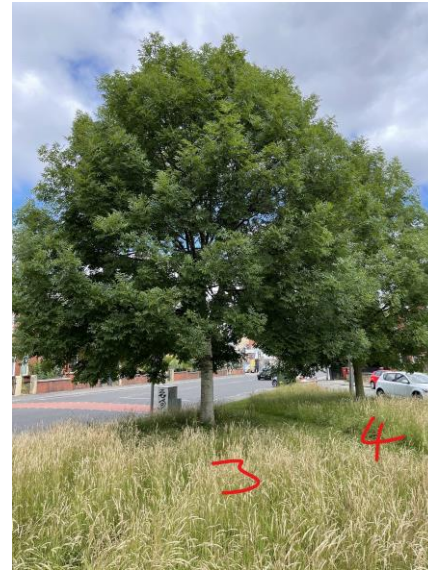
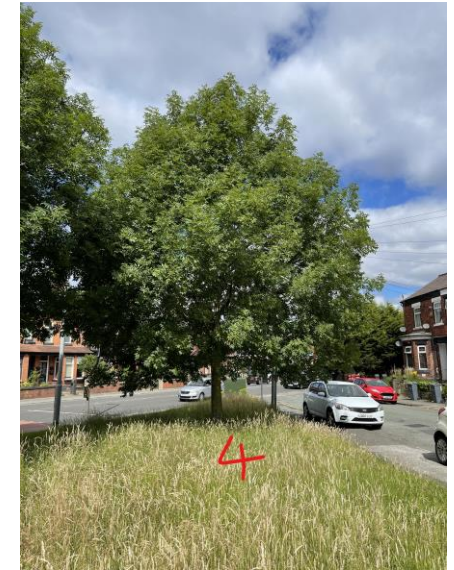
Trees 3 Ash and 4 Ash to be  
retained

| Tree ID | Common Name | Latin Name | Maturity | Likely Bat Habitat | Height (m) | Height of first significant branch (m) | Number of Stems | Stem 1 (mm) | Spread - N E S W (m) | CH (m) | Crown | Stem | Basal Area | Cat | Life Expectancy | Subcategories | Phys Condition | Comment |
|---|---|---|---|---|---|---|---|---|---|---|---|---|---|---|---|---|---|---|
| 3 | Common Ash | Fraxinus excelsior | Semi-mature | No | 10 | 2.2 | 1 | 295 | 4 | 1.5 | Good | Good | Good | C | 20 to 40 yrs | 2 Landscape Values | Good | Reasonable quality tree, no evidence yet of Ash Dieback. |

| Tree Removal, Retention (and Treeworks Required) | | |
|---|---|---|
| T3 Ash | | Retain, Raise the crown to 4m and a light reduction required against the GRP enclosure to allow for installation |
| T4 Ash | | Retain, Raise the crown to 4m and a light reduction required against the GRP enclosure to allow for installation |

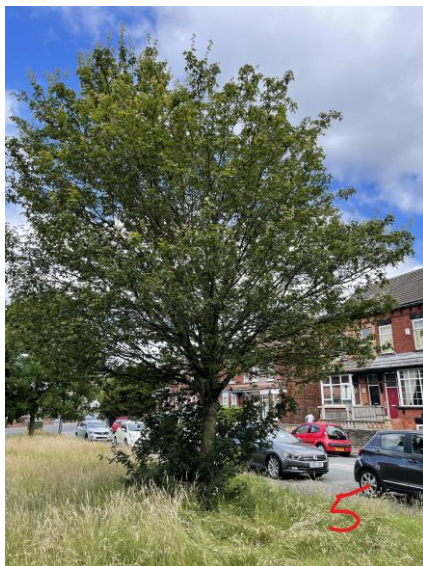
Tree 5 Field Maple to be retained

| Tree Removal, Retention (and Treeworks Required) | | |
|---|---|---|
| T5 Field Maple | | Retain, Raise the crown to 4m and a light reduction required against the GRP enclosure to allow for installation |

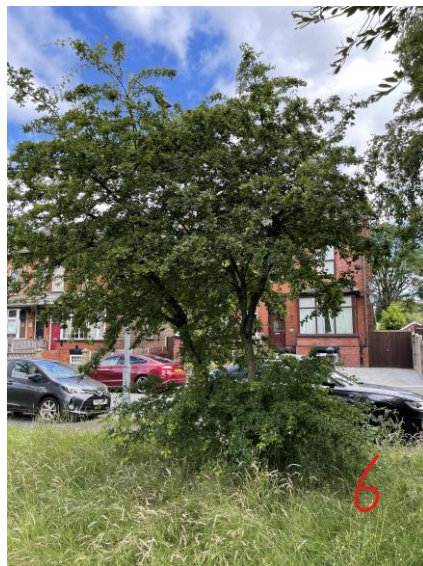
Tree 6 Hawthorn to be retained

| Tree Removal, Retention (and Treeworks Required) | | |
|---|---|---|
| T6 Hawthorn | | Retain |

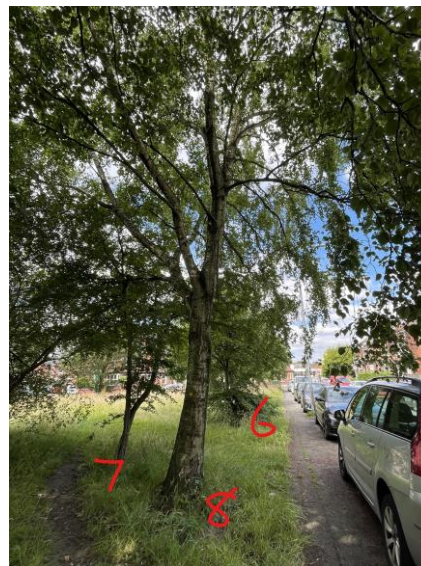
T8 and T10 are mature Birch that have an expected life of 10 to 20 years. They are required to have their crown lightly raised to install the EV Charging bays.

Tree 7 Hawthorn to be retained  
Tree 8 Birch to be crown raised

| Tree Removal, Retention (and Treeworks Required) | | |
|---|---|---|
| T7 Hawthorn | | Retain |
| T8 Birch | | Raise Crown |

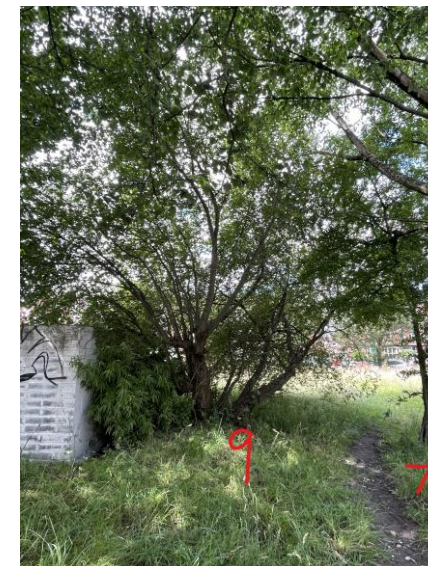
Tree 9 Willow to be removed

| Tree Removal, Retention (and Treeworks Required) | | |
|---|---|---|
| T9 Goat Willow | Remove | |

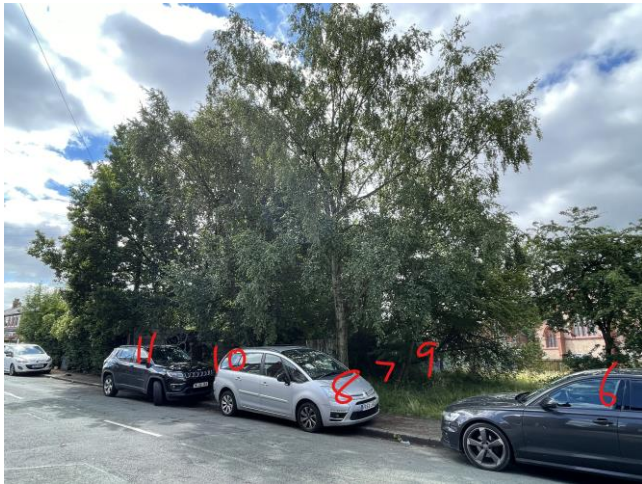
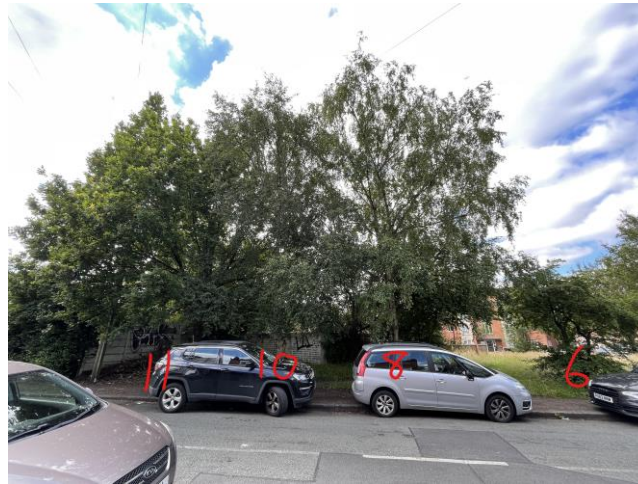
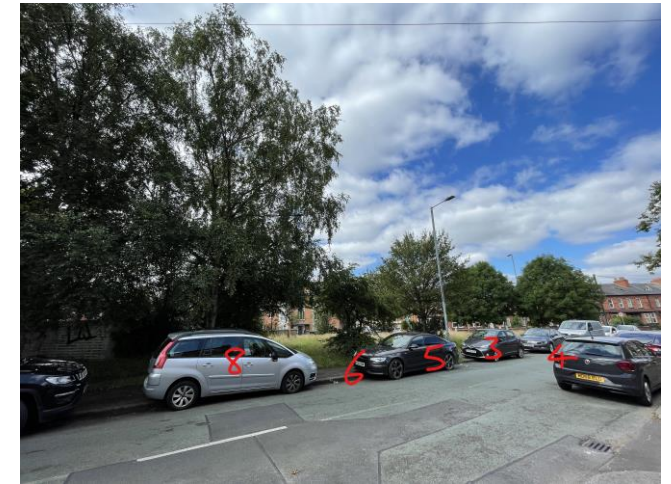
T11 is and Early Mature Oak that will required to have its crown lightly raised to allow the installation of the EV Charging Bays.

Street scene to show tree locations along Cringle Road  
 Tree 6 Hawthorn, to be retained  
 Tree 7 Hawthorn, to be retained  
 Tree 8 Birch, to be crown raised  
 Tree 9 Willow, to be removed  
 Tree 10 Birch, to be crown raised  
 Tree 11 Oak, to be crown raised

| Tree Removal, Retention (and Treeworks Required) | | |
|---|---|---|
| T10 Birch | | Raise Crown |
| T11 Oak | | Raise Crown |

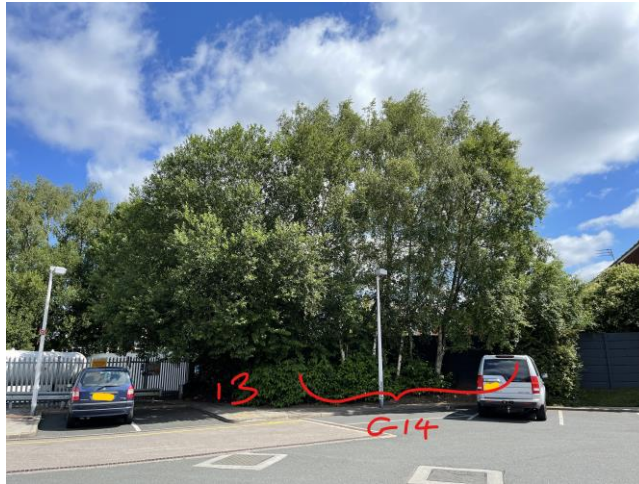
Adjacent to the customer parking is a large mature Goat Willow, growing out on a lean to the car parking. This tree is full mature with limited safe useful life.

T13 is a full mature Goat Willow, Single trunk, bifurcating inclined with a heavy lean to the PFS hard standing. There is limited safe useful life for this tree. The recommendation is that while it may last 10years or more, it is becoming an increasing liability and should be removed regardless of any proposed development.

Tree 13 Goat Willow, to be removed

| Tree ID | Common Name | Latin Name | Maturity | Likely Bat Habitat | Height (m) | Height of first significant branch (m) | Number of Stems | Stem 1 (mm) | Spread - N E S W (m) | CH (m) | Crown | Stem | Basal Area | Cat | Life Expectancy | Subcategories | Phys Condition | Comment |
|---|---|---|---|---|---|---|---|---|---|---|---|---|---|---|---|---|---|---|
| 13 | Goat Willow | Salix caprea | Mature | No | 13 | 4 | 1 | 570 | 4 2 5 8 | 1.5 | Fair | Fair | Poor | C | 10 to 20 yrs | 2 Landscape Values | Fair | Large mature tree, leaning out to the forecourt. Limited life expectancy |

| Tree Removal, Retention (and Treeworks Required) | | |
|---|---|---|
| T13 Goat Willow | Remove | |

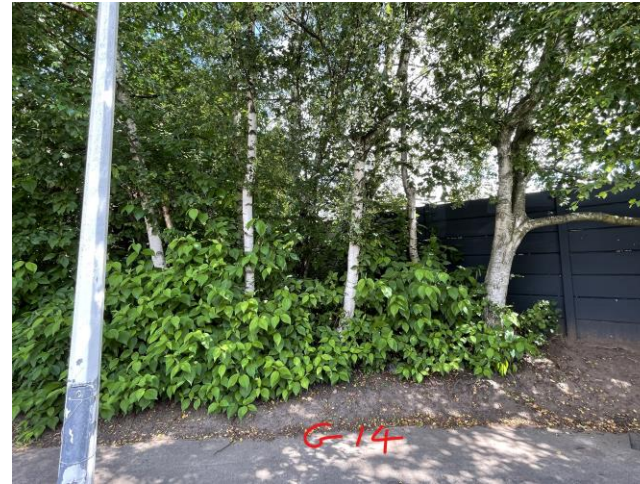
G14 is a densely planted group of Birches that are crowded, leading individually to bad form. The edge trees are typical edge trees with branches towards the outside of the group.

The group of Birch G14 is recommended to be removed as a group. The planting is dense, the growth is therefore affected in each individual tree. Removal of just a selected few to install the Vac unit would damage the roots of any remaining trees, hence removal of the group as a whole.

G14, Crowded group of young Birch. The edge trees are mediocre and unbalanced. To be removed

| Tree ID | Common Name | Latin Name | Maturity | Likely Bat Habitat | Height (m) | Height of first significant branch (m) | Number of Stems | Stem 1 (mm) | Spread - N E S W (m) | CH (m) | Crown | Stem | Basal Area | Cat | Life Expectancy | Subcategories | Phys Condition | Comment |
|---|---|---|---|---|---|---|---|---|---|---|---|---|---|---|---|---|---|---|
| G14 | Birch | Betula pendula | Semi mature to mature | No | 14 | Varies from 1.5 | 1 | 140+ | Group spread as per the map | 1.5 | Fair | Fair | Fair | C | 20 to 40 yrs | 2 Landscape values | Good | Group of variable trees of variable maturity planted too close together with no room to develop properly, edge trees unbalanced due to group shading. |

| Tree Removal, Retention (and Treeworks Required) | | |
|---|---|---|
| G14 Birch Group | Remove | |
