## Potential Bat Roost Assessment Report

14A Kenworthy Lane  
Northenden  
Wythenshawe  
Manchester  
M22 4EJ

Job Ref: 21038-A

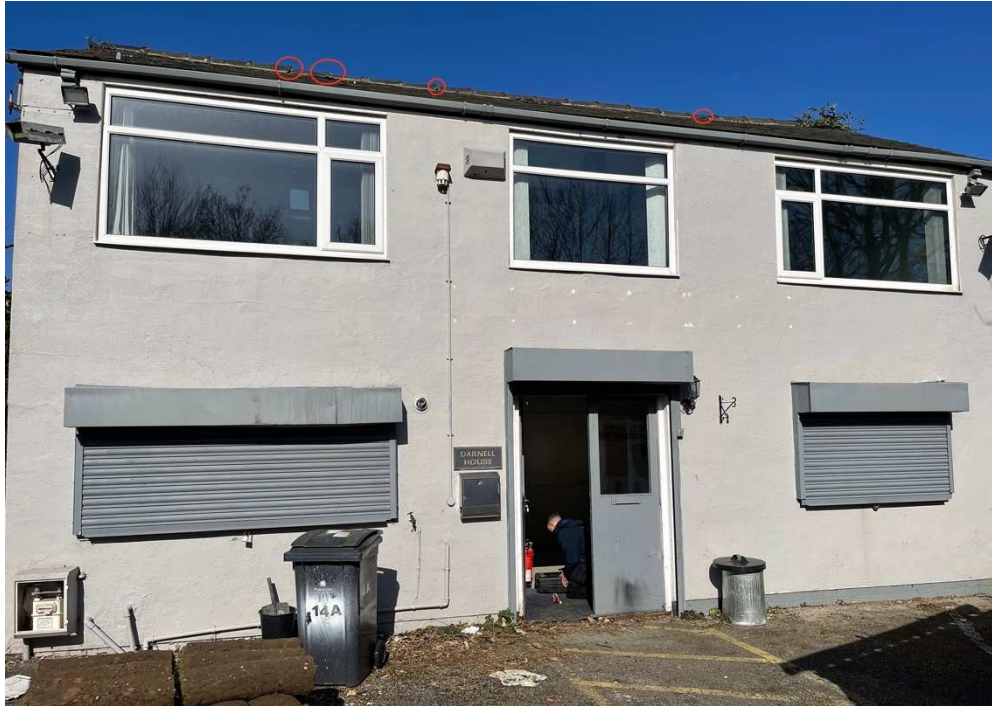
- 8.2 The building has a pitched roof with slate tiles and ridge tiles. Tiles are intact on both aspects, a few of the ridge tiles are missing the mortar leaving access to small void gaps on both aspects.

Plate 1: Missing mortar on ridge tiles at various locations

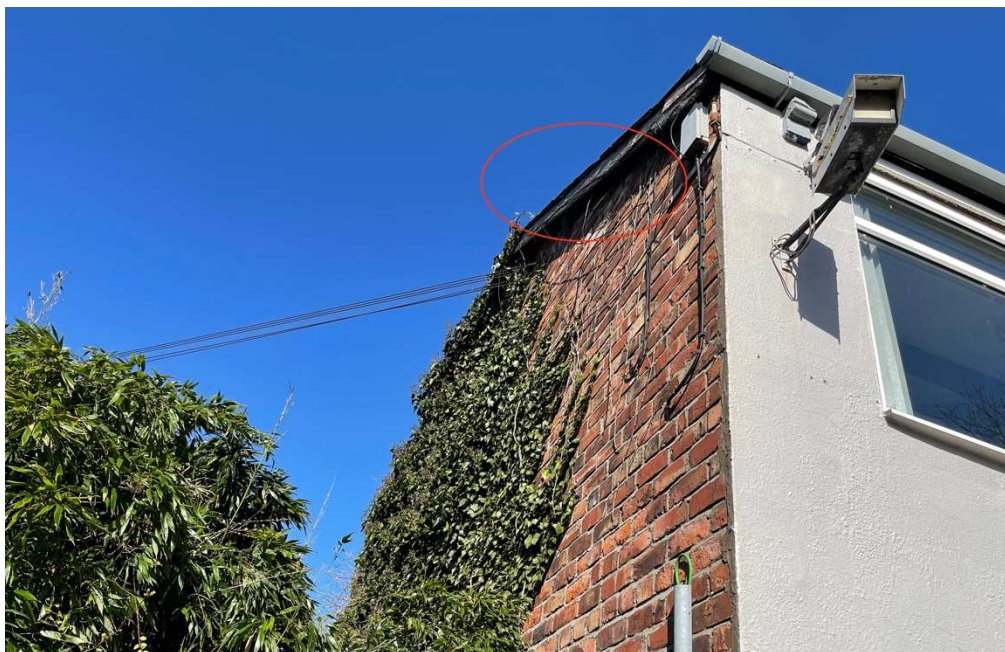
- 8.3 A wooden fascia board is present on all aspects of the building. The fascia board is intact and well-sealed on the front and rear of building but has few gaps on the gable ends of the building the gaps are of a suitable size for a potential roost feature.

Plate 2: wooden fascia on southern aspect gable end forms small cavities where it is fixed to the wall

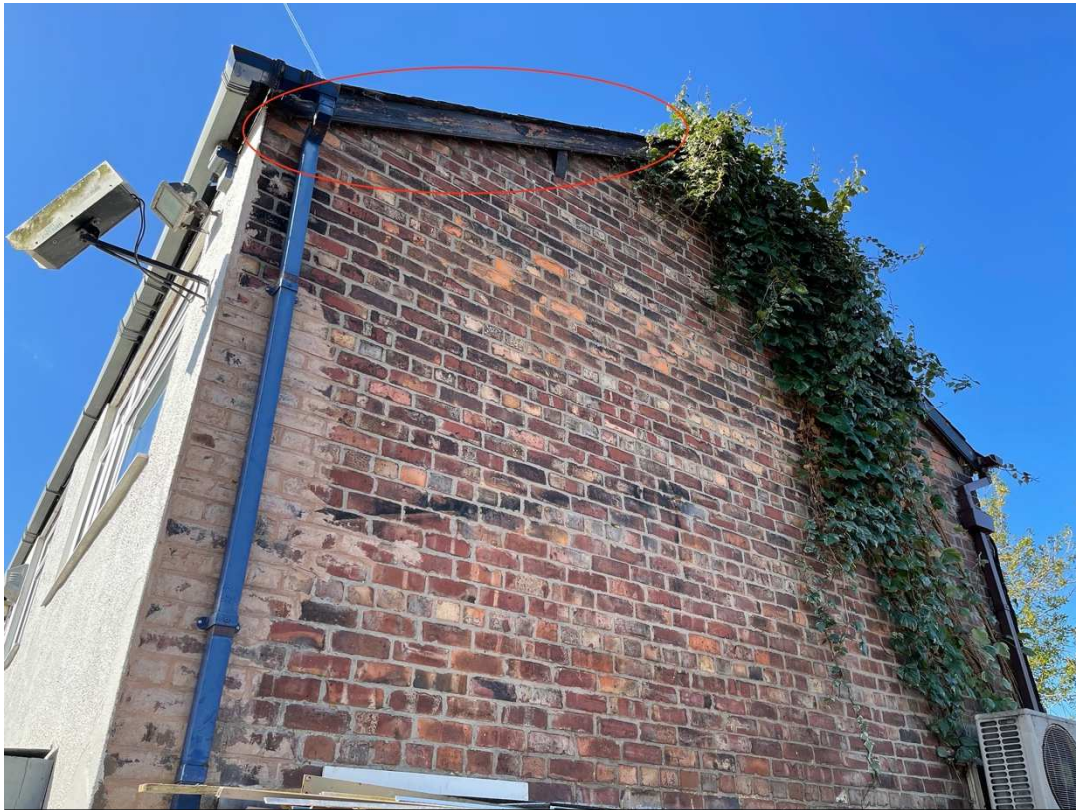
Plate 3: wooden fascia on southern aspect gable end forms small cavities where it is fixed to the wall.

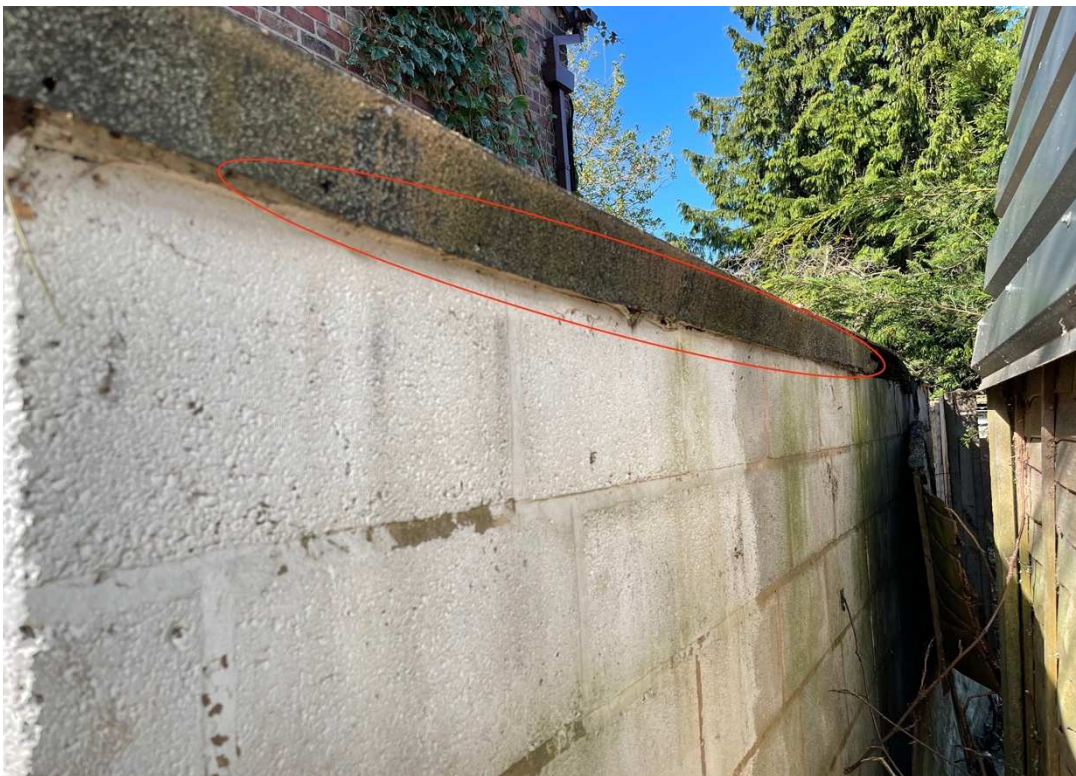
- 8.5 PVC windows and doors are all intact and well-sealed. Roller shutters are present on the ground floor windows and door.
- 8.6 A flat felt-roofed single-storey storage outbuilding is annexed to the north of the building. This is constructed from breezeblock and mortar, all intact. Parts of the felt roof has lifted at the edge and the wooden fascia board has a few small gaps. The potential features are in close proximity to an adjacent fence.

Plate 4: Overhanging felt and damage to wooden fascia behind forms gaps

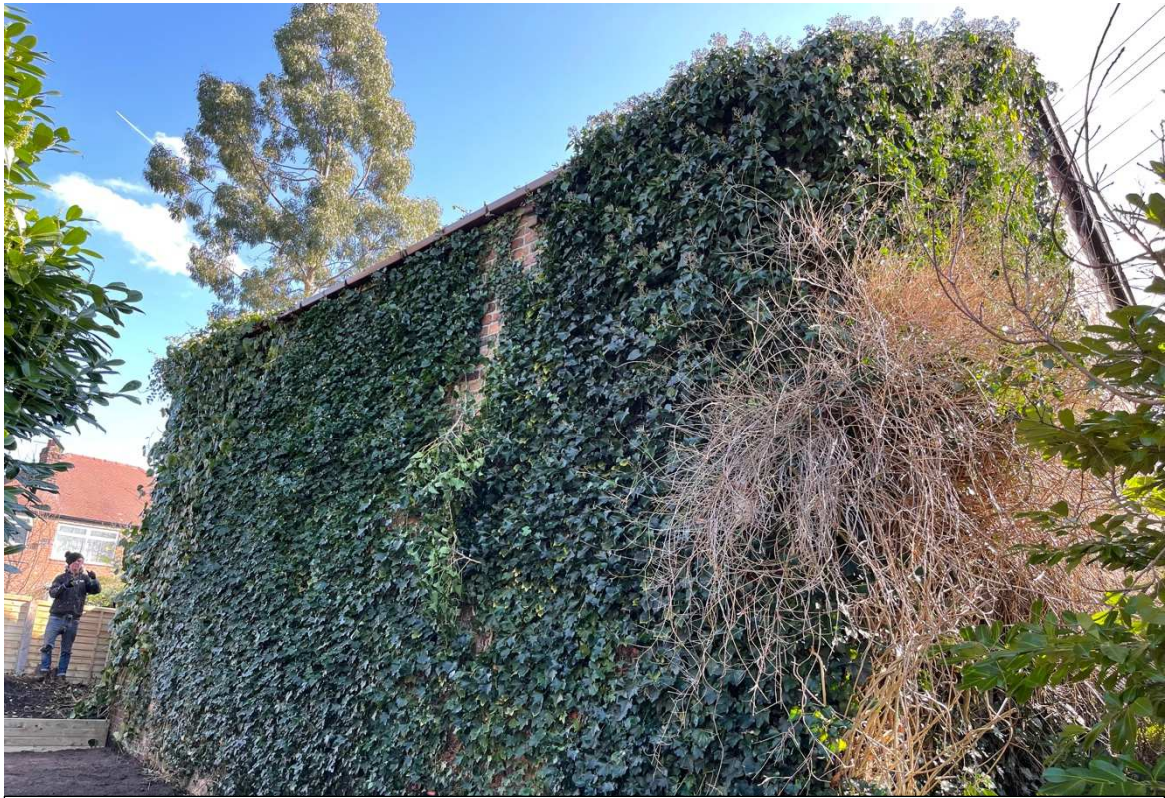
- 8.4 Ivy has grown on the north, western and eastern aspects of the building partially obscuring the wooden fascia board and brickwork mortar, however the ivy is thin and what can be seen is all intact.

Plate 5: Ivy cover restricts views of other potential features
