# GEOSHIELD

## Verification Report

McAlear & Rushe

101 Charles Street

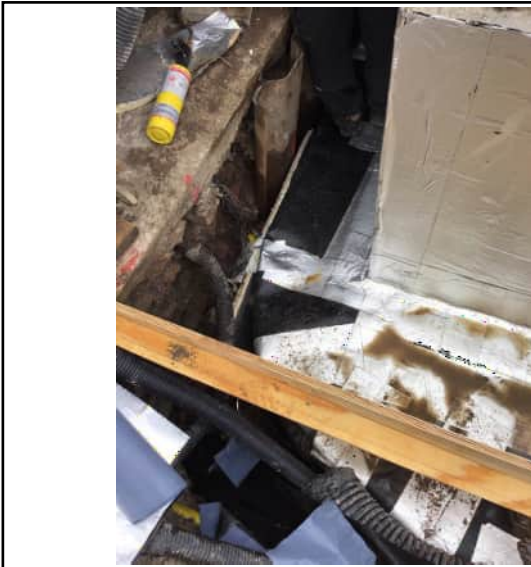
Left photo) this shows the corner of the East and South Toe Detail, the GR SAM has been applied vertically down and lapped onto the DPC. The DPC has then been sealed using GR SAM.

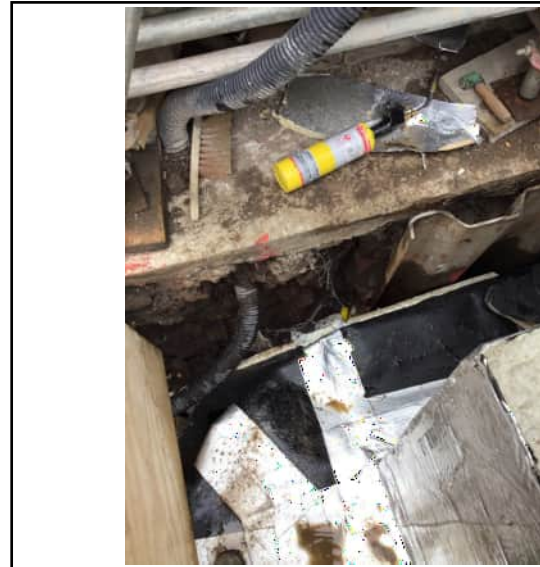
Right photo) overview of the corner and DPC
