**Report No:** LTM0263.ATN.02

**Project:** 623 Burnage Lane, Manchester, M19

# Arboricultural Technical Note

**Re 623 Burnage Lane Manchester-Structural Assessment of Cracking**

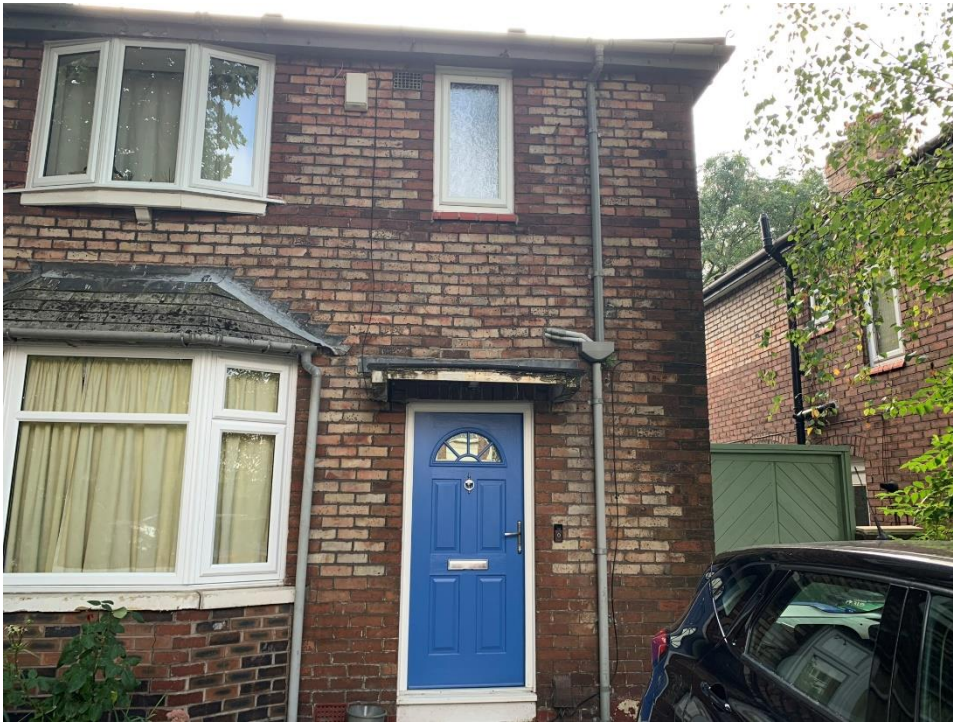
**Photograph 1**

External inspection to the front of the property shows that in general the masonry dips at the gable corner.

The dip in the masonry bed joints at the front corner of the property is old and not considered to have been caused by any recent movement of the structure. It is possible that the wall was originally built this way.

Front Elevation

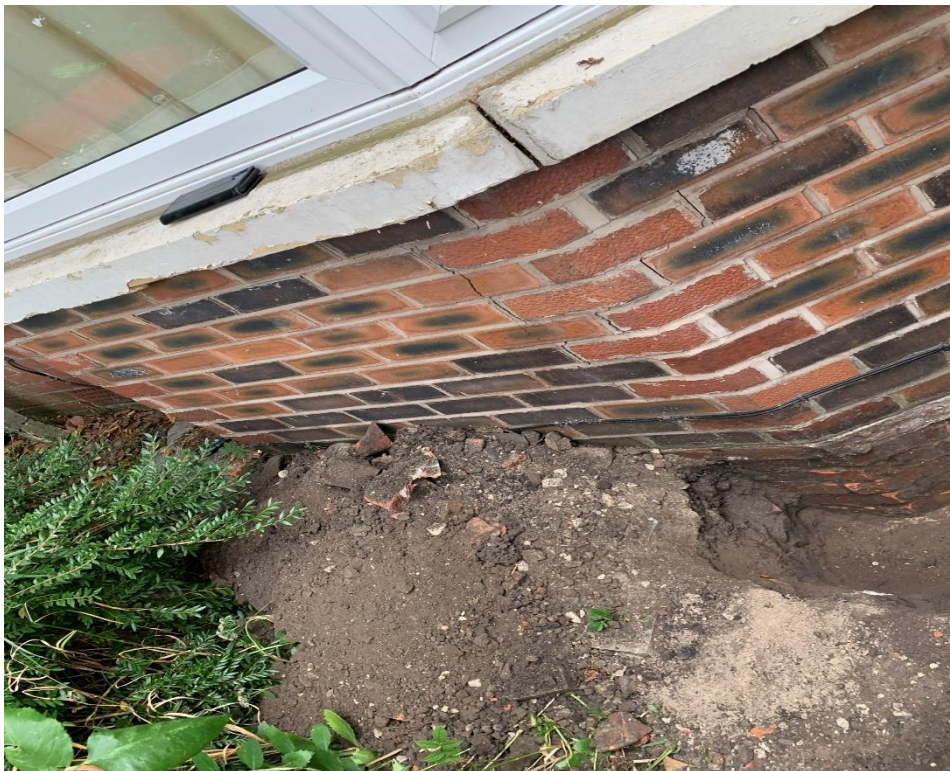
**Photograph 2**

From ground level to cill level the front of the bay window has been re-built. There is a near vertical crack on the lower right-hand side of the bay. The crack is 2- 3mm wide and travels from ground level to the underside of the cill. The joint in the concrete cill above the crack has opened to 10mm wide.

The damage to the bay window has been caused by root damage from the tree in the neighbouring front garden. The root exposed in the trial pit has applied pressure on the base of the wall causing cracking and movement.

Bottom of Bay Window

It is recommended that a trial trench is excavated 1m away from the front of the property to check for any more roots. An Arboriculturist should be consulted to advise on whether the roots can be severed without killing the tree and on an appropriate root barrier that could be installed to prevent further damage.

Once the root barrier has been installed it is advised that the masonry at the bottom of the bay window is rebuilt with a brick to match the brick used on the front elevation.

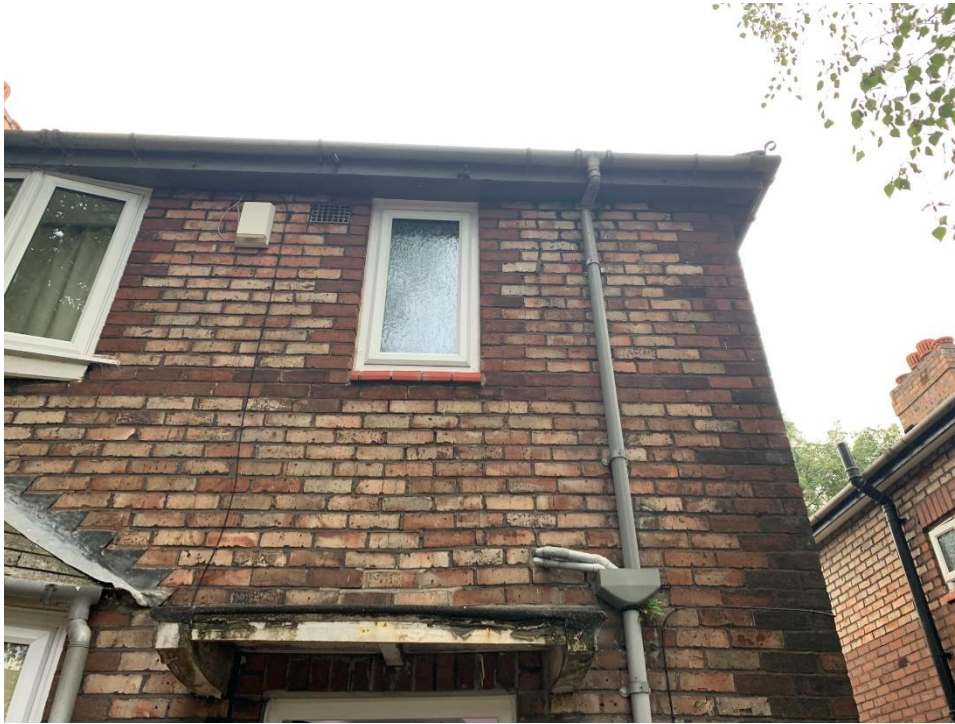
**Photograph 3**

The brick above the front door is cracked. Diagonal cracks, 2-3mm wide have formed above the door and the bricks above the door opening have dropped.

The cracking of the masonry above the front door and internally to the front of the hallway and in the upstairs bathroom is caused by the failure of the lintel above the front door. It is recommended that the lintel is replaced with a new proprietary lintel sized accordingly. The masonry could be repaired using crack stitching techniques however a better solution would be to re-build the masonry locally.

Masonry above Front Door

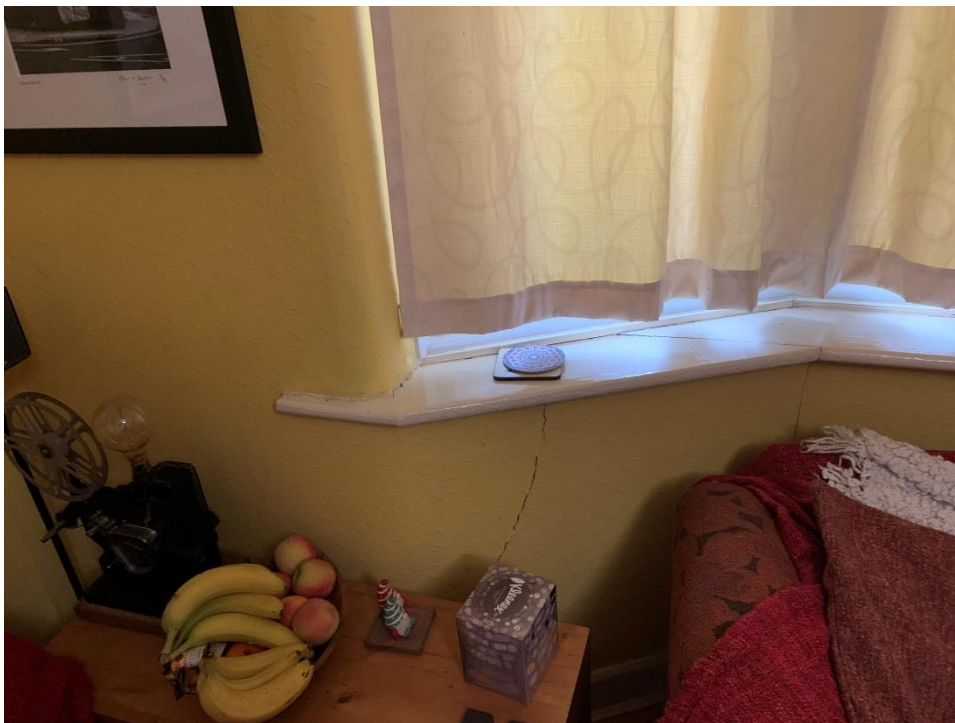
**Photograph 4**

Internal inspection of the front room shows cracking approximately 2-3mm wide in the bay window wall below cill level. There is also cracking at higher level at the junction between the hall wall and the front wall. Some hairline cracking as observed in the ceiling above the bay window.

Crack to Inside of Bay Window

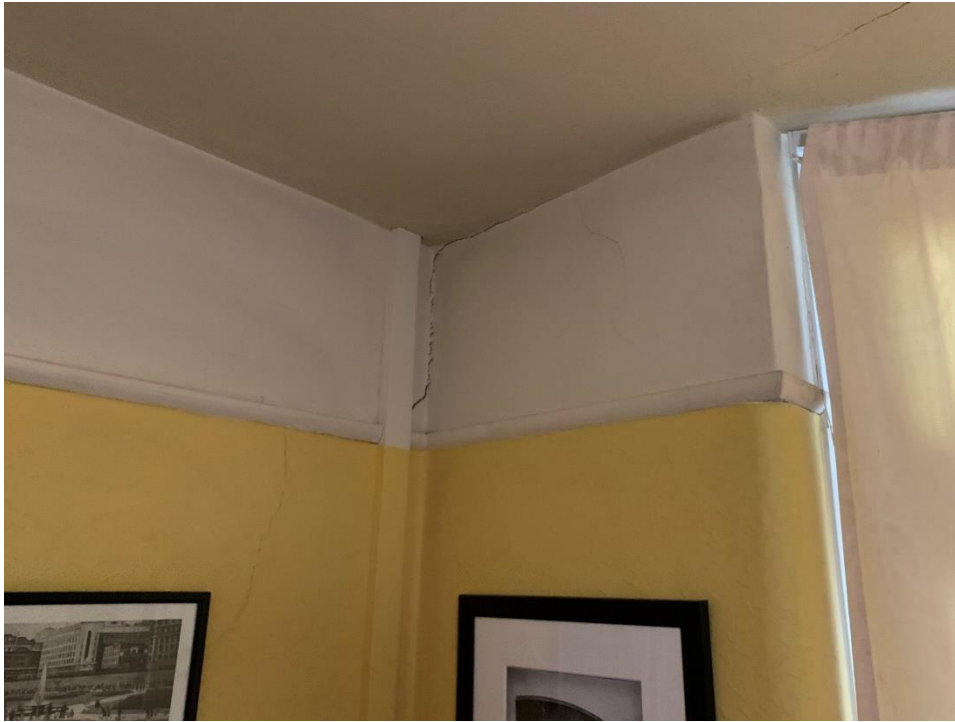
**Photograph 5**

Crack at hall wall,

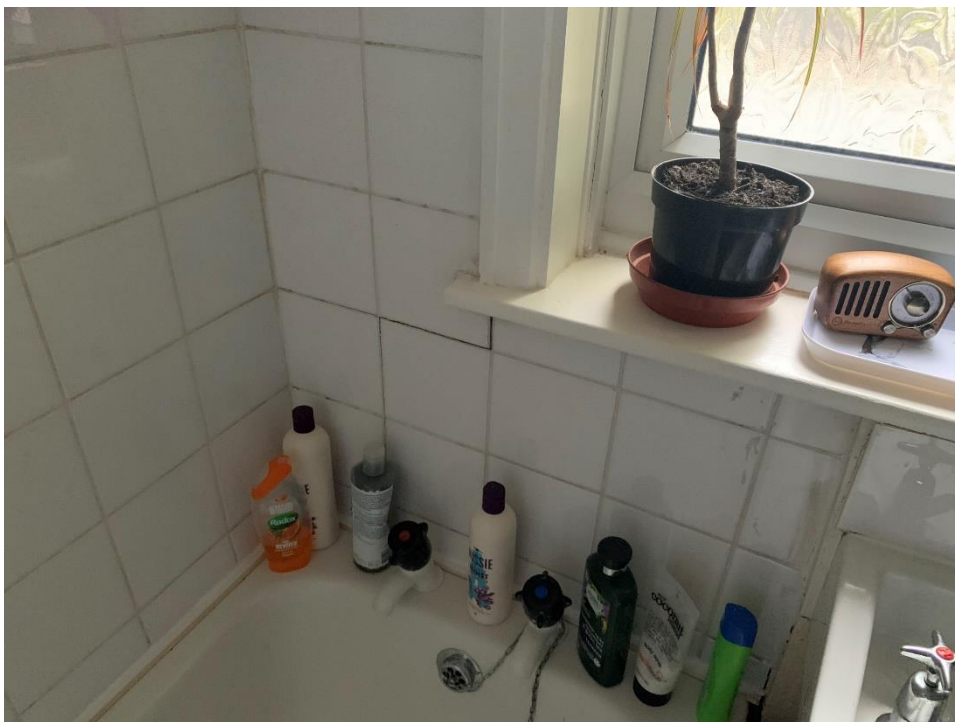
**Photograph 6**

Upstairs the bathroom faces onto the front of the property. Cracking has formed around the window to the front elevation. Lower down the wall the joints in the tiling have opened.

Cracking to Tiling in Bathroom

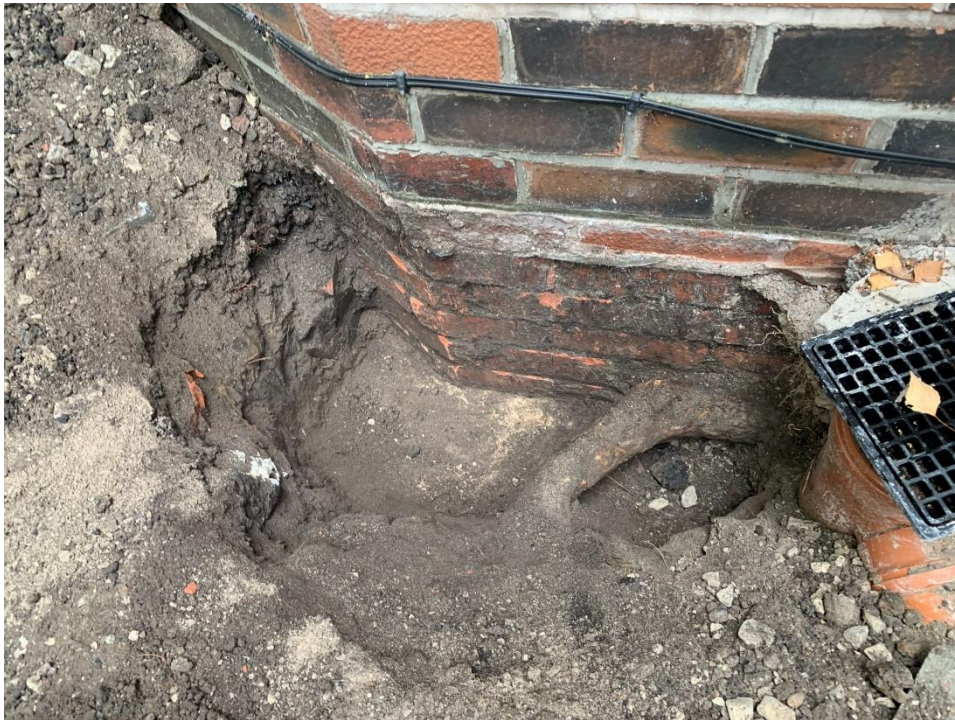
**Photograph 4**

At a depth of approximately 300mm below ground level a tree root was uncovered. The root was measured at 75mm in diameter and was found to travel in a direction towards the bay window wall and then running along the wall behind the gulley.

Trial Pit Showing Root

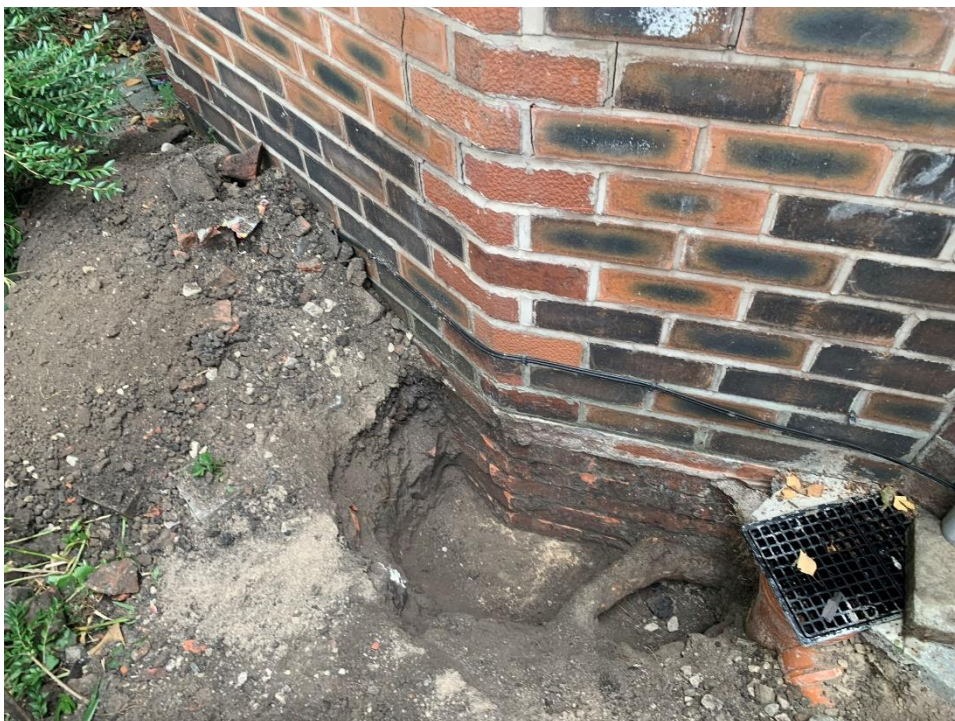
**Photograph 4**

Trial Pit with Root and Crack Shown

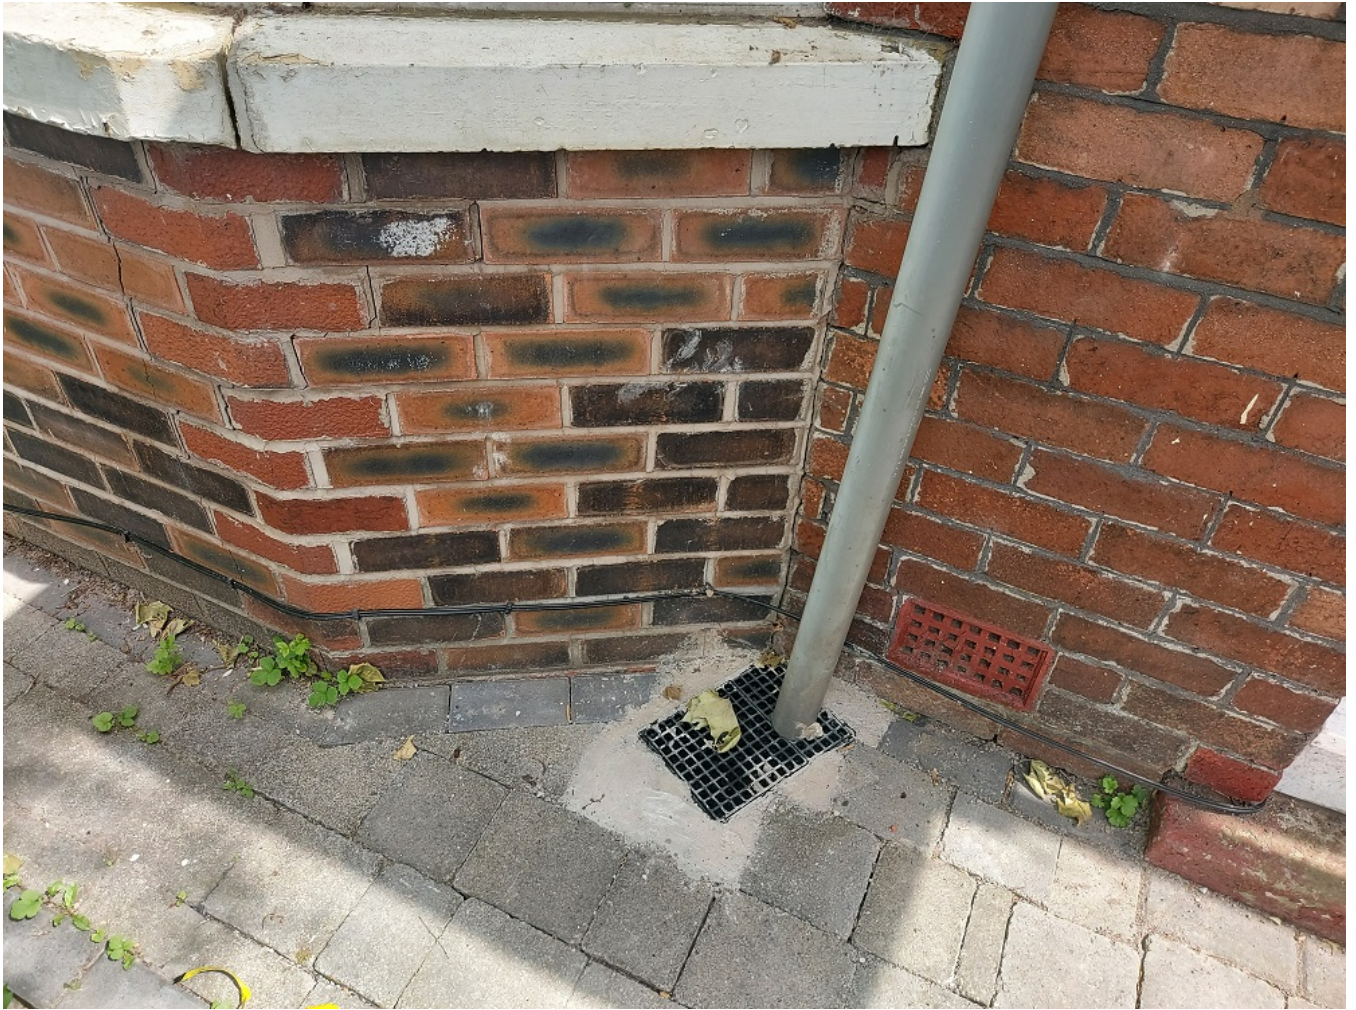
This report attributes the cracking in the bay window brickwork to root damage through direct pressure

*Figure 1 Cracking is evident in the brickwork of the bay windows*

Prune roots at a distance no greater than 1m from 623 Burnage Lane and install root barrier.

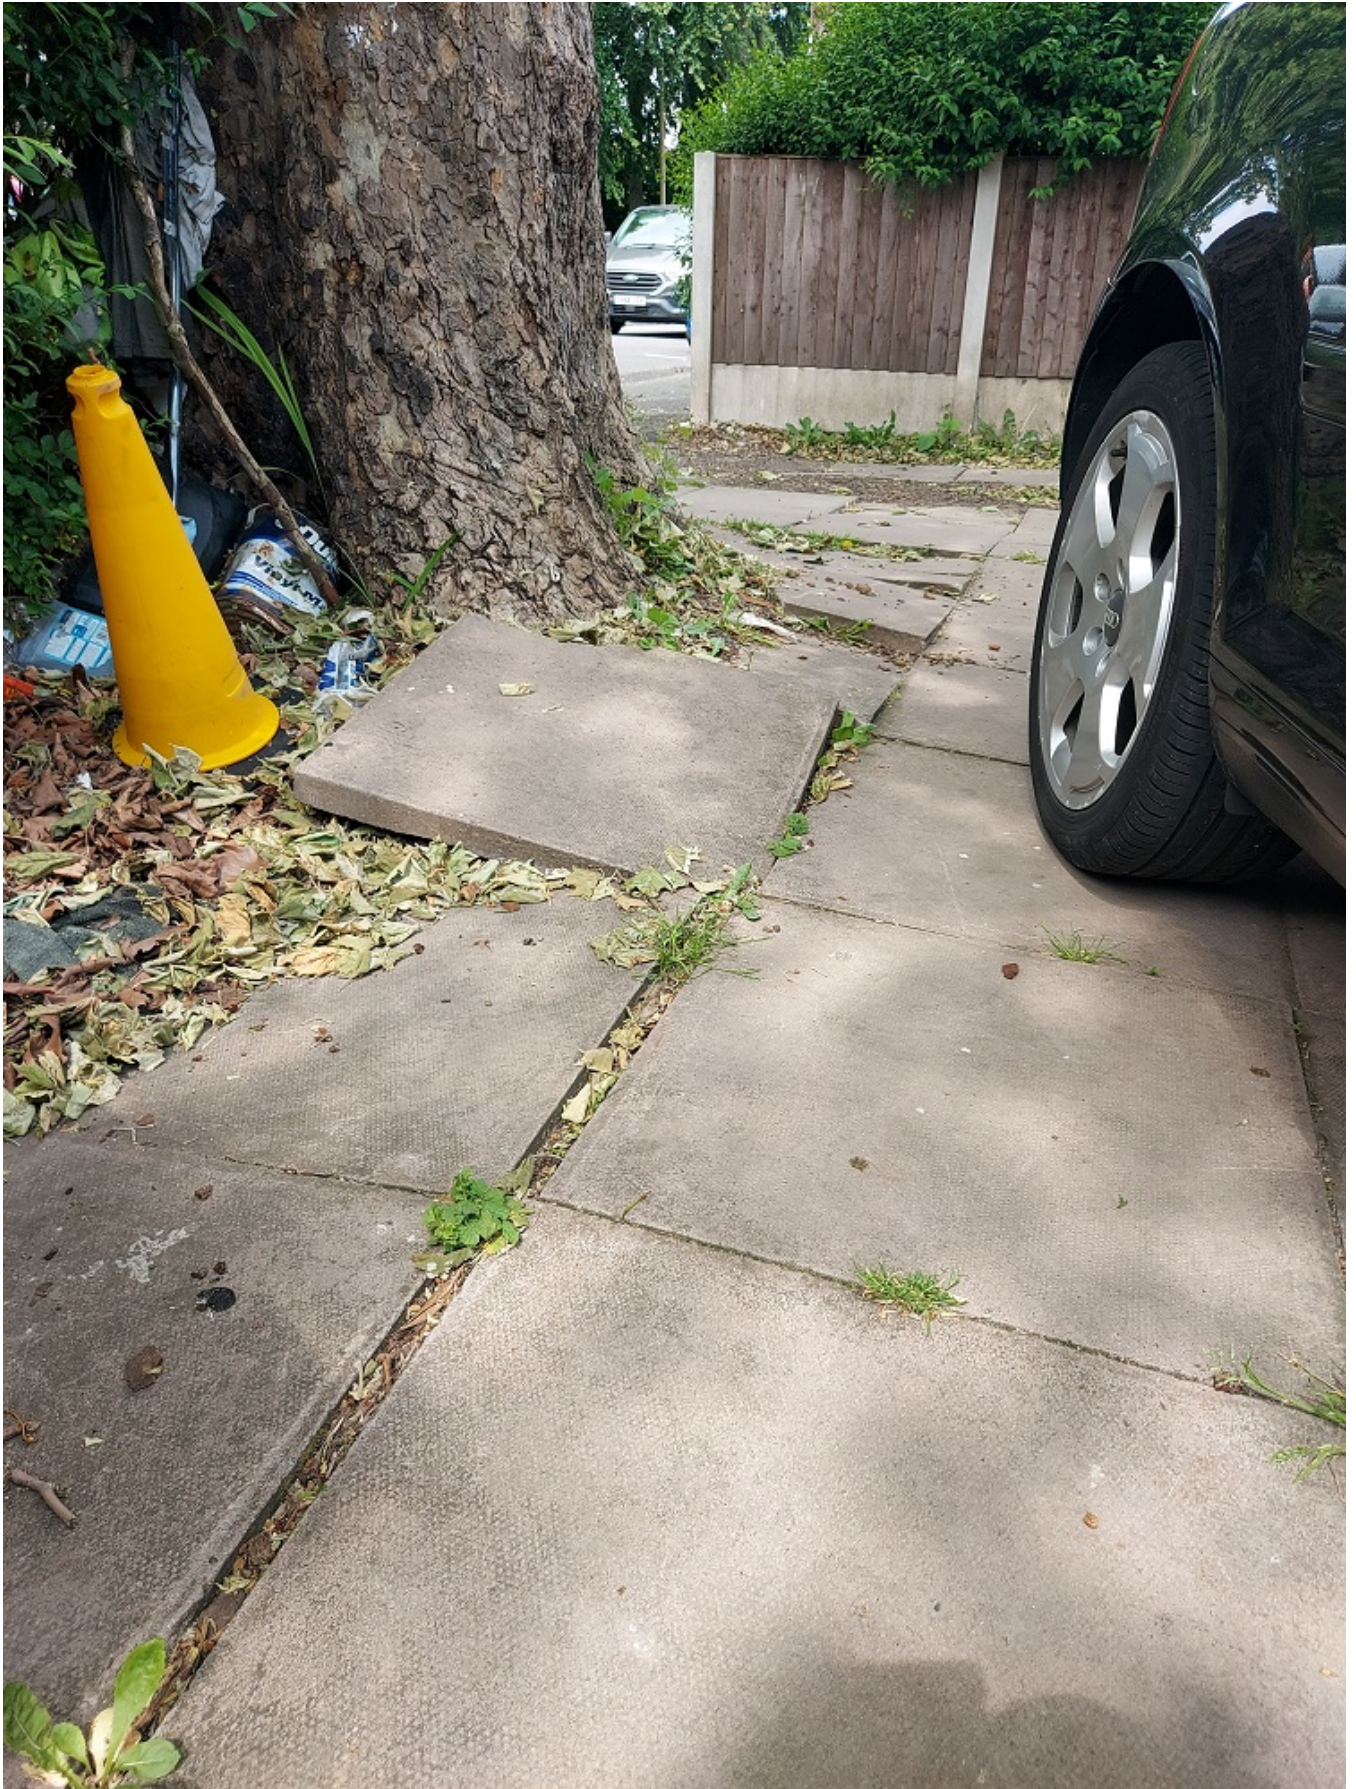
The London Plane tree has good vitality with no obvious risk features evident on the day of the visit. The tree is highly visible from public viewpoints. Large surface roots are present which are disrupting the drive. It is likely that further root damage to the drive will occur.

*Figure 2 Roots from T1 are disrupting the driveway of 621 Burnage Lane*

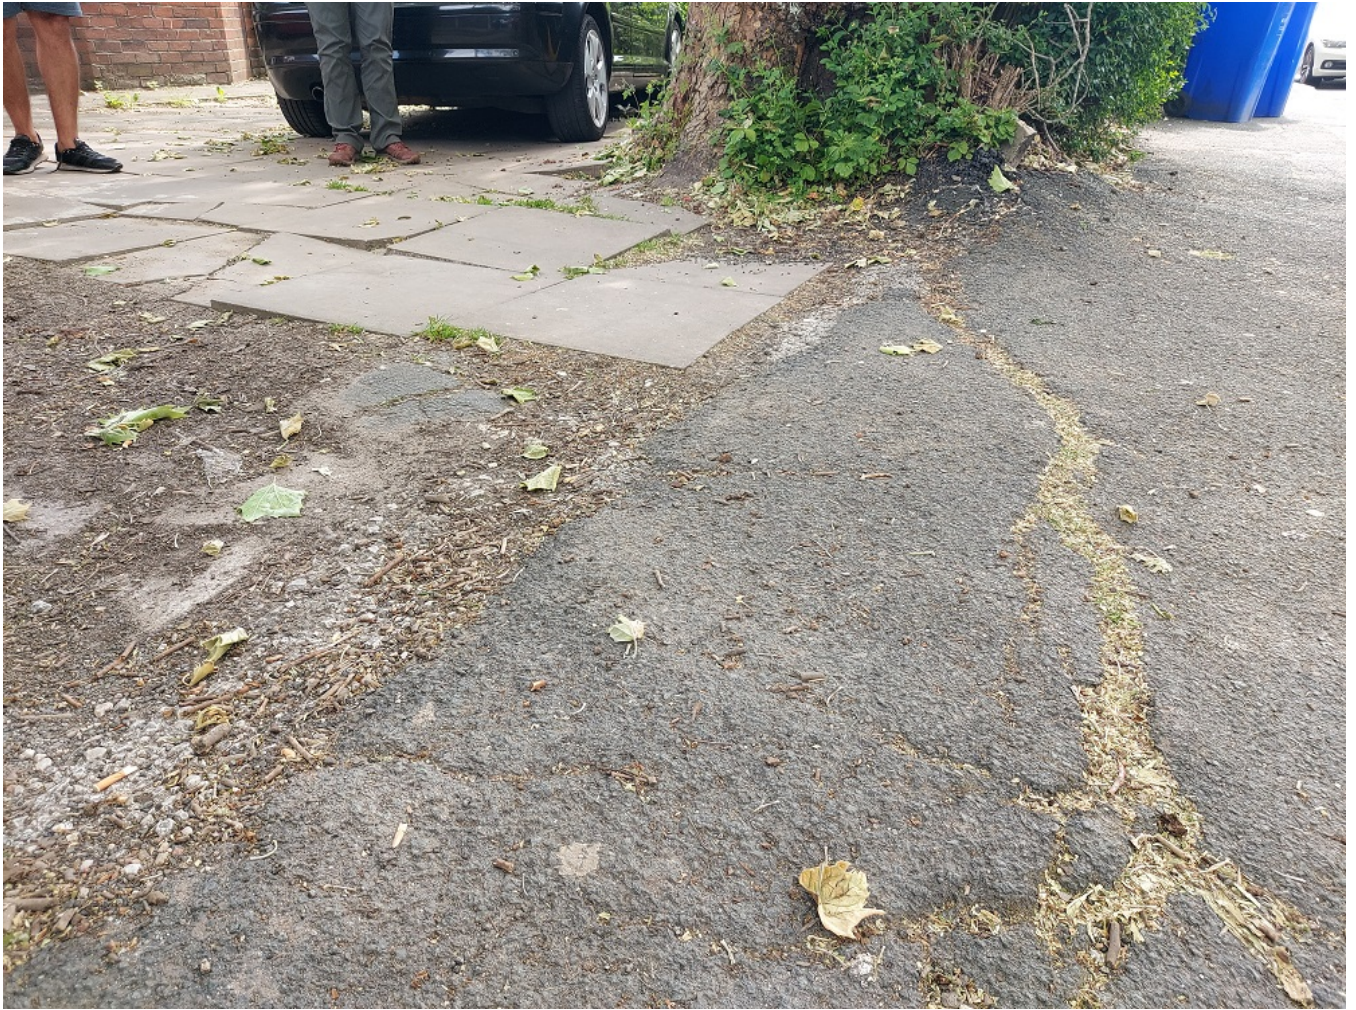
*Figure 3 Drive disruption from T1*

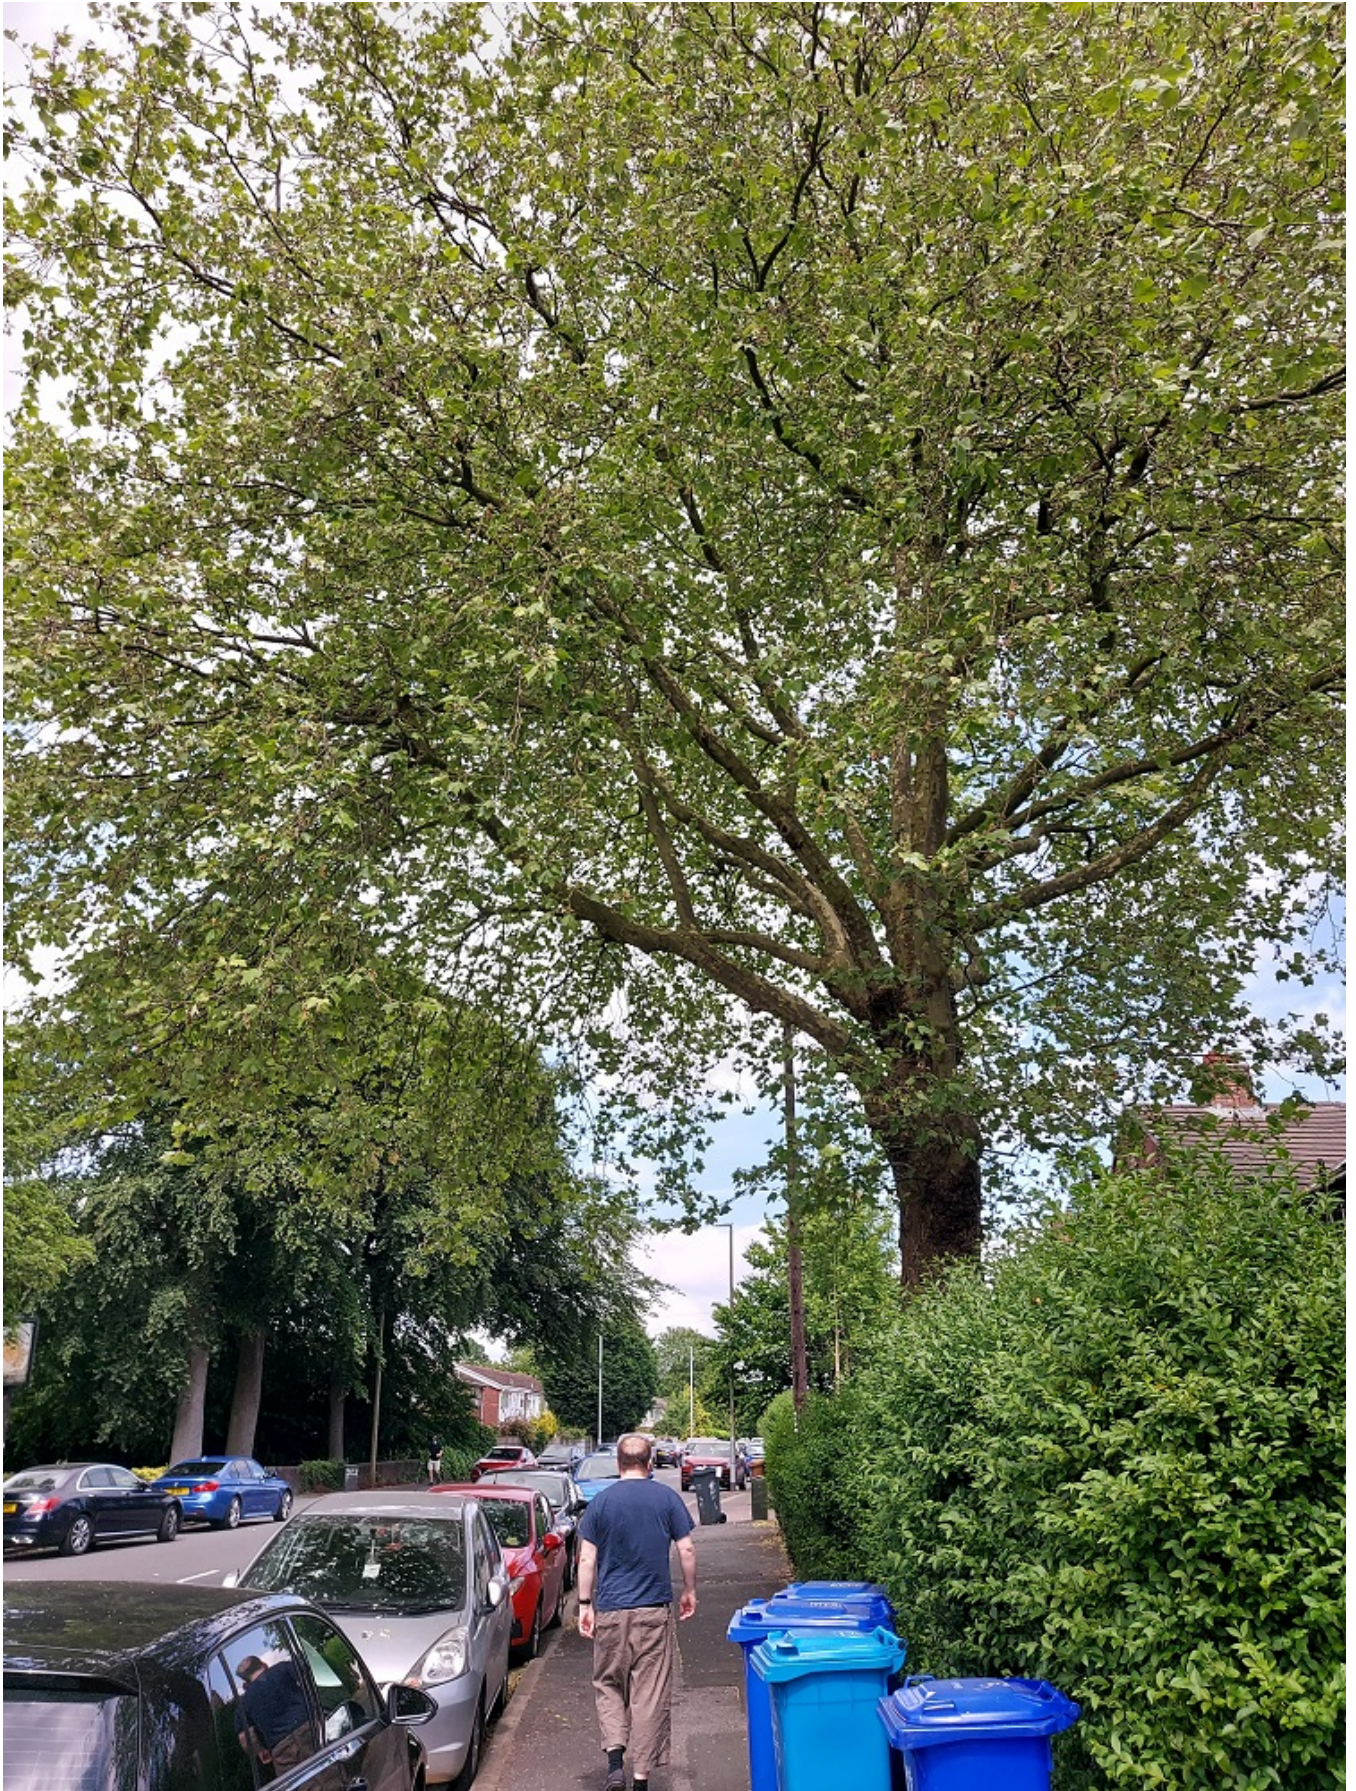
*Figure 4 T1 is highly visible from public viewpoints and has good vitality*

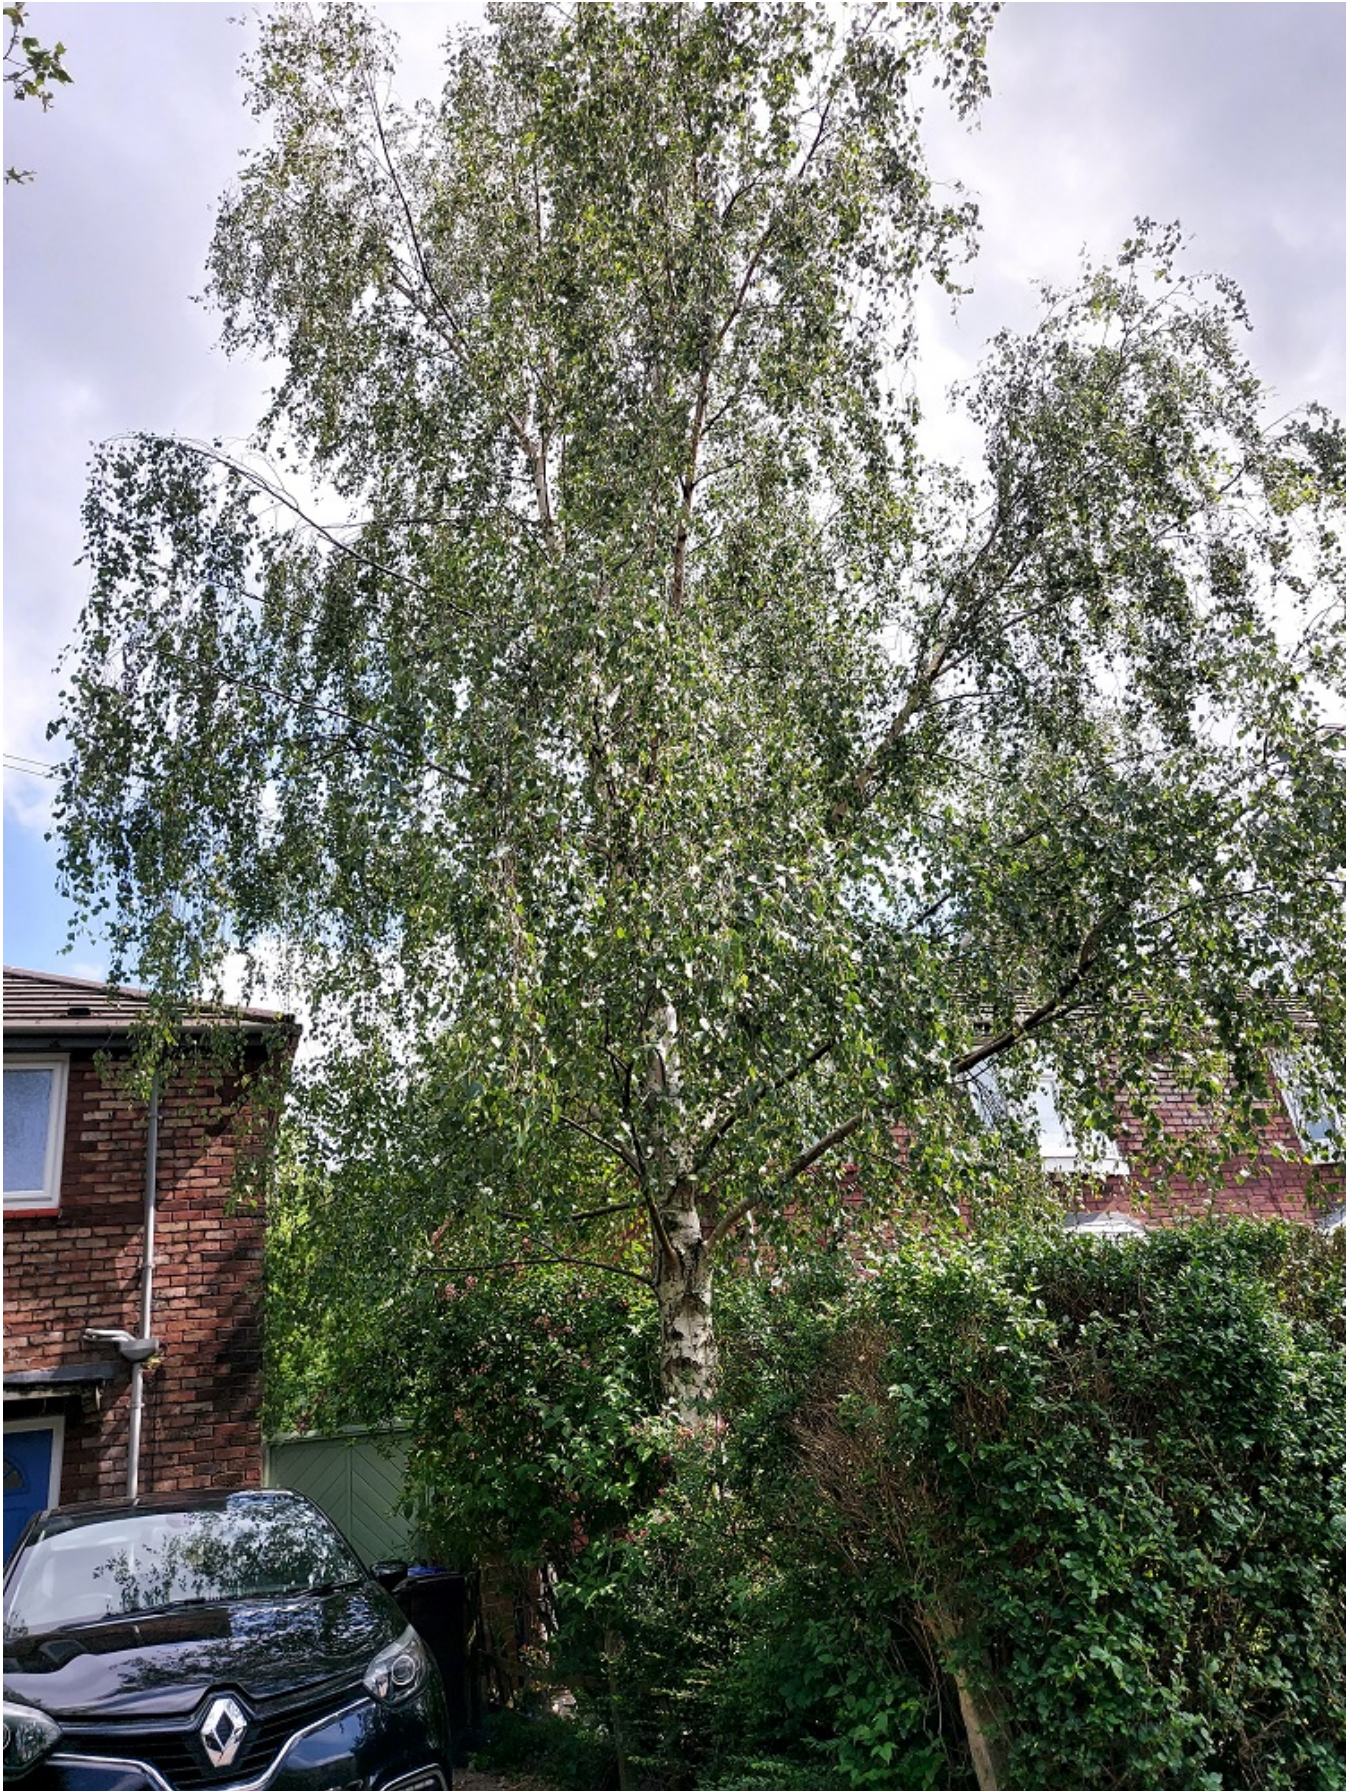
The Birch has good form and vitality with no obvious risk features observed. The tree is highly visible from public viewpoints.

*Figure 5 T2 has good vitality and is highly visible from public viewpoints*
