# GEOSHIELD Verification Report

GEO101021

McAlear & Rushe

AREA SURVEYED: Pile Cap on A10 and B6 and Cores D7 and D5

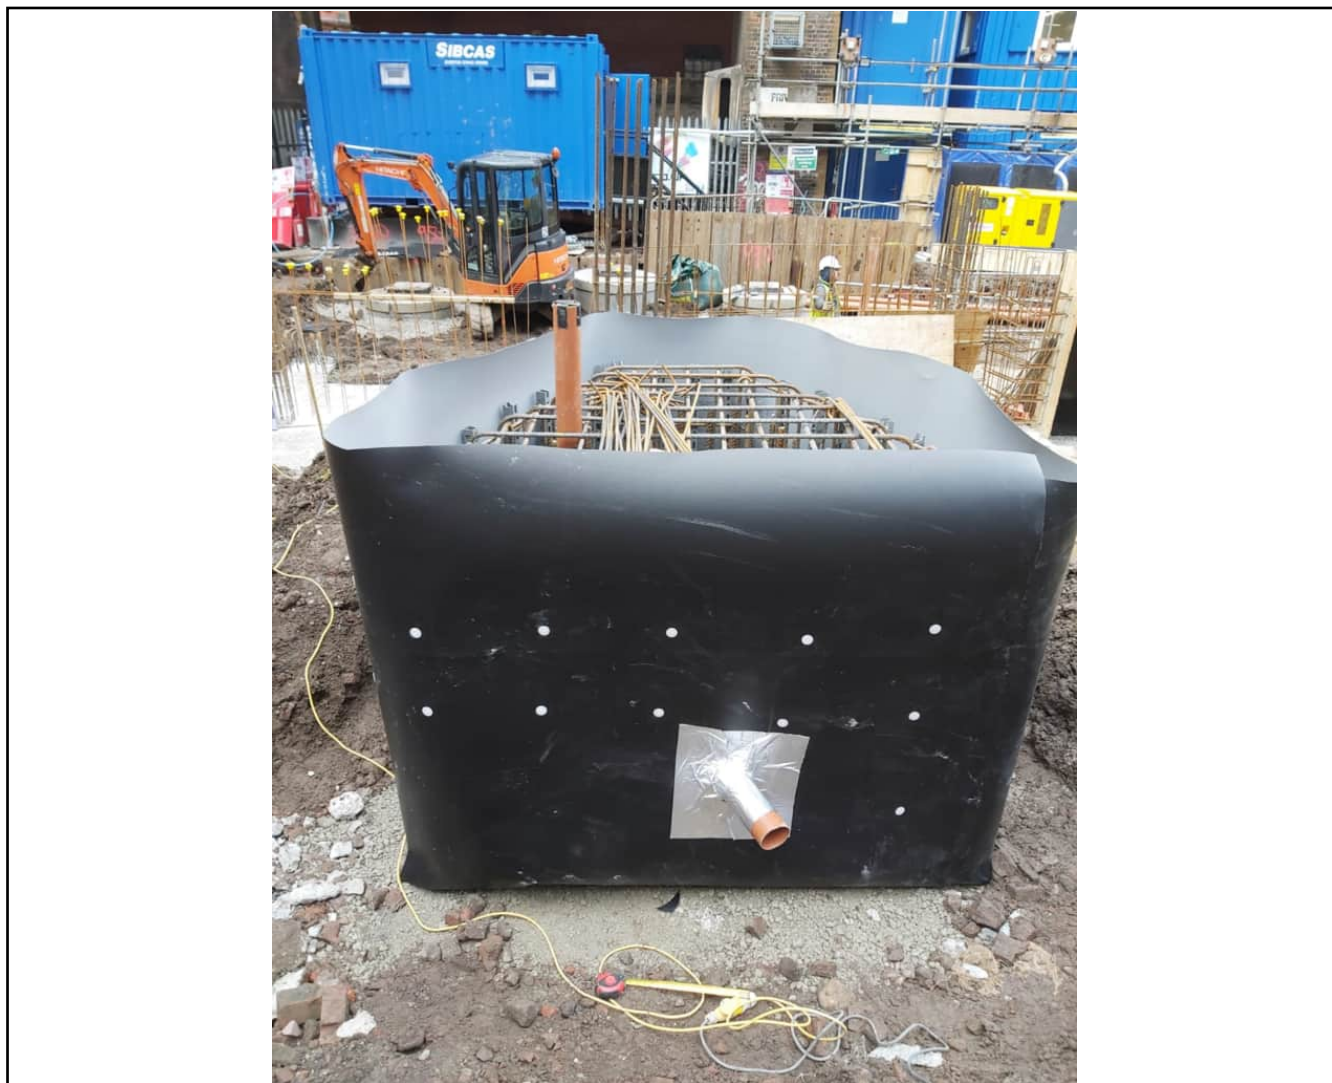
Overview of pile cap sealed

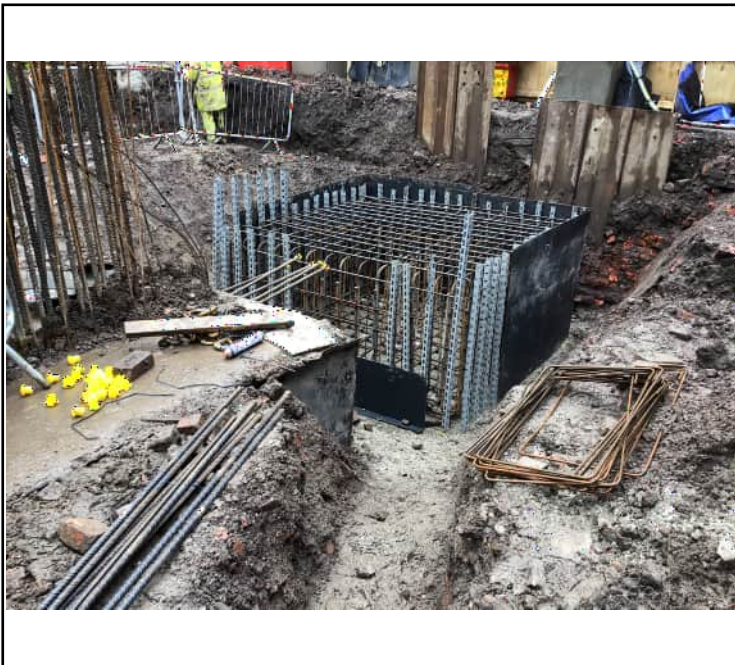
1. Steel rebar covered with tric trac spacers before being wrapped

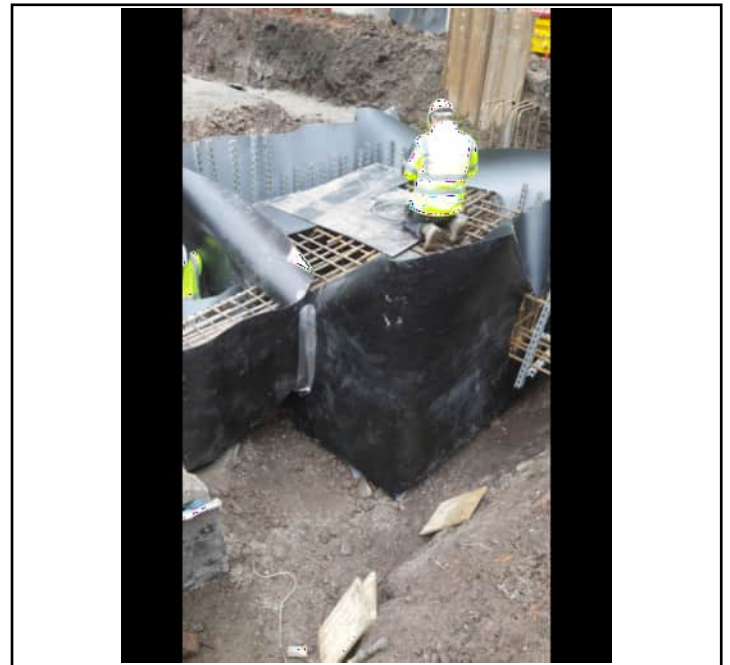
Geoseal with joints hot welded and extrusion welded. Correct spacers used and membrane lapped under pile cap 200mm as per design detail.

2. Pile cap wrapped with Geoseal and sealed with extrusion welds

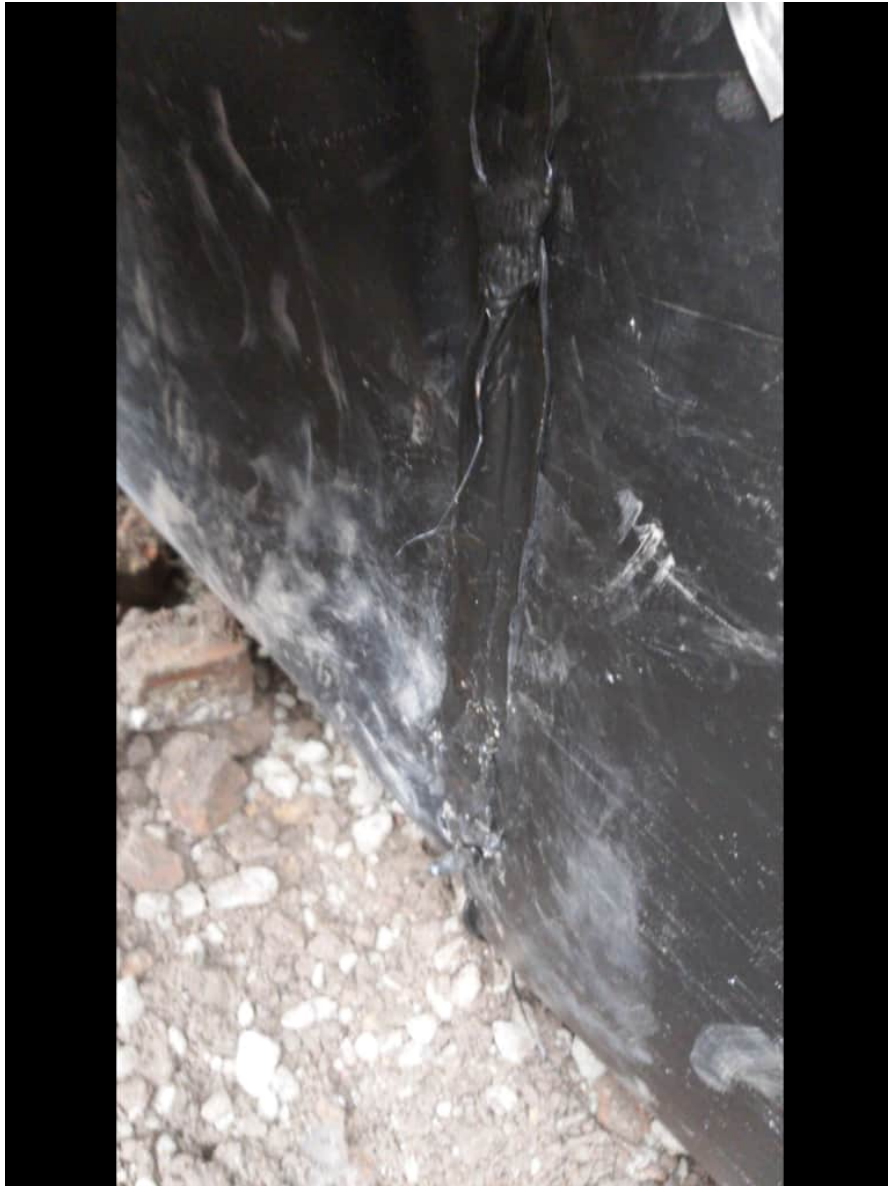
3. Close up of extrusion weld completed from exterior of pile cap. Joint hot welded

before being extrusion welded.

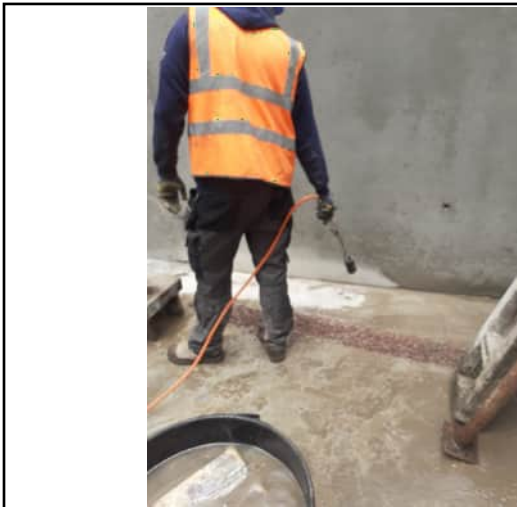
1. Base of D5 swept clear of standing water and dried with a blow torch.

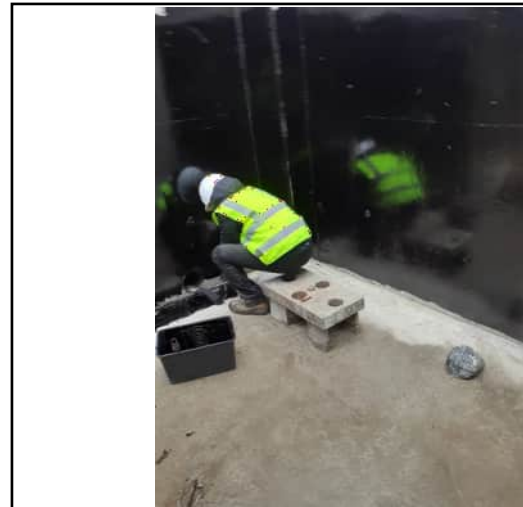
2. Base of D5 dry enough for bitumen primer before GR SAM applied.

D5 core is now complete

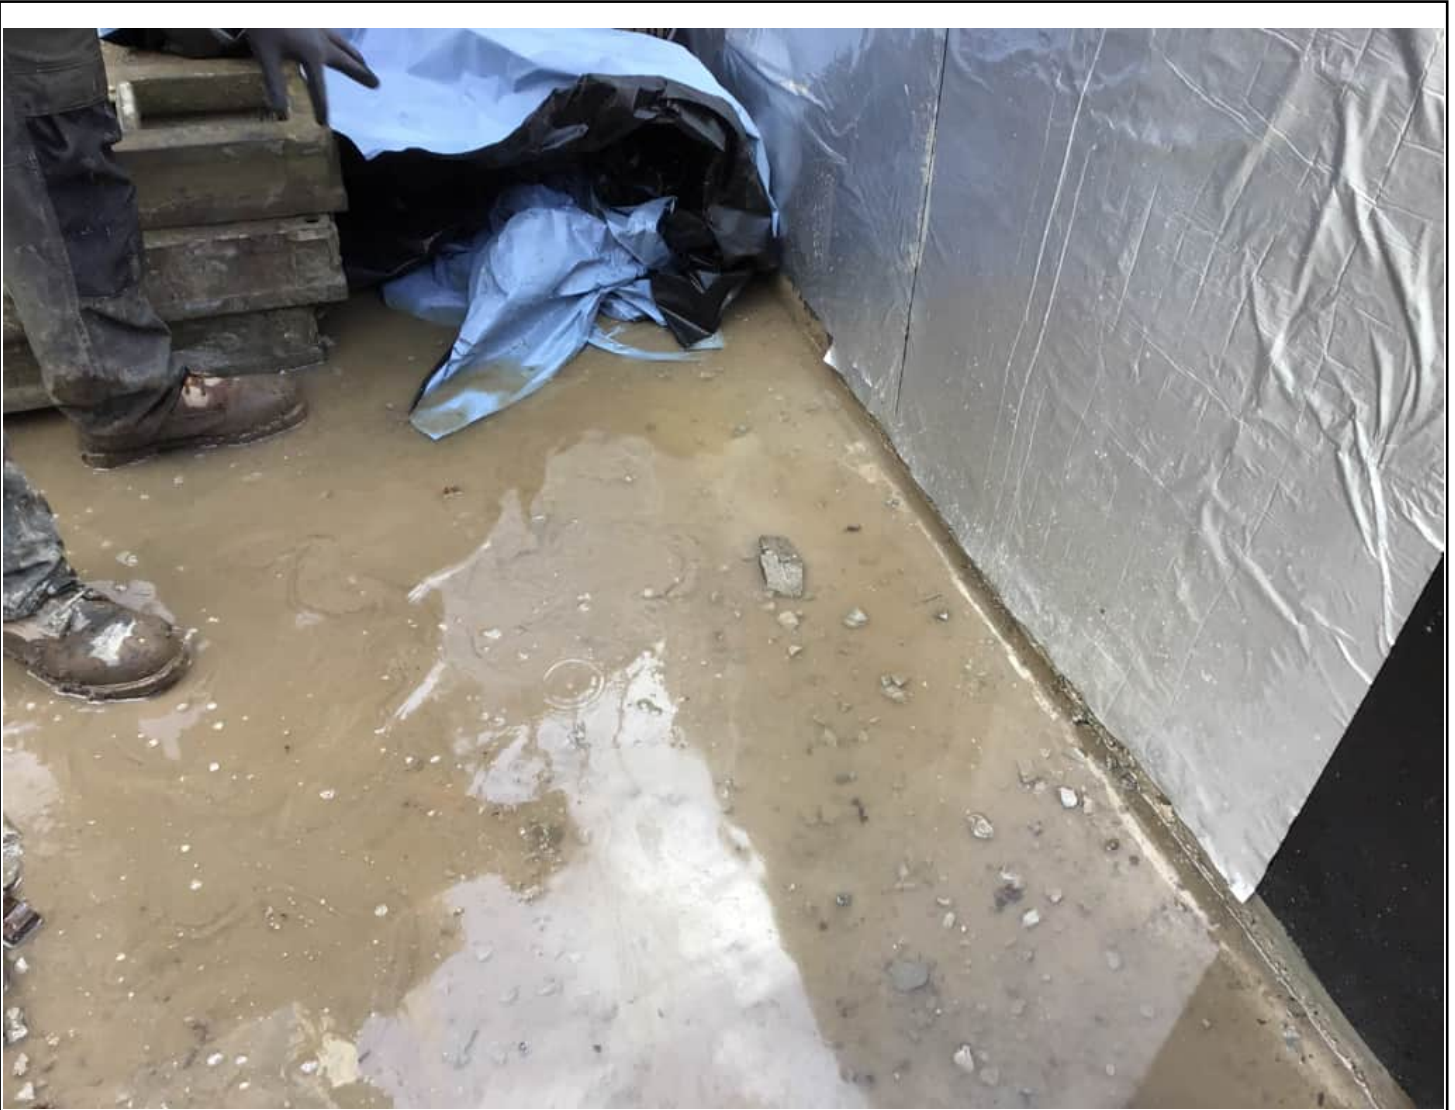
3. D7 core has standing water on the base. GR SAM applied to walls

but the base requires the same prep as carried out on D5 before being

sealed

Works to Core D7 is on going. Standing water at the base is preventing

requires water removing from the base to allow a good seal with the GR SAM.

Further prep works required on D7 as done with D5

installation of GR SAM. This is to be prepped as in Core D5. D7 core requires

further works to the walls and base.

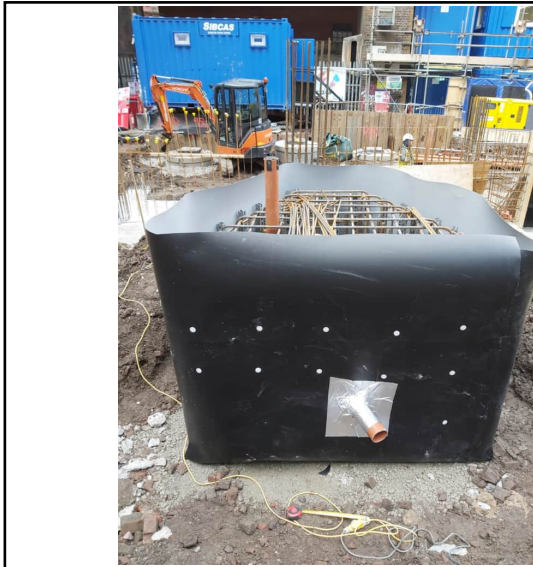
NOTES: Pile cap on B6 complete to good standard. Geoseal

1. Overview of Pile Cap B6 complete

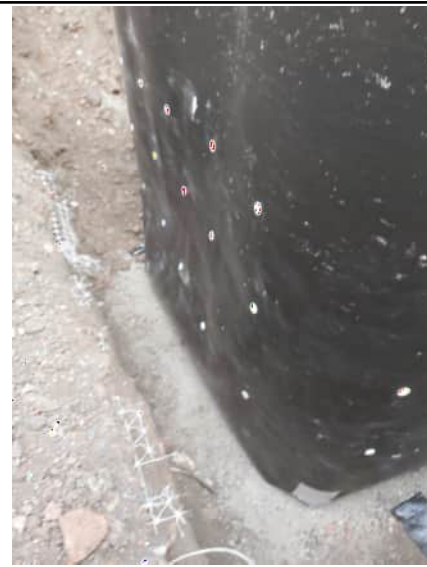
2. Pegs installed to grip concrete and ensure solid bond to pile cap

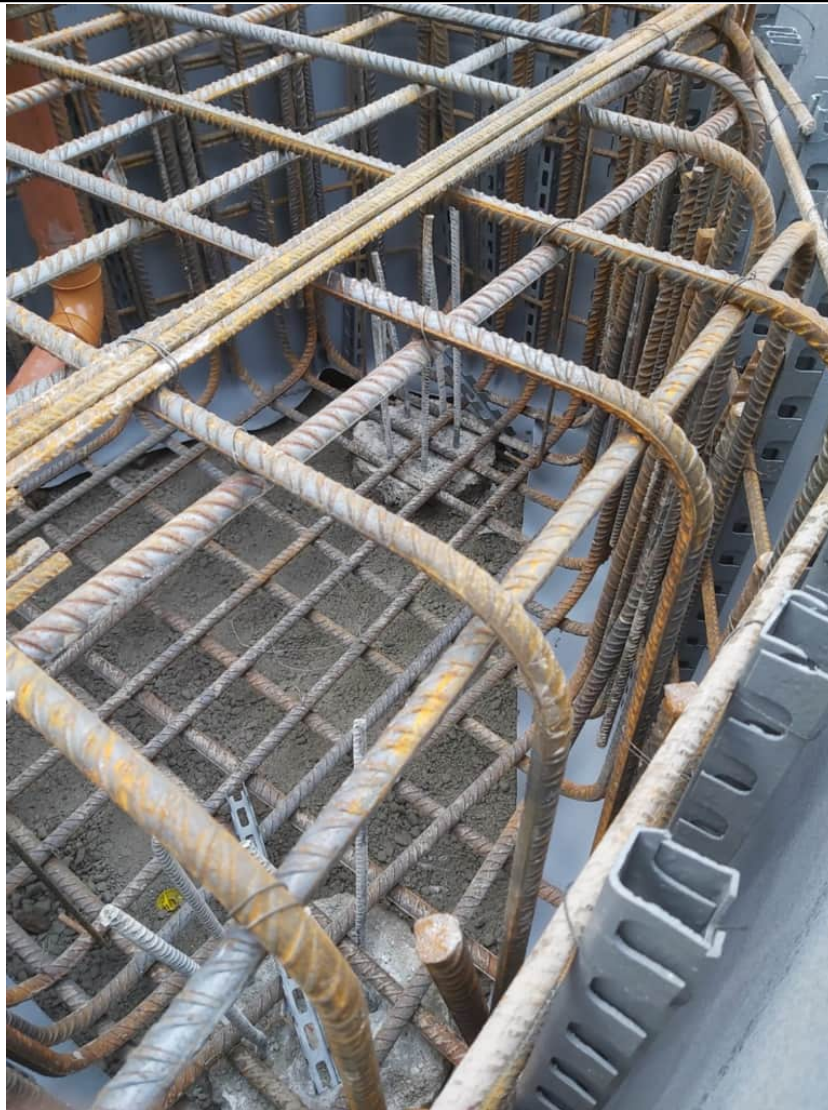
3. Minimum 200mm beneath the pile cap, as per the design detail, has  
been achieved. Passed and verified.

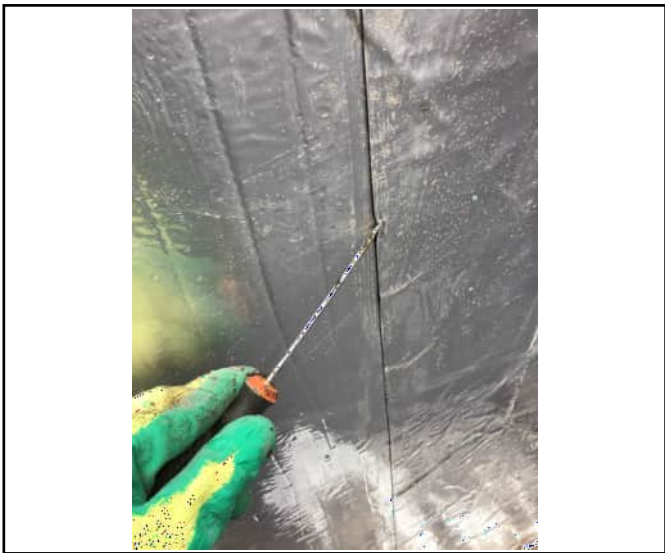
Pick and probe test carried out to D7

core

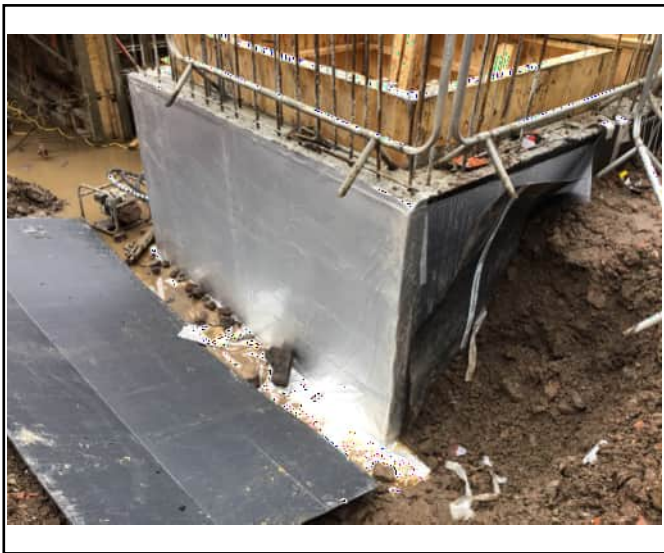
D5 core is now complete

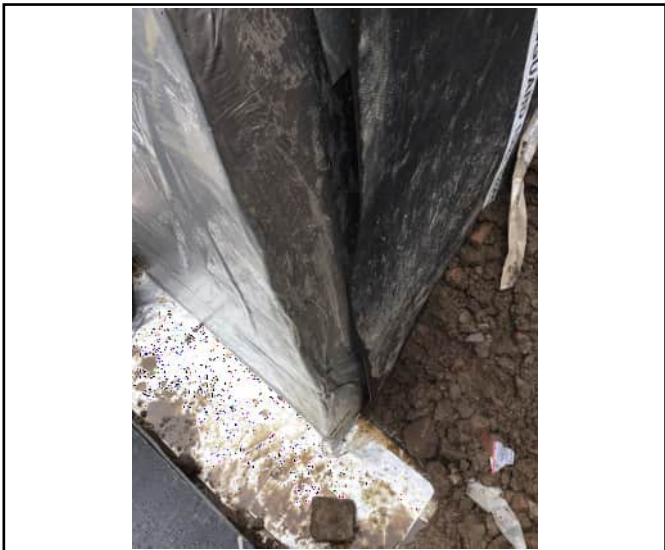
Final corner of D5 complete

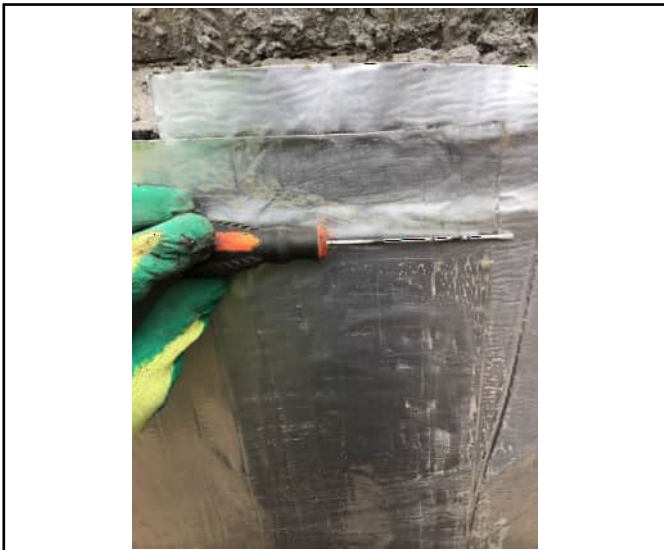
Good overlaps used in D7 core
