# Air & Space Hall

## Discharge of Conditions

Discharge of Conditions  
129991/LO/2021  
Ref: Condition 3a & 6

February 2022

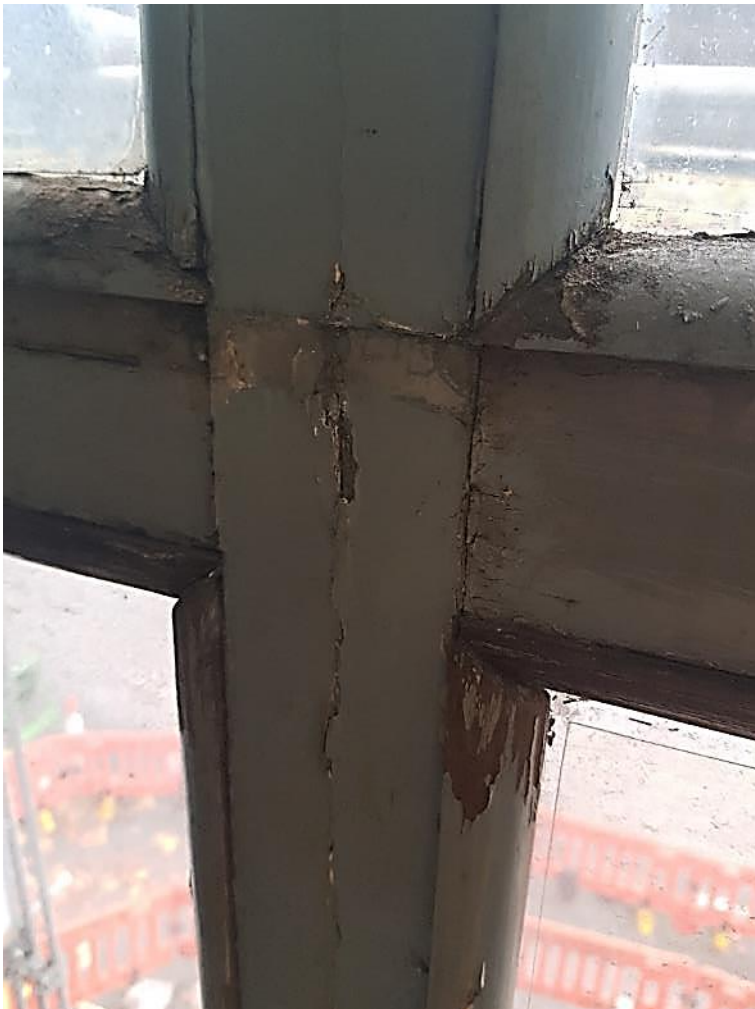
Fig.01 – Photograph at intersection of mullion and transom

Due to site access restrictions, including cables and projecting beams it was not possible to carry out a full tactile survey. However, from the access provided the upper timber frame appeared to be in fair condition. There was localised minor surface decay in areas, with defects typically including defective finishes with blistered and flaking surfaces (Fig.01).

Pending further onsite review and analysis, the consented package included for 50% replacement of timber framing members, including 100% replacement of timber beading.

Specification, 8869DS section RS5. Provides a detailed method statement for timber repair and replacement works.

All other 'original' elements and components are to be reinstated within there original pre decant locations. All woodwork is to be prepared and redecorated to match existing RAL colours.

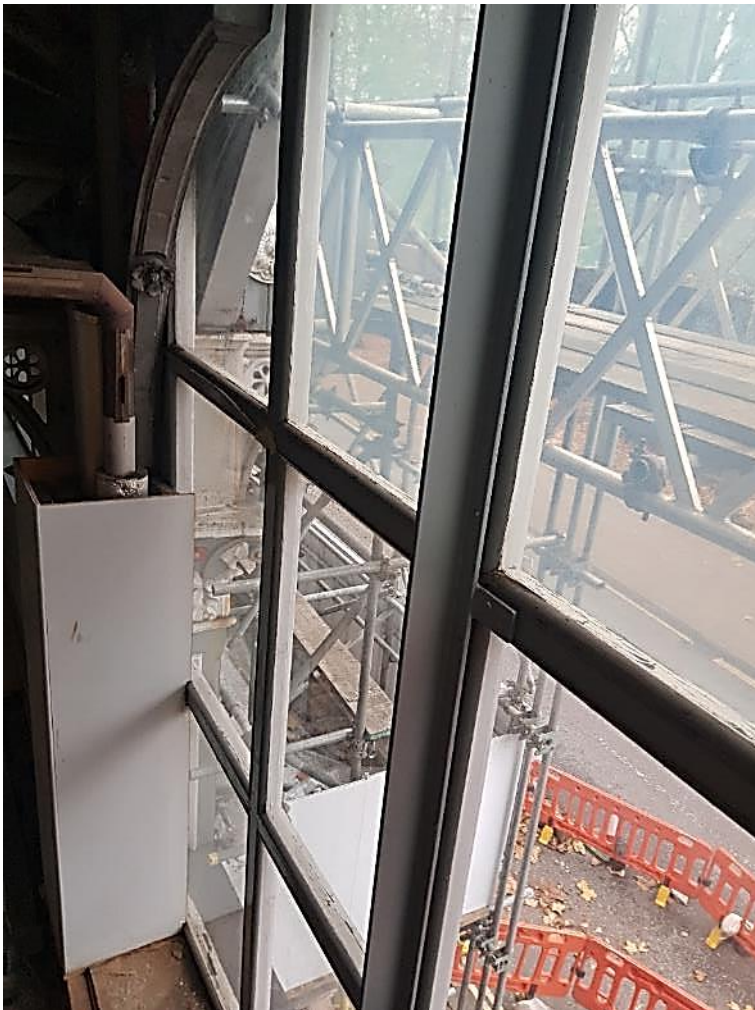
The upper section of timber glazing is further supported by a steel 'T' section, which was introduced in 2016 due to concerns with the timber framed section showing signs of distortion, due to wind loadings.

Decorations were observed externally and was seen to be in poor condition with blistered, flaking and detached surfaces generally.

Fig.02 – Photograph at high level with 'T' section

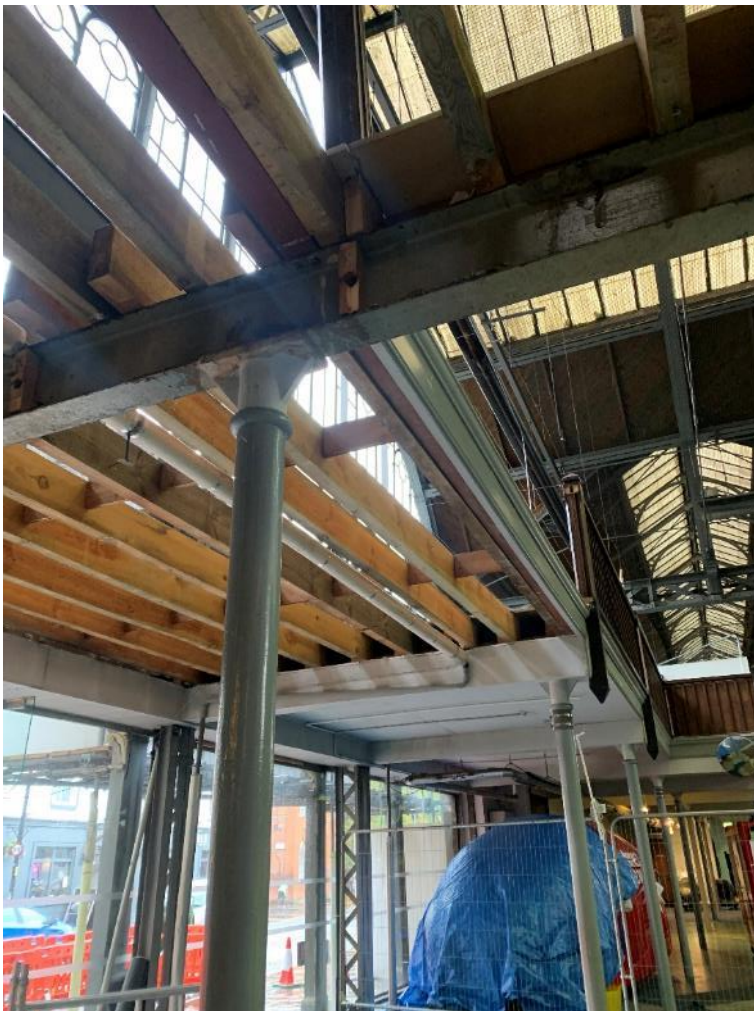
Once the contractor started to carefully peel back the structure, they found that the floor joists within this location were loosely side lapped with adjacent floor joists. Meaning the removal of this section of floor was a simple exercise and involved no cutting out.

Fig.03 – Photograph to the underside of Mezzanine floor

The mezzanine floor, balustrading, finishes and all associated elements and components will be returned to match the pre decant arrangement.

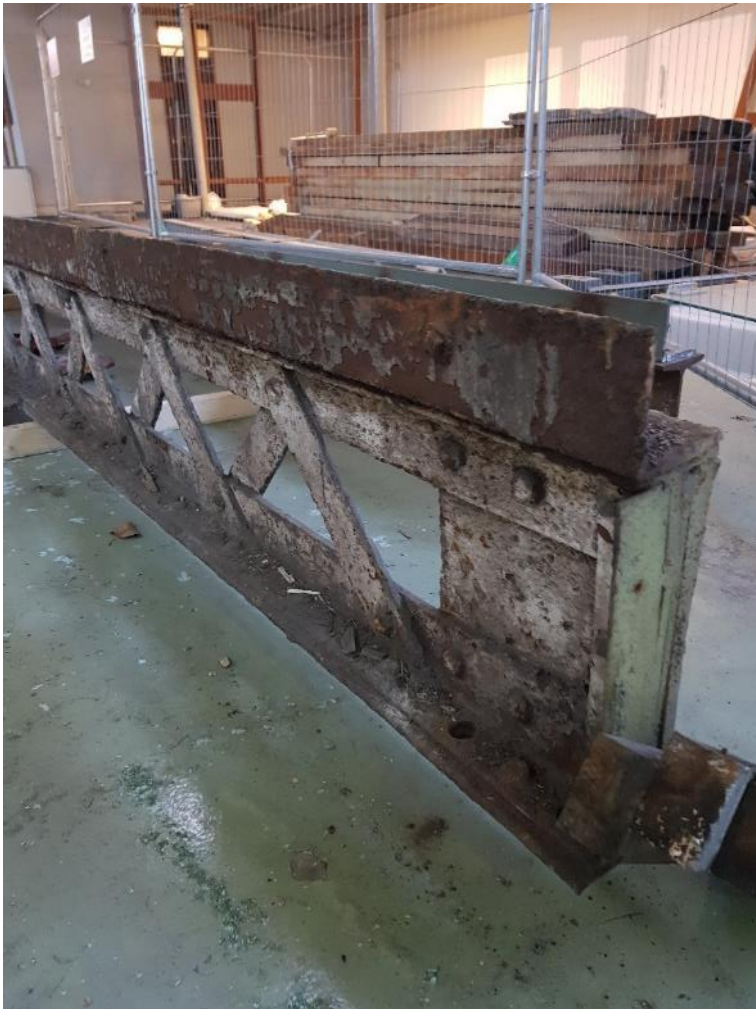
Embedded and concealed ironwork beams were found to the south elevation (Fig.04), used to support the upper timber glazed section. The beams were all carefully removed, set aside, protected and tagged, allowing for reinstatement. It was not necessary to undertake any 'hot Works'.

Fig.04 – Photograph of lattice beam

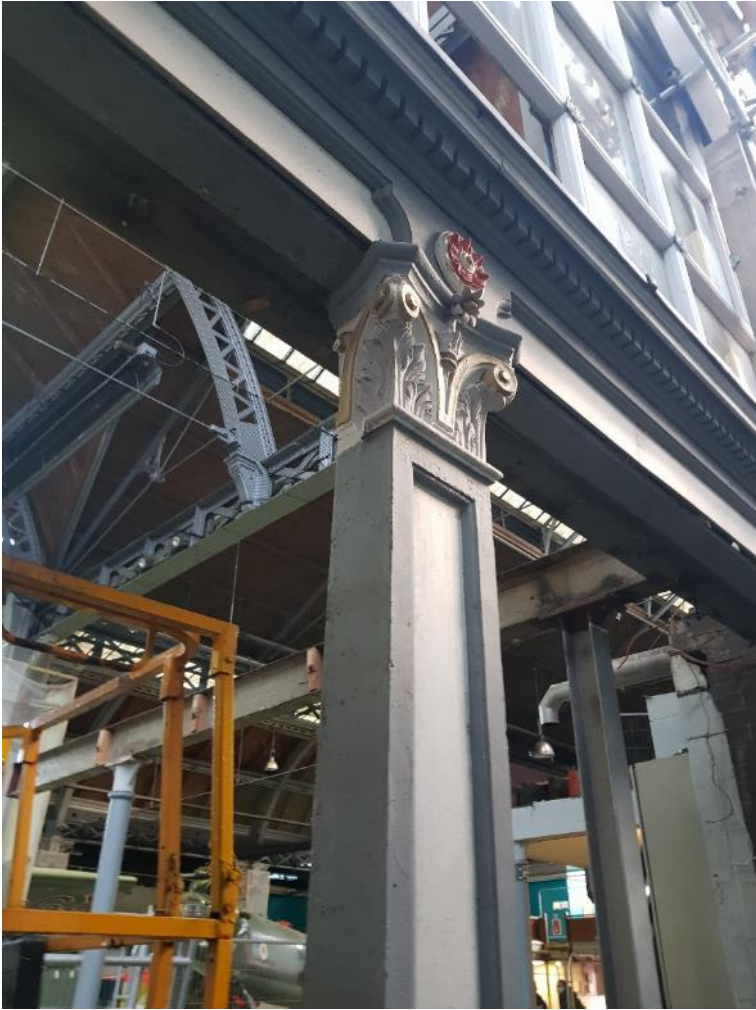
The decorative external cast iron column, which extends from ground to first floor level was carefully removed by Calibre Metalwork, specialists in cast iron restoration. From a superficial inspection (Fig.05) carried out at ground level onsite, the column appeared to be in fair condition with localised redecoration necessary only. The column was found to be purely decorative, it did not provide any support to the horizontal lattice beam, which spans the opening.

Fig.05 – Photograph of decorative cast iron beam

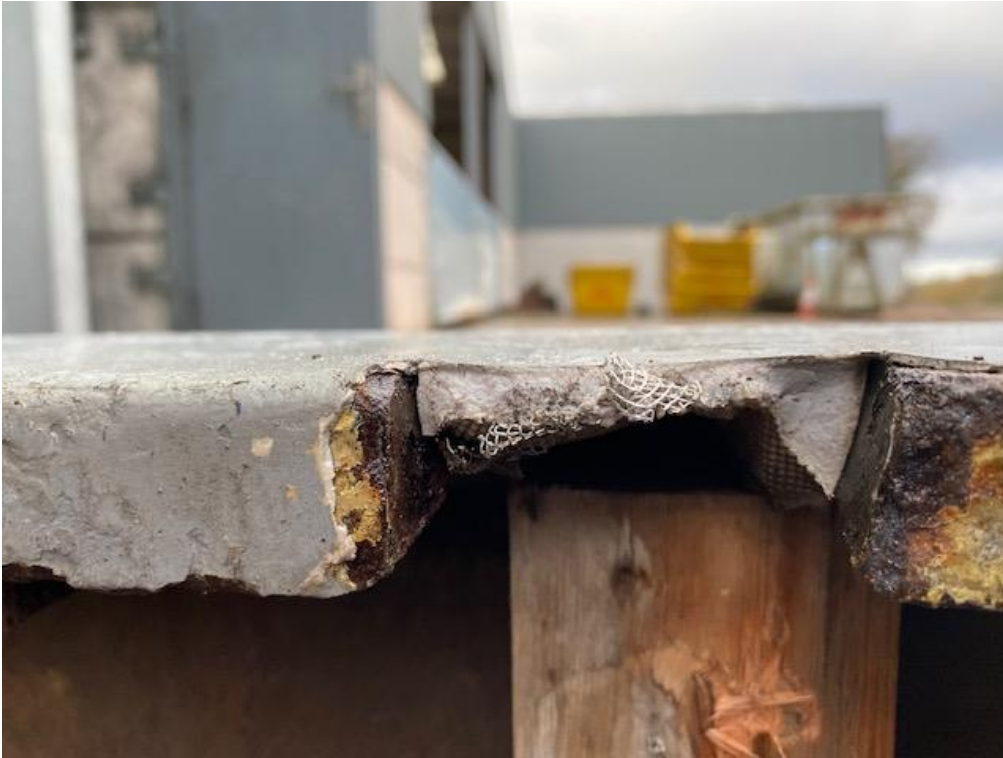
Calibre Metalwork carefully removed the column, protected and transported the column to their controlled workshop. Following a more exhaustive inspection in the workshop, Calibre Metalwork reported the following minor issues, the column had been inappropriately repaired in the past using filler and fibre glass (Fig.06) by others, with some localised cracking.

Fig.06 – Photograph of poor-quality previous repairs to cast iron column

Calibre Metalwork proposed fabricating a bespoke u-shaped mild steel bracket to fit to the inside of the column base and to be fixed by drilling and tapping either side of the crack, to assist with bracing. The 2 number side repairs are to be made good with mild steel plates, drilled and tapped, the same process as for the upper section. All repairs to be painted, to match the current RAL colours.

These works are currently being carried out, in preparation for reinstatement.

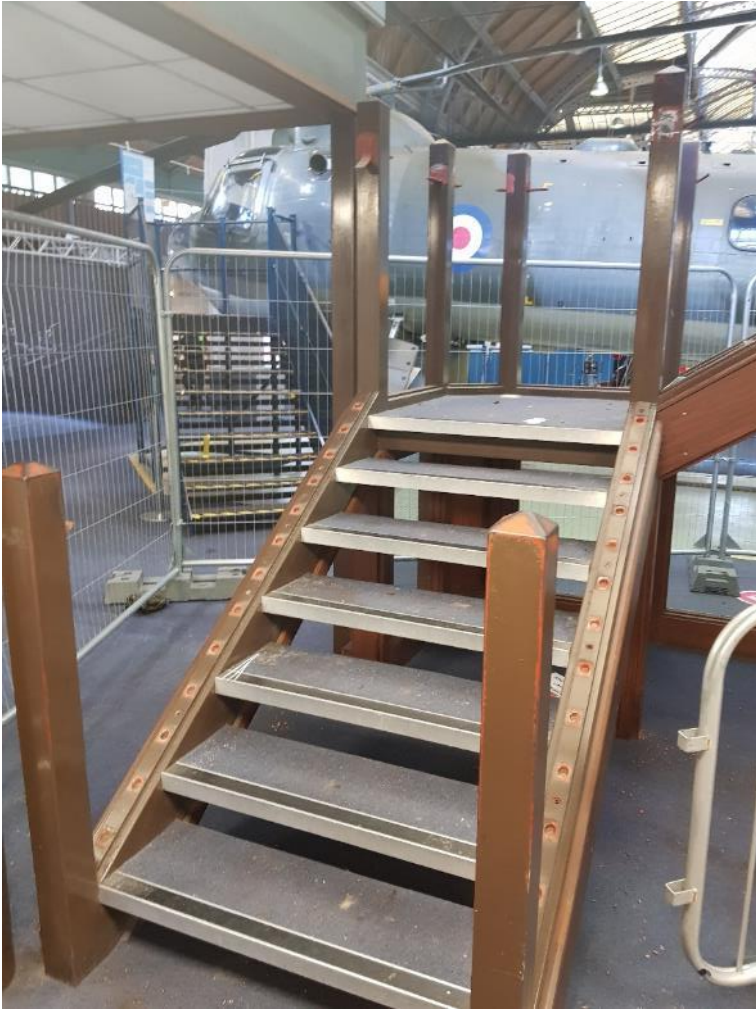
The staircase was found to have a modern steel internal frame, clad with timber. 'Hot Works' were required to allow for the safe and careful removal of main fixing points. All elements and components were carefully removed, tagged, protected and stored within a secure, watertight location (Fig.08) internally within the Hall.

Fig.07 – Photograph of staircase components being removed

The staircase is to be reinstated to match its pre decant arrangement, including all elements components and all other associated items.

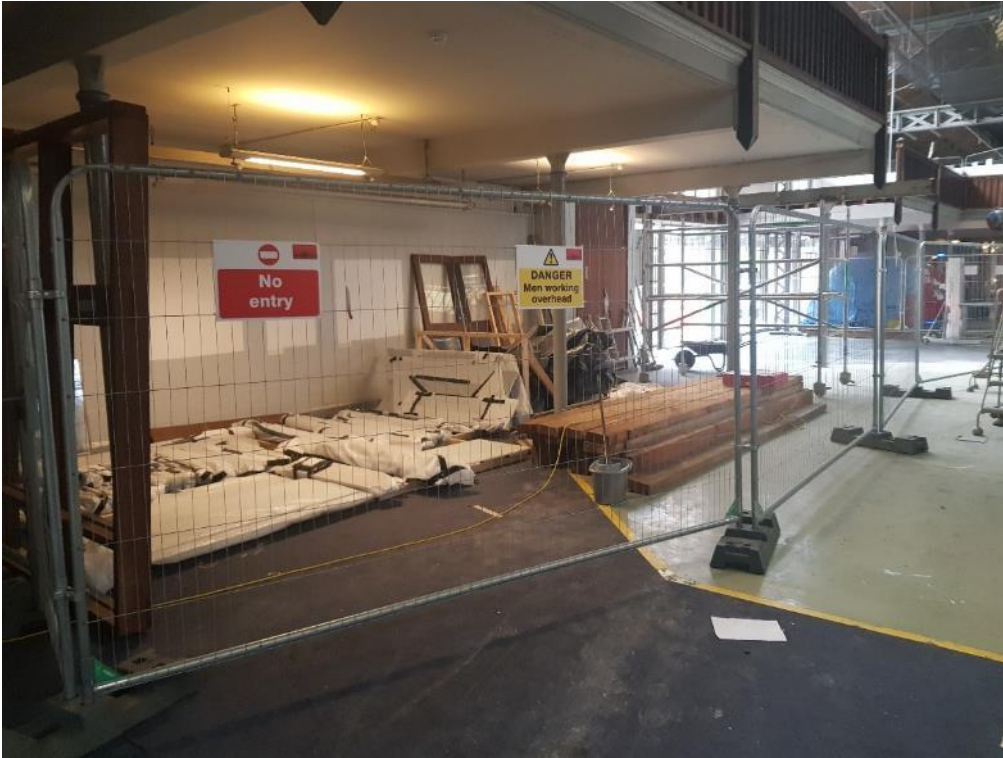
Fig.08 – Photograph of tagged, protected and stored elements and components

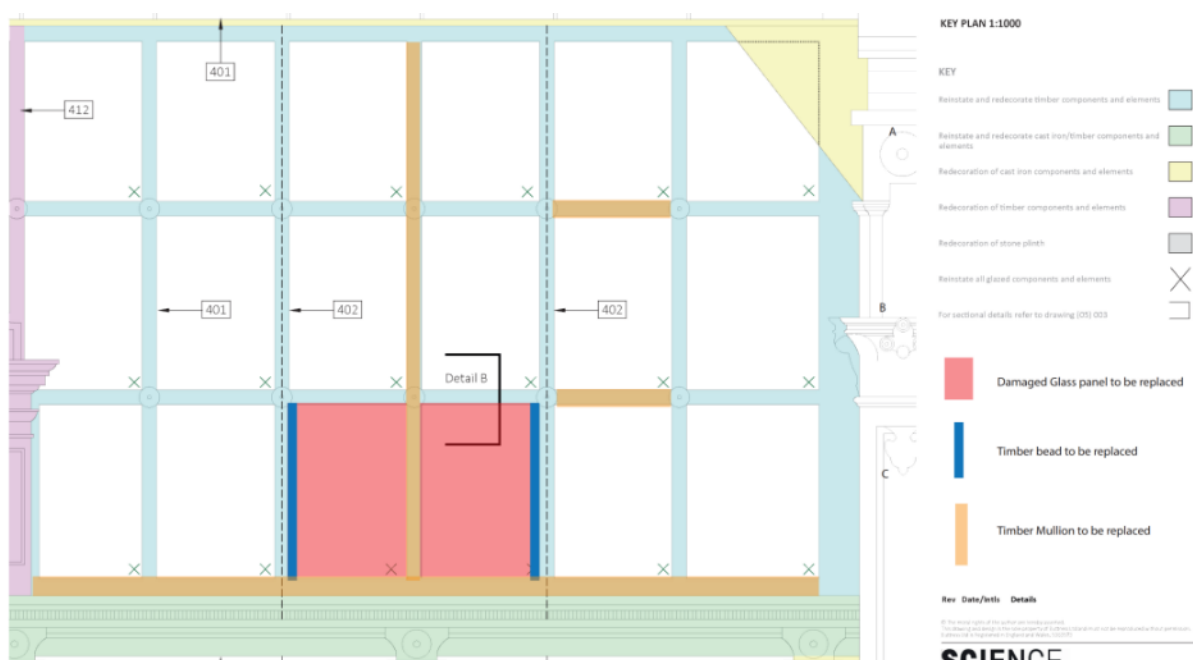
H.H.Smith proceeded to carefully remove framing members, allowing for the wholesale temporary removal of the upper glazed section. H.H.Smith provided the below graphical mark-up (Fig.09) which identifies a very small percentage of replacement components, this includes the following:

- 1 number full length mullion (shaded orange).
- 2 number transoms (shaded orange).
- 1 number full length cill (shaded orange).
- 2 number glazing beads (shaded blue).
- 2 number windowpanes (shaded red).

**Fig.09 – H.H.Smith graphical mark-up illustrating repair works**
