## Ground Floor

As at December 2021, during strip out works, this floor comprises:

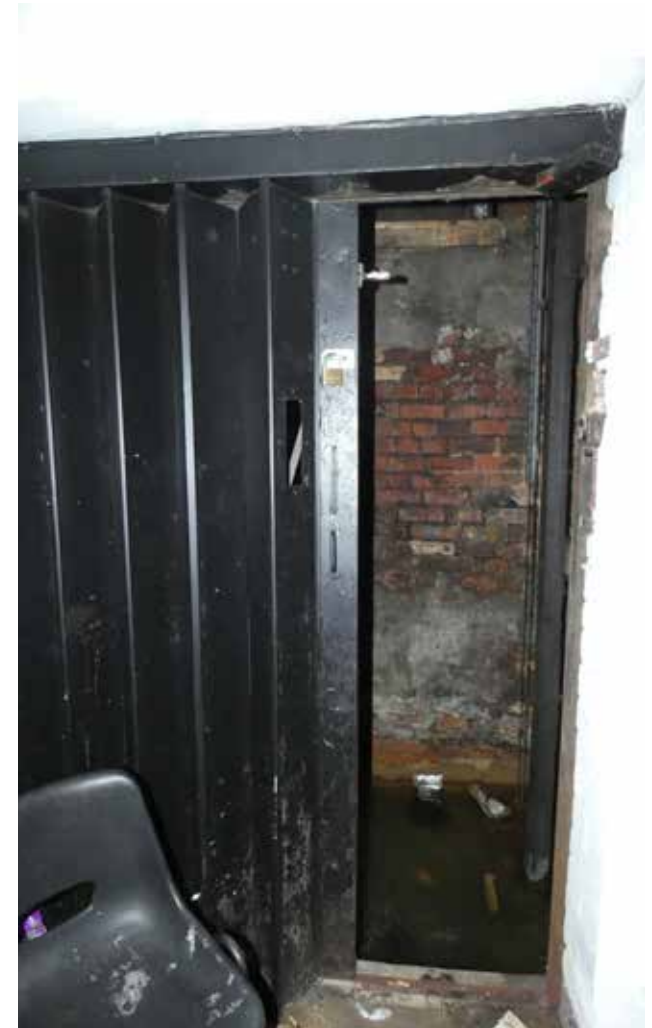
**3.23** B017 and B017a (Insal)

**B017** is the lift shaft. It contains metal concertina doors, probably from the 1960 refurbishment. The shaft is red brick lined and a double opening with concertina door is visible at ground level – parallel with the Newton Street elevation [Plates 3.23-3.24]. **B017a** is a small lift lobby, it is finished much the same as the main corridor, with screed floors, painted walls and a boarded ceiling [Plate 3.25].

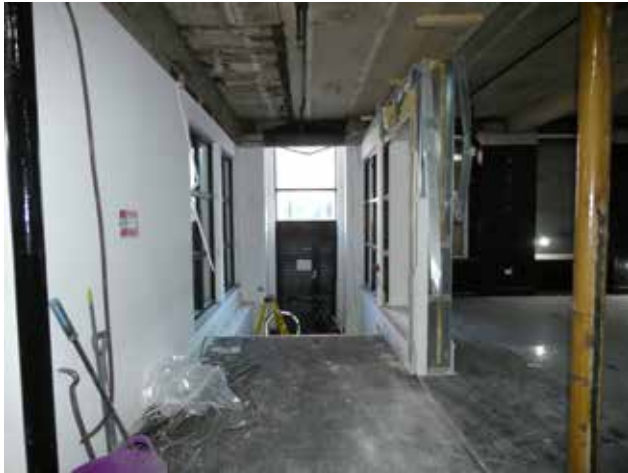
- Main entrance lobby with tiled 1960 steps, metal balustrades, suspended ceiling and later ramp (G001).
- Small offices – formed by mid- and late-20<sup>th</sup> century partitions – to be removed as part of the soft strip (G002, currently used as site office) **[Plate 3.35]**.

**3.35** Partitions forming office - G002, Ground Floor

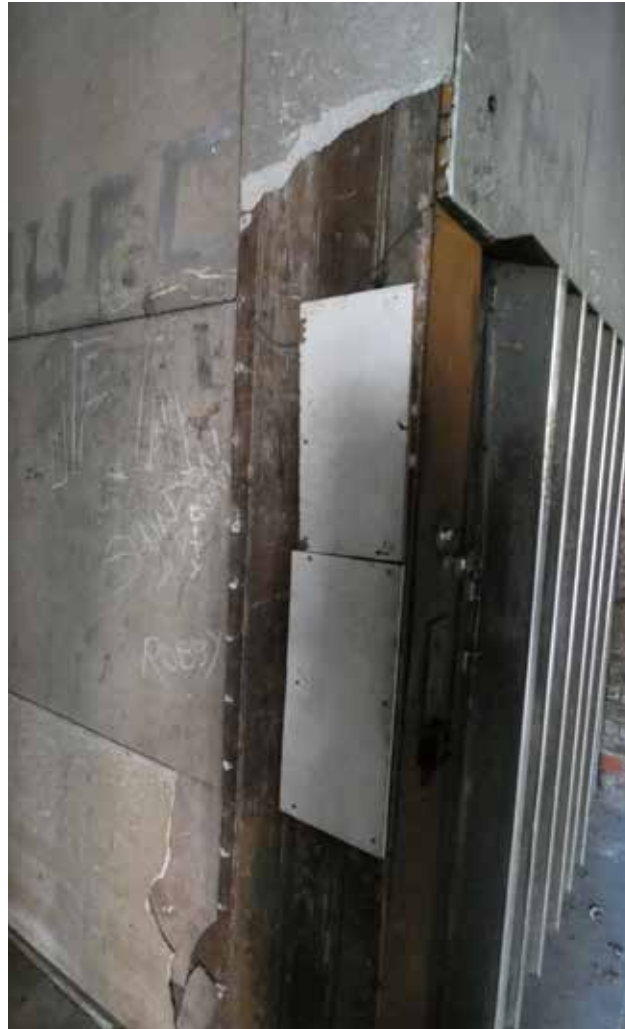
- Small service area with lift in the north east corner (G004) **[Plate 3.36]**. Timber, tongue and groove clad lift shaft with asbestos sheeting over. Screed floor. Metal-clad (modern) ceiling with bulkhead. Exposed brick walls of a variety of ages. Top of an arch in the Newton Street elevation is visible (access to undercroft), now blocked with flettons.

**3.36** Lift shaft in G004, Ground Floor

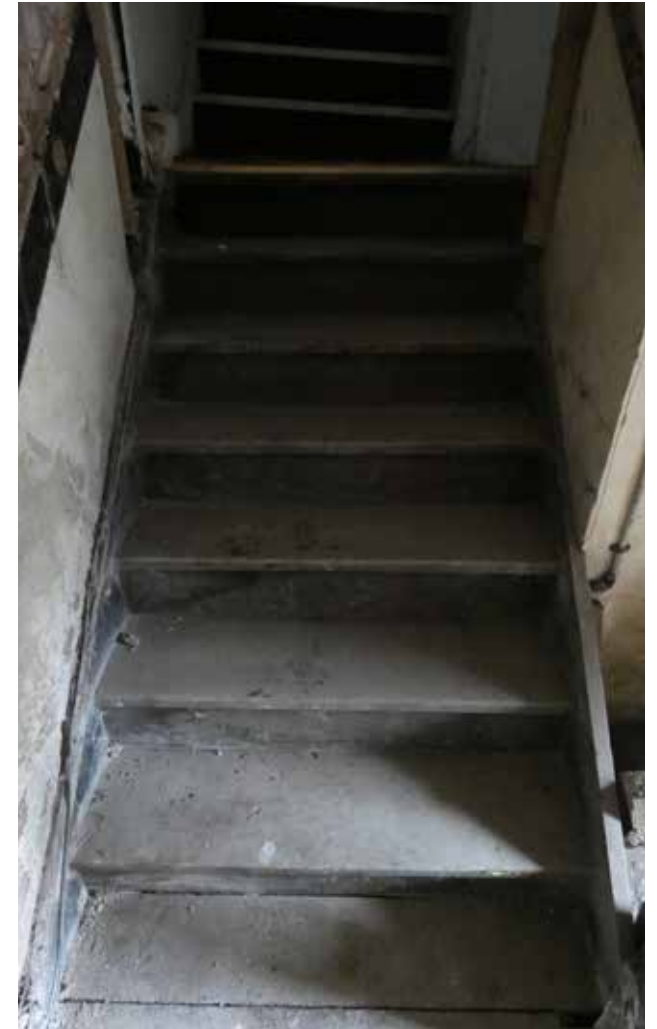
- A timber stair leading to the rear yard has been uncovered during the soft strip – it sits within an entrance lobby constructed in 1960. Some of the treads appear more historic - suggested possible reuse **[Plate 3.37]**.

**3.37** Ground Floor Stair to Yard

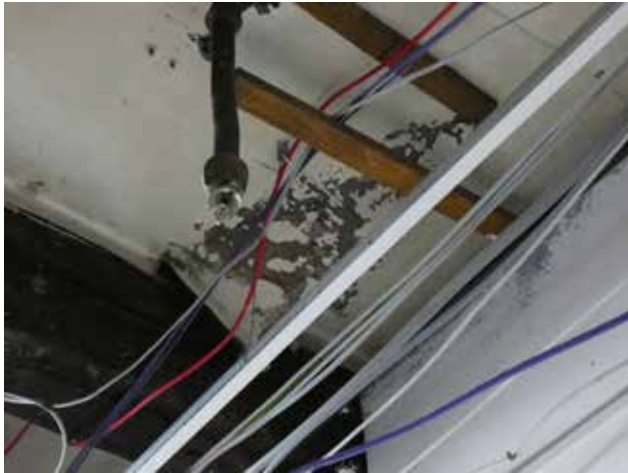
- The ceiling is finished in thin tin sheets in some locations **[Plate 3.39]**.
- The suspended ceiling has revealed arch-headed lintels to the rear windows **[Plate 3.40]** and the arched opening to Newton Street **[Plate 3.41]**.

**3.39** Ceiling in G001, Ground Floor

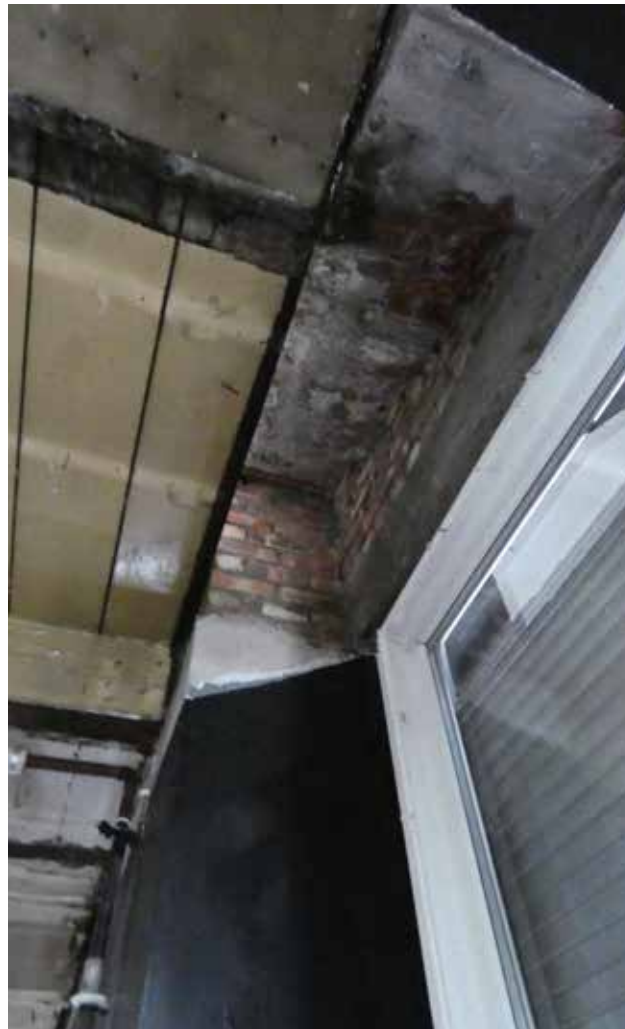
**3.41** Arched entrance from Newton Street, Ground Floor

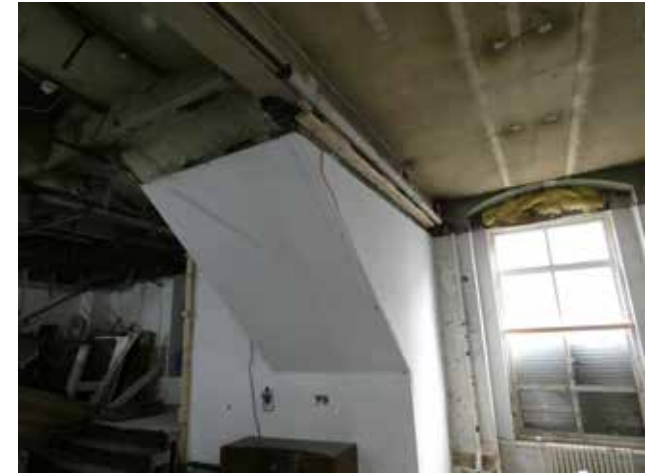
- Modern plaster wall finishes and radiators with grilles set beneath uPVC windows in the NW wall.
- Plasterboard casing over the historic timber staircase remains in situ **[Plate 3.42]**.

**3.42** Plasterboard around timber staircase, Ground Floor

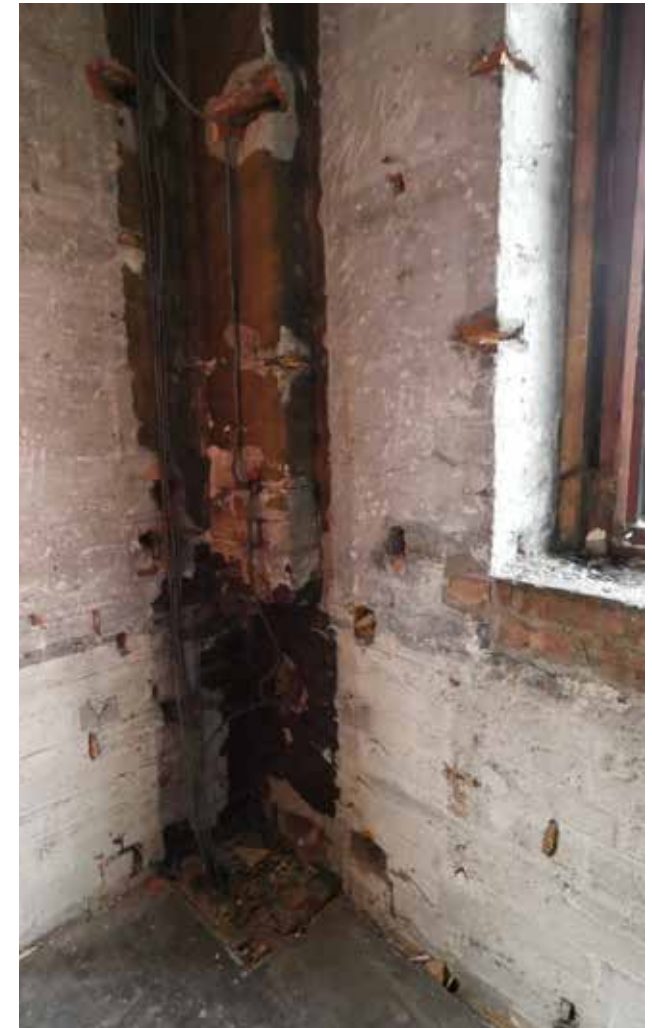
- The floors are screed. No historic floor finishes are visible at present.
- Flue revealed at the SW angle **[Plate 3.51]**.
- Some late-20<sup>th</sup> century timber stud and plasterboard partitions remain around the historic timber staircase **[Plate 3.52]**.

3.51 Flue, S002, Second Floor

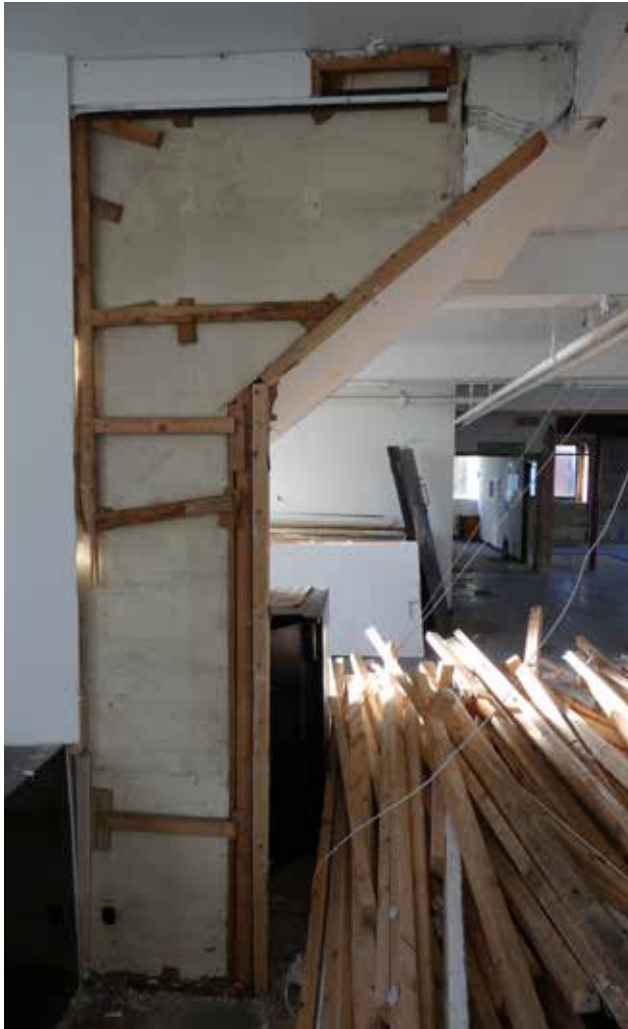
**3.52** *Partition around timber stair, S002, Second Floor*

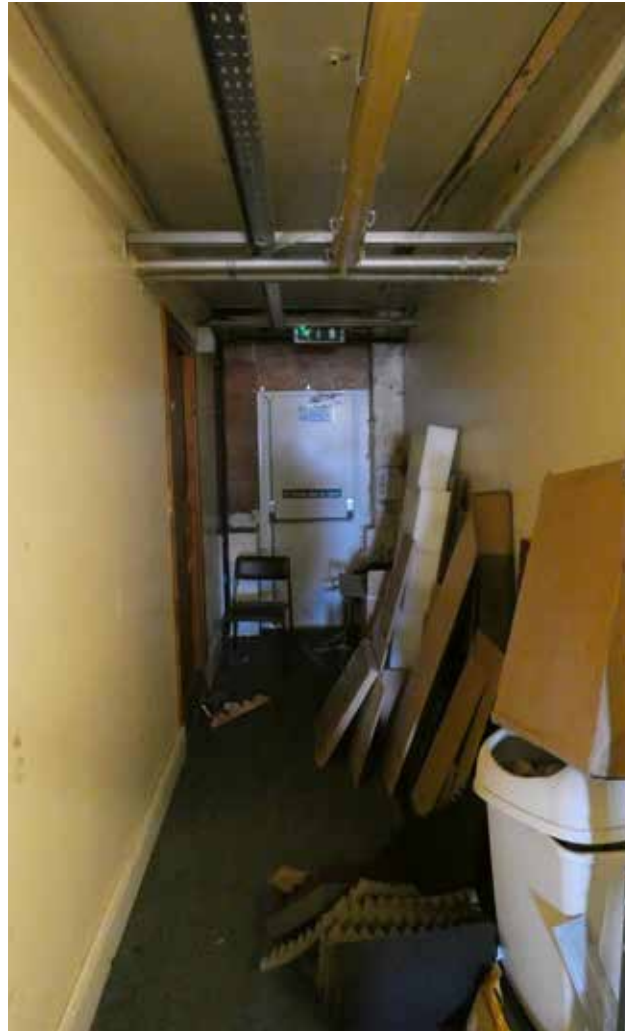
**3.78** T019

**T019** is a stretch of corridor leading off T016 to the northern fire exit. Same as T016. The fire exit door is modern, surrounded by ply infill. Clearly an adapted window, brickwork is visible to the right [Plate 3.78].

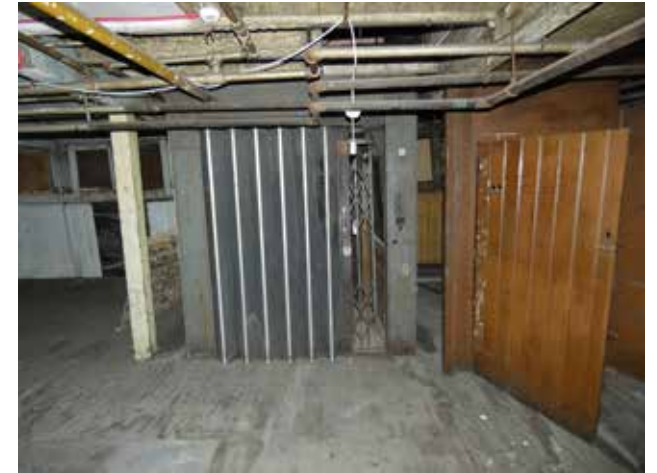
sheeting [see Plate 3.91 and 3.95]. Fixed to the beams and boards is a range of services – a mid-20<sup>th</sup> century sprinkler system, later strip lighting, mid- to late-20<sup>th</sup> century conduit / ceiling roses. At the northern end of FF005 is a service lift with mid-20<sup>th</sup> century outer concertina shutters and boarding externally, early-20<sup>th</sup> century scissor shutters and a timber-panelled lift car **[Plate 3.96]**.

**3.96** Lift shaft, FF05

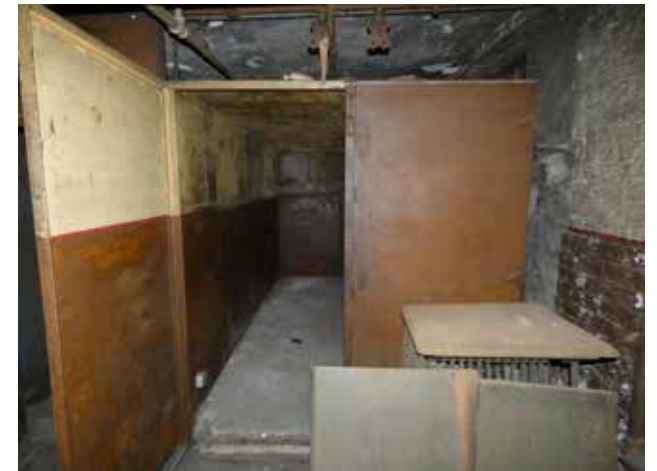
- FF006 is a free-standing early-20<sup>th</sup> century cold store in metal, with Bakelite light switch within **[Plate 3.97]**.
- FF007 is a fire escape passage, with two timber steps, plain vertical timber cladding to the walls and ceiling with cross-bracing. 20<sup>th</sup> century timber fire escape door **[Plate 3.98]**.

**3.97** Cold store, FF006

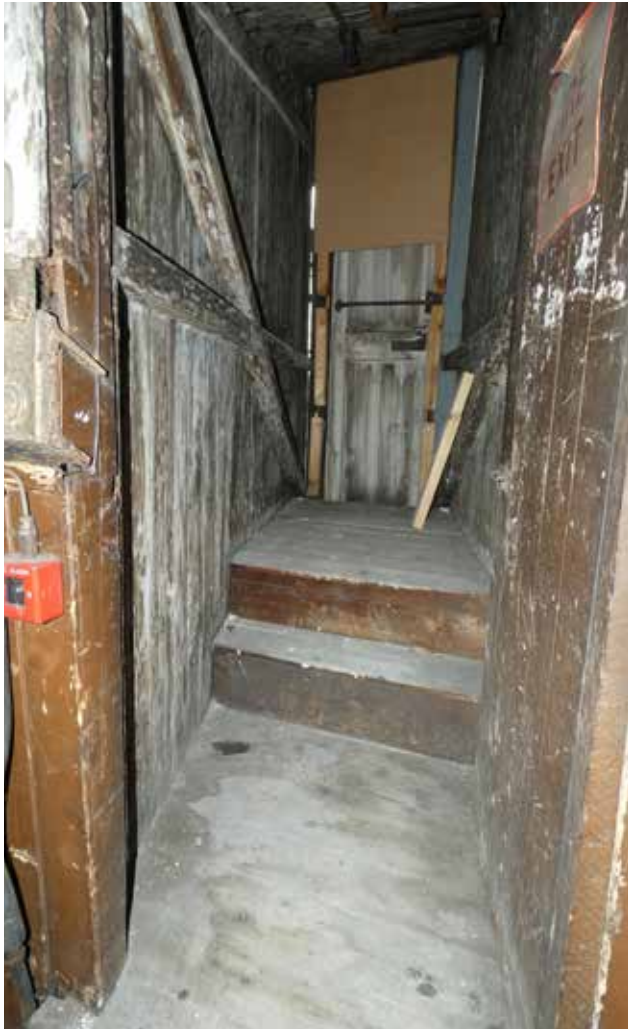
**3.98** *Fire escape passage, FF007*

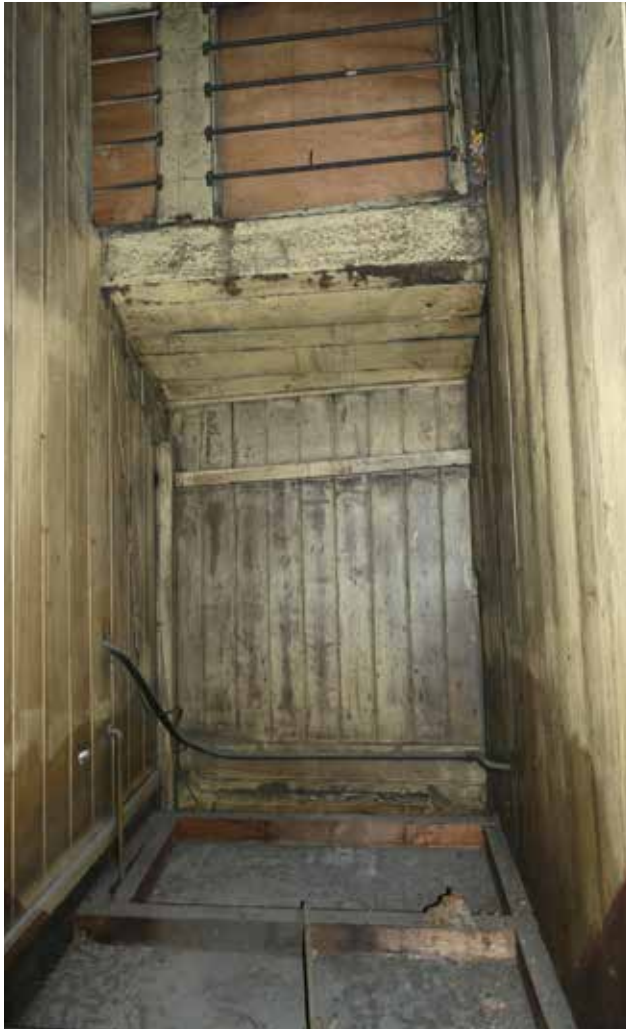
- Room FF009 is not fully accessible – contains a WC – features tongue and groove vertical panelling **[Plate 3.100]**.
- The historic timber staircase has been overboarded off FF10 **[Plate 3.101]**.

**3.101** Boarded over staircase off FF010

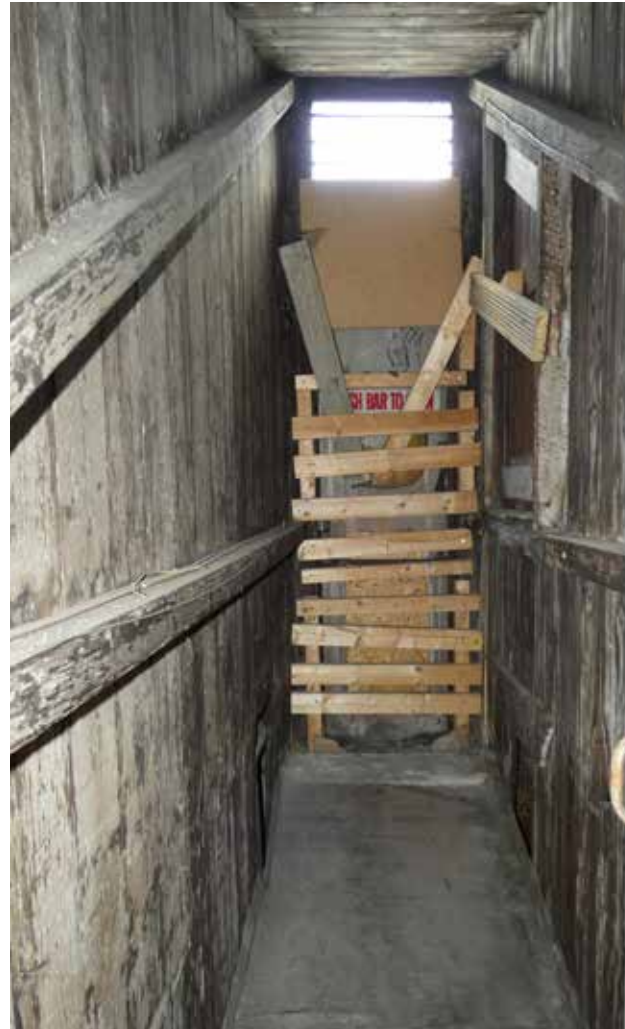
- FF011 is another fire escape passage, much the same as FF007 but with a four-panelled timber door providing access to the passage, the mid-20<sup>th</sup> century exit door has modern timbers providing a temporary barrier **[Plate 3.102]**.

**3.102** Fire escape passage, FF011

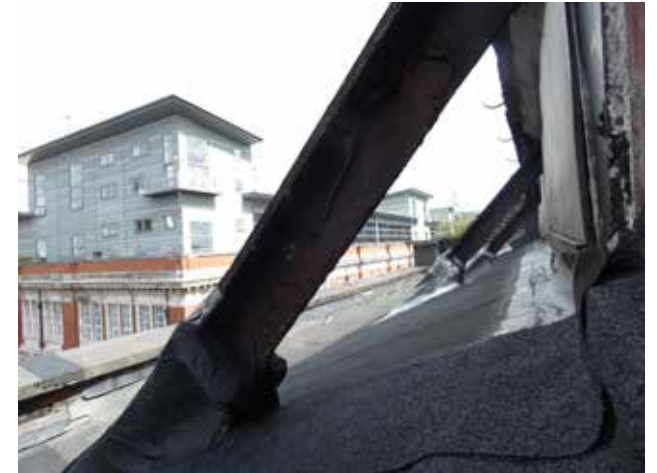
*The roof structure is a composite of timber and iron, taking a mansard form. Iron I-section upper rafters are connected by an iron pin to the timber collar. A central wrought-iron tension rod runs from the ridge to the collar. Additional iron T-section rafters run at a steeper pitch down from the collar. The collar rests on cast-iron posts with a shoe for the purpose cast into their heads. A wrought-iron tension rod runs from the shoe to the timber tie-beam. The lower principal rafters are partly external as they rise through the lower-pitched roof below the clerestory, and are fixed to the external face of the shoe. The trusses are connected by cast-iron purlins with lugs to retain timber rafters in place, and which curve upwards at their ends where they are bolted to the principal rafter. Between the trusses, the loft wall is formed of a cast-iron framework which is pinned together, with a middle rail, posts forming three windows between trusses, and a top rail incorporating a gutter for the upper slate roof. The junctions of the middle rail display sockets which would accommodate vertical posts (now absent) supported off the tie-beam, thus supporting the clerestory. The structure now displays some distortion and cracking to the tie-rods and the rails.*

**3.104** View of cast iron principle rafters, NW

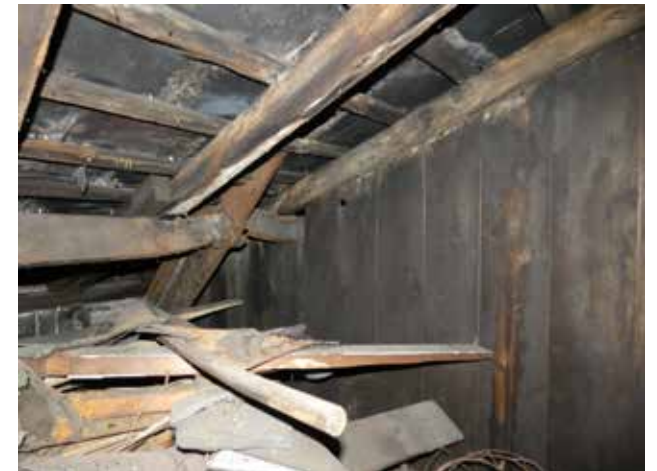
**3.105** View of eaves, with cast iron rafters and purlins
