# GEOSHIELD

## Verification Report

McAlear & Rushe

101 Charles Street

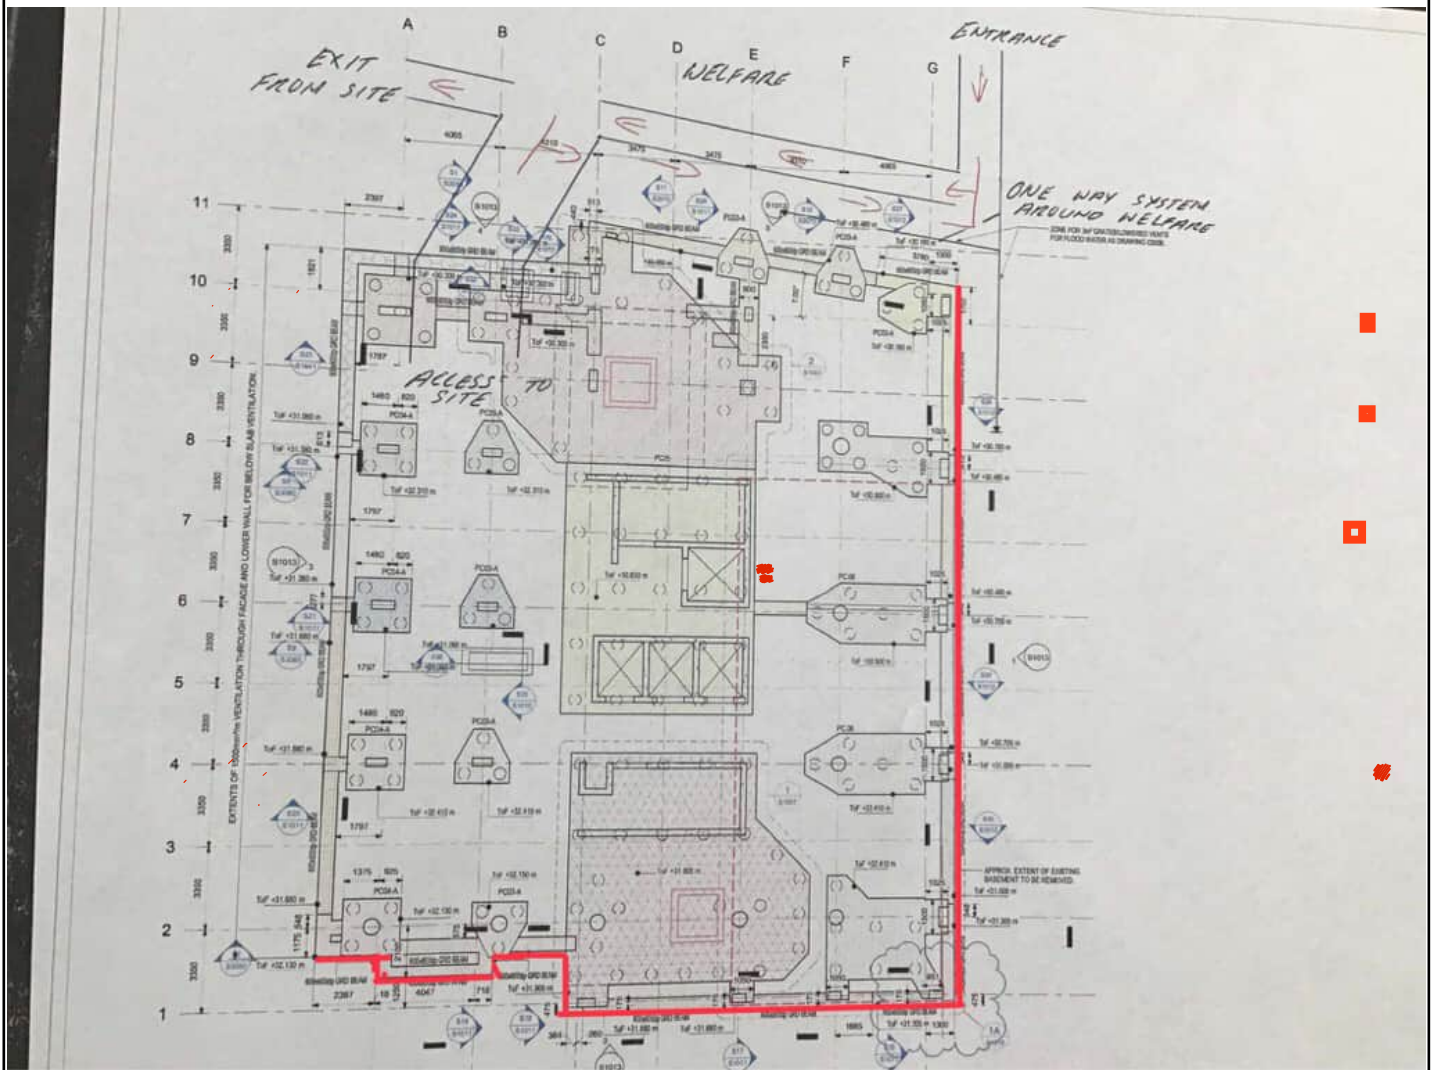
Area highlighted East and South Toe Detail

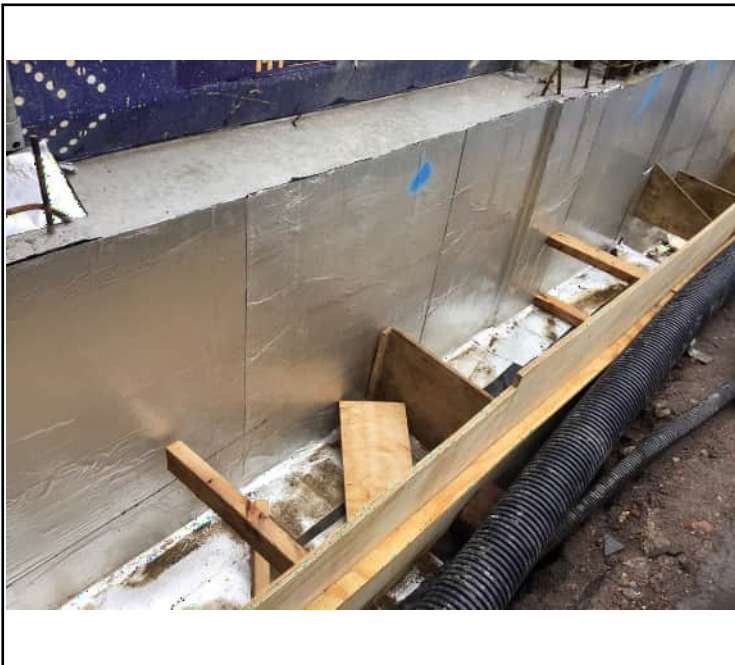
LOCATION/GRID LINE: East Toe Detail

Down both the East and South toes, large rolls of Gas Resistant Self Adhesive Membrane has been applied. The toe has first been primed and left to dry, then the GR SAM has been had heat applied and then installed onto the toe.

Left photo) overview of East Toe Detail

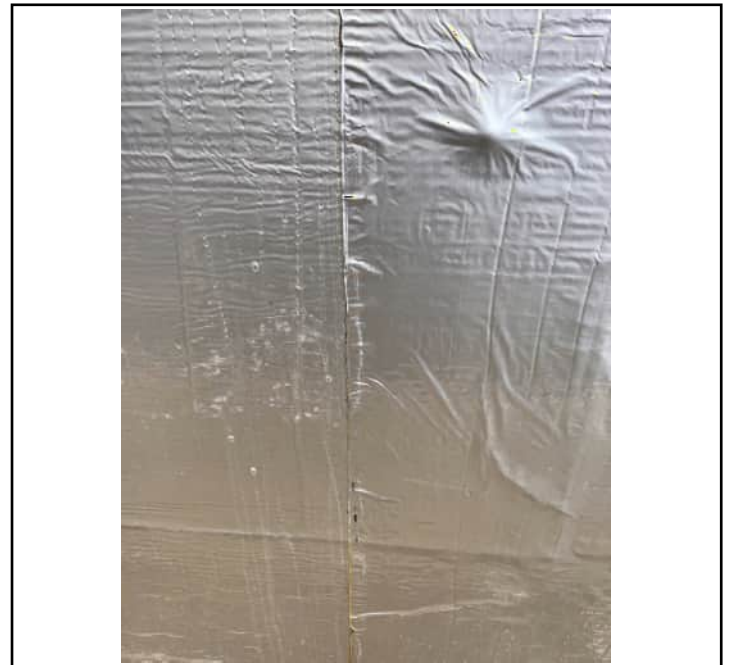
Right photo) this shows an overlap of the GR SAM

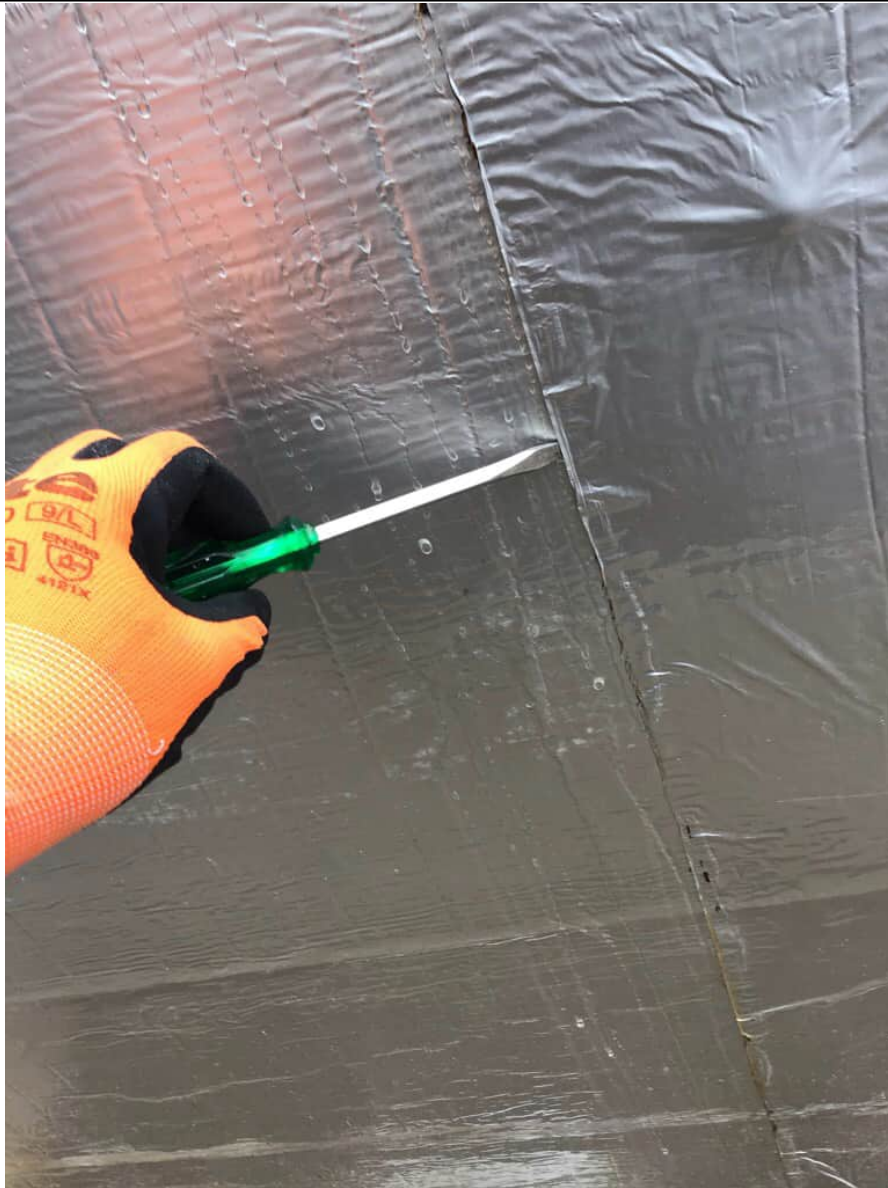
Above photo) a pick and probe test was carried out on the vertically applied GR SAM on the East and South Toes. A good seal has been created between the GR SAM and the primed concrete underneath.

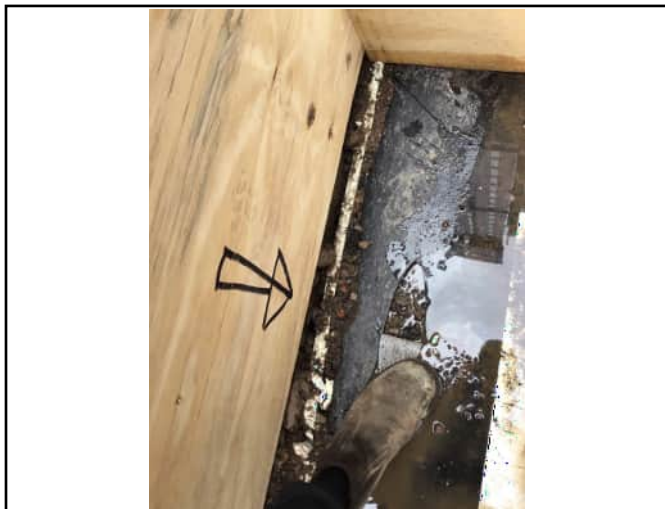
LOCATION/GRID LINE: East Toe Detail

During the visit a visual inspection was carried out, a large hole was found in the DPC where the GR SAM is lapped down onto it. Installers remediated the hole during the visit using a patch of GR SAM.

Left photo) this shows the large hole in the DPC found during the visual inspection of the verified area.

Above photo) this shows the patch of GR SAM that was applied to the hole found

during the visual inspection. Heat was applied to the patch using a leister, the DPC

was then dried and cleaned and the patch was applied.

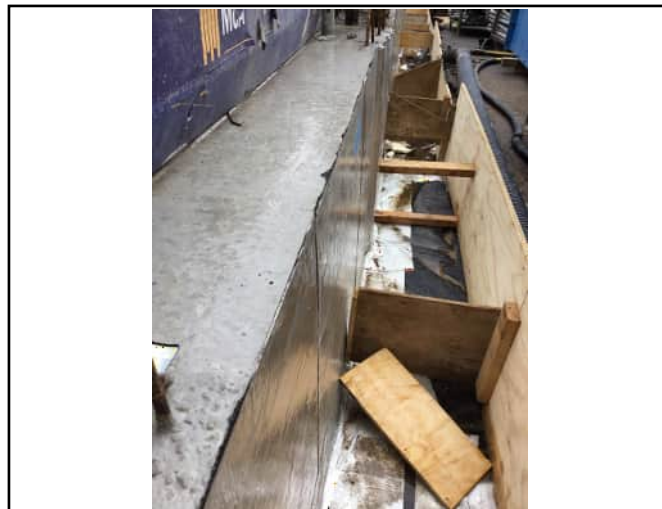
Right photo) reverse angle overview of where the hole was found

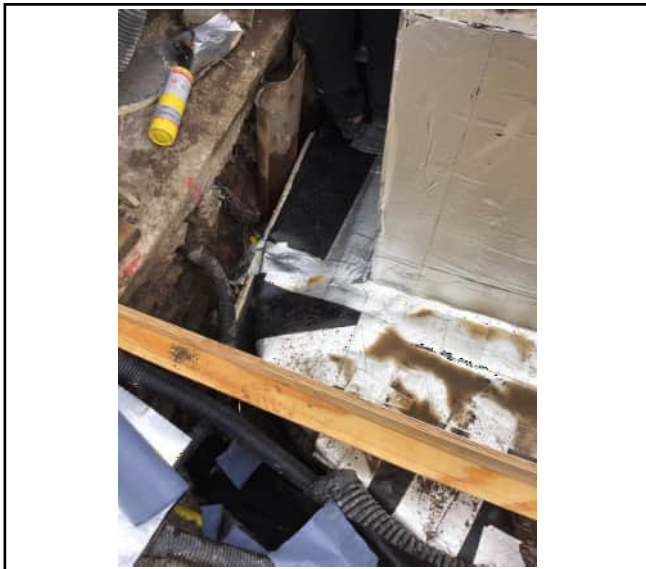
LOCATION/GRID LINE: East/South Corner

Gas resistant self adhesive membrane has been applied to the DPC where joints have needed to be sealed. Pick and probe test were carried out to ensure a good bond has been created.

Left photo) this shows the corner of the East and South Toe Detail, the GR SAM has been applied vertically down and lapped onto the DPC. The DPC has then been sealed using GR SAM.

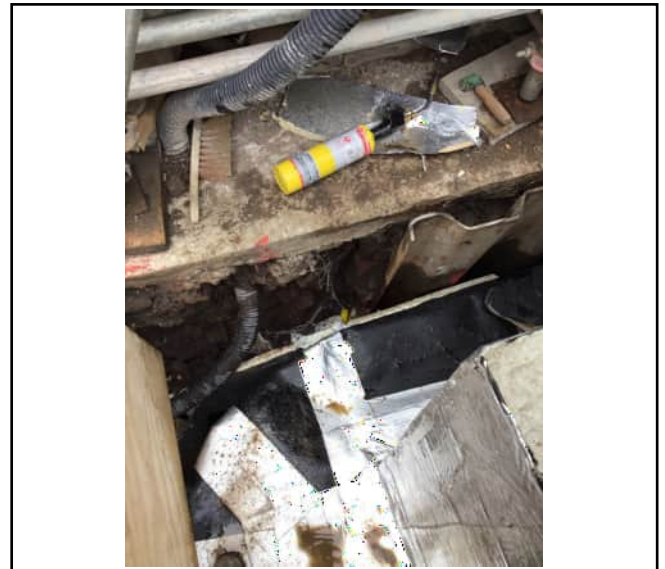
Right photo) overview of the corner and DPC

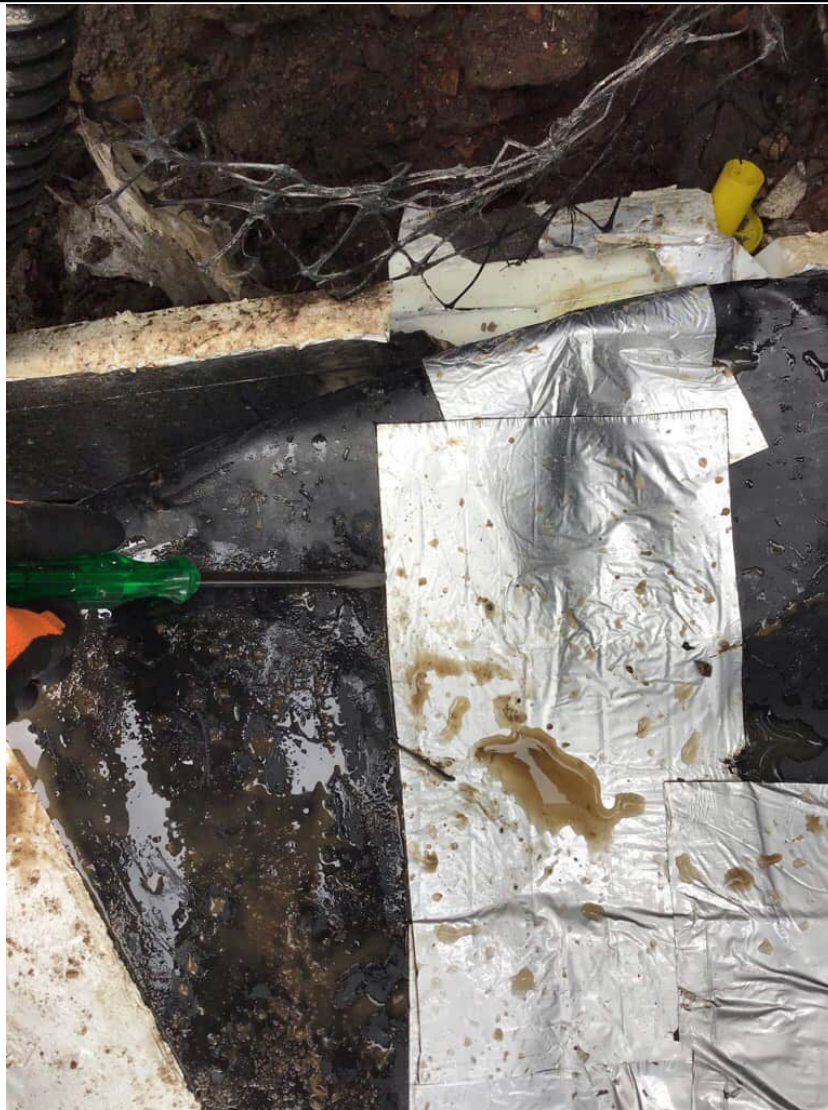
Above photo) a pick and probe test was carried out on the GR SAM which has been applied to the DPC, to ensure that a good seal has been created.

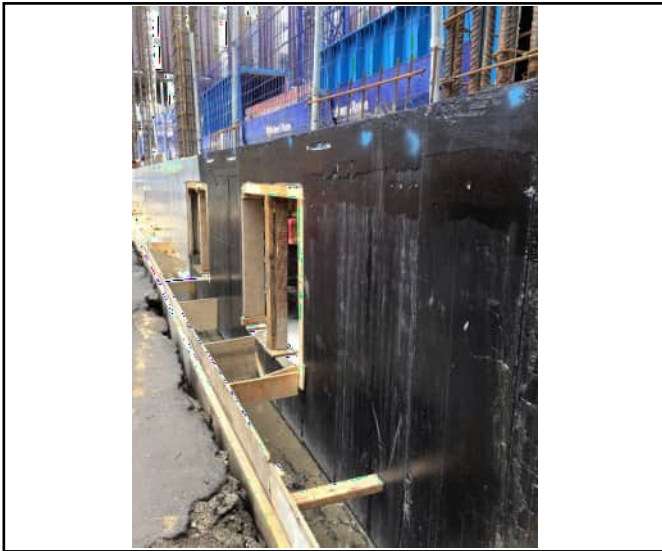
Primed concrete wall on

Eastern Toe

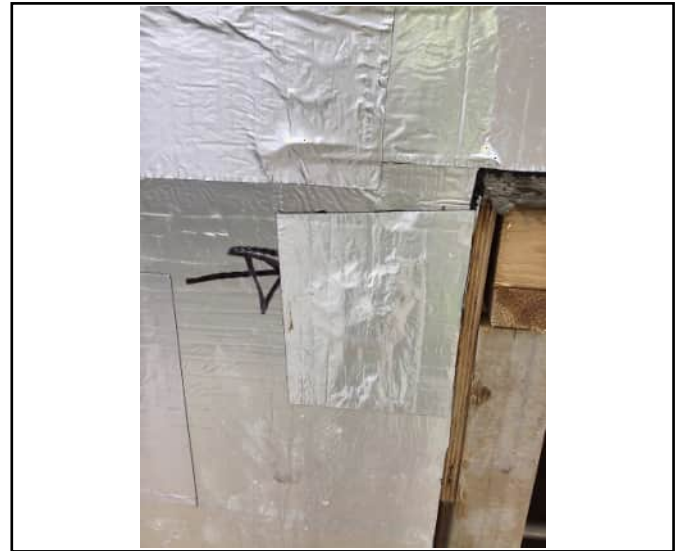
GR SAM patched applied to

hole

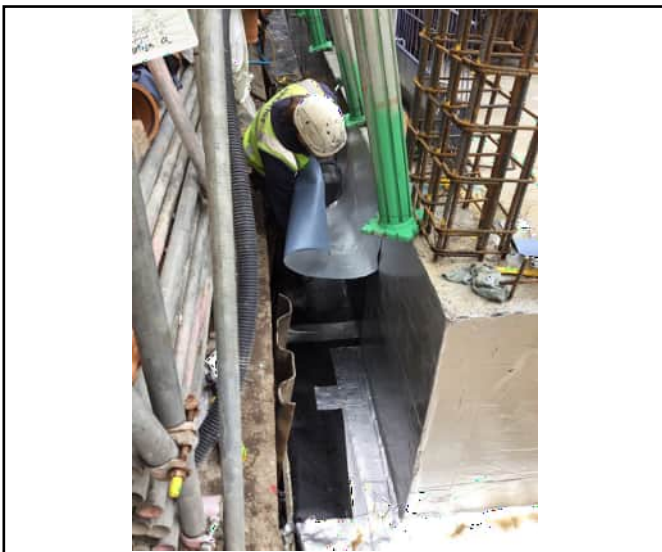
GR SAM applied to southern toe

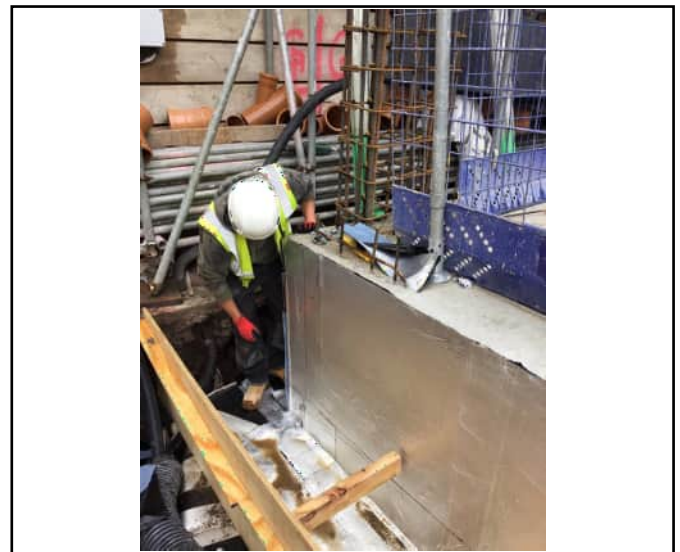
Installer applying GR SAM to South

toe
