PROJECT :  
BARRACKS HOUSE  
M15 4HA

DRAWING TITLE :  
WINDOW INSPECTION  
RECORD

DWG BH-P-001 00

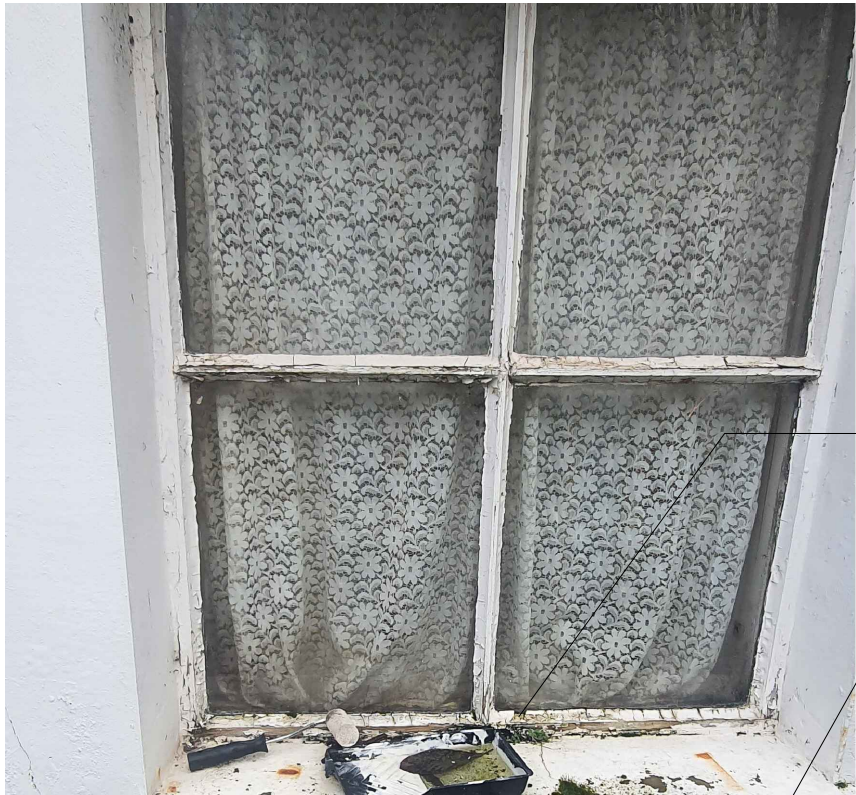
Photo from outside

Cracking and rot

GLAZING BAR mold and rot when too much moisture, swell and move from increased moisture content. (Cause of Condensation)

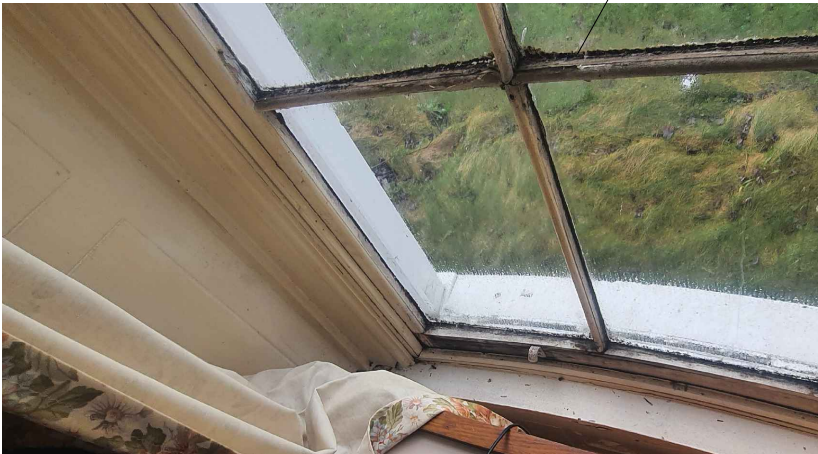
Glazing section n.t.s.

Thermal upgrading

REPLACE EXISTING SINGLE GLASS TO LIGHT WEIGHT ACRYLIC DOUBLE GLAZING"

GLAZING BAR (REPAIR OR REPLACE) TO MATCH

RUBBER ROD
