## Verification Report

PROJECT REFERENCE: GEO101021

REPORT NUMBER: 007 REPORT DATE: 01/06/2020

PROJECT ADDRESS: 101 Charles Street

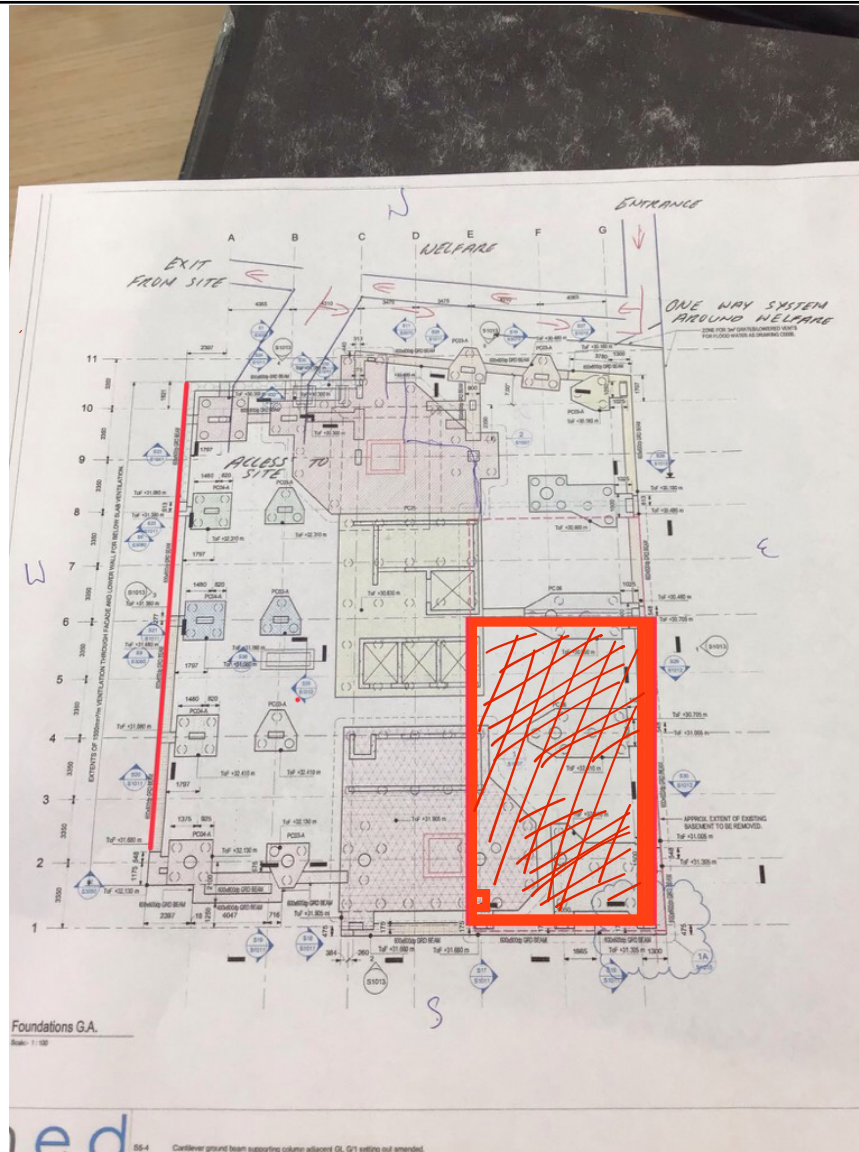
Area highlighted GL 1-6/E-G and West Toe Detail verified on this visit.

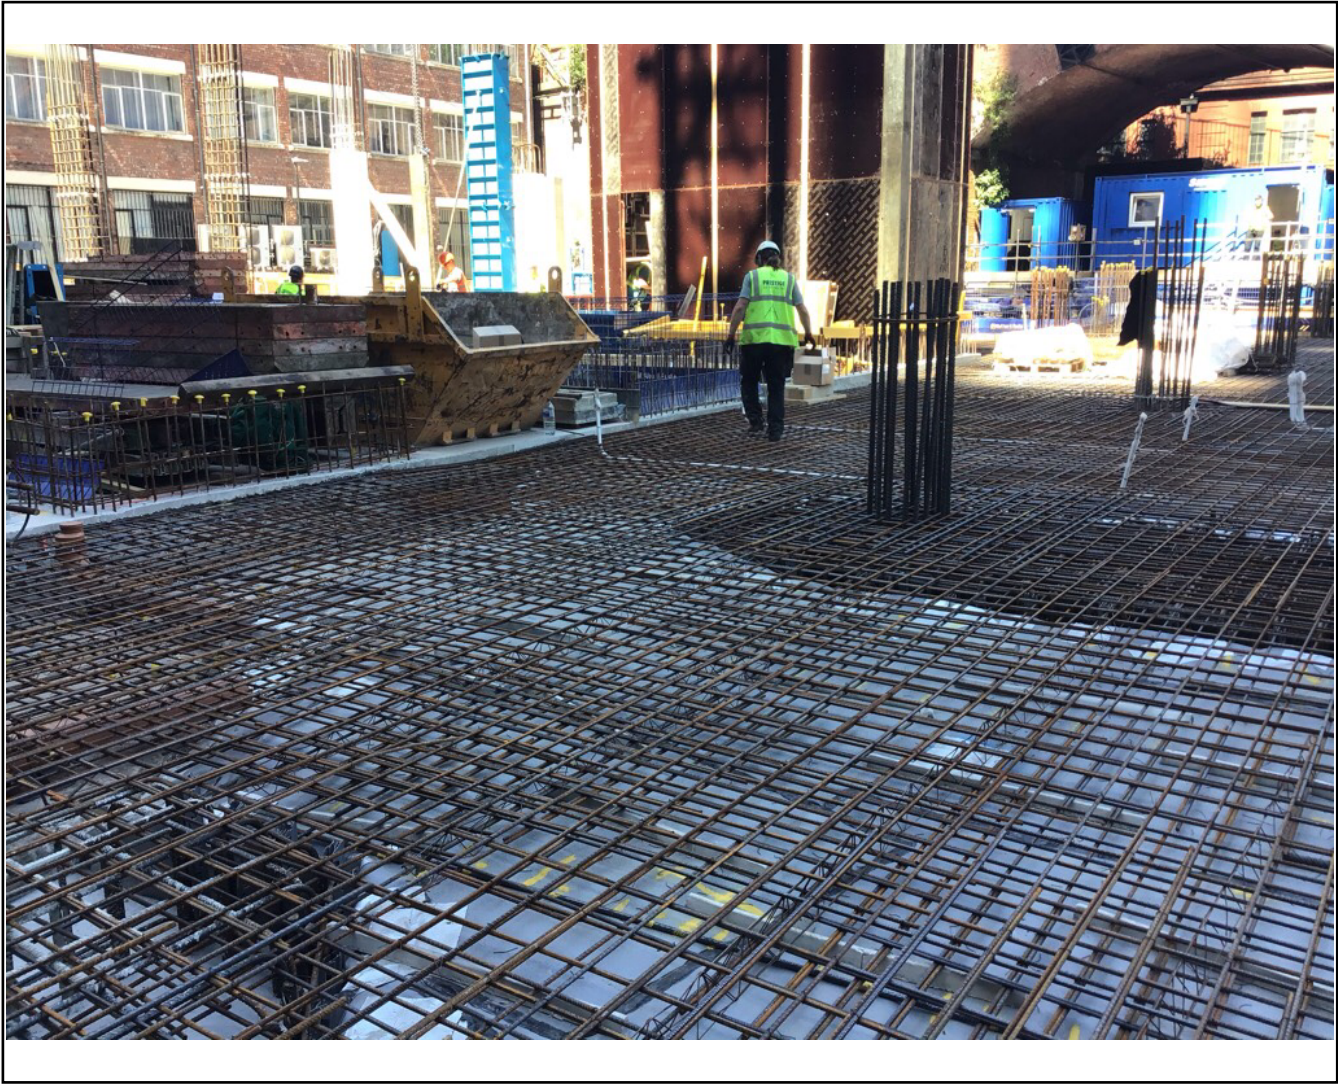
Overview of verified area

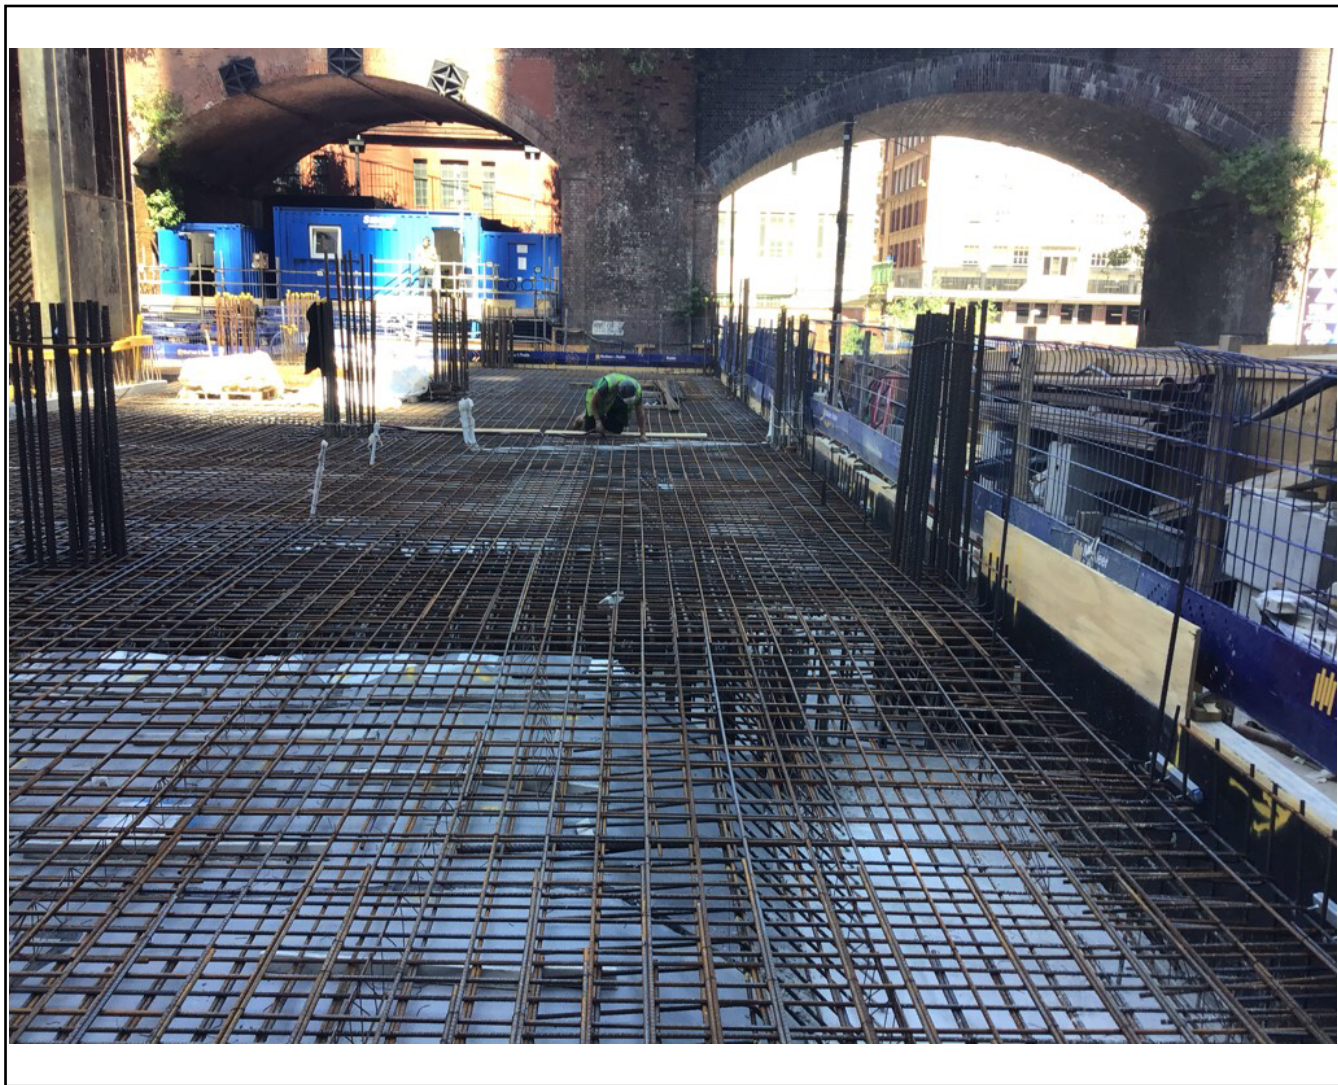
Overview of verified area

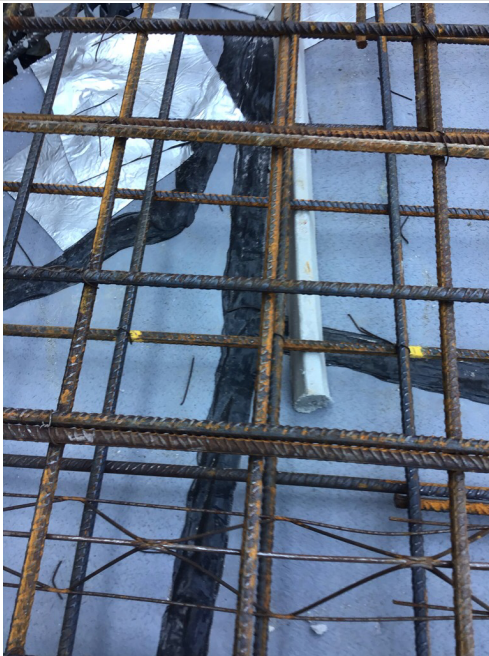
LOCATION/GRID LINE: Gridlines 1-6/E/G

NOTES: Visqueen Ultimate Geoseal has been applied to a large area within the grid lines given above. It has been extrusion welded on every joint to ensure that a good bond has been created. A pick and probe was carried out on welds, however due to limitations it wasn't possible to check all.

Left photo) Visqueen Geoshield Ultimate, with extrusion weld on joint.

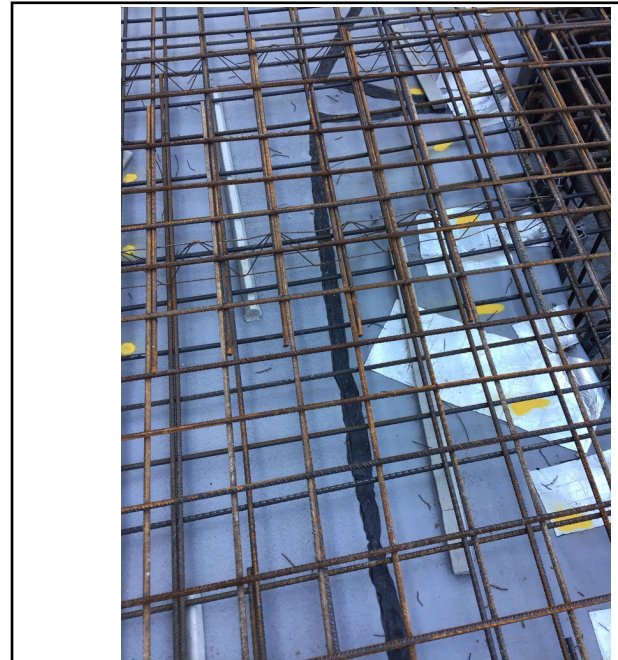
Right photo) Overview of membrane with concrete spacers holding the rebar above it.

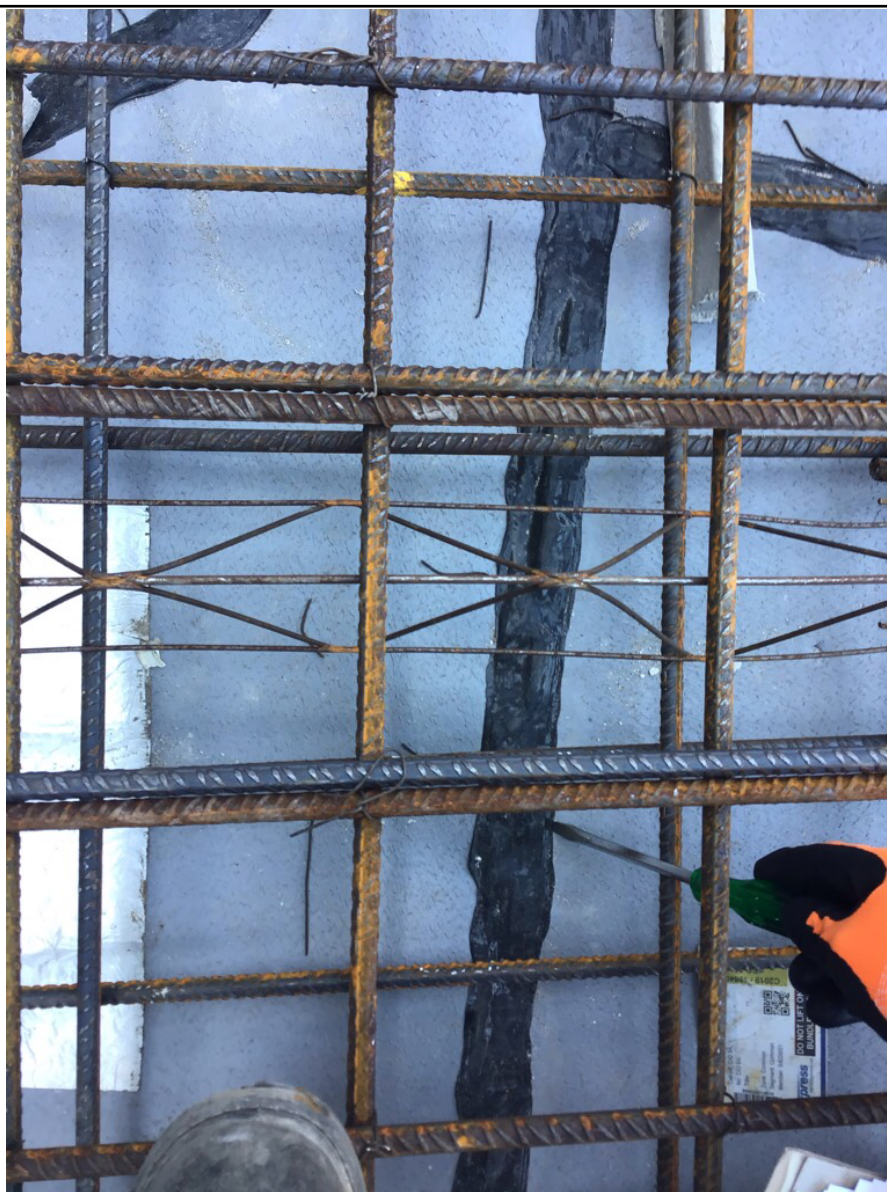
Above photo) this show a pick and probe test being carried out on the extrusion weld, which has been carried out on the overlap of Visqueen Geoshield Ultimate. Due to the rebar already been installed pick and probe tests couldn't be carried out on every weld.

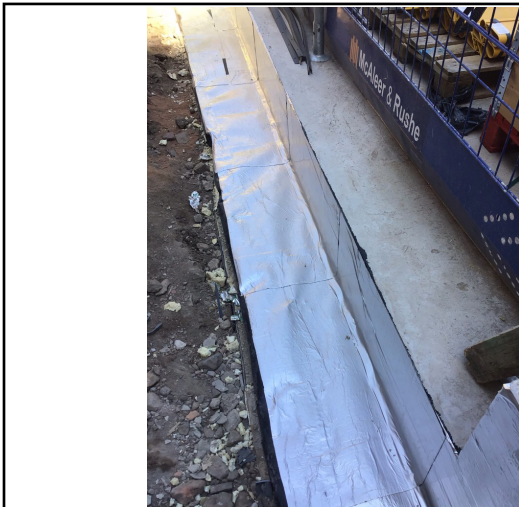
LOCATION/GRID LINE: West Toe Detail

NOTES: Gas Resistant Seal Adhesive Membrane has been

applied to the length of the western toe detail. A pick and probe test was carried out

on the overlaps to ensure that a good seal has been created.

Left photo) overview of Western Toe Detail, which as had GR SAM applied to it by the installers.

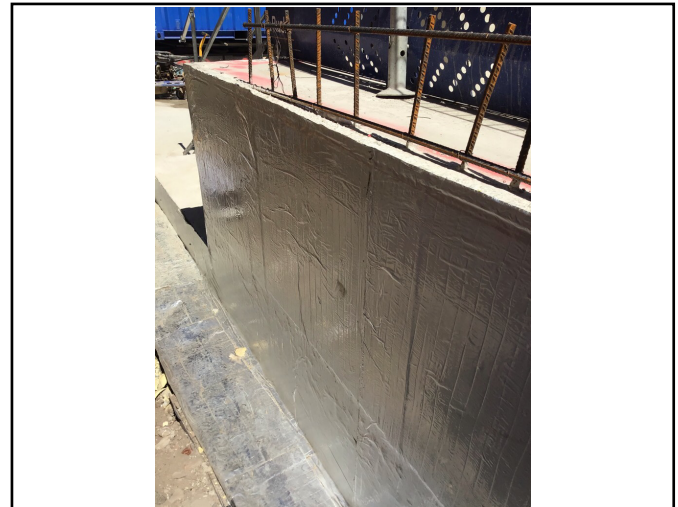
Right photo) GR SAM applied to Western Toe Detail.

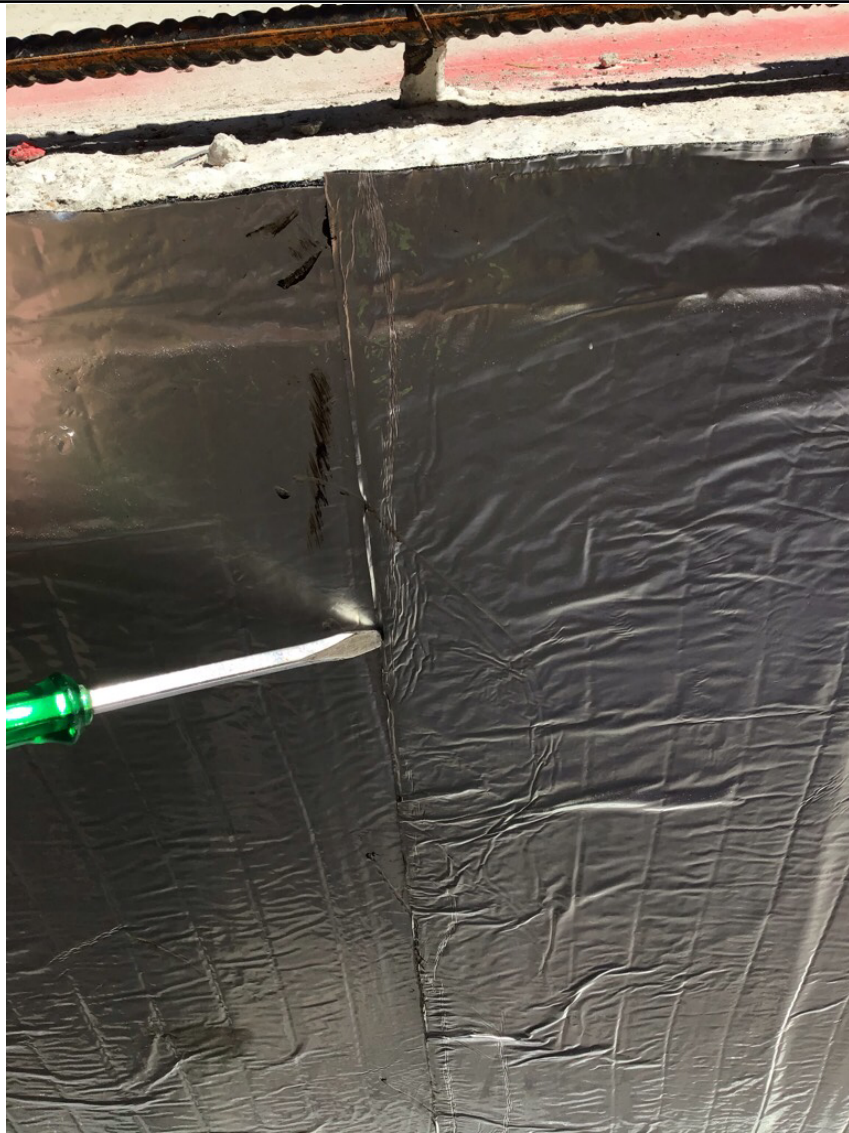
Above photo) a pick and probe test was carried out on the GR SAM that has been

applied to the Western Toe Detail. The length of the toe was firstly coated with

Bitumen primer, a good seal was created across the whole verified item.

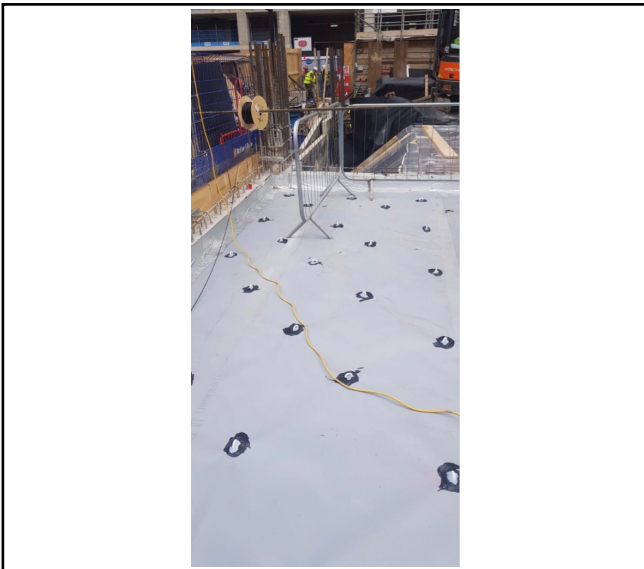
LOCATION/GRID LINE: Membrane Hooks

NOTES: This item is a follow on from the previous visit, hooks have been extrusion welded to the Visqueen Ultimate Geoseal as per manufacturers design. Wire has then been threaded through the loop on the hook and tied to the rebar which has been installed on the insulation covering the membrane.

Left photo) this is an overview of the Visqueen Ultimate Geoseal which has been covered with hooks and the extrusion welded to the membrane.

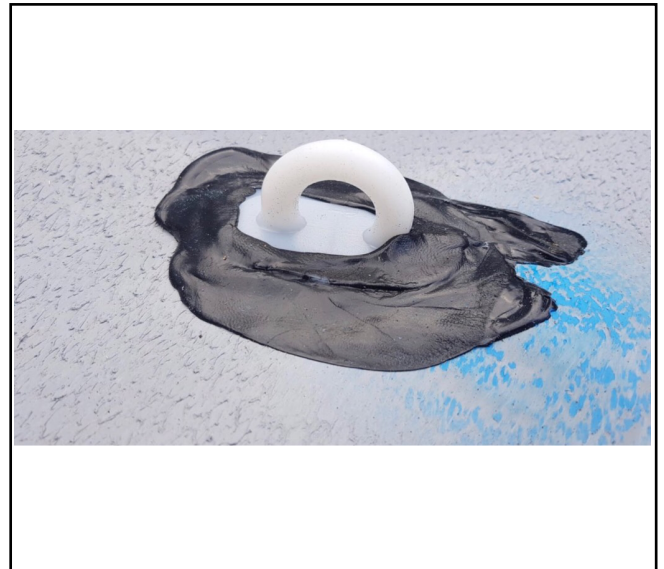
Right photo) close up of a welded hook.

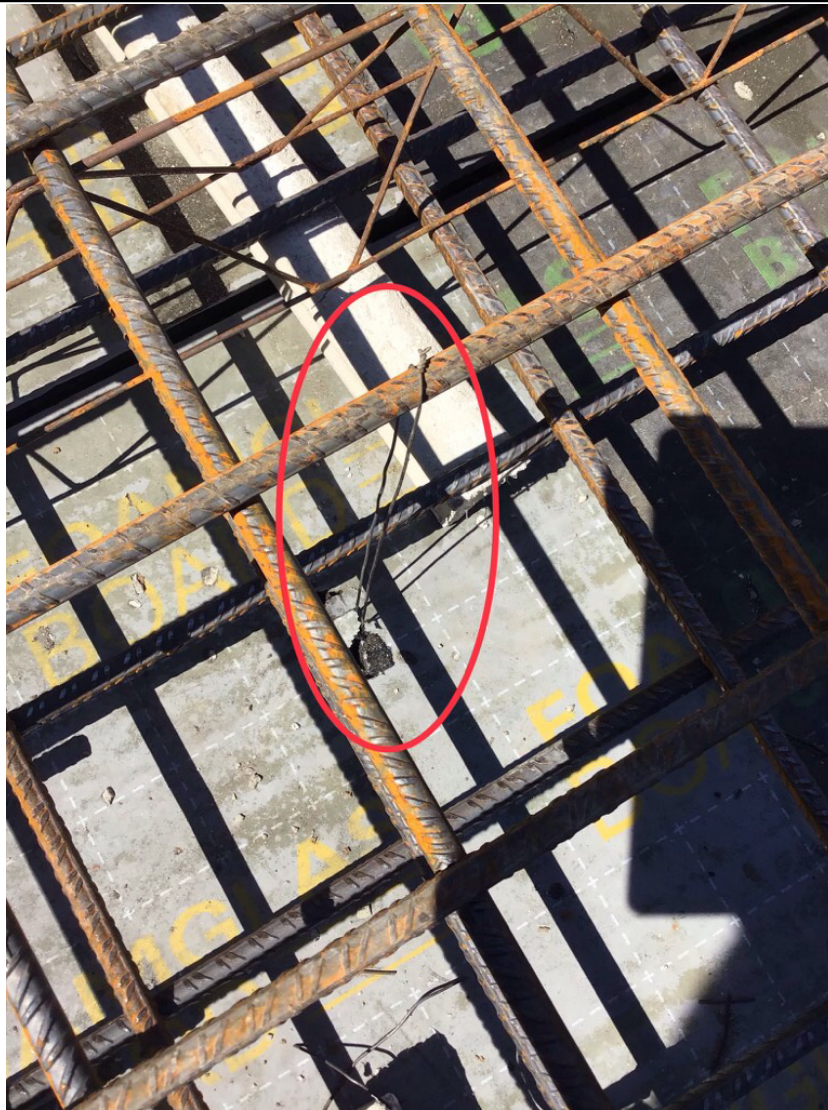
Above photo) this show wire that has been tied to the steel rebar sitting on top of the insulation. The insulation has been laid on top of the membrane. The other end of the wire is tied to the hook attached to the membrane.

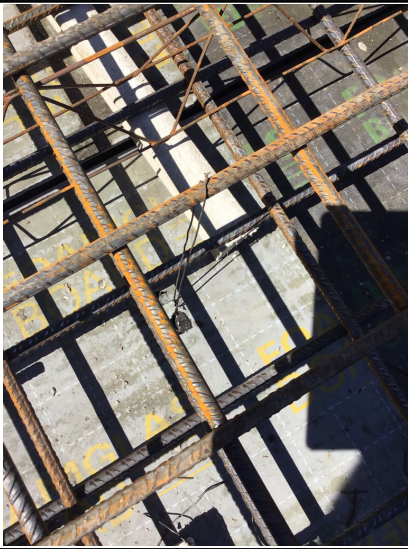
Wire ties holding the membrane  
to the rebar.

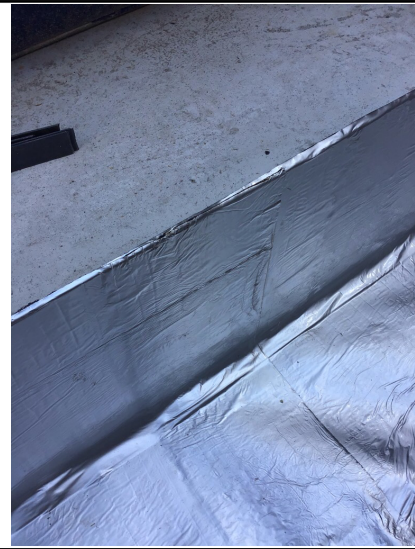
GR SAM applied to Western

Toe Detail

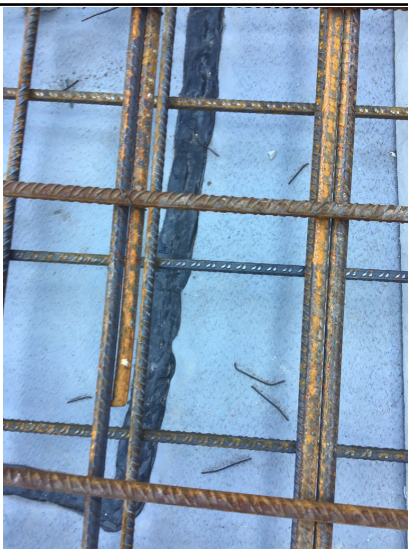
Extrusion weld on Visqueen

Geoshield Ultimate
