## Rooflight Repairs and Replacement

### POST STRIP-OUT ADDENDUM:

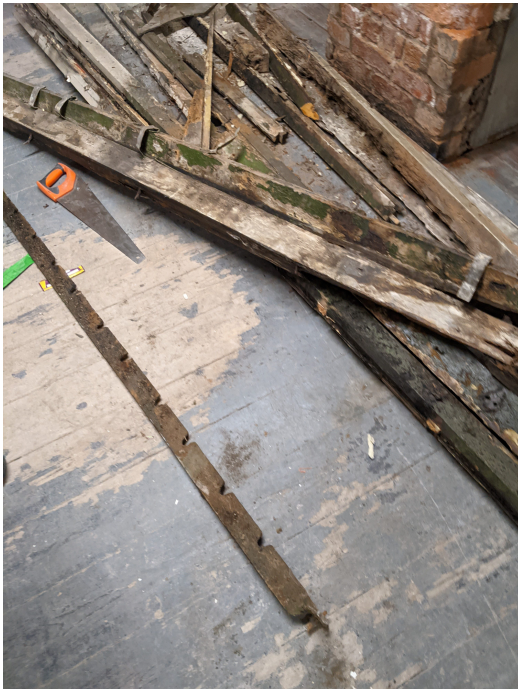
Existing frame found to be too badly rotten with little sound timber. Repair by traditional methods not possible. New frame to be constructed from traditional joinery jointing techniques to match the existing frame. Slow grown Redwood timber. Refer to drawing C(420) for further details.

Dismantled frame pieces found to be significantly rotten and unsuitable for re-use.

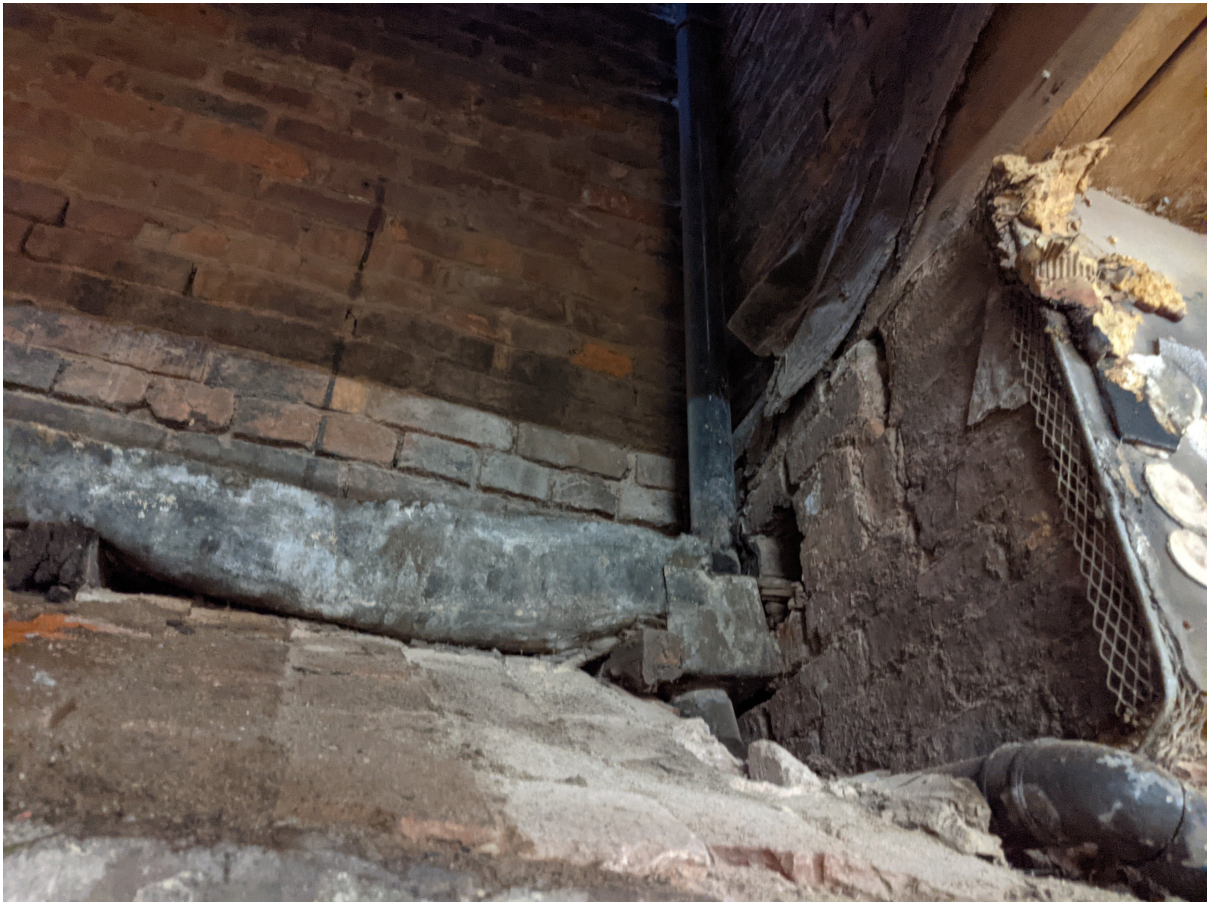
A replacement lead gutter could not be installed in accordance with current LSTA recommendations due to insufficient space and falls. The failure of the existing lead gutter is likely to have caused some of the damage to the original frame, and lead to water ingress. Therefore, reinstating something similarly unsuitable and robust is not considered acceptable. As a more robust and appropriate alternative, ensuring the longevity of the fabric, a new PPC aluminium box gutter is to be installed in place of the deformed lead gutter. All flashings will be lead in accordance with LSTA guidelines.

Failed lead guttering uncovered following strip-out.

It must also be noted that this rooflight and gutter cover small lightwell (approx. 4x3m) which is not easily overlooked from within the Clients property. There is nowhere to install a 'tell tale' overflow spout. Whilst it is unlikely that significant debris could be accumulated, it is nevertheless prudent to ensure that the design of the new rainwater drainage is as far as possible an improvement on the historic design. The walkway over the rooflight is being modified to allow the panels to be lifted to assist in future regular maintenance of the rooflight and its gutter.
