## Project

**Project Name:** 2022-03-17090 Countryside Properties Bellvue Dog Track  
Bellevue

**Project Date:** 21/03/2022

**Inspection Standard:** MSCC4 Sewers & Drainage GB (SRM4 Scoring)

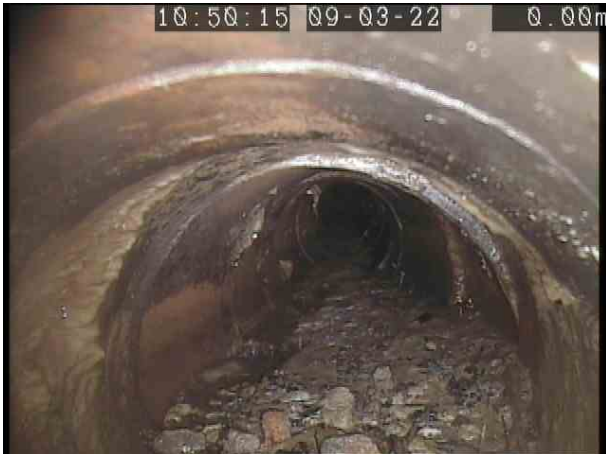
| Scale: 1:152 | Position [m] | Code | Observation | MPEG | Photo | Grade |
|---|---|---|---|---|---|---|
| | 0.01 | DER | Settled deposits, coarse, 15% cross-sectional area loss | 00:00:30 | USX_9668<br>2c14-87e8<br>-4f9c-8cd7 | 3 |

USX\_96682c14-87e8-4f9c-8cd7-850dc85c04b4\_20220321\_151034\_333.jpg, 00:00:30, 0.01 m  
 Settled deposits, coarse, 15% cross-sectional area loss

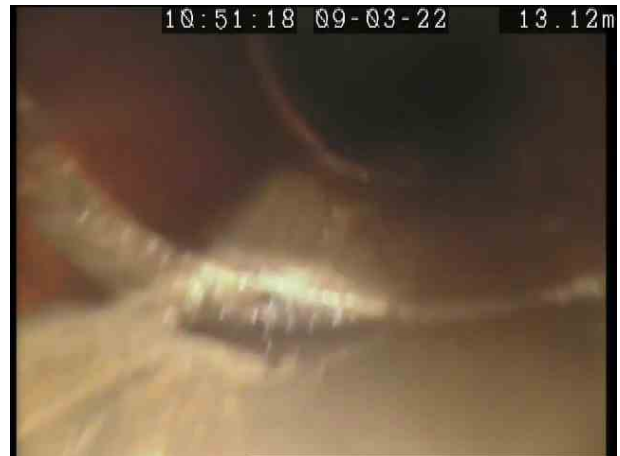
| Scale: 1:152 | Position [m] | Code | Observation | MPEG | Photo | Grade |
|---|---|---|---|---|---|---|
| | 13.12 | JDM | Joint displaced, medium | 00:01:33 | USX_3208<br>c41a-7825<br>-4b88-8ce | 1 |

USX\_3208c41a-7825-4b88-8ce2-a3c79e204f2e\_20220321\_162300\_163.jpg, 00:01:33, 13.12 m  
 Joint displaced, medium

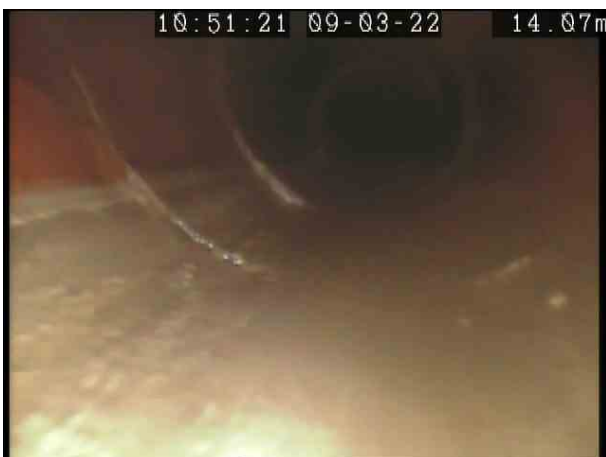
| Scale: 1:152 | Position [m] | Code | Observation | MPEG | Photo | Grade |
|---|---|---|---|---|---|---|
| | 14.07 | FC | Fracture, circumferential from 5 o'clock to 9 o'clock | 00:01:37 | USX_d93a<br>463c-32b1<br>-47e3-960 | 3 |

USX\_d93a463c-32b1-47e3-9606-291f37a0c3ca\_20220321\_162520\_364.jpg, 00:01:37, 14.07 m  
 Fracture, circumferential from 5 o'clock to 9 o'clock
