## Victoria North HIF Infrastructure and Enabling Works

Red Bank and Plateau Avenue  
Stage 1 Road Safety Audit

**Document Reference:** 10030/01/00/02032022/cvl

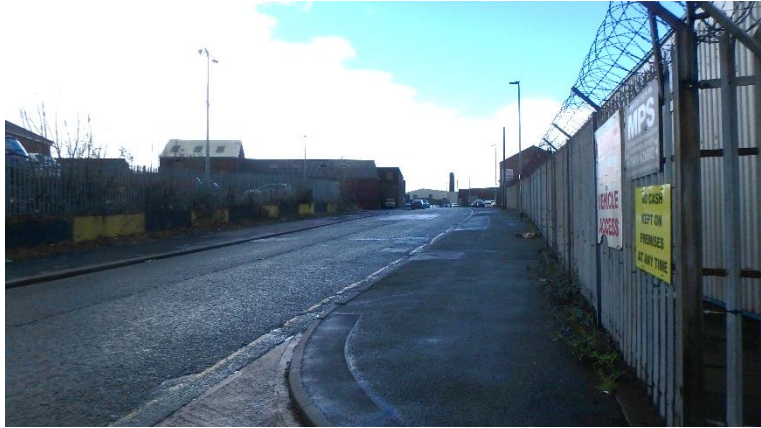
| <b>Summary:</b> | High vehicle speeds leading to turning collisions |
| <b>Problem:</b> | <p>High traffic speeds were observed on Red Bank, particularly vehicles travelling south-west (downhill).</p> <p>High traffic speeds through the junction could lead to misjudgements when turning into or across the traffic streams resulting in collisions between vehicles at the junction. Excess speed for a vehicle turning into the junction could lead to loss of control collisions.</p> |
| <b>Photograph:</b> | <p>View northeast on Red Bank showing the approach gradient [P2241709.jpg]</p> |

| <b>Recommendation:</b> | It is recommended that the designer introduce additional traffic calming to reduce traffic speeds on Red Bank. |
