# DAYTIME BAT SURVEY & ECOLOGICAL SCOPING SURVEY

## ANCOATS WORKS, MANCHESTER

NOVEMBER 2021

**RACHEL  
HACKING  
ECOLOGY**

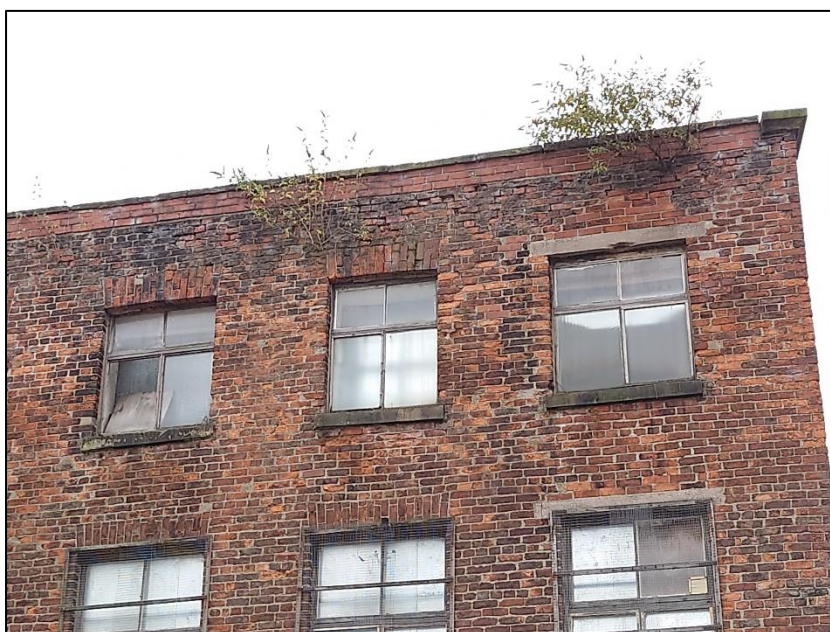
- 3.2 The property external brickwork is intact, though the bricks are damaged in places with recessed mortar (see Photograph 1). The brick chimneys are complete and intact. The window lintels are complete, providing a firm seal around the windows. The coping stones around the edges of the roof are complete, though gaps between the stones are present.

*Photograph 1 showing the external brickwork*

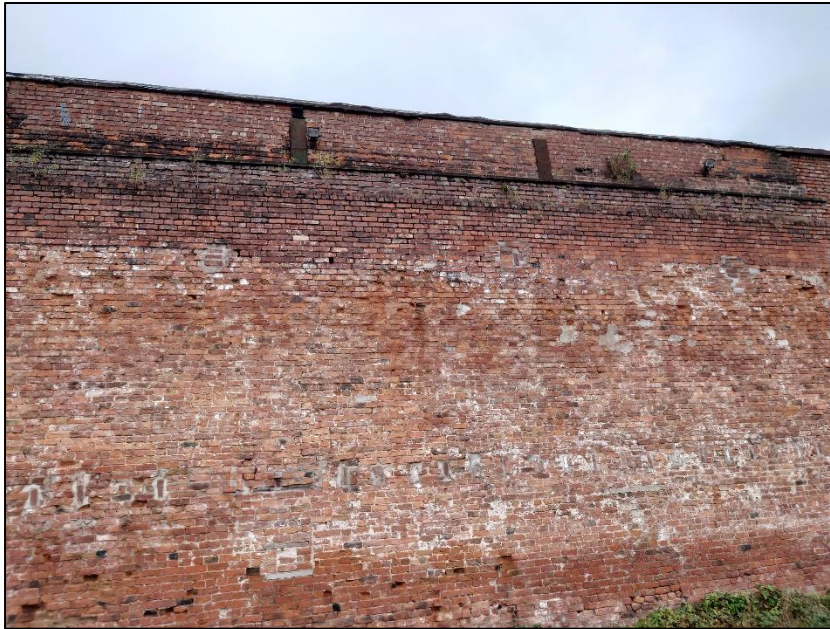
- 3.3 The roof of the building is pitched and tiled, with all roof tiles in position and flush to one another (see Photograph 2). The decorative clay ridge tiles are in situ and mortared. Small amounts of lead flashing occur at the base of the chimney stacks, and this is flat and flush to the brickwork. Vegetation is penetrating several parts of the building (see Photograph 3).

*Photograph 2 showing the brickwork*

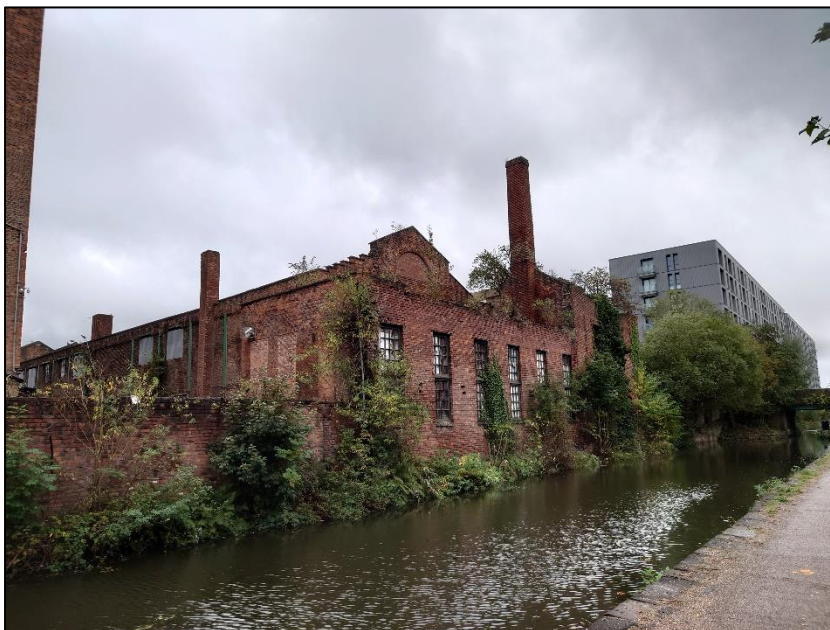
*Photograph 3 showing the exterior of the building from the canal towpath*

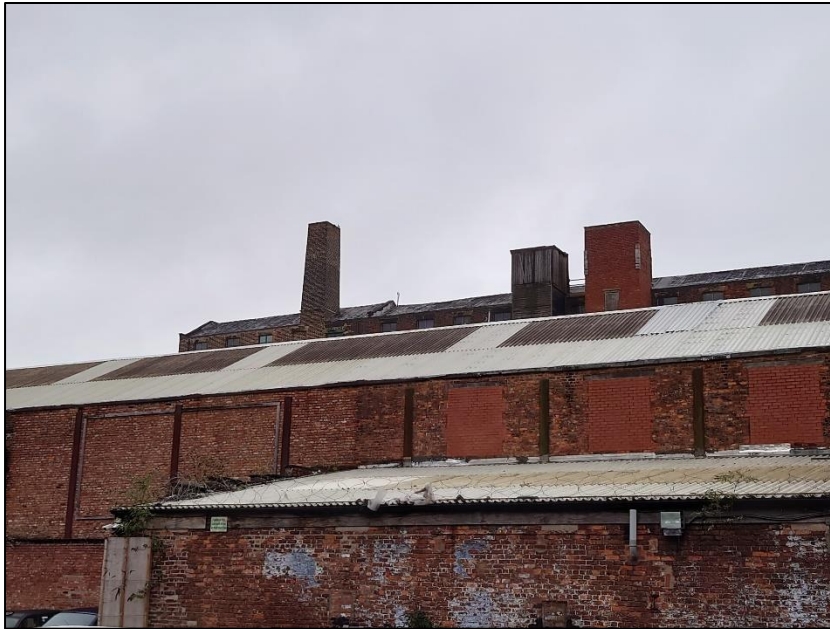
- 3.4 The roof above the warehouses is pitched and constructed from sheet-metal (see Photograph 4). The roofing is intact, with all panels flush to one another. The roofing above the upper floor offices also has pitched, metal roofing (see Photograph 5), and this is also complete and intact. The three-storey section of the building has parapet walls.

*Photograph 4 showing the roof of the warehouses*

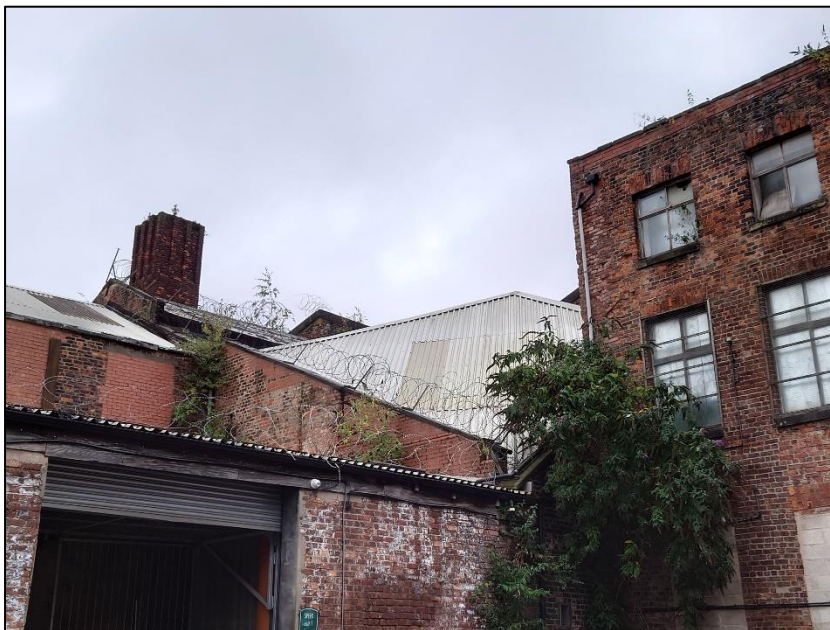
*Photograph 5 showing the roof of the upper floor*

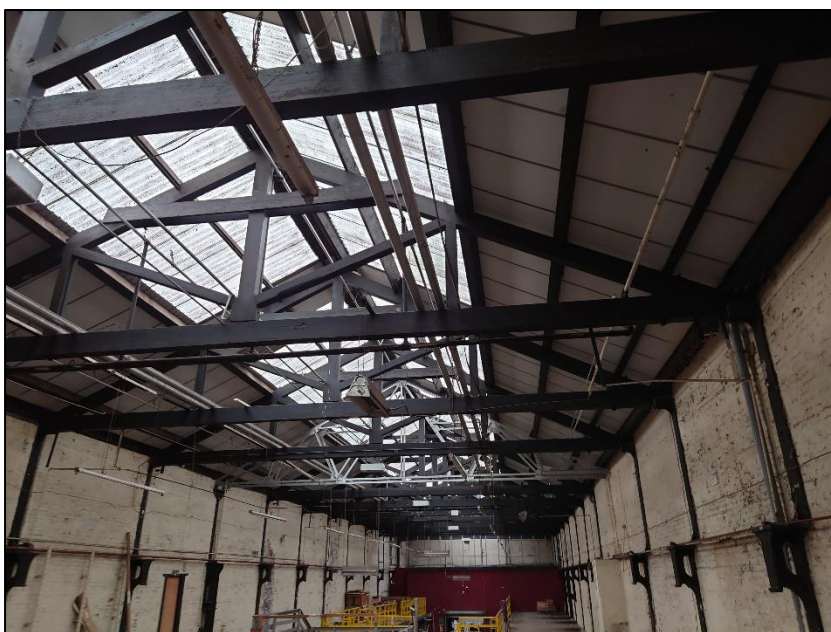
- 3.5 The warehouses are open to the roof, with no separate roof voids present (see Photograph 6). The roof beams are constructed from wood, with no cracks or gaps for bats to exploit. The interior of the warehouses is well-lit via roof skylights. The internal walls are complete and mortared, offering no suitable crevices. The upper floor offices also have no separate roof voids (see Photograph 7).

*Photograph 6 showing the interior of the warehouses*

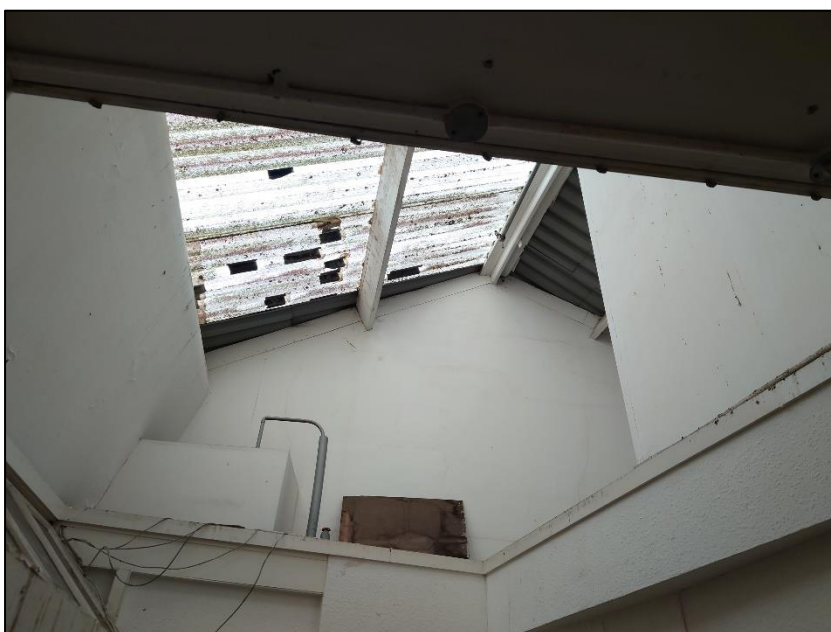
*Photograph 7 showing the upper floor of the office spaces*

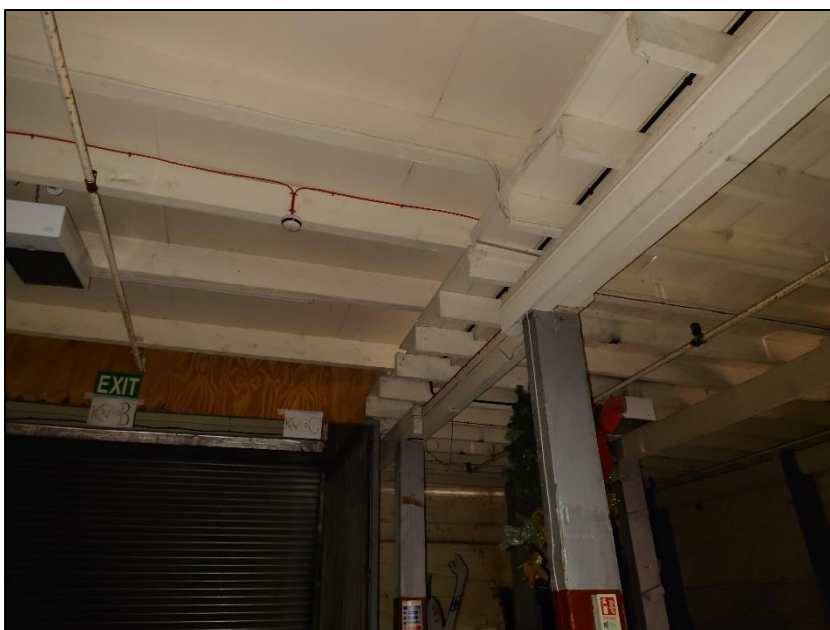
- 3.6 The ground floor of the office spaces offers no suitable bat roosting cavities. The ceiling joists are complete, offering no crevices for bats to use (see Photograph 8). No evidence of bat activity was found inside the Ancoats Works buildings.

*Photograph 8 showing the interior ground floor of the warehouse area*

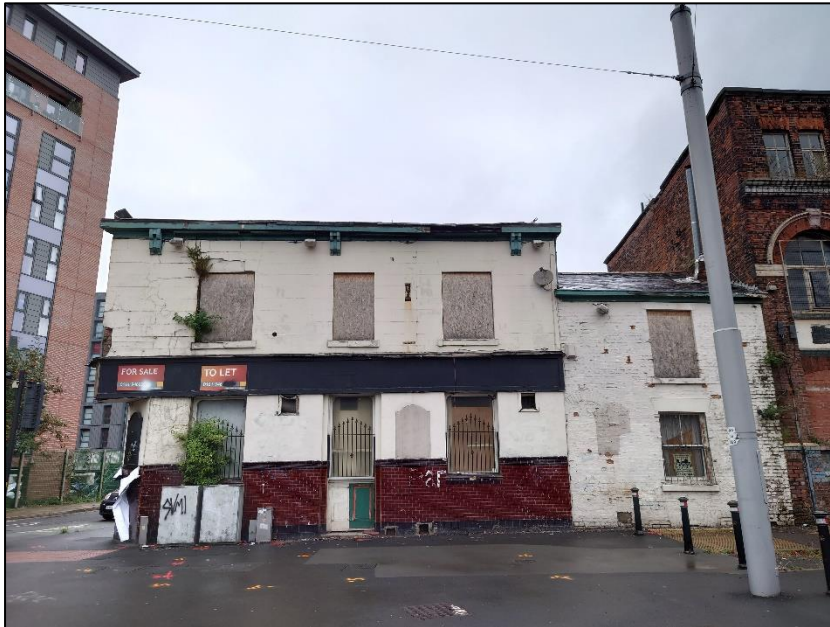
- 3.7 The former public house is constructed from brick and has a pitched, tiled roof. The building is in a derelict state of repair (see Photographs 9 and 10). The external brickwork is complete, with only minor amounts of damage to the bricks. The front and side elevations are rendered, with only minor cracks appearing in the external render. The windows and doors are boarded up.

*Photograph 9 showing the exterior of the former public house*

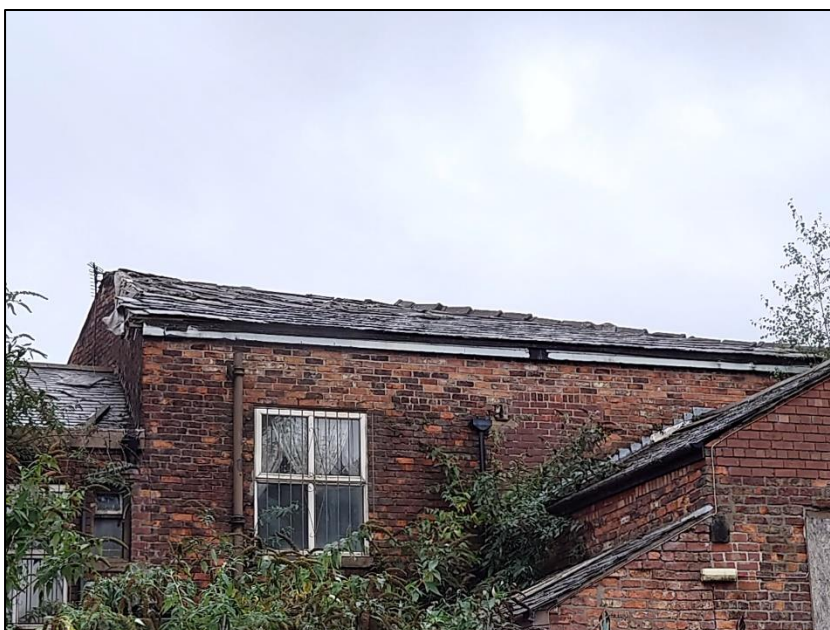
- 3.8 The roof is pitched and tiled (see Photographs 10 and 11). The roof is in a poor state of repair with tiles and ridge tiles missing. Parts of the roof have collapsed. The roofing above the two single-storey extensions to the side both have a complete roof. The lead flashing around the chimney pipe is flat. The wooden soffits at the roof edges are in a poor state of repair, with the soffits rotten in places. The bargeboards on the rear of the building are firmly attached to the brickwork.

*Photograph 10 showing the roof of the former public house*

- 5.4 It should be noted that bat absence is very difficult to prove definitively due to their mobility and size, and single or small numbers of bats are able to roost in extremely small spaces, such as in gaps between panels. The development work should be undertaken with care, for example with roof tiles lifted rather than dragged.

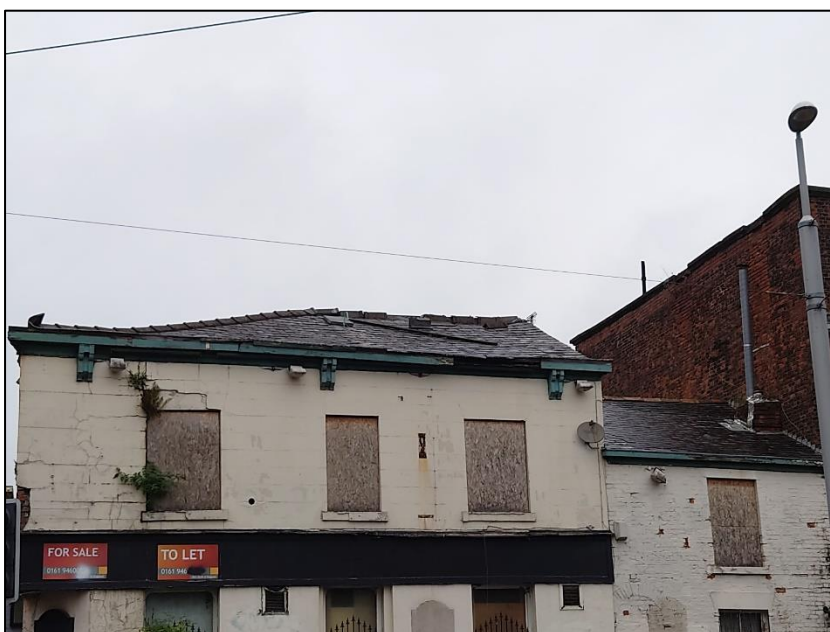
*Photograph 11 showing the roof of the former public house*

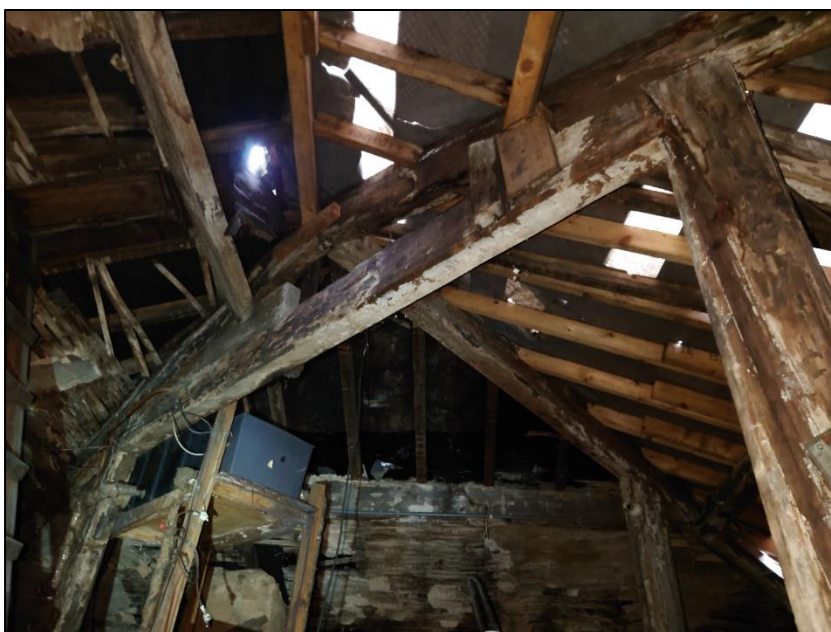
- 3.9 The former public house has one large roof void (see Photographs 12 and 13). The roof timbers are in a poor state of repair. The roof void is considerably damp internally. The roof felt is missing in large parts of the roof. No evidence of bat activity, such as bat droppings, could be found inside the roof void.

*Photograph 12 showing the roof void of the former public house*

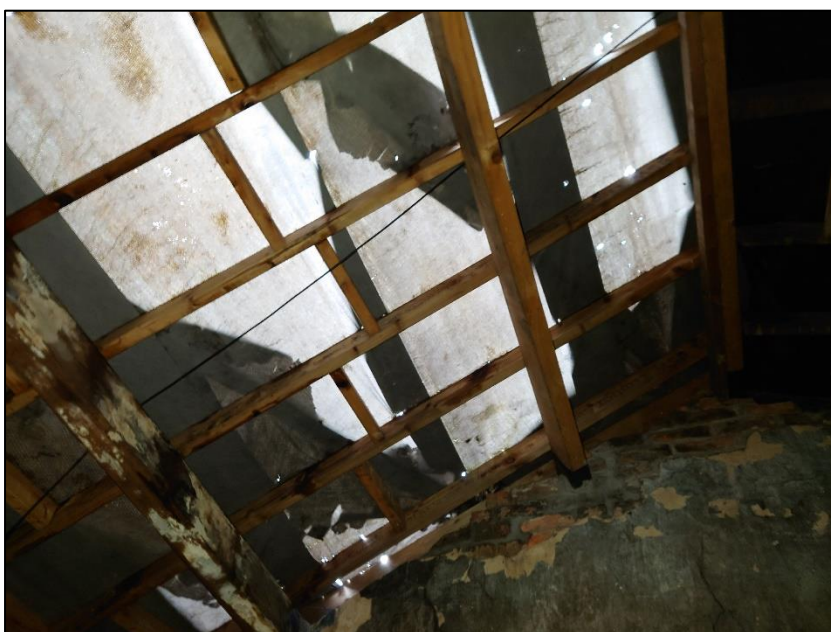
*Photograph 13 showing the poor state of the roof*

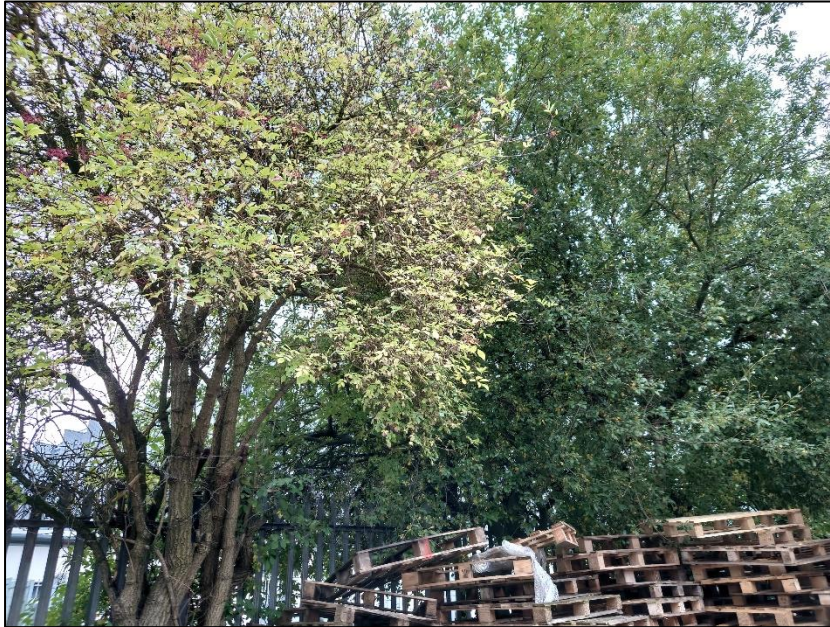
- 4.1 The property has no mature trees on the site, with only a few scattered self-seeded Willow trees *Salix* sp. around the site boundaries (see Photograph 14). None of the trees offer suitable bat roosting features. The remainder of the site is dominated by hardstanding, with small areas of scrub adjacent to the buildings (see Photograph 15).

*Photograph 14 showing the semi-mature trees on the site boundary*

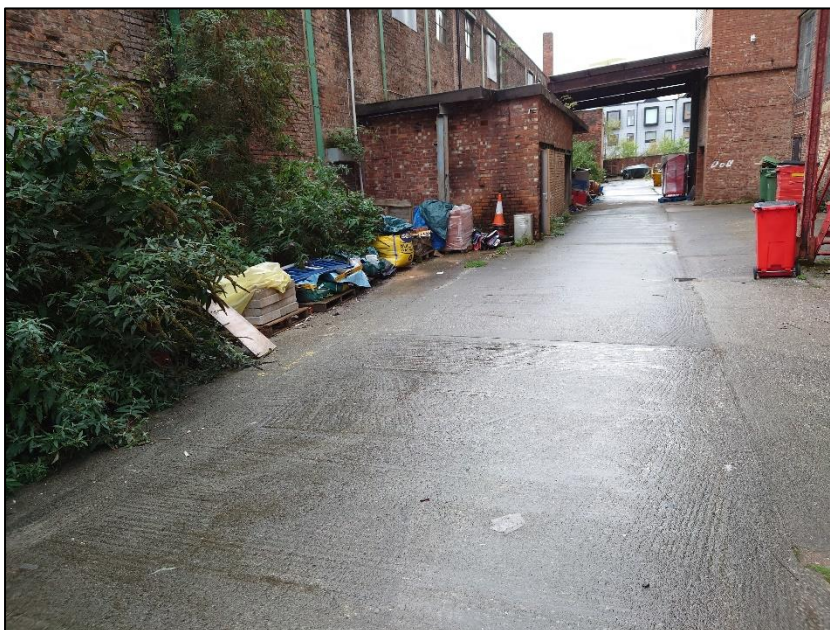
*Photograph 15 showing the hardstanding and scrub*

- 5.6 If vegetation removal is to be carried out within the bird nesting season (generally March to August), a nesting bird survey will be required immediately prior to work commencing.

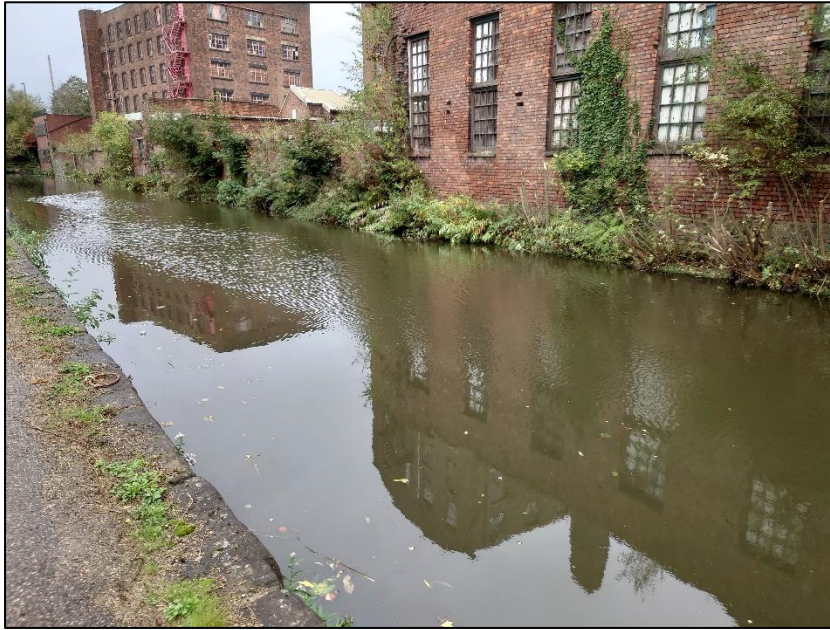
- 4.2 The Ashton Canal lies immediately adjacent to the building (see Photograph 16). No evidence of Otter or Water Vole could be found directly adjacent to the building or within a reasonable distance of the site. The canal (Ashton Canal (West)) is designated

*Photograph 16 showing the canal adjacent to the building*
