## Verification Report

GEO101021

003

McAlear & Rushe

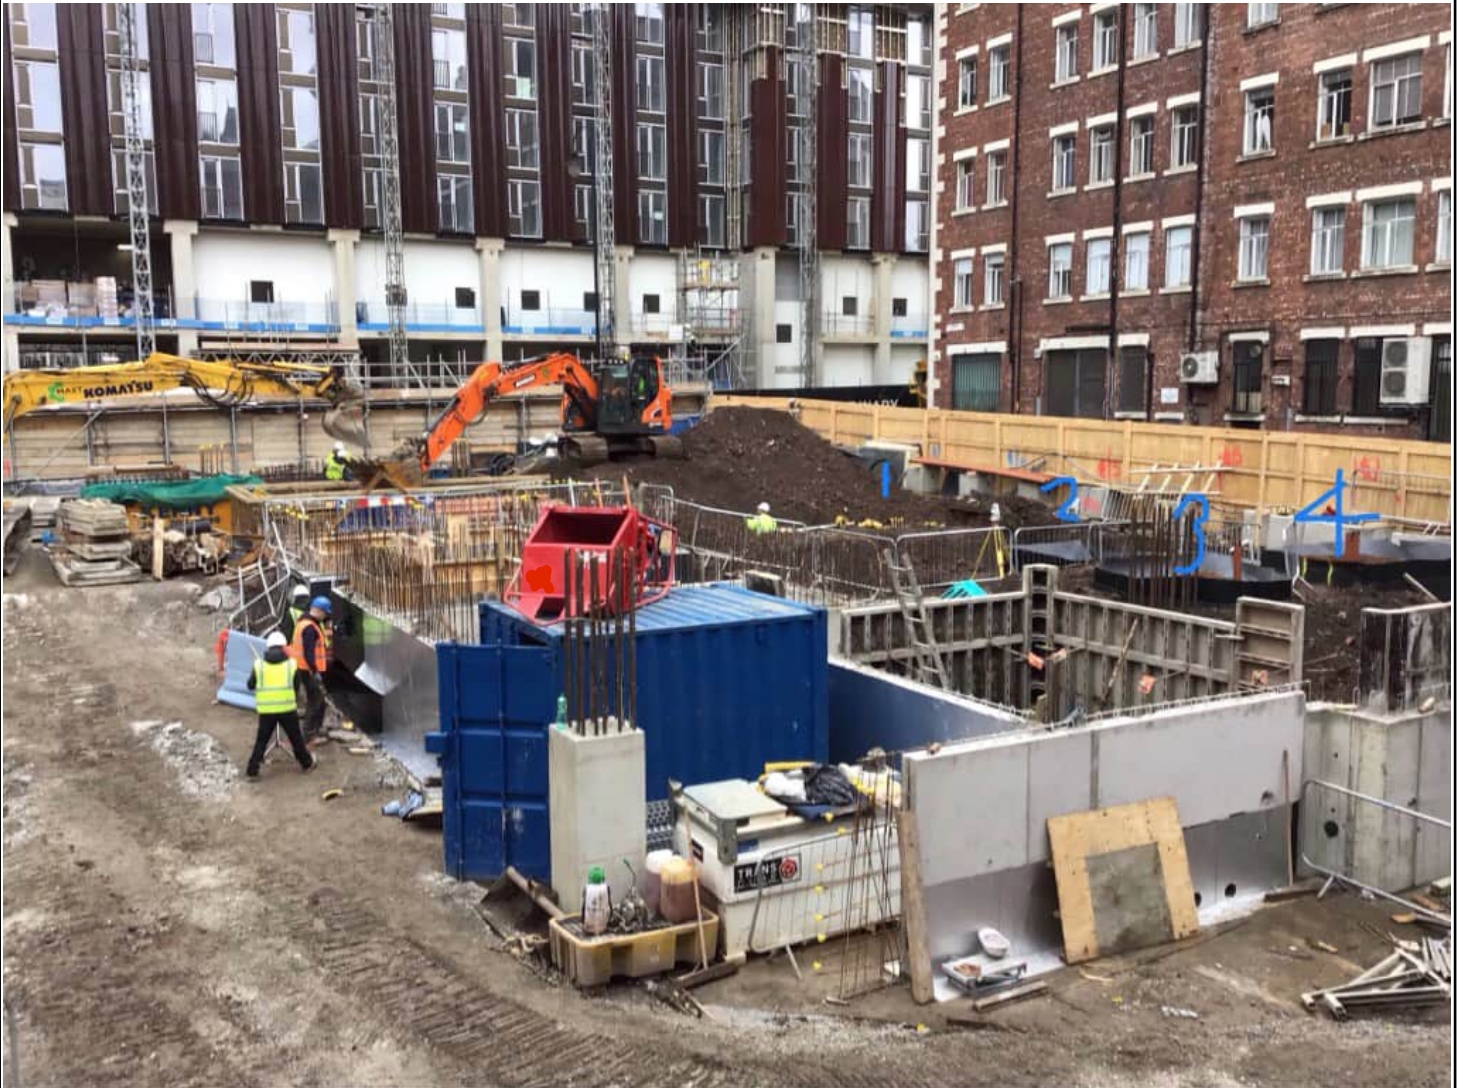
Overview of site. The four piles are labelled in blue.

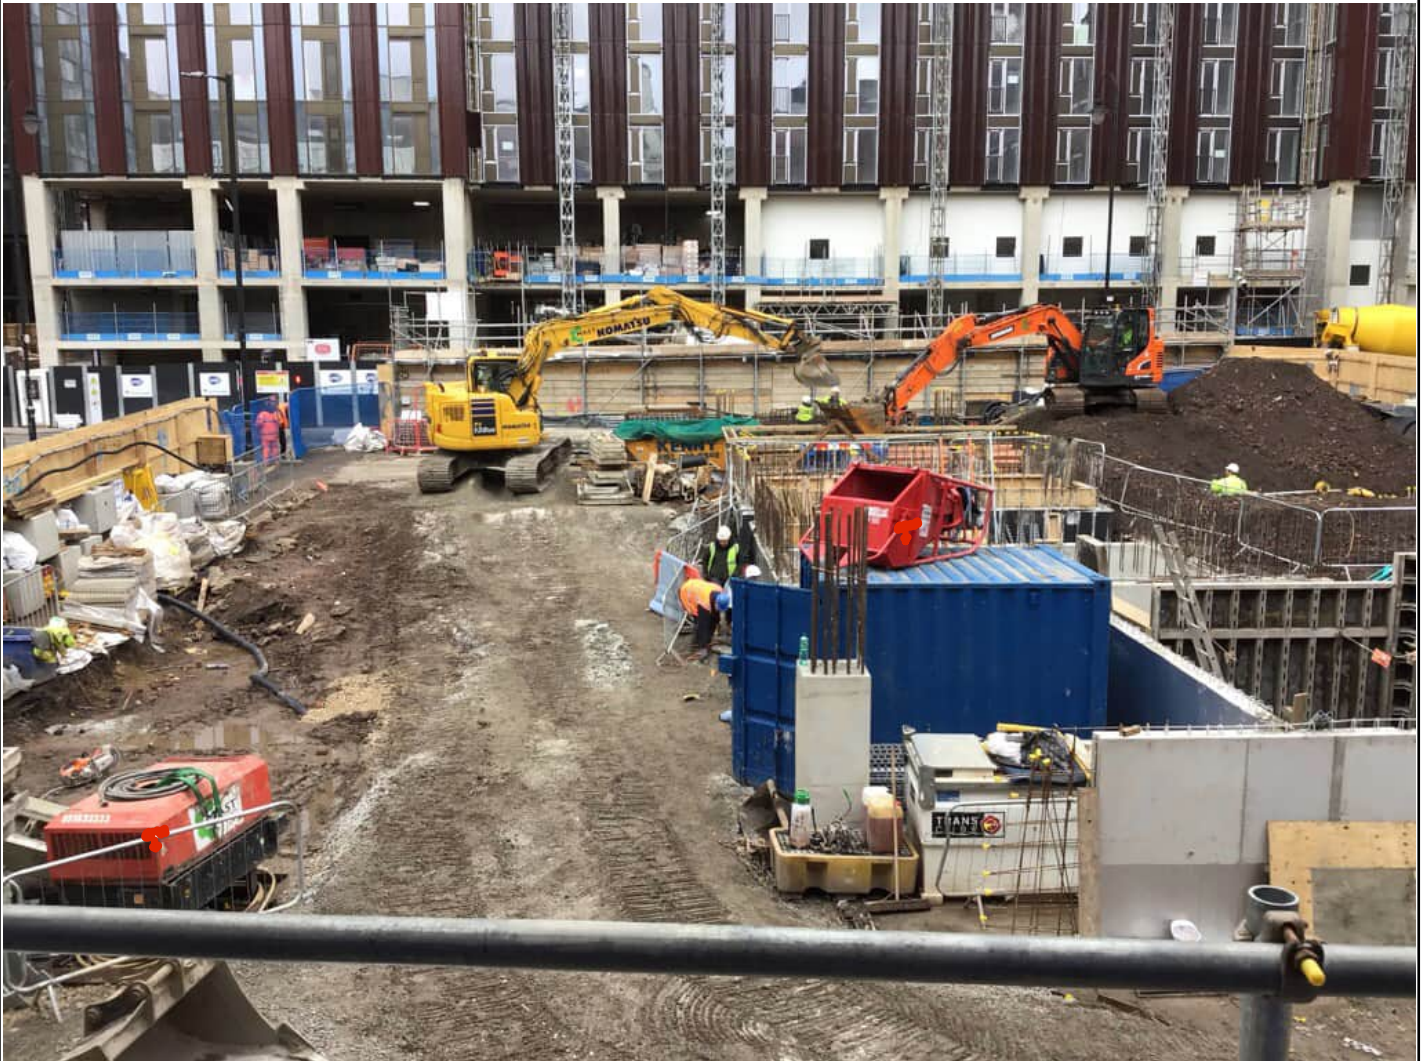
Overview of Site with Prestige Air working on H Block wall

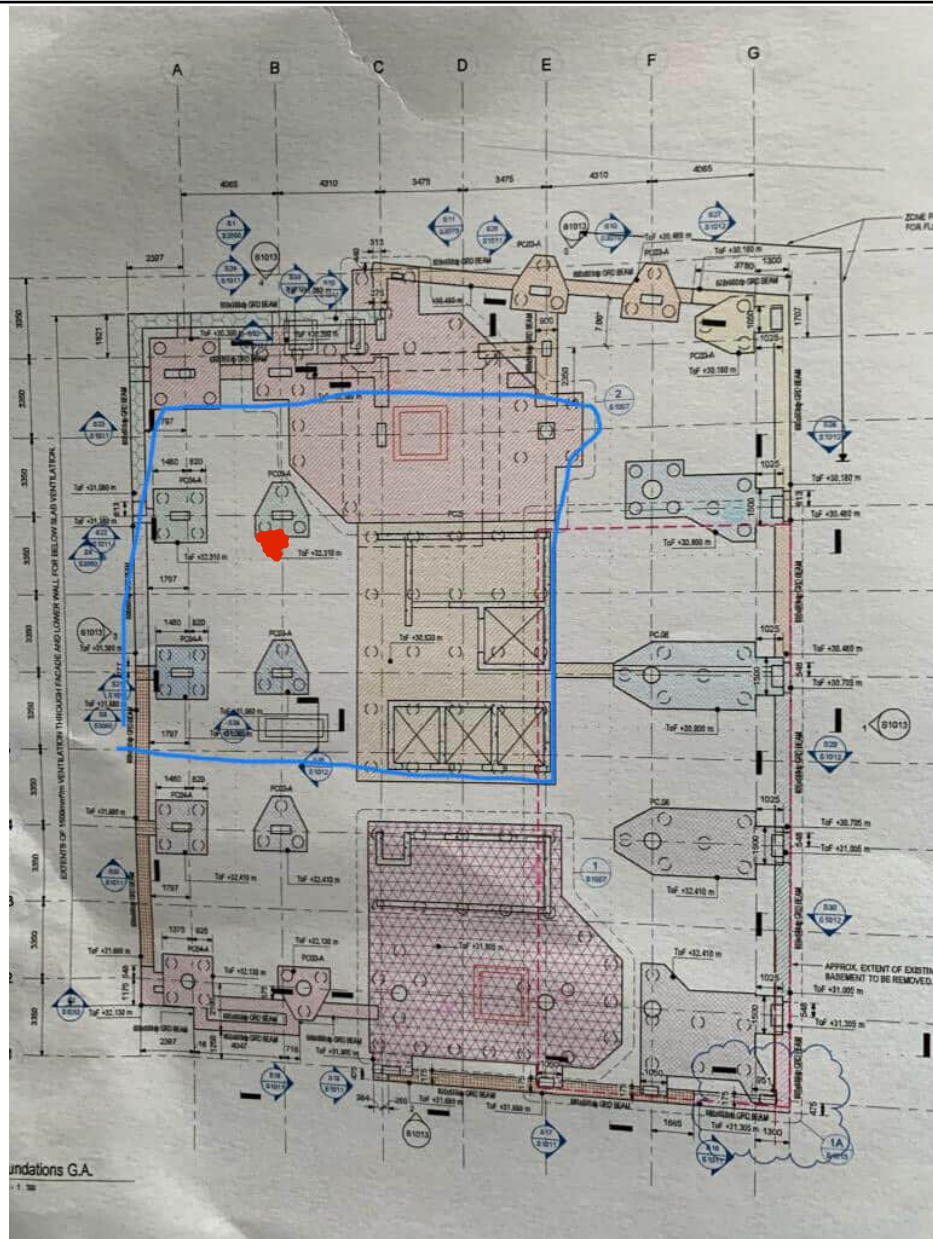
Overview of areas verified

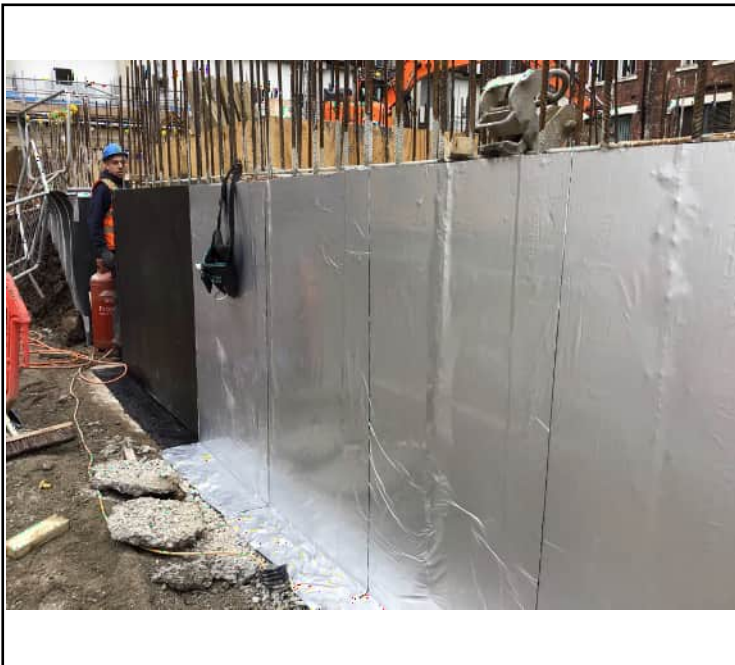
LOCATION/GRID LINE: H Block wall

NOTES: The walls of H Block have been primed with bitumen and

GR SAM has been installed with a 300mm overlapped has been installed onto the

Left photo) GR SAM installed vertically with 300mm overlap on slab

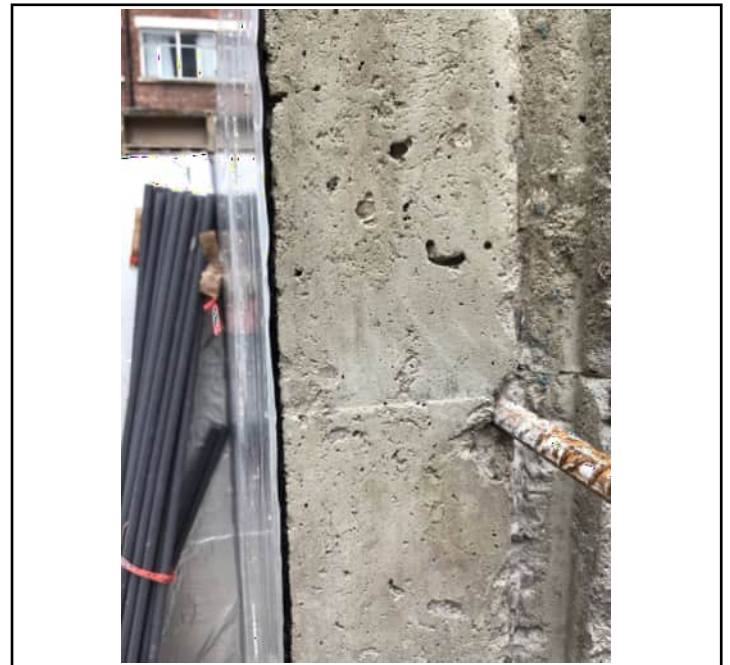
Right photo) GR SAM sealed to concrete wall

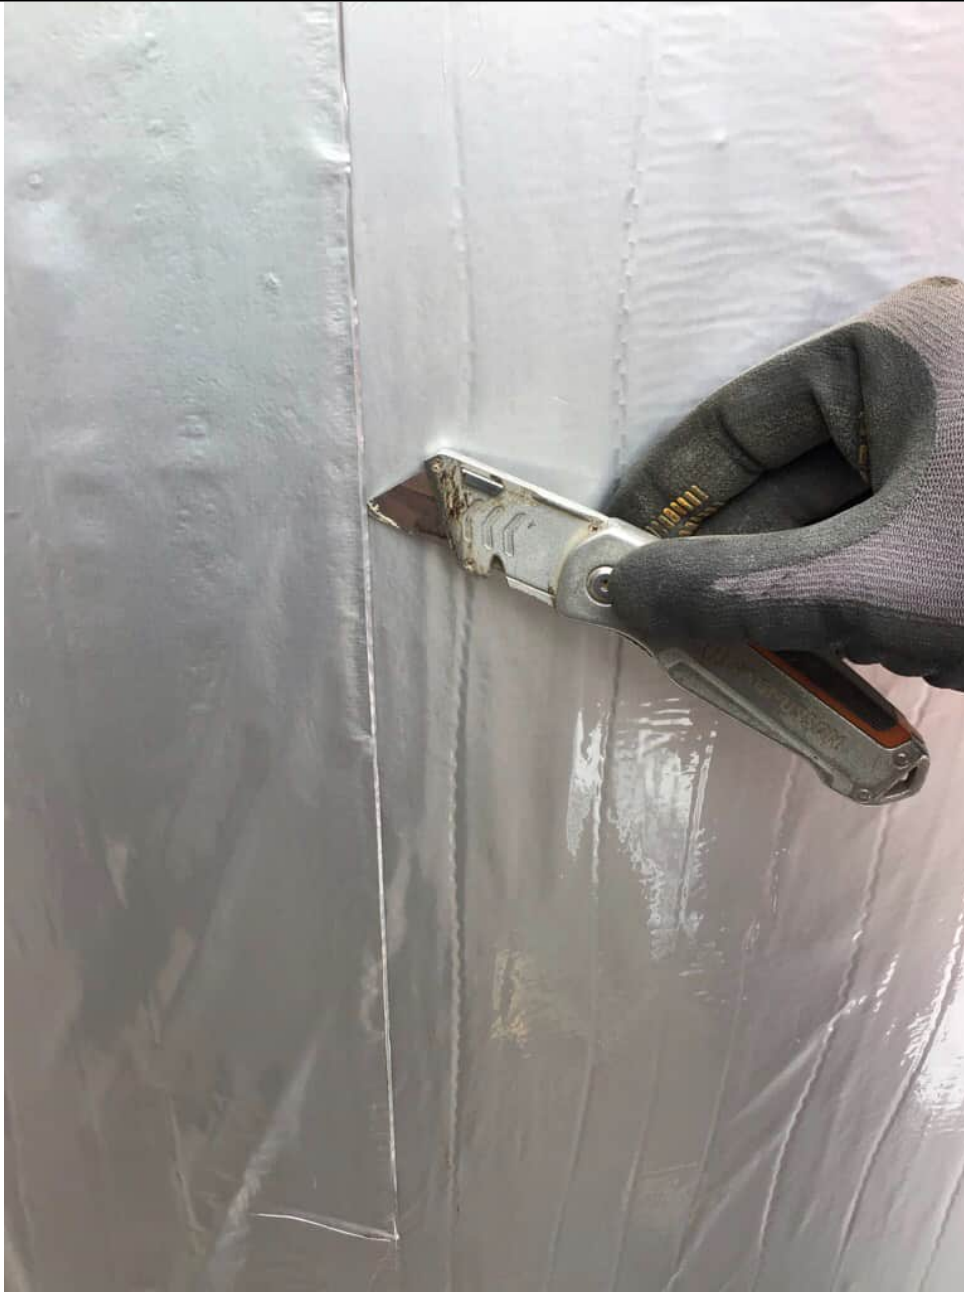
Concrete slab. A pick and probe test was carried out to ensure a good seal.

3. Pick and probe test on GR SAM

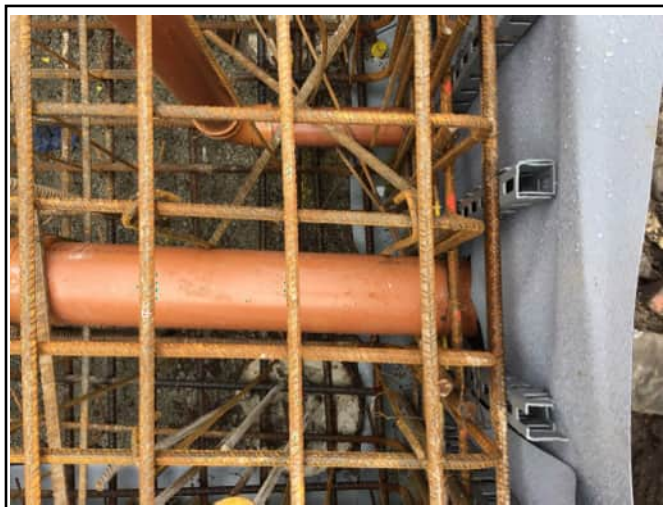
LOCATION/GRID LINE: Pile cap 04-A (Gridline 8)

NOTES: Whilst inspecting the pile caps I noticed a piping had been

Fitted within PC04-A. Due to the steel rebar cage already being fitted, visual inspection

Left photo) section of pipe work within the pile cap

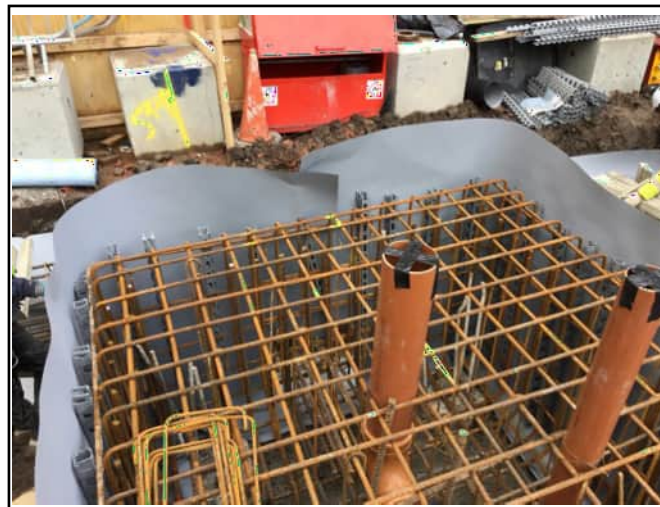
Right photo) overview of pile cap 04-A, showing 150mm overlap under the rebar cage

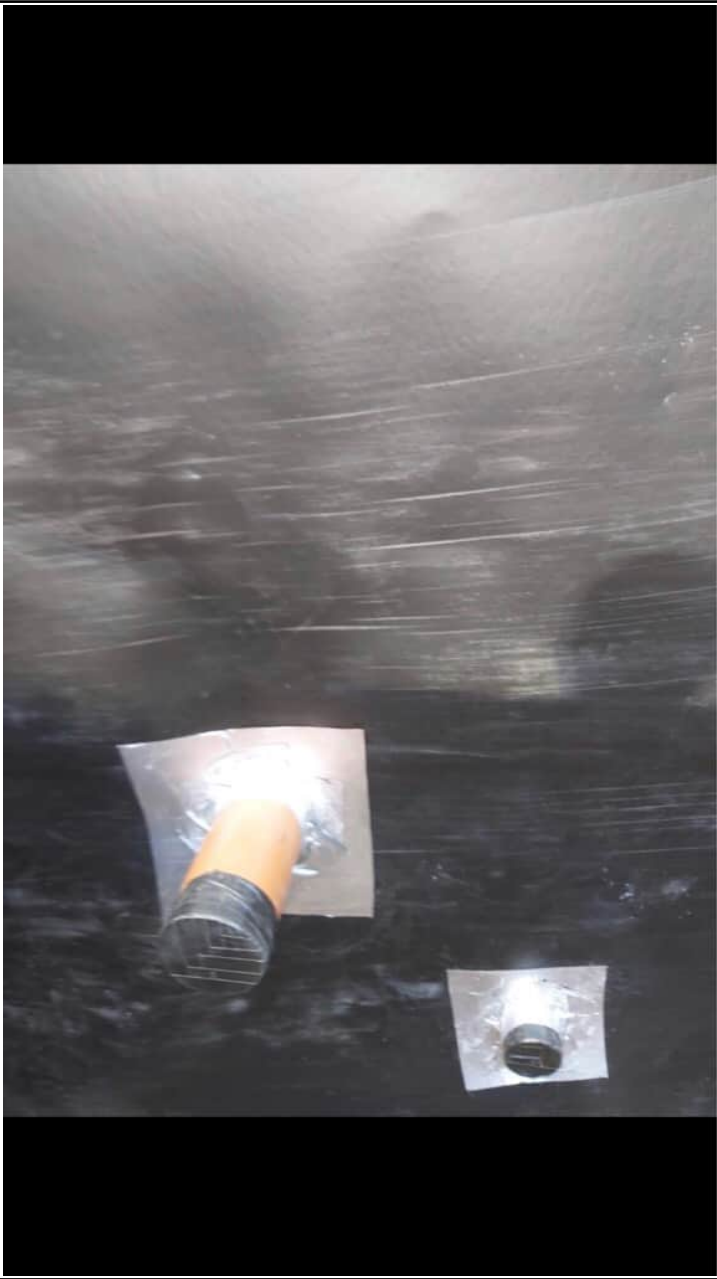
Was limited. The exterior section of piping has been sealed to the Visqueen Geoseal

Ultimate with GR SAM as per specification.

Above photo) external pipe work sealed with GR SAM

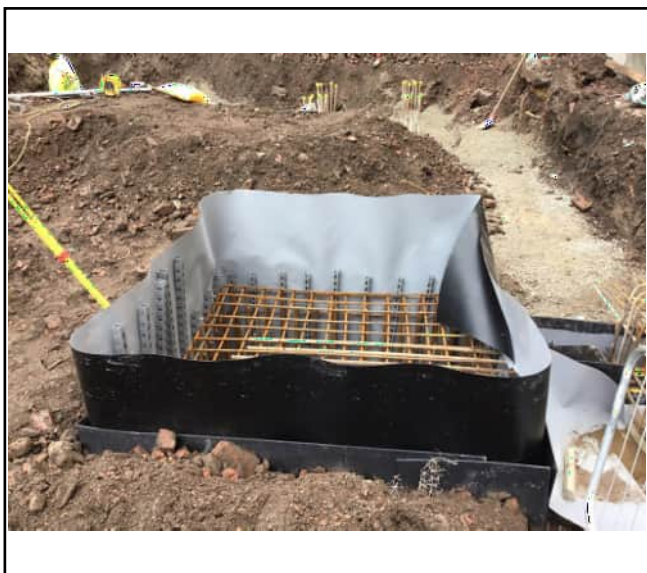
LOCATION/GRID LINE: Pile cap 04-A (Gridline 6)

NOTES: 3 piles were wrapped in Visqueen Geoseal Ultimate, they

Left photo) overview of pile cap, showing Visqueen and protection board

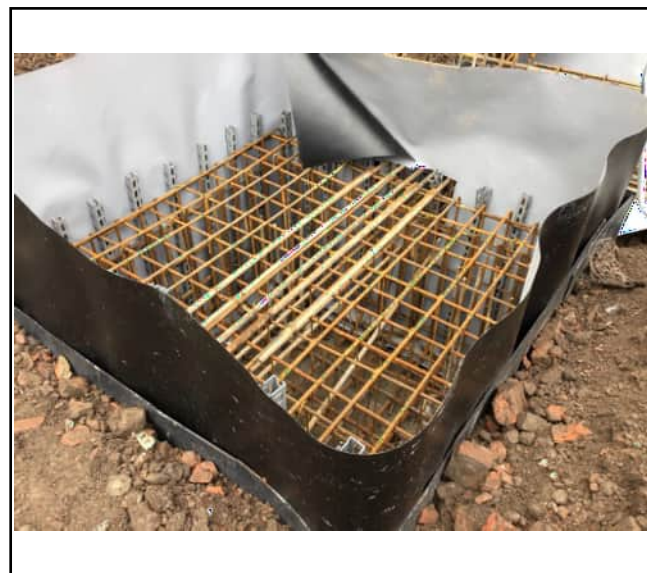
Carried out on the seal. 150mm overlap of Visqueen Geoseal Ultimate was also

Installed under the bear cage.

Right photo) closer photo showing the lap under the rebar

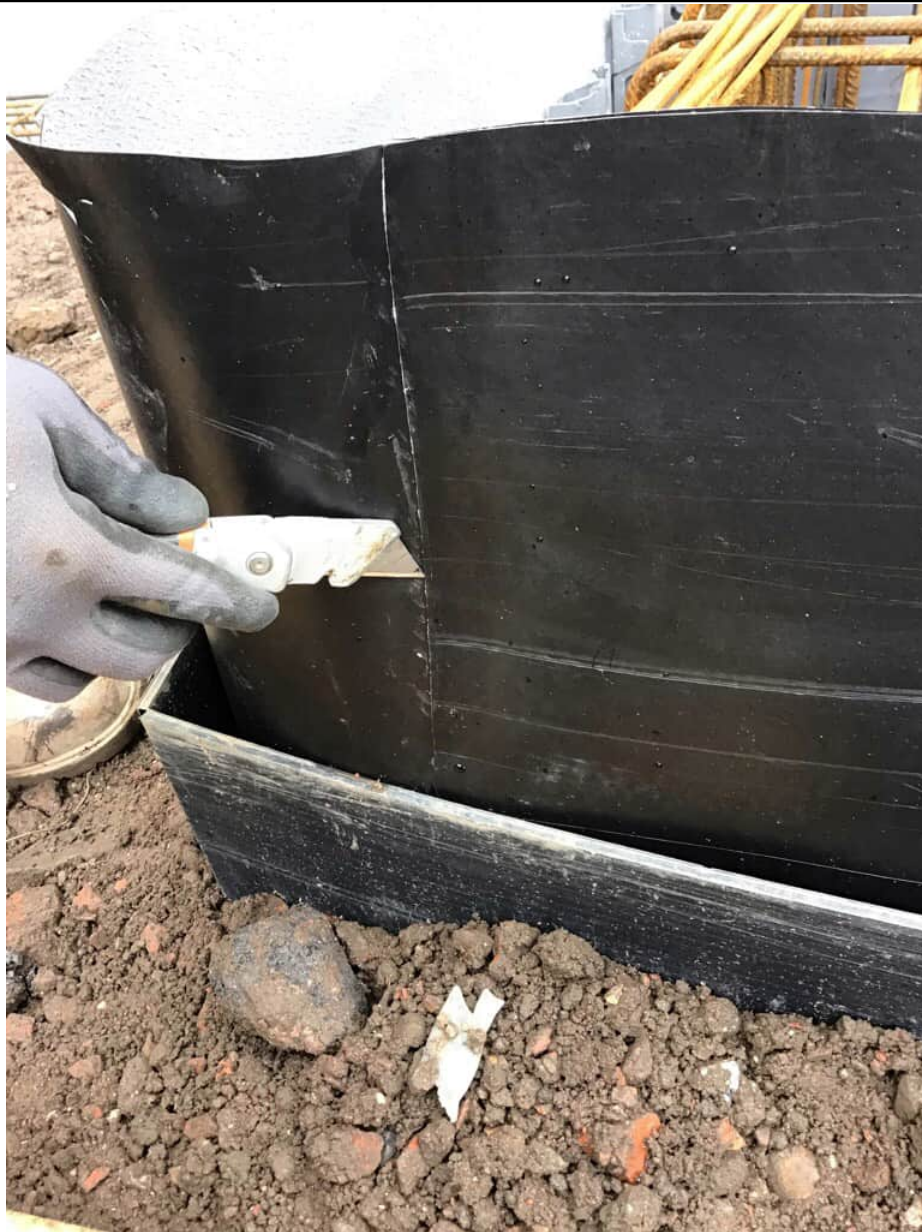
Have been overlapped and hot welded to form a seal. A pick and probe test was

Above photo) pick and prob carried out on the hot welded joint, also

Showing the protection board, to protect against backfill

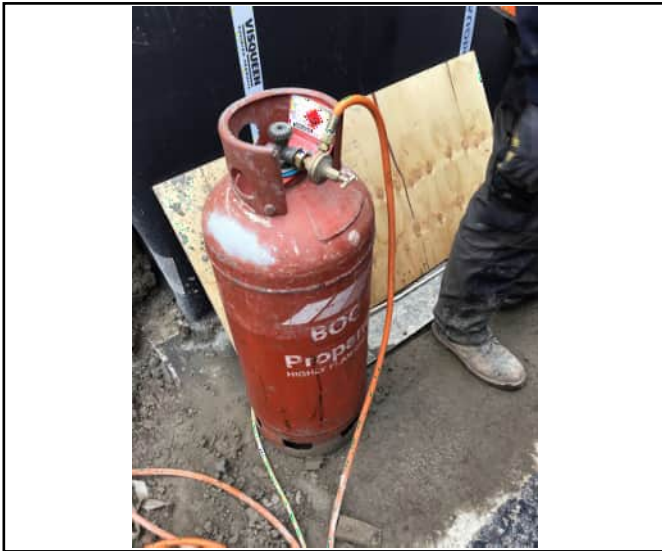
Gas used to prime bitumen

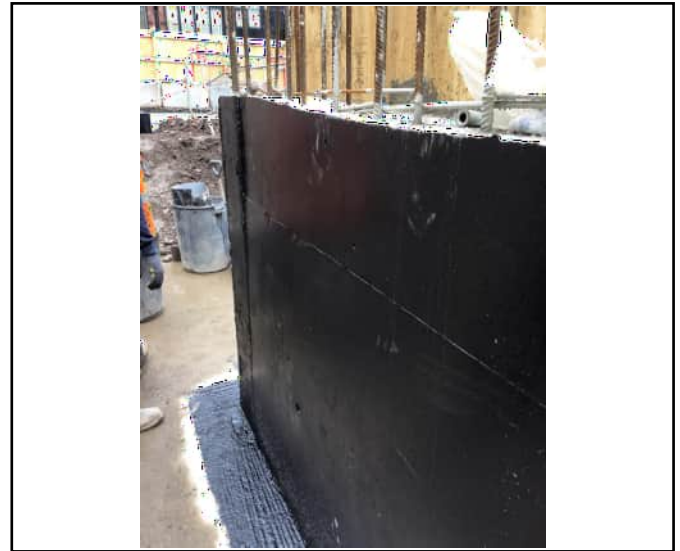
Primed wall waiting for GR SAM

To be applied

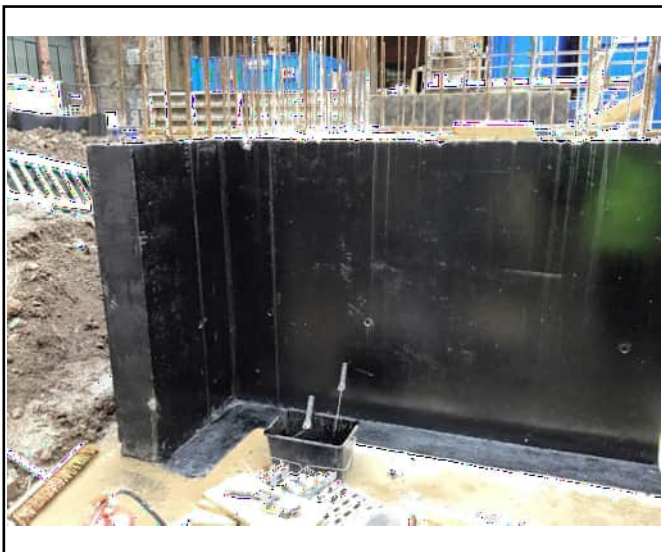
Primed wall with bucket of primer

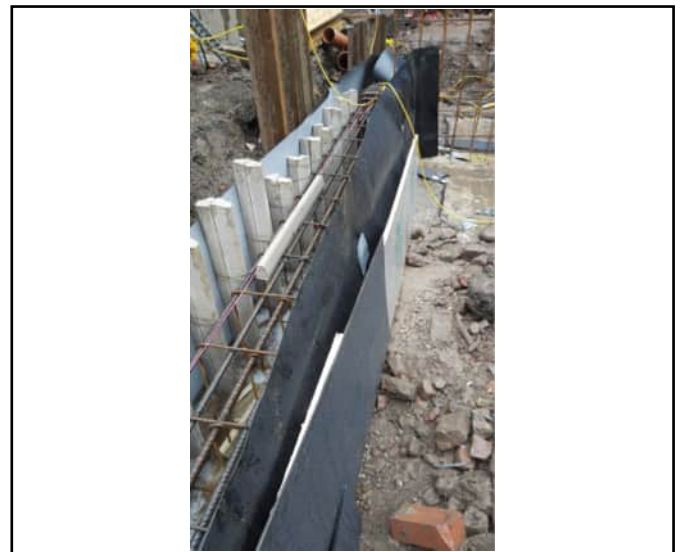
Ring beam showing wrapped membrane

And protection board on back filled side

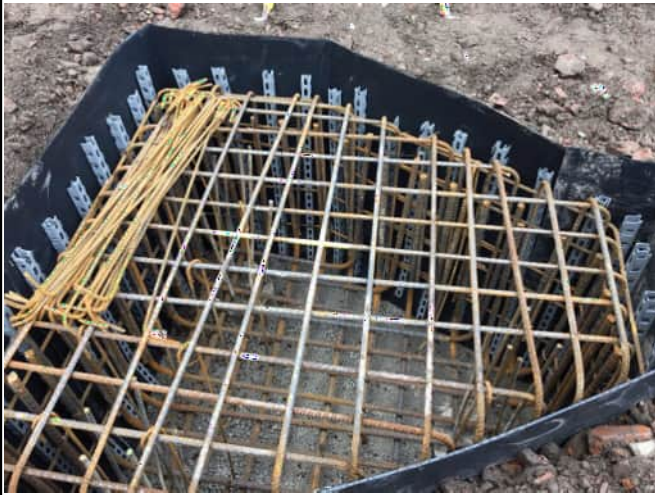
One of the pile caps did not need

Membrane as per design

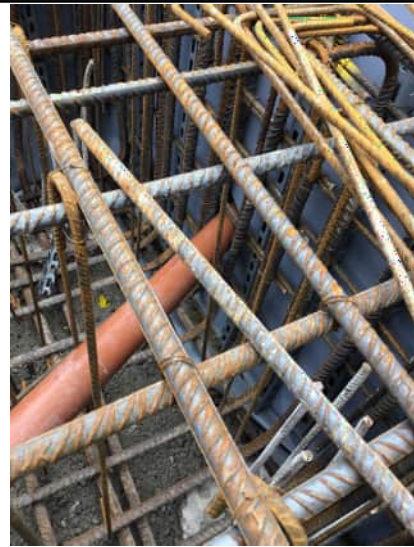
Internal section of pipe within pile cap

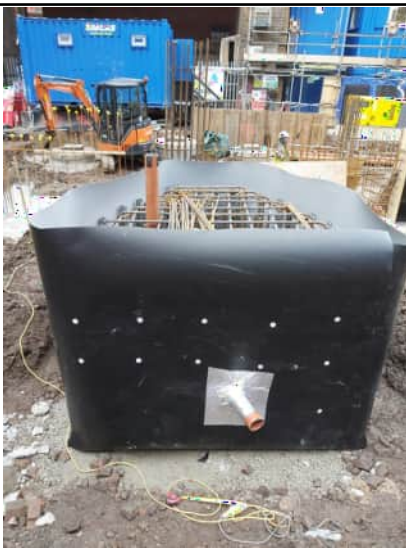
External pipe from above right photo

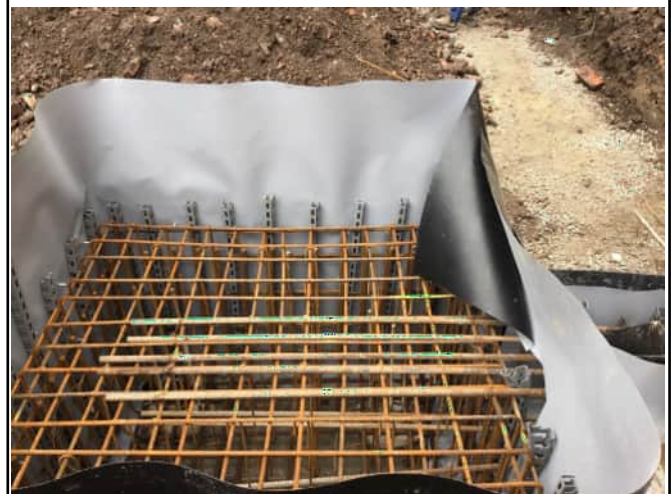
Pile cap with Visqueen Geoseal

Ultimate

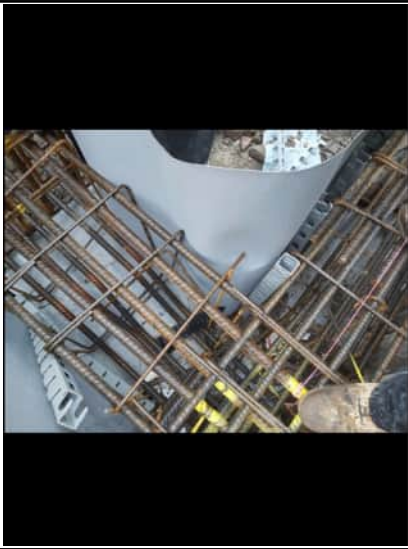
Visqueen Geoseal Ultimate wrapped

Under the ring beam, with overlap

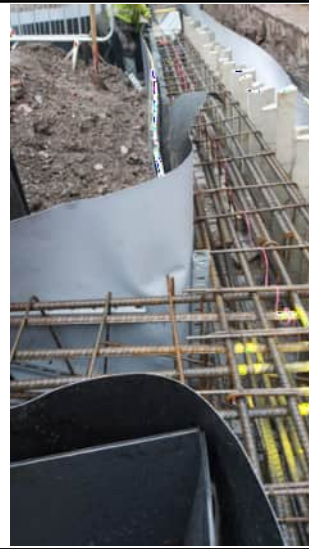
Overview of ring beam with visqueen

Overlap

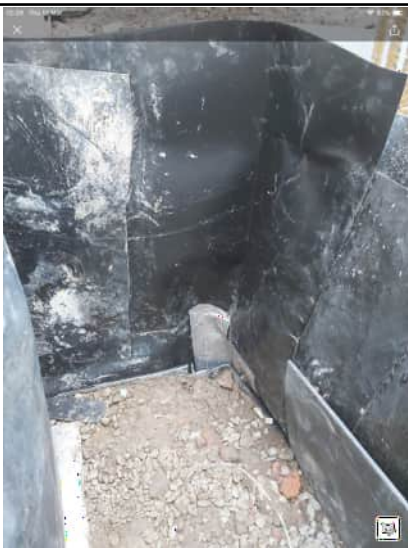
Exterior corner detail of Visqueen

Sealed at the joint with GR SAM

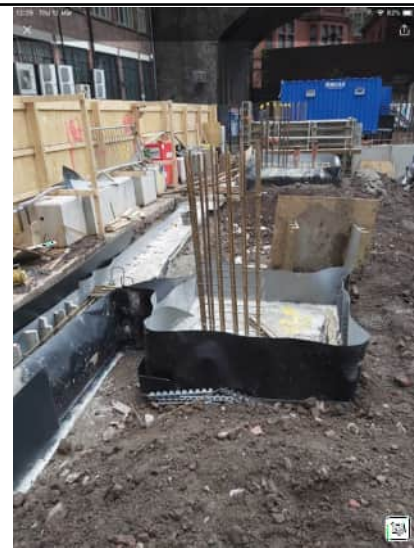
Pile cap and ring beam, both have

Been wrapped with Visqueen Geoseal
