# Inspection Report

Detail: Works Following Condition Survey

Site: Kings House

Ref No: QRN.CR.2370

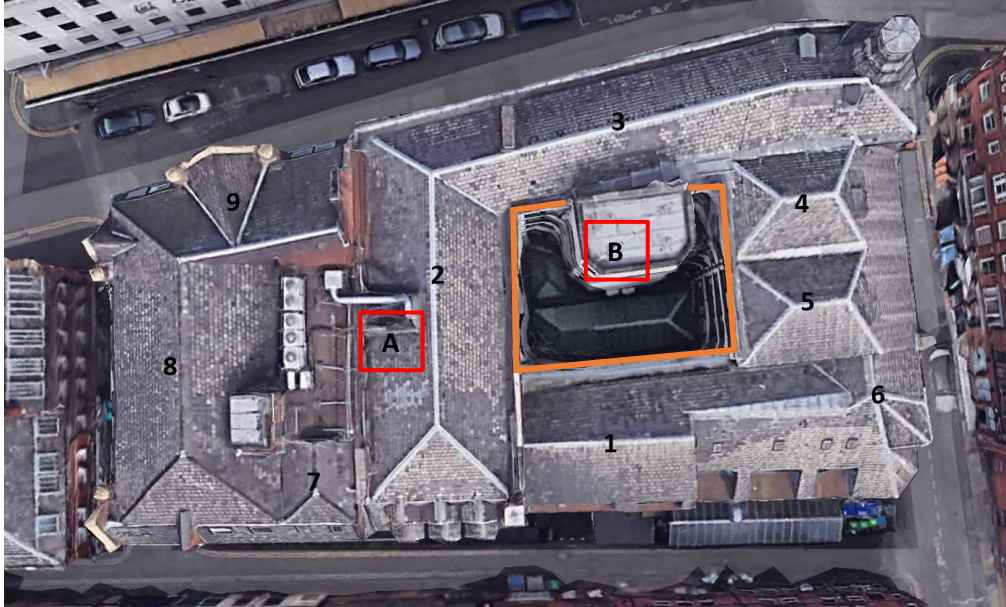
#### Roof Plan

For ease of reference while reading the roof condition report, the roof has been split into areas numbered as per the photo files.

Area highlighted orange on the above roof plan.

There are two lightwells which have been inspected marked A and B on the above roof layout plan.

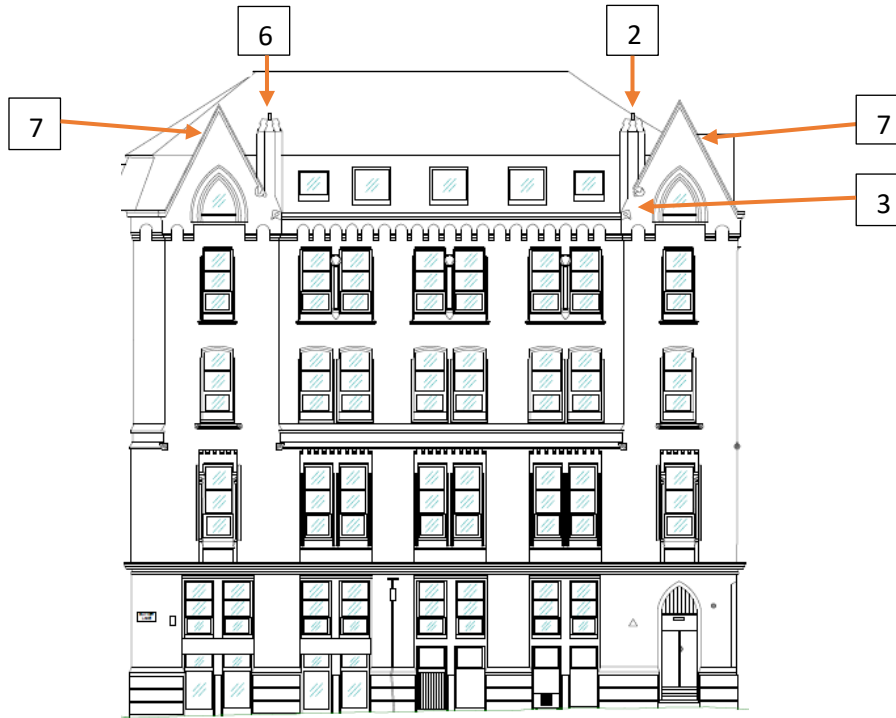
**Butter Lane Defects**

- 1. Chimneys 2&6:** The two brick chimney stacks are both in bad condition. The mortar joints have perished and are showing moss growth on the face of the brickwork. There are several patches of vegetation growing through some minor cracks but there are none currently indicating structural concerns.

Several bricks have begun to spawl and have lost sections of their face, this is being made worse by the poor pointing allowing the bricks to become saturated.

The stone capping to the tops is in good condition although the mortar joints do require attention.

- 2. Stone Apex's 7&3:** The two stone apex's are securely fixed and in good condition although the mortar joints have perished and require raking out and repointing as per the above brickwork specification. There is also a square metre area of brickwork (3) to the bottom LHS of the right hand apex, where a blocked outlet has caused water to overflow – treatments of brickwork as per above chimney works.

We would recommend the full refurbishment of both stacks and we have allowed to undertake the following works:

- Rake out all mortar joints to a minimum of 15mm from the surface of the brick face and reinstate with a lime-based mortar in a colour to match existing.
- Remove all moss and lichen and clean brickwork with a light spray mist and a stiff brush, treat areas of removal with a masonry biocide.
- Remove and replace any bricks (one at a time) which have spalled. More than 20% of bricks will be reclaimed and a sample will be removed to source an appropriate match. For the purpose of this quotation, we have allowed for approx. 10no. bricks per stack to be replaced.
- All lead flashing will be securely clipped into the mortar joint with lead packers and subsequently repointed.

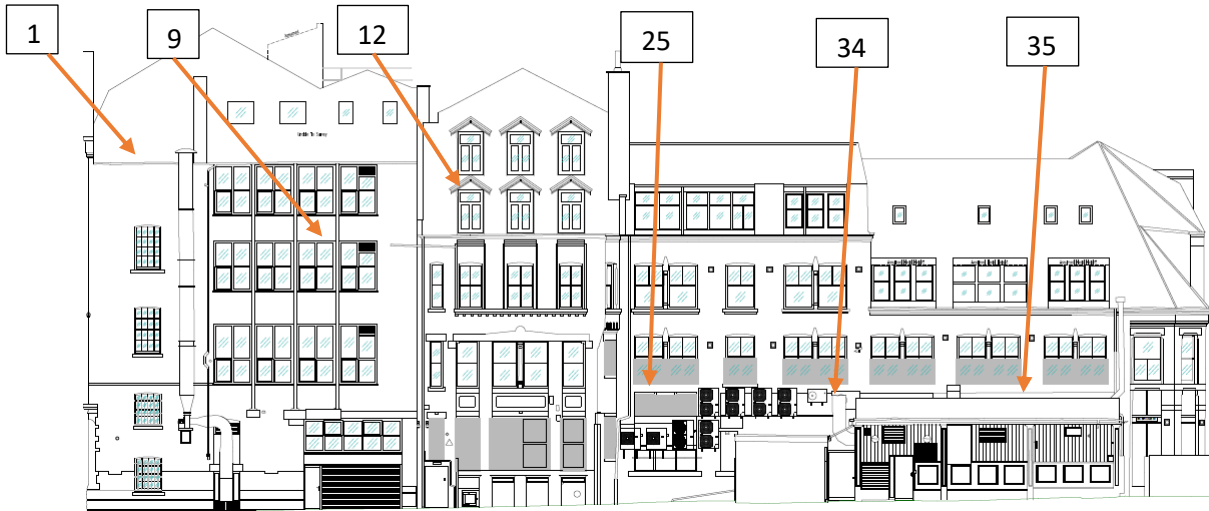
**Back Bridge Street Defects**

1. There is a large split in the UPVC gutter, it appears a previous silicone repairs has failed and is causing the brickwork below to become saturated. We would recommend replacing the 4m length of gutter with 150mm half round to match existing and repairing the 2SqM of glazed brickwork by cleaning staining, raking out and repointing.

9. There is evidence of minor corrosion to the steel lintel above the windows, the expansion has caused a small amount of mortar failure. The steel should be treated by cleaning back to a good surface, painting with an anti-corrosion system and reinstatement of missing pointing.

12. There are 3 missing soakers to the top of the roof dormer. These soakers form the seal at the junction of slate and the timber structure. The soakers will be replaced using a code 4 lead, several slate will need to be stripped back to allow the lead to be secured. Any stripped slates will be subsequently reinstated with copper tingle fixings.

25. There is a broken Georgian glass unit behind the window caging which needs replacing. We have assumed the clients internal glazing contractors will undertake glazing replacement works. Crown Services would be happy to quote for these items if required.

34. There is a missing cowl on the ducting which will be allowing rainwater into the building. We would recommend installing a Galvanised HU roof cowl or similar and appropriately fixed rivets.

35. The glazed roof above San Carlo is in poor condition; there are three broken glazed units, several slipped units and slipped section of lead, plus poor lead dressing. There would be several options for repair from patch replacement to full roof refurbishment/replacement. No works have been costed for within this report.

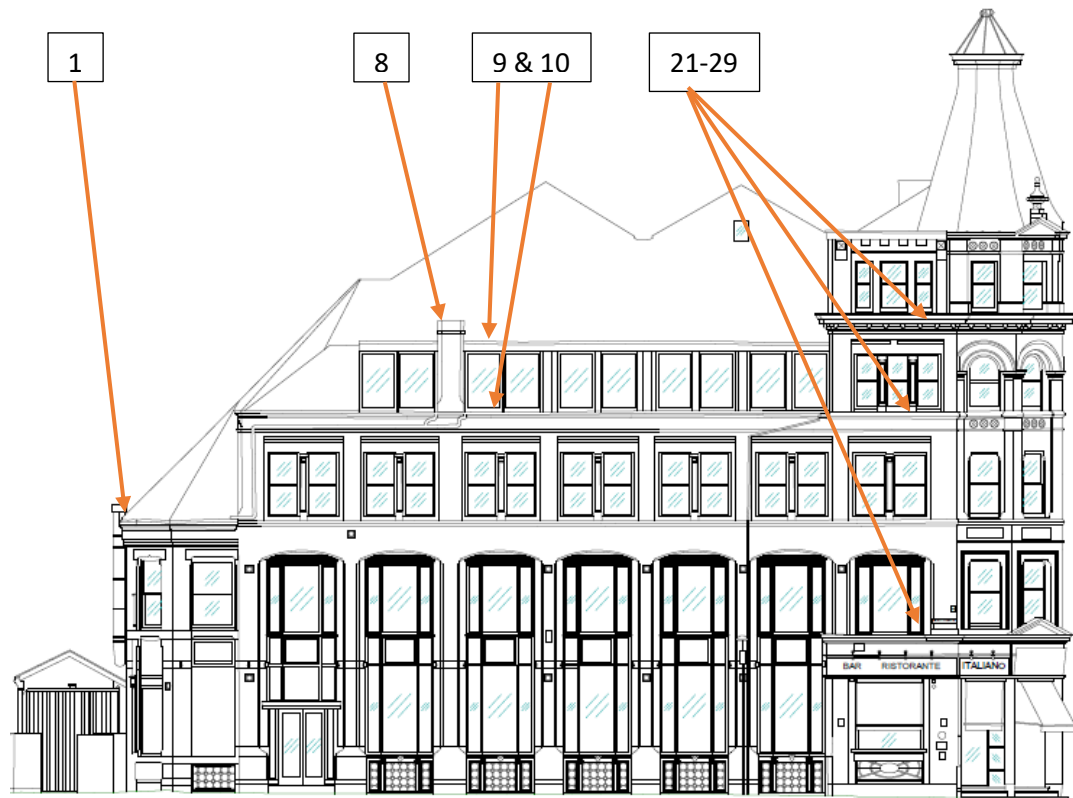
**Southgate Defects**

1. There is a defective gutter where the long run is not connecting into the corner bracket as it is too short. The defective section will be removed and replaced with the correct length and the rubber seals replaced. The area of brickwork below the gutter as a result of the leak is heavily stained and the mortar joints deteriorated. We propose power washing to remove the staining, raking out the mortar joints and subsequently complete the repointing to the required area.

8. The top 4 courses of the chimney stack and the mortar flaunching/capping has deteriorated and requires replacing. All vegetation will be removed and treated with masonry biocide, mortar joints raked out and reinstated and the capping hacked off and replaced with a strong cementitious mortar mix with a bevelled edge to assist the cast-off of rainwater.

- 9&10. The gutters and soffits are showing signs of deterioration with the hopper above being blocked. The hopper needs to be unblocked and following the gutter clean this area will be re-inspected and recommendations made. The hopper/gutter clean is included in the general items, no further works have been included for the purposes of this quote.

- 21-29. The stone cornice has begun to deteriorate on the underside, and several sections of stone have been removed due to the health and safety risk they pose. There are also a number larger sections of coin stone above the ledge where spalling has occurred. The ledge appears to have been coated in asphalt or similar as a means to prevent water ingress, however this system has failed, and the corbels have become saturated. This could be repaired with a liquid plastic system or alternatively a new lead capping detail if conservation spec is deemed appropriate. All friable and dangerous sections of stone have now been removed; although this will need monitoring frequently as the condition is likely to deteriorate.

Additionally, the stonework has been coated in a heavy layer of gloss paint, we feel this may be contributing to the deterioration as it is trapping water and reducing the sand stones natural breathability.

30. There is an exposed wire which needs to be inspected internally by an electrician – we have not quoted for these works, although if required can provide external cherry picker access.

We would recommend further review by a specialist stone mason and for the purposes of this quotation, we have allowed for an out of hours cherry picker inspection to devise a specification and subsequently quotation for the recommended works. Critical measurements would be taken of each of the sections of stone requiring indent repairs or full replacement.

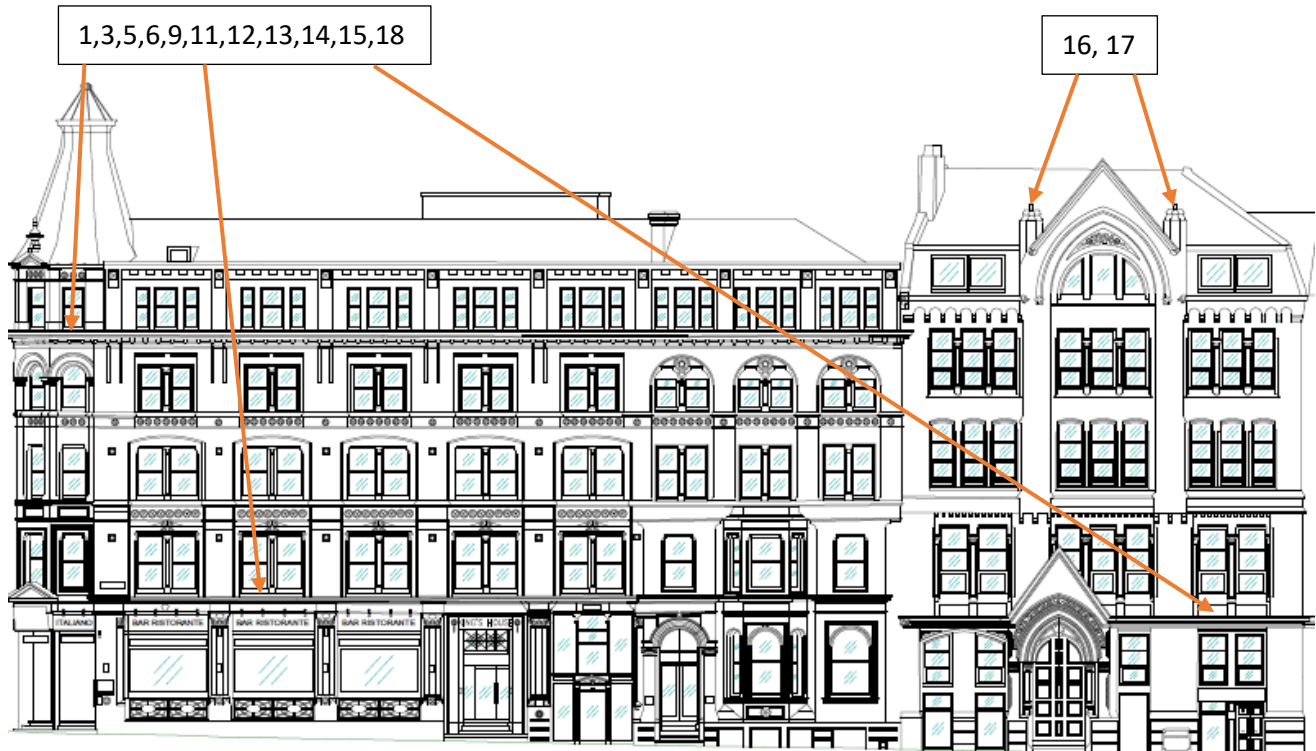
**King Street West Defects**

16&17 The two brick chimney stacks are both in bad condition. The mortar joints have perished and are showing moss growth on the face of the brickwork. There are several patches of vegetation growing through some minor cracks but there are none current indicating structural concerns.

Several bricks have begun to spawl and lost sections of their face, this is being made worse by the poor pointing allowing the bricks to become saturated.

The stone capping to the tops is in good condition although the mortar joints do require attention.

Defects 1,3,5,6,9,11,12,13,14,15,18:

The stone cornice has begun to deteriorate on the underside, and several sections of stone have been removed due to the health and safety risk they pose. There are also a number of larger sections of coin stone above the ledge where spalling has occurred. The ledge appears to have been coated in asphalt or similar as a means to prevent water ingress, however this system has failed, and the corbels have become saturated. This could be repaired with a liquid plastic system or alternatively a new lead capping detail if conservation spec is deemed appropriate. All friable and dangerous sections of stone have now been removed; although this will need monitoring frequently as the condition is likely to deteriorate.

Additionally, the stonework has been coated in a heavy layer of gloss paint, we feel this may be contributing to the deterioration as it is trapping water and reducing the sand stones natural breathability.

Turret: The turret lower structure is in good condition with all slates in place and the stonework below the finial appears to be in good condition. The iron finial is in a very poor condition, some sections have corroded quite heavily and been removed as they were at risk of falling. We would recommend replacing this for aesthetic purposes. Crown to provide fabrication and make a like for like section in mild steel and painted red to match existing. The upper most sections of the finial are now missing therefore a design drawing would be issued to the client and seek approval prior to fabrication works.

We would recommend the full refurbishment of both stacks and have allowed to undertake the following works:

- Rake out all mortar joints to a minimum of 15mm from the surface of the brick face and reinstate with a lime-based mortar in a colour to match existing.
- Remove all moss and lichen and clean brickwork with a light spray mist and a stiff brush, treat areas of removal with a masonry biocide.
- Remove and replace any bricks (one at a time) which have spalled more than 20%, bricks will be reclaimed, and a sample will be removed to source an appropriate match. For the purpose of this quotation, we have allowed for 14 approx. 10 no. bricks per stack to be replaced.
- All lead flashing will be securely clipped into the mortar joint with lead packers and subsequently repointed.

We would recommend further review by a specialist stone mason and for the purposes of this quotation, we have allowed for an out of hours cherry picker inspection to devise a specification and subsequently quotation for the recommended works. Critical measurement would be taken of each of the sections of stone requiring indent repairs or full replacement.

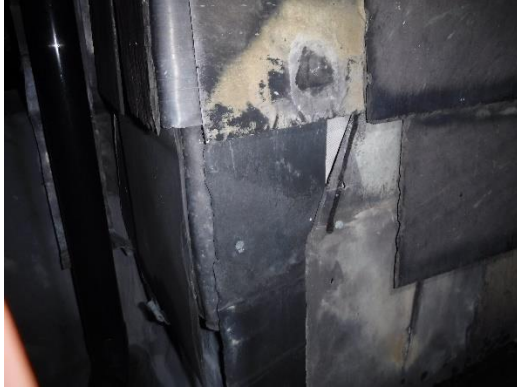
Missing leadwork, blocked dirty gutters, missing and broken slates.

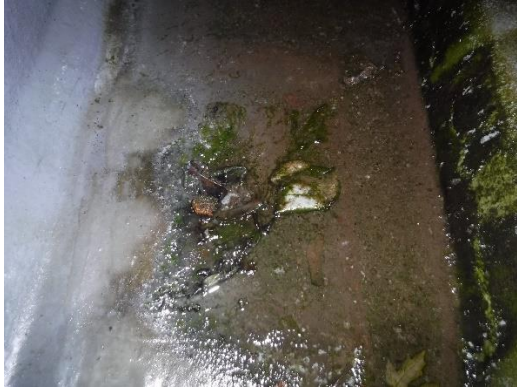
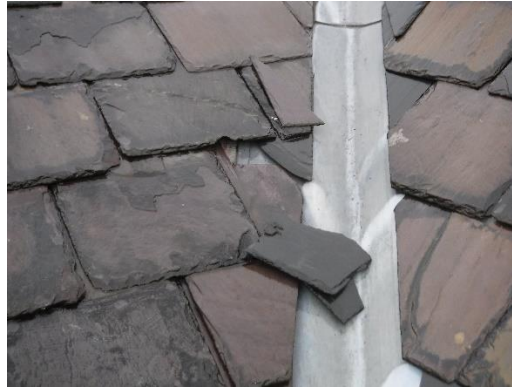
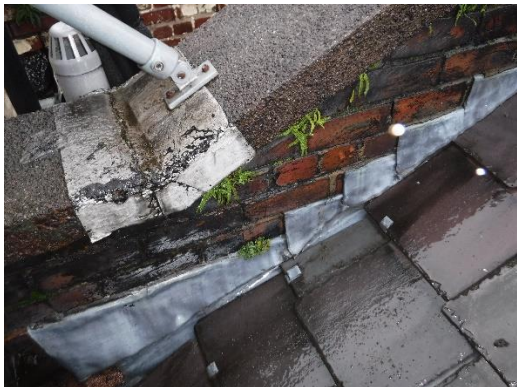
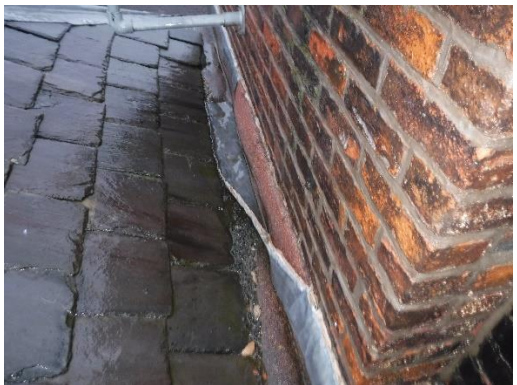
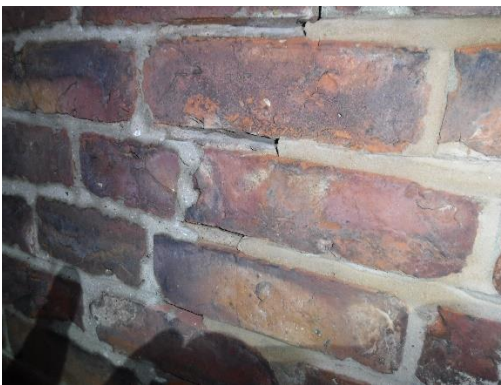
Vegetation, failed lead and mortar joints.
