## Roof Inspection

New MaldrenHotel Manchester Report 3

| Title: | New Maldren Hotel Manchester |

This report is prepared for SPS Flat Roof Systems Ltd, and its purpose is to report on the non-destructive electronic integrity test of the exposed waterproofing membrane of level 16 of the New Maldren Hotel, Charles Street, Manchester.

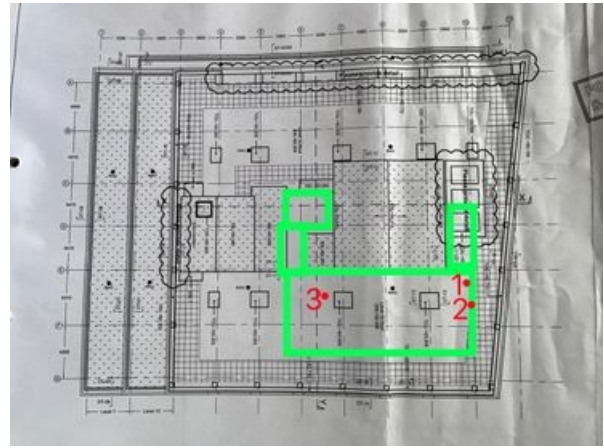
Photo 10

The testing identified three (3) breaches (shown in red on the roof plan sketch) where water may penetrate into the construction.

3 mechanical damage identified.

Three breaches caused by mechanical damage were identified during the testing and inspection; these were repaired by SPS operatives.
