**Project Title:** Premier House

**Task Title :** Vibration Assessment and Movement Monitoring Report

**Report Reference:** 30397-11-PPO-PH-VA-REPORT R3

# Premier House - Vibration Assessment and Movement Monitoring Report

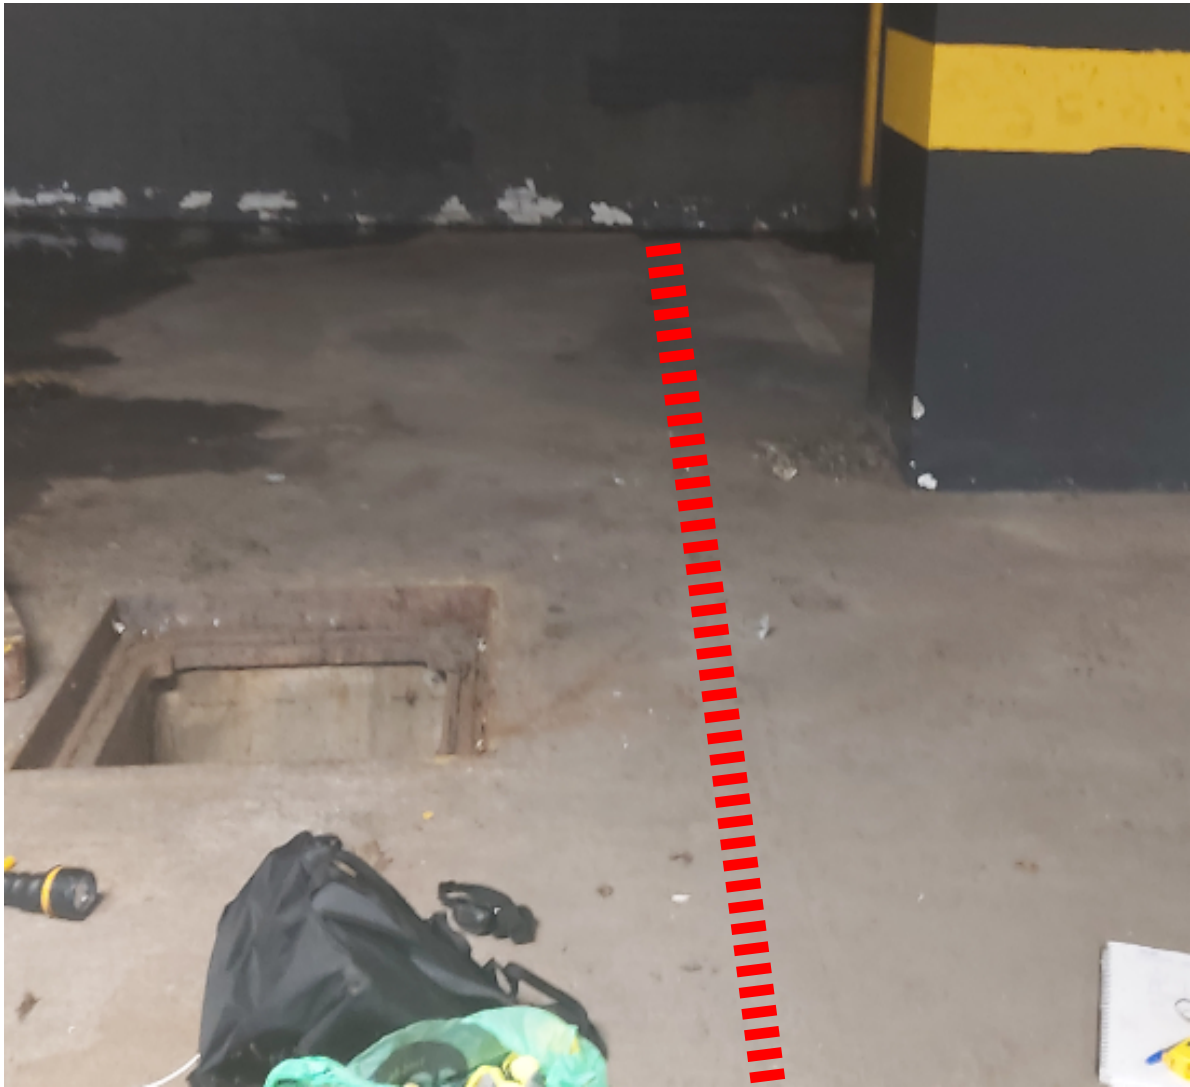
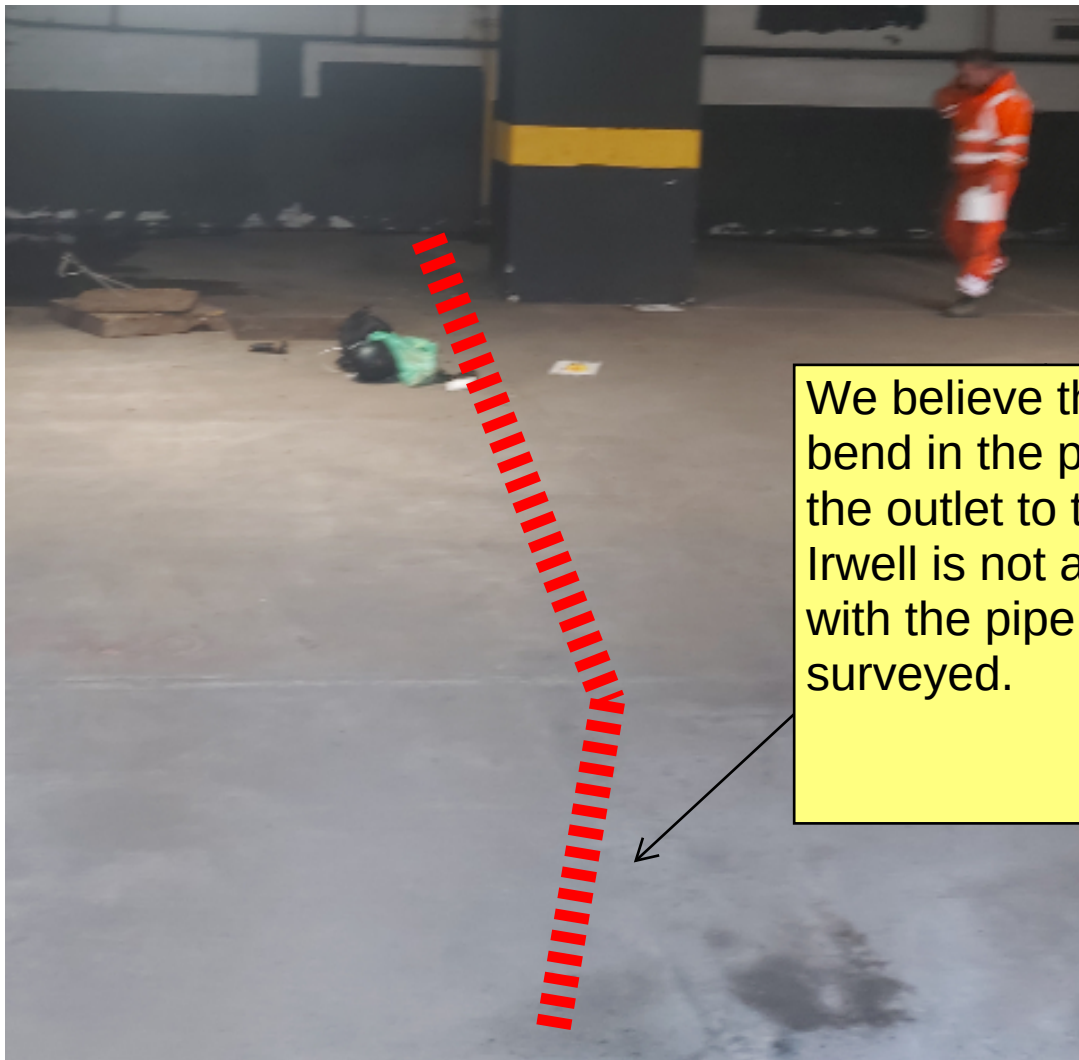
We believe there is a bend in the pipe, as the outlet to the River Irwell is not aligned with the pipe surveyed.

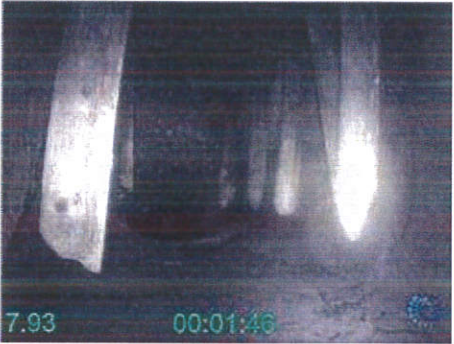
This line is in poor condition & appears to have had a repair carried out at some time in the past, as there is evidence of shuttering supports & also plywood on the top of the drain, possibly to support a concrete repair.

| Pos | Video Ref | Code | Description | Image |
|---|---|---|---|---|
| 06.38m | 0:00:52 | REM | General remark<br>ply wood shuttering on the roof<br>of the drain | Image Provided - Ref: 0_2<br><br>7.93 00:01:46 |

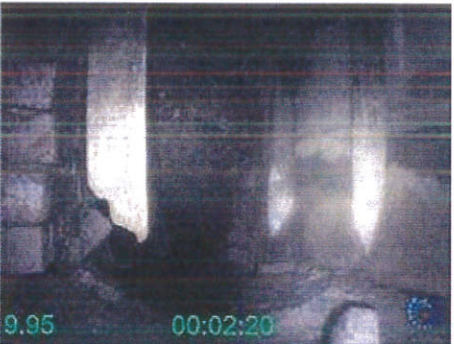
| Pos | Video Ref | Code | Description | Image |
|---|---|---|---|---|
| 07.90m | 0:01:28 | S1 REM | General remark 7.9m - 10.02m<br>support for shuttering | Image Provided - Ref: 0_3<br><br>9.95 00:02:20 |

| Pos | Video Ref | Code | Description | Image |
|---|---|---|---|---|
| 09.95m | 0:03:13 | OB | Other obstacles: 20% Cross sectional area loss - Severity 3 support for shuttering will not let the camera past the brick drain can be seen in the distance | |

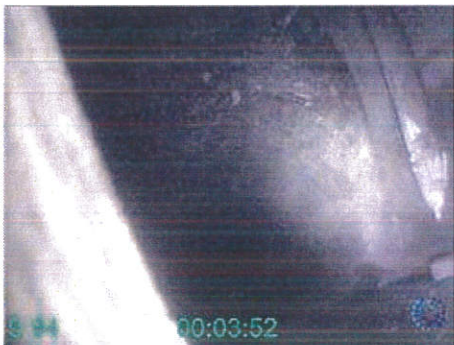
| Pos | Video Ref | Code | Description | Image |
|---|---|---|---|---|
| 09.95m | 0:02:19 | REM | General remark bricks missing | Image Provided - Ref: 0_5<br> |

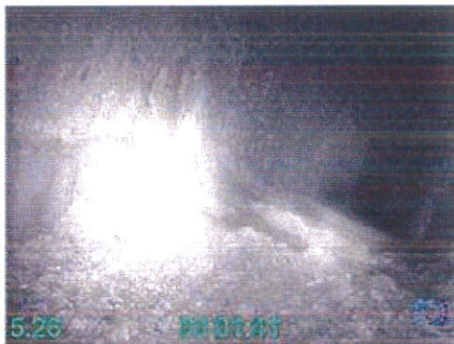
| Pos | Video Ref | Code | Description | Image |
|---|---|---|---|---|
| 05.26m | 0:01:24 | SC | Dimension of drain/sewer<br>changes: 0mm Diameter | Image Provided - Ref: 1_4<br> |
| 05.30m | 0:01:24 | OB | Other obstacles: 20% Cross<br>sectional area loss - Severity 3<br>POSSIBLE CONCRETE IN<br>THE INVERT 20% | |
| 06.53m | | SA | Survey abandoned<br>UNABLE TO PASS<br>OBSTRUCTION | |
