DETAIL 01: ELEVATION ON OPENING TO BAY WINDOW  
(APPROX. 1:10)

DETAIL 02: SECTION A-A THROUGH OPENING TO BAY WINDOW  
(APPROX. 1:5)

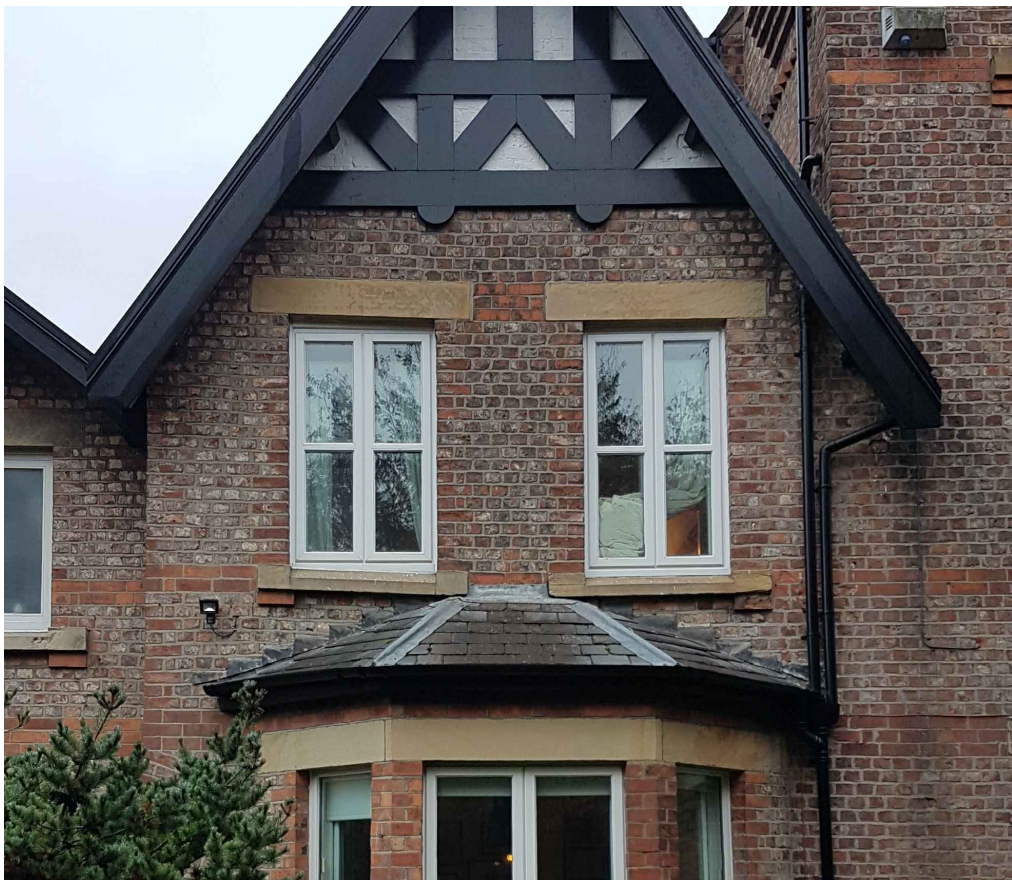
IMAGE 01: EXTERNAL ELEVATION ON STRUCTURAL OPENING TO BAY WINDOW. NOTE THE SIGNIFICANT DOWNWARD CRANK OF FIRST FLOOR WINDOW OPENINGS, DOWNWARD TRANSLATION OF CENTRAL PIER OF MASONRY

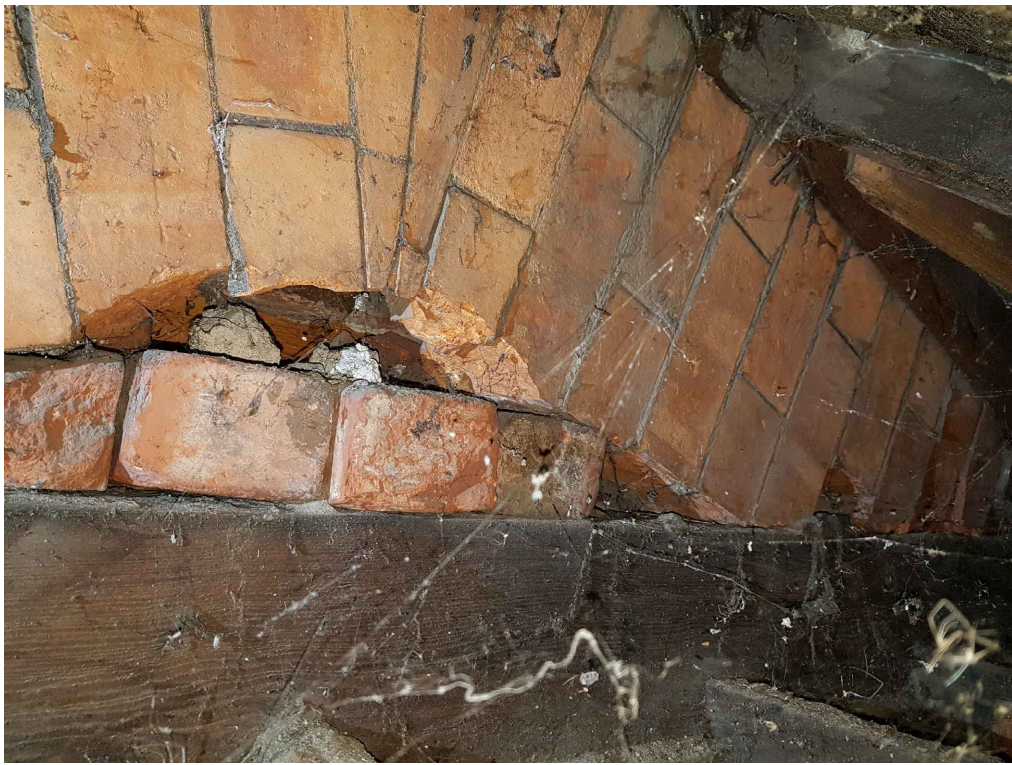
IMAGE 02: EXTERNAL VIEW OF RELIEVING ARCH OVER TIMBER BEAM SHOWING AWKWARD FLAT CHAMFER OF INTRADOS. DROP-OUT OF INTRADOS AND PACKING UNITS BELOW CROWN.

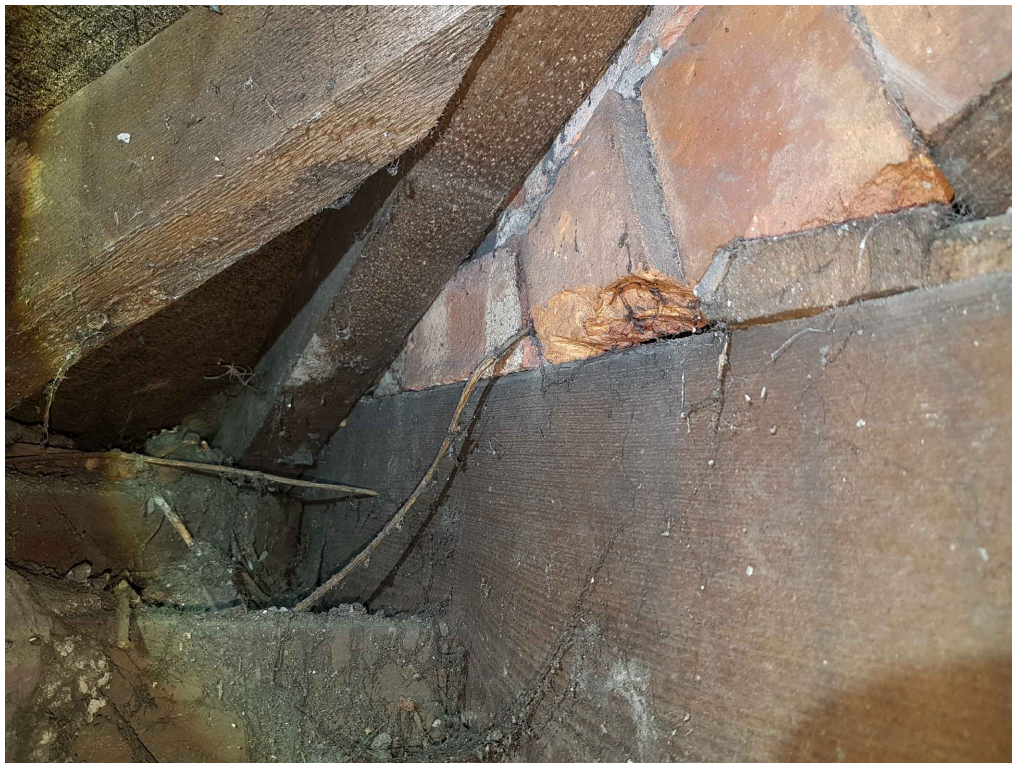
IMAGE 04: VIEW OF LEFT-HAND BEARING (AS VIEWED EXTERNALLY. SEE IMAGE 01) SHOWING TIMBER WEDGES AND CUT BRICK PACKERS TO AWKWARD TAPERED END OF RELIEVING ARCH, SIMILAR TO OPPOSITE BEARING (IMAGE 03). TIMBER BEAM APPEARS IN SOUND TIMBER CONDITION.
