10 Minshull Street and 11 Bloom Street

**TANKING DETAILS PROPOSALS - WALLS**

PLANNING CONDITIONS RELEASE 11(e)

Planning Permission 119374/FO/2018 – BOTH BUILDINGS

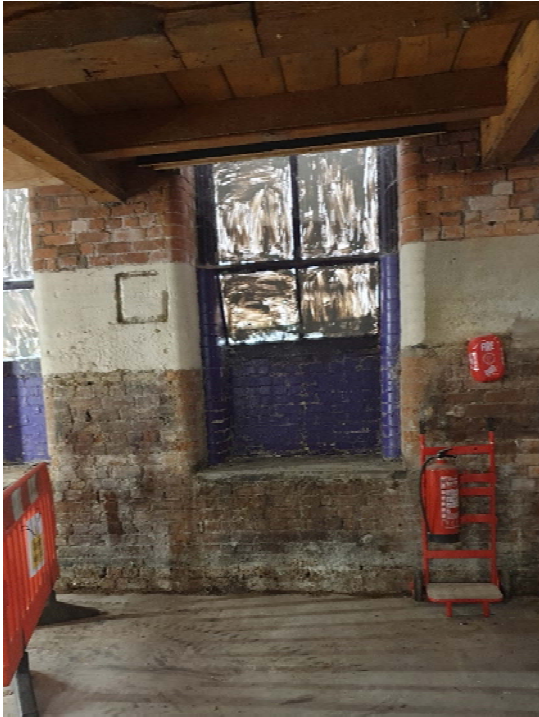
### BLOOM BUILDING

Effervescence, salt, water and damp ingress to the full height of the wall. Spalling brickwork, staining and mould.

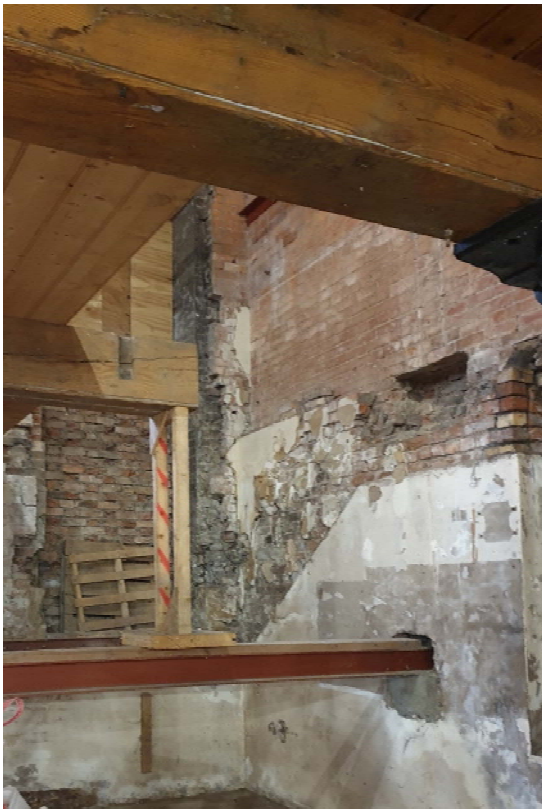
### BLOOM BUILDING

Effervescence, salt, water and damp ingress to the full height of the wall. Spalling brickwork, staining and mould. Scarring from previous fixtures.

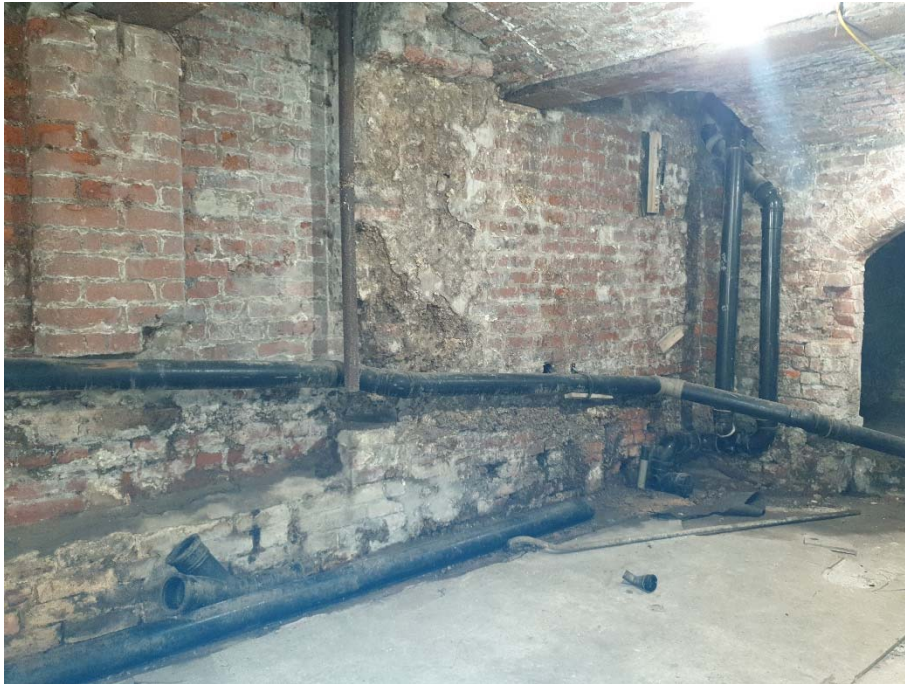
BLOOM  
BUILDING

Effervescence, salt, water and damp ingress to the full height of the wall. Spalling brickwork, staining and mould.

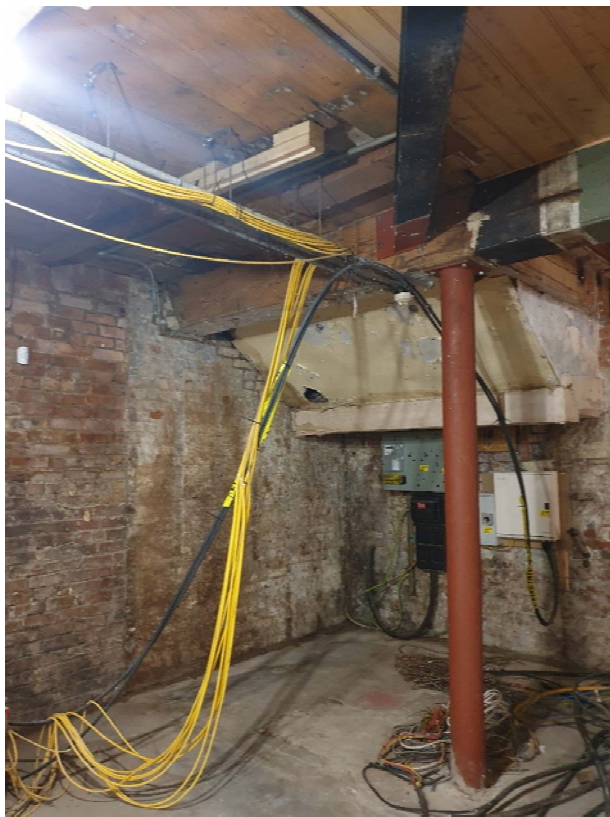
BLOOM BUILDING

Effervescence, salt, water and damp ingress to the full height of the wall. Spalling brickwork, staining and mould.

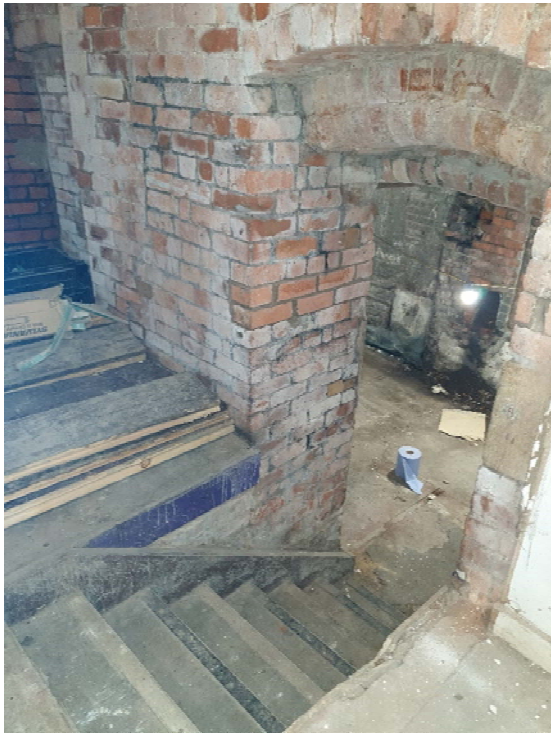
#### BLOOM BUILDING

Effervescence, salt, water and damp ingress to the full height of the wall. Spalling brickwork and staining.

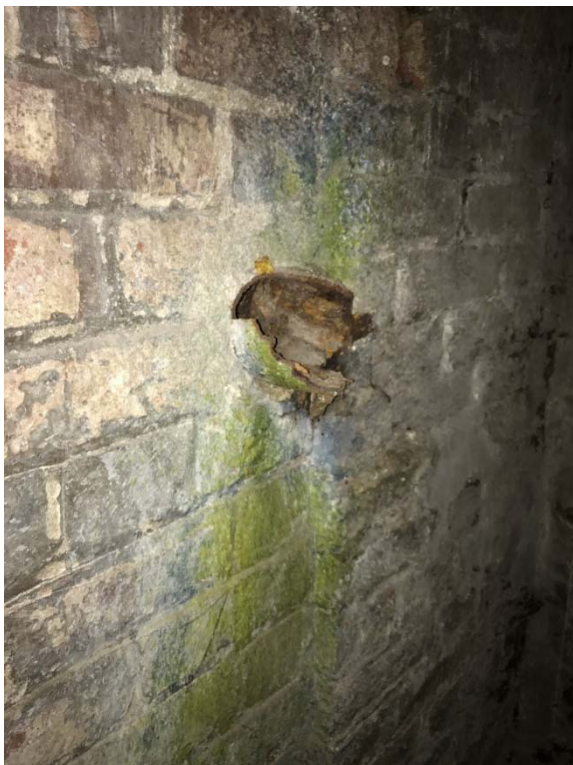
#### BLOOM BUILDING

Effervescence, salt, water and damp ingress to the full height of the wall. Spalling brickwork, staining and mould and mildew.

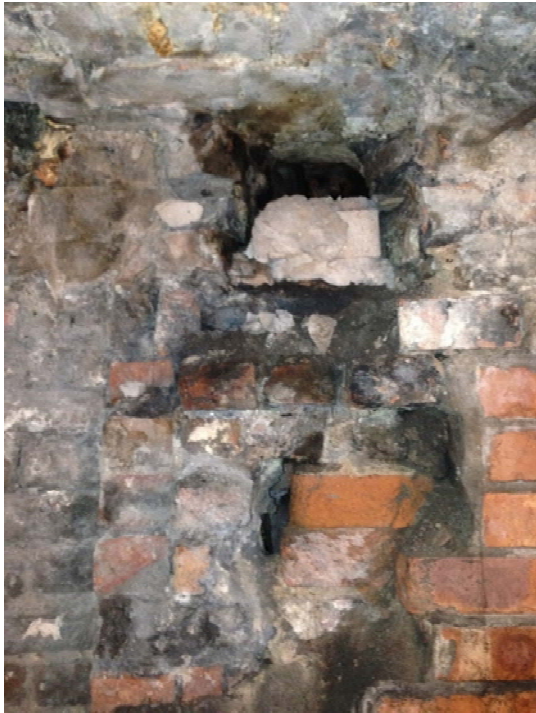
#### BLOOM BUILDING

Effervescence, salt, water and damp ingress to the full height of the wall. Spalling brickwork, staining and mould.

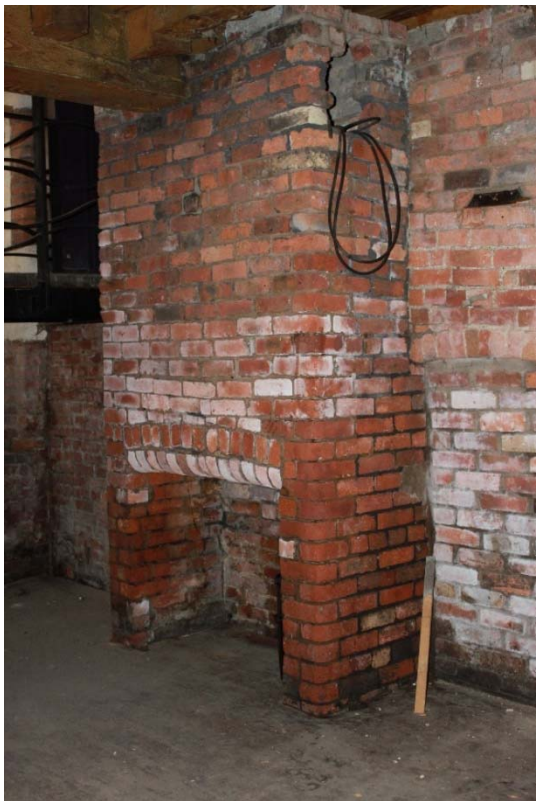
#### BLOOM BUILDING

Effervescence, salt, water and damp ingress to the full height of the wall. Spalling brickwork, staining and mould.

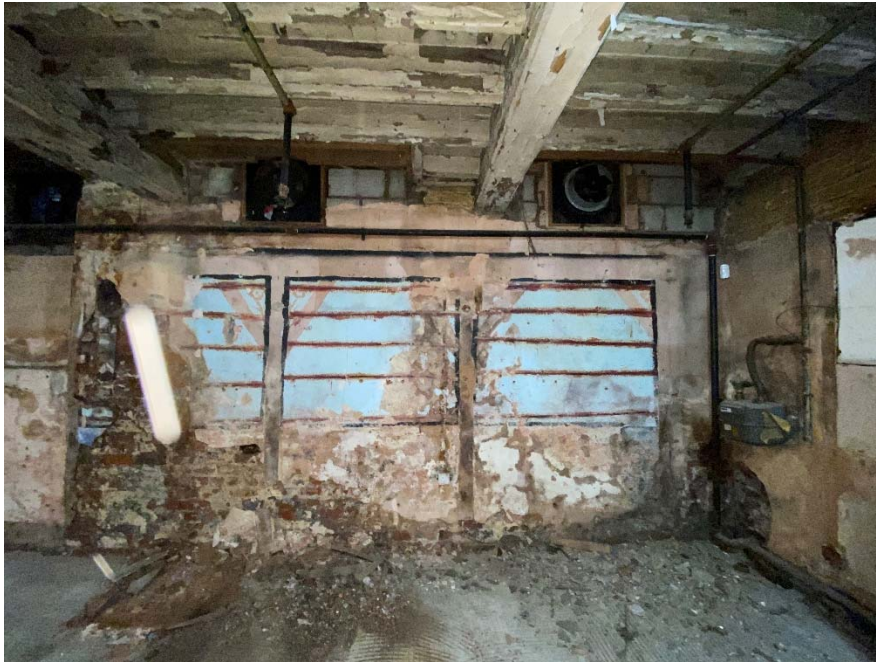
#### MINDEL HOUSE

Effervescence, salt, water and damp ingress to the full height of the wall. Spalling brickwork, staining and mould. Degraded gypsum plasterwork.

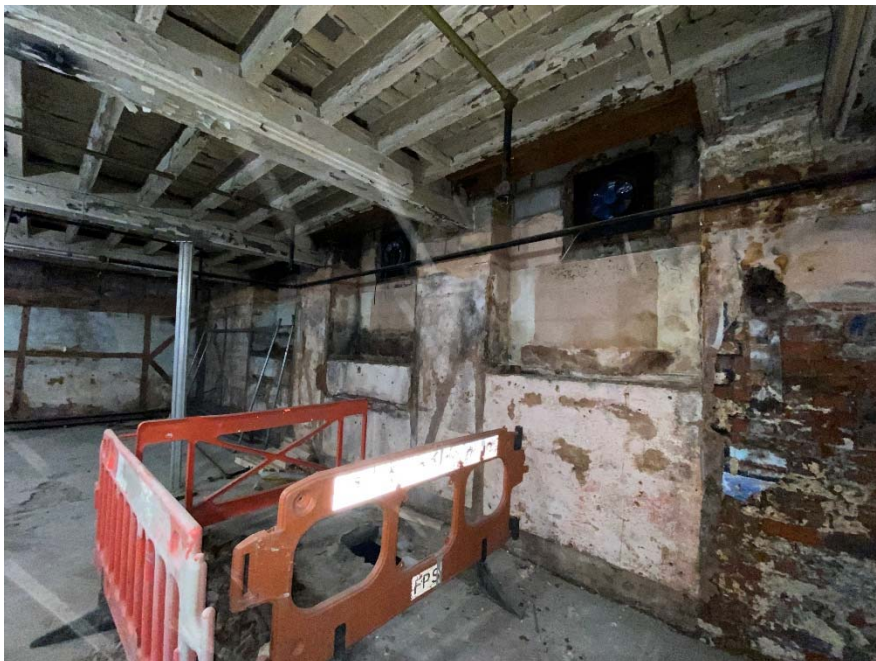
#### MINDEL HOUSE

Effervescence, salt, water and damp ingress to the full height of the wall. Spalling brickwork, staining and mould. Degraded gypsum plasterwork.

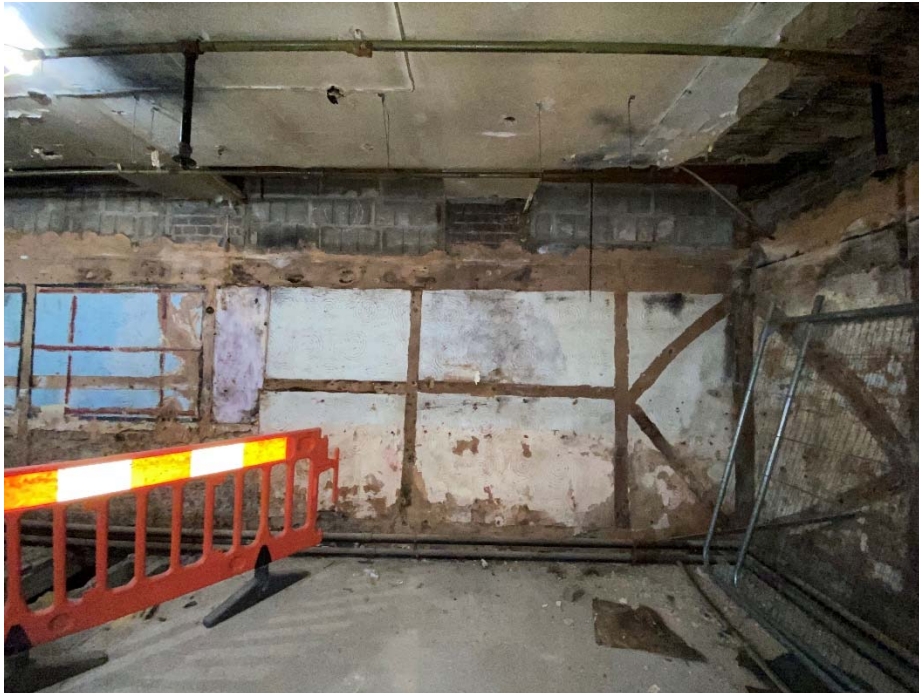
MINDELE HOUSE

Efflorescence, salt, water and damp ingress to the full height of the wall. Staining and mould. Degraded gypsum plasterwork.

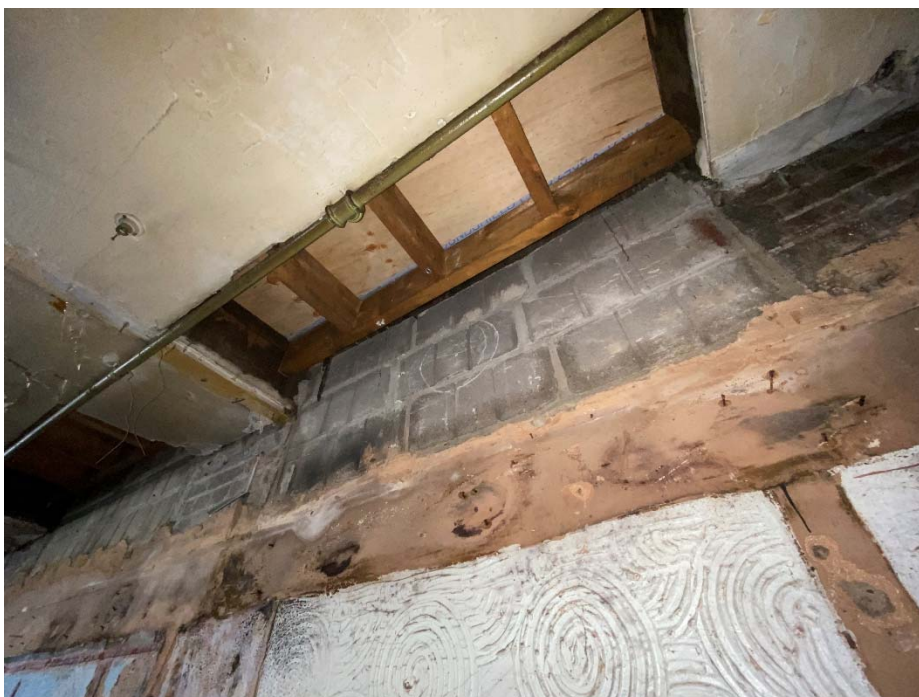
MINDELE HOUSE

Efflorescence, salt, water and damp ingress to the full height of the wall. Staining and mould. Degraded gypsum plasterwork.

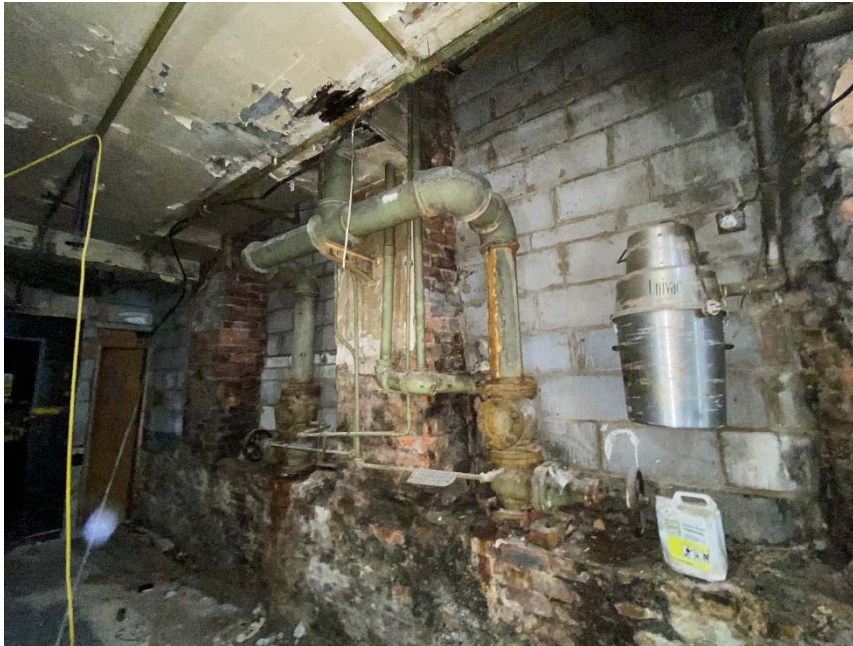
#### MINDEL HOUSE

Effervescence, salt, water and damp ingress to the full height of the wall. Spalling brickwork, staining and mould. Degraded gypsum plasterwork.

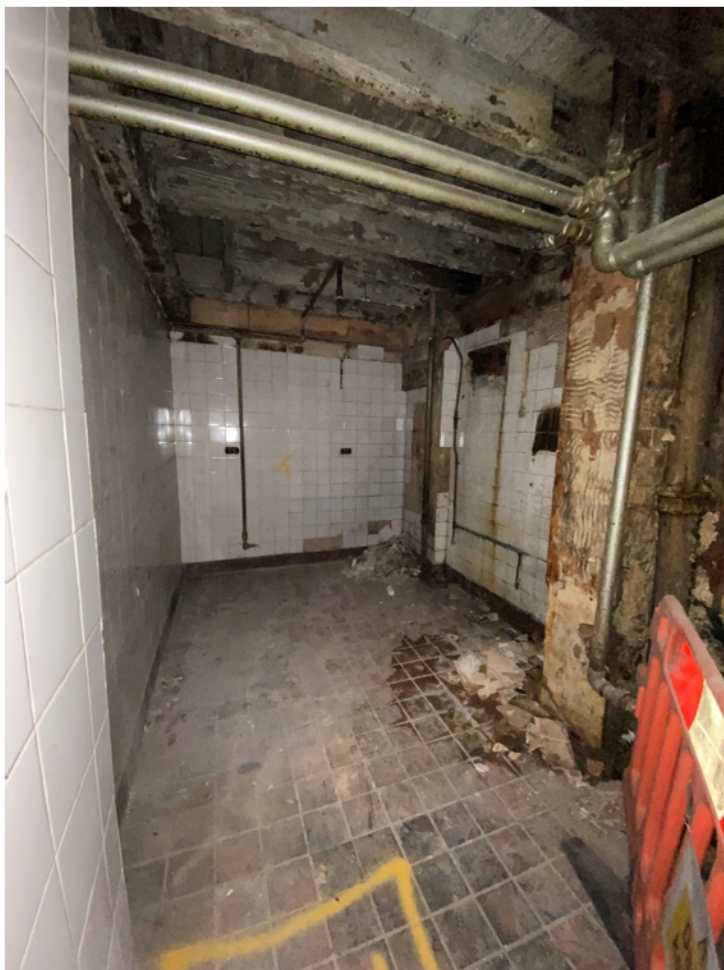
#### MINDEL HOUSE

Effervescence, salt, water and damp ingress to the full height of the wall. Staining and mould. Degraded gypsum plasterwork.

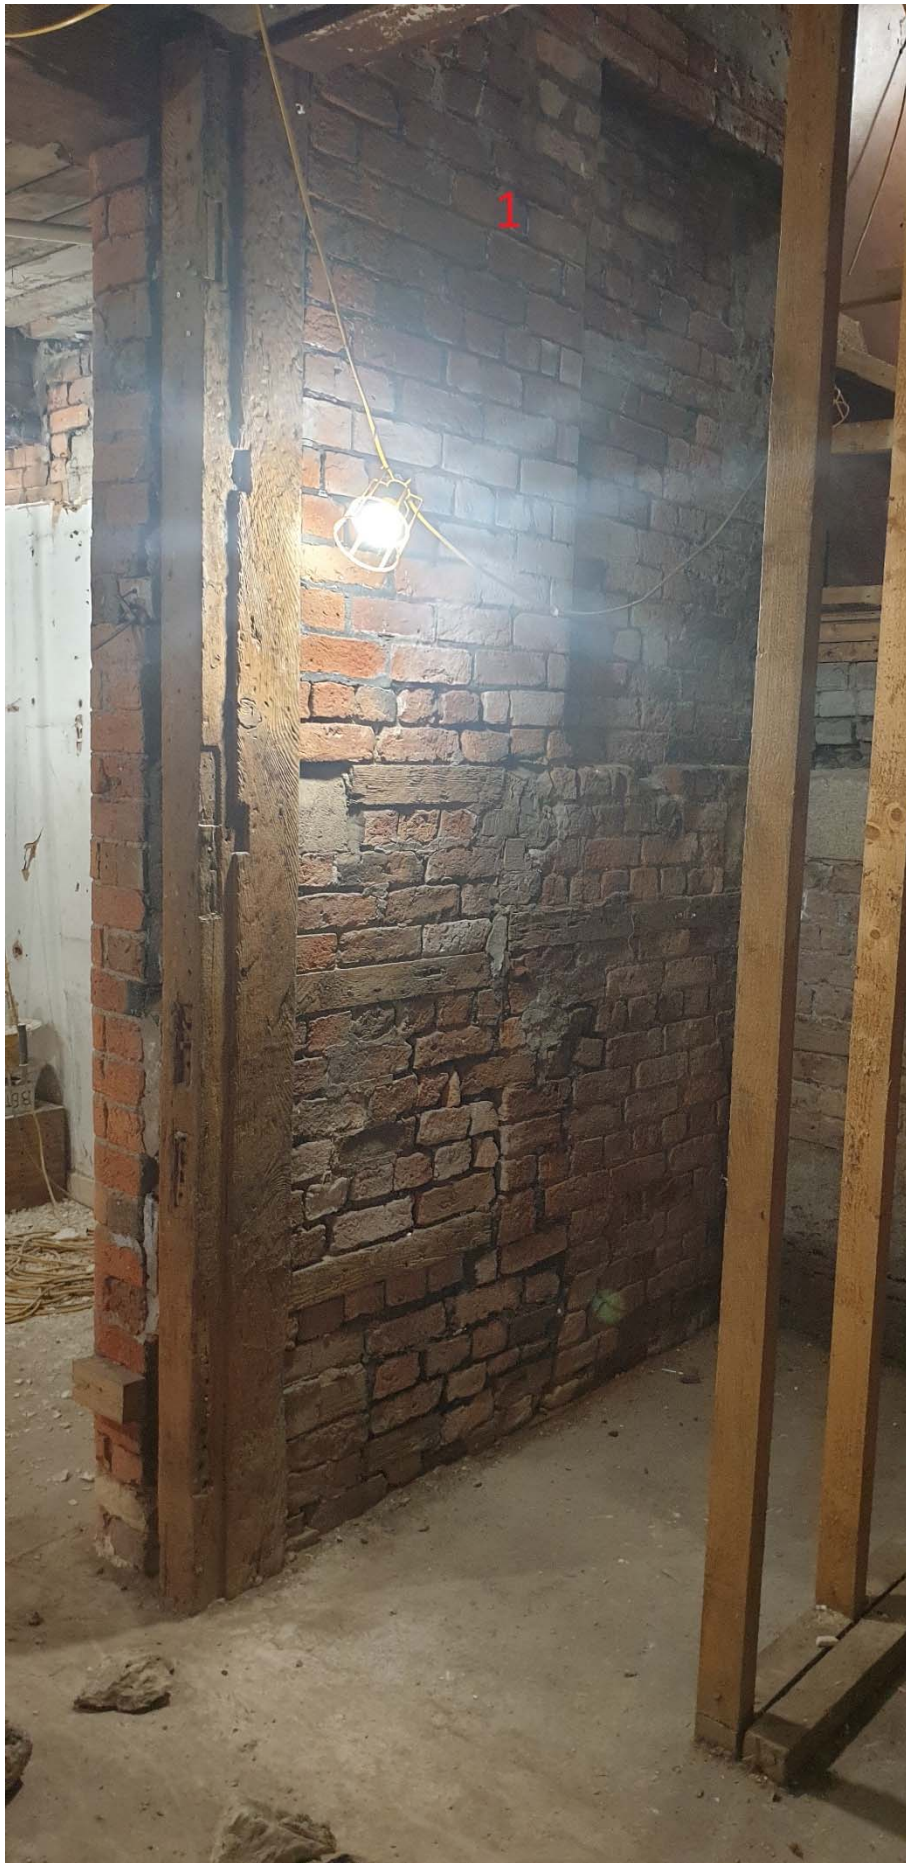
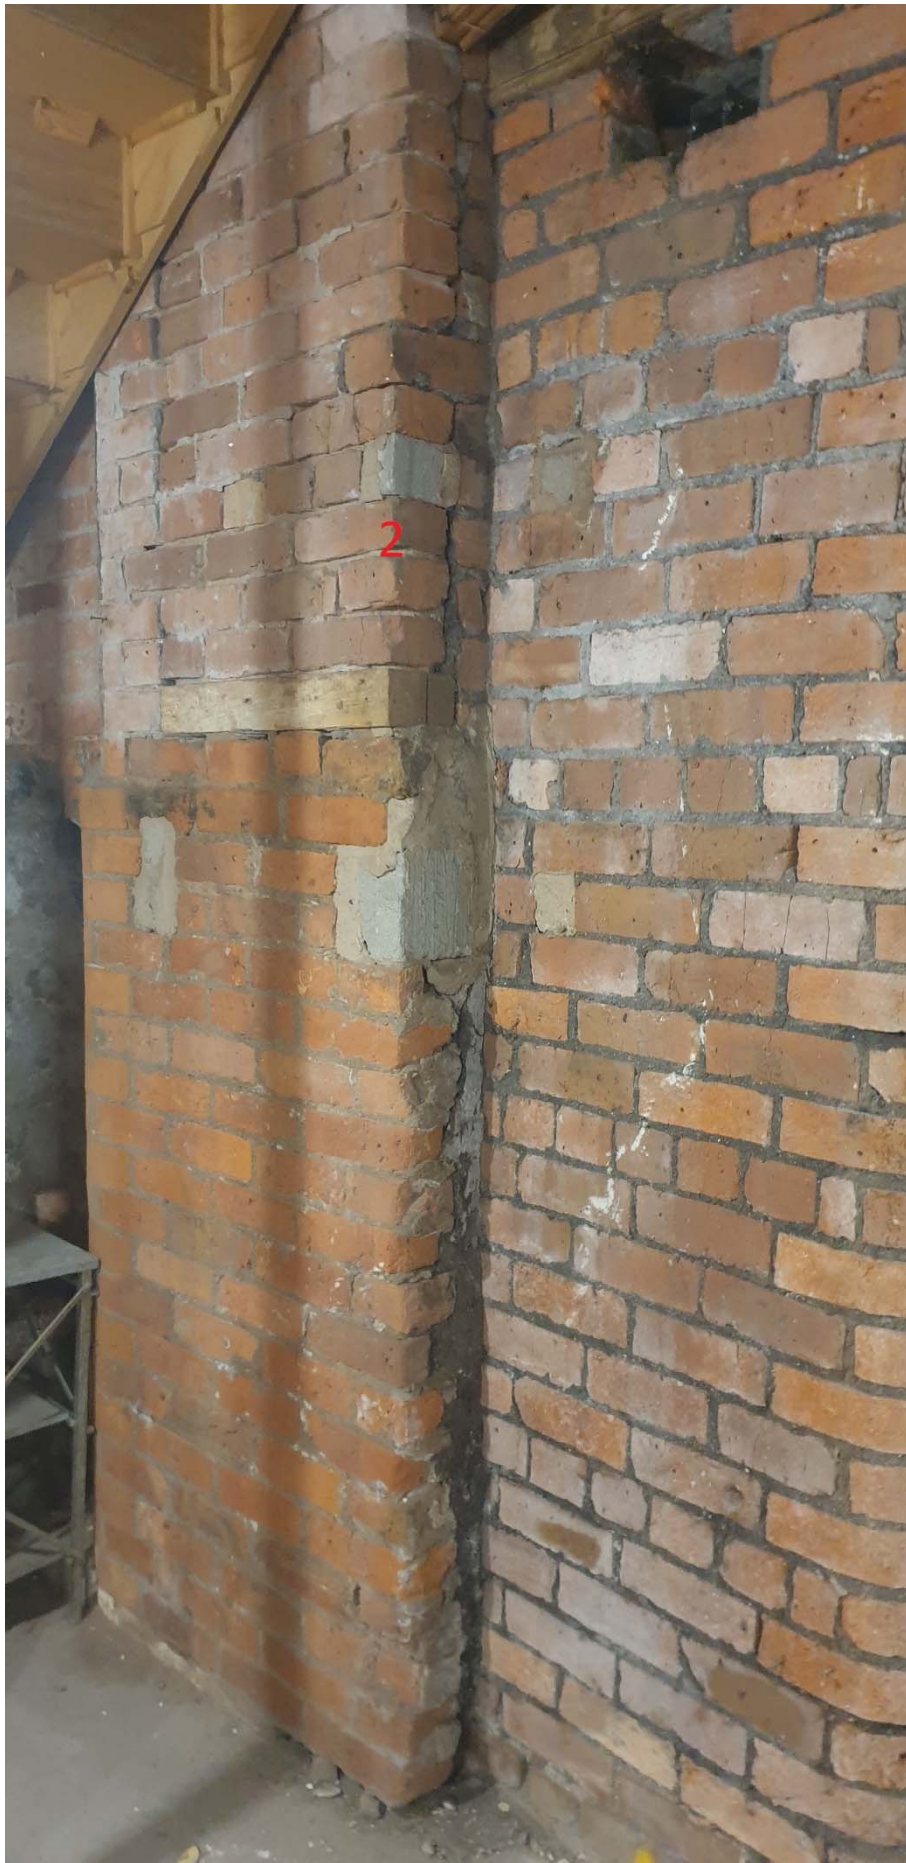
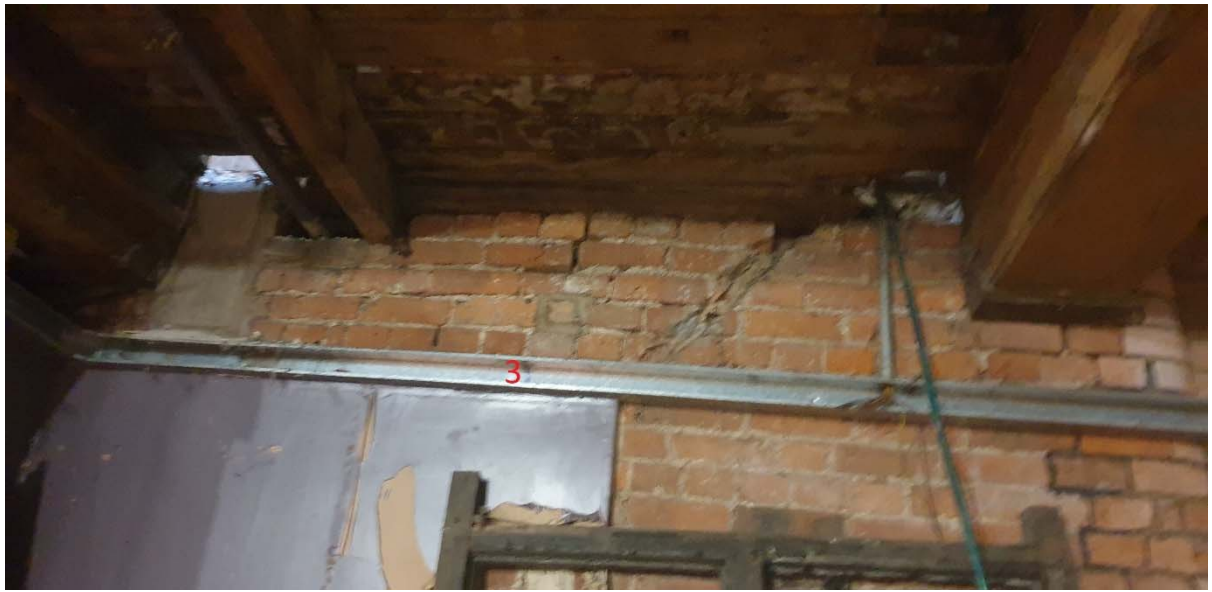
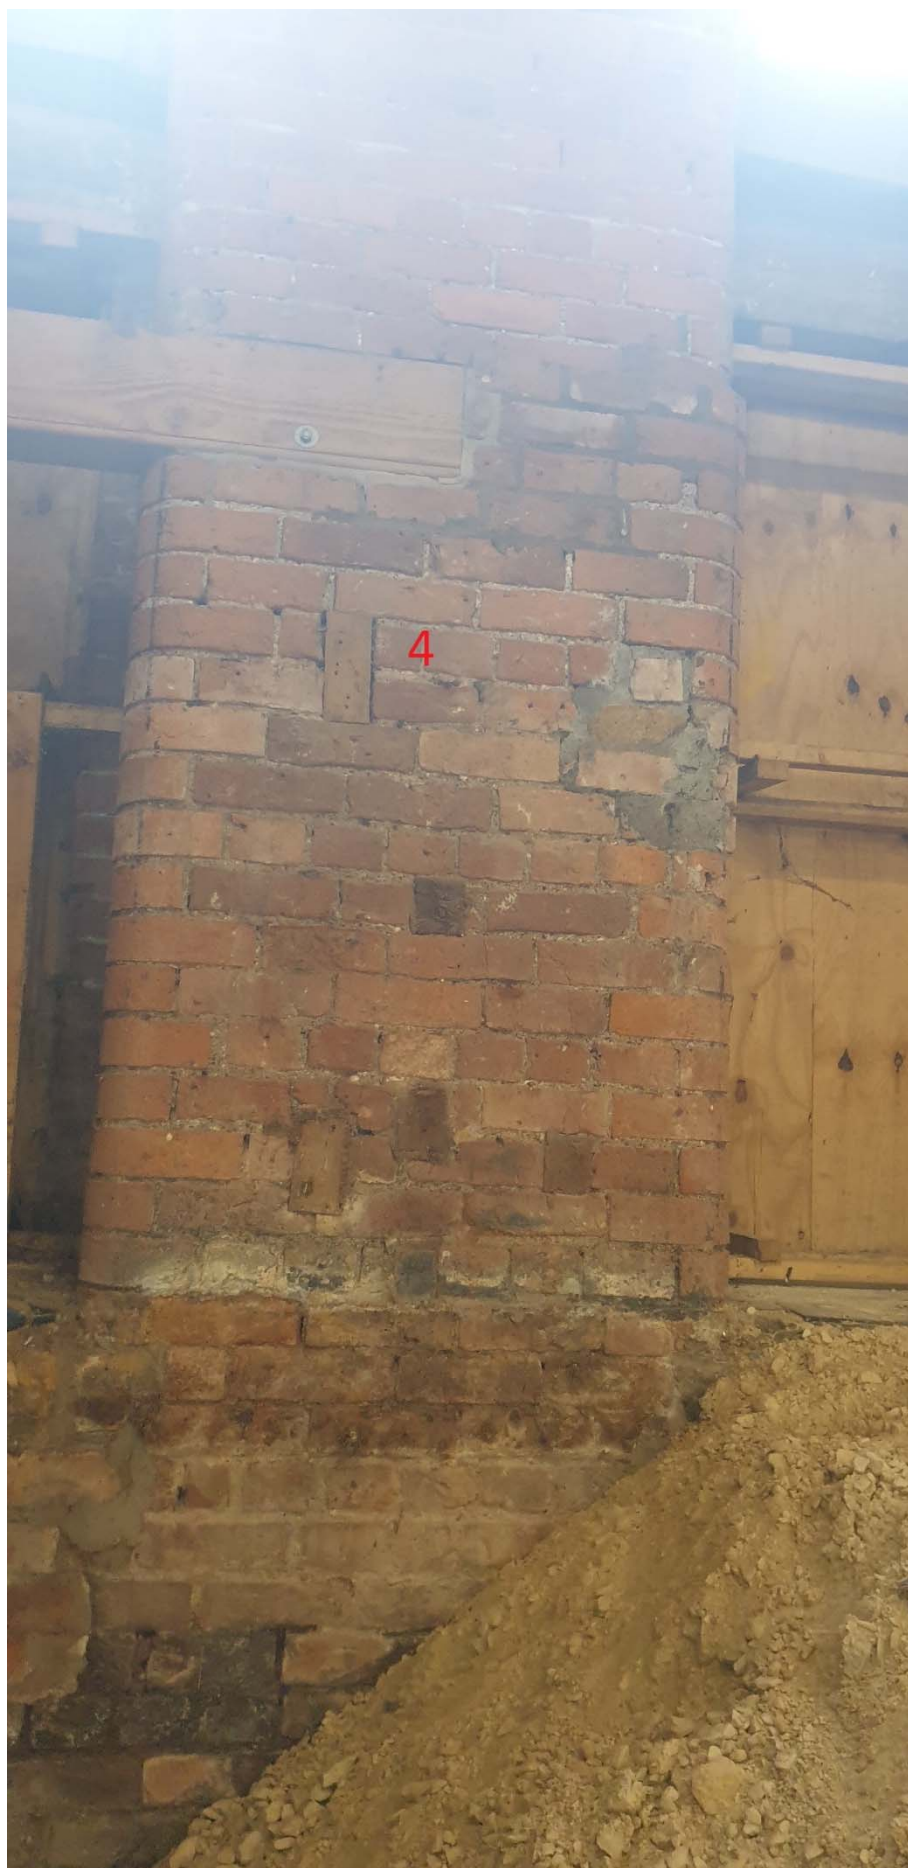
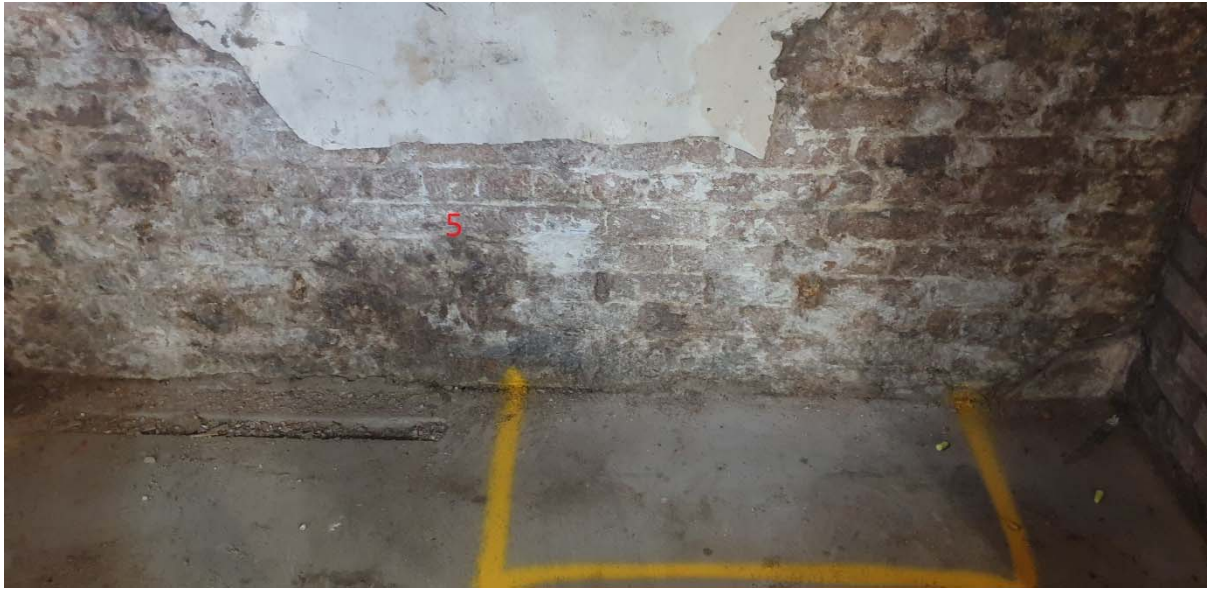
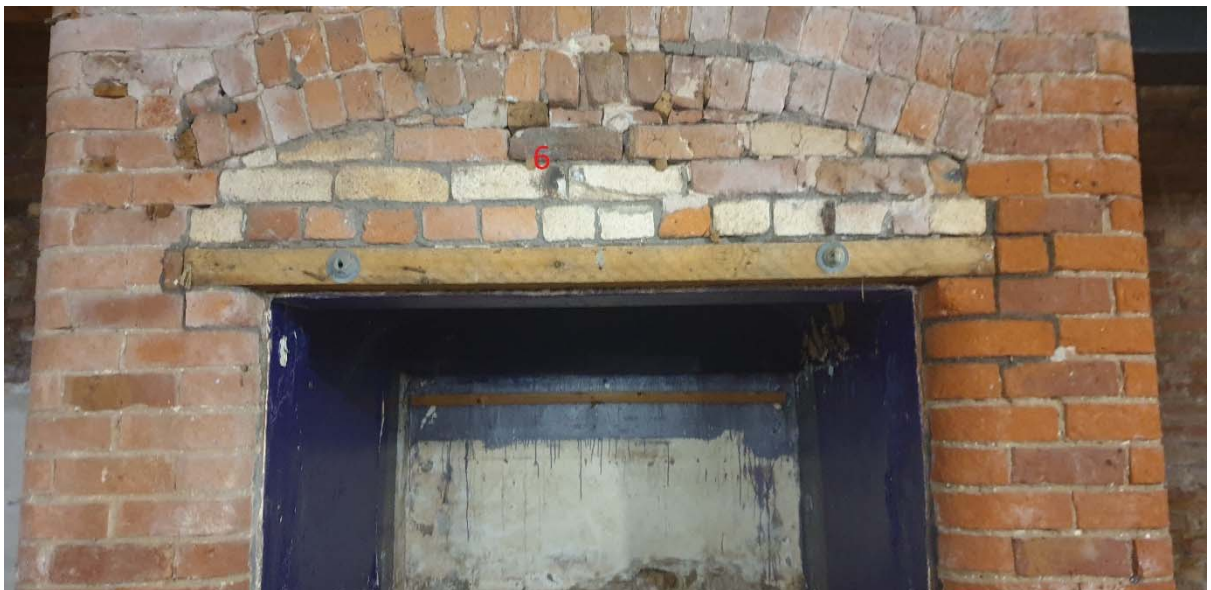
IMAGES OF EMBEDDED TIMBER WITHIN WALLS OF BLOOM STREET LOWER GROUND FLOOR:  
HIGHLIGHTED BY HUTTON & ROSTRON
