# QD Checklist-P1-Drainage

MHF6a to MHF6 inclusive

| Project Name | K00221 - The Manchester College, City Centre |
| Location | Ground Drainage>QUALITY DELIVERY |

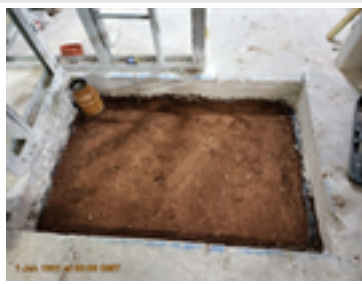
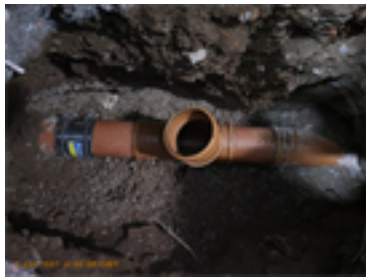
#2

| # | Checks carried out |
|---|---|
| 2 | Missing SVP11 works |

| # | Comments | Created By | Date |
|---|---|---|---|
| 2 | SVP11 found to be missing. Mayos broke out slab and hand dug down to find existing Fould line. Connection made by 6 inch T junction, Band seal and 2nr rocker piles. Position agreed with Briggs and Willmotts. | Scott Billington (Mayo Civils) | 03/09/2021 14:18:02 |
