# GEOSHIELD Verification Report

GEO101021

003

McAlear & Rushe

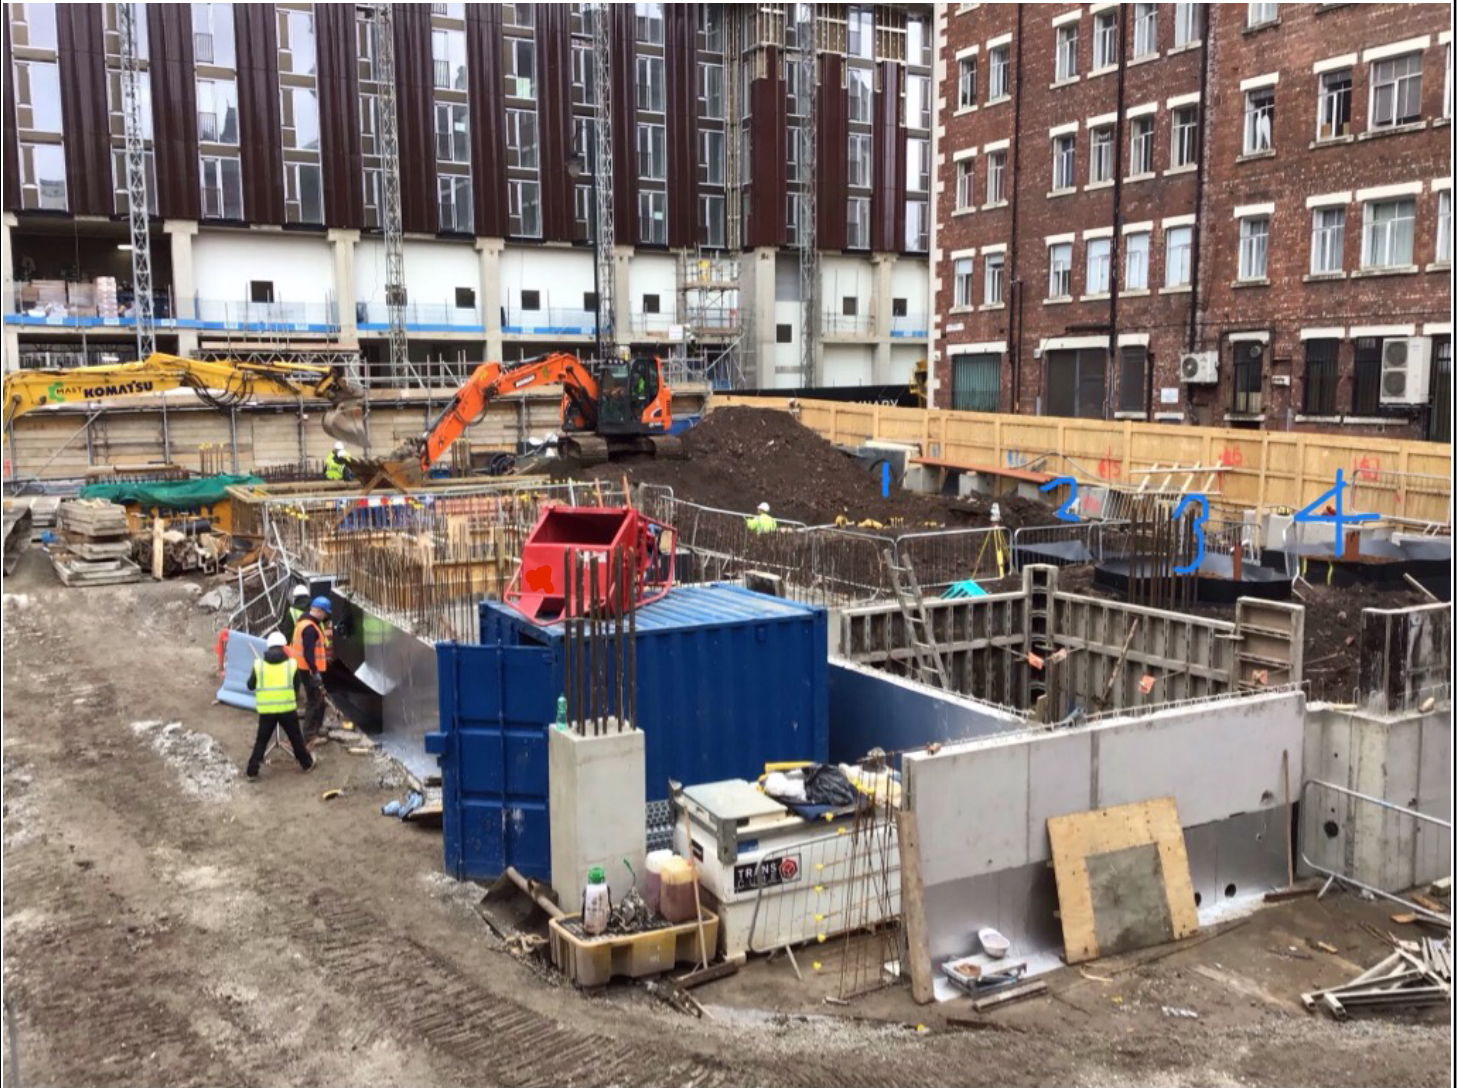
Overview of site. The four piles are labelled in blue.

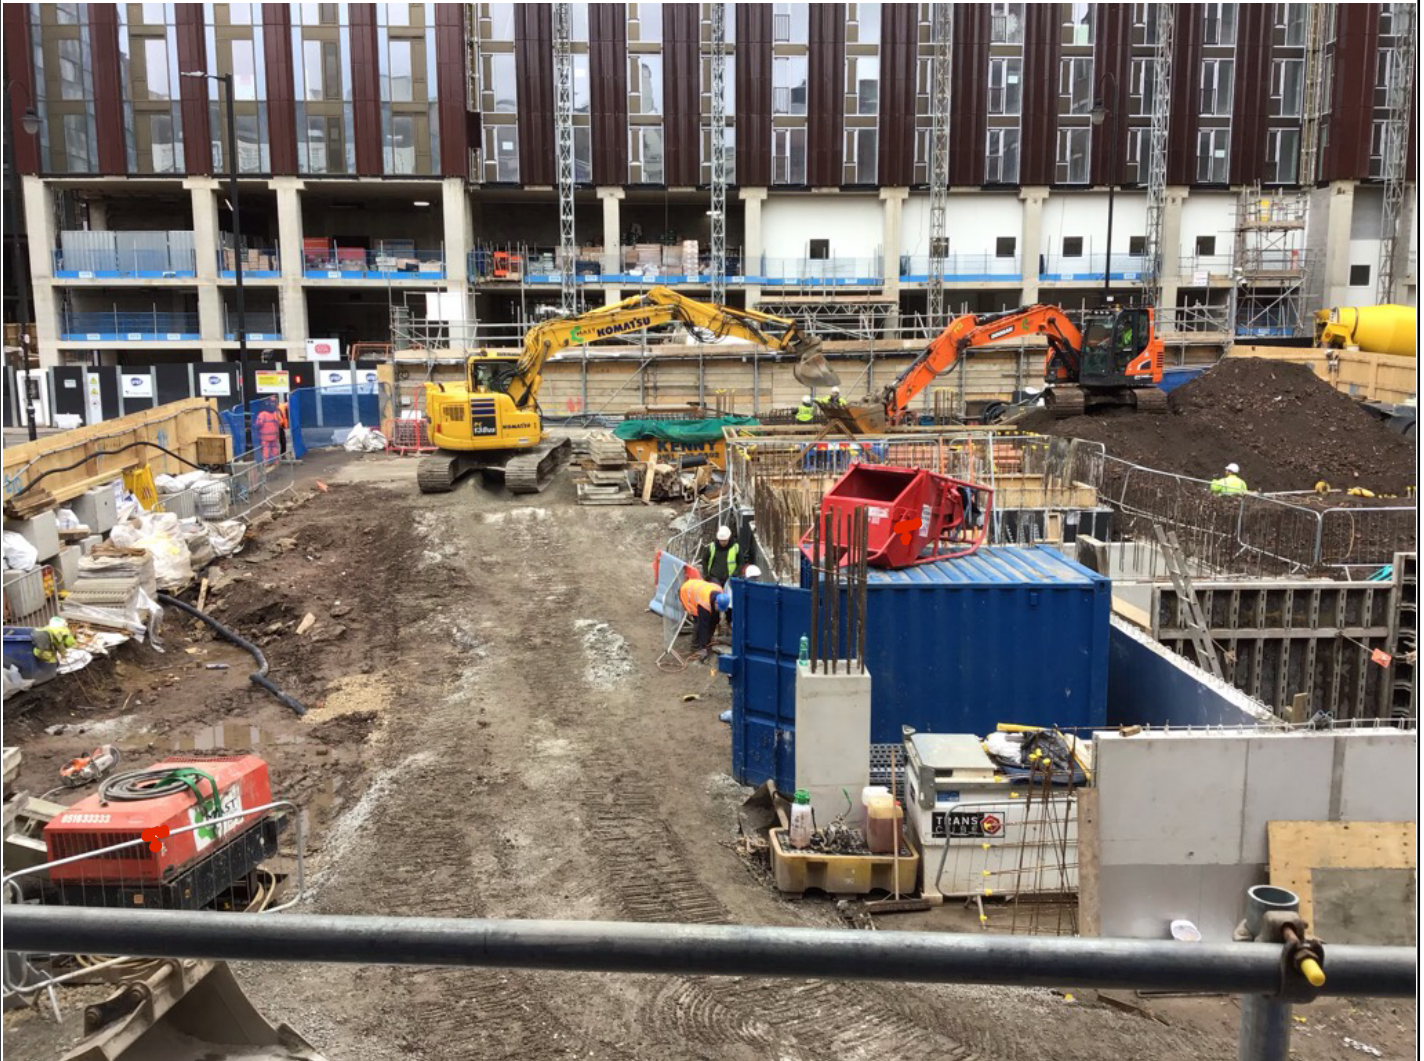
Overview of Site with Prestige Air working on H Block wall

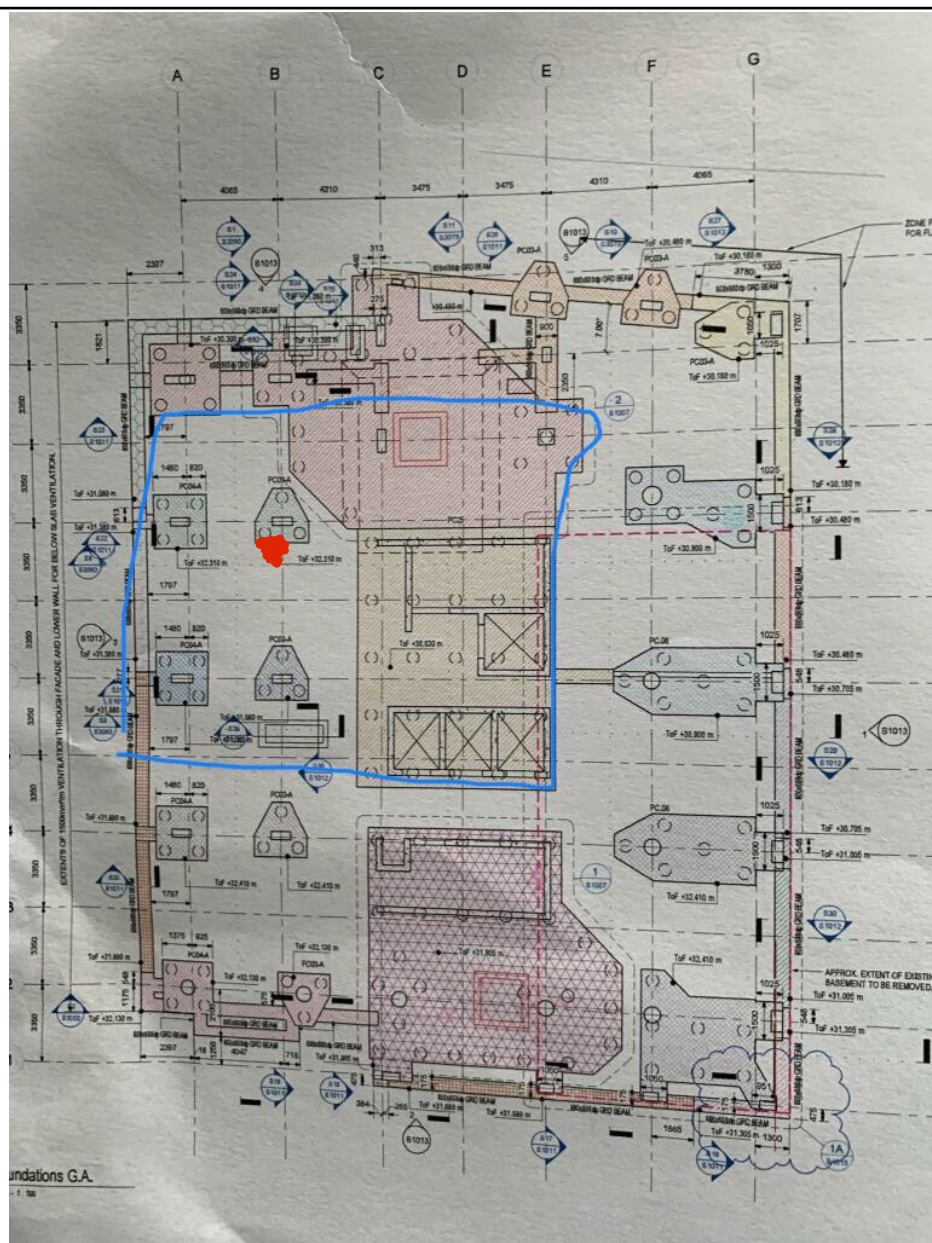
Overview of areas verified

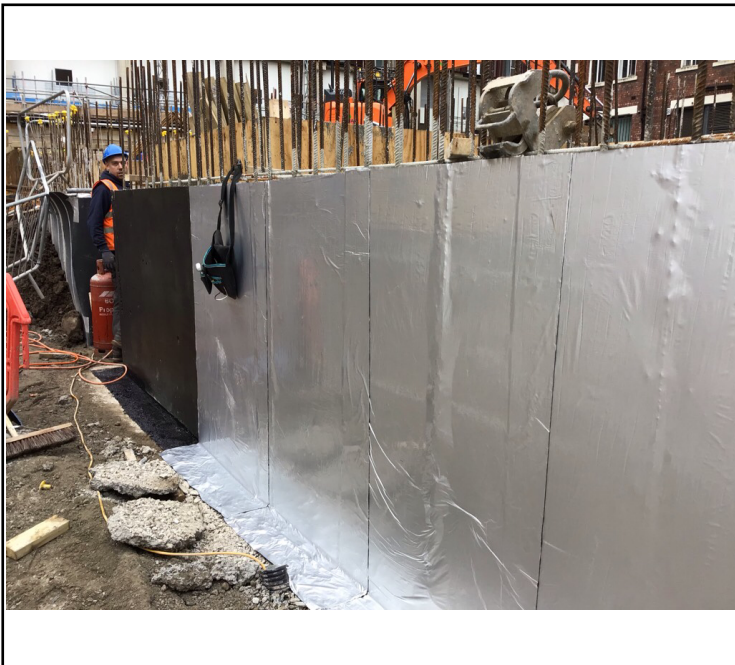
LOCATION/GRID LINE: H Block wall

NOTES: The walls of H Block have been primed with bitumen and

GR SAM has been installed with a 300mm overlapped has been installed onto the  
Concrete slab. A pick and probe test was carried out to ensure a good seal.

Left photo) GR SAM installed vertically with 300mm overlap on slab

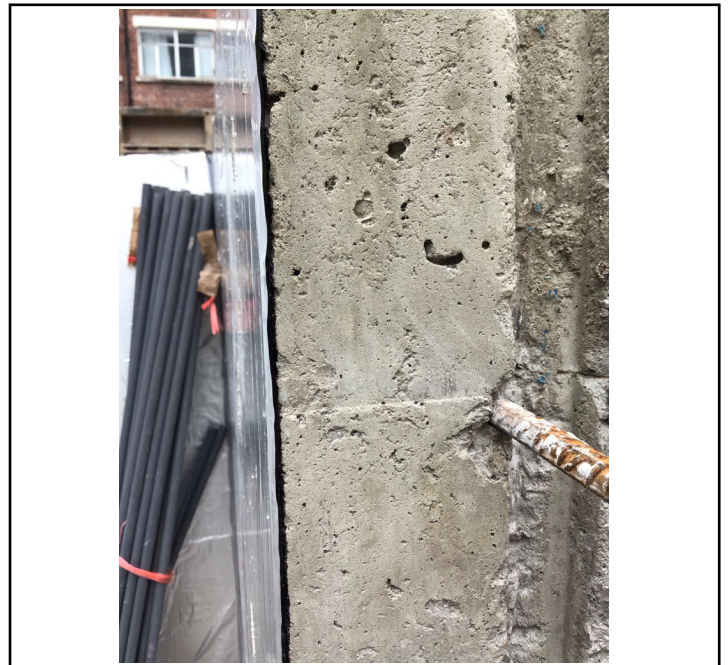
Right photo) GR SAM sealed to concrete wall

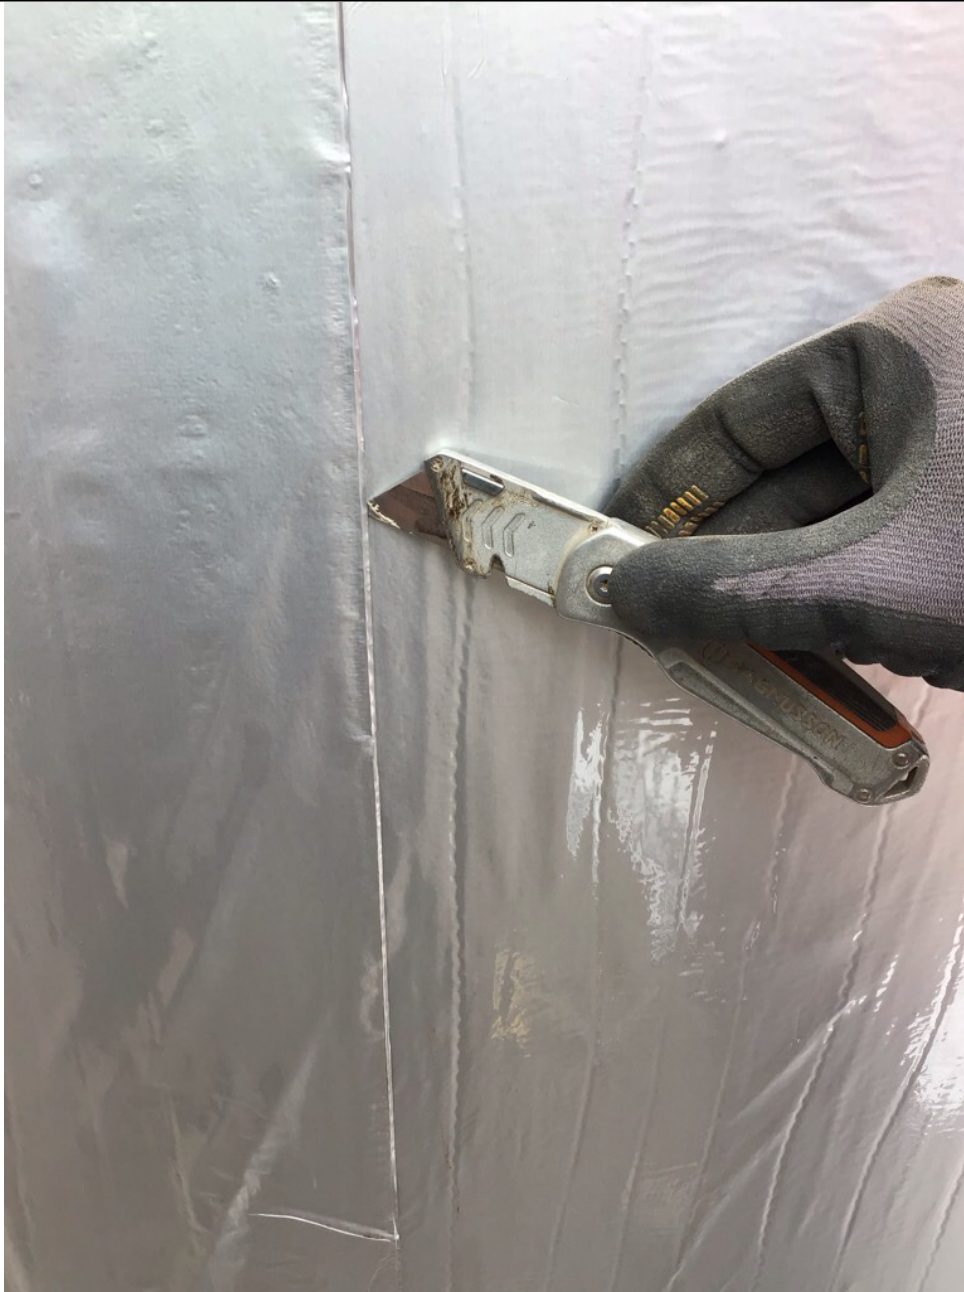
3. Pick and probe test on GR SAM

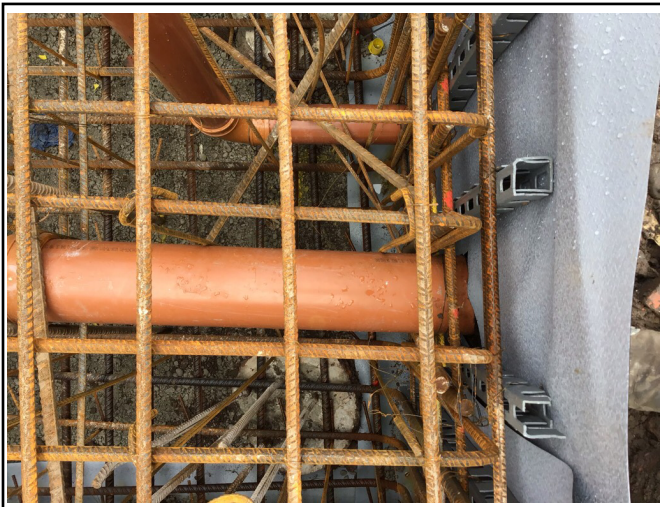
LOCATION/GRID LINE: Pile cap 04-A (Gridline 8)

NOTES: Whilst inspecting the pile caps I noticed a piping had been

Fitted within PC04-A. Due to the steel rebar cage already being fitted, visual inspection

Was limited. The exterior section of piping has been sealed to the Visqueen Geoseal

Ultimate with GR SAM as per specification.

Left photo) section of pipe work within the pile cap

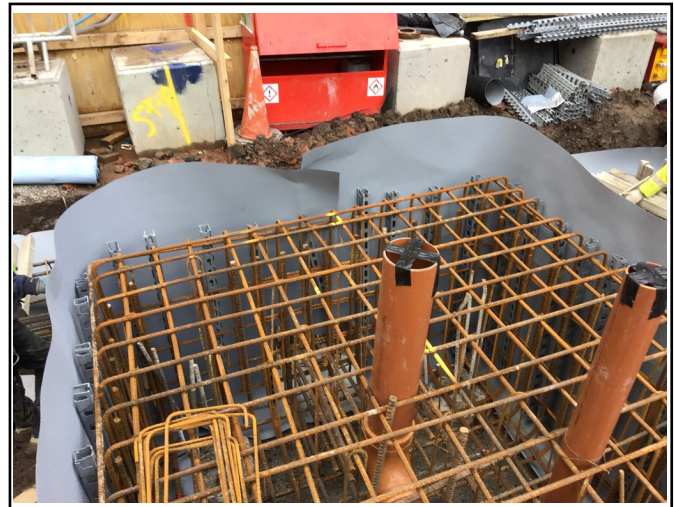
Right photo) overview of pile cap 04-A, showing 150mm overlap under the rebar cage

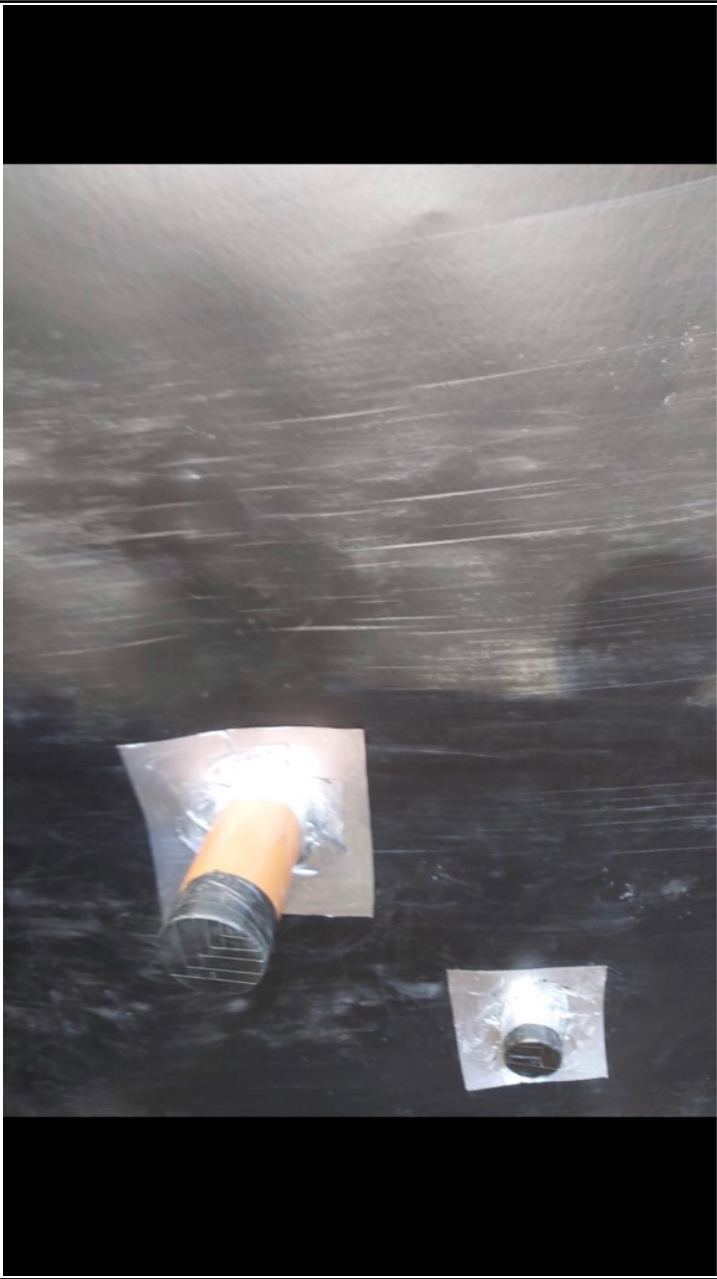
Above photo) external pipe work sealed with GR SAM

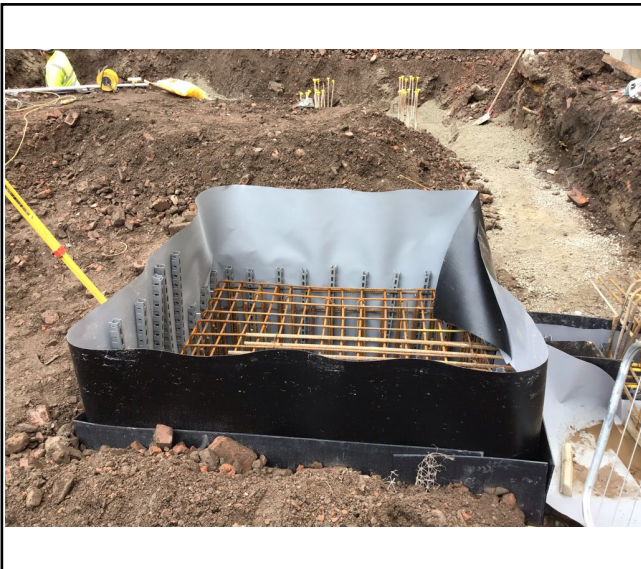
LOCATION/GRID LINE: Pile cap 04-A (Gridline 6)

NOTES: 3 piles were wrapped in Visqueen Geoseal Ultimate, they

Have been overlapped and hot welded to form a seal. A pick and probe test was

Carried out on the seal. 150mm overlap of Visqueen Geoseal Ultimate was also

Installed under the bear cage.

Left photo) overview of pile cap, showing Visqueen and protection board

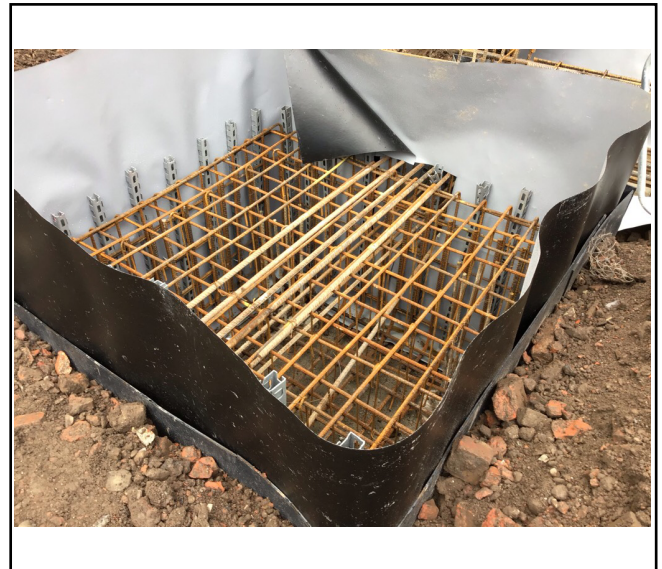
Right photo) closer photo showing the lap under the rebar

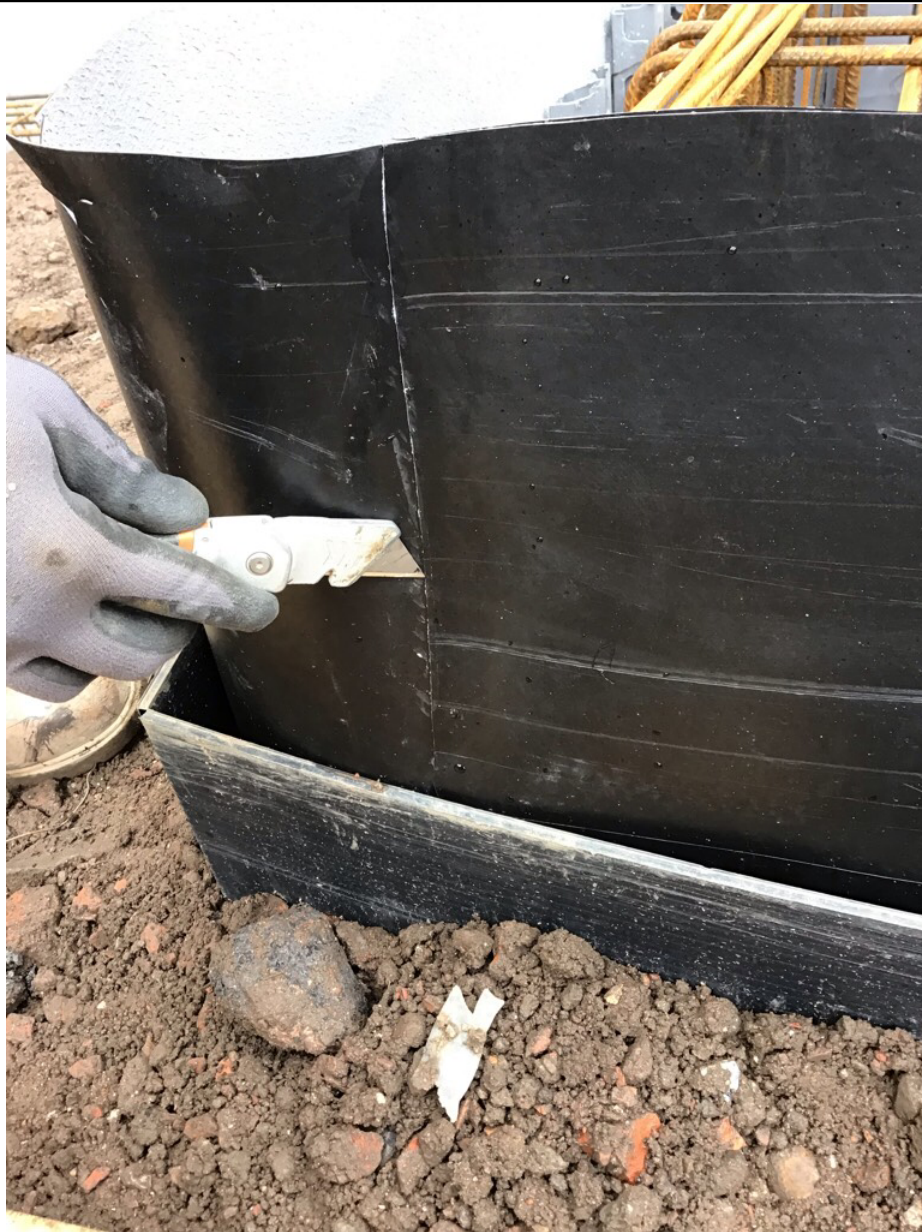
Above photo) pick and prob carried out on the hot welded joint, also

Showing the protection board, to protect against backfill

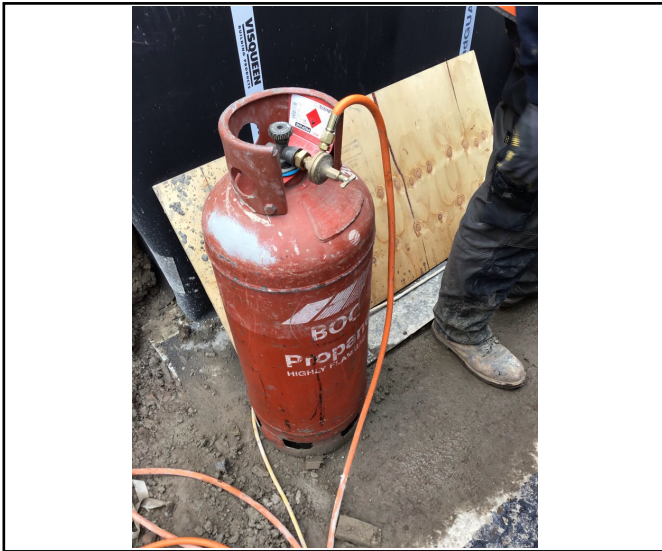
Gas used to prime bitumen

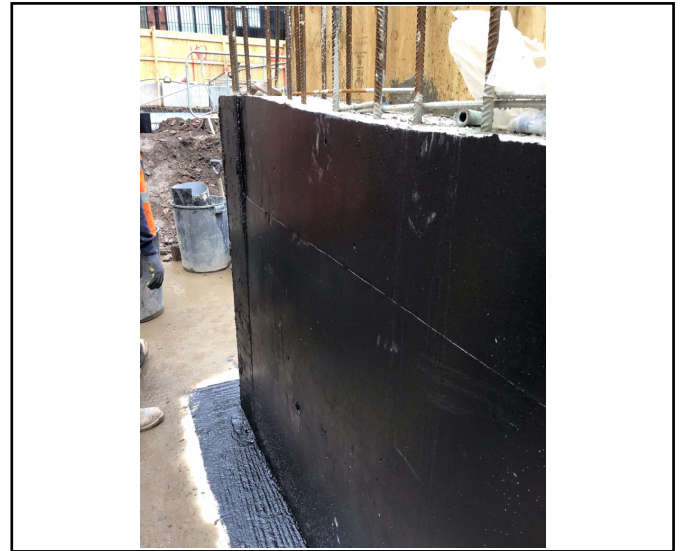
Primed wall waiting for GR SAM

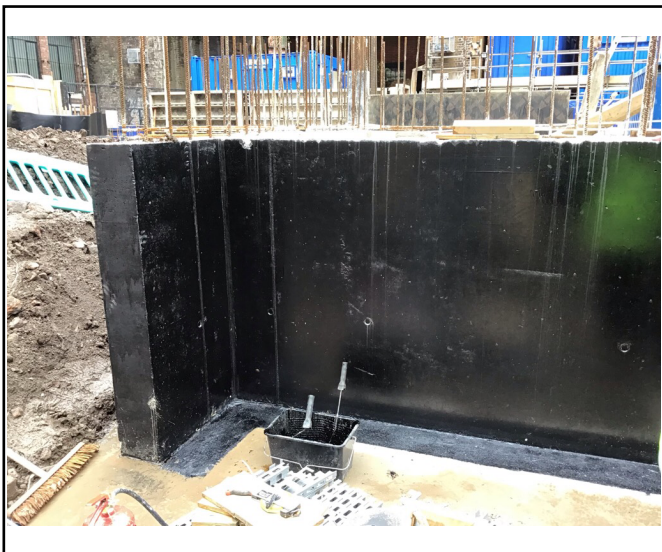
Primed wall with bucket of primer

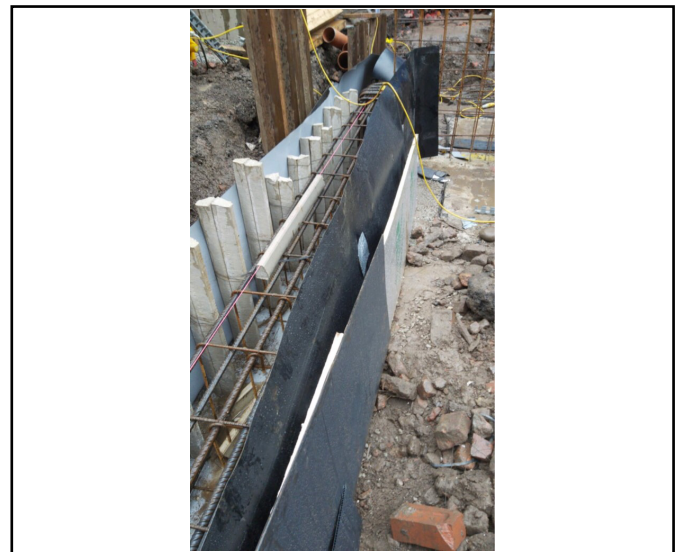
Ring beam showing wrapped membrane

And protection board on back filled side

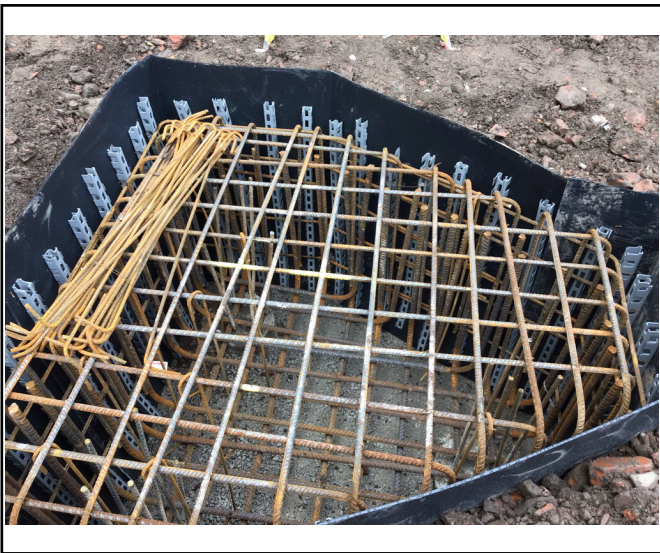
One of the pile caps did not need

Membrane as per design

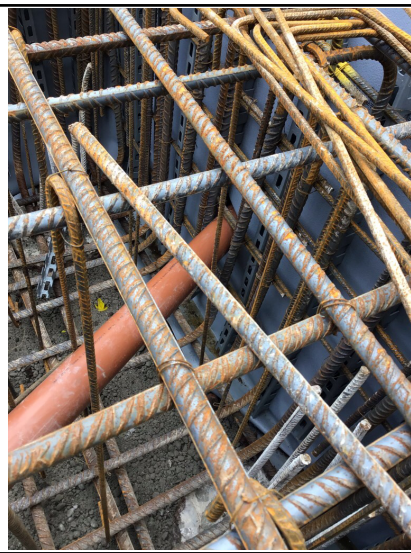
Internal section of pipe within pile cap

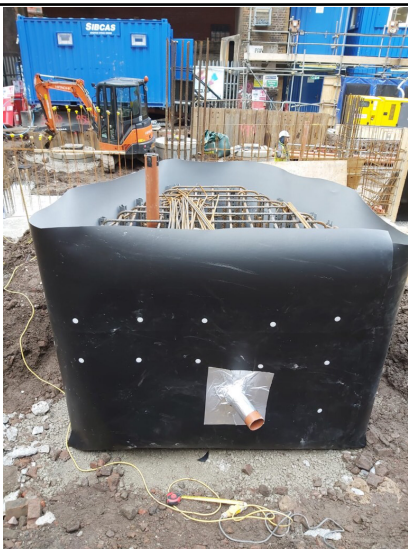
External pipe from above right photo

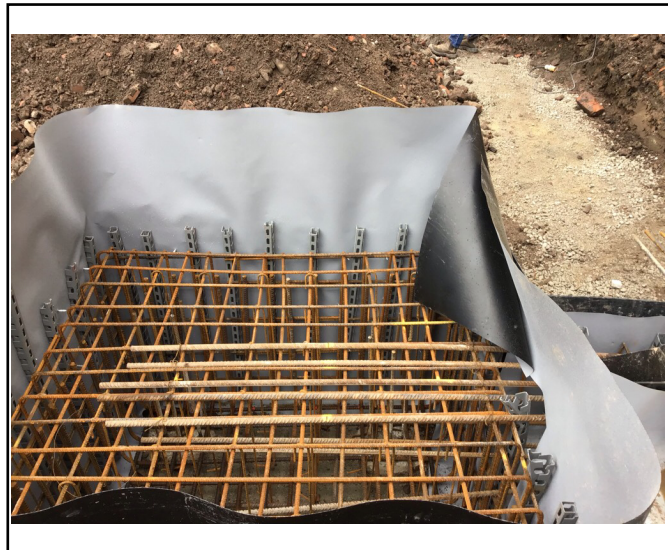
Pile cap with Visqueen Geoseal

Ultimate

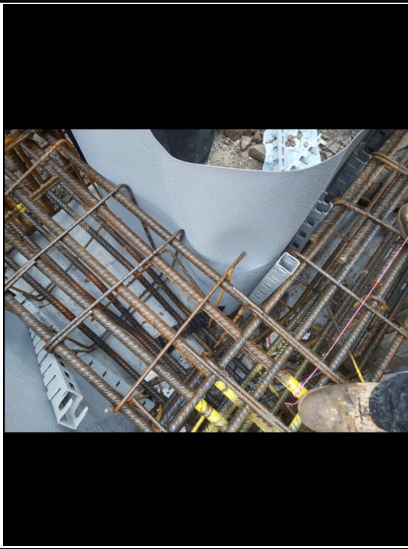
Visqueen Geoseal Ultimate wrapped

Under the ring beam, with overlap

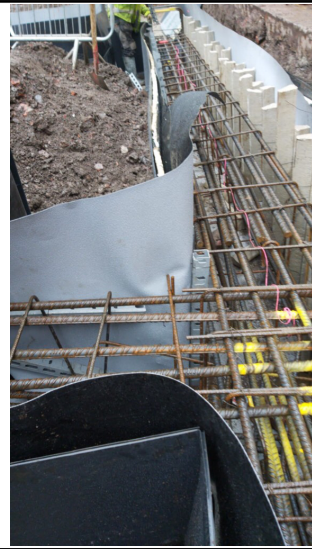
Overview of ring beam with visqueen

Overlap

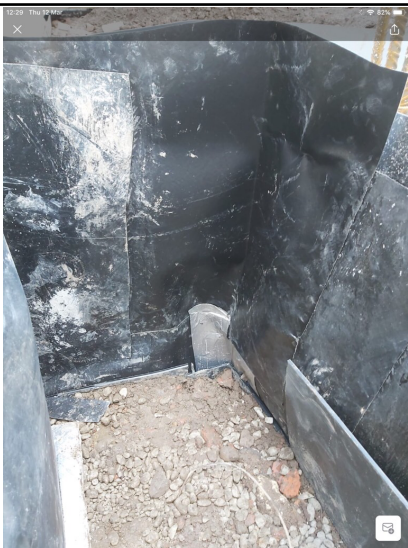
Exterior corner detail of Visqueen

Sealed at the joint with GR SAM

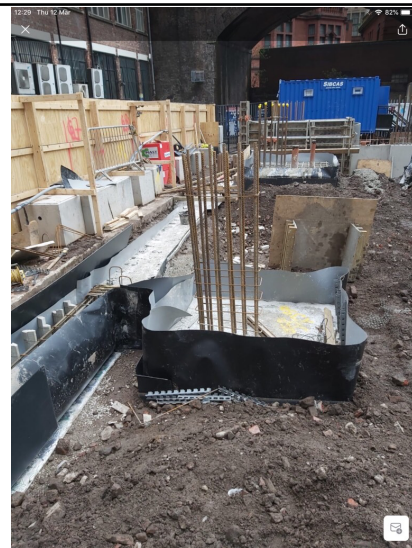
Pile cap and ring beam, both have

Been wrapped with Visqueen Geoseal
