# GEOSHIELD Verification Report

GEO101021

McAlear & Rushe

101 Charles Street

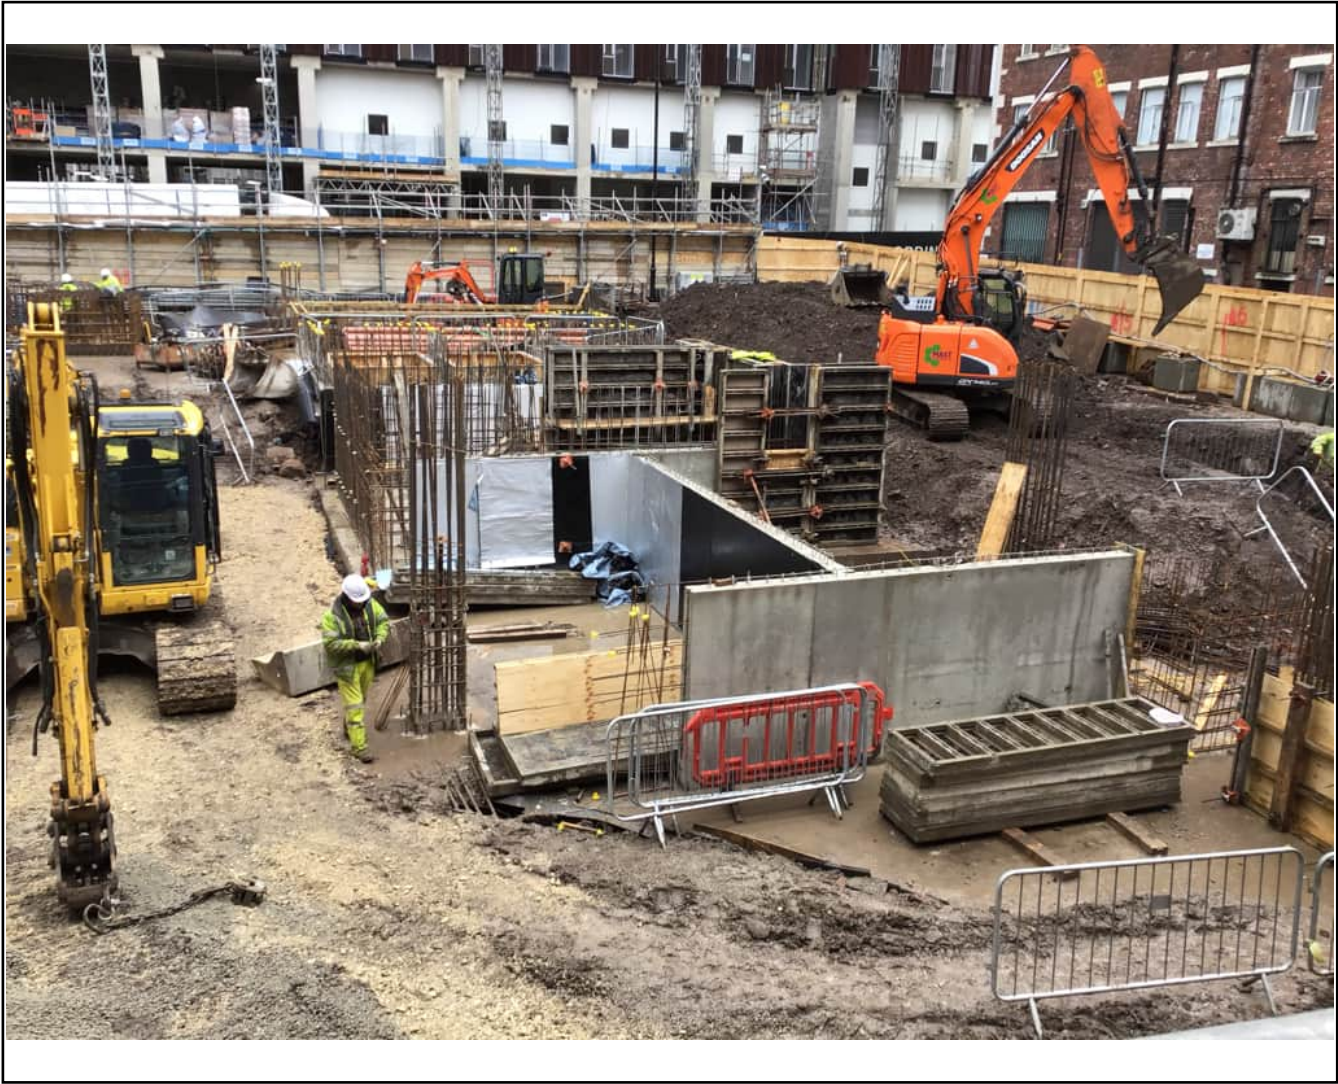
Overview of site

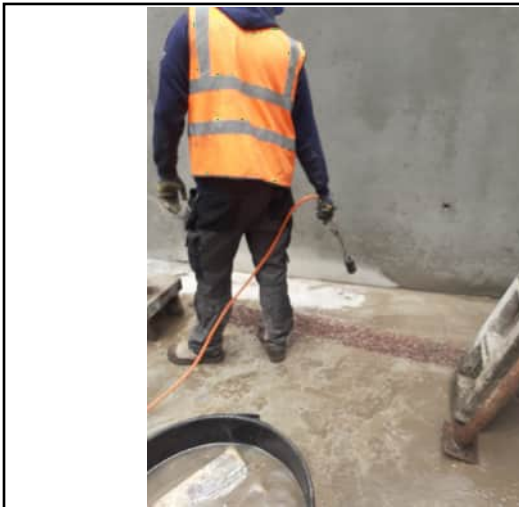
1. Base of D5 swept clear of standing water and dried with a blow torch.

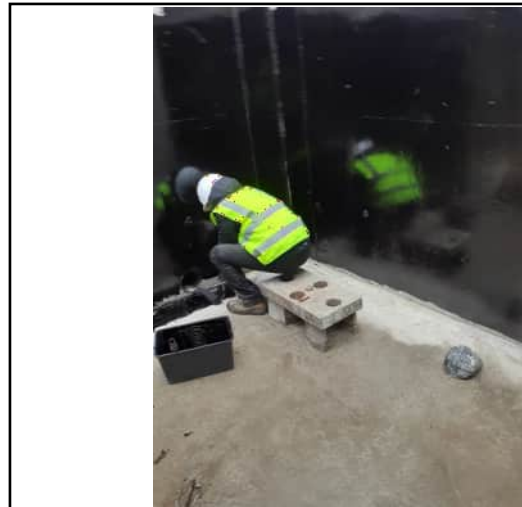
2. Base of D5 dry enough for bitumen primer before GR SAM applied.

D5 core is now complete

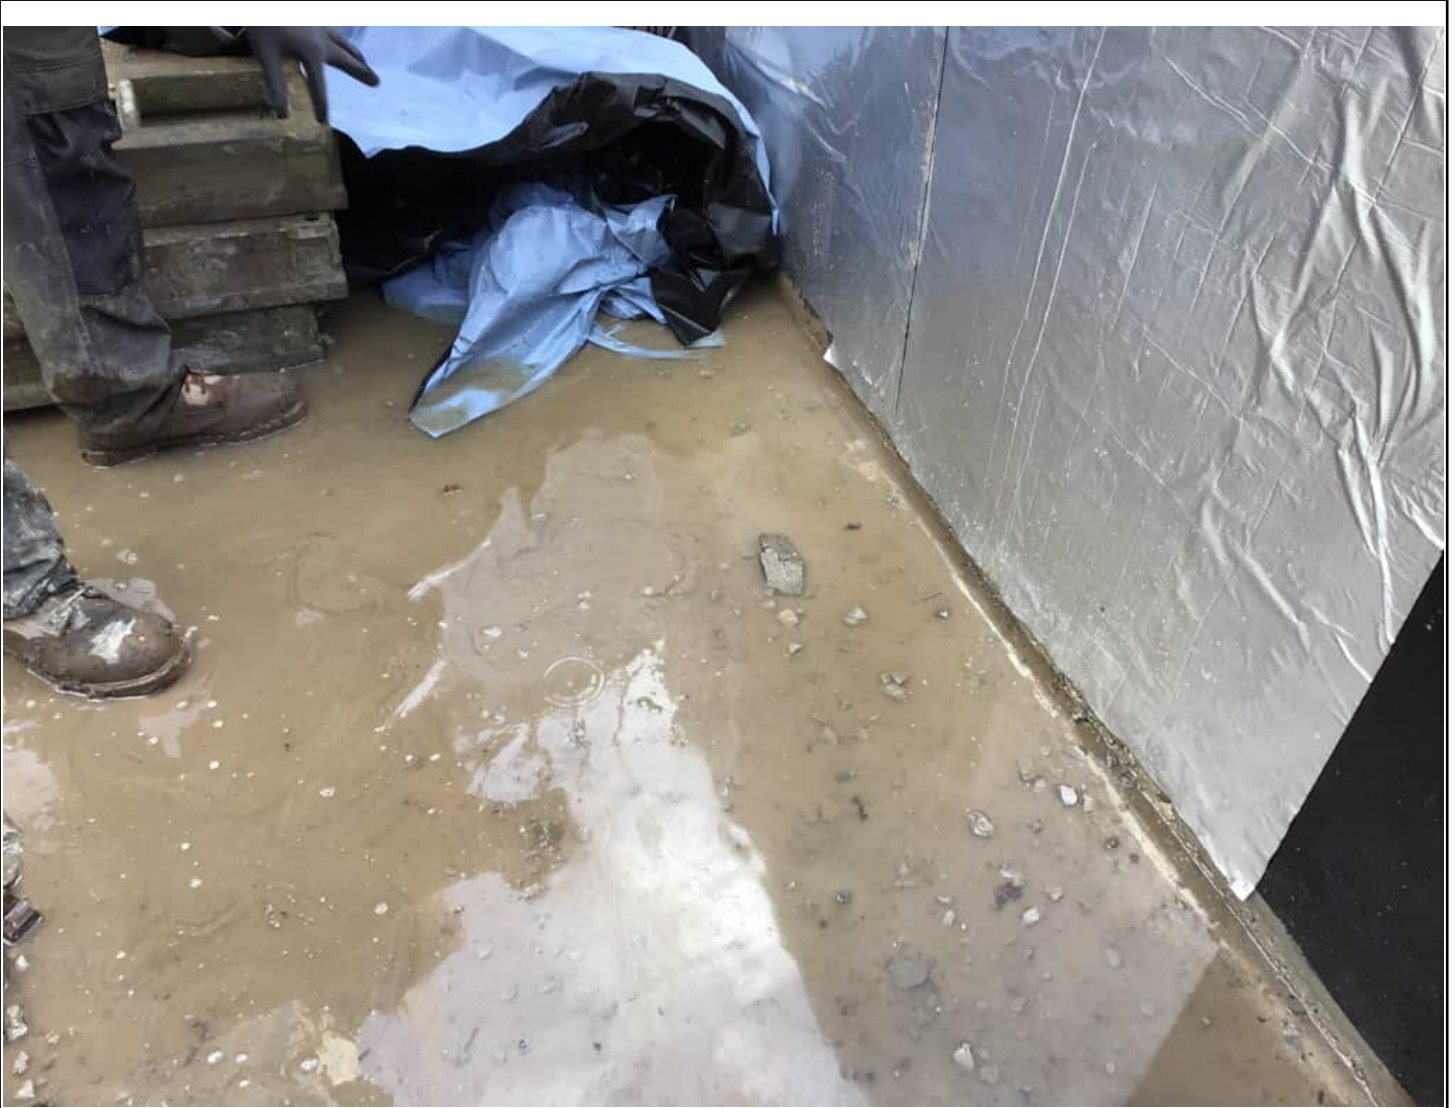
requires water removing from the base to allow a good seal with the GR SAM.

3. D7 core has standing water on the base. GR SAM applied to walls

but the base requires the same prep as carried out on D5 before being

sealed

Further prep works required on D7 as done with D5

installation of GR SAM. This is to be prepped as in Core D5. D7 core requires

further works to the walls and base.

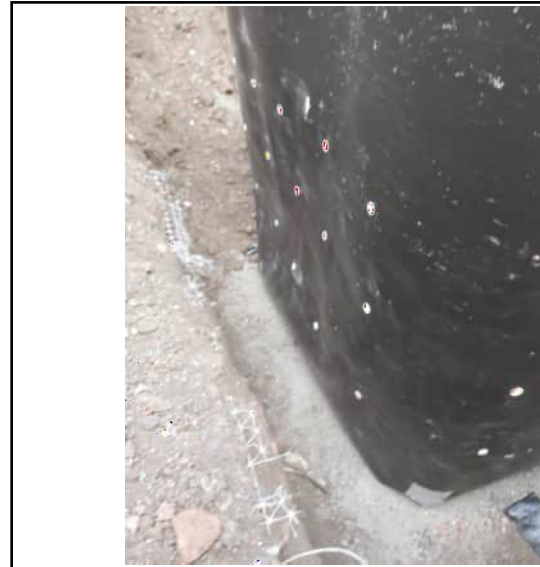
2. Pegs installed to grip concrete and ensure solid bond to pile cap

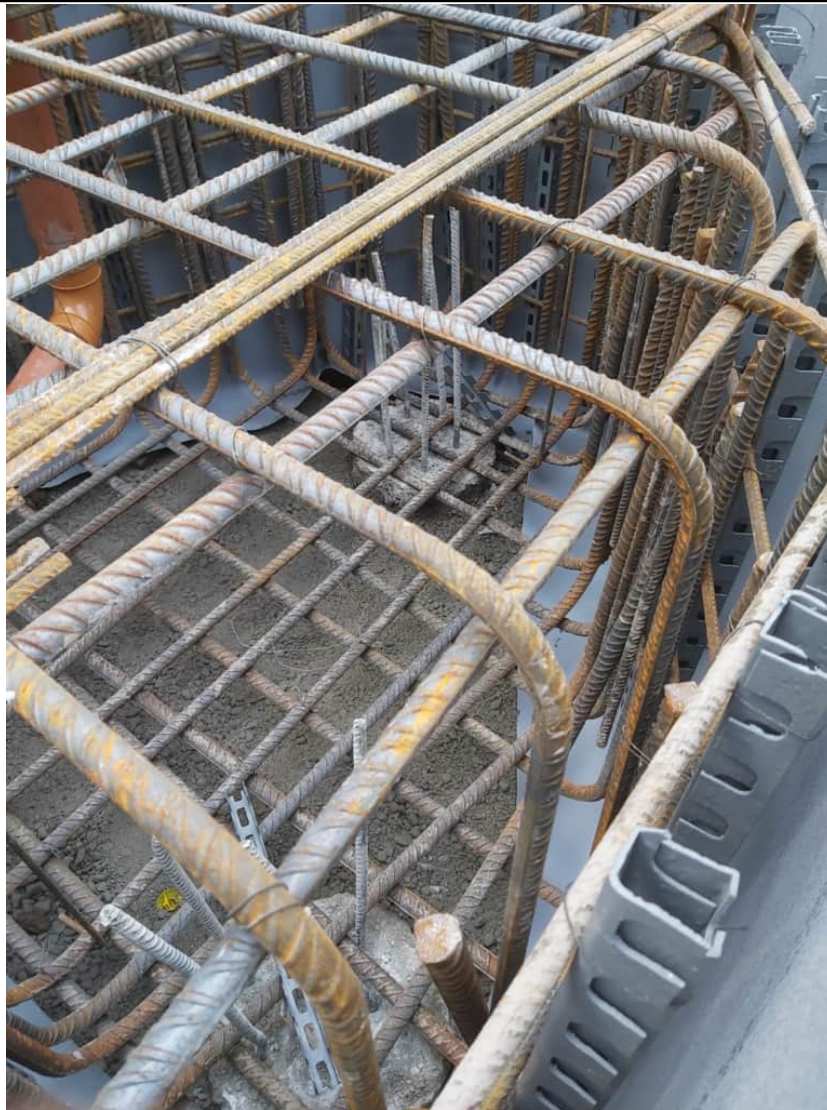
3. Minimum 200mm beneath the pile cap, as per the design detail, has  
been achieved. Passed and verified.

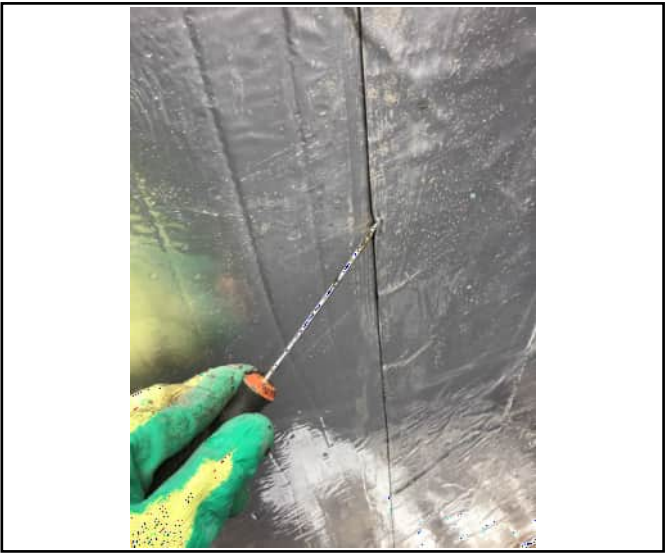
Pick and probe test carried out to D7

core

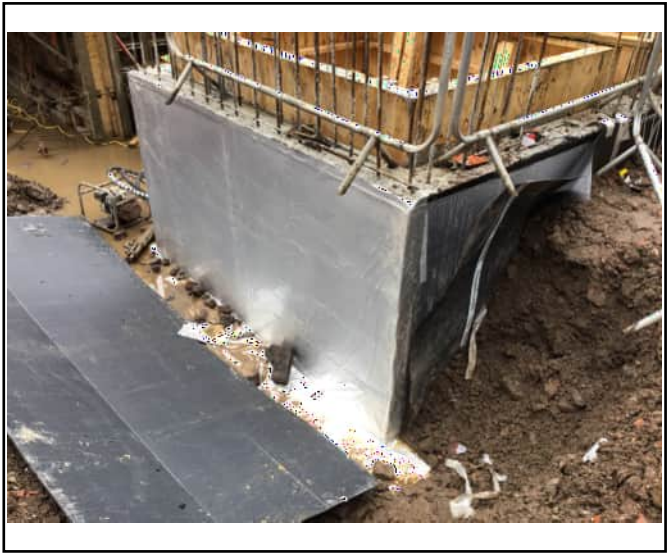
D5 core is now complete

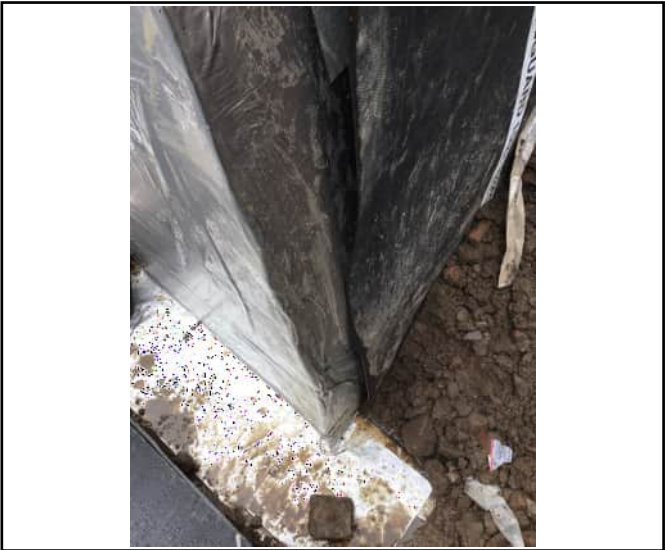
Final corner of D5 complete

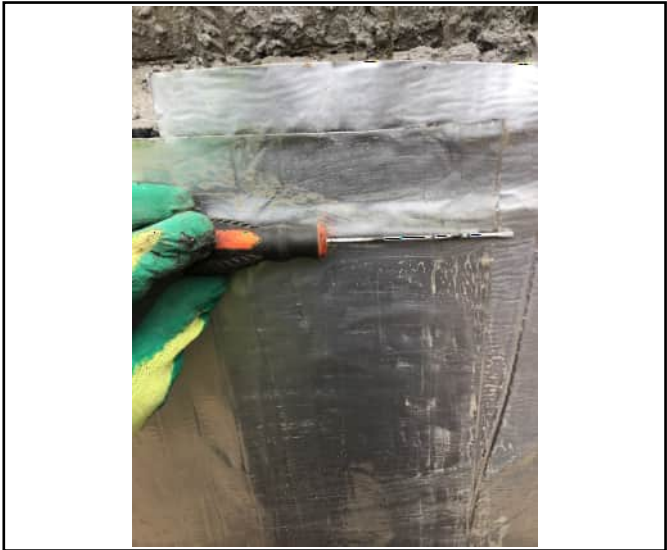
Good overlaps used in D7 core
