# Supplementary Ground Appraisal Report

Portugal Street East, Manchester

| Document No.: | 1007-GEO-GAR-001 |

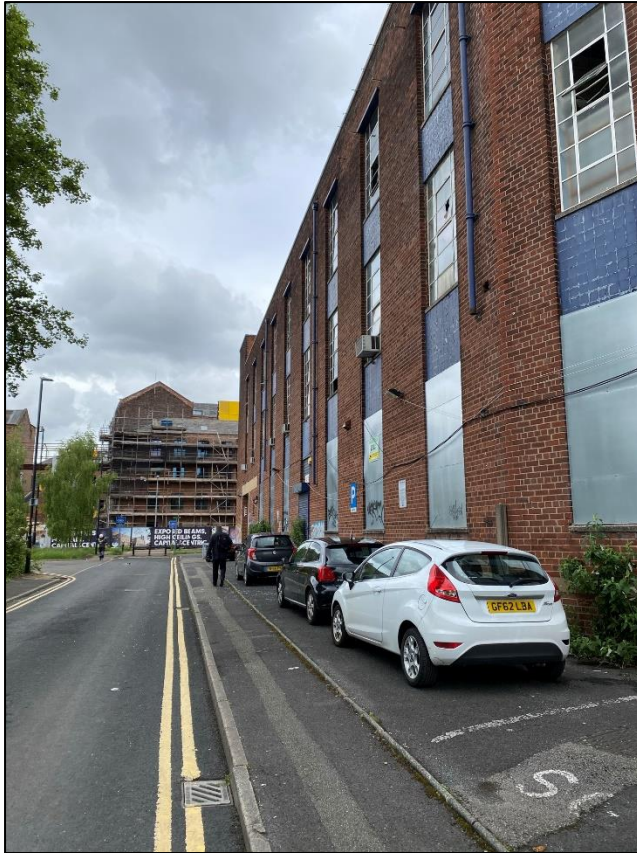
*Figure 1 -Rammon House looking north along Portugal Street East*

At the time of the walkover, the building was in a poor state of repair and only limited access to internal areas was available. On the ground floor, the building is mainly occupied by a large, open room with a concrete floor slab and intermittent supporting concrete columns. Rainwater was dripping through onto the ground floor from above and forming large areas of standing water.

Evidence of vandalism was noted throughout and there was a large amount of debris on the floor

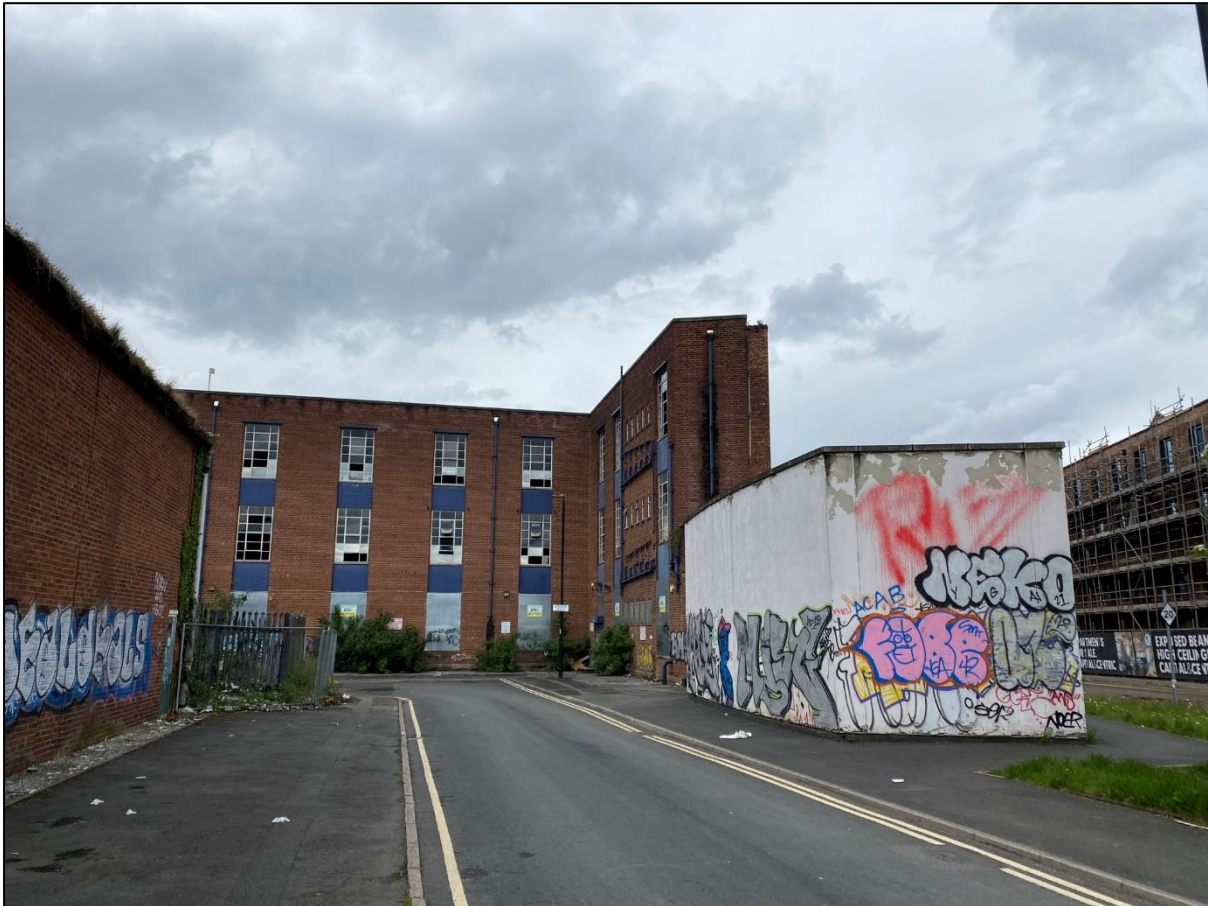
*Figure 2 - Rammon House looking south-west along Longacre Street*

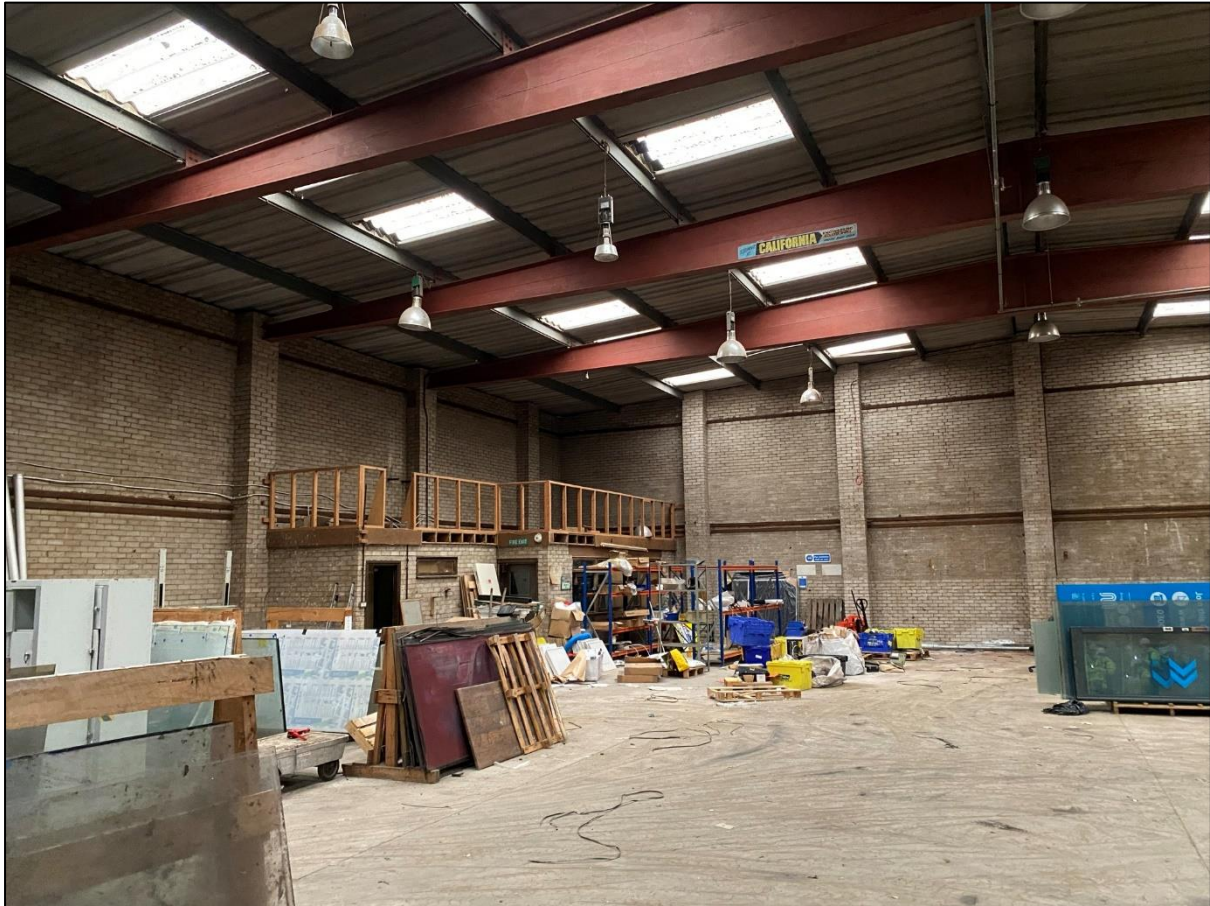
primarily used as a storage unit for various equipment, furniture, bus shelter components (metal seating, glass panels etc), grit boxes and wooden pallets.

*Figure 3 - Internal of TfGM building looking at south corner*

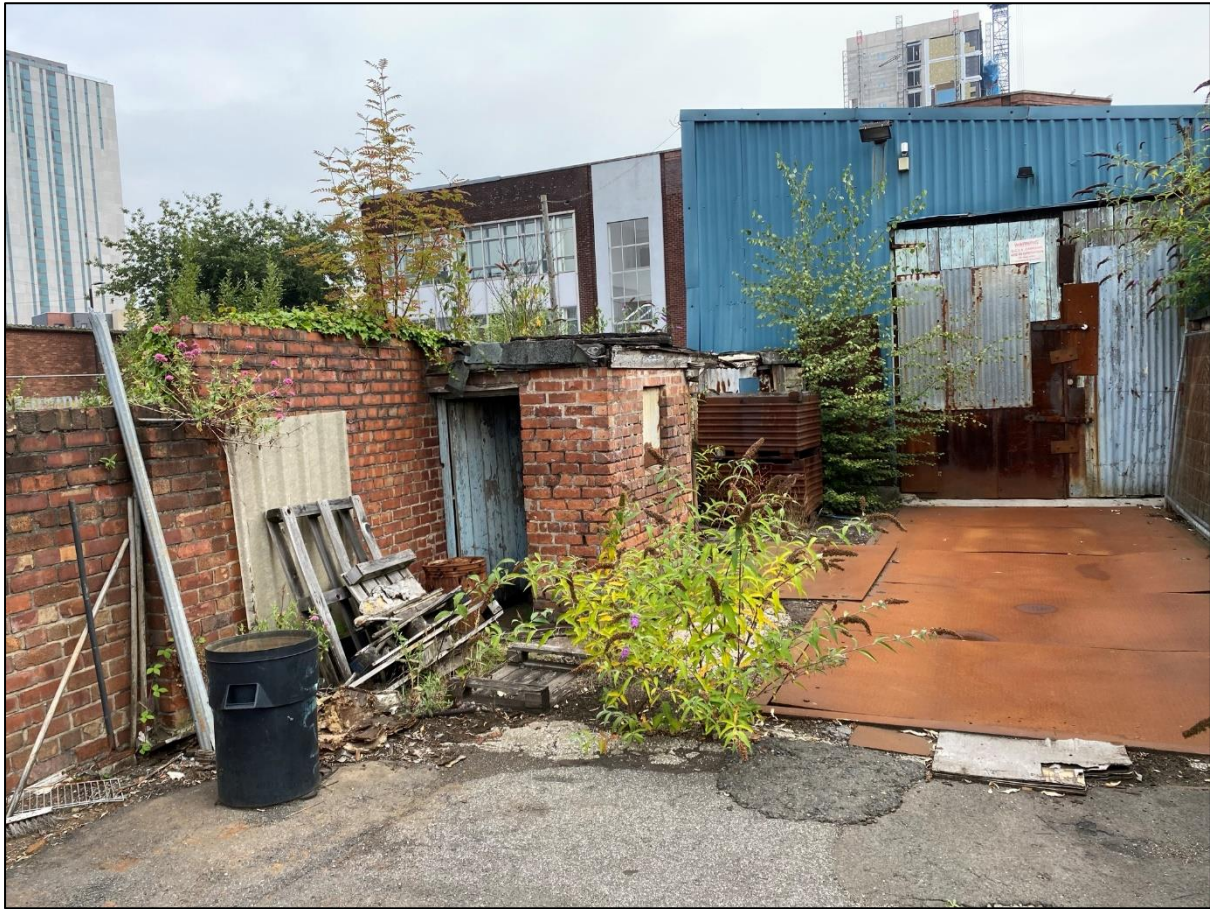
*Figure 4 - Main Scrap Yard looking north-east*

Beyond the weighbridge, the yard is surfaced in rough broken concrete and macadam hardstand. In some areas where the hardstand was absent/had been broken away, scrap metal deposits could be seen at surface having formed a layer of orange (rust-stained) gravel-sized fragments of metal, mixed with hardcore, fragments of glass and other gravel.

Given the above, the Scrap Metal Deposits should be stripped and carefully segregated from other made ground types and placed in a designated stockpile during earthworks. It is recommended that these deposits be removed from site.

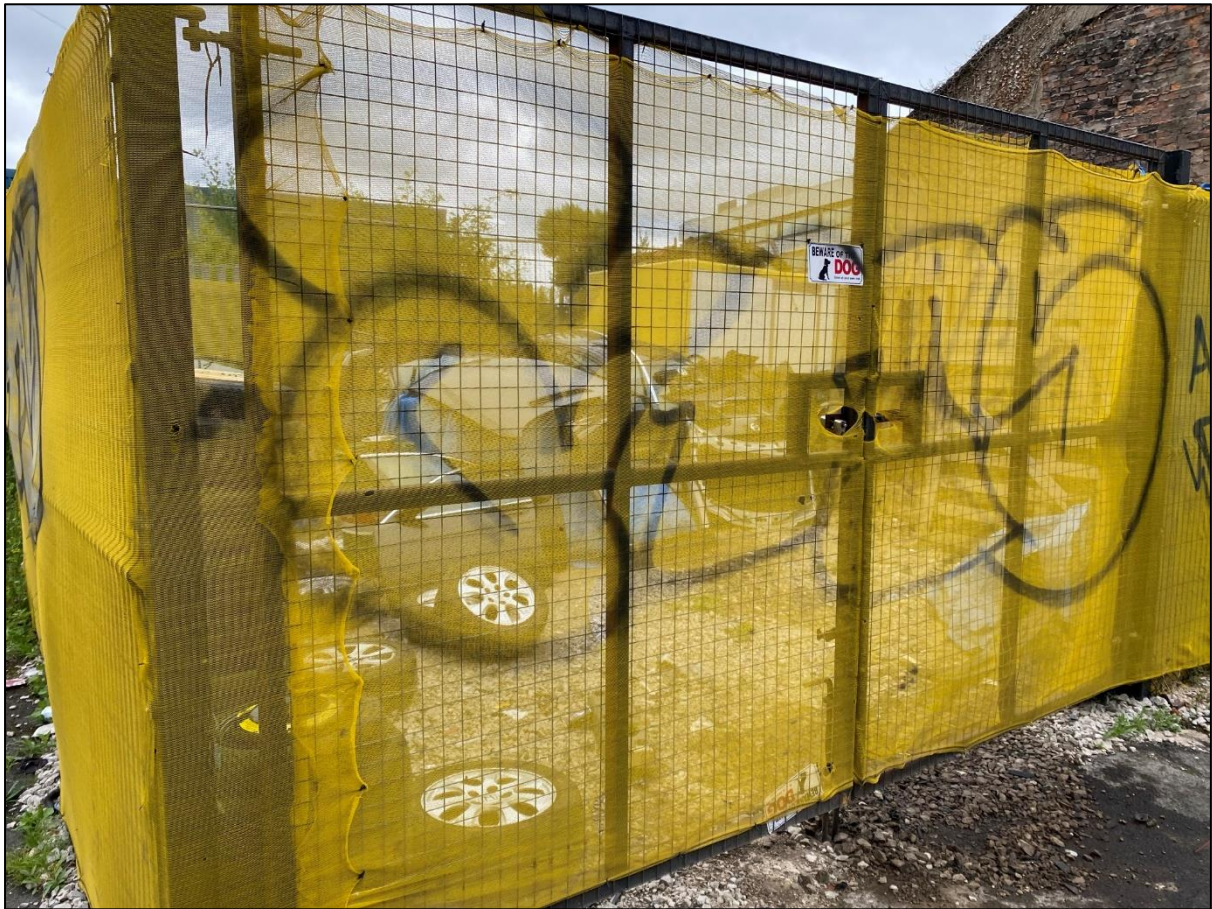
A smaller scrapyard is present on the corner of Betley Street and Heyrod Street, adjoining both the printer's premises and the main scrapyard area, occupying c. 100m<sup>2</sup>. This area is enclosed by Heras fencing with yellow netting around, and no access was available inside. Looking from outside, this area appeared to be surfaced with hardcore gravel. Numerous broken car parts could be seen including chassis, wheels and tyres.

*Figure 5 - Small Scrap Yard looking south from Heyrod Street*

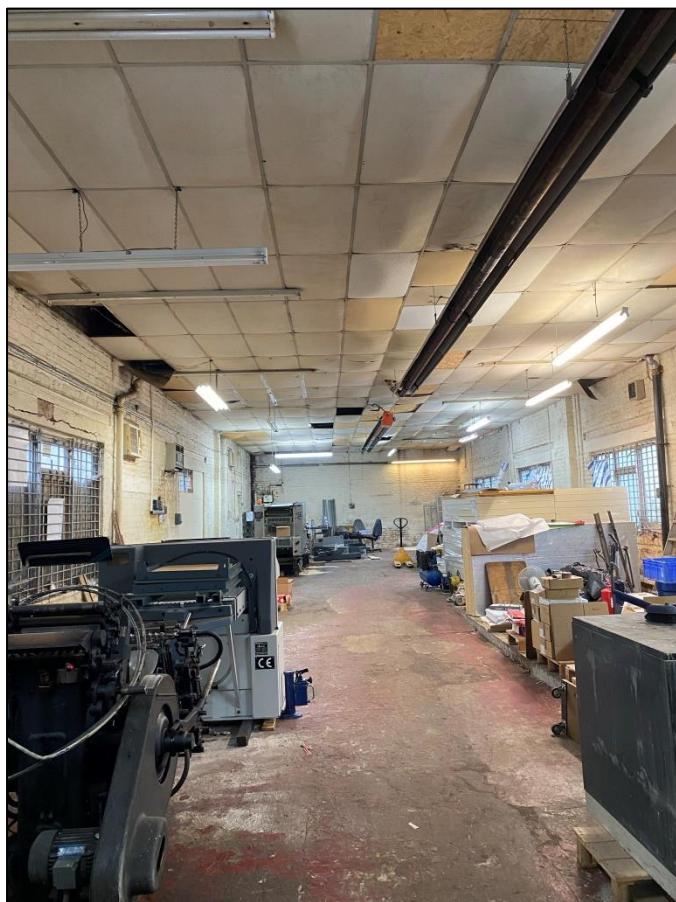
Figure 6 - internal of printer's premises looking north-east

The rectangular building in the south-east, off Heyrod Street was in use as a printers at the time of the walkover.
