REPORT OF VICTORIA MILL

LOWER VICKERS ST, MANCHESTER M40 7LH

Date of project: 02/08/2021—Ongoing

| <p><b>F.A.O:</b> Medlock</p> <p><b>Author:</b> Lee Armstrong</p> <p><b>Project Description:</b><br/>Rope Access Remedial Works Various</p> <p><b>Technicians who carried out works/inspection:</b><br/>Marc Stirrup Lv 3<br/>Anthony Smith Lv 2<br/>Simon Powers Lv 1<br/>Chris Odonnell Lv 3<br/>Craig Samson Lv 2</p> <p><b>Contents:</b></p> <ul style="list-style-type: none"><li>Introduction</li><li>List of defects provided by Medlock, descriptions of works and links to evidence of works</li></ul> | <p><b>Introduction</b></p> <p>This report shows the evidence of works for all the remedial carried out at Victoria Mill</p> <p><b>NOTE</b></p> <p>Site meeting carried out. Paul Mason the Conservation Officer in attendance to agree scope of works.</p> <p>If you have any questions regarding the project please contact us on 0141 433 8040 or email lee.armstrong@opalaccess.co.uk</p> <p><b>Materials Used On Site</b></p> <p>Hammerite Ultima Matt Black <a href="#">Hammerite Ultima Matt - Hammerite UK</a></p> <p>Blue Cicle Lime <a href="#">Blue Circle Natural Hydraulic Lime 3.5 25kg Travis Perkins</a></

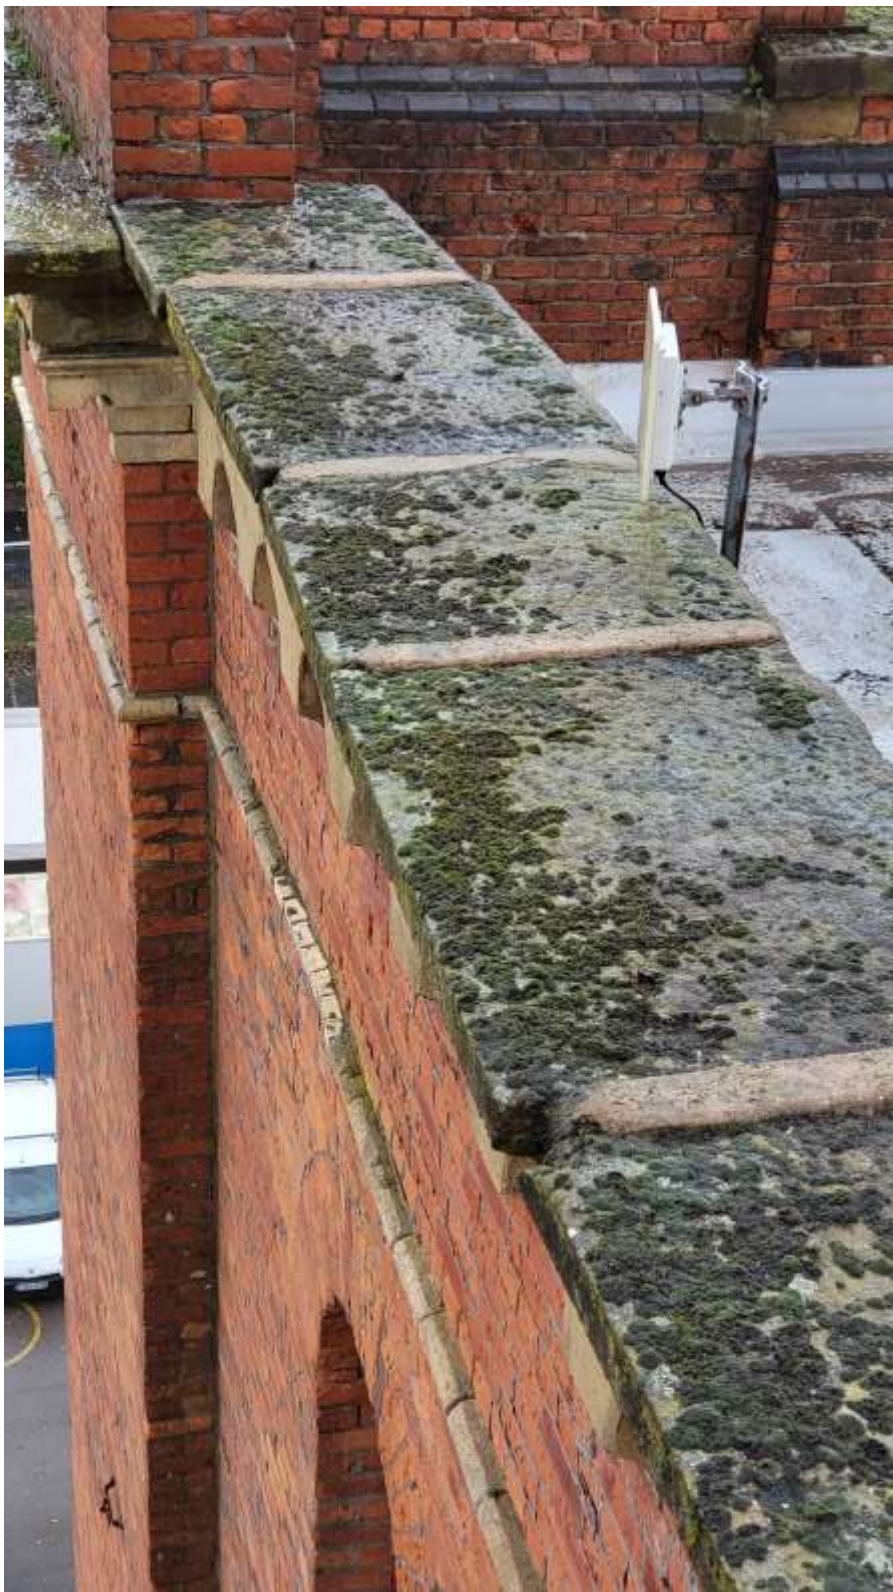
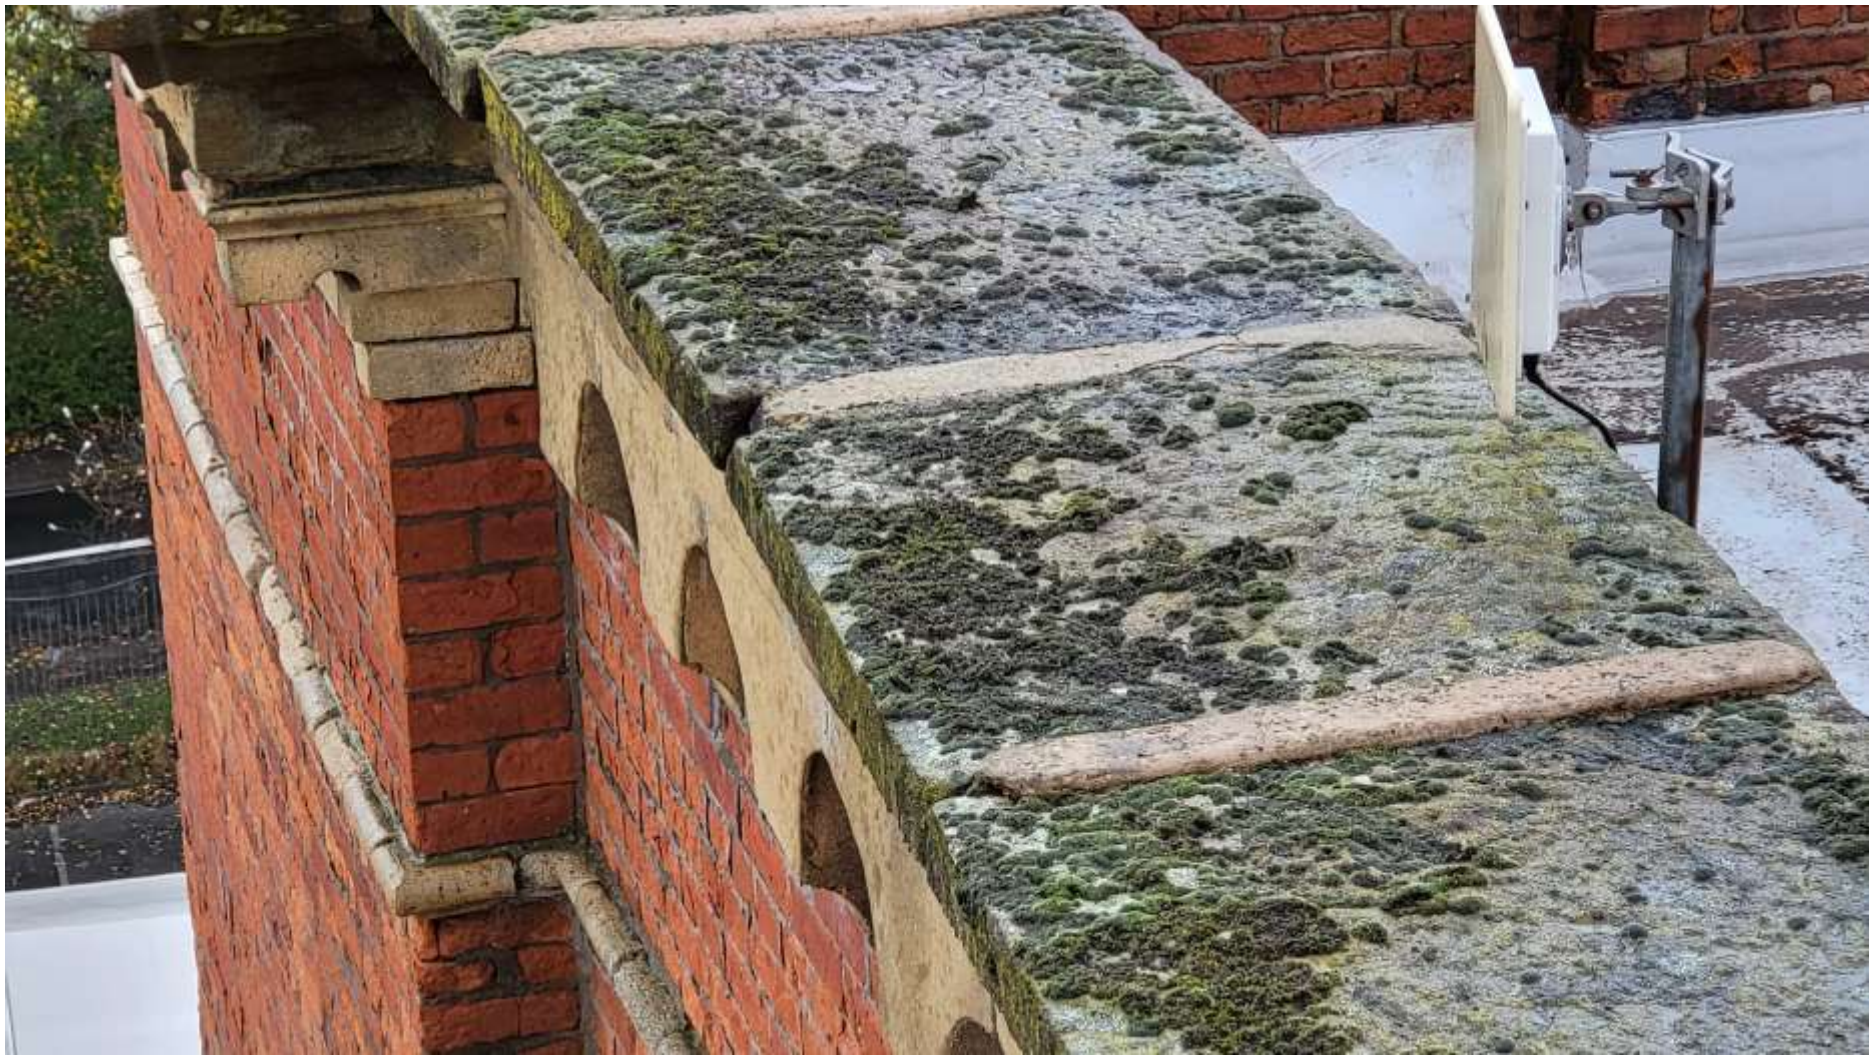
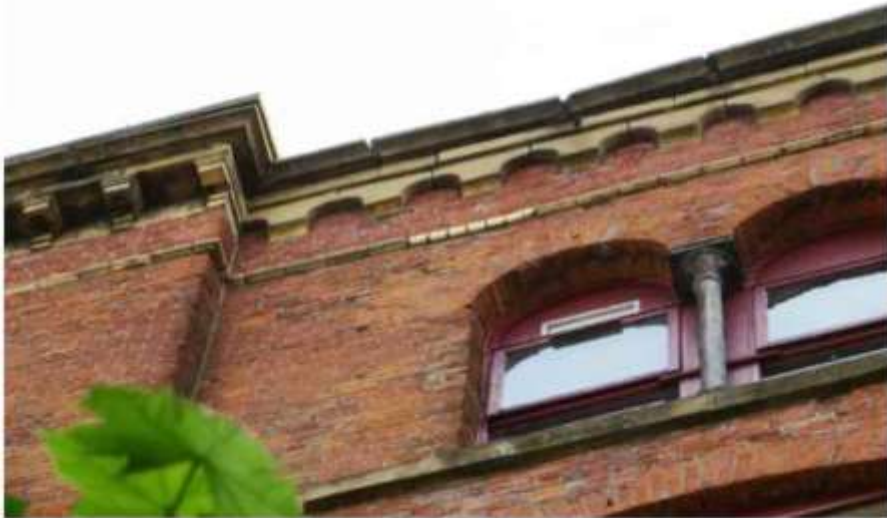
1: North West Elevation: Damage to edge of coping stone

Inspection carried out, coping structurally sound.

Work to carry out agreed by Paul Mason. Fill gap to the end. Make flush so from the ground it is aesthetically appealing

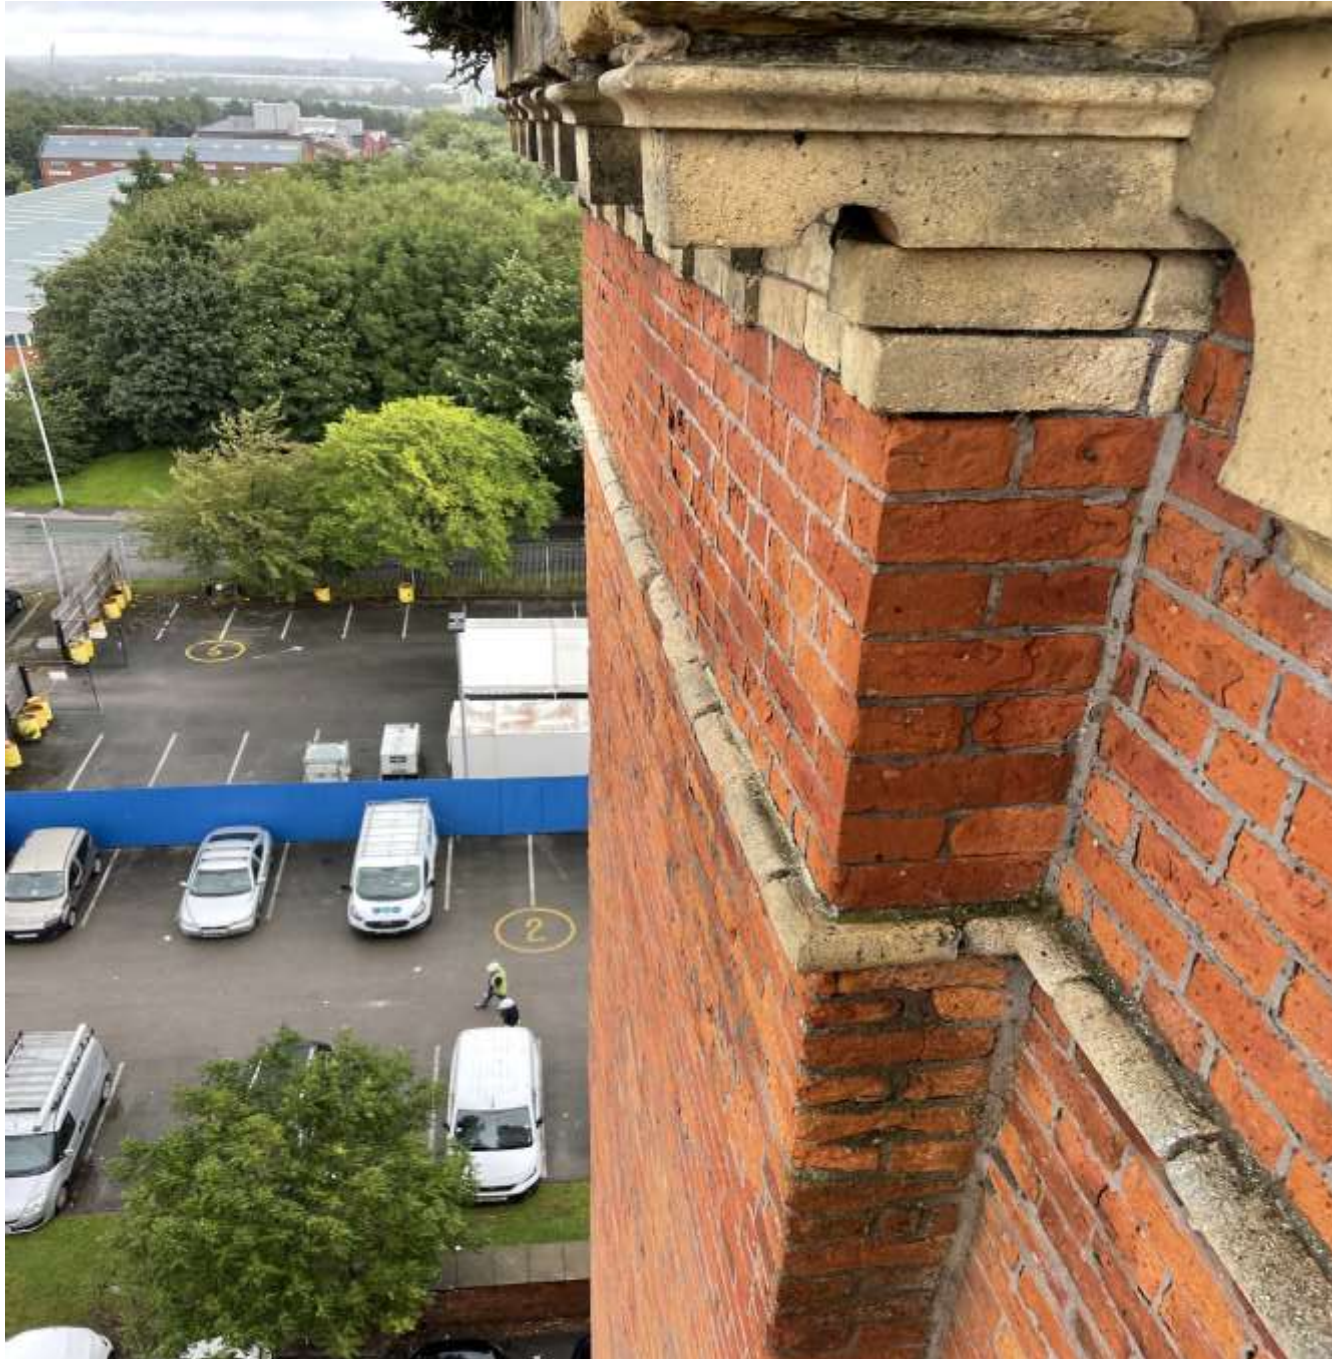
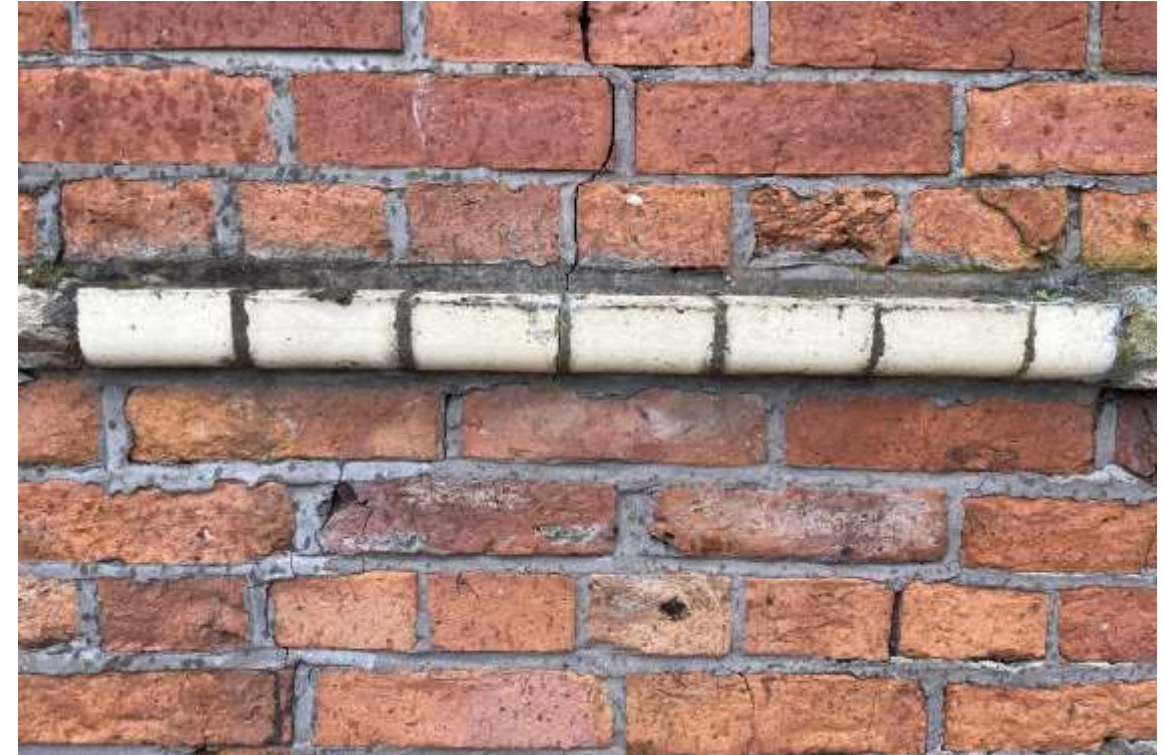
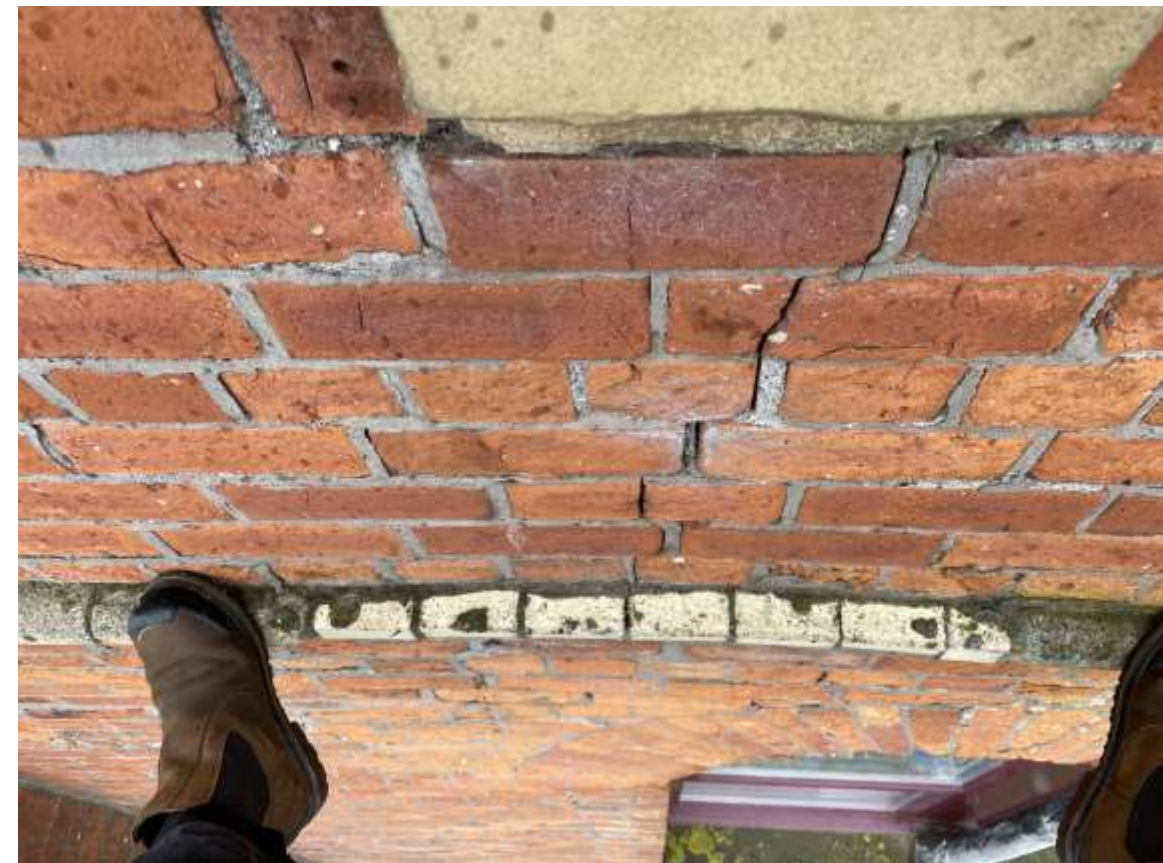
### 2: North West Elevation: Repair to Strong Course

String course x2 inspected and repointed. Closest profile match, will darken over time. Additional work added by Paul Mason. Pointing to be carried out including the brickwork and detail on top coping. 2 days

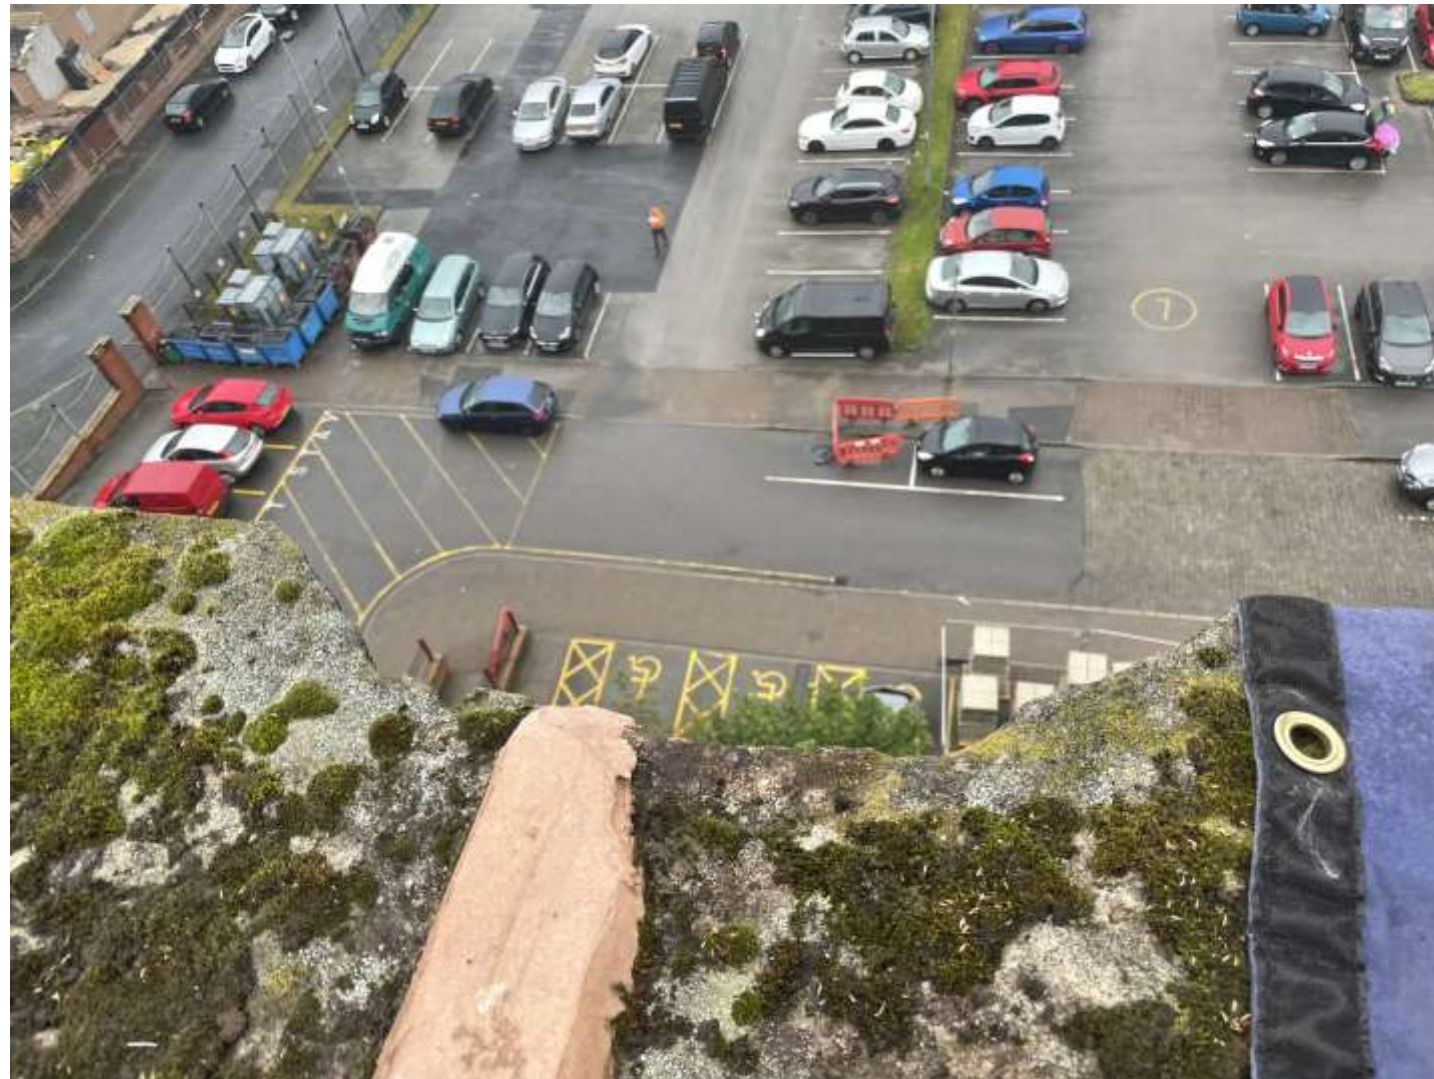
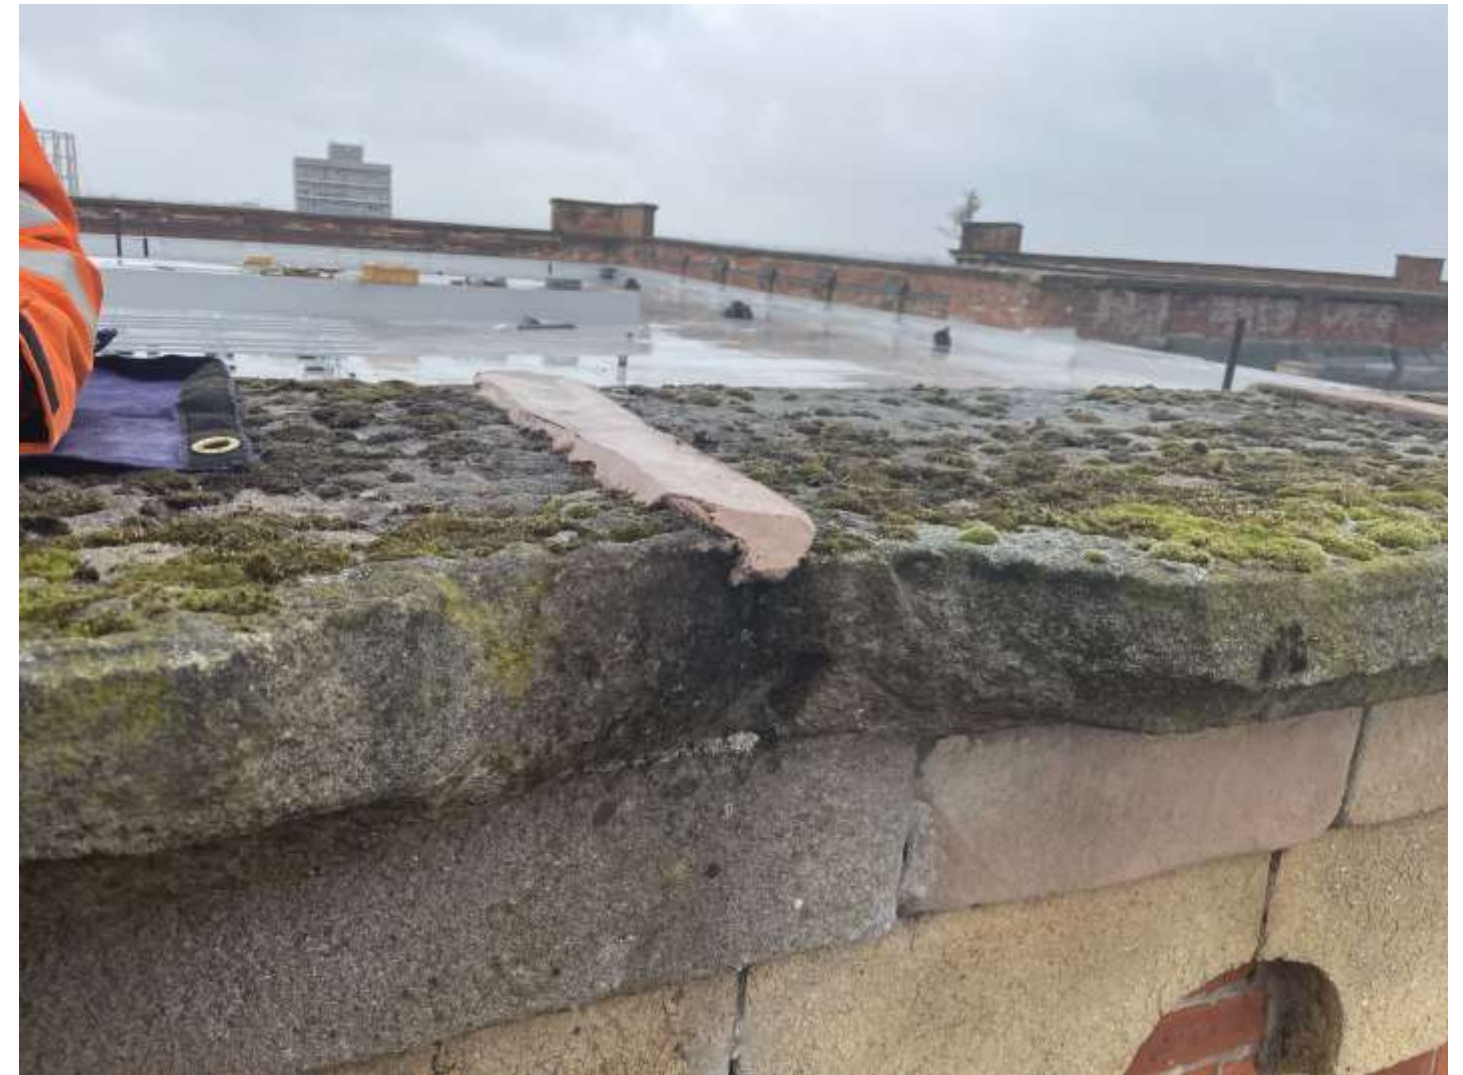
### 3/4: North West Elevation: Cornice Repair

Inspection carried out, coping structurally sound, pointing carried out to aesthetically match. Conservation happy block is solid. No further works required.

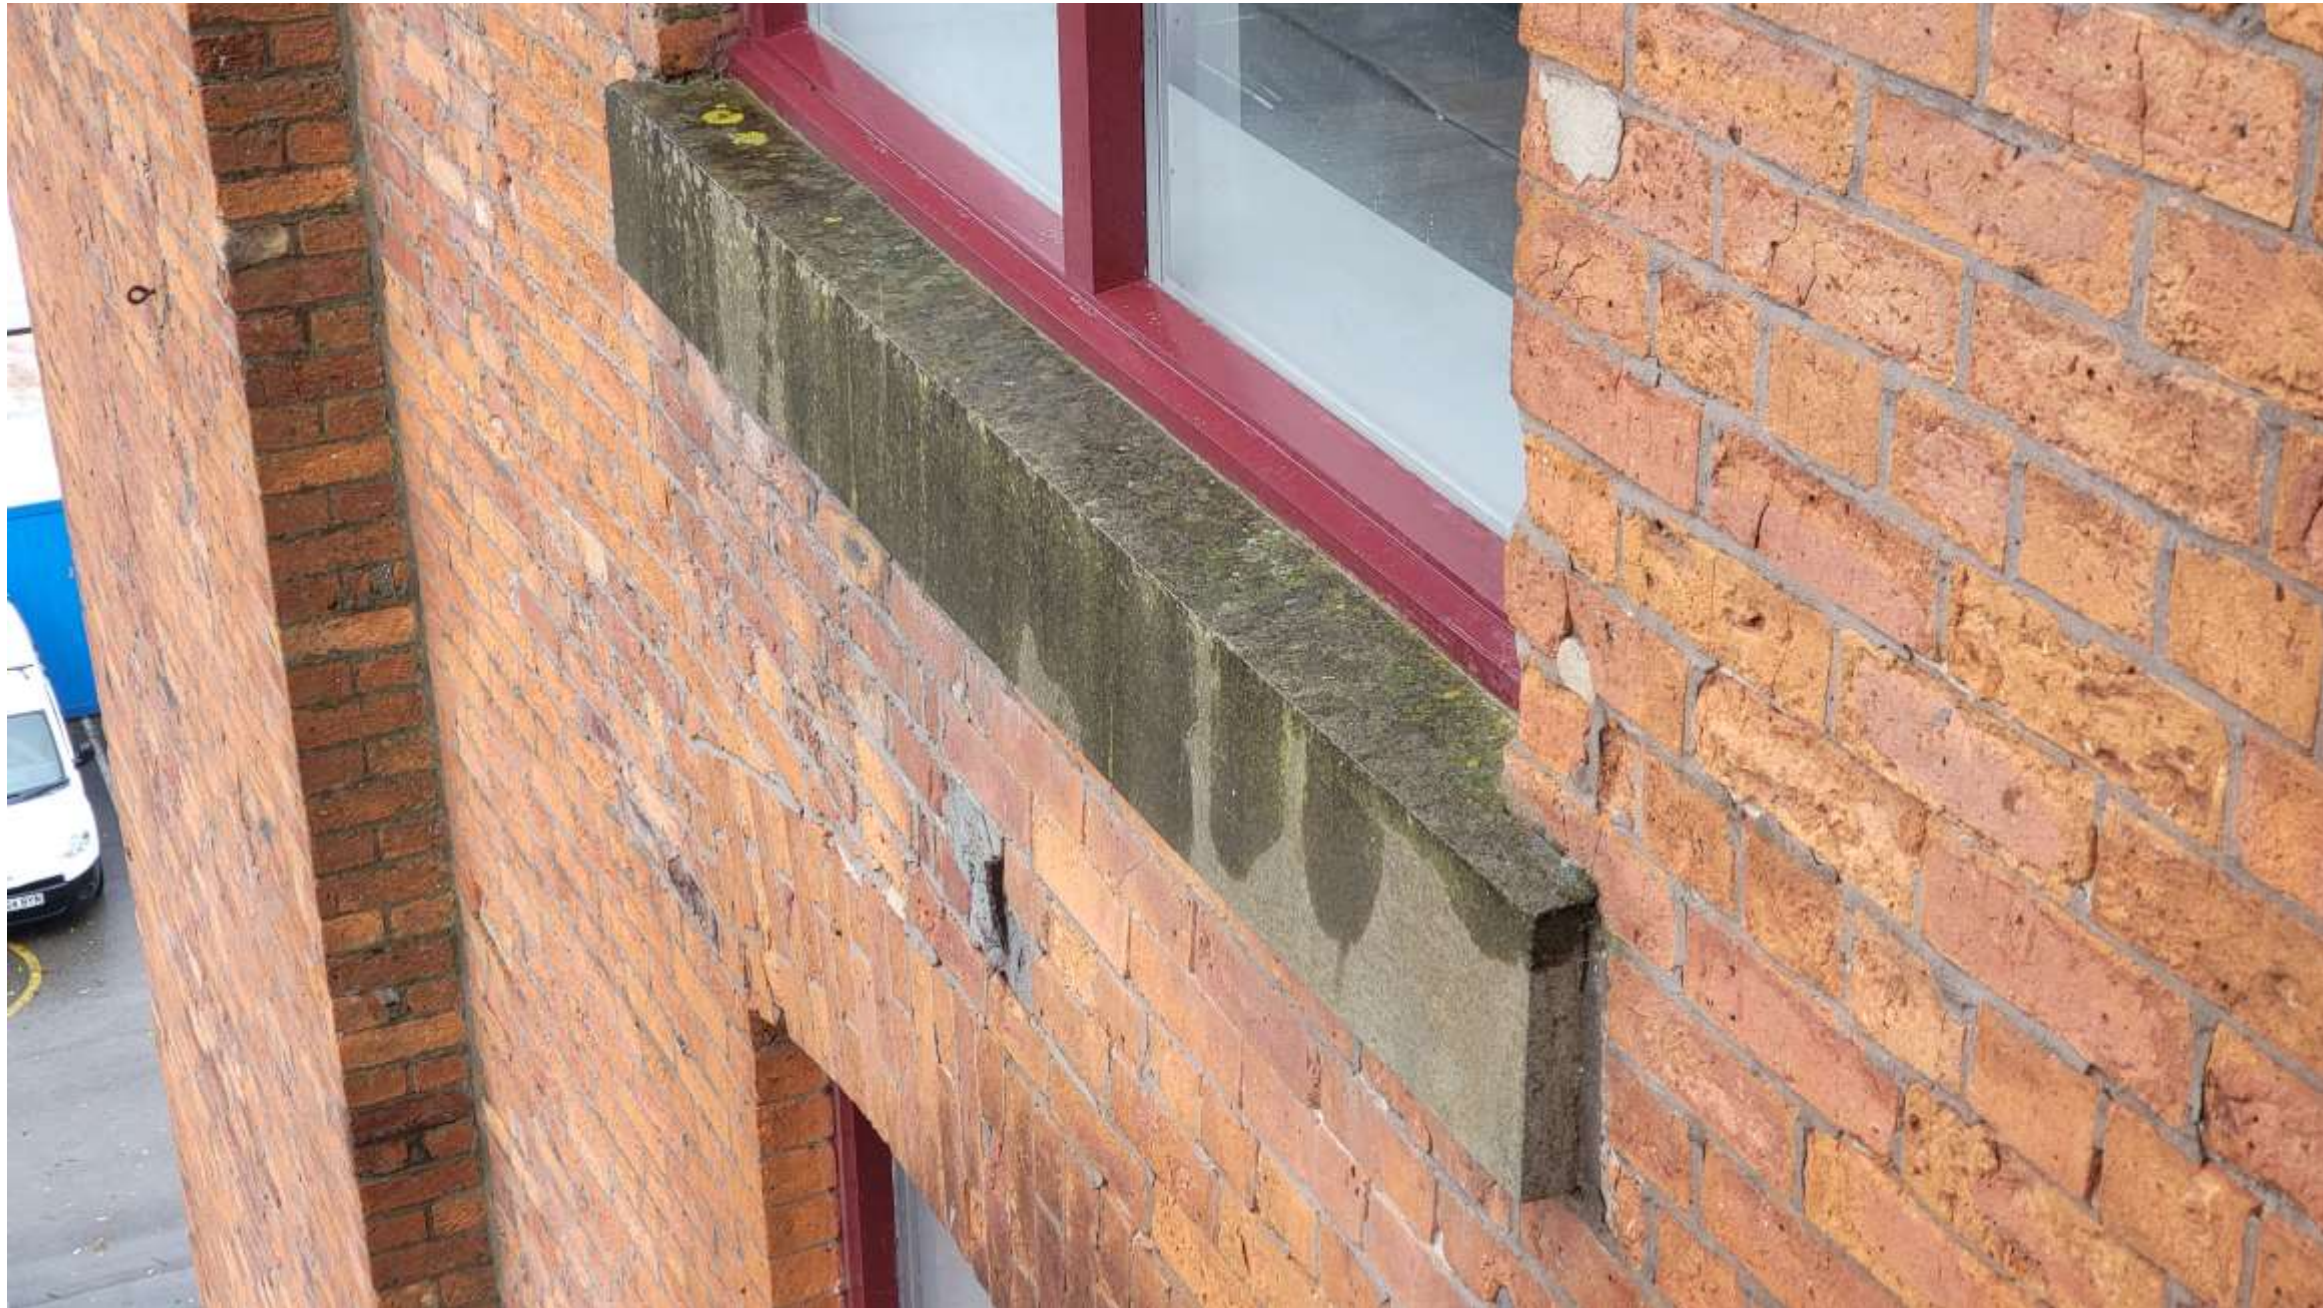
### 5: North West Elevation: Sill Cleaned and Pointing Carried Out

Inspection carried out, pointing carried out to aesthetically match and sill cleaned. No ref picture provided. Noted moss growth has returned. Solution is application of a Benzalkonium Chloride product.

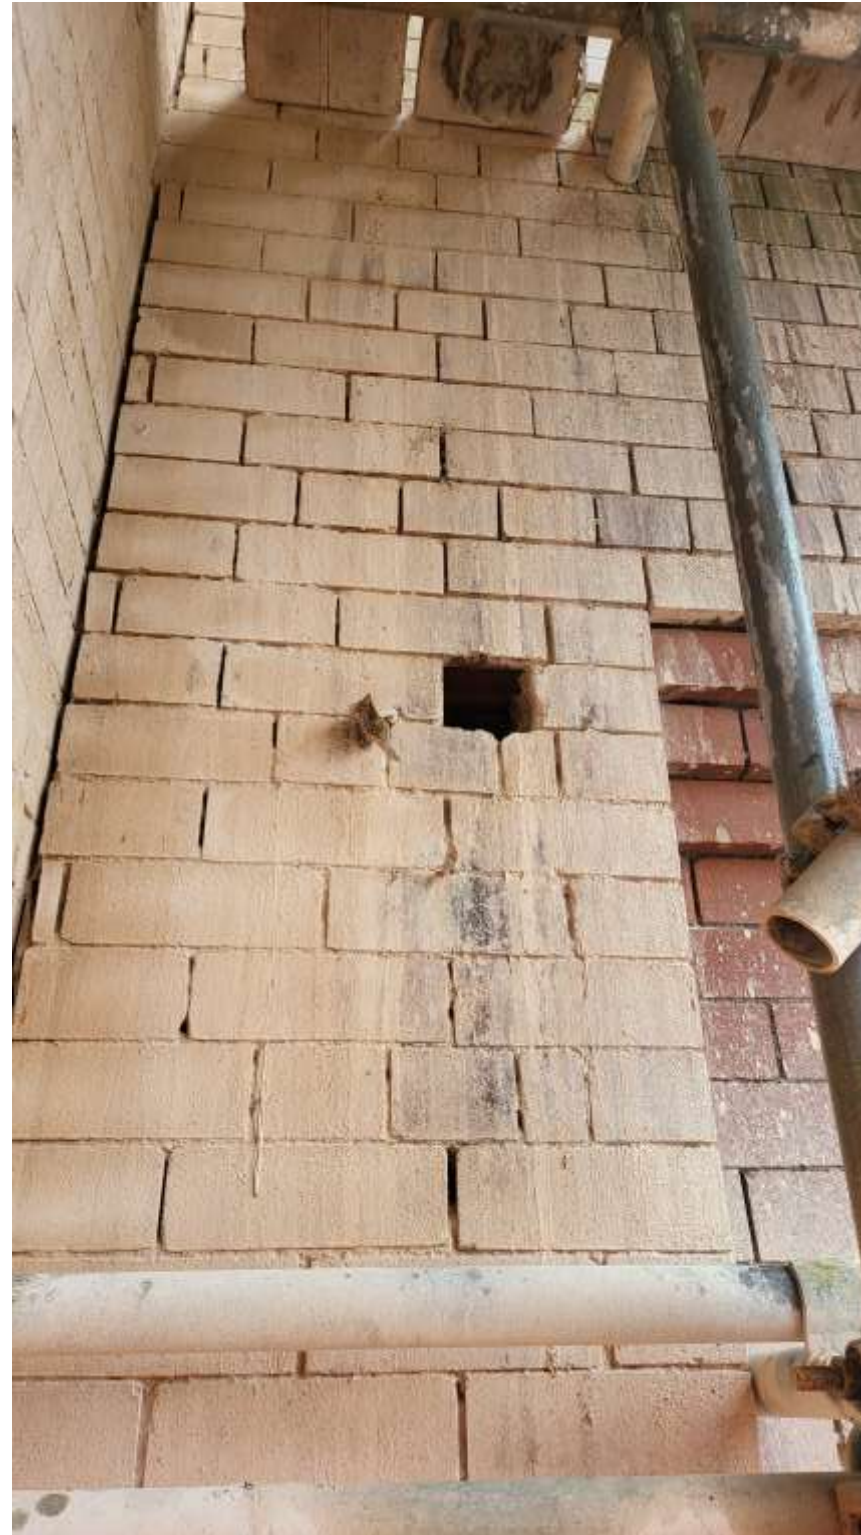
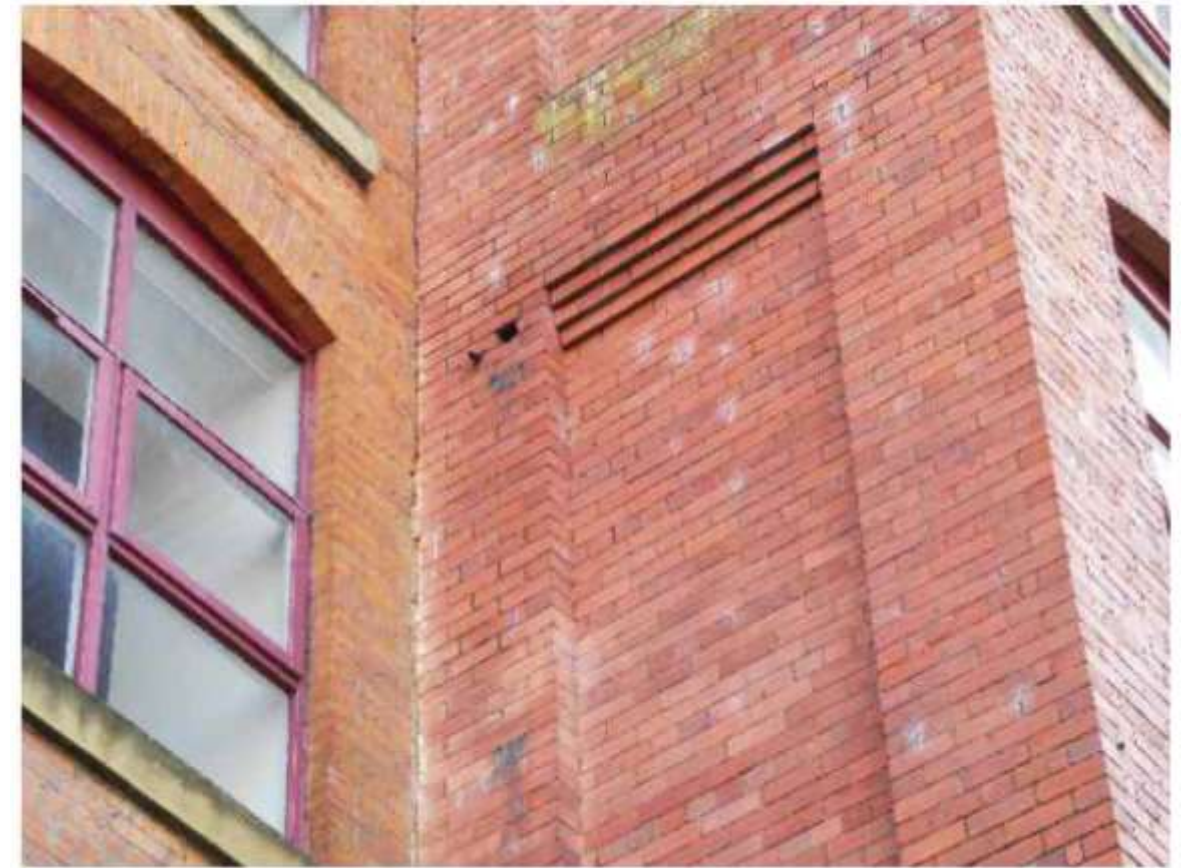
### 6: North West Elevation: Damaged Brick Work

To be repaired. Replace brick, point with similar colour match. Ref picture far right. Require brick from Medlock

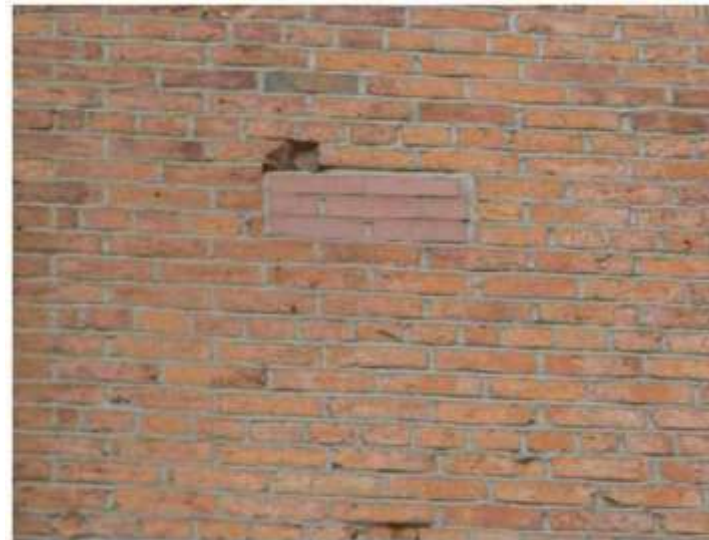
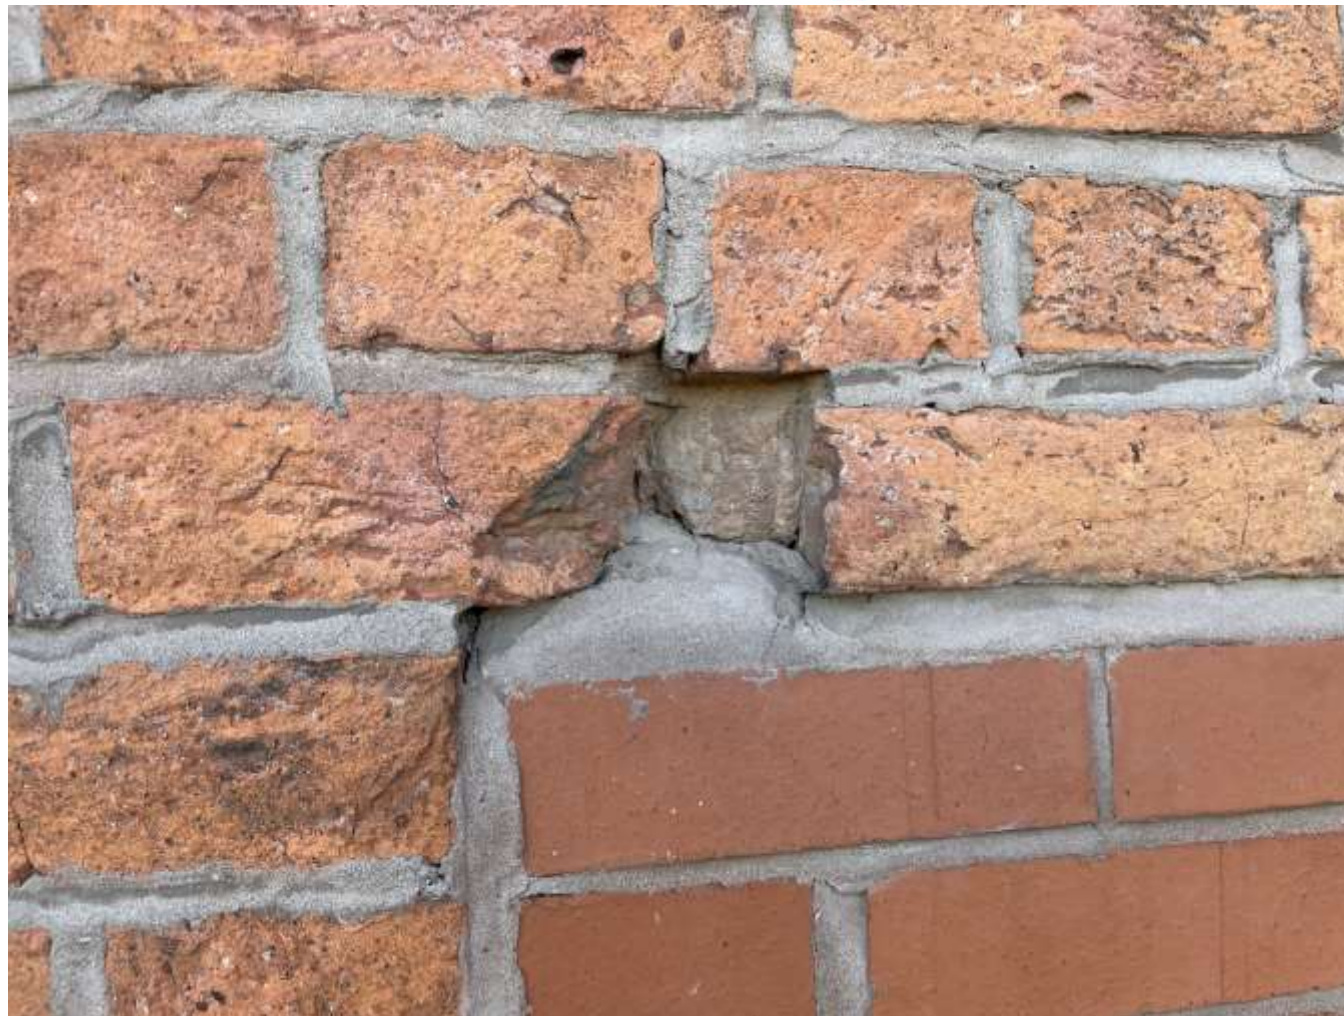
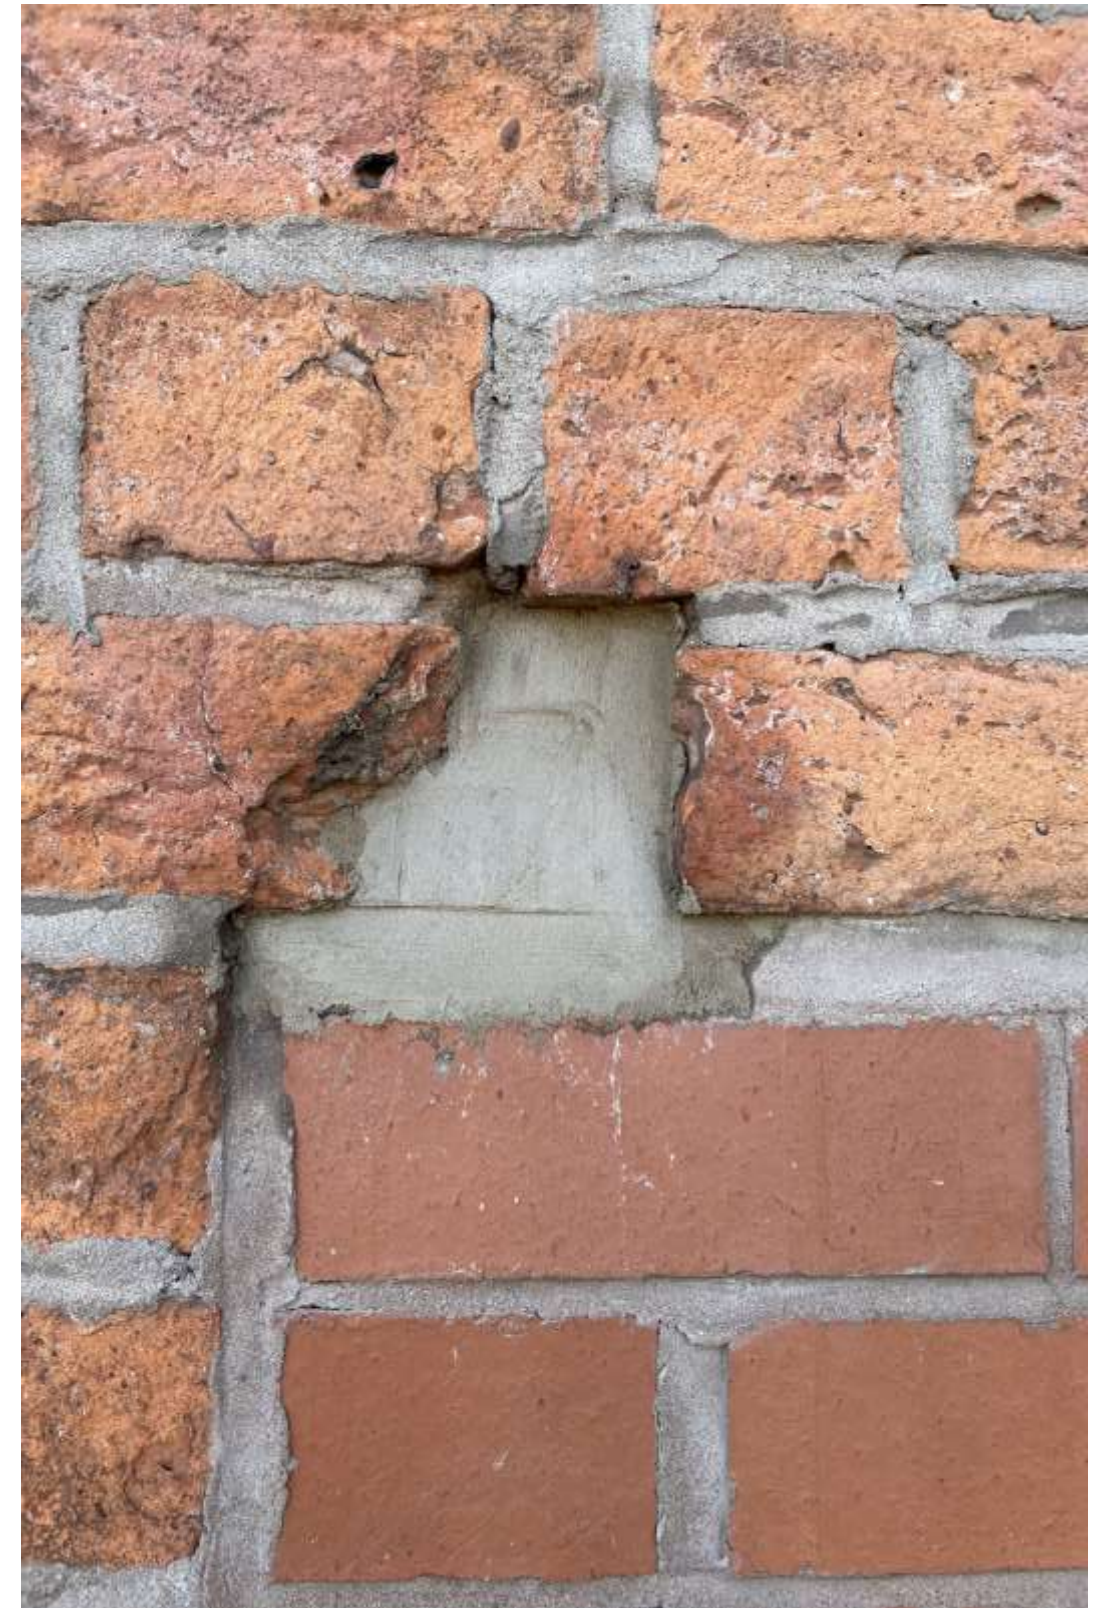
### 7: North West Elevation: Poor Brickwork Repair

Inspection /Pointing carried out with mortar mix matching surround. Ref pic provided right picture, picture below before, after work far right. Single Brick to replace the mortar. Agreed by Paul Mason

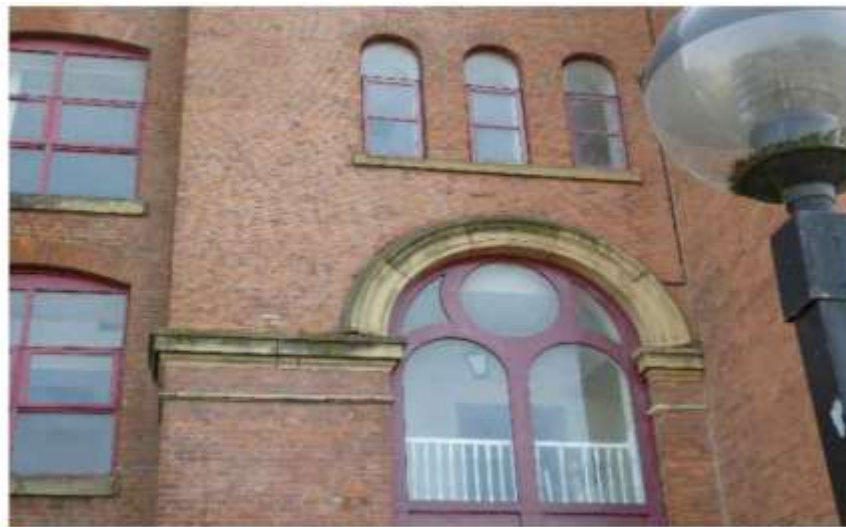
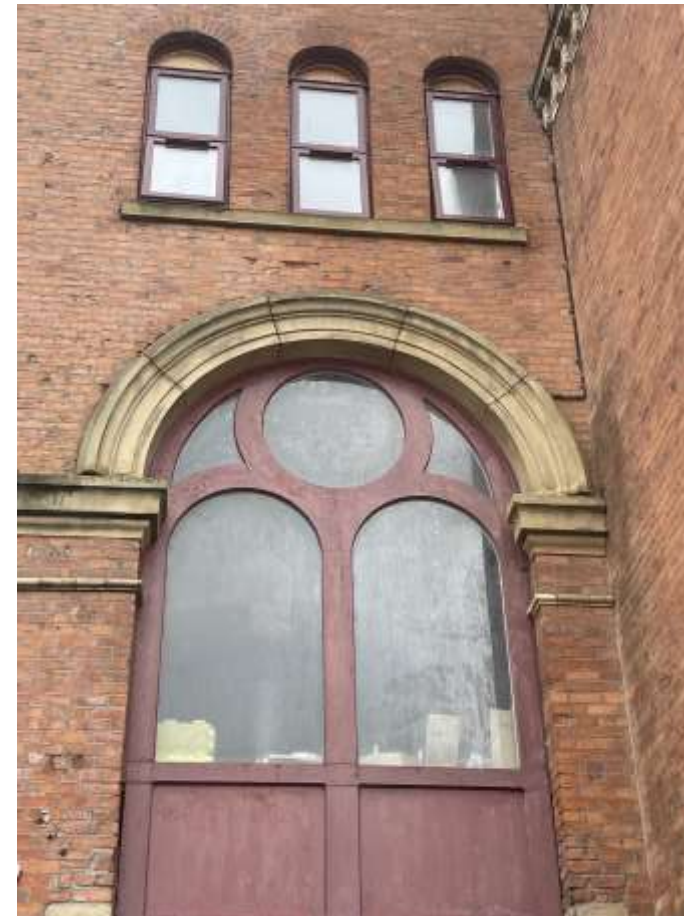
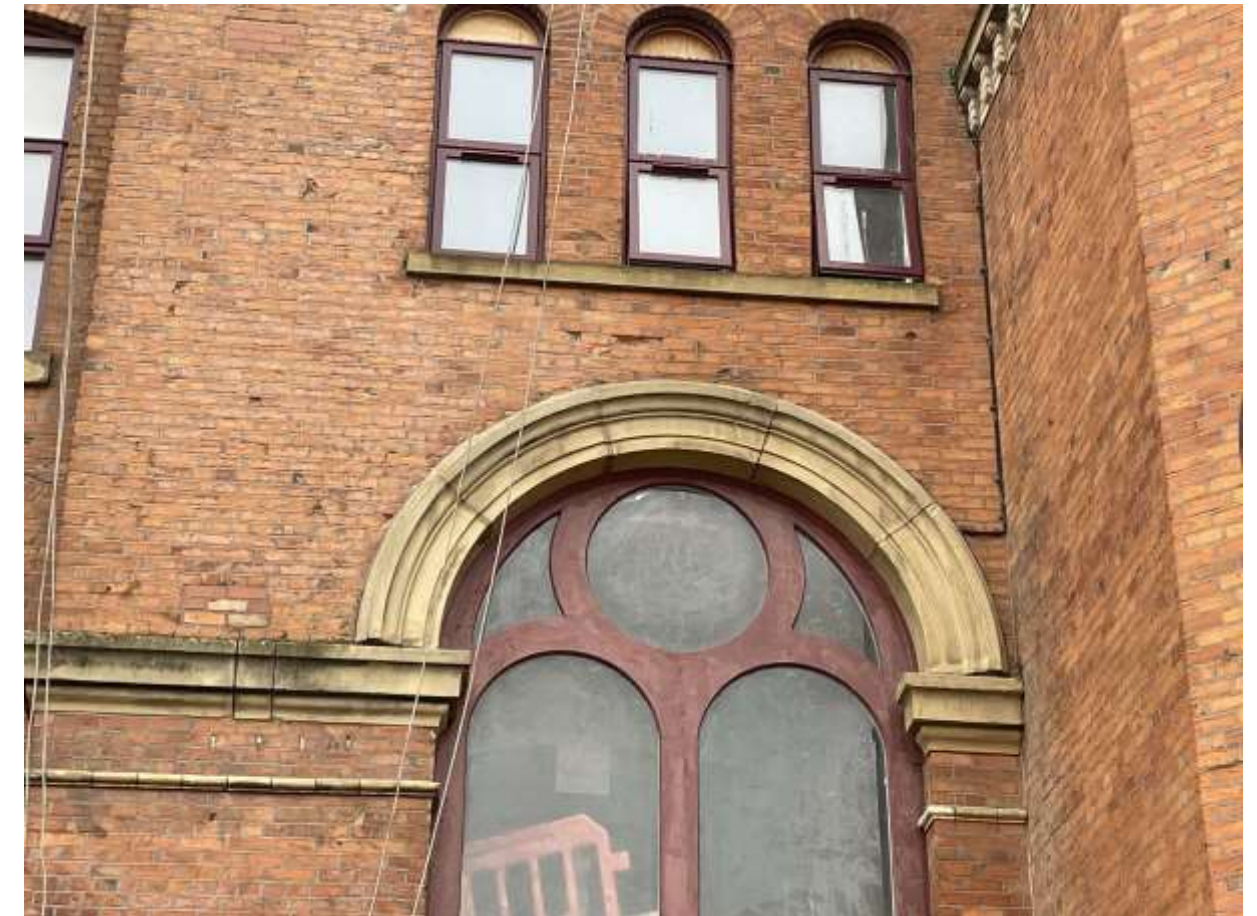
### 8: North West Elevation: Arch water staining

Inspection carried out. Ref picture 1st pic below. Water staining in the majority cleaned. See second picture below - black oil marks can not be removed. Arch cleaned see the two pictures to the right. Repointing of arch with lime mortar mix. See bottom three pictures. All Pictures are of completed works. Noted there are many other areas that could have work carried out but not in scope.

Additional work requested by Paul Mason. Pointing to the surround brickwork
