REPORT OF VICTORIA MILL

LOWER VICKERS ST, MANCHESTER M40 7LH

Date of project: 02/08/2021—Ongoing

| <p><b>F.A.O:</b> Medlock</p> <p><b>Author:</b> Lee Armstrong</p> <p><b>Project Description:</b><br/>Rope Access Remedial Works Various</p> <p><b>Technicians who carried out works/inspection:</b><br/>Marc Stirrup Lv 3<br/>Anthony Smith Lv 2<br/>Simon Powers Lv 1<br/>Chris Odonnell Lv 3<br/>Craig Samson Lv 2</p> <p><b>Contents:</b></p> <ul style="list-style-type: none"><li>Introduction</li><li>List of defects provided by Medlock, descriptions of works and links to evidence of works</li></ul> | <p><b>Introduction</b></p> <p>This report shows the evidence of works for all the remedial carried out at Victoria Mill</p> <p><b>NOTE</b></p> <p>Site meeting carried out. Paul Mason the Conservation Officer in attendance to agree scope of works.</p> <p>If you have any questions regarding the project please contact us on 0141 433 8040 or email lee.armstrong@opalaccess.co.uk</p> <p><b>Materials Used On Site</b></p> <p>Hammerite Ultima Matt Black <a href="#">Hammerite Ultima Matt - Hammerite UK</a></p> <p>Blue Cicle Lime <a href="#">Blue Circle Natural Hydraulic Lime 3.5 25kg Travis Perkins</a></

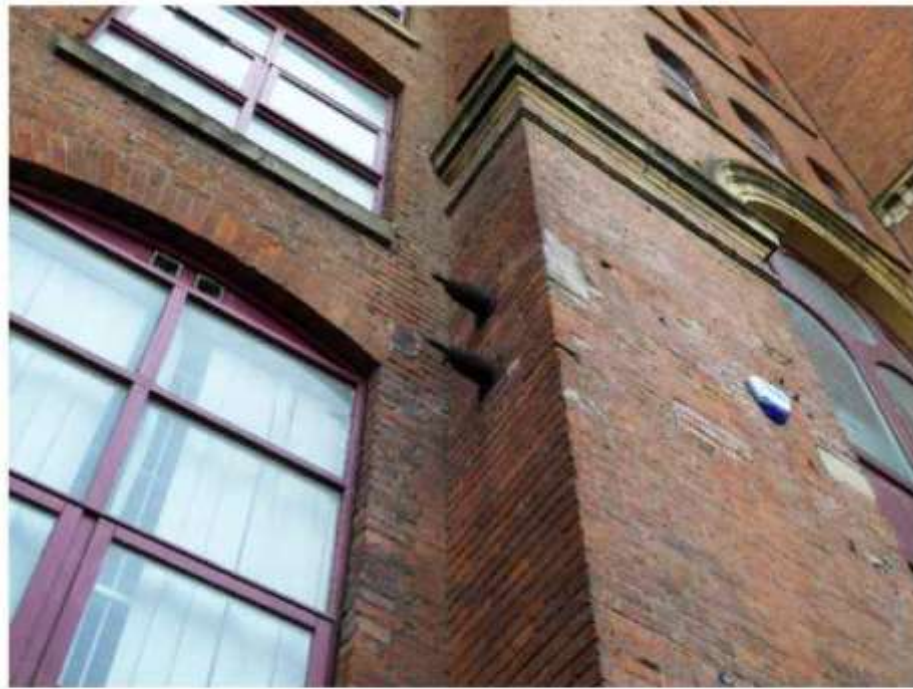
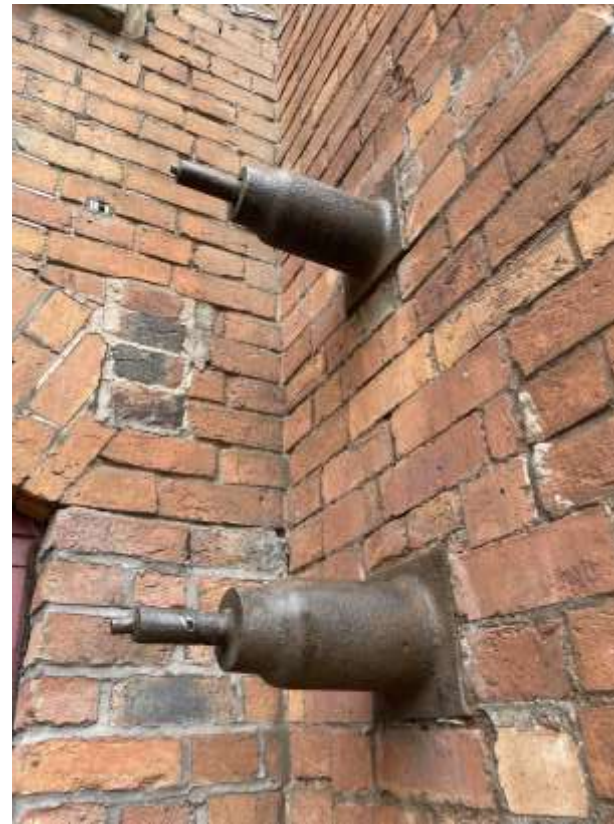
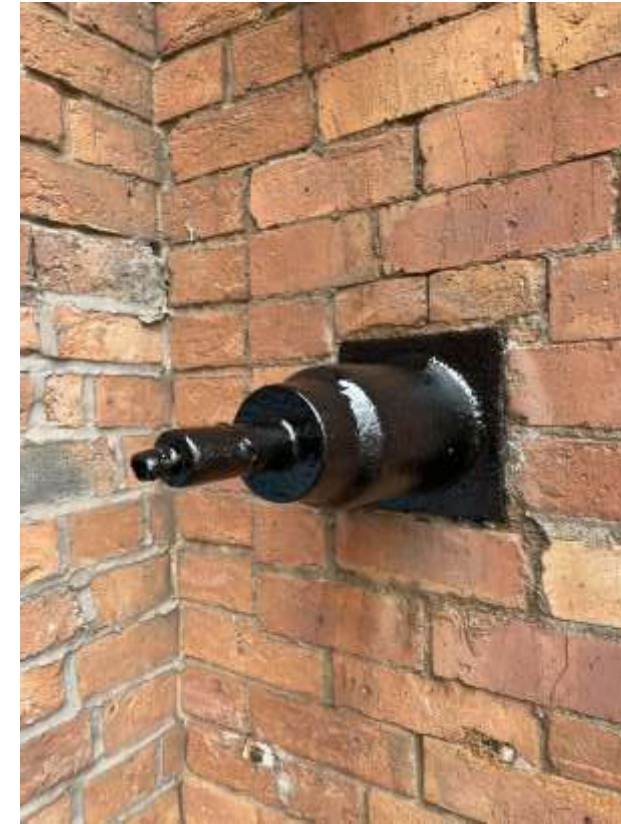
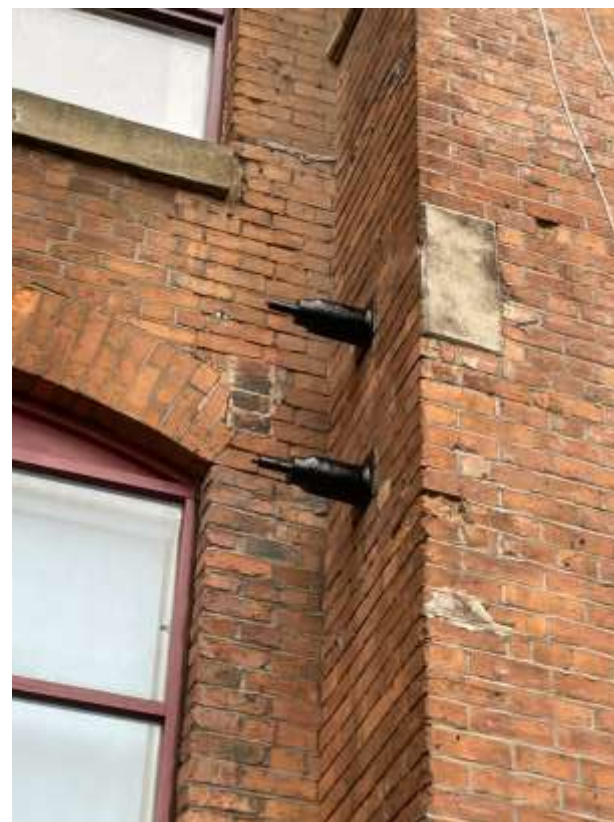
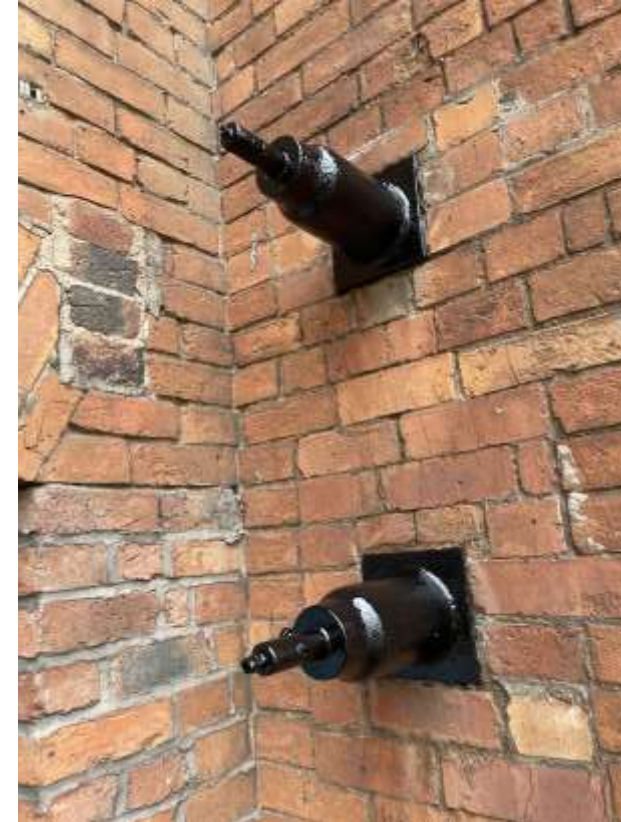
### 12: North West Elevation: Existing Pipe work

Inspection carried out, no building integrity issues, metal work refurbished.  
Ref pic below and right. Corrosion removed through use of needle guns and angle grinders. Hammarite Metal Paint black applied.

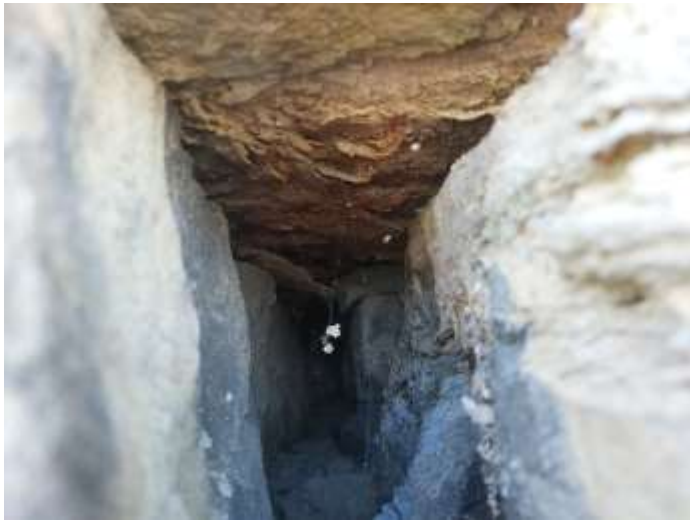
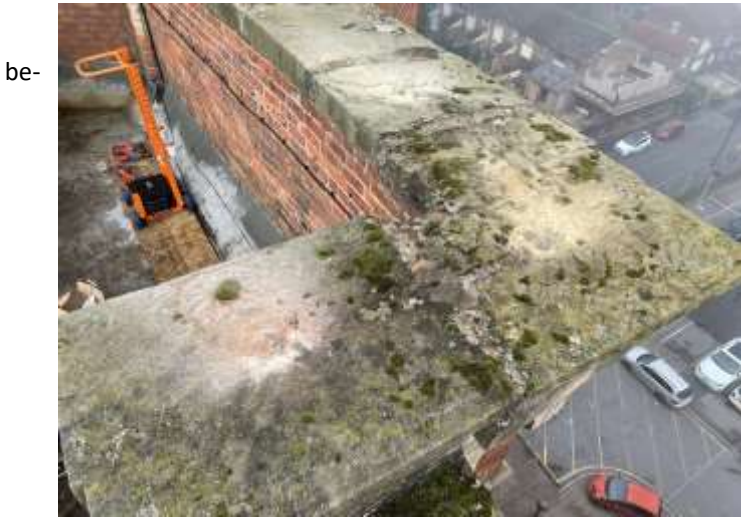
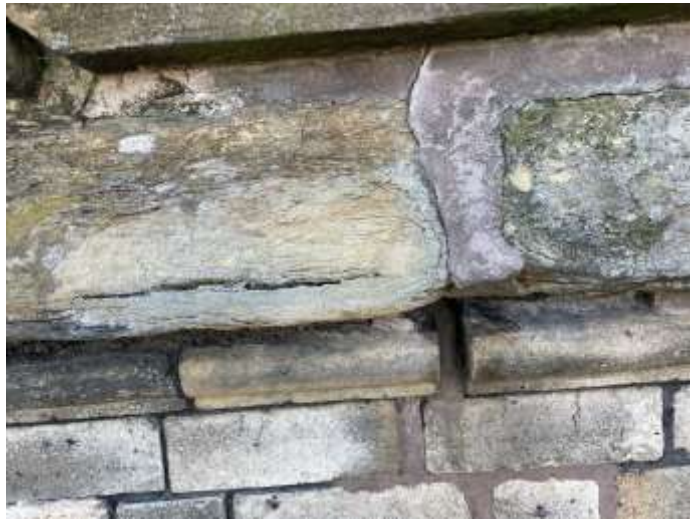
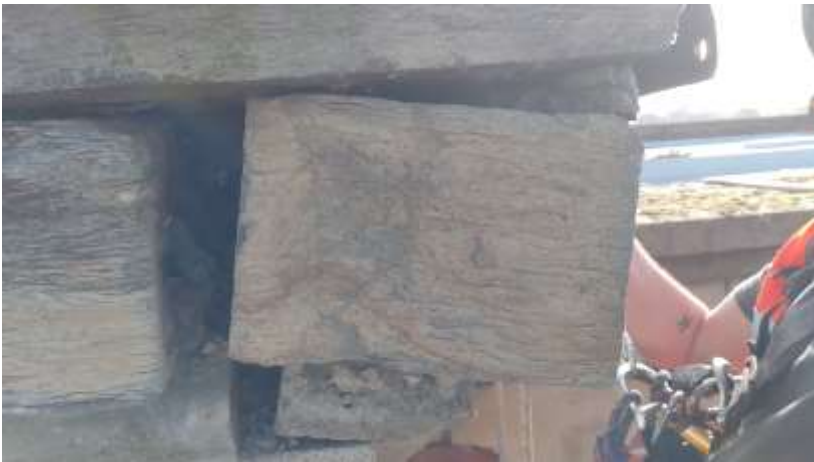
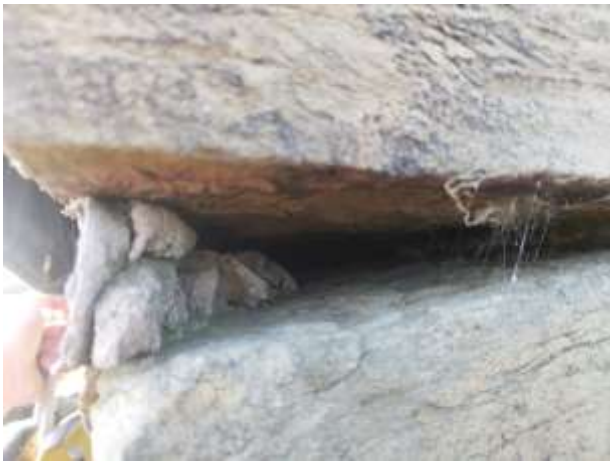
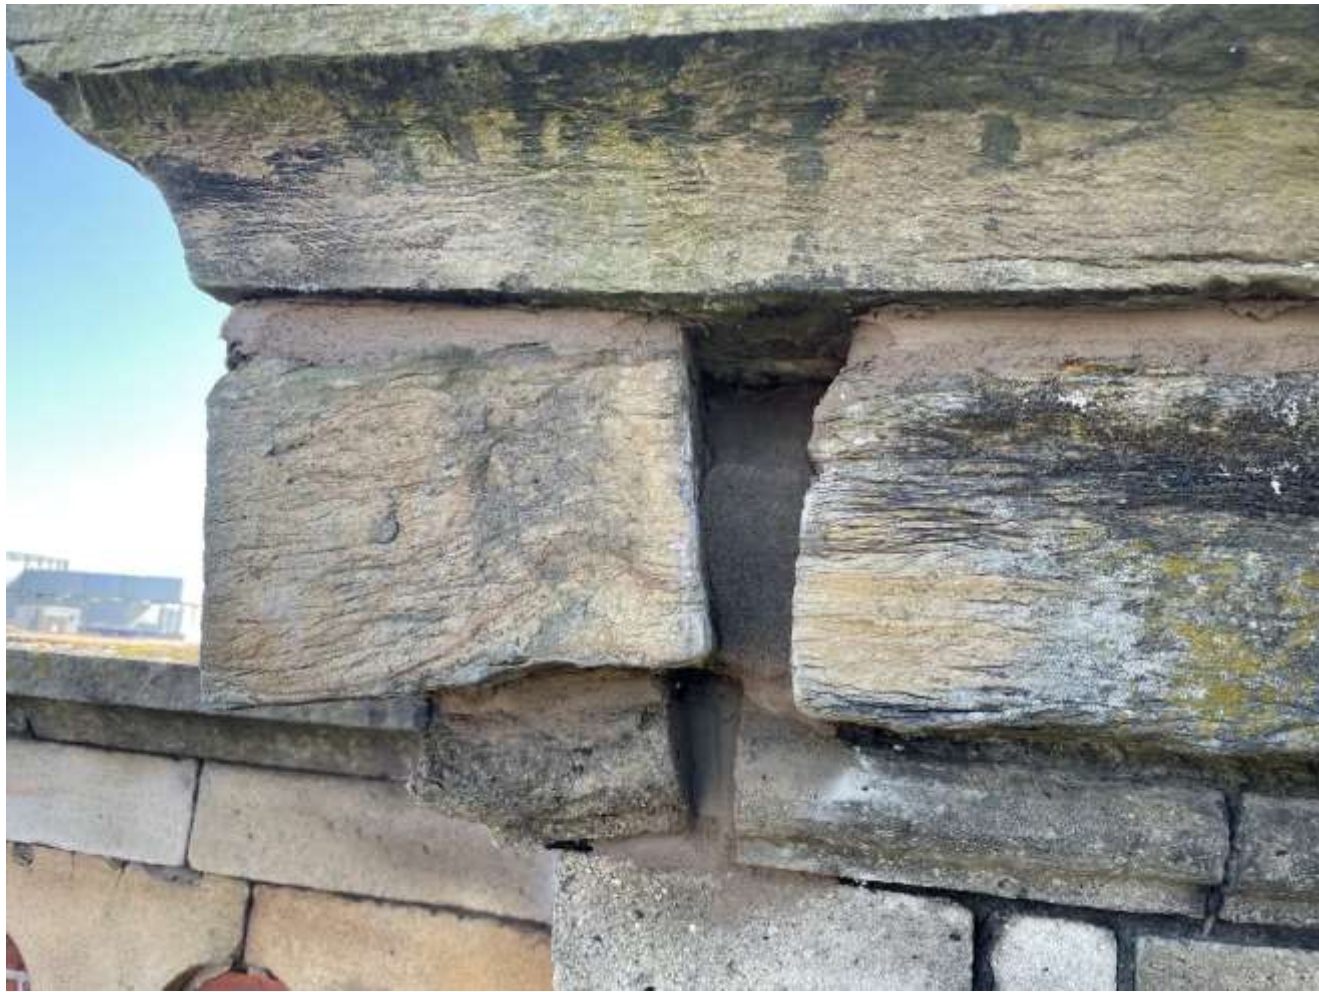
14: North West Elevation: Coping Stone pinned, rebed of top level block, Spalling to be repaired

Comments:  
370 x 6mm helical rods resined through coping blocks. Voids hind displaced block packed with mortar. Upon return larger gaps will be filled with Fosroc Renderock and skimmed with Lime mortar to finish. Approval of method confirmed. SEE Springrise Structural Report

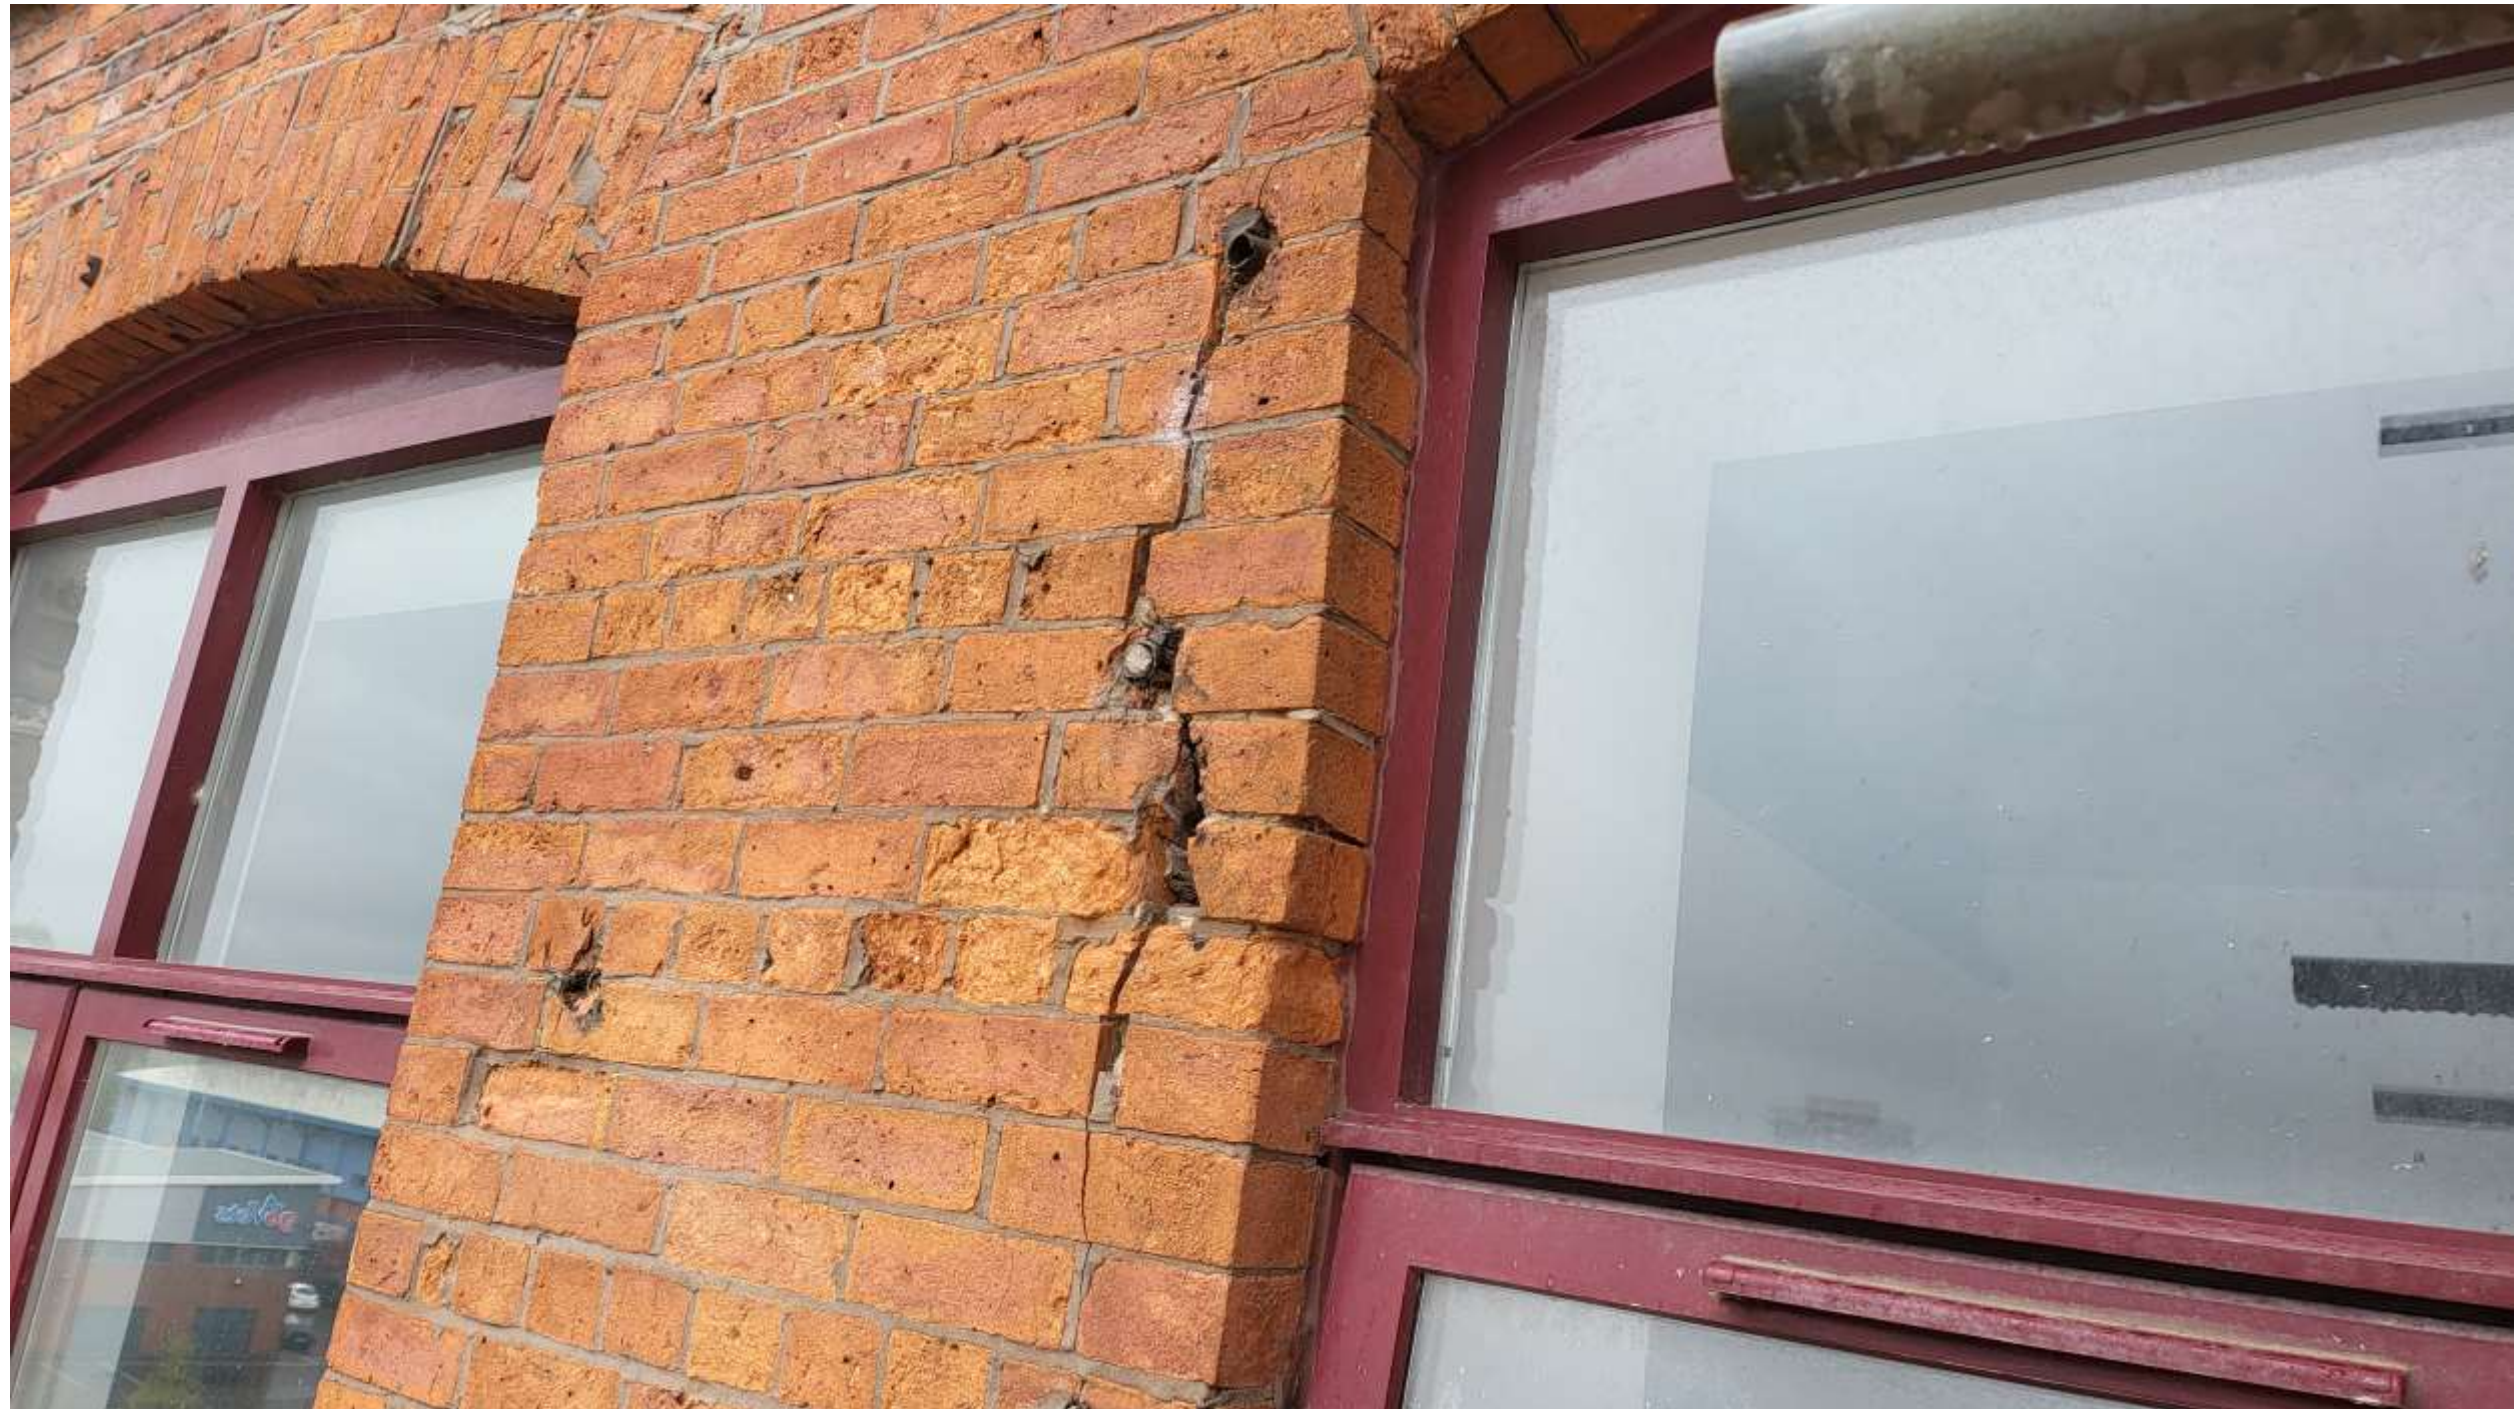
19: North West Elevation: Cracked Brickwork. To lime mortar point up.

To be repaired. NOTE. Top metal work redundant overflow pipe. Pipe penetrates into the building and it is possible it cannot be removed. Other metal work will be removed upon return to site. Brickwork to be replaced.

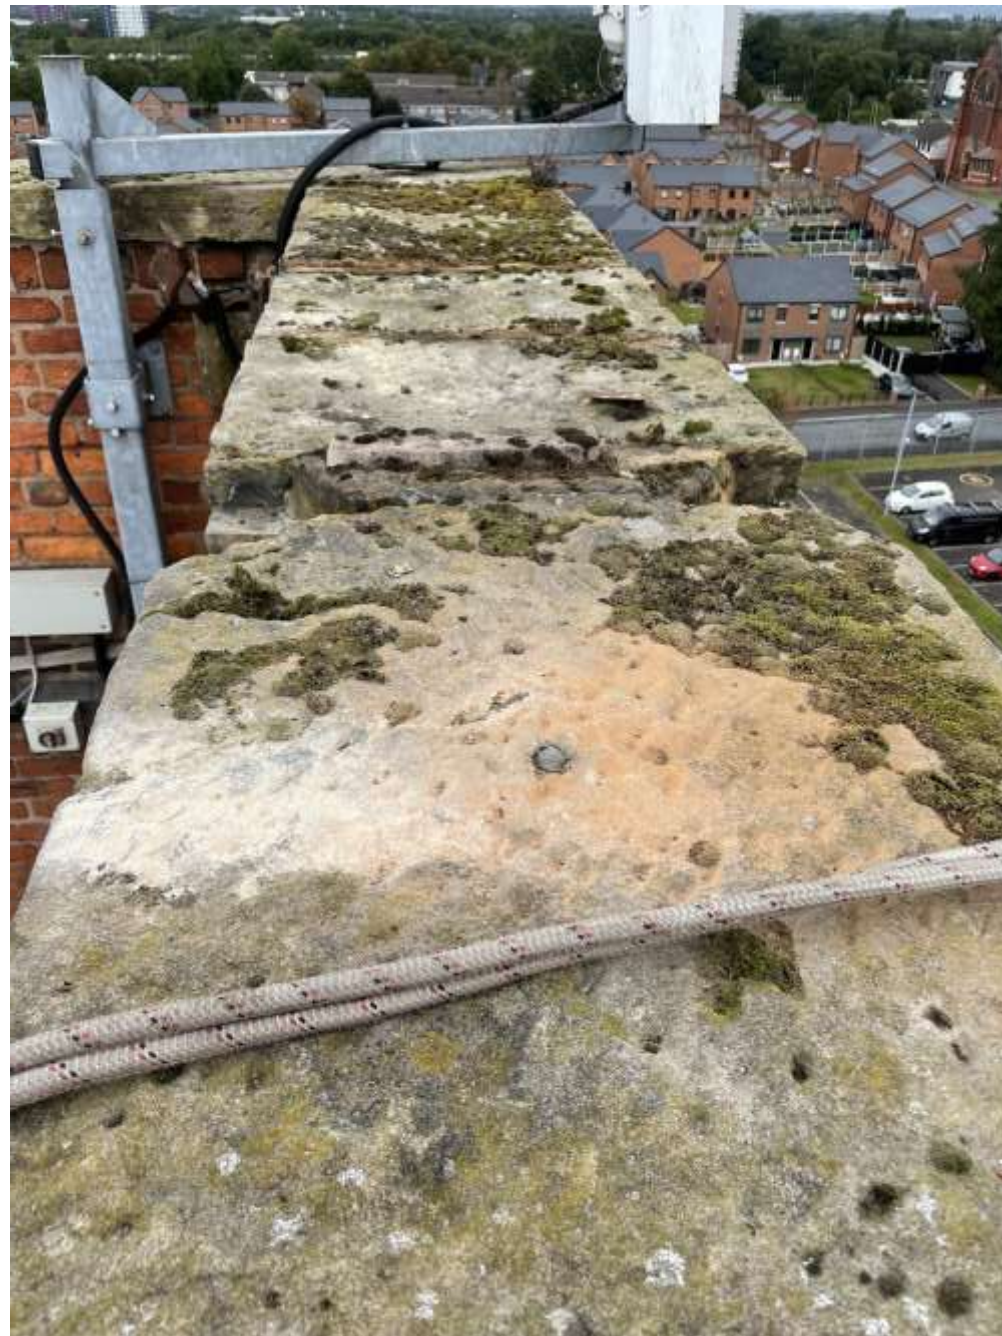
### 1: North East Elevation: Coping / Stones decorative repairs

Inspection carried out, lime mortar pointing to match existing, coping blocks pinned. No Ref picture provided, Opal ref pic of location bottom right. Pointing carried out.

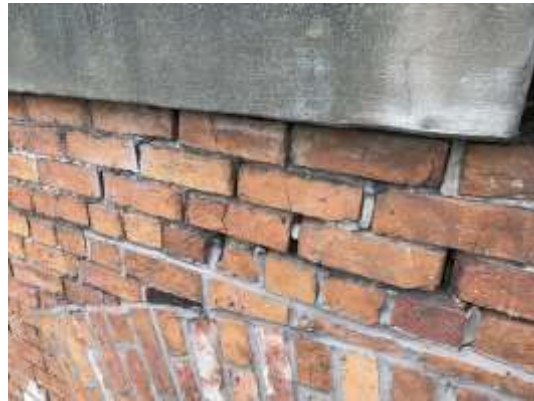
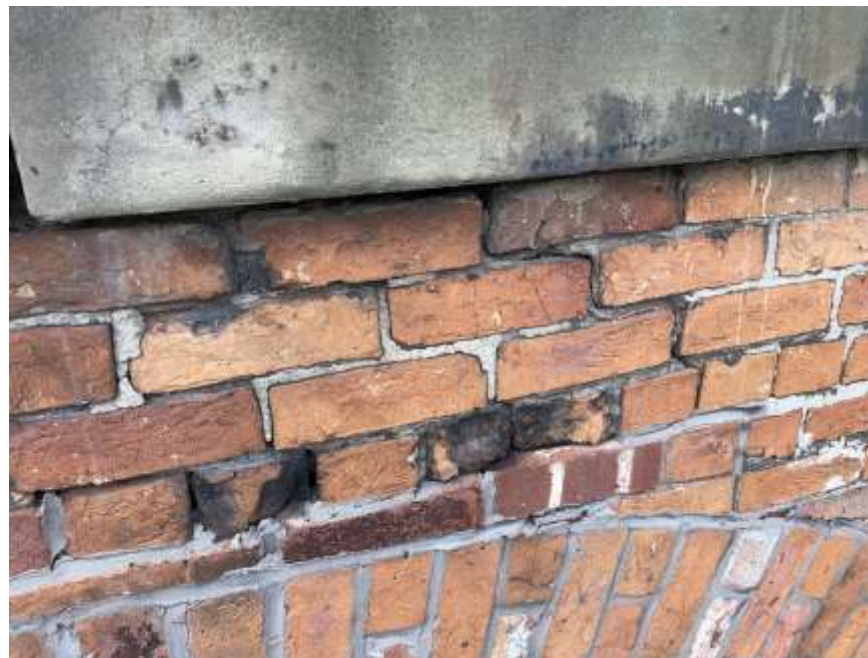
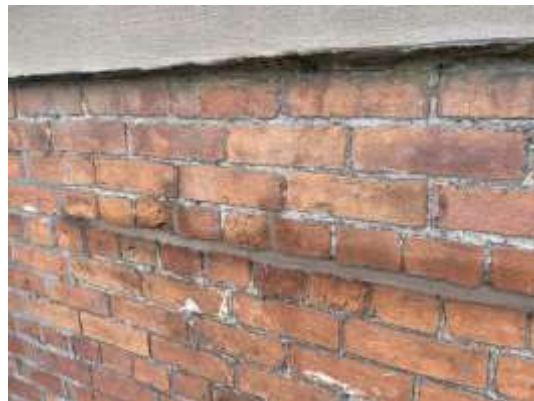
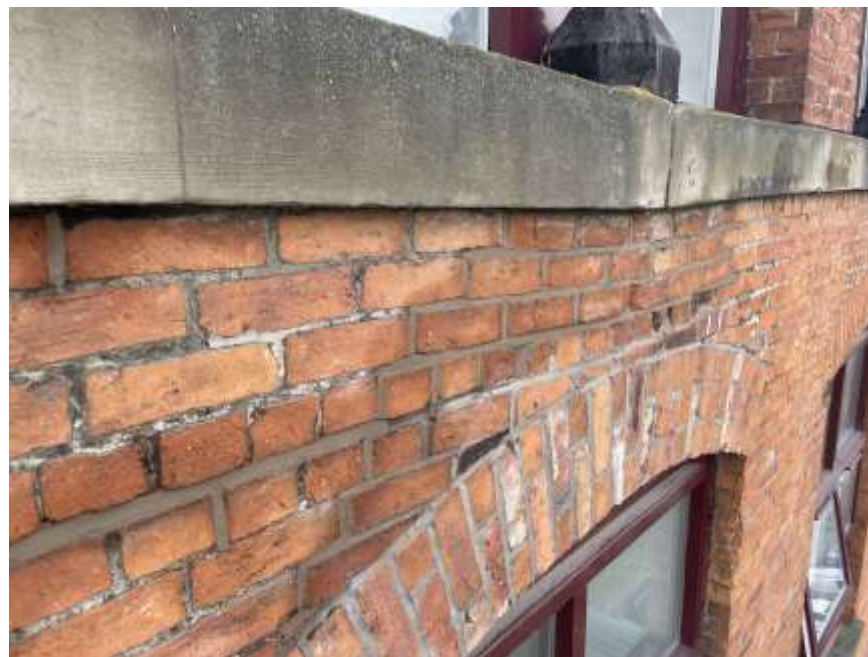
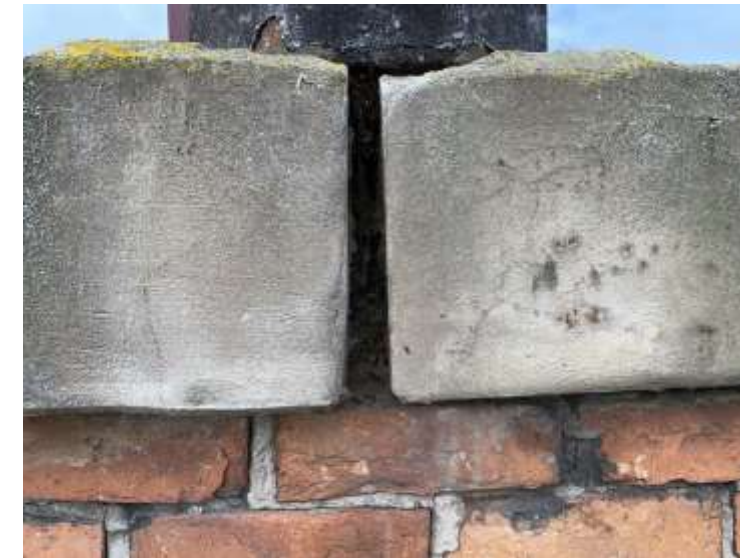
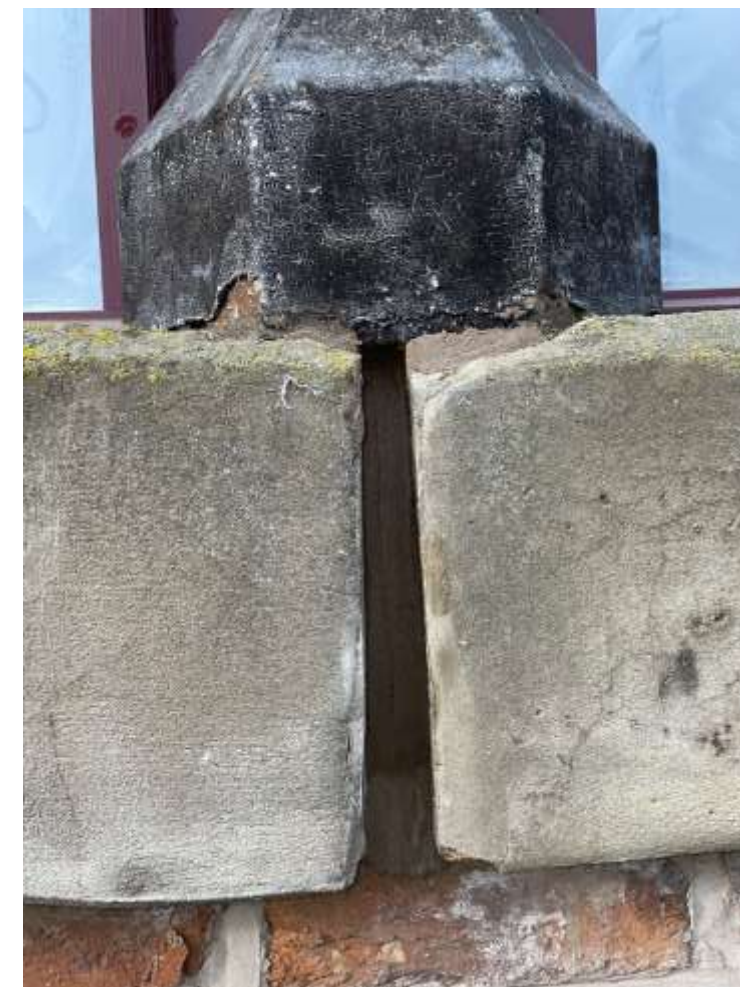
2: North East Elevation: Evidence of brickwork movement.

Inspection carried out, Area inspected, pointing carried out lime mortar mix.

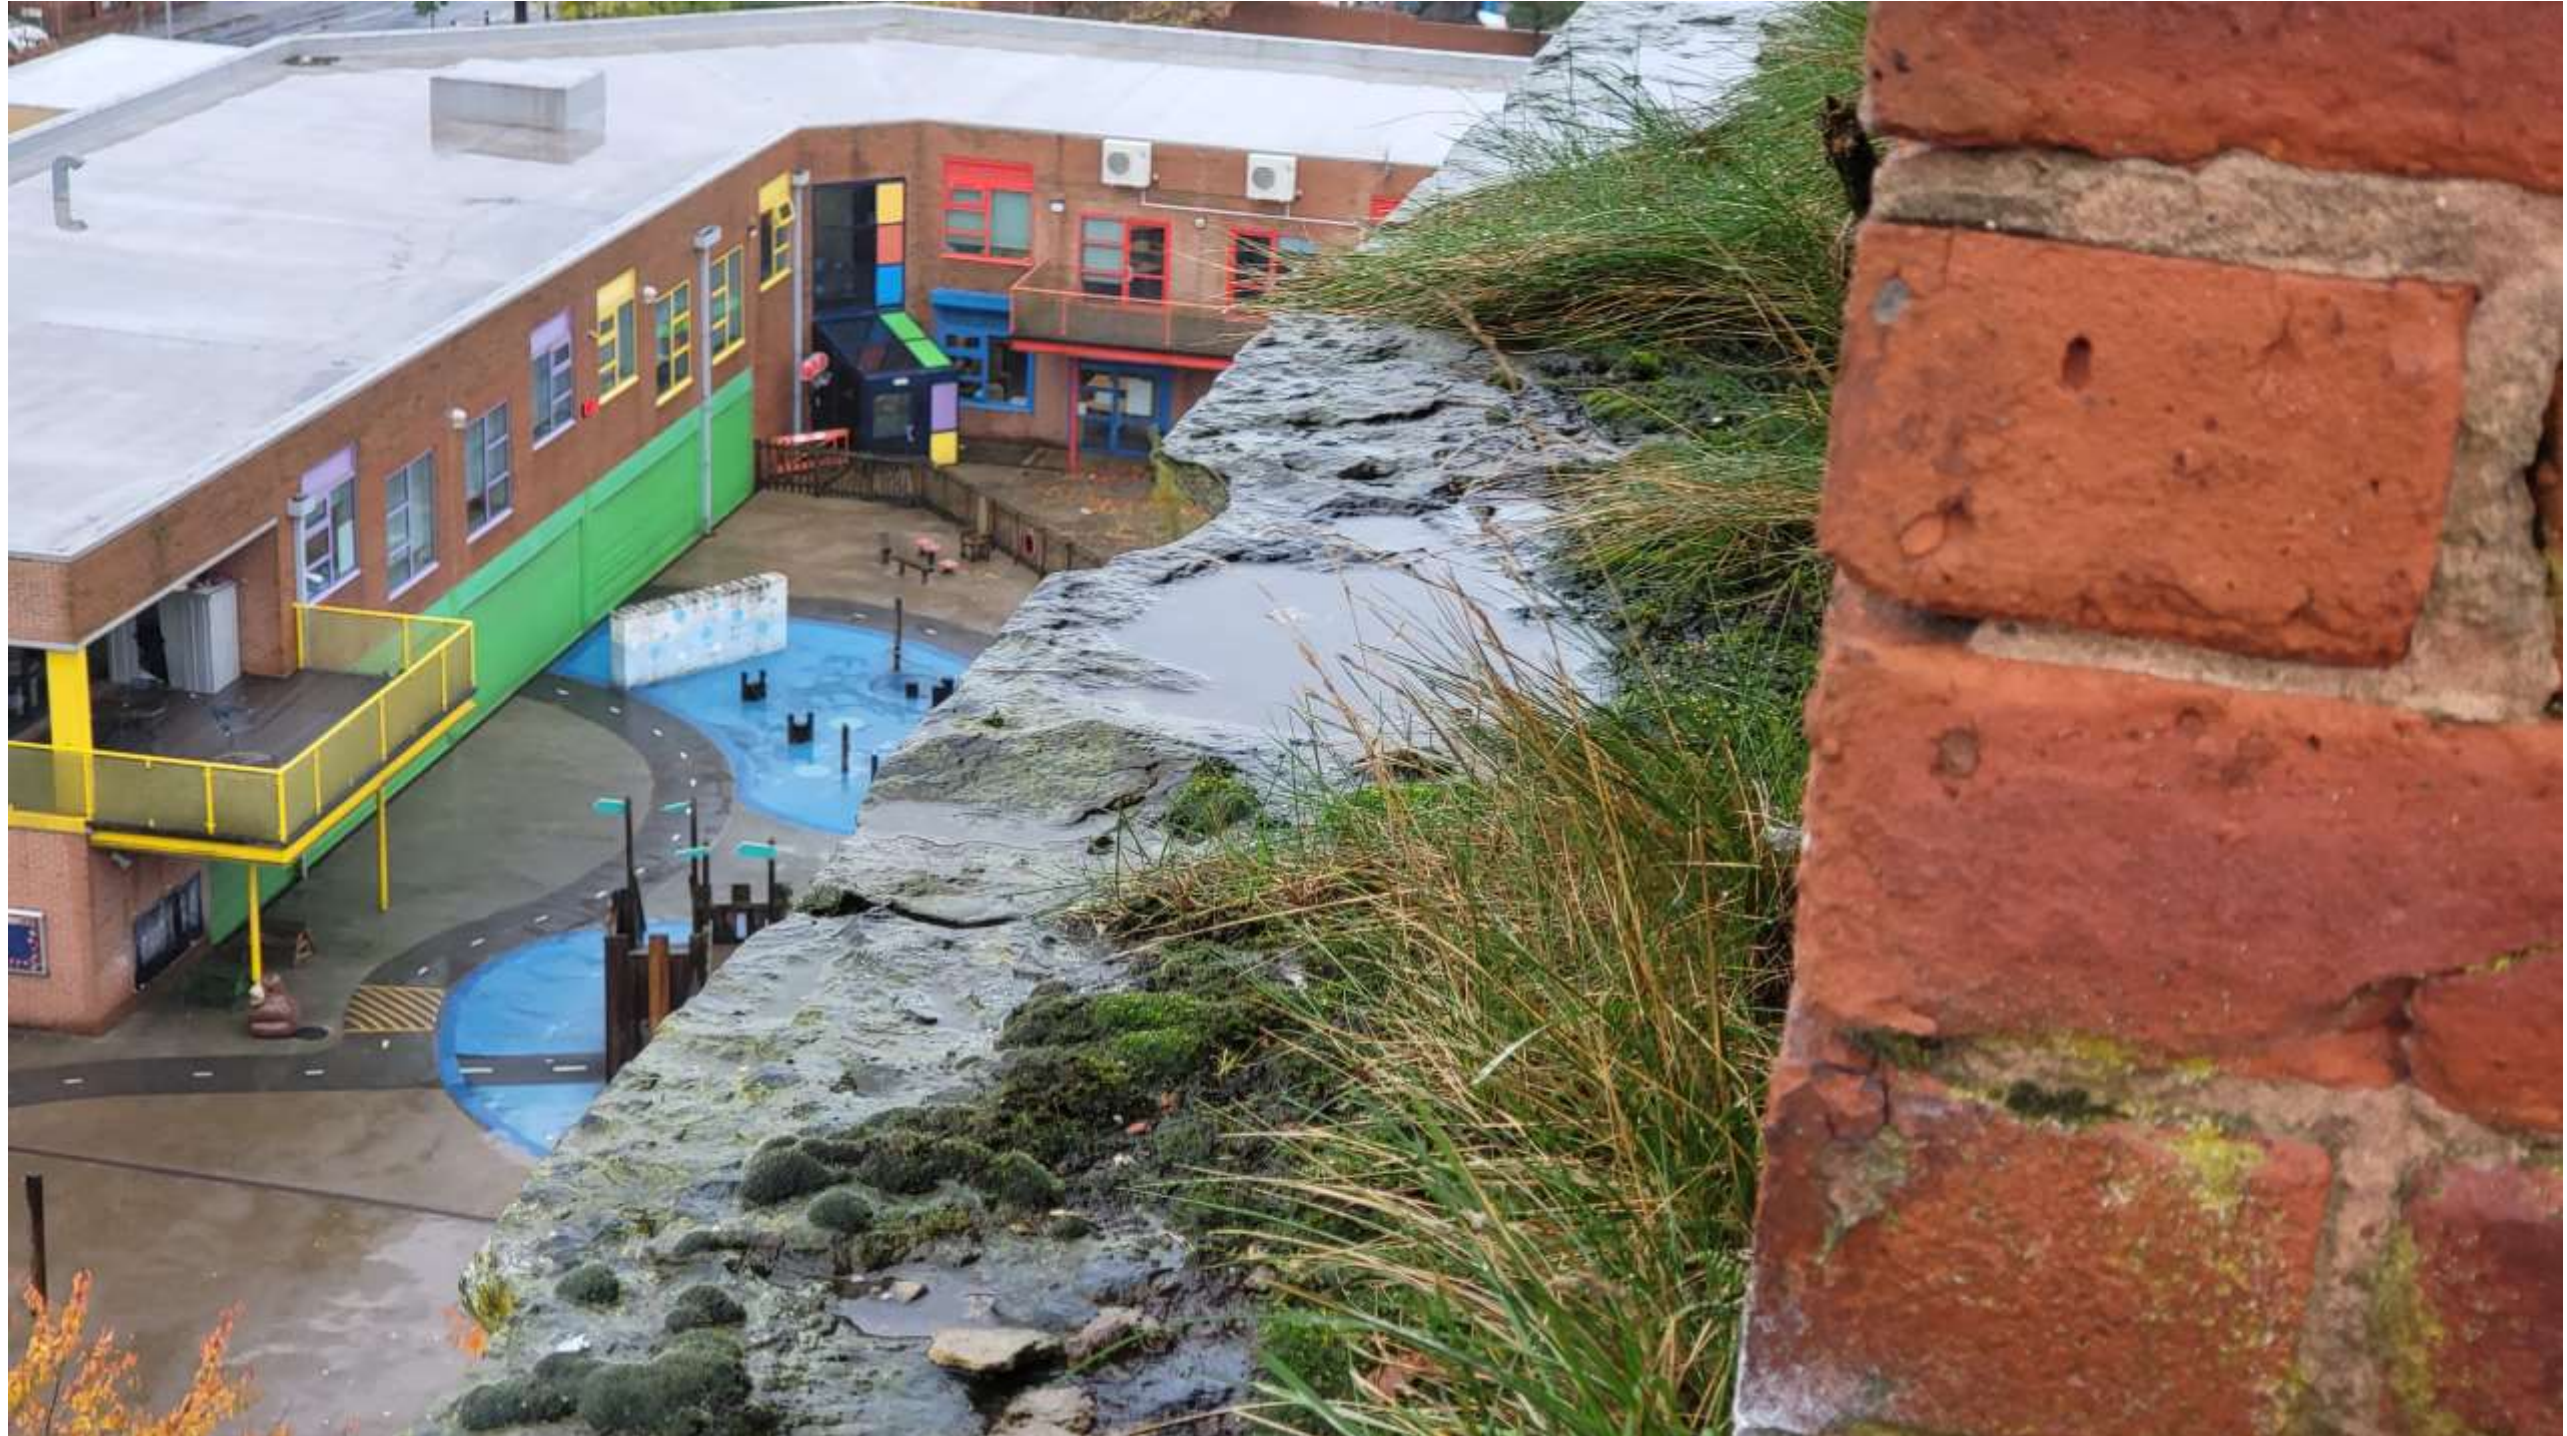
### 8: North East Elevation: Damaged Cornice

Veg to be removed. Inspection carried out, structurally sound. Gap in coping found but not unsafe

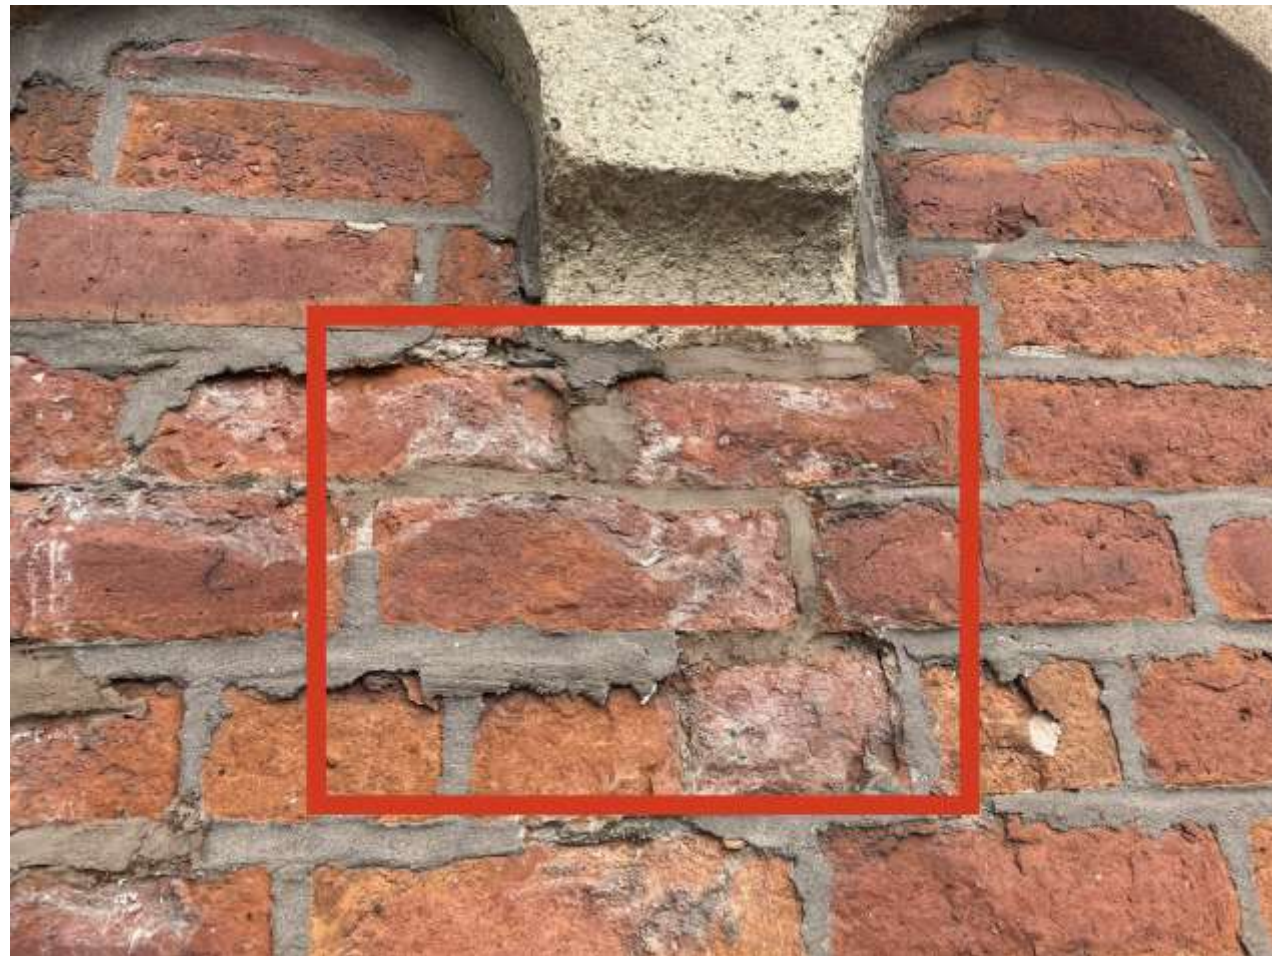
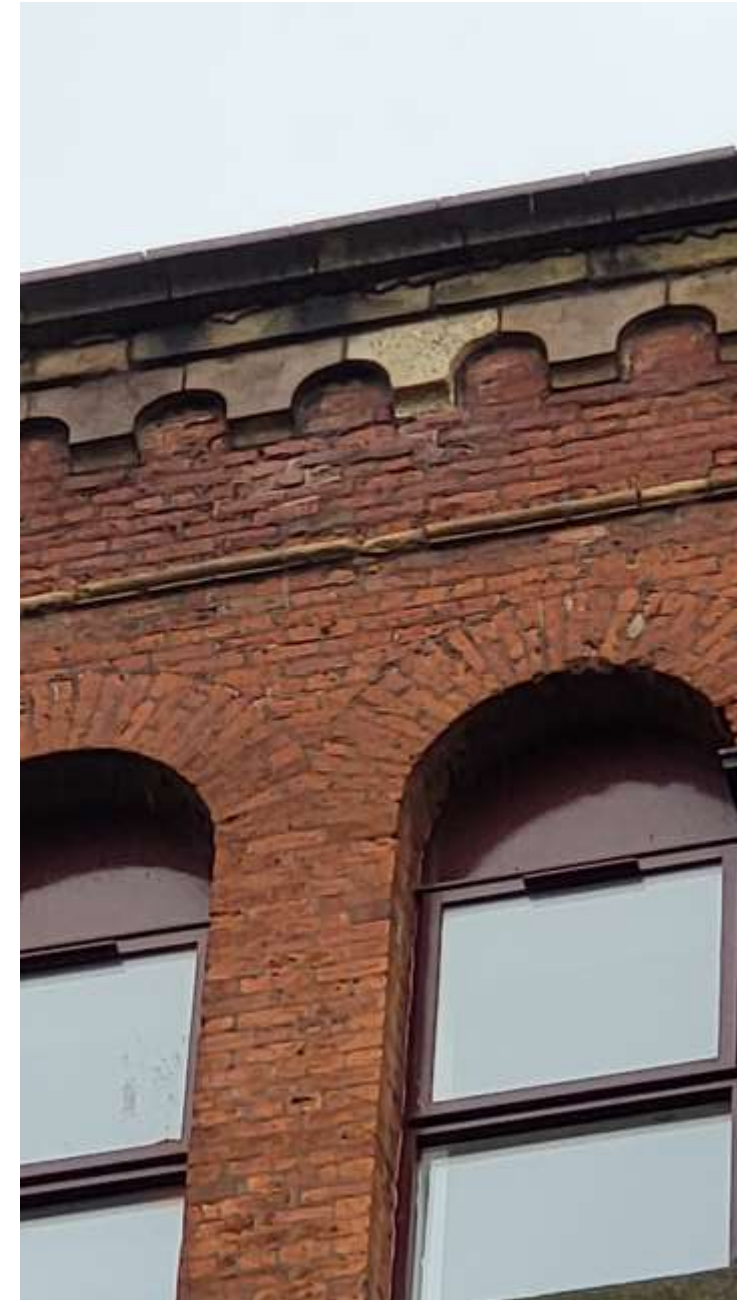
### 1: South East Elevation: Water Ingress Causing Salt To Appear

Inspection carried out. Salt removed, small area of pointing done with lime mortar mix. Structurally sound upon the date of inspection

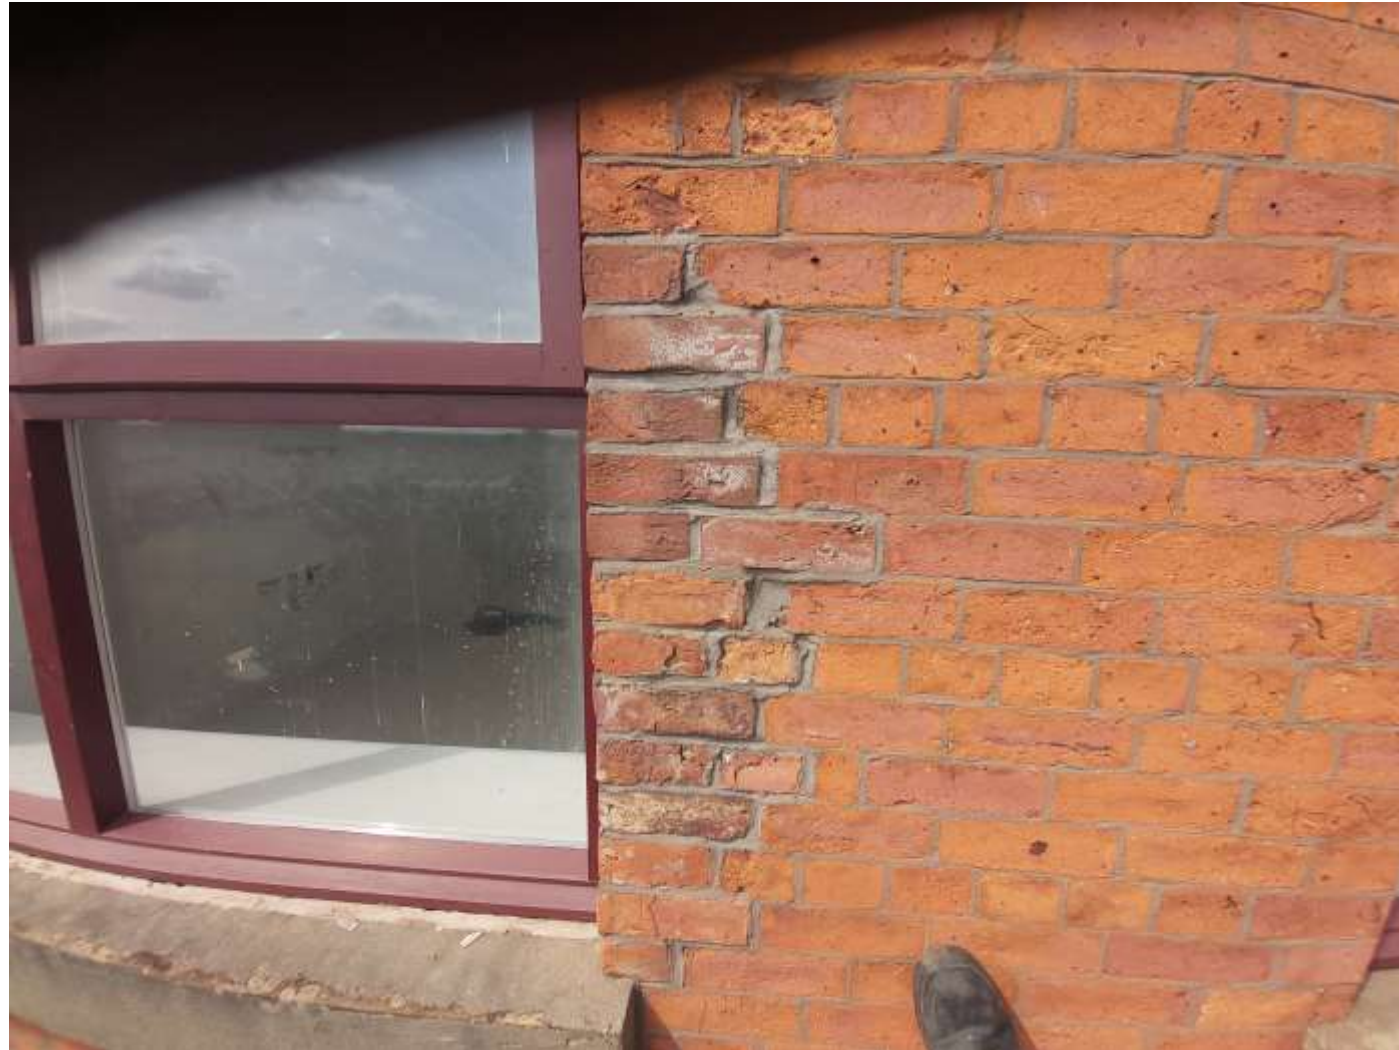
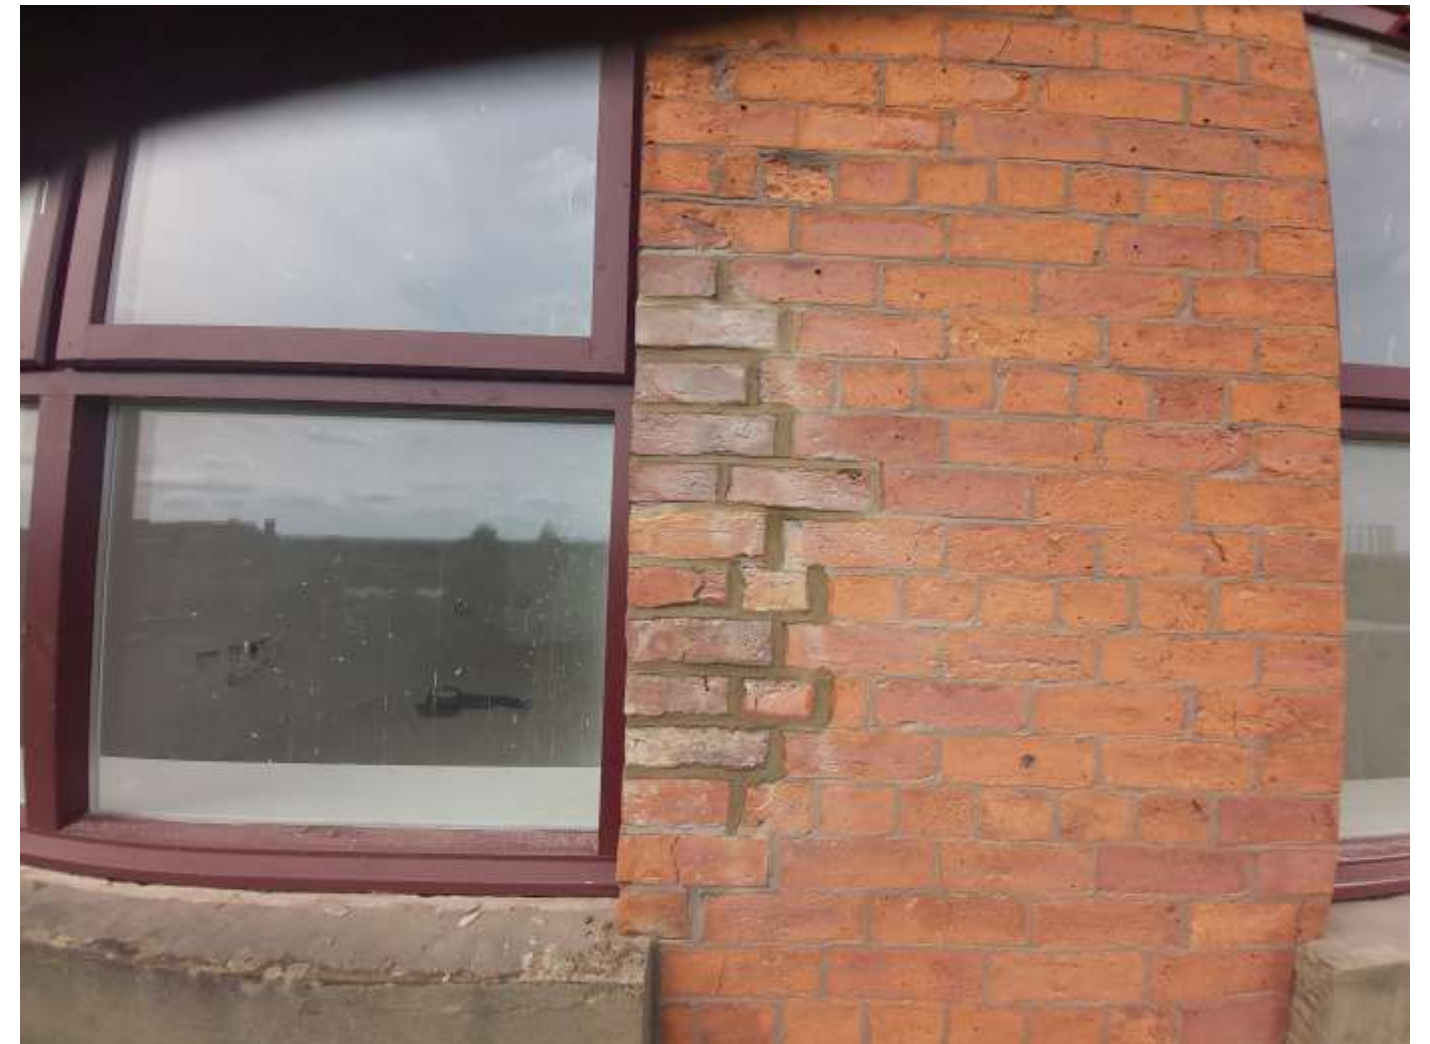
### 4: South East Elevation: Poor Brickwork Pointing

Inspection carried, pointed up
