REPORT OF VICTORIA MILL

LOWER VICKERS ST, MANCHESTER M40 7LH

Date of project: 02/08/2021—Ongoing

| <p><b>F.A.O:</b> Medlock</p> <p><b>Author:</b> Lee Armstrong</p> <p><b>Project Description:</b><br/>Rope Access Remedial Works Various</p> <p><b>Technicians who carried out works/inspection:</b><br/>Marc Stirrup Lv 3<br/>Anthony Smith Lv 2<br/>Simon Powers Lv 1<br/>Chris Odonnell Lv 3<br/>Craig Samson Lv 2</p> <p><b>Contents:</b></p> <ul style="list-style-type: none"><li>Introduction</li><li>List of defects provided by Medlock, descriptions of works and links to evidence of works</li></ul> | <p><b>Introduction</b></p> <p>This report shows the evidence of works for all the remedial carried out at Victoria Mill</p> <p><b>NOTE</b></p> <p>Site meeting carried out. Paul Mason the Conservation Officer in attendance to agree scope of works.</p> <p>If you have any questions regarding the project please contact us on 0141 433 8040 or email lee.armstrong@opalaccess.co.uk</p> <p><b>Materials Used On Site</b></p> <p>Hammerite Ultima Matt Black <a href="#">Hammerite Ultima Matt - Hammerite UK</a></p> <p>Blue Cicle Lime <a href="#">Blue Circle Natural Hydraulic Lime 3.5 25kg Travis Perkins</a></

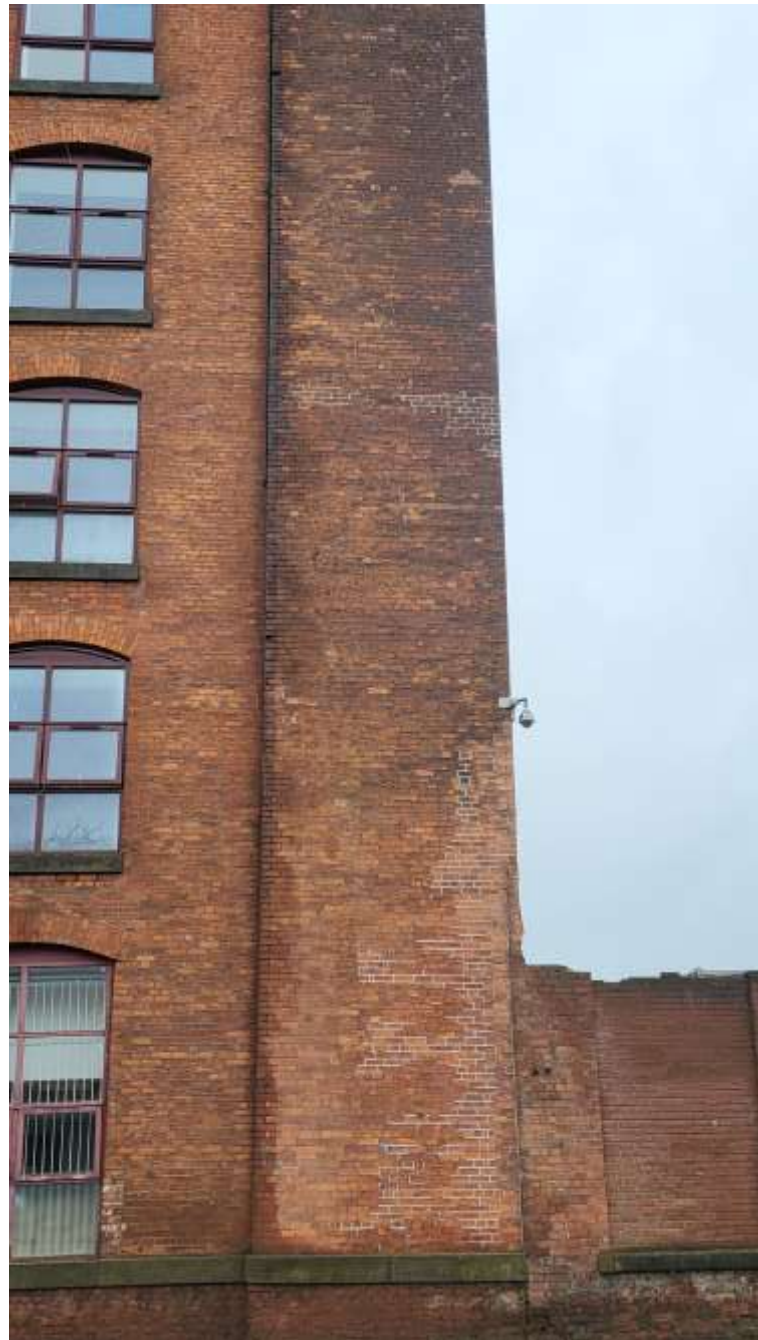
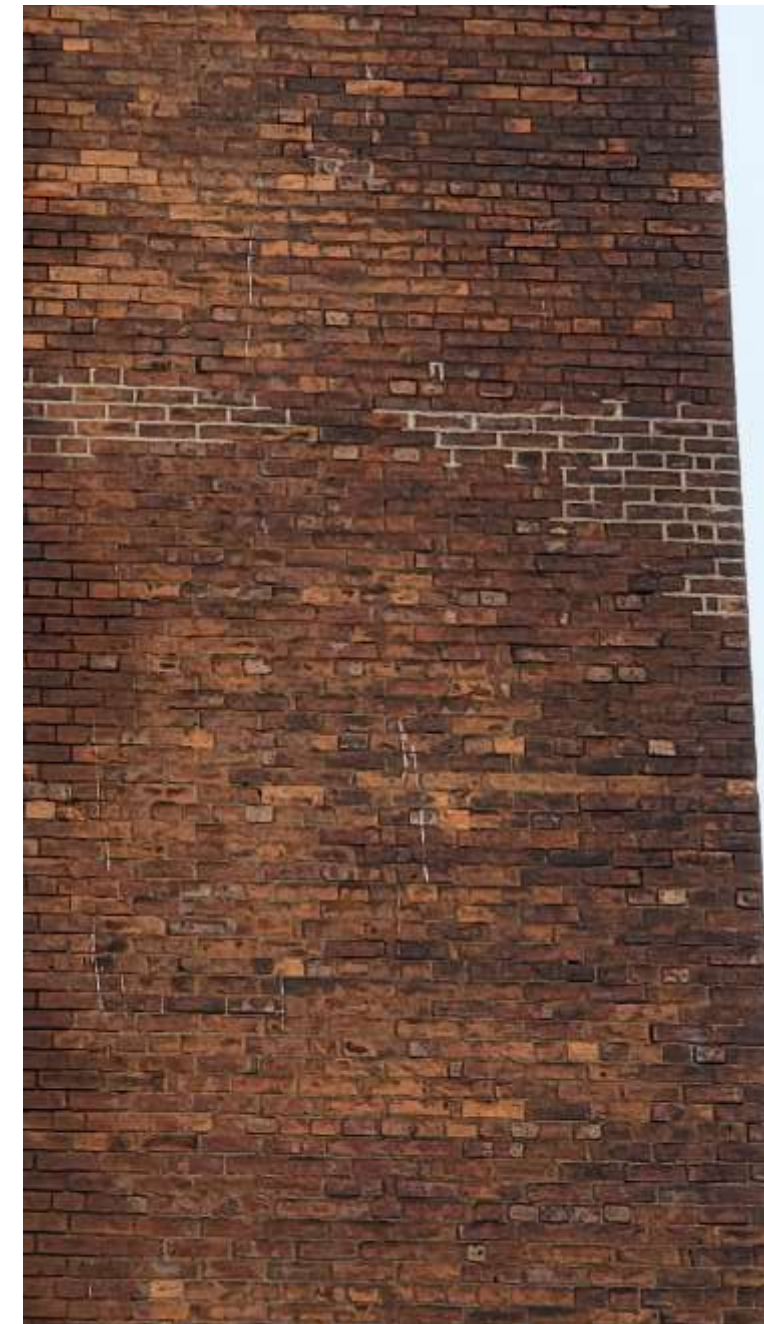
5: South East Elevation: Poor pointing to brickwork

Inspection carried, pointed up bad areas

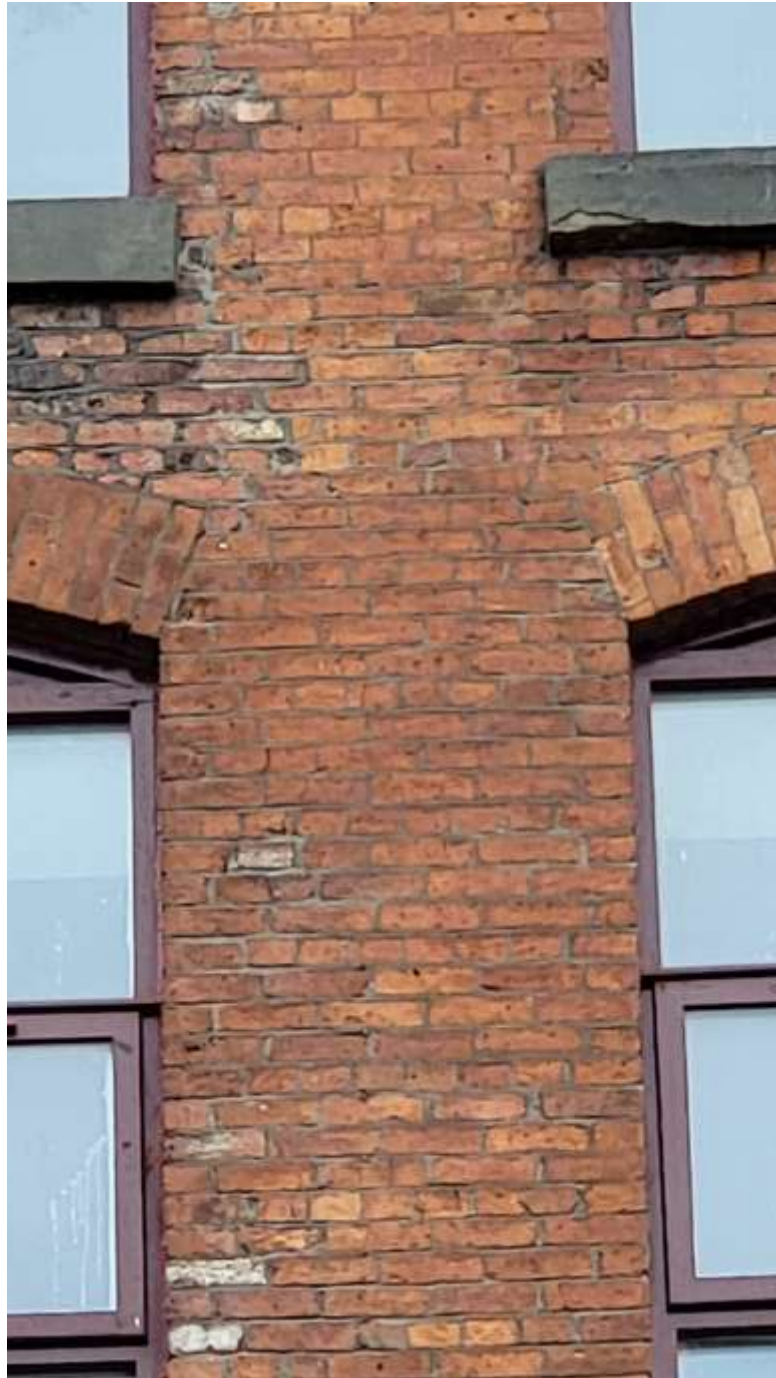
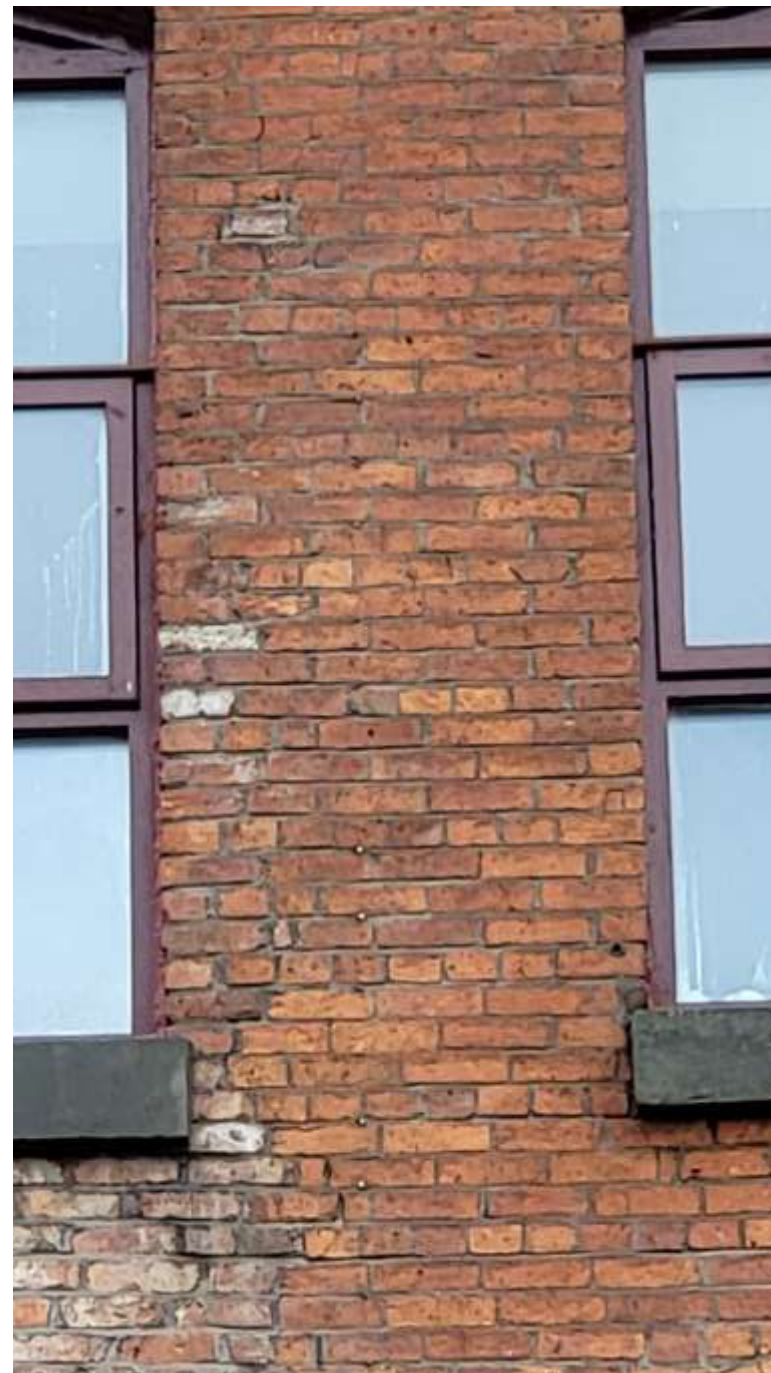
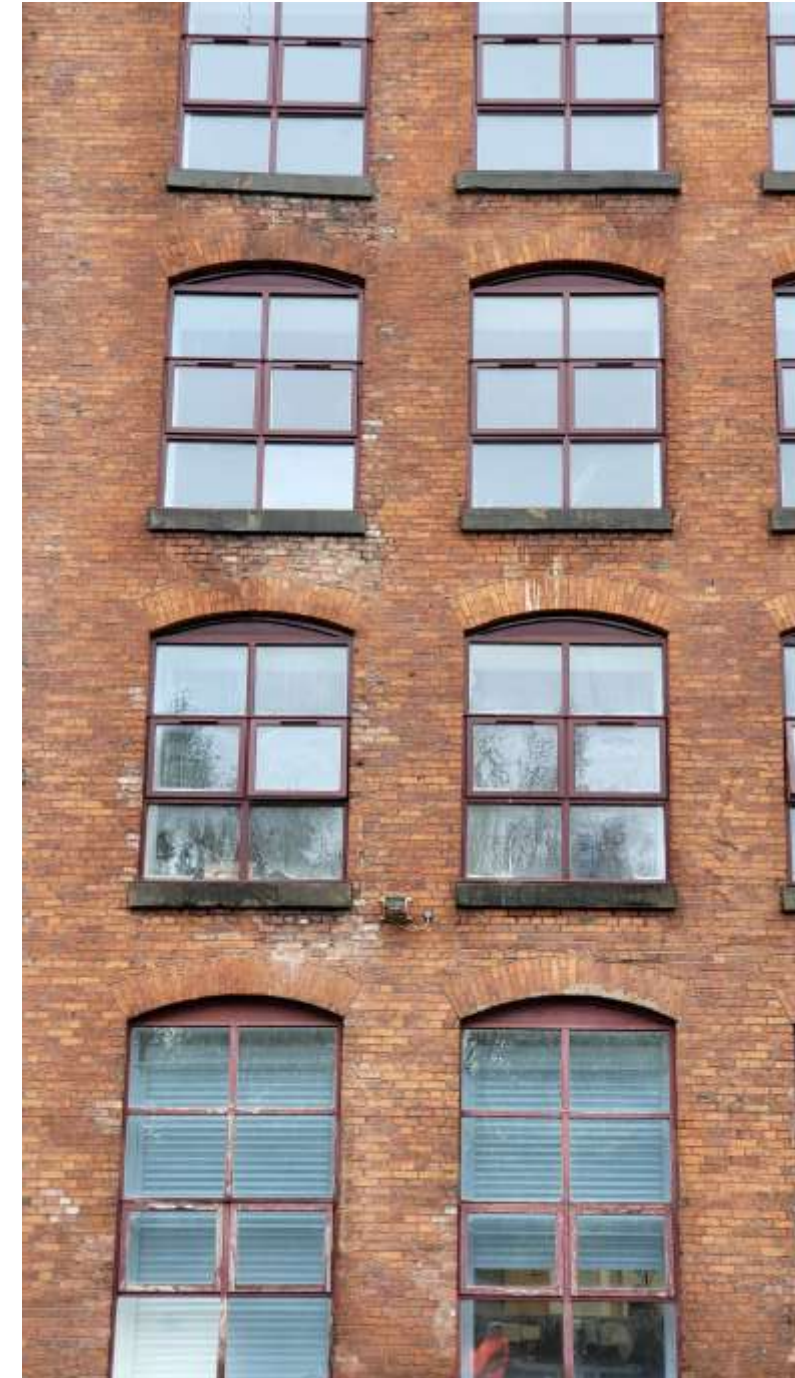
6: South East Elevation: Poor pointing to brickwork

Inspection carried, pointed up bad areas

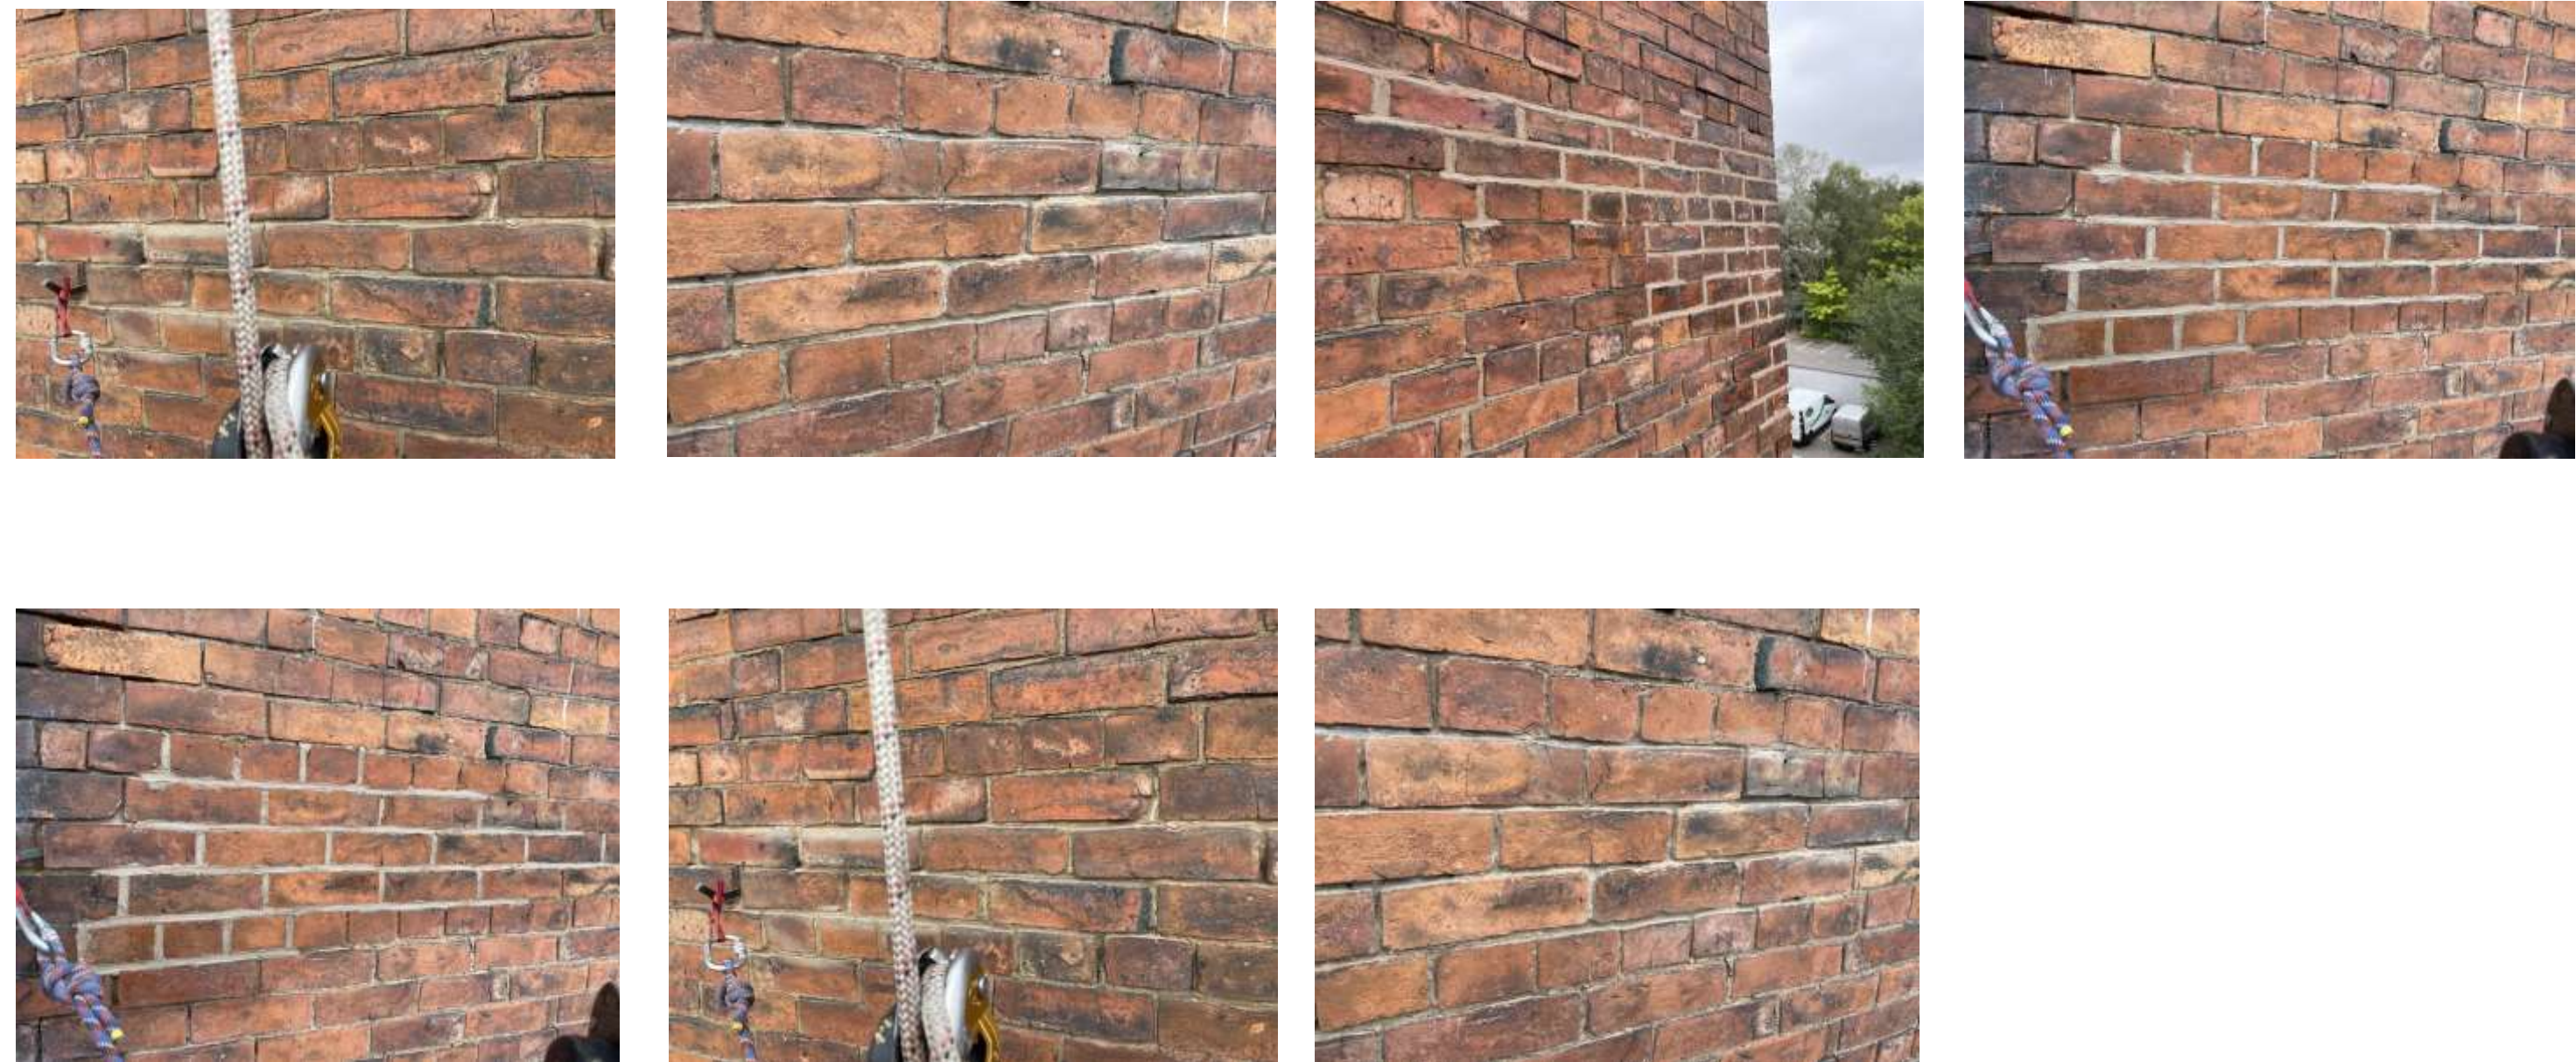
7: South East Elevation: Poor pointing to brickwork

Inspection carried, pointed up bad areas

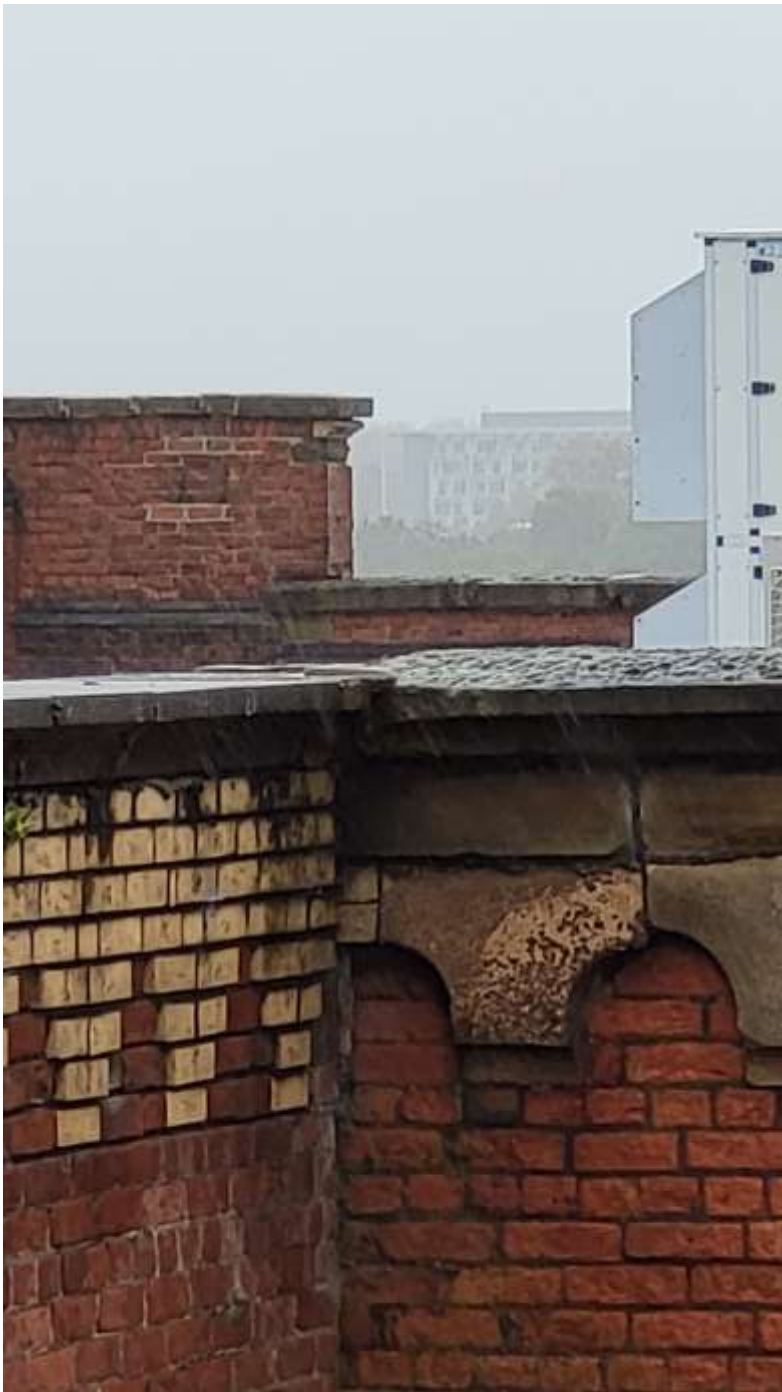
1: Courtyard Elevation: Brickwork Replacement

Inspected, Brickwork has been repaired. Not Opal Access

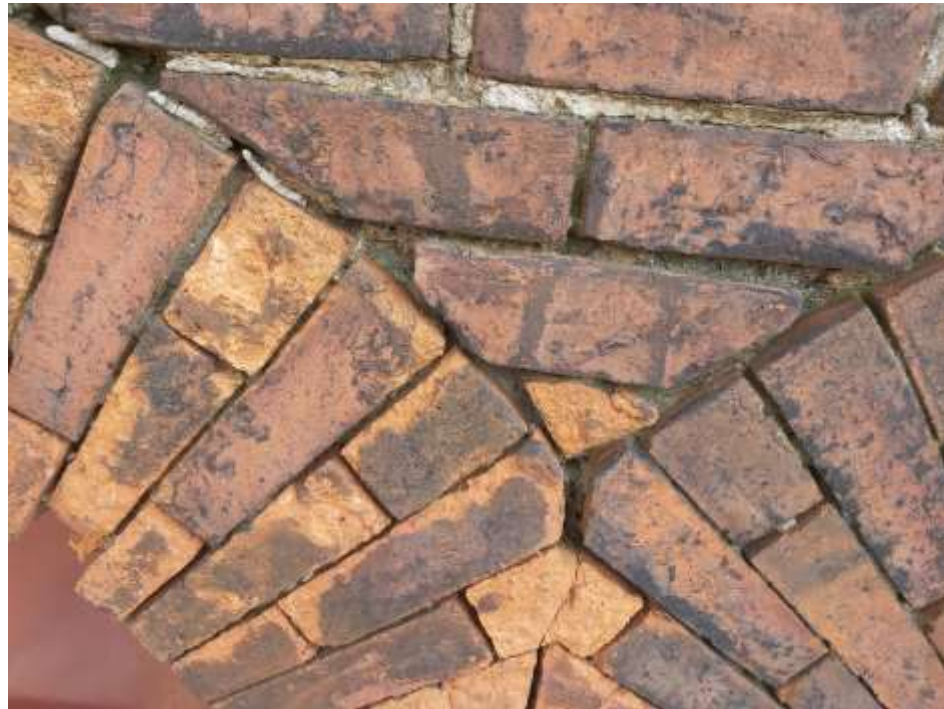
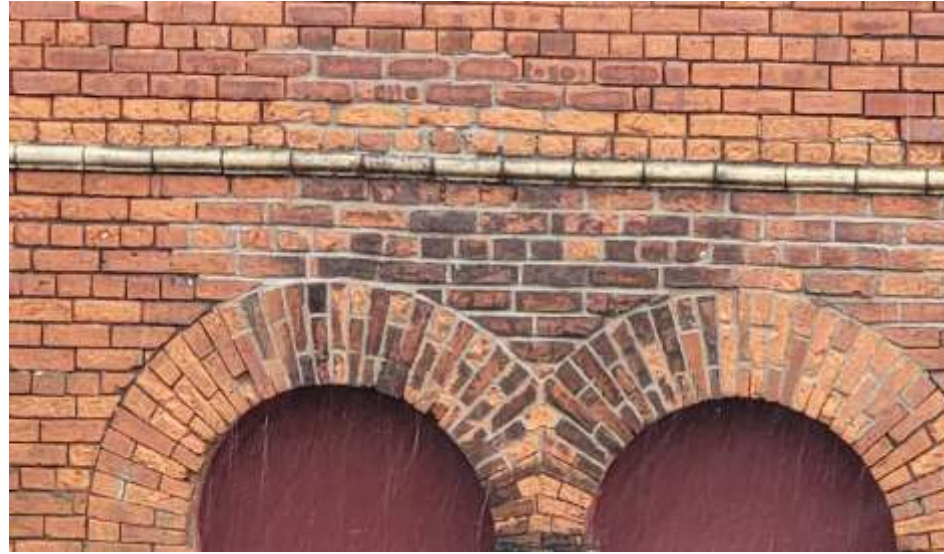
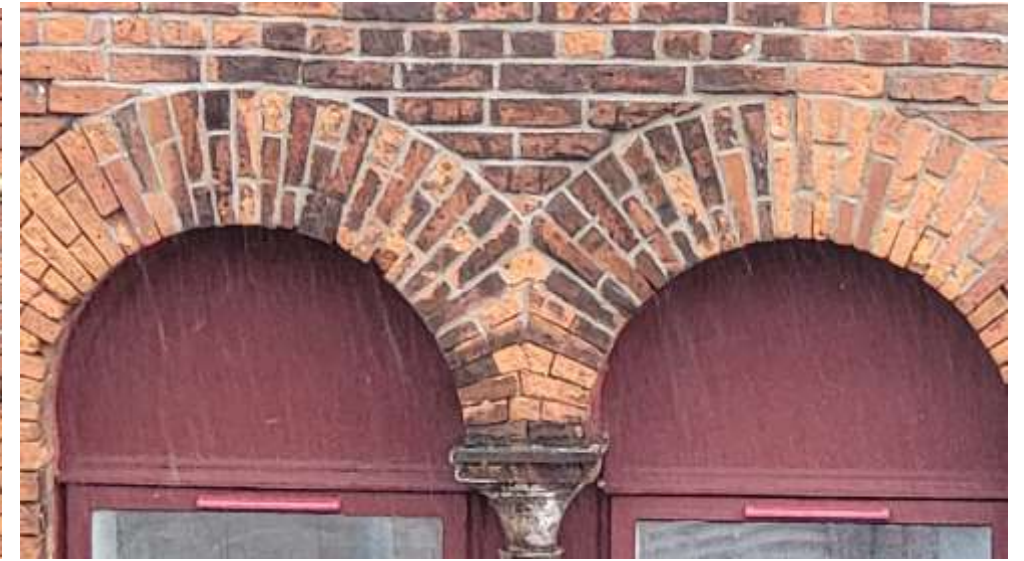
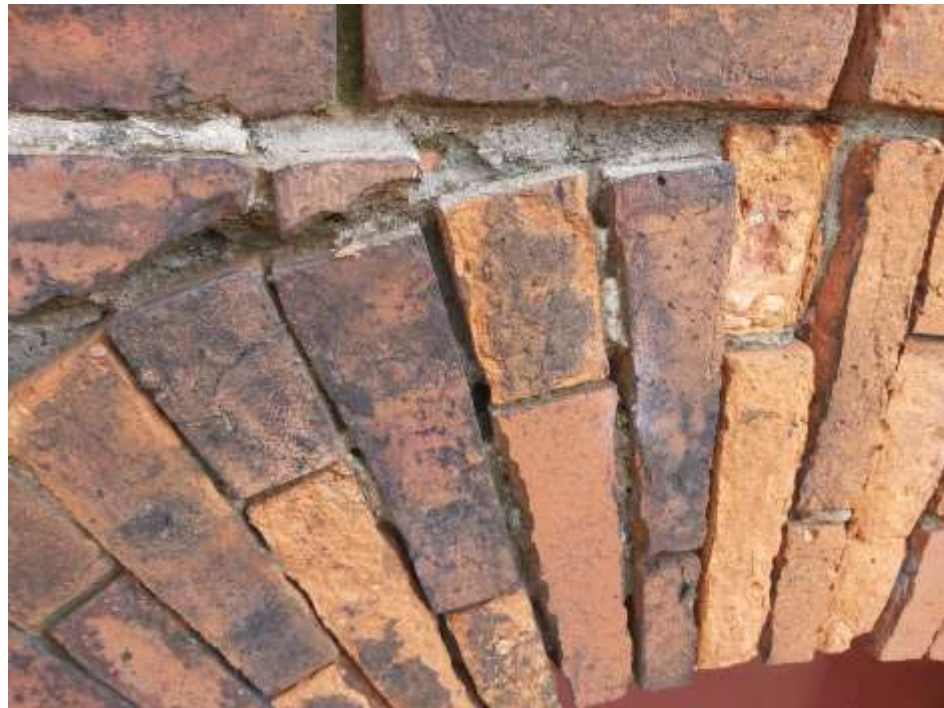
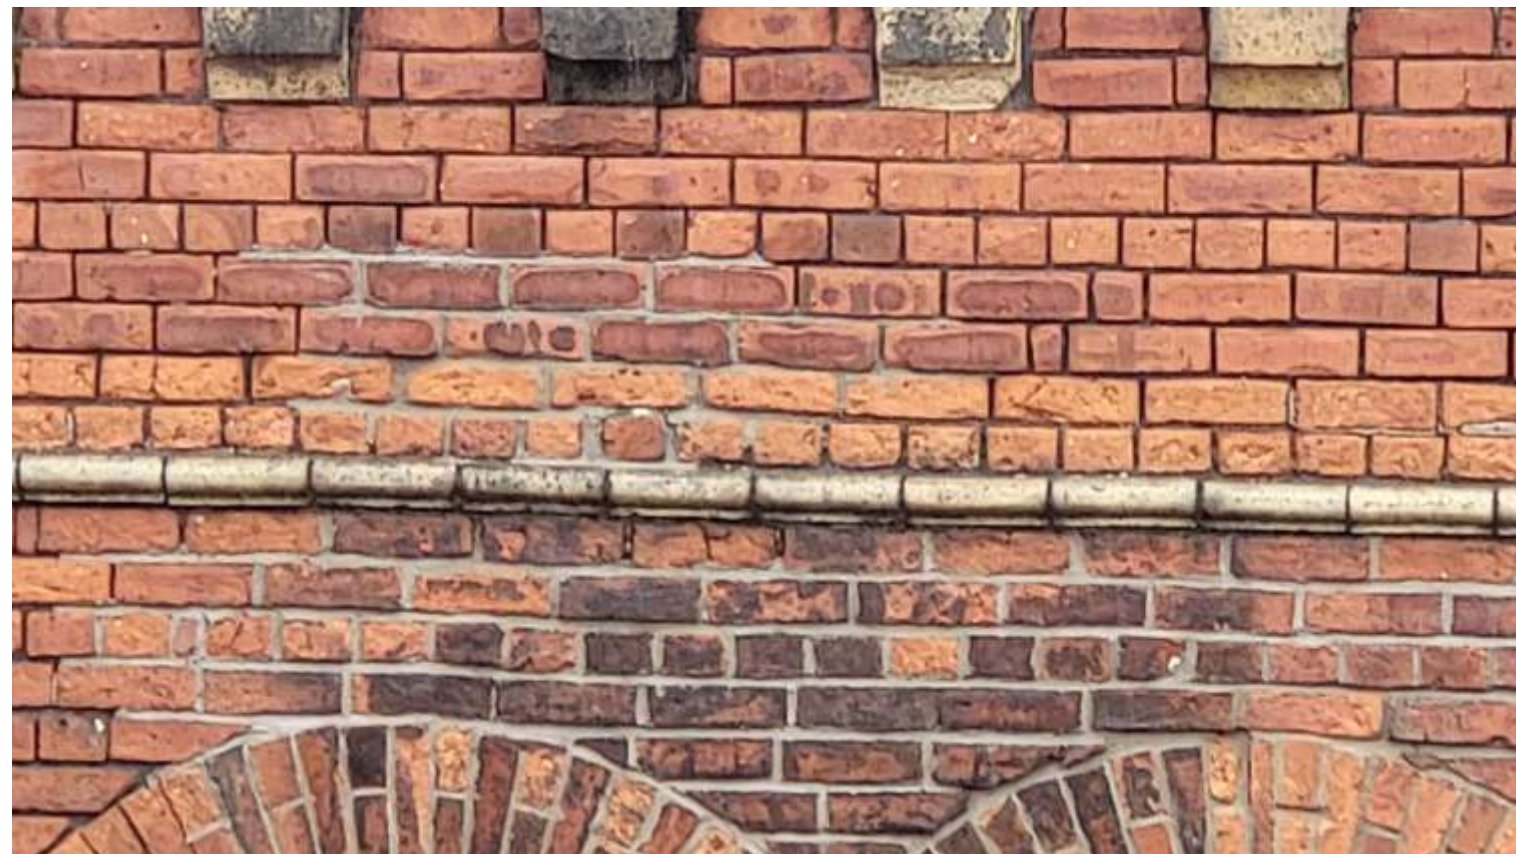
### 2: Courtyard Elevation: Water Staining

Inspection carried out, not water straining but in fact oil residue. Cleaned to as good as it can be. Will repoint surround and replace the missing brick.

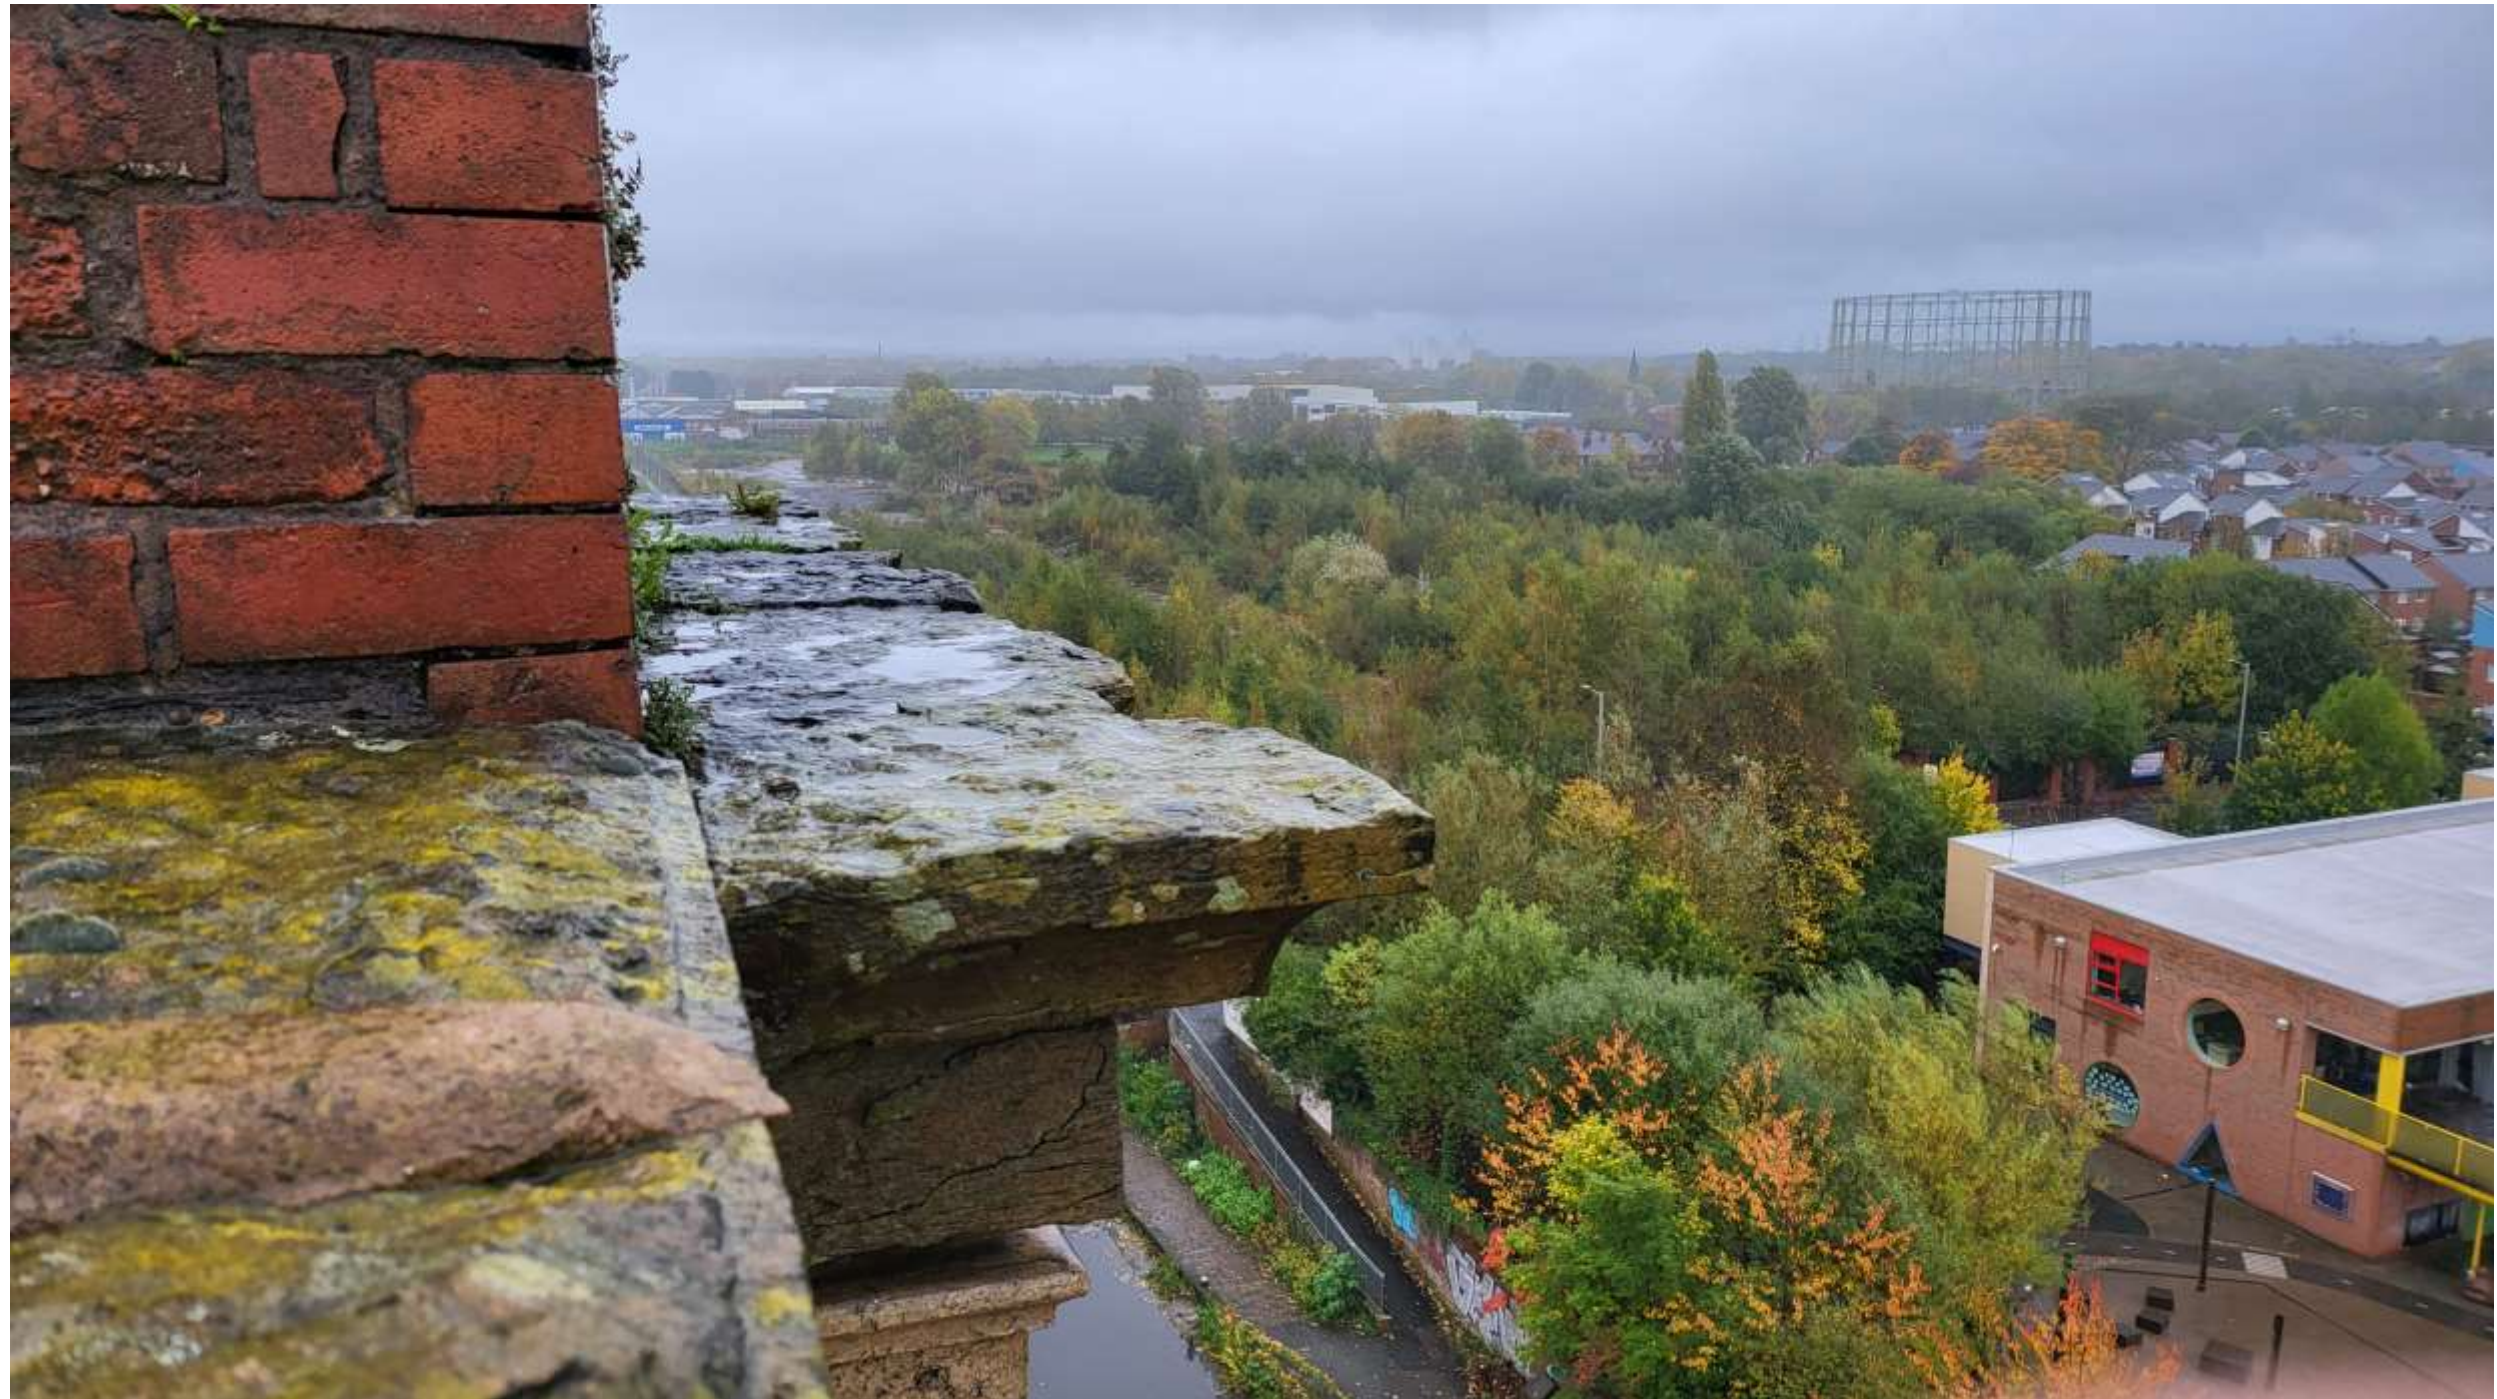
### 3: Courtyard Elevation: Top Veg Removal

Veg to remove upon return

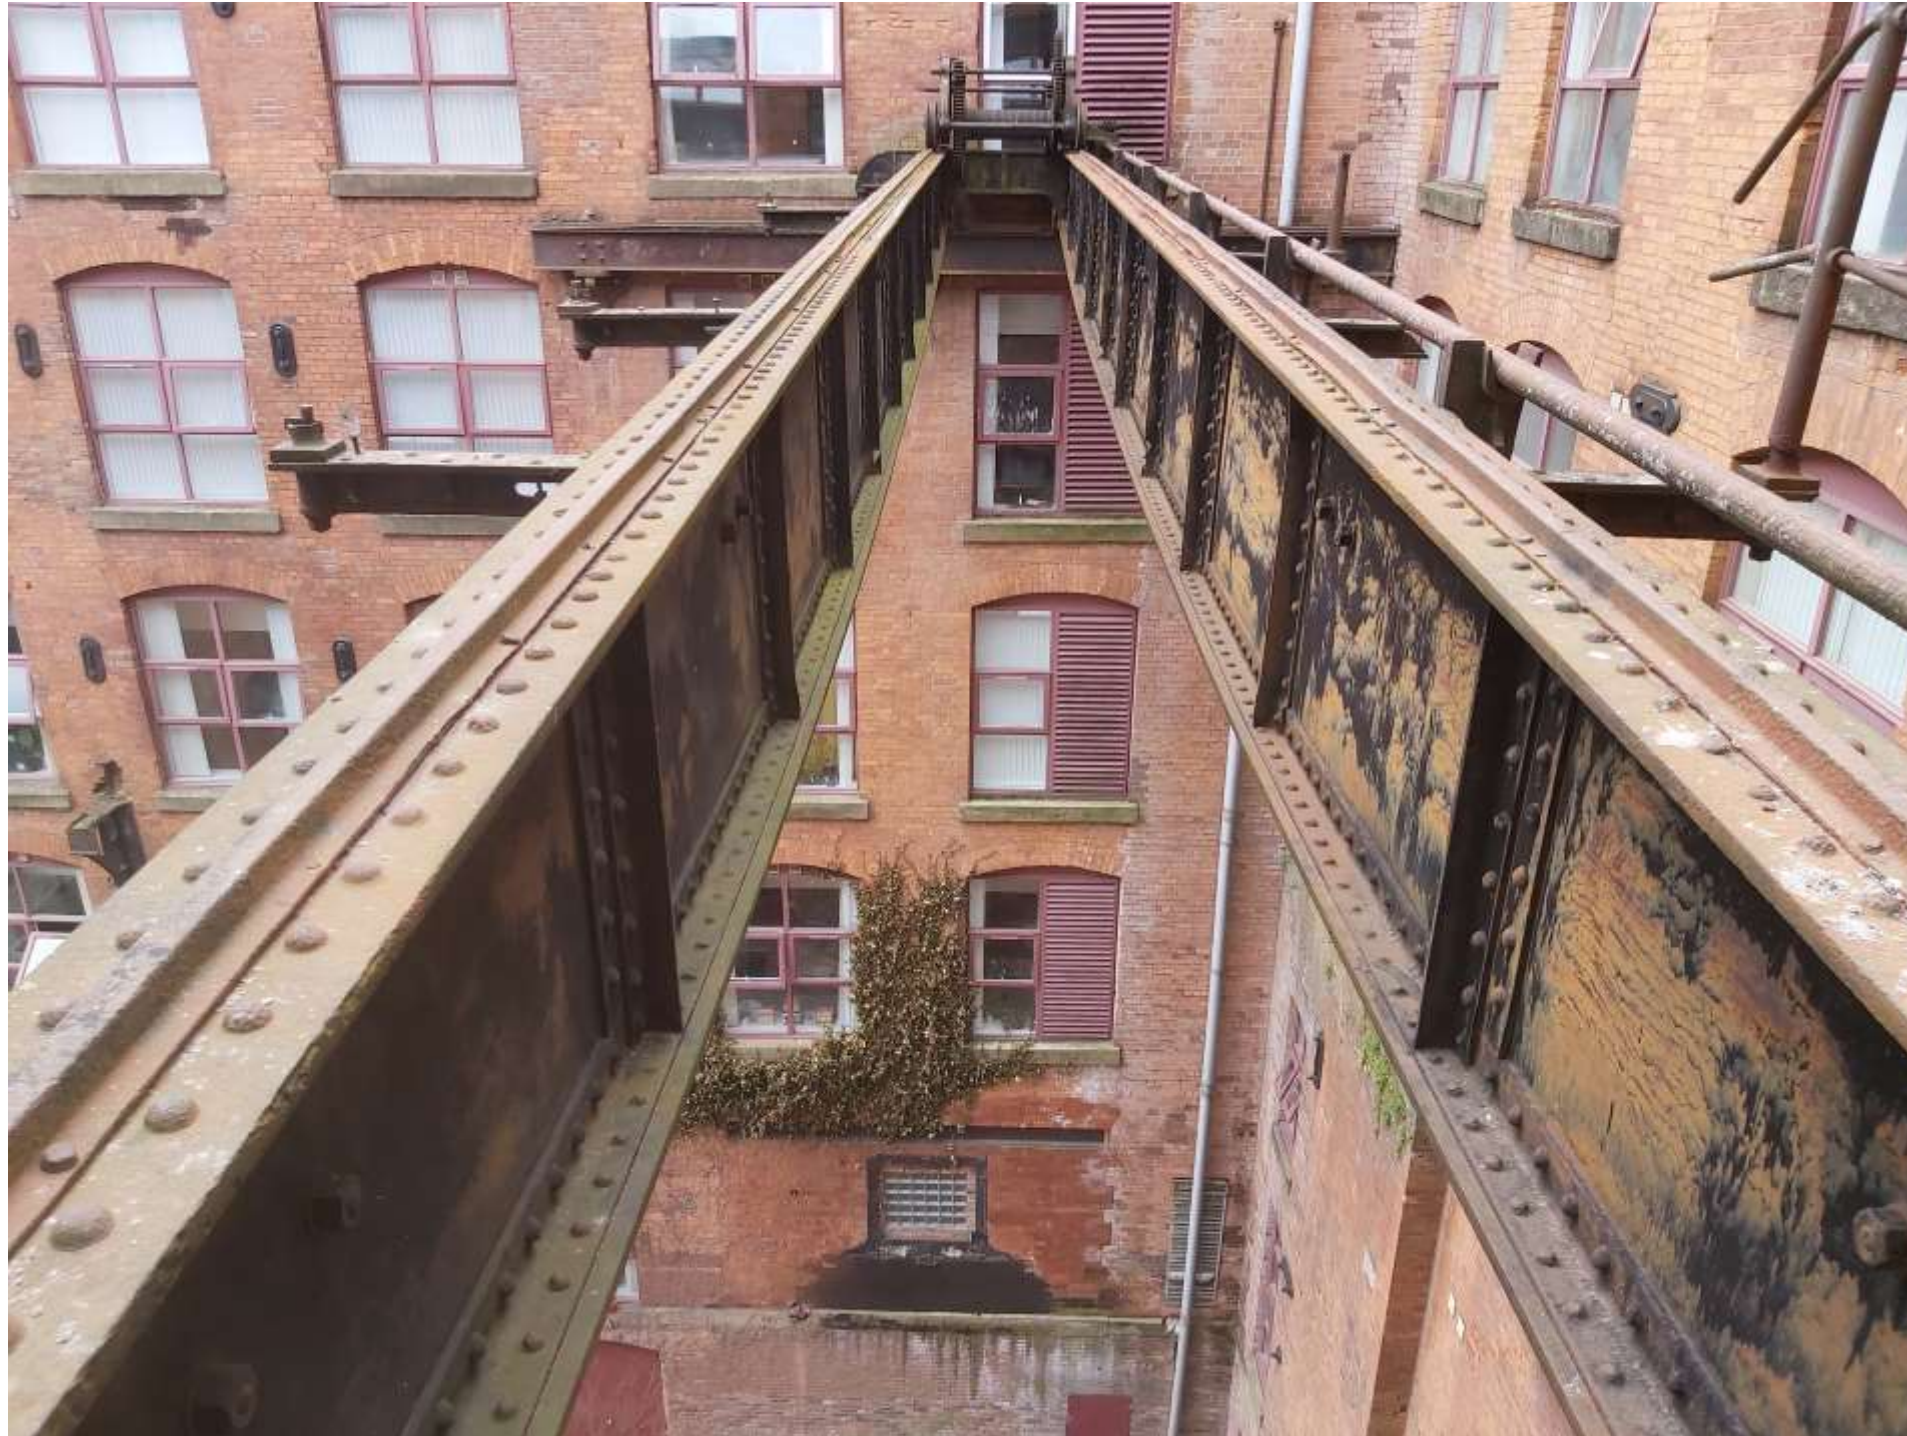
### 4: Courtyard Elevation: Metal Work Refurbishment

Cleaned with sugar mineral spirits and manual hand abrasion tools, however, only marginal improvement.

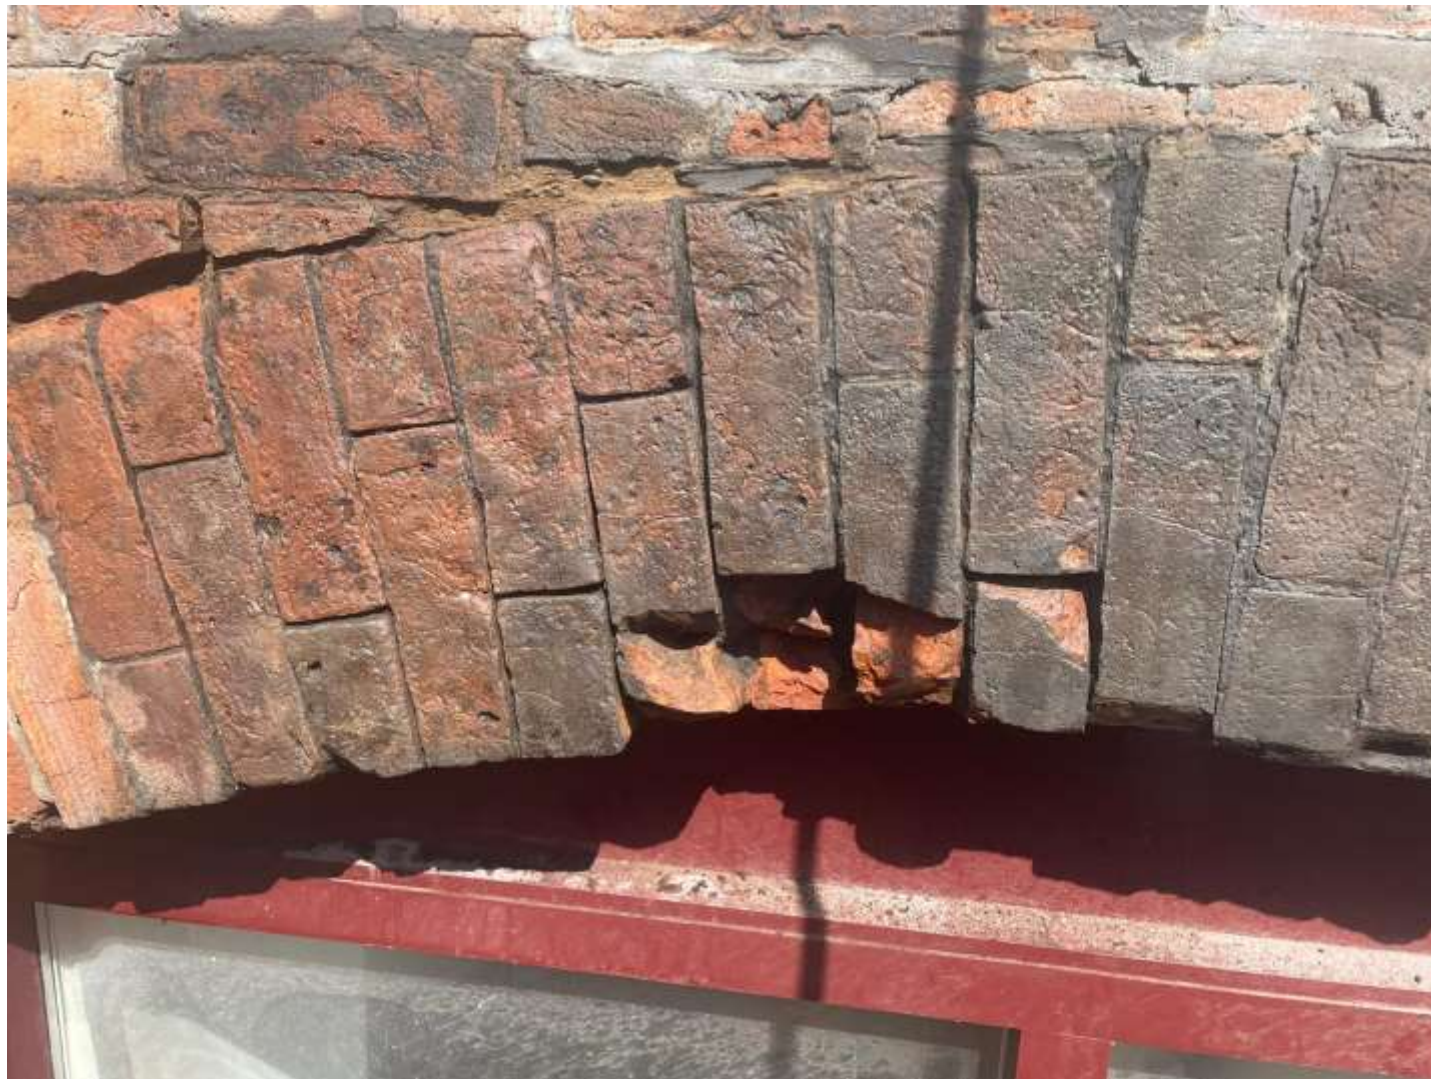
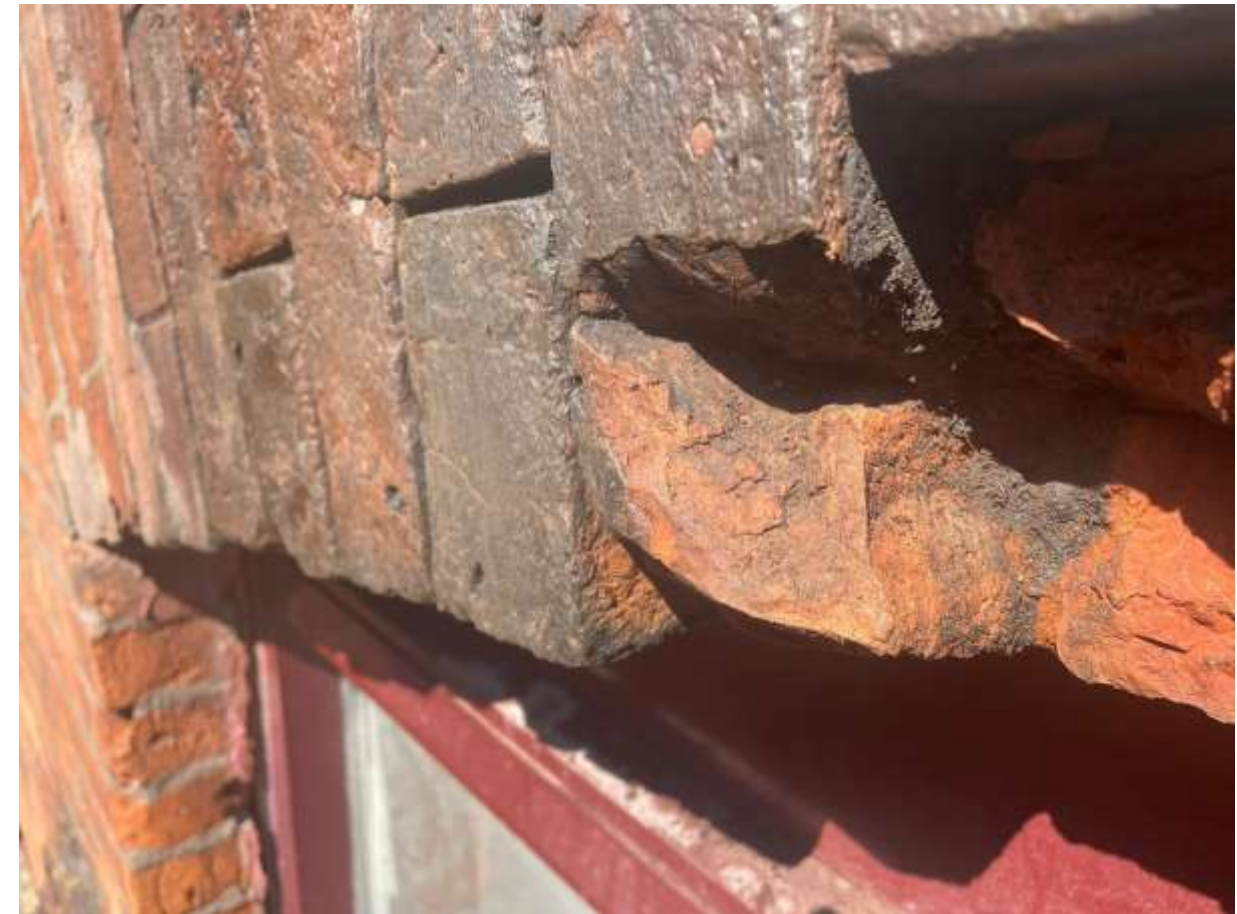
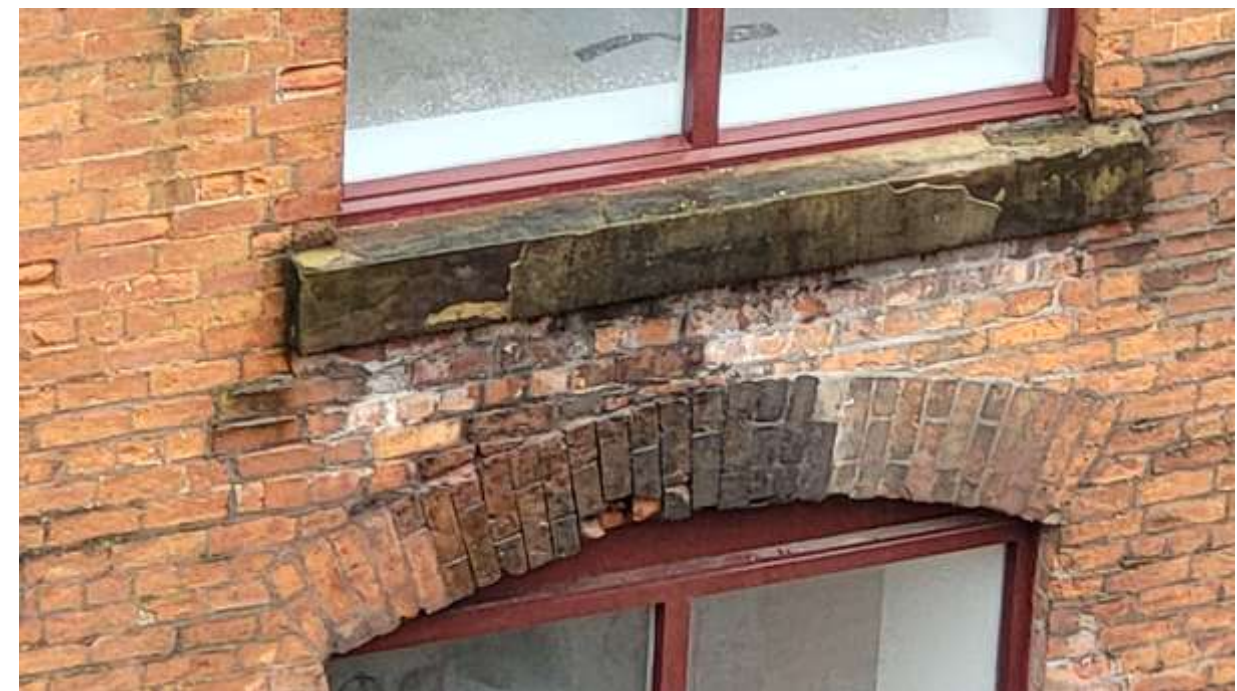
### 5: Courtyard Elevation: Water Staining requires investigation

Area inspected, it was found the staining was not water but oil residue. Cleaned to the best it can be with chemicals. Same for 6/7

Additional work added by Paul Mason: Replace cracked bricks. 1 Day added
