REPORT OF VICTORIA MILL

LOWER VICKERS ST, MANCHESTER M40 7LH

Date of project: 02/08/2021—Ongoing

| <p><b>F.A.O:</b> Medlock</p> <p><b>Author:</b> Lee Armstrong</p> <p><b>Project Description:</b><br/>Rope Access Remedial Works Various</p> <p><b>Technicians who carried out works/inspection:</b><br/>Marc Stirrup Lv 3<br/>Anthony Smith Lv 2<br/>Simon Powers Lv 1<br/>Chris Odonnell Lv 3<br/>Craig Samson Lv 2</p> <p><b>Contents:</b></p> <ul style="list-style-type: none"><li>Introduction</li><li>List of defects provided by Medlock, descriptions of works and links to evidence of works</li></ul> | <p><b>Introduction</b></p> <p>This report shows the evidence of works for all the remedial carried out at Victoria Mill</p> <p><b>NOTE</b></p> <p>Site meeting carried out. Paul Mason the Conservation Officer in attendance to agree scope of works.</p> <p>If you have any questions regarding the project please contact us on 0141 433 8040 or email lee.armstrong@opalaccess.co.uk</p> <p><b>Materials Used On Site</b></p> <p>Hammerite Ultima Matt Black <a href="#">Hammerite Ultima Matt - Hammerite UK</a></p> <p>Blue Cicle Lime <a href="#">Blue Circle Natural Hydraulic Lime 3.5 25kg Travis Perkins</a></

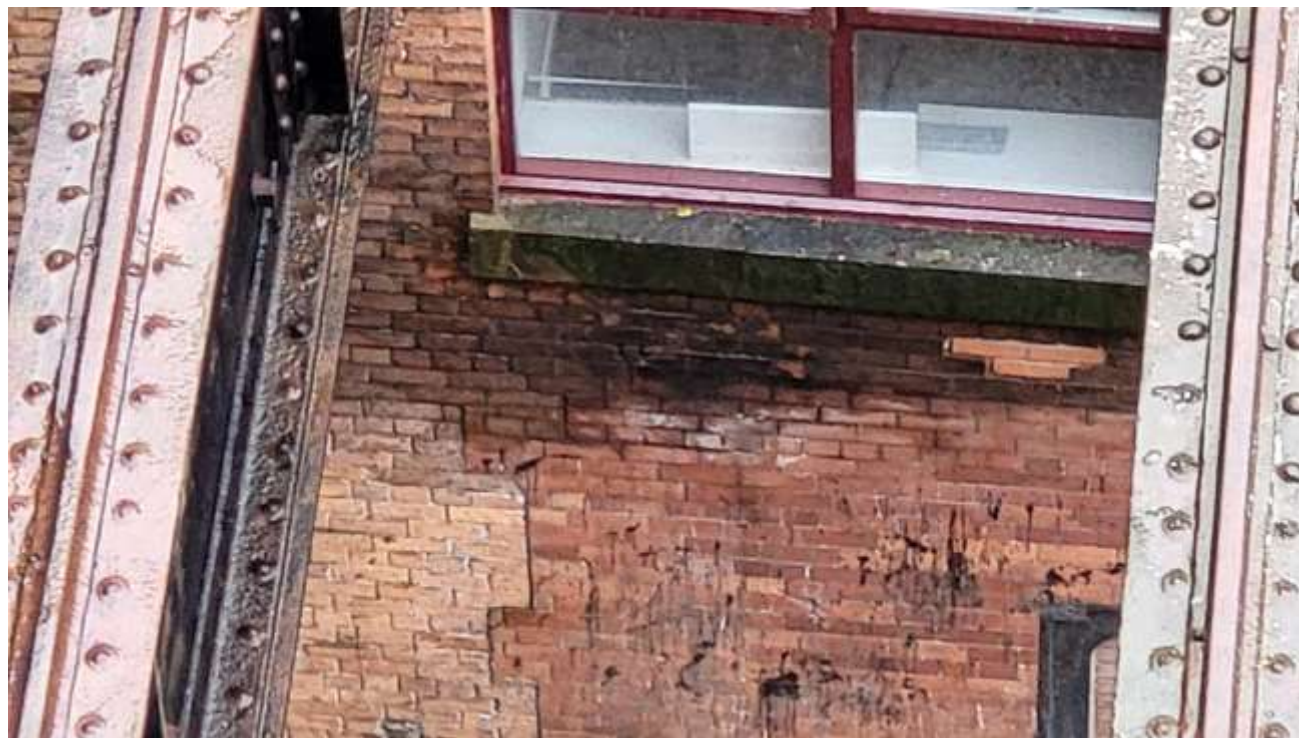
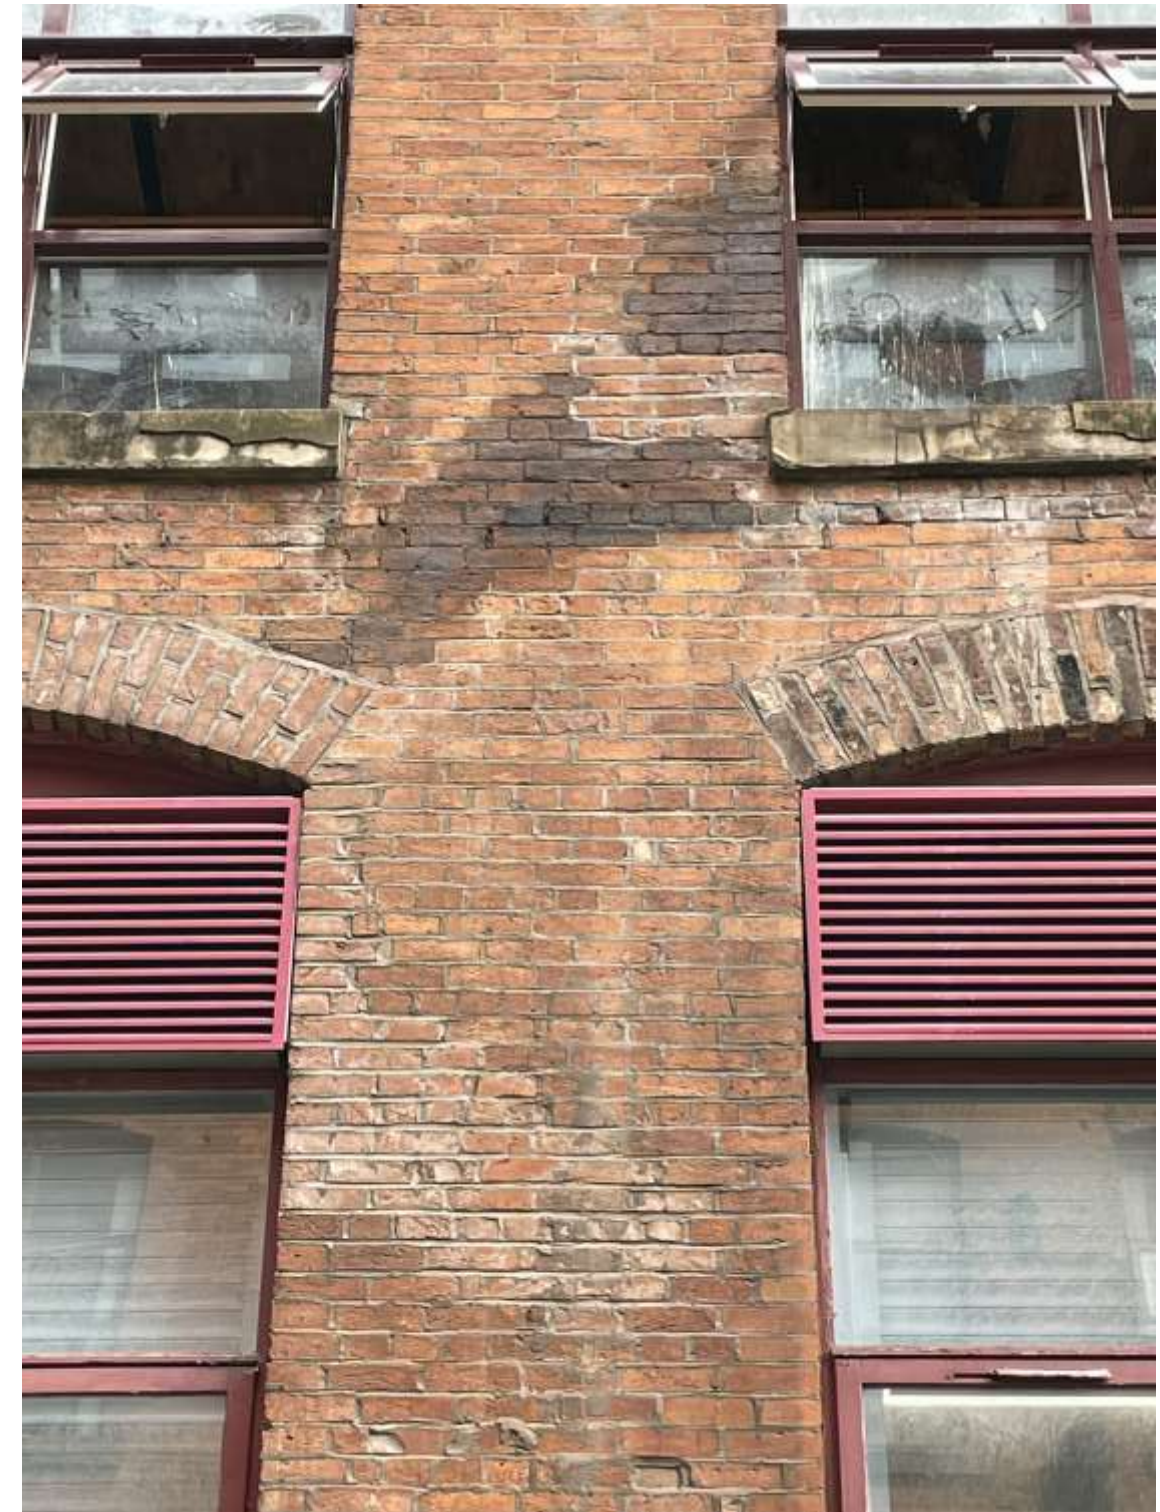
6/7: Courtyard Elevation: Water Staining requires investigation

Area inspected, it was found the staining was not water but oil residue. Cleaned to the best it can be with chemicals.

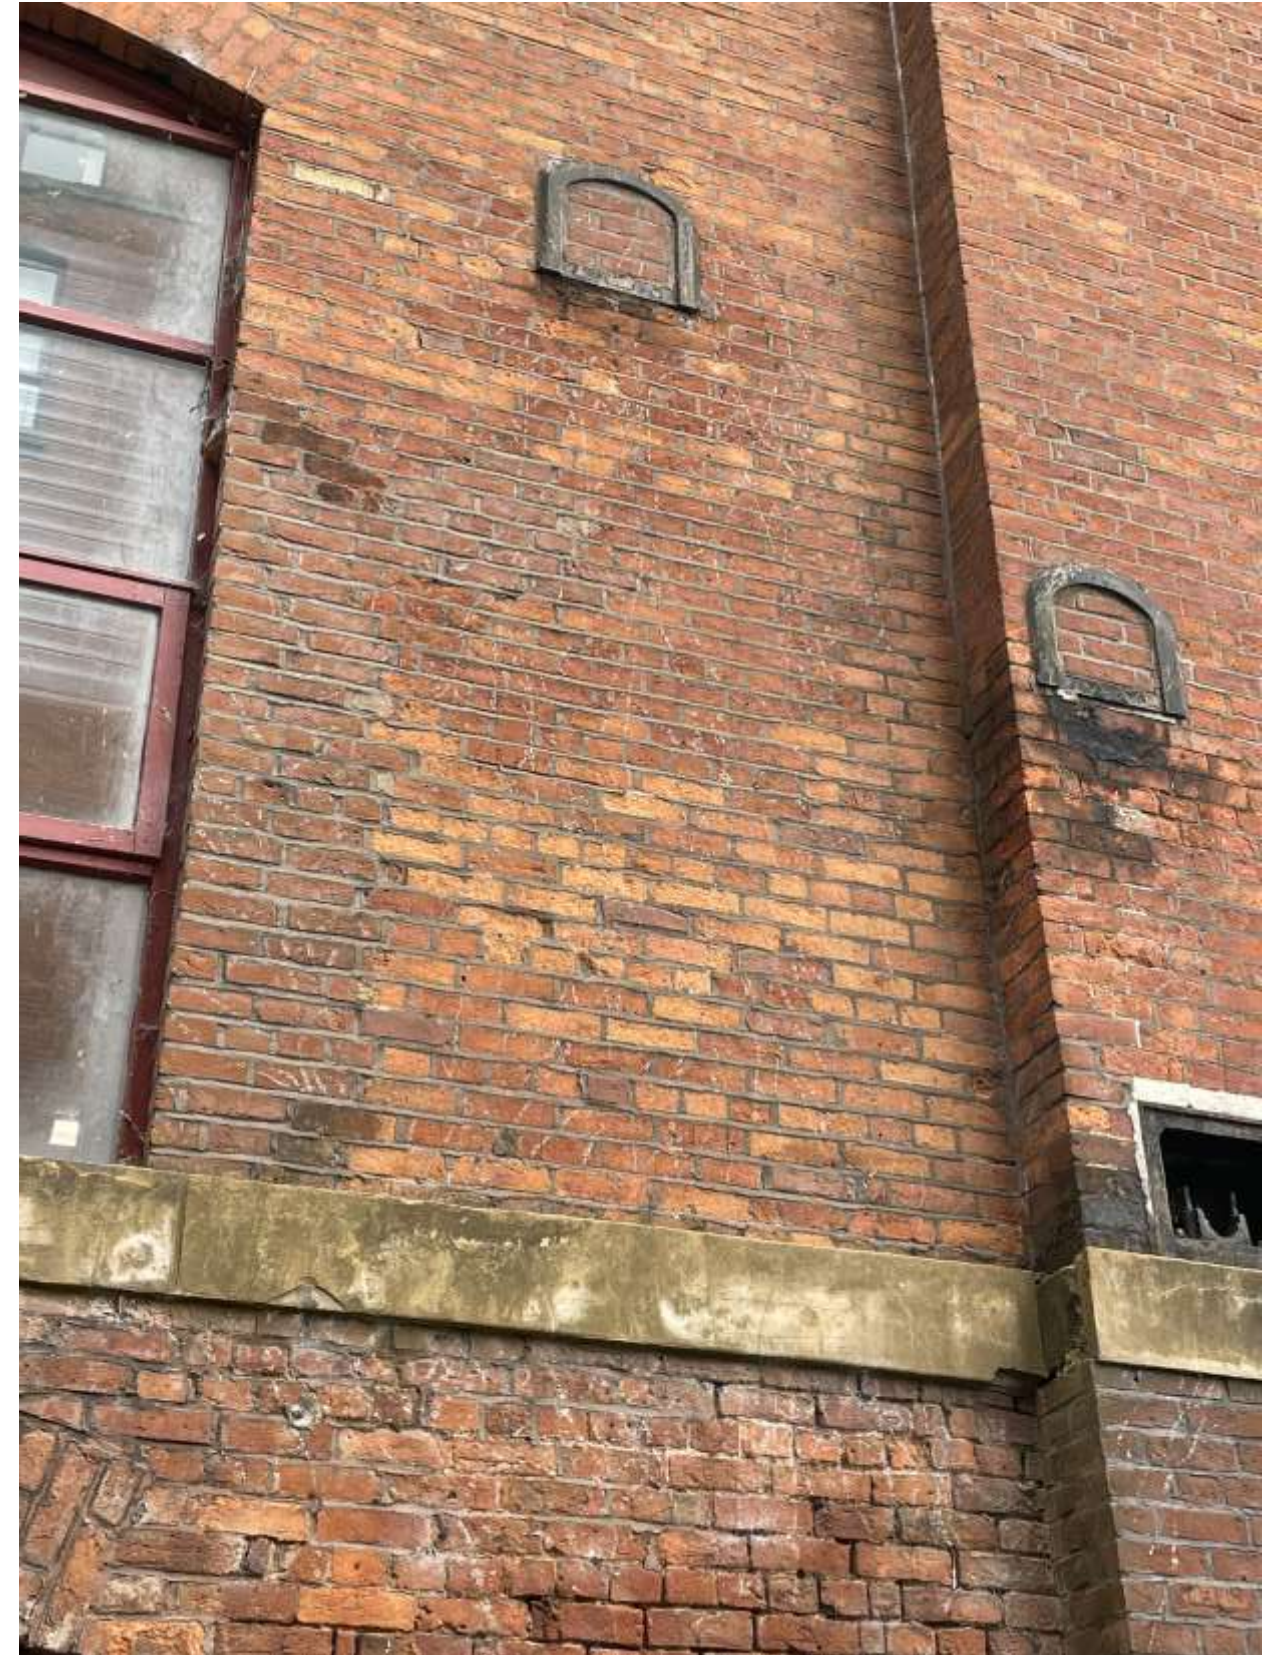
### 8/9: Courtyard Elevation: Veg Growth Removal

Area inspected and repointed with lime mortar mix carried out. Veg has been removed

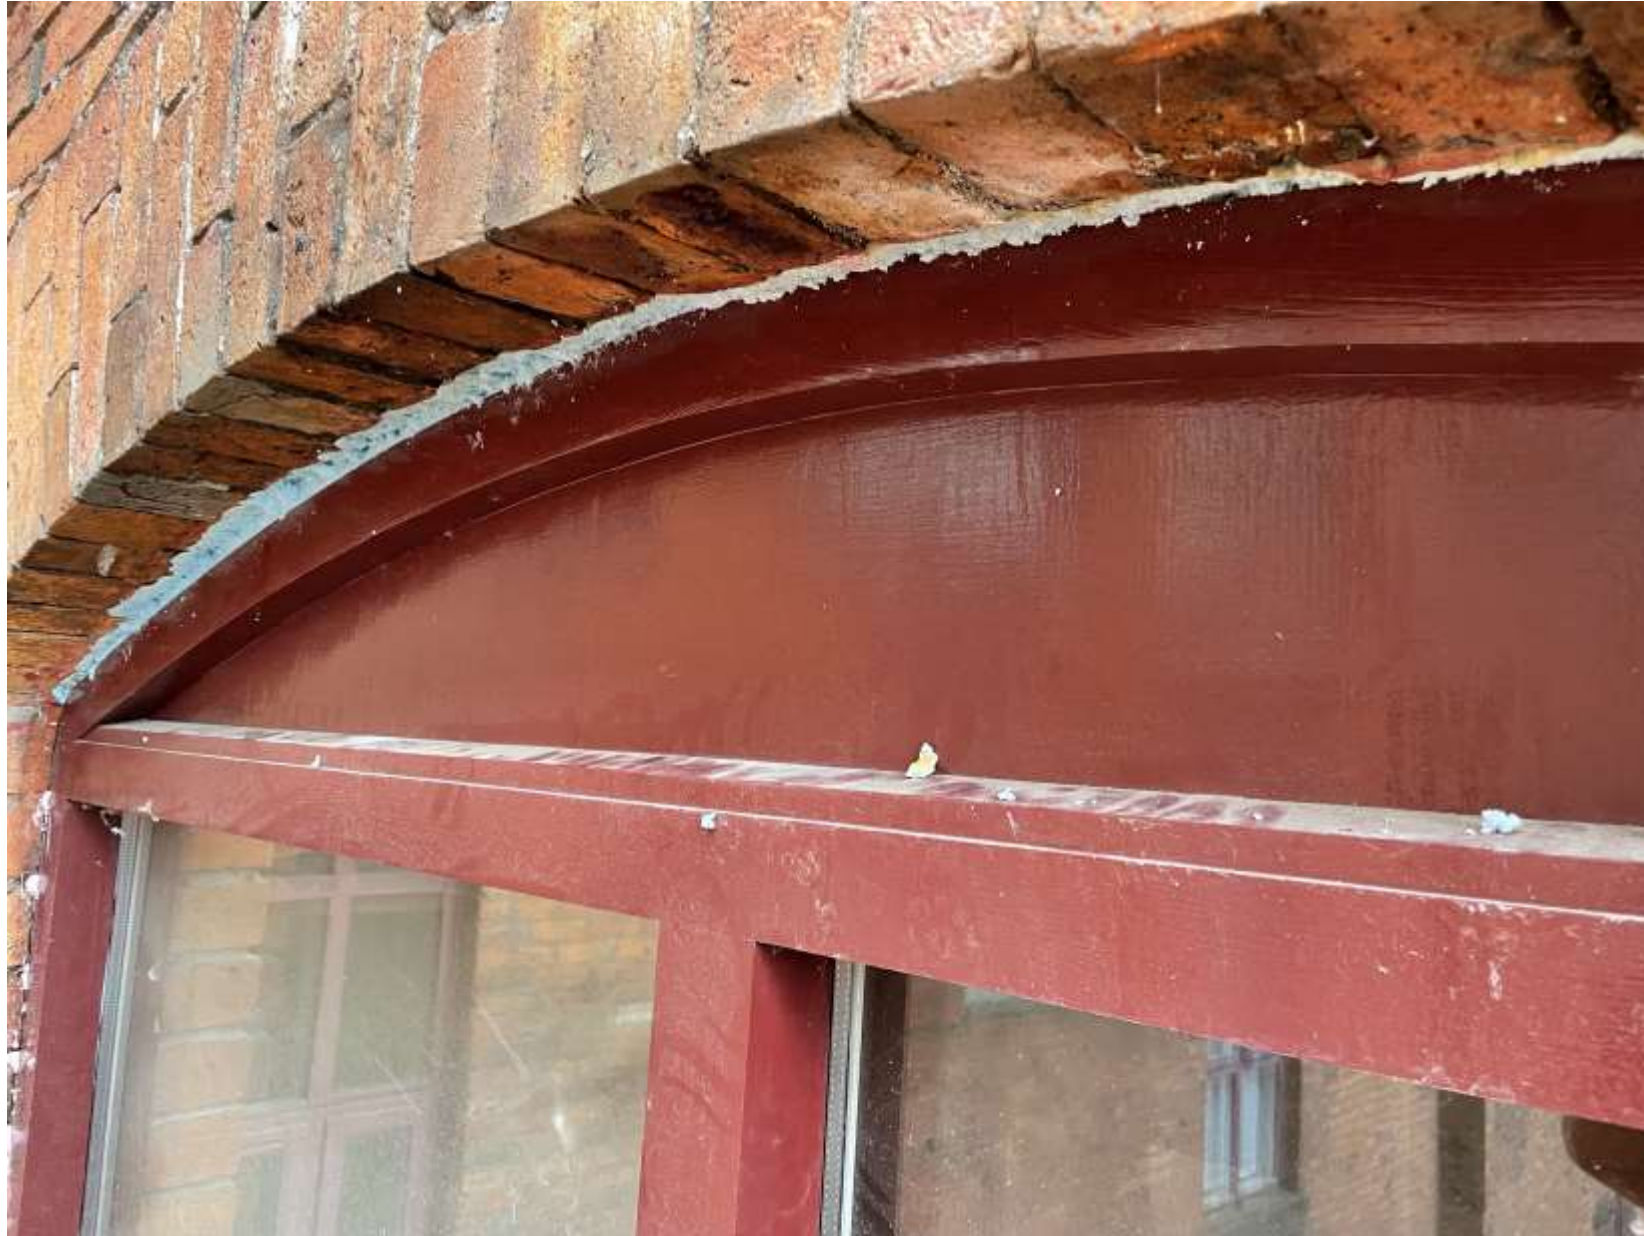
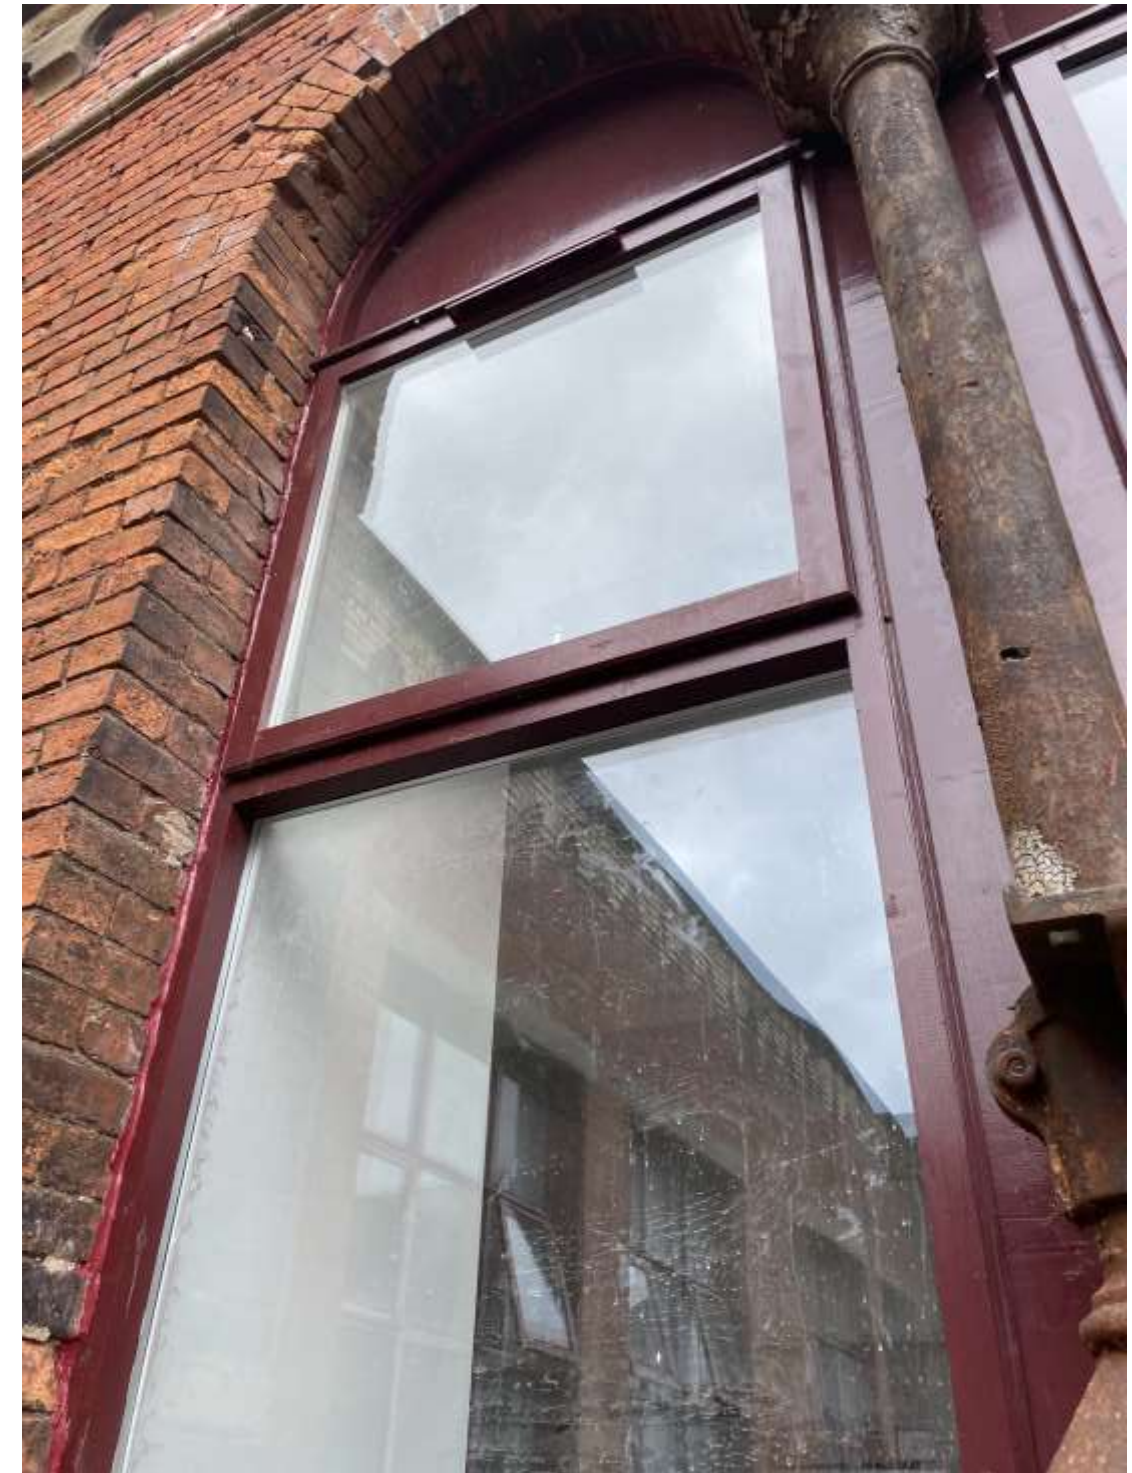
Trickle Vents installed and mastic of windows

Comments:: Mastic completed to courtyard and south east elevation Trickle vents installed to all elevations within scope.

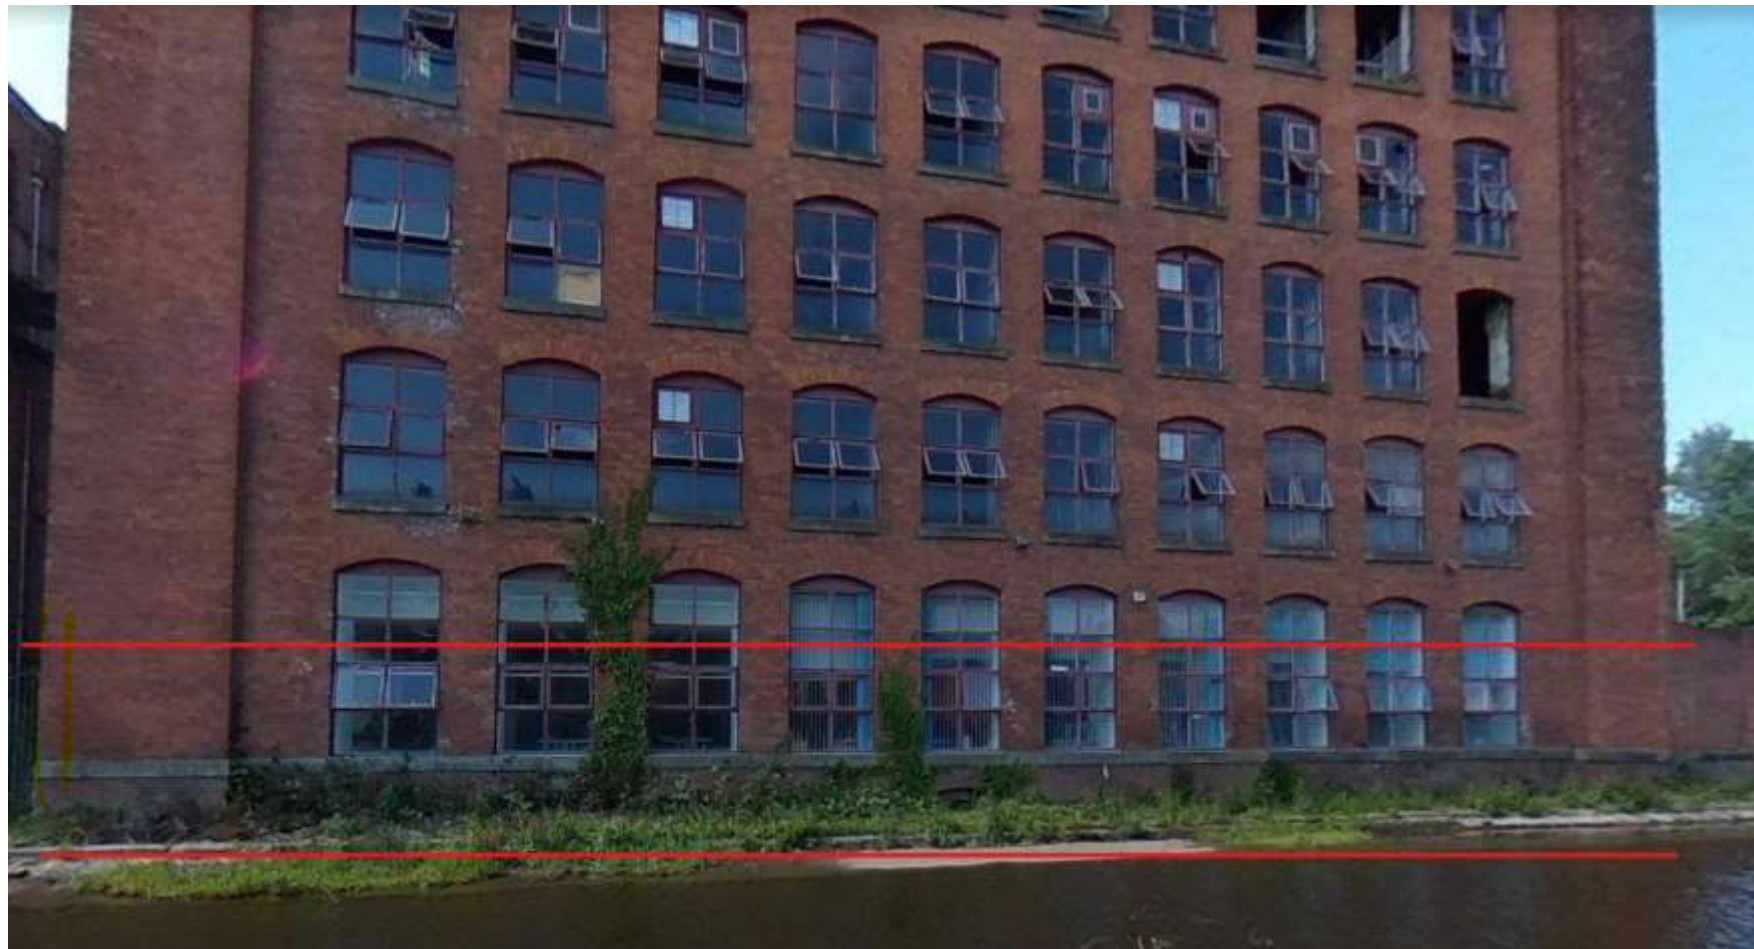
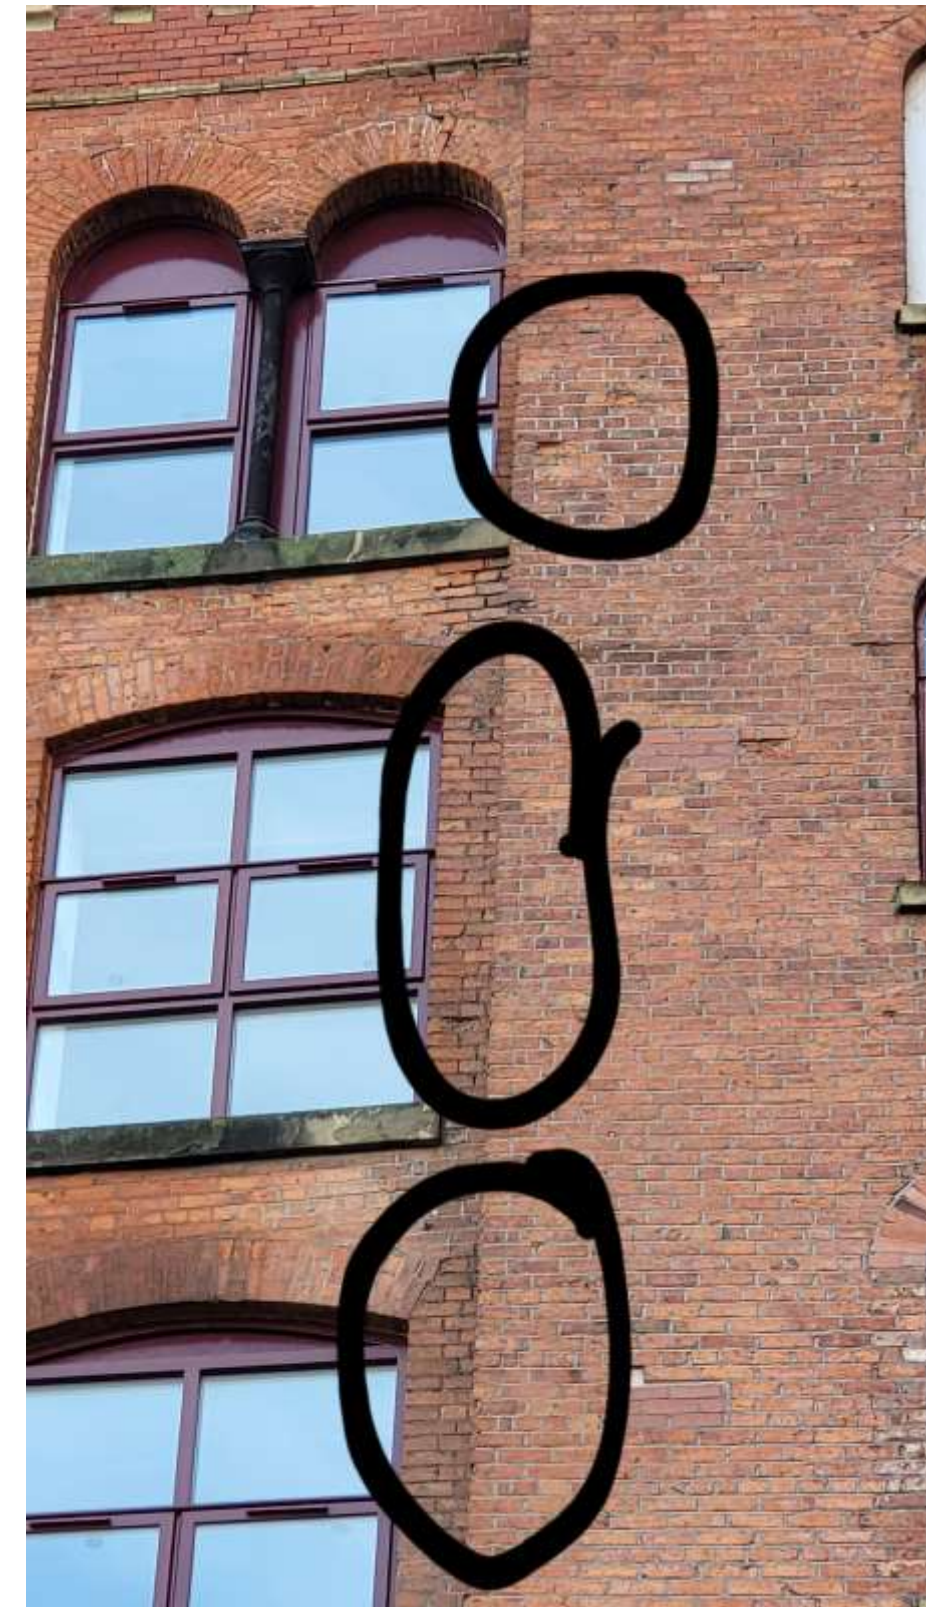
Additional works: Pointing of low level brickwork along the canal side. Three areas highlighted by Paul Mason on the North West Elevation. 3 days added for North West elevation. 2 days for the low level elevation.
