# GEOSHIELD

## Verification Report

McAlear & Rushe

101 Charles Street

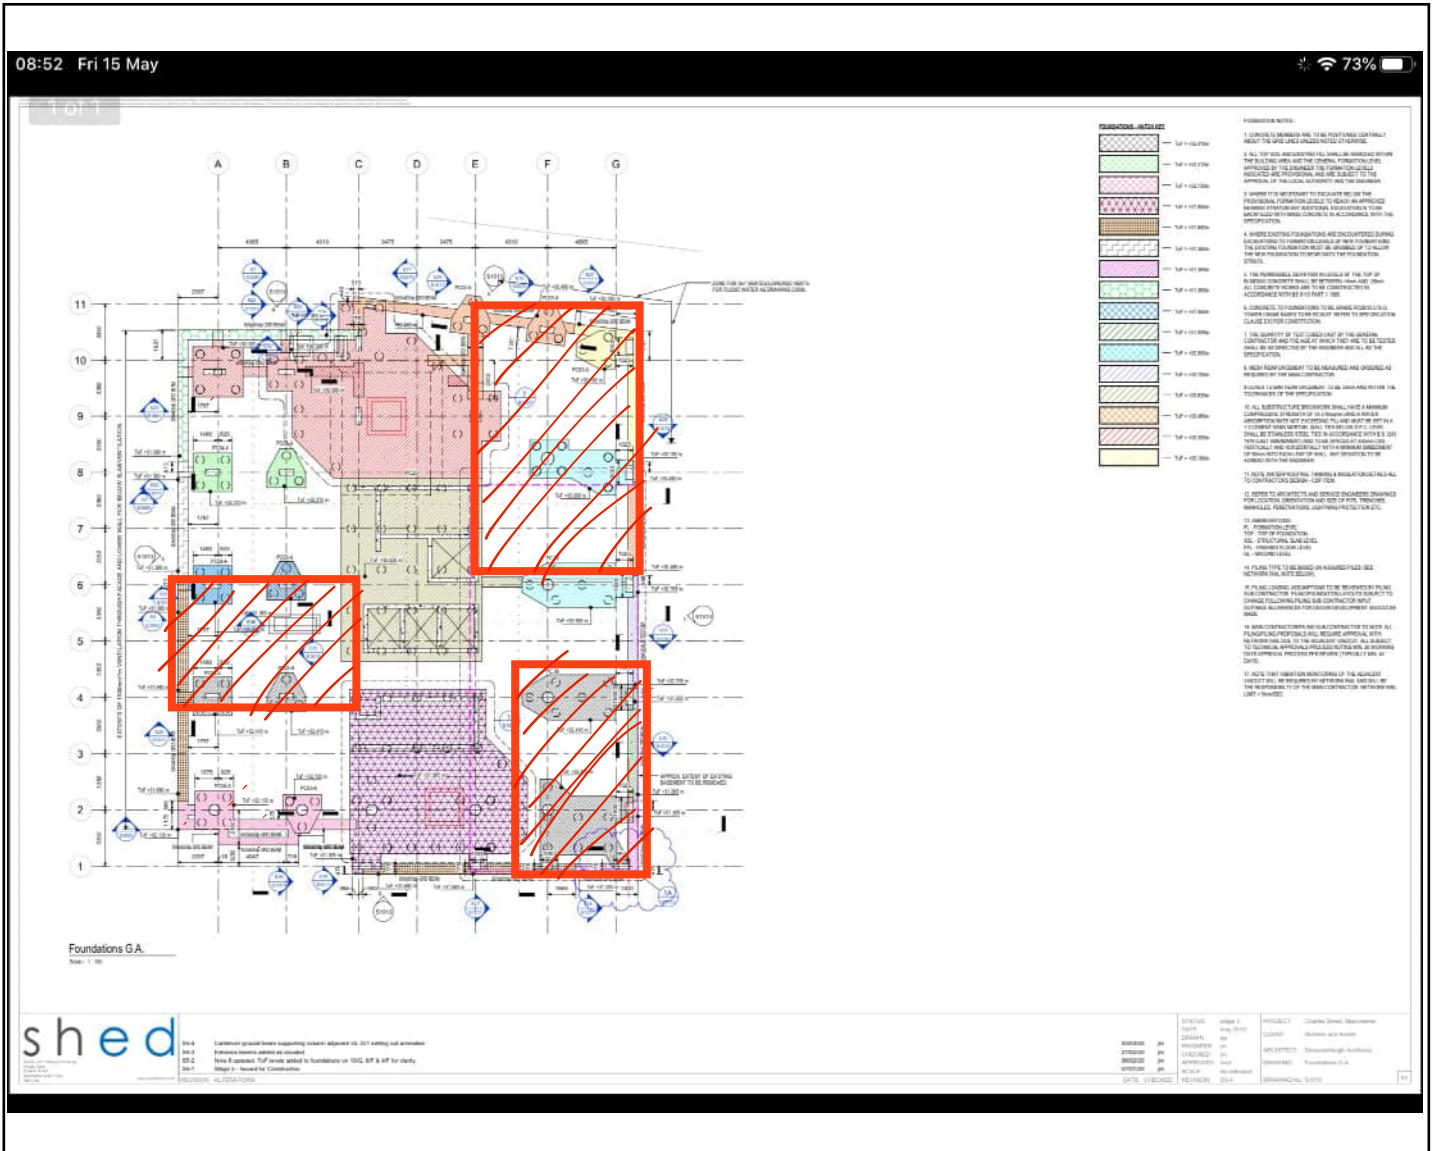
Gridlines 11/6:E/G, Gridlines 6/4:A/C and ring beams to 3/1:E/G

Verified in this report as highlighted above

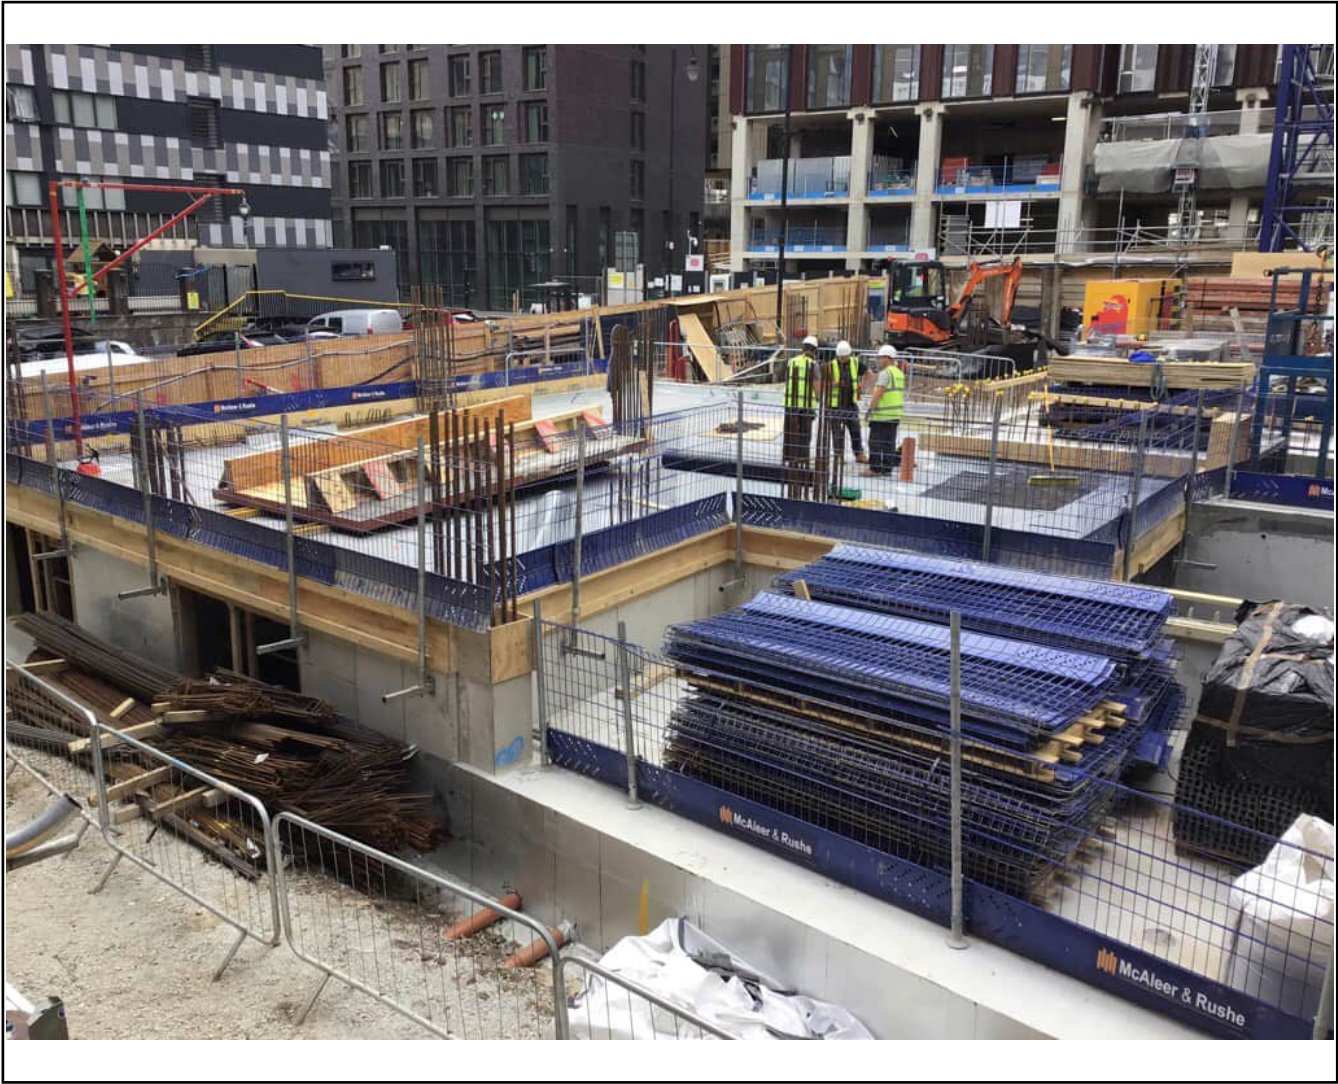
Overview of Site

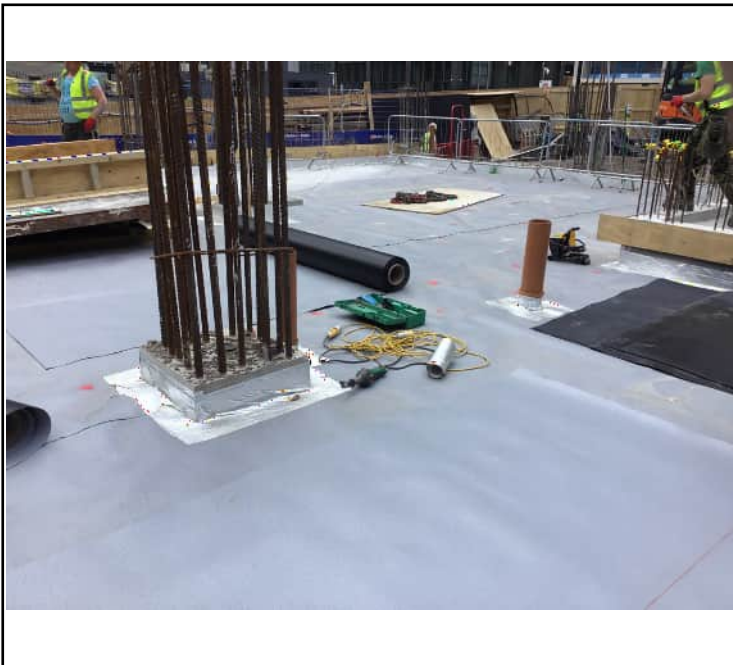
NOTES: Visqueen Ultimate Geoseal installed with Pro Demtech

Welded joints. Location of hooks marked on the membrane, extrusion welder to be used to installed hooks to support the membrane from steel re bar with in the slab. Hooks to be installed but strength will be tested on next visit.

1. Overview of Gridlines 11/6:E/G

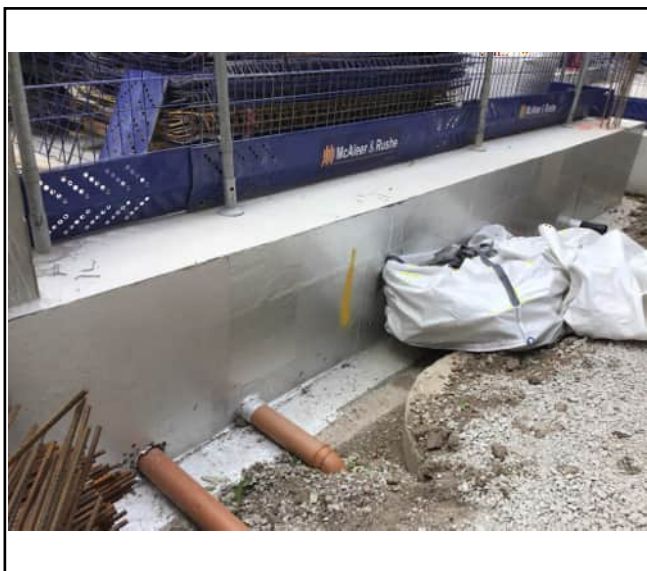
NOTES: Visqueen GR SAM installed to the perimeter details

to a bitumen primer concrete base. Works visually inspected and tested with pick and probe. Pipe penetrations sealed to a good standard. Works on going but complete works installed to a good standard with no faults found.

1. Overview of perimeter detail

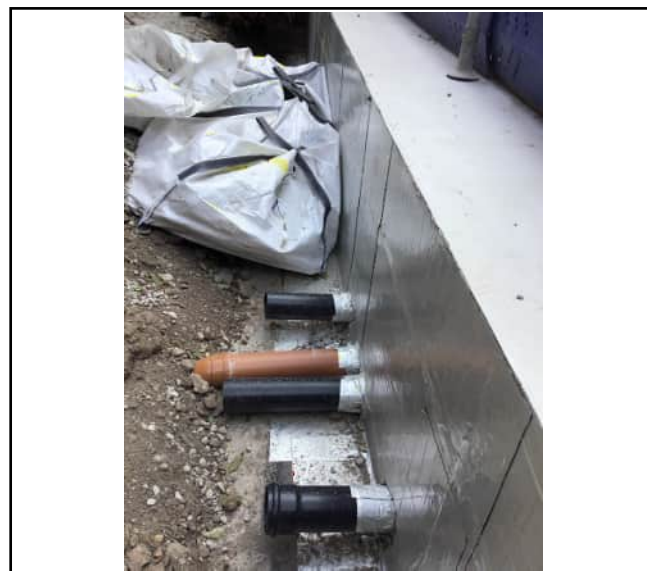
2. Pipe penetrations sealed to a good standard as per NVQ Level 2.

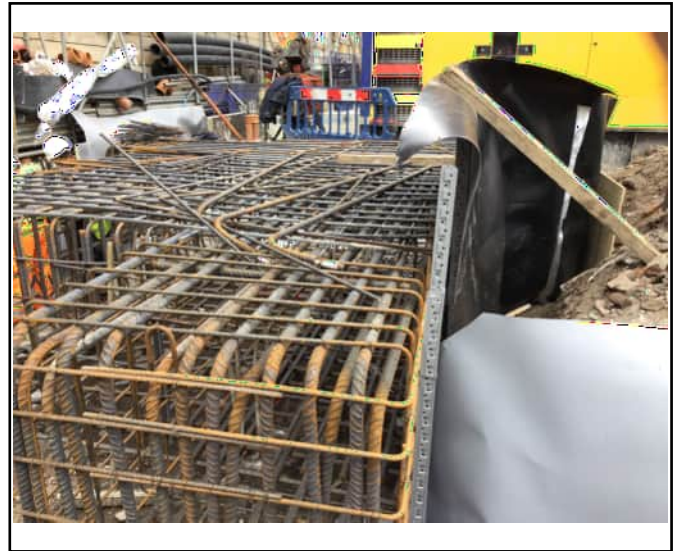
Visqueen Geoseal beneath

steel rebar 300mm as design detail

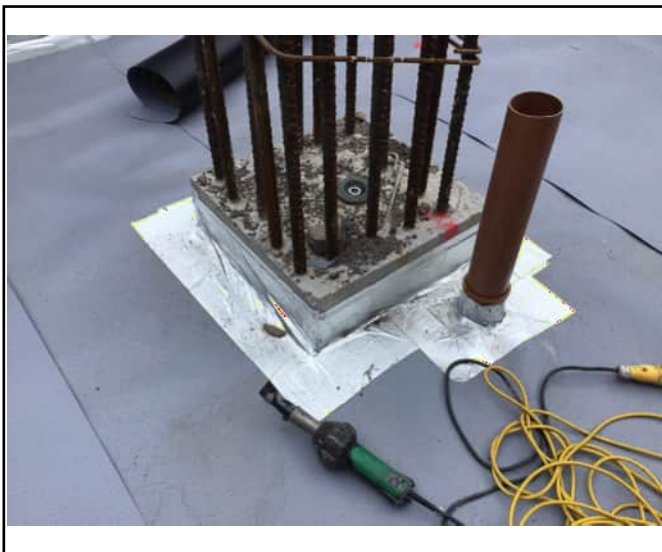
Penetrations in Gridlines 11/6:E/G

sealed to a good standard

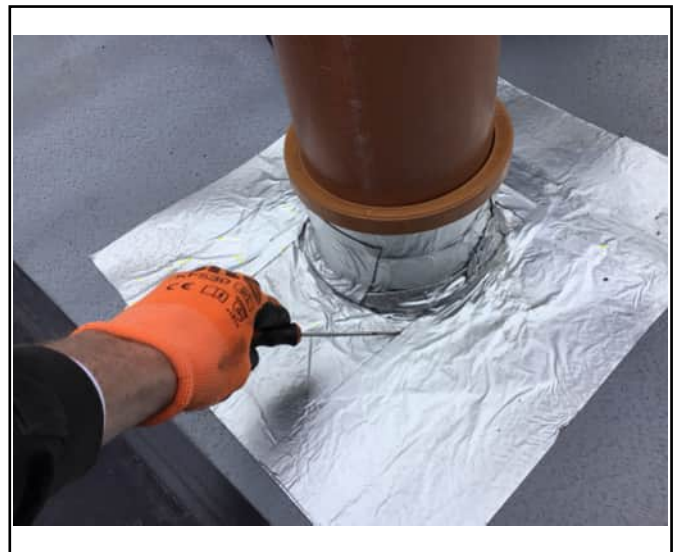
Penetrations in Gridlines 11/6:E/G

sealed to a good standard

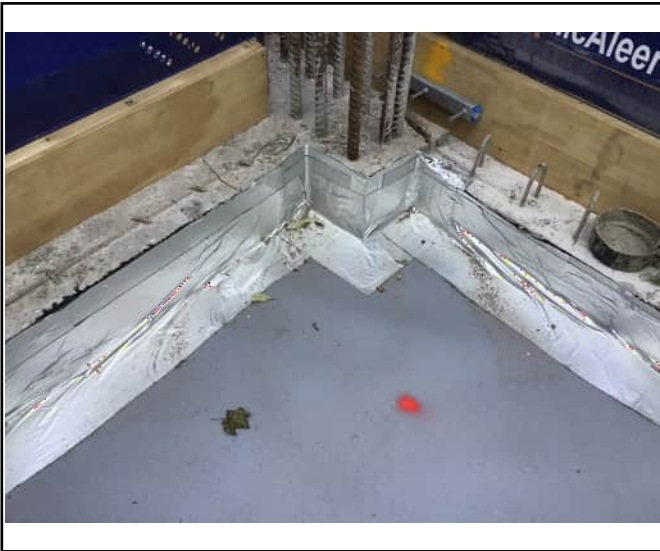
Perimeter to Gridlines 11/6:E/G

sealed to a good standard

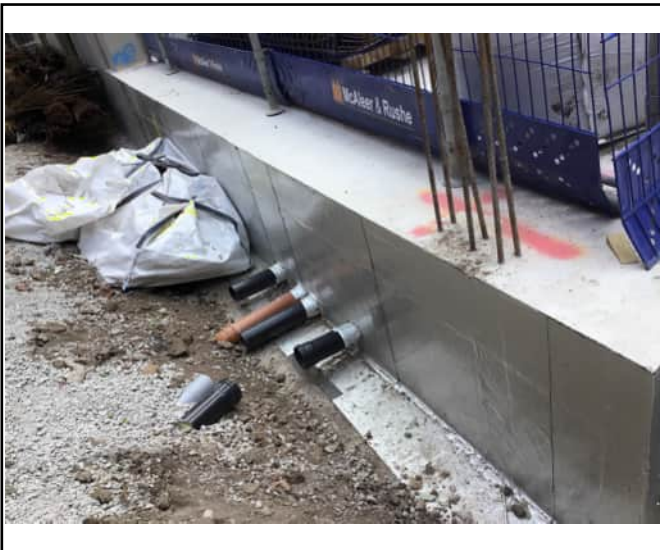
Perimeter detail sealed with no

faults found

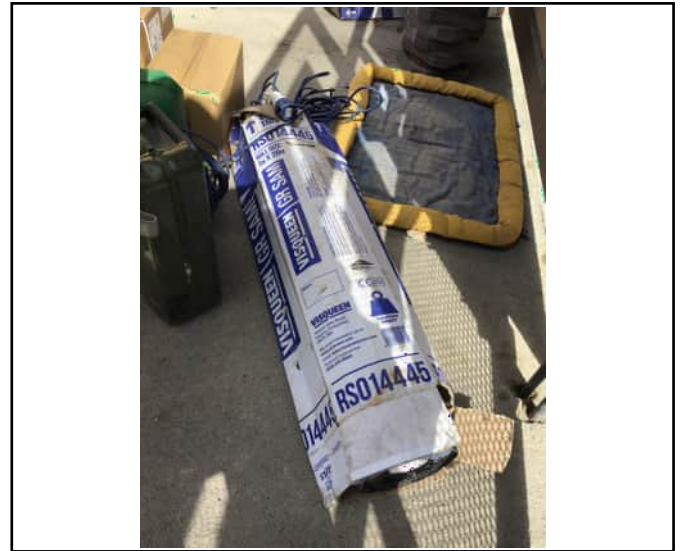
Visqueen GR SAM used throughout

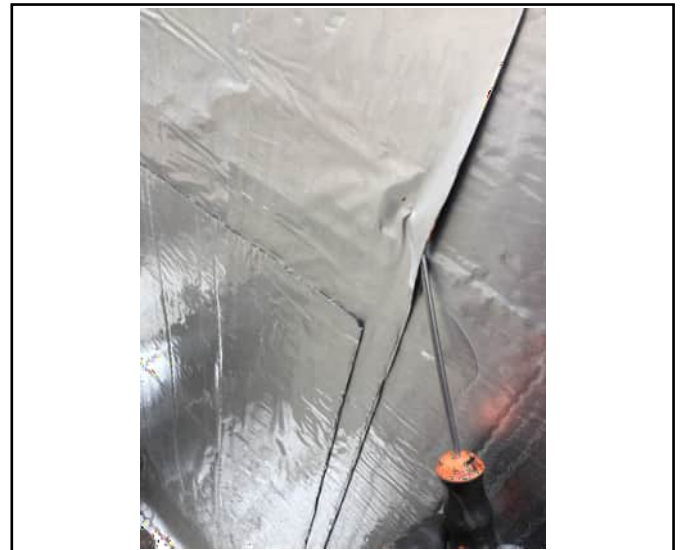
Pick and probe test to perimeter

detail. Good bond and overlaps
