## 40-46 Princess Street, Manchester Paint Analysis

### Report on Findings Report No HPMTA01

ISSUE 01– 18/11/2021

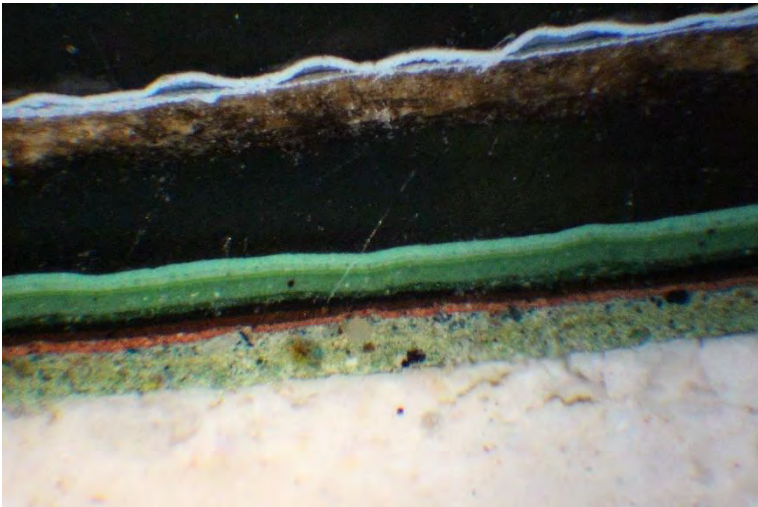
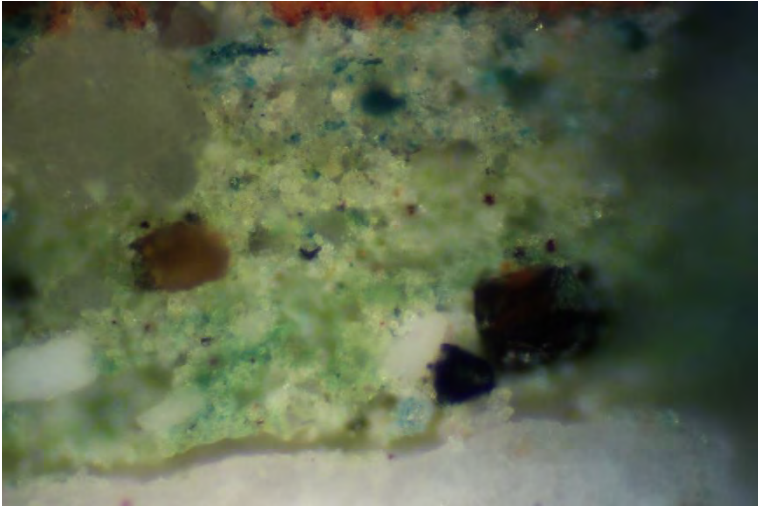
| Sample Ref:PS.01 | Location: 40-46 Princess Street |
|---|---|
| <br><br> | <p>X50 – Magnification</p> <p>Current blue paint scheme (2No layers) over wallpaper.</p> <p>4No layers of varying greens</p> <p>Red scheme with varnish over</p> <p>Earliest green paint scheme over lime plaster.</p><br><br><p>X400 -</p> <p>Earliest paint layers.</p> <p>A light green oil paint based on lead carbonate with Verdigris pigment.</p> |
| Early schemes tested for lead | Yes – positive. |

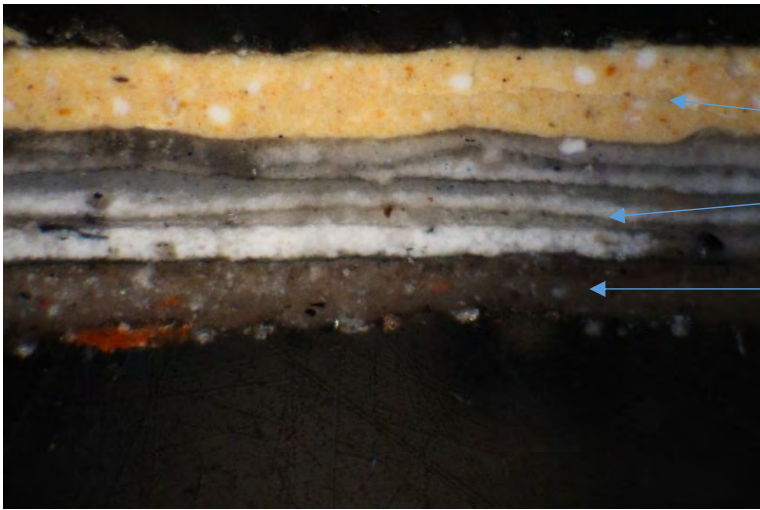
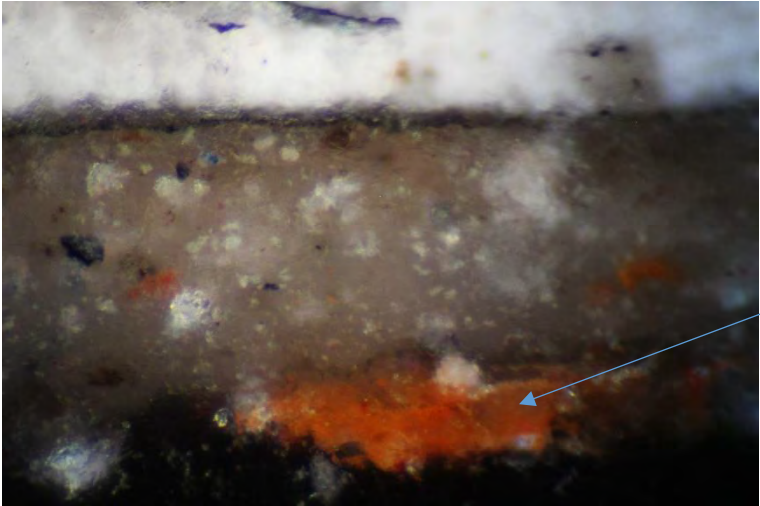
| Sample Ref:PS.02 | Location: 40-46 Princess Street |
|---|---|
| <br> | <p>X100 Magnification</p> <p>Current stone coloured scheme.</p> <p>Earlier white and blue limewash applications.</p> <p>Earliest scheme.</p><br><p>X400 -<br/>Earliest paint layers.</p> <p>A white limewash – note dirt on surface of the paint.</p> <p>Brickwork fragment.</p> |
| Early schemes tested for lead | Yes – negative |

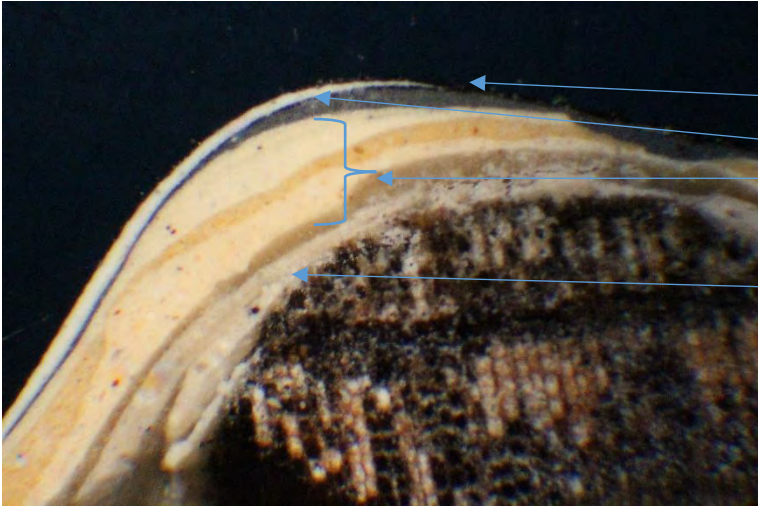
| Sample Ref:PS.03 | Location: 40-46 Princess Street |
|---|---|
| <br> | <p>X50 –</p> <p>Current black paint scheme</p> <p>White scheme over earlier blue.</p> <p>4No stone coloured paint applications.</p> <p>Earliest paint layer on timber beam.</p><br><p>X400 -</p> <p>Earliest paint layers.</p> <p>Layer of white oil paint based on lead carbonate.</p> |
| Early schemes tested for lead | Yes – positive. |

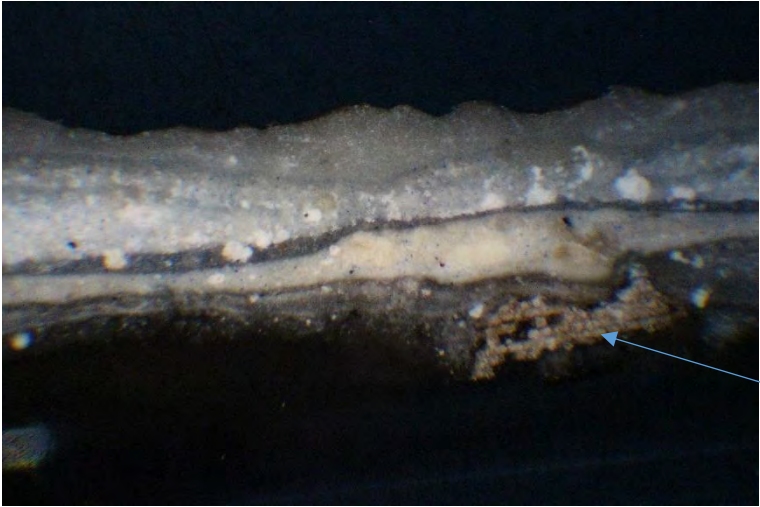
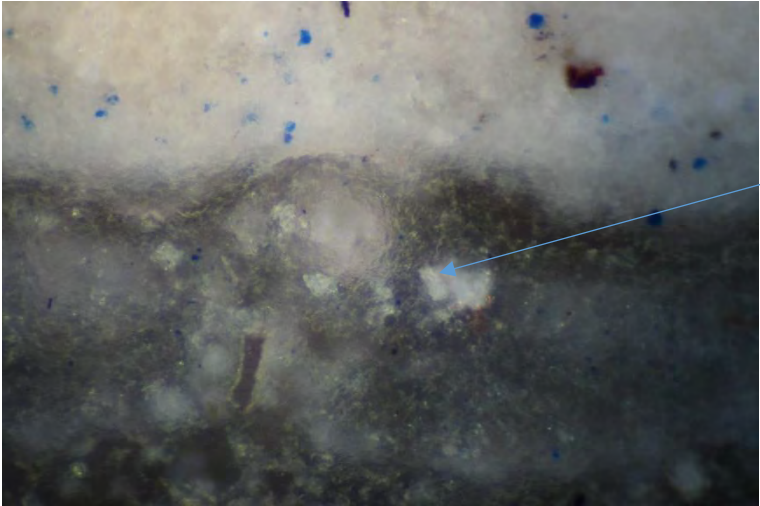
| Sample Ref:PS.04 | Location: 40-46 Princess Street |
|---|---|
| | <p>X50 –</p> <p>Current visible paint layer – light blue.</p> <p>Approx. 7No layers of blue limewash over original white limewash.</p> <p>Timber fragment</p> <p>X400 -</p> <p>Earliest paint layers.</p> <p>White limewash paint system.</p> |
| Early schemes tested for lead | Yes – negative. |

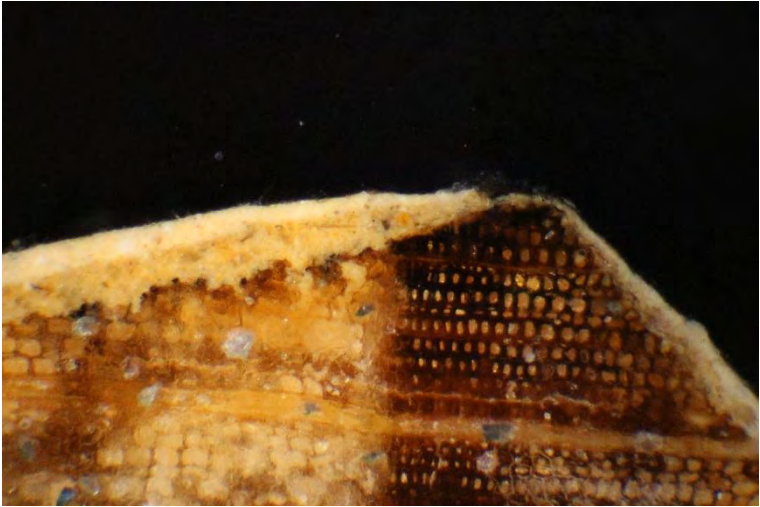
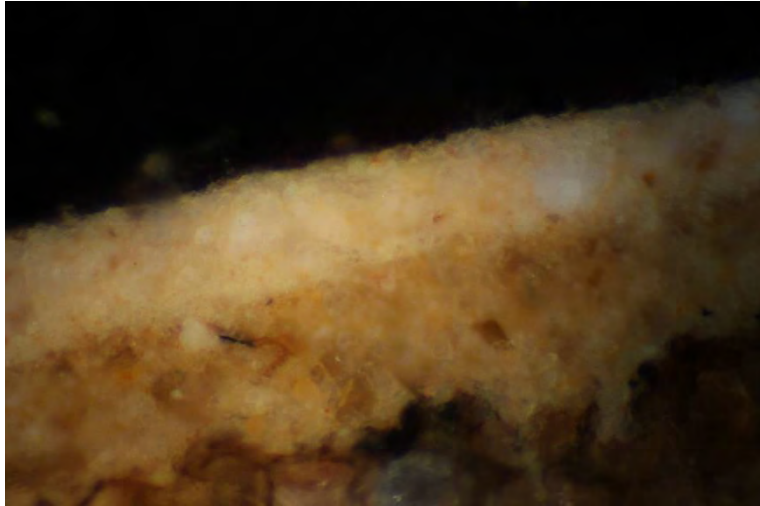
| Sample Ref:PS.05 | Location: 40-46 Princess Street |
|---|---|
| <br> | <p>X100 Magnification–</p> <p>Only 2No paint layers are present in the sample.</p> <p>2No layers of stone coloured paint.</p><br><p>X400 -</p> <p>Earliest paint layers.</p> <p>A light brown oil paint with umber pigments.</p> |
| Early schemes tested for lead | Yes – positive. |

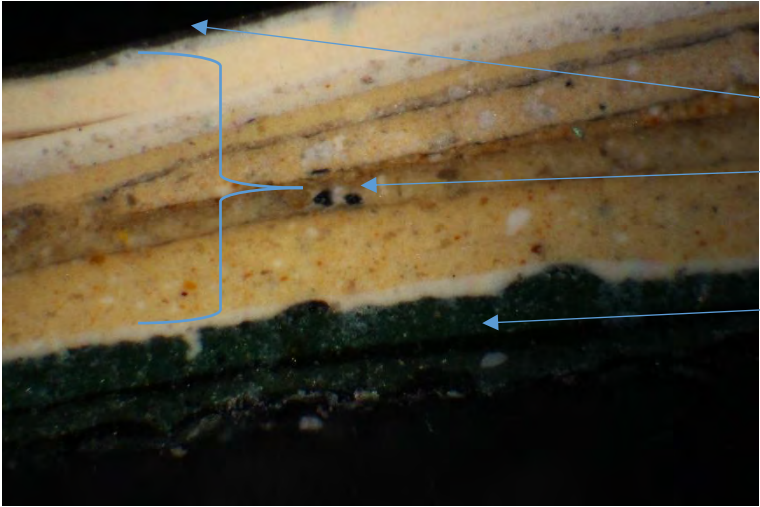
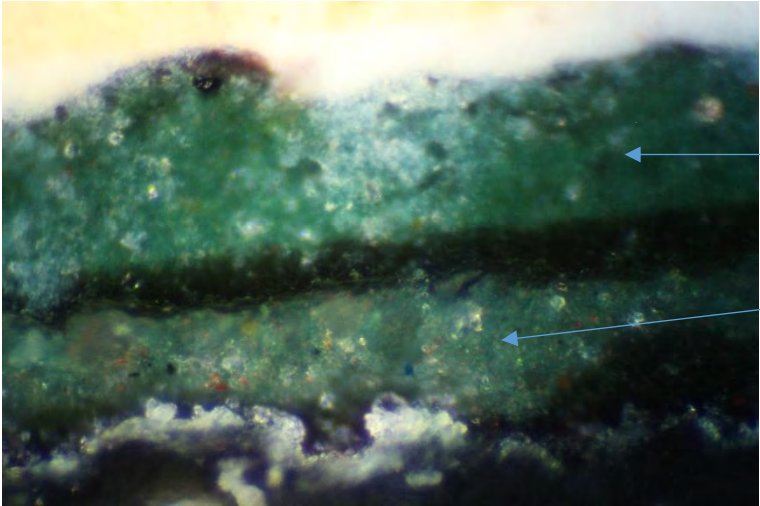
| Sample Ref:PS.06 | Location: 40-46 Princess Street |
|---|---|
| <br> | <p>X100 Magnification–</p> <p>Current green paint scheme</p> <p>10 separate layers of white and stone coloured coatings (zinc oxide based).</p> <p>Two layers of a rich green paint.</p><br><p>X400 -</p> <p>Earliest paint layers.</p> <p>Later application with similar varnish finish.</p> <p>A rich green oil paint with a varnish finish.</p> |
| Early schemes tested for lead | Yes – positive. |

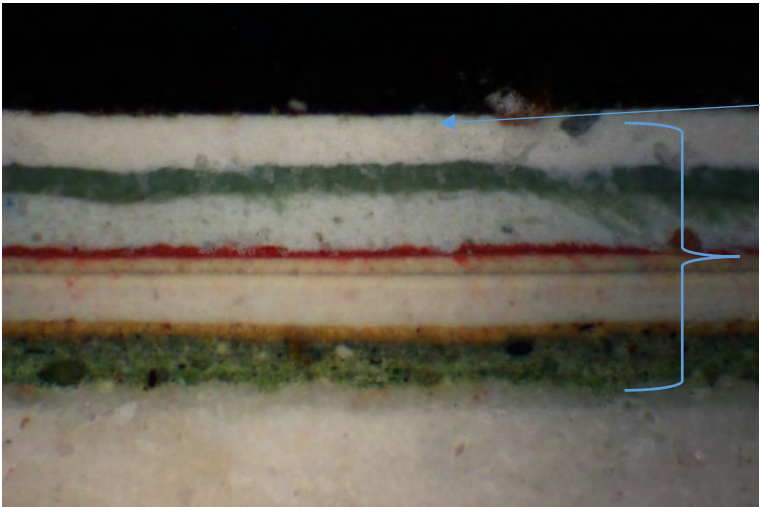
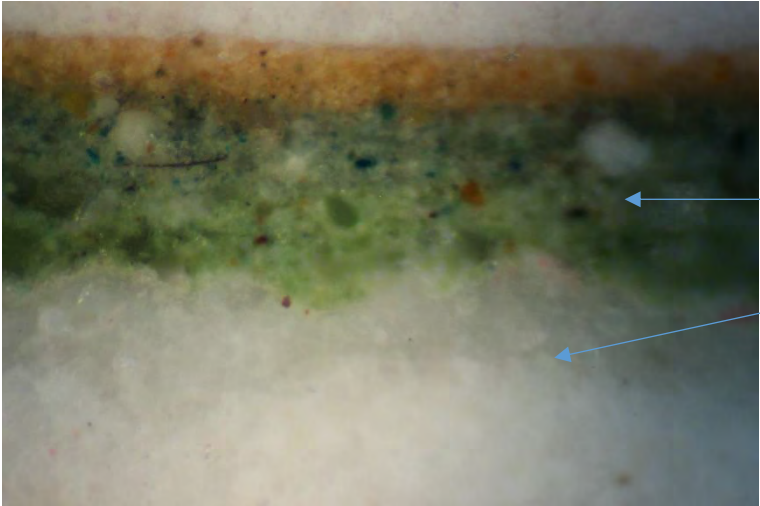
| Sample Ref:PS.07 | Location: 40-46 Princess Street |
|---|---|
| <br> | <p>X100 Magnification –</p> <p>Current off-white paint scheme</p> <p>10 separate paint layers are visible.</p><br><p>X400 -</p> <p>Earliest paint layers.</p> <p>Original wall colour – a mid green oil paint based on lead carbonate..</p> <p>Lime plaster</p> |
| Early schemes tested for lead | Yes – positive. |

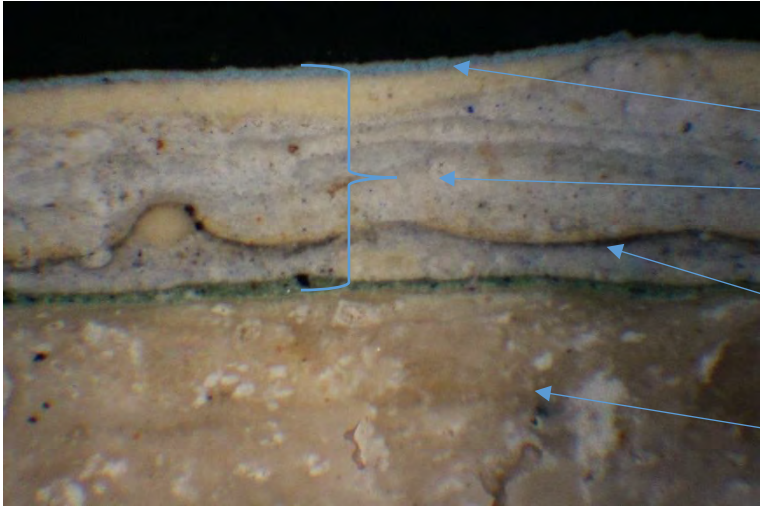
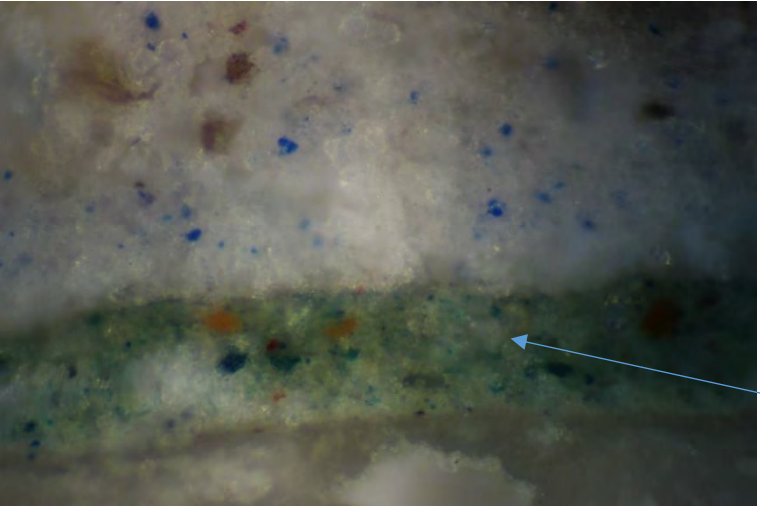
| Sample Ref:PS.08 | Location: 40-46 Princess Street |
|---|---|
| <br> | <p>X50 Magnification –</p> <p>Current mid-blue paint scheme.</p> <p>No separate paint layers are visible.</p> <p>Thick dirt layer over second paint layer – indicating that it was present for some time.</p> <p>Lime plaster</p><br><p>X400 -</p> <p>Earliest paint layers.</p> <p>(The original green paintwork is overpainted with a light blue limewash / distemper).</p> <p>Original paint scheme – a mid-green oil paint.</p> |
| Early schemes tested for lead | Yes – positive. |

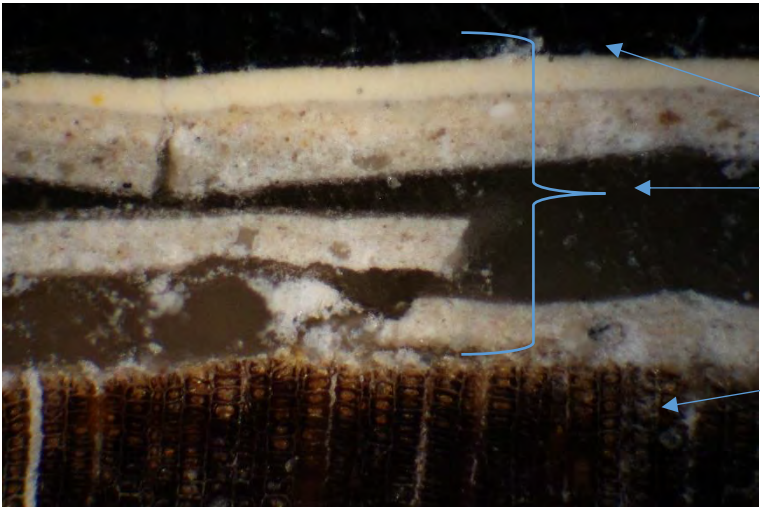
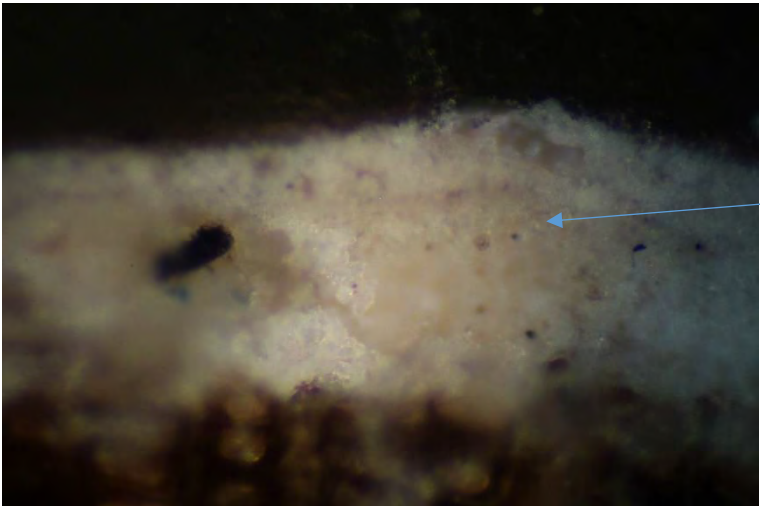
| Sample Ref:PS.09 | Location: 40-46 Princess Street |
|---|---|
| <br> | <p>X100 Magnification –</p> <p>Current black paint scheme.</p> <p>Only 3No separate paint layers noted in sample.</p> <p>Timber beam.</p><br><p>X400 -</p> <p>Earliest paint layers.</p> <p>Earliest paint scheme – a light stone coloured oil paint.</p> <p>(The paint is in a very friable condition and easily detached from the substrate. Given the limited number of coatings this earliest coating is unlikely to be the original colour).</p> |
| Early schemes tested for lead | Yes – negative. |

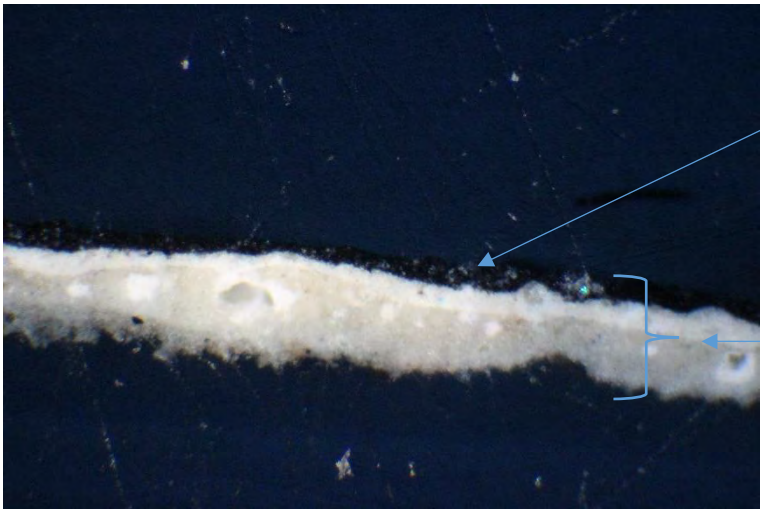
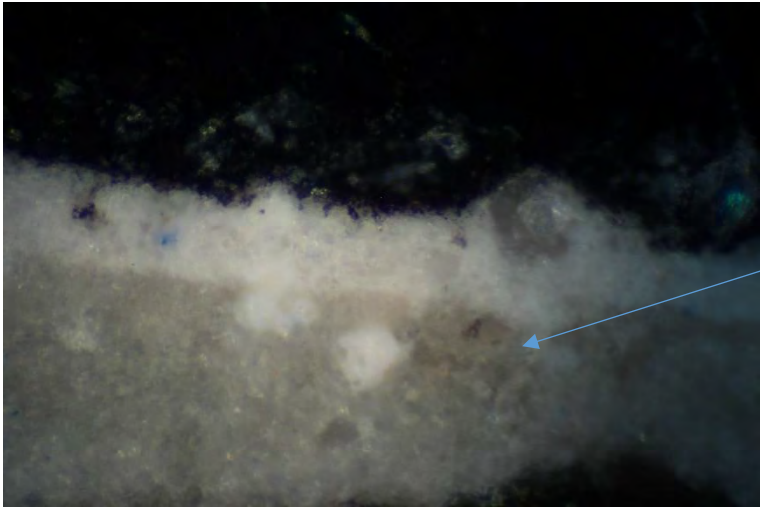
| Sample Ref:PS.10 | Location: 40-46 Princess Street |
|---|---|
| <br> | <p>X100 Magnification–</p> <p>Current black paint scheme.</p> <p>Only 3No separate paint layers are visible.</p> <p>Earliest paint layer.</p><br><p>X400 -</p> <p>Earliest paint layers.</p> <p>Earliest paint scheme – a white lime wash coating.</p> |
| Early schemes tested for lead | Yes – negative. |

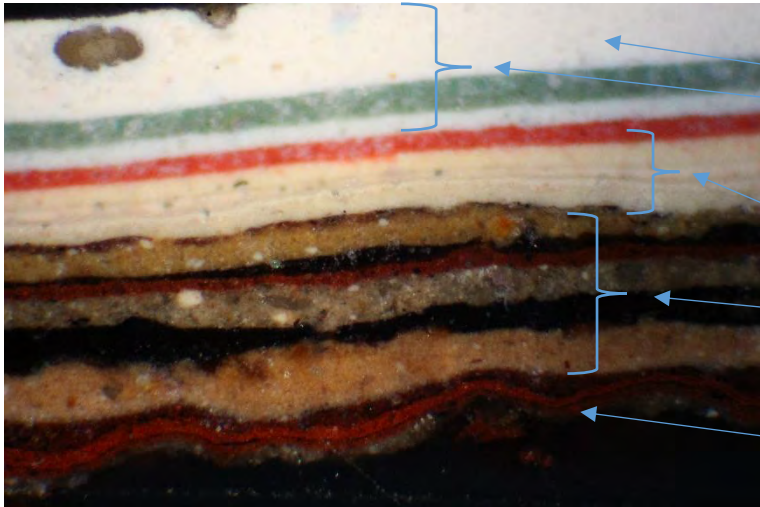
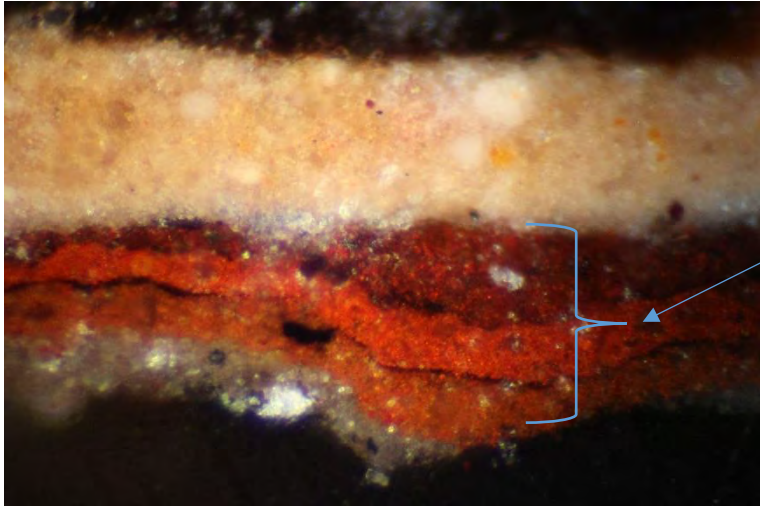
| Sample Ref:PS.11 | Location: 40-46 Princess Street |
|---|---|
| <br> | <p>X100 Magnification –</p> <p>Current white paint scheme</p> <p>3No modern paint layers based on Titanium whites.</p> <p>3No off whites based on zinc oxides</p> <p>Paint schemes based on lead carbonates.</p> <p>Iron oxide reds</p><br><p>X400 -</p> <p>Earliest paint layers.</p> <p>3No applications of a red iron oxide paint.</p> <p>(Trace of a white – possibly primer layer)</p> |
| Early schemes tested for lead | Yes – negative. |

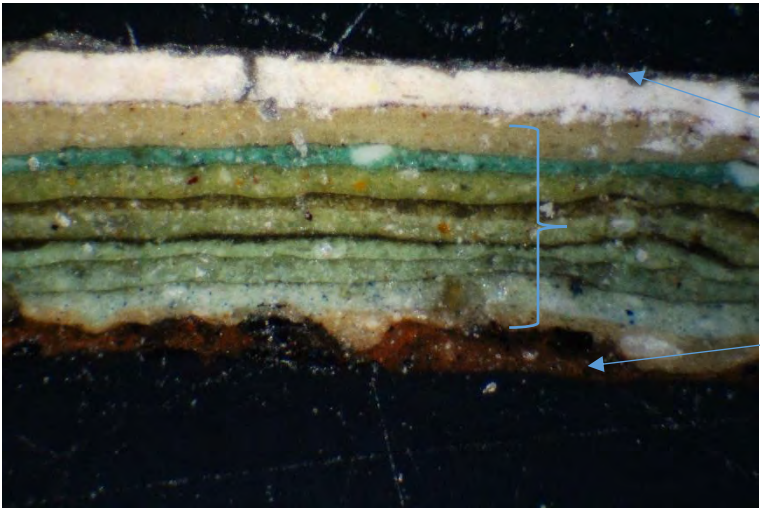
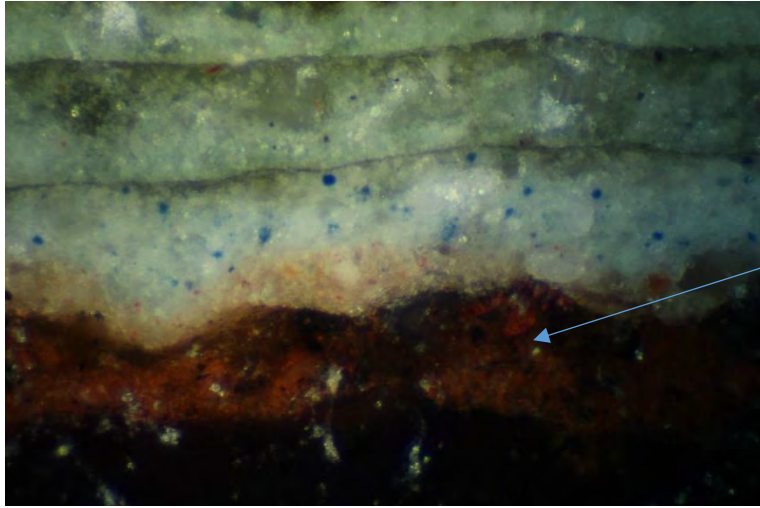
| Sample Ref:PS.12 | Location: 40-46 Princess Street |
|---|---|
| <br> | <p>X100 Magnification –</p> <p>Thin layer of aluminium paint over a modern Titanium white.</p> <p>8No layers of green paints.</p> <p>Earliest brown paint layer</p><br><p>X400 -</p> <p>Earliest paint layers.</p> <p>Earliest decorative coating – a mid green oil paint.</p> <p>Earliest paint layer – a mid-brown oil paint (most likely applied at the mill before delivery to site).</p> <p>Each of the green paint layers has a layer of dirt showing that they were present for some time and redecorated regularly.</p> |
| Early schemes tested for lead | Yes – positive. |

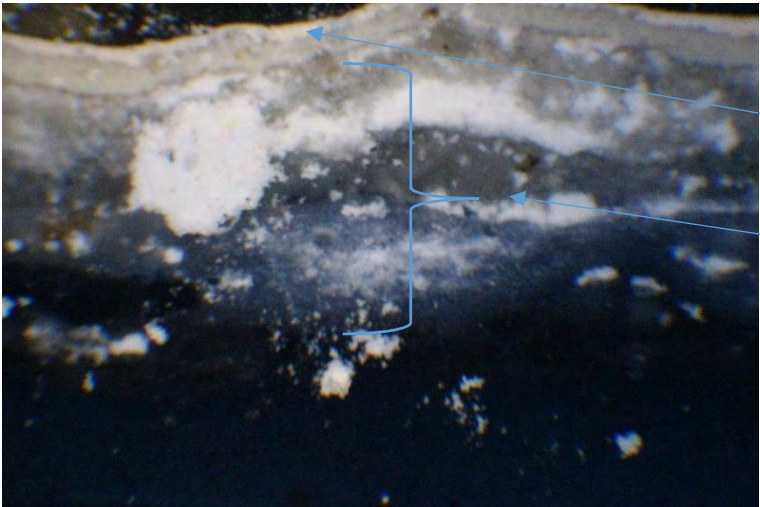
| Sample Ref:PS.13 | Location: 40-46 Princess Street |
|---|---|
| <br> | <p>X50 Magnification–</p> <p>Current stone coloured paint scheme.</p> <p>Limewash paint layers.</p><br><p>X400 -</p> <p>Earliest paint layers.</p><br><p>Original paint scheme – a light blue limewash.</p> |
| Early schemes tested for lead | Yes – negative. |

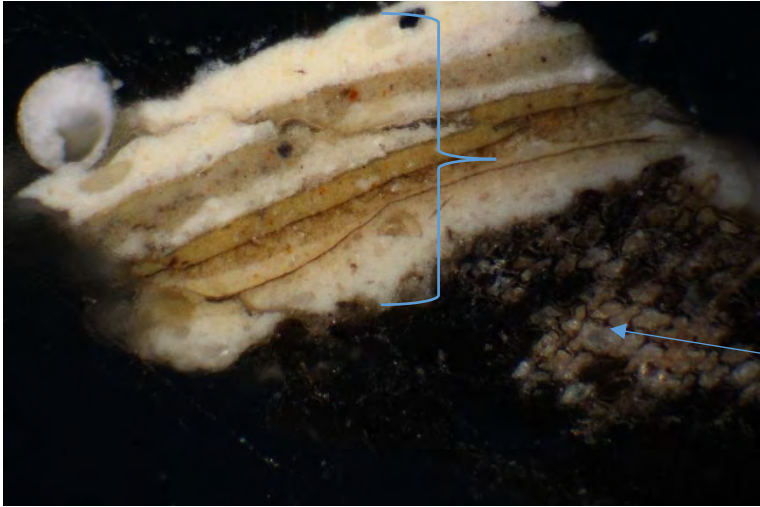
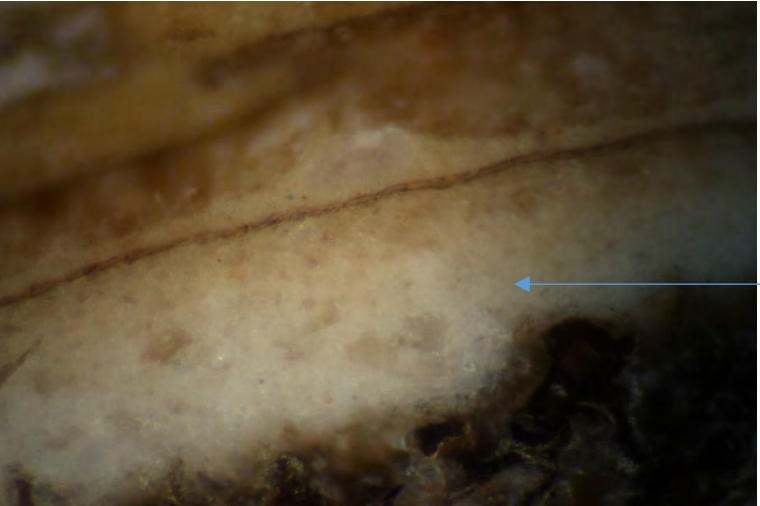
| Sample Ref:PS.14 | Location: 40-46 Princess Street |
|---|---|
| | <p>X100 Magnification–</p> <p>Current off-white paint scheme.</p> <p>7No separate paint layers in the sample.</p> <p>Timber beam.</p> |
| | <p>X400 -</p> <p>Earliest paint layers.</p> <p>Original paint scheme – a white oil paint based on lead carbonate.</p> |
| Early schemes tested for lead | Yes – positive. |

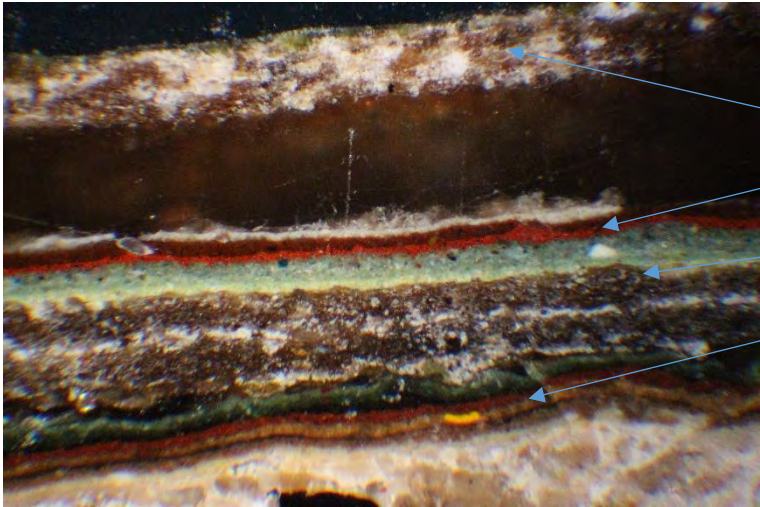
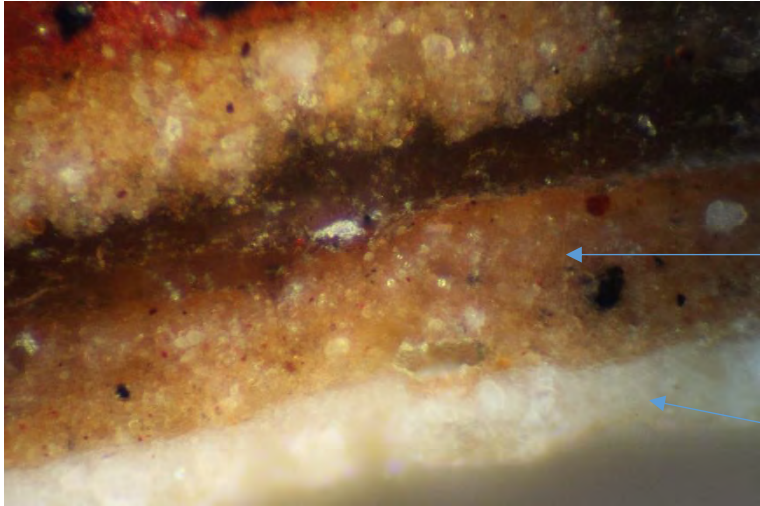
| Sample Ref:PS.15 | Location: 40-46 Princess Street |
|---|---|
| <br> | <p>X50 Magnification -</p> <p>Wallpaper</p> <p>White, brown and red paint layers.</p> <p>2No green layers over 2x wallpaper</p> <p>Green and red layers over historic stone coloured layers.</p><br><p>X400 -</p> <p>Earliest paint layers.</p> <p>Original paint scheme – a light brown / stone coloured oil paint.</p> <p>Lime plaster</p> |
| Early schemes tested for lead | Yes – positive. |

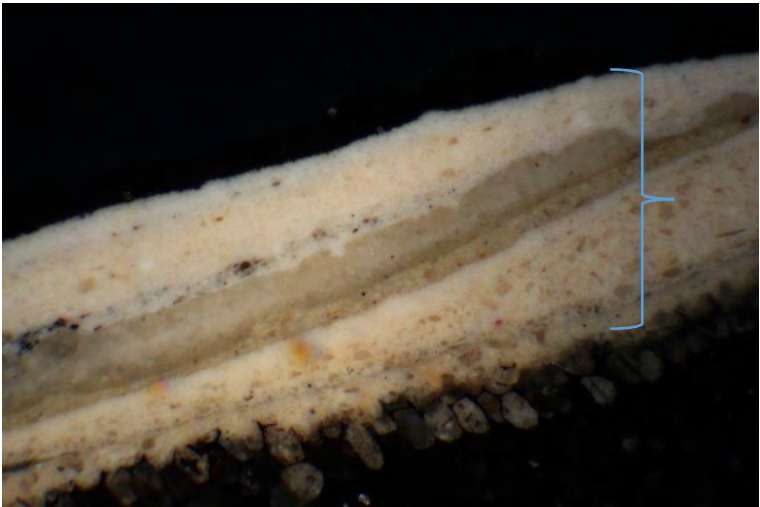
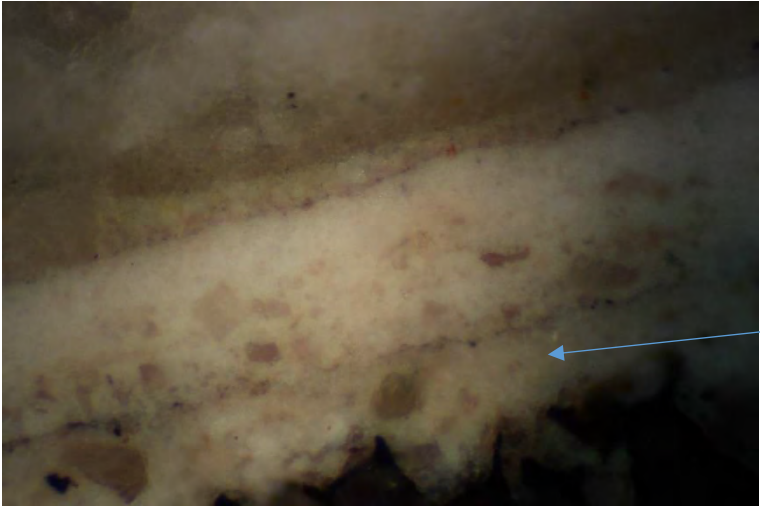
| Sample Ref:PS.16 | Location: 40-46 Princess Street |
|---|---|
| <br> | <p>X100 Magnification –</p> <p>Current black paint scheme</p> <p>10 No paint layers are visible in the sample. The most recent is black however prior to this all coats were off-white / white.</p><br><p>X400 -</p> <p>Earliest paint layers.</p><br><p>Earliest paint scheme – a white oil paint.</p> <p>Note: charring to timber.</p> |
| Early schemes tested for lead | Yes – negative. |

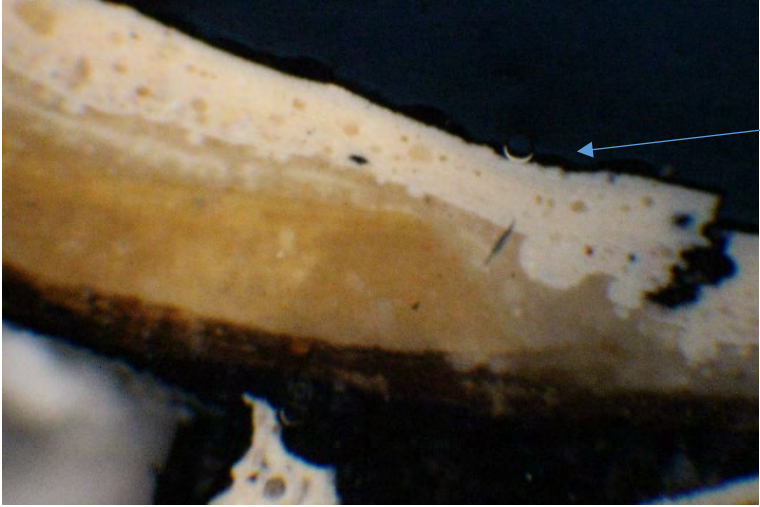
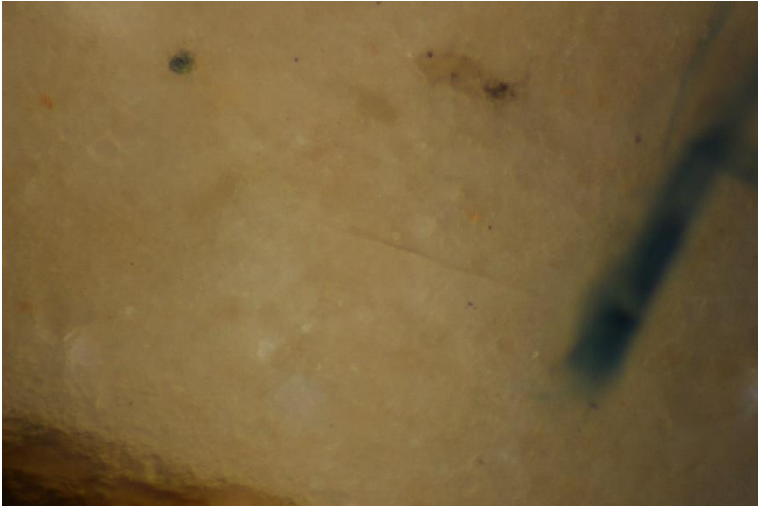
Front soffit – The soffit timbers are similar in condition to the beams with heavy charring. The earliest paint layer is a white limewash which is covered by traces of wallpaper and white and finally black paints. The original decorative schemes are not present in the sample.

| Sample Ref:PS.17 | Location: 40-46 Princess Street |
|---|---|
| | <p>X50 magnification –</p> <p>Current black paint scheme</p> <p>2No layers of off-white</p> <p>Thick layer of limewash over charred timber.</p><br><p>X400 -</p> <p>Earliest paint layers.</p> <p>Earliest paint scheme – a thick layer of an off-white limewash covering the charred timbers.</p> <p>Note: This is unlikely to be the original colour as there is evidence of fire damage.</p> |
| Early schemes tested for lead | Yes – negative. |

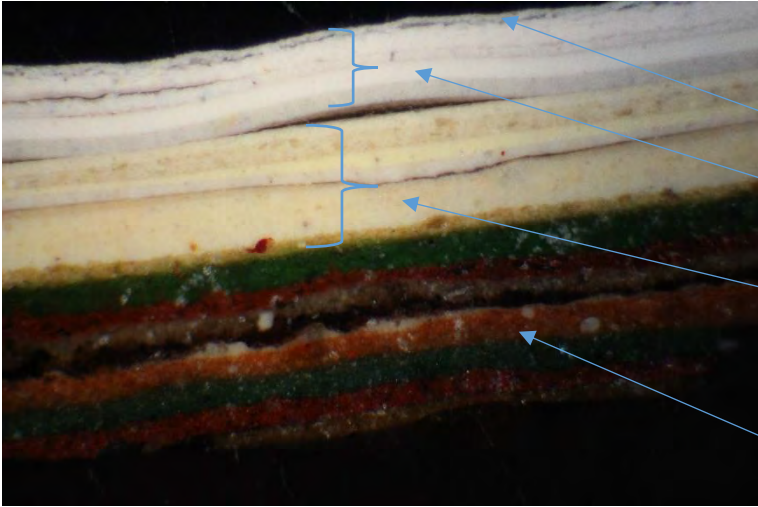
| Sample Ref:PS.18 | Location: 40-46 Princess Street |
|---|---|
| <br> | <p>X100 Magnification –</p> <p>Current white paint scheme</p> <p>4No layers of modern white gloss and undercoat layers based on Titanium white.</p> <p>6No layers of off-white gloss and undercoat paints based on zinc oxides.</p> <p>Earlier green, red and brown paint schemes.</p><br><p>X400 -</p> <p>Earliest paint layers.</p> <p>Original paint scheme – light brown oil paint (containing lead carbonate).</p> |
| Early schemes tested for lead | Yes – positive. |

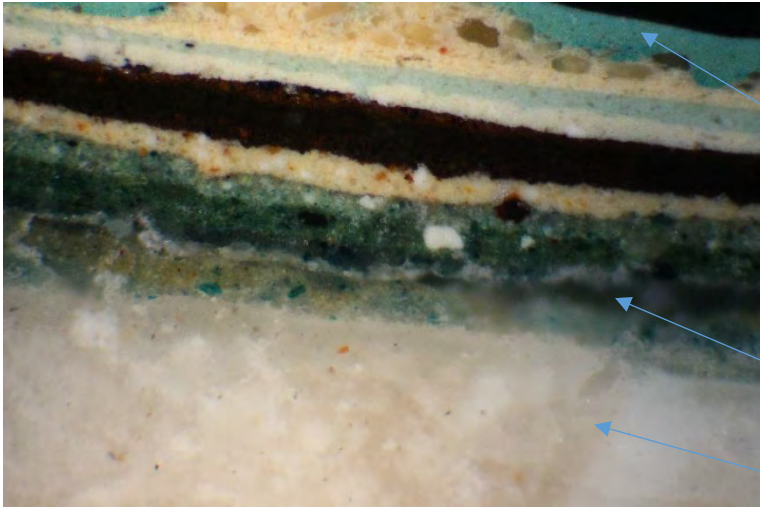
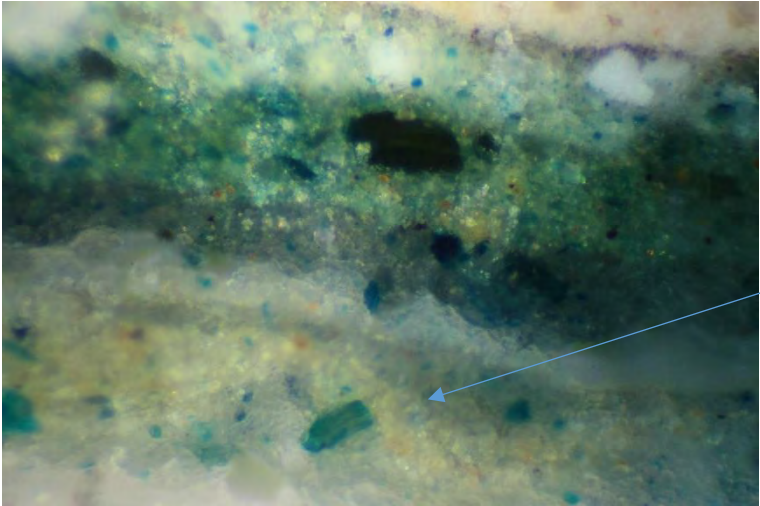
| Sample Ref:PS.19 | Location: 40-46 Princess Street |
|---|---|
| | <p>X100 Magnification –</p> <p>Current green paint scheme.</p> <p>8No separate paint layers present in the sample.</p> <p>Light blue limewash early layers.</p> <p>Lime plaster</p> <p>X400 -</p> <p>Earliest paint layers.</p> <p>Original paint scheme – a light blue limewash</p> |
| Early schemes tested for lead | Yes – negative. |

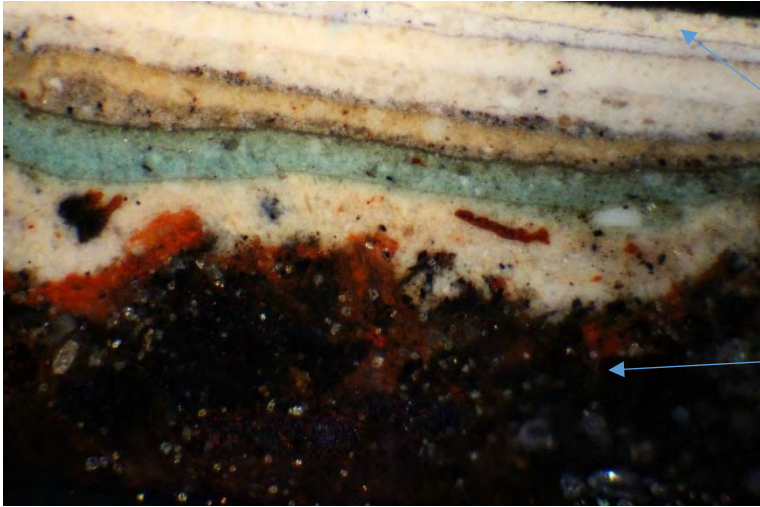
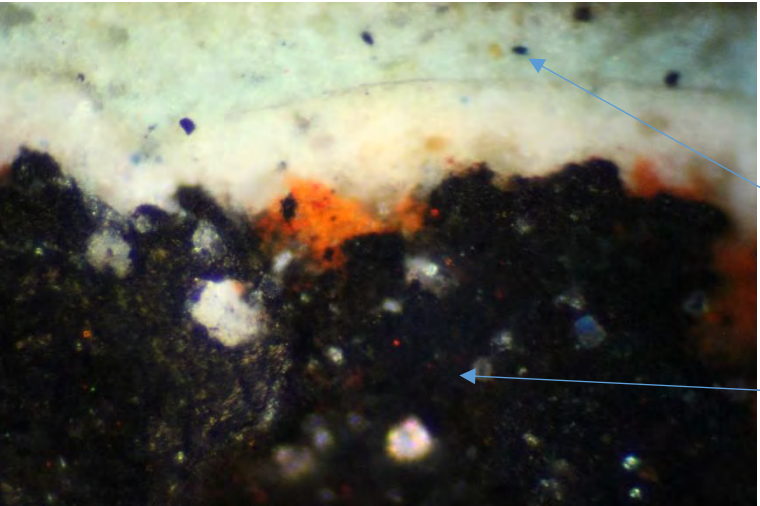
| Sample Ref:PS.20 | Location: 40-46 Princess Street |
|---|---|
| <br> | <p>X100 Magnification –</p> <p>Current stone coloured paint scheme.</p> <p>9No separate paint layers visible in the sample.</p> <p>Thick coating – possibly mill applied.</p><br><p>X400 -</p> <p>Earliest paint layers.</p> <p>Original “finished” paint coating was likely to be the green oil paint layer applied over a white primer.</p> <p>Thick layer of carbon black / red lead oil paint. This is likely to have been applied at the mill before delivery to site.</p> |
| Early schemes tested for lead | Yes – positive. |

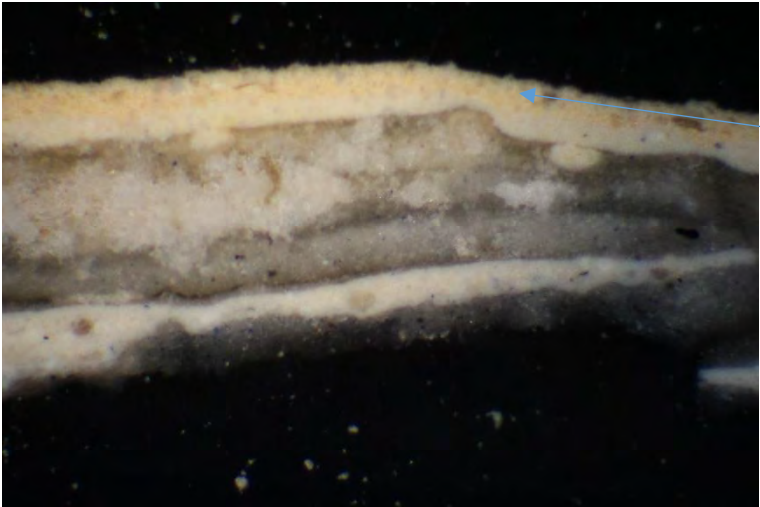
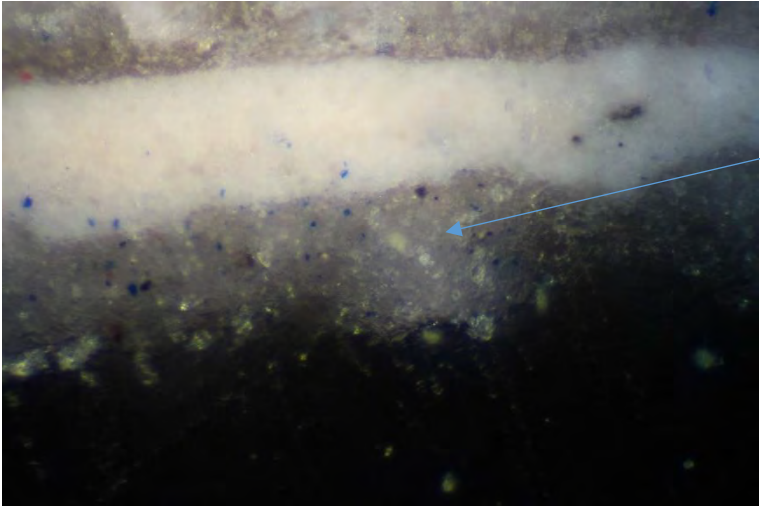
| Sample Ref:PS.21 | Location: 40-46 Princess Street |
|---|---|
| <br> | <p>X100 Magnification –</p> <p>Current stone coloured paint scheme.</p> <p>The two most recent layers are modern and based on Zinc oxide.</p> <p>4No white / light blue lime wash applications.</p><br><p>X400 -</p> <p>Earliest paint layers.</p> <p>Earliest paint scheme – a white limewash paint.</p> <p>Note: The white limewash includes a small amount of Prussian Blue pigment to off-set its slightly yellow colour.</p> |
| Early schemes tested for lead | Yes – negative. |

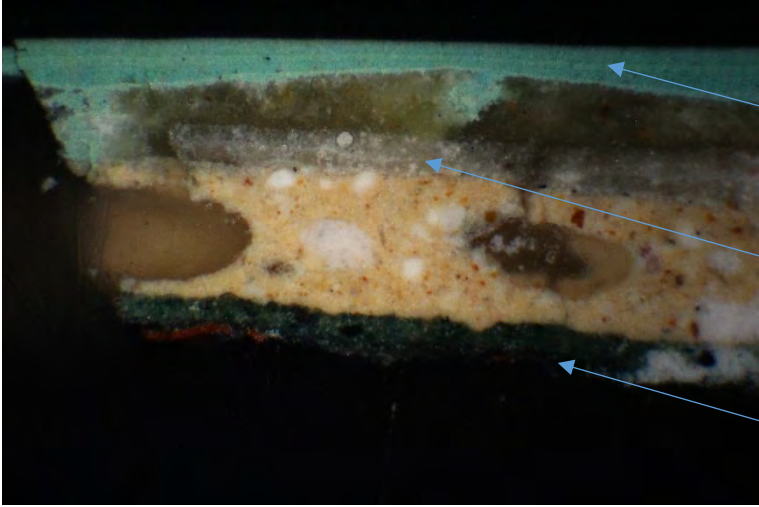
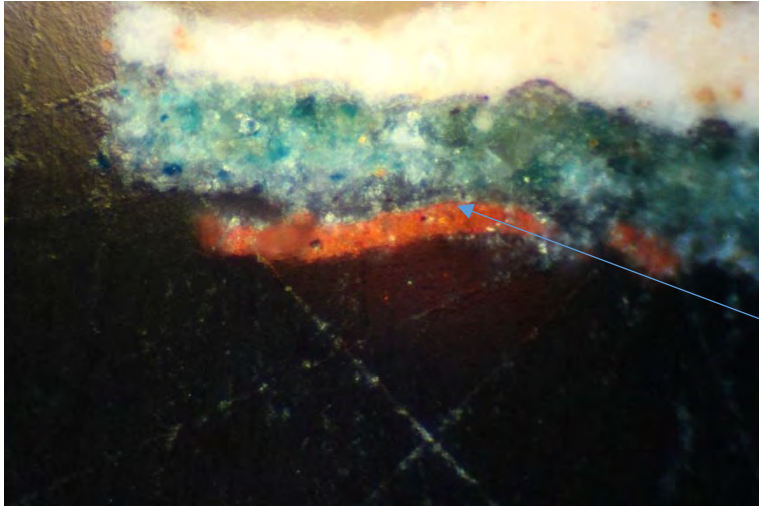
| Sample Ref:PS.22 | Location: 40-46 Princess Street |
|---|---|
| <br> | <p>X100 Magnification –</p> <p>Current green paint scheme.<br/>(3No separate green layers are present)</p> <p>Single layer of limewash (later coats partly separated)</p> <p>Thick stone coloured paint layer.</p> <p>Earlier green and red paint schemes.</p><br><p>X400 -<br/>Earliest paint layers.</p> <p>Earliest paint layer – a red oxide oil paint. Later covered by two layers of mid greens.</p> |
| Early schemes tested for lead | Yes – positive. |

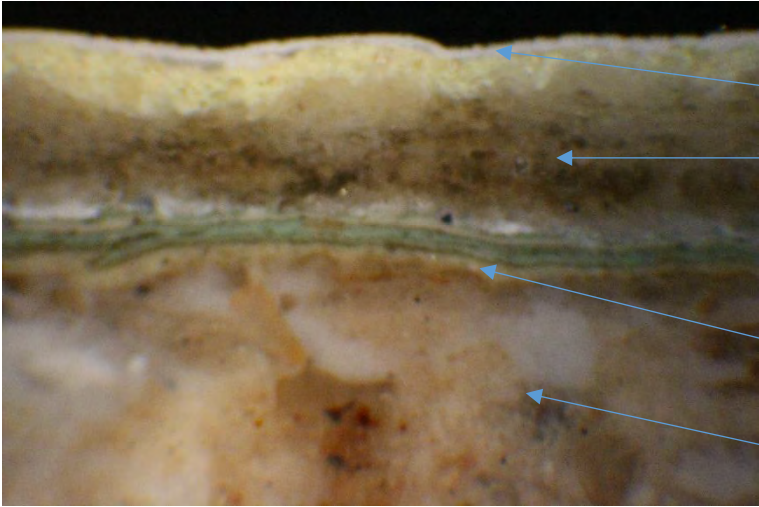
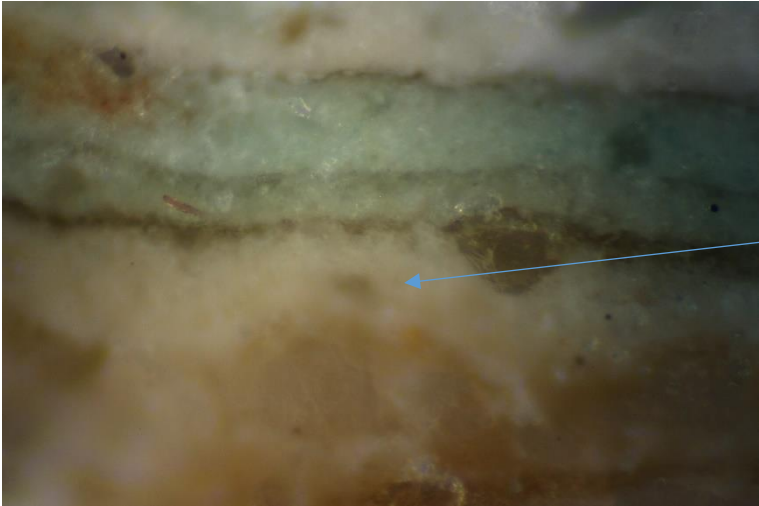
| Sample Ref:PS.23 | Location: 40-46 Princess Street |
|---|---|
| <br> | <p>X50 Magnification –<br/>Current light blue paint scheme.</p> <p>Woodchip wallpaper.</p> <p>White paint layer<br/>2No mid green layers.</p> <p>Off-white layer (earliest layer).</p> <p>Lime plaster</p><br><p>X400 -<br/>Earliest paint layers.</p> <p>Original paint scheme – an off-white oil paint based on lead carbonate.</p> |
| Early schemes tested for lead | Yes – positive. |

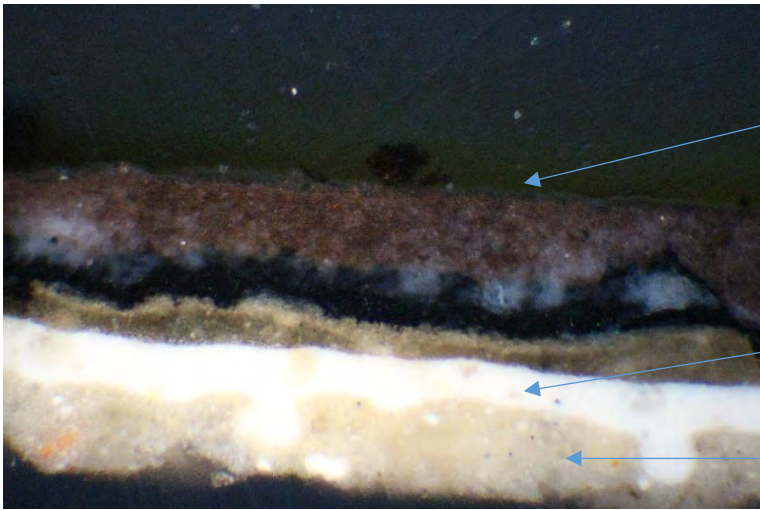
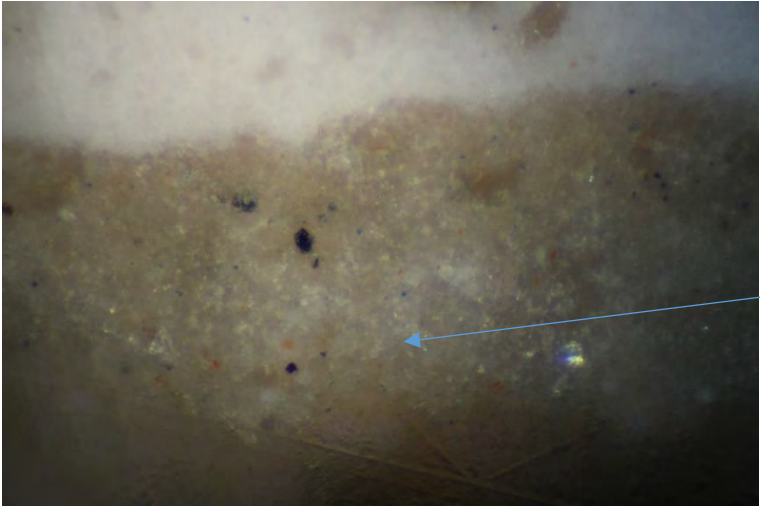
| Sample Ref:PS.24 | Location: 40-46 Princess Street |
|---|---|
| <br> | <p>X100 Magnification –</p> <p>Current black scheme (paint very friable and easily disturbed).</p> <p>Grey paint layer.<br/>White oil paint</p> <p>A bright zinc oxide white paint layer.</p> <p>Stone coloured limewash / distemper.</p><br><p>X400 -<br/>Earliest paint layers.</p> <p>Earliest paint scheme – a stone coloured limewash / distemper.</p> |
| Early schemes tested for lead | Yes – negative. |

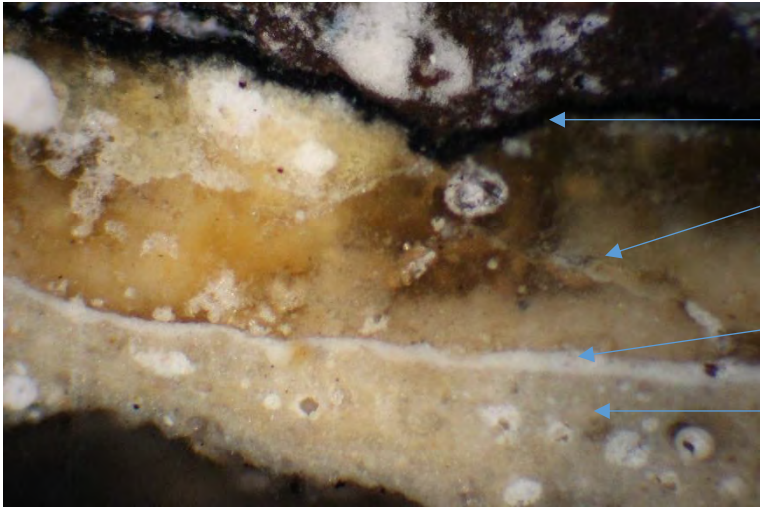
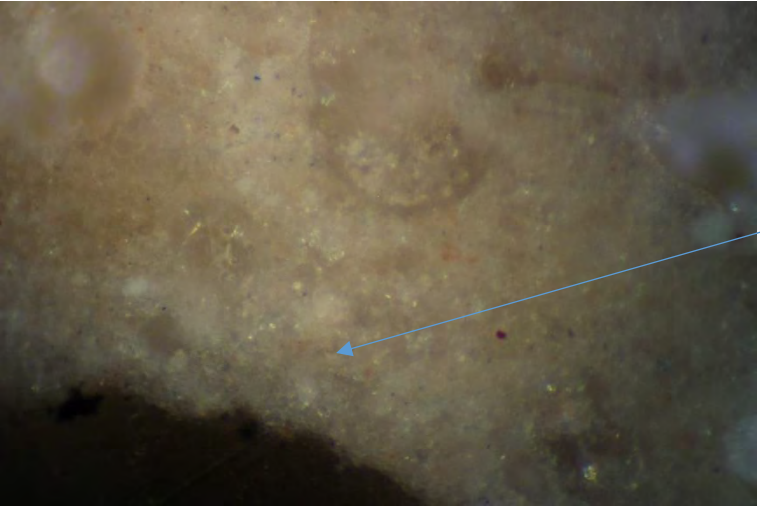
| Sample Ref:PS.25 | Location: 40-46 Princess Street |
|---|---|
| <br> | <p>X100 Magnification –</p> <p>Current black paint scheme.</p> <p>Thick layer of a stone coloured oil paint.</p> <p>White zinc oxide white paint layer.</p> <p>Thick layer of stone coloured lime wash.</p><br><p>X400 -</p> <p>Earliest paint layers.</p> <p>Earliest paint colour – a stone coloured limewash / distemper.</p> |
| Early schemes tested for lead | Yes – negative. |

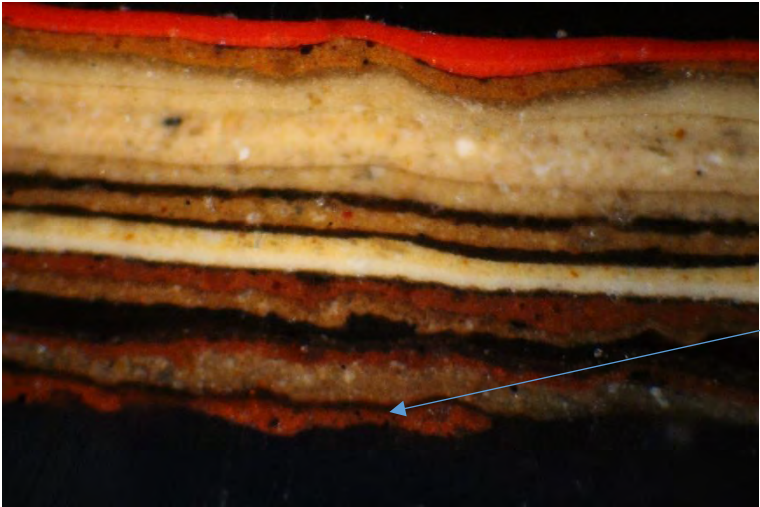
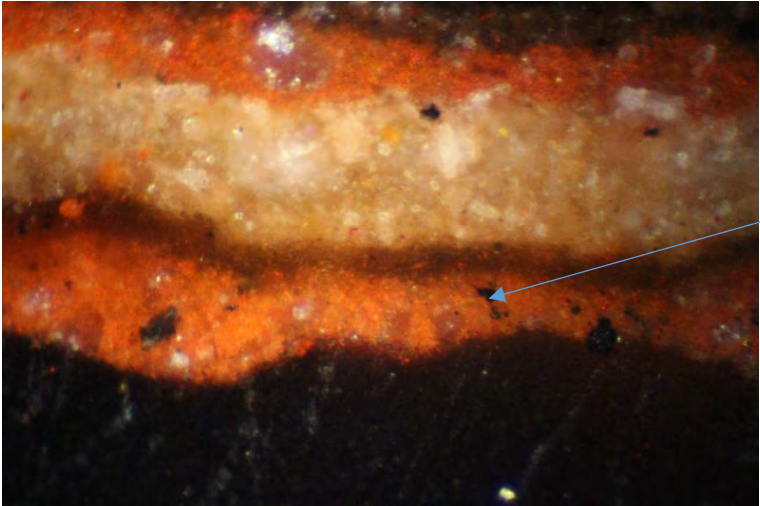
| Sample Ref:PS.26 | Location: 40-46 Princess Street |
|---|---|
| | <p>X100 Magnification –</p> <p>Current red paint scheme.<br/>17 separate layers are visible in the sample.</p> <p>Earliest red schemes.</p> <p>X400 -<br/>Earliest paint layers.</p> <p>Original paint scheme – a red iron oxide oil paint with a varnish coating bringing the finish to a gloss.</p> |
| Early schemes tested for lead | Yes – positive. |
