## 40-46 Princess Street, Manchester Paint Analysis

### Report on Findings Report No HPMTA01

ISSUE 01– 18/11/2021

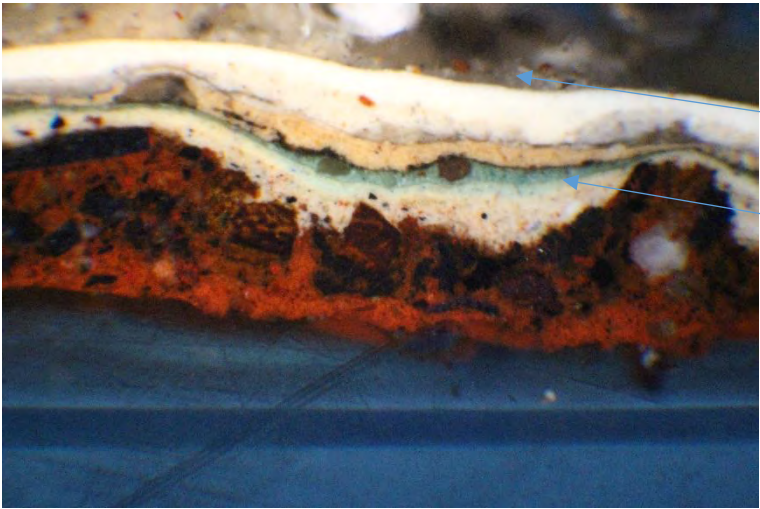
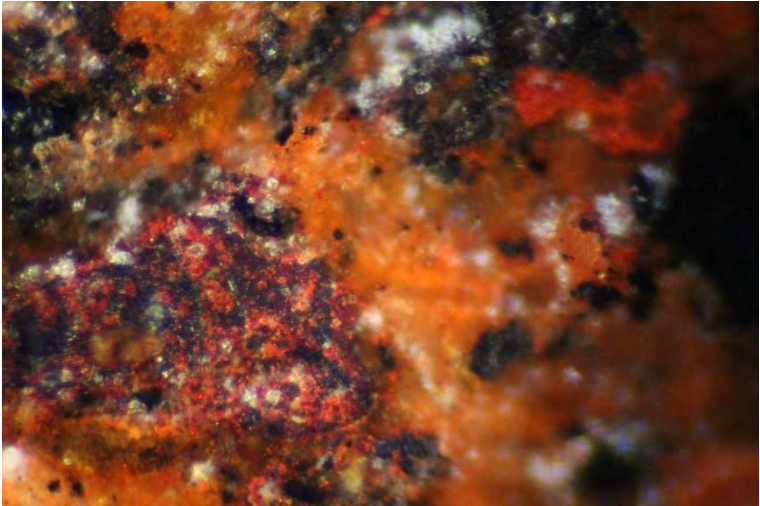
| Sample Ref:PS.28 | Location: 40-46 Princess Street |
|---|---|
| | <p>X50 –</p> <p>Current grey paint scheme.</p> <p>First finished decorative coating green over off-white primer. Note thick dirt layer on surface of the green indicating that it was present for some time.</p><br><p>X400 -</p> <p>Earliest paint layers.</p> <p>Earliest layer – a rough coating likely to be applied at the mill consisting of iron oxide red, carbon black and some red lead pigments.</p> |
| Early schemes tested for lead | Yes – positive. |

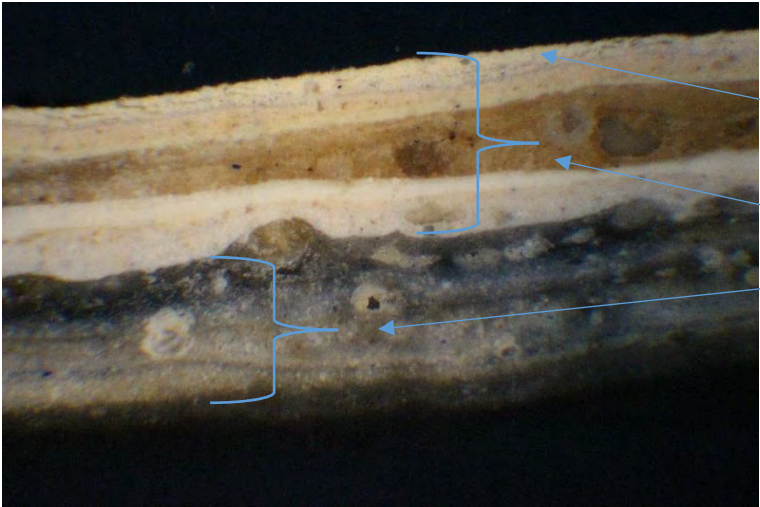
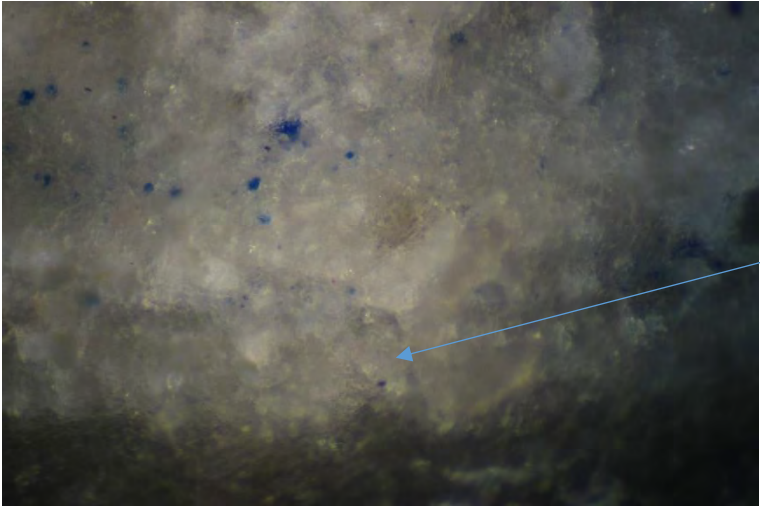
| Sample Ref:PS.29 | Location: 40-46 Princess Street |
|---|---|
| | <p>X50 Magnification -</p> <p>Current stone coloured paint scheme.</p> <p>8No white / off paint layers.</p> <p>5No light blue lime wash layers.</p><br><p>X400 -</p> <p>Earliest paint layers.</p> <p>Earliest paint scheme – white limewash. Later limewashes tinted with Prussian Blue.</p> |
| Early schemes tested for lead | Yes – negative. |

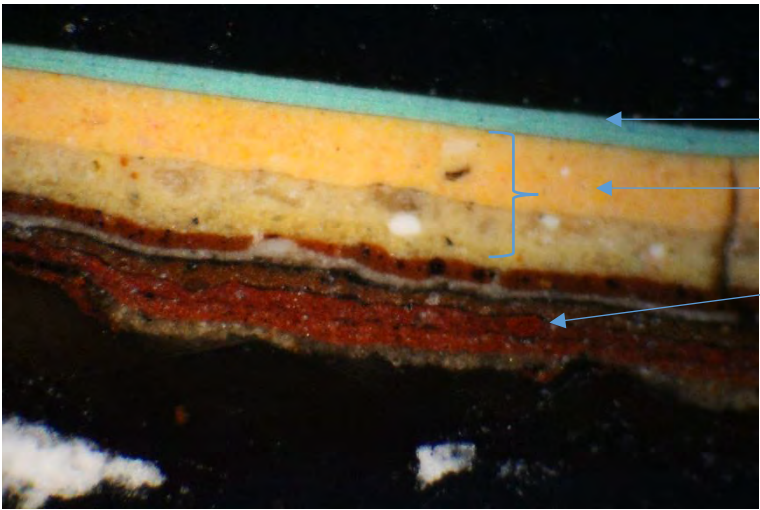
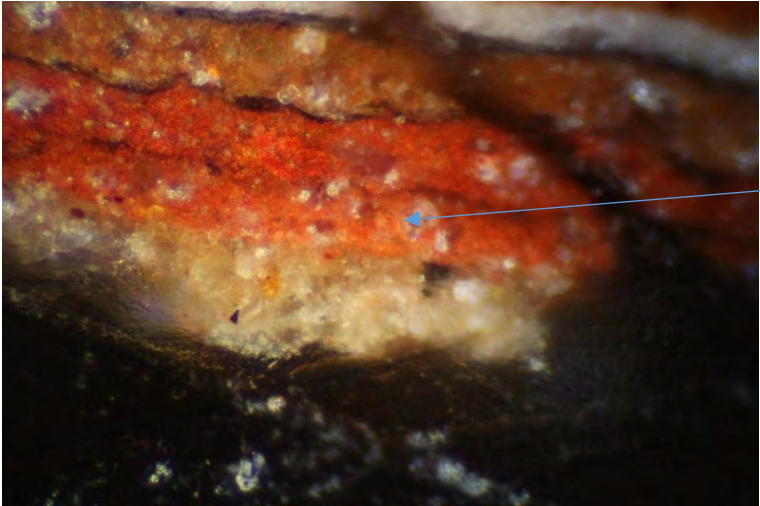
| Sample Ref:PS.30 | Location: 40-46 Princess Street |
|---|---|
| <br> | <p>X100 Magnification –</p> <p>Current green paint scheme.</p> <p>Thick orange gloss with matching undercoat based on zinc white.</p> <p>Earlier iron oxide red paint schemes.</p><br><p>X400 -</p> <p>Earliest paint layers.</p> <p>Original paint scheme – red iron oxide oil paint over off-white primer coating.</p> |
| Early schemes tested for lead | Yes – positive. |

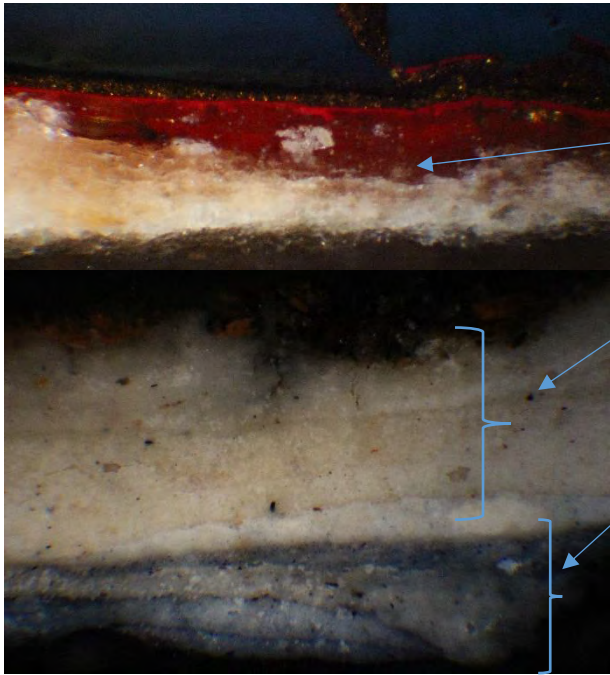
| Sample Ref:PS.31 | Location: 40-46 Princess Street |
|---|---|
| <br> | <p>X50 Magnification –</p> <p>Red faced wallpapers over plaster fill.</p> <p>4No white limewash / distemper paint layers.</p> <p>4No light blue limewash paint layers.</p><br><p>X400 -</p> <p>Earliest paint layers.</p> <p>Earliest paint layer – a white limewash tinted with Prussian Blue pigments.</p> |
| Early schemes tested for lead | Yes – negative. |

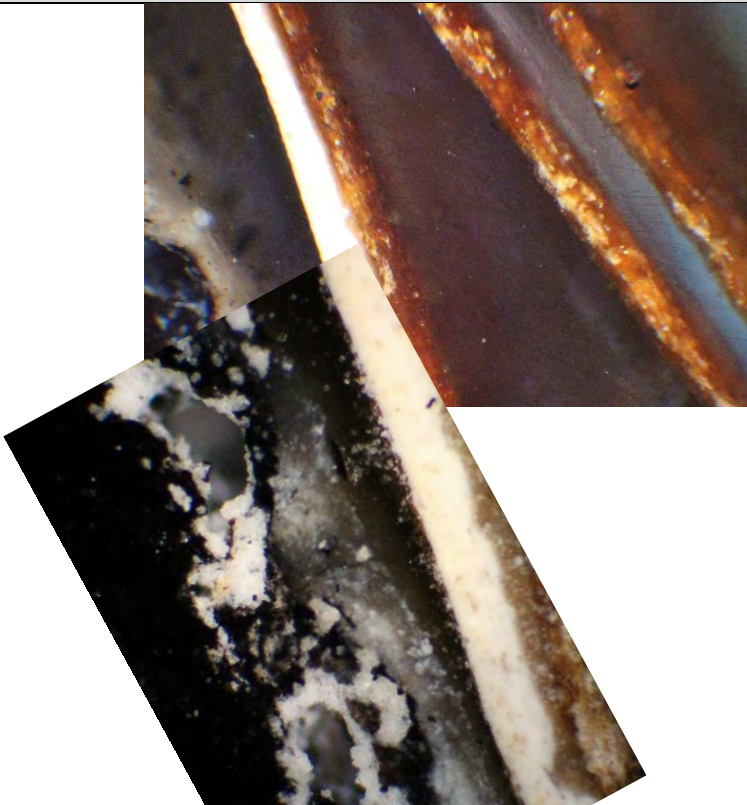
| Sample Ref:PS.32 | | Location: 40-46 Princess Street | |
|---|--|---|--|
| | | <p>X50 –</p> <p>3No layers of wallpapers over a white zinc oxide based paint.</p> <p>Single layer of white limewash.</p> <p>Note: Timber is heavily charred from fire.</p> | |
| | | <p>X400 -</p> <p>Earliest paint layers.</p> <p>Earliest paint layers – light brown oil paint surrounded by light blue limewash.</p> | |

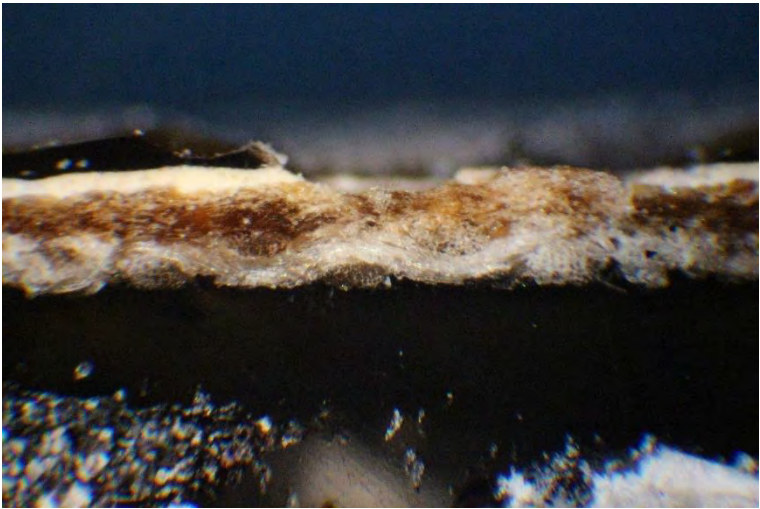
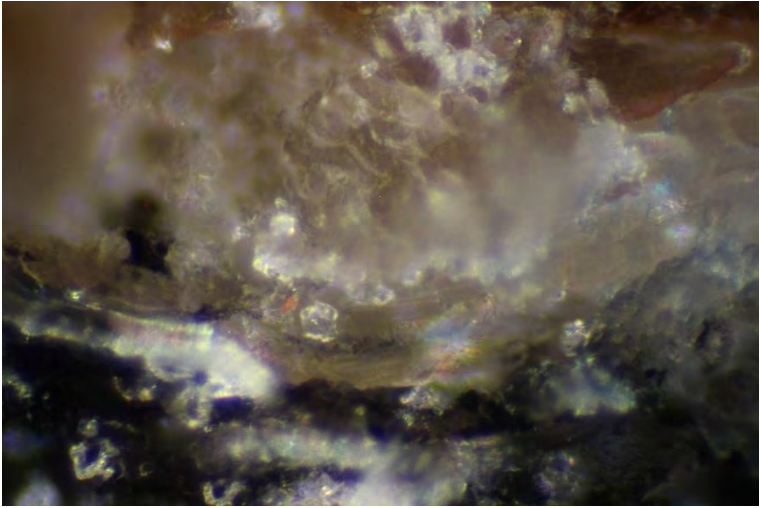
| Sample Ref:PS.33 | Location: 40-46 Princess Street |
|---|---|
| <br> | <p>X50 Magnification –</p> <p>Current visible black paint layer.<br/>Current white visible paint layer.</p> <p>Wallpaper.</p> <p>Heavily charred timber.</p><br><p>X400 -<br/>Earliest paint layers.</p><br><p>Earliest paint layer – a white limewash over charred timber.</p> |
| Early schemes tested for lead | Yes – negative. |

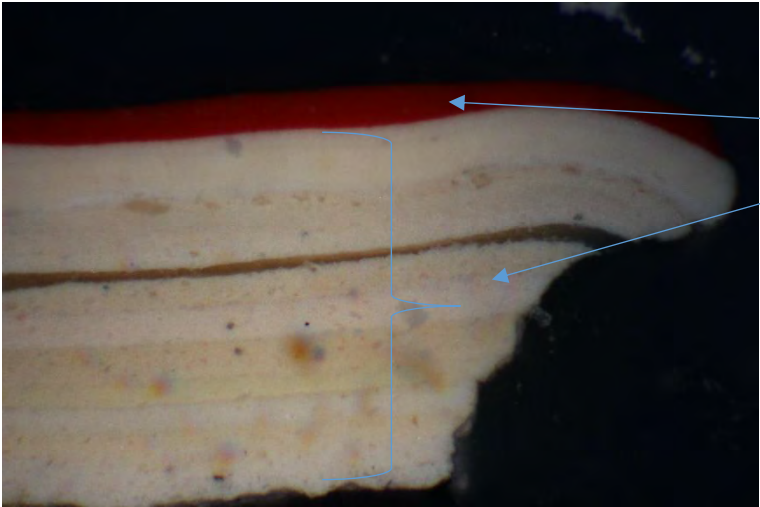
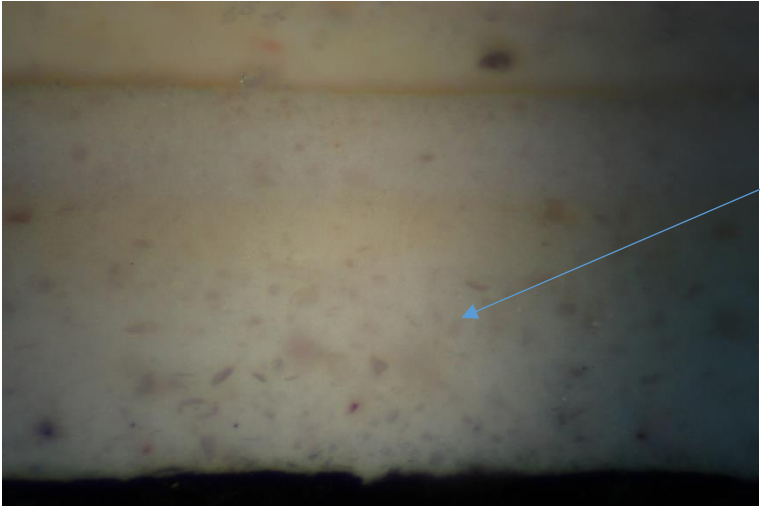
| Sample Ref:PS.34 | Location: 40-46 Princess Street |
|---|---|
| <br> | <p>X100 Magnification –</p> <p>Current red paint scheme.</p> <p>10No layers of white paint (none based on lead carbonate).</p><br><p>X400 -</p> <p>Earliest paint layers.</p> <p>Earliest paint layer – white oil paint most likely a Lithopone possibly indicating that the original paint finishes have been removed.</p> |
| Early schemes tested for lead | Yes – negative. |

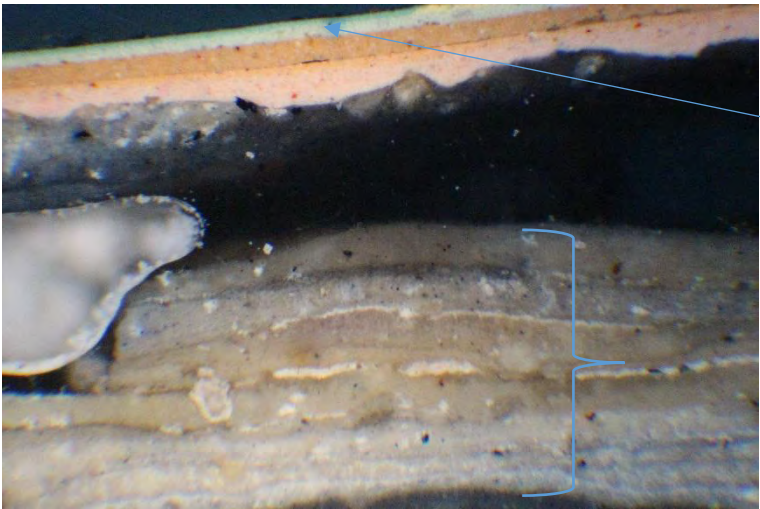
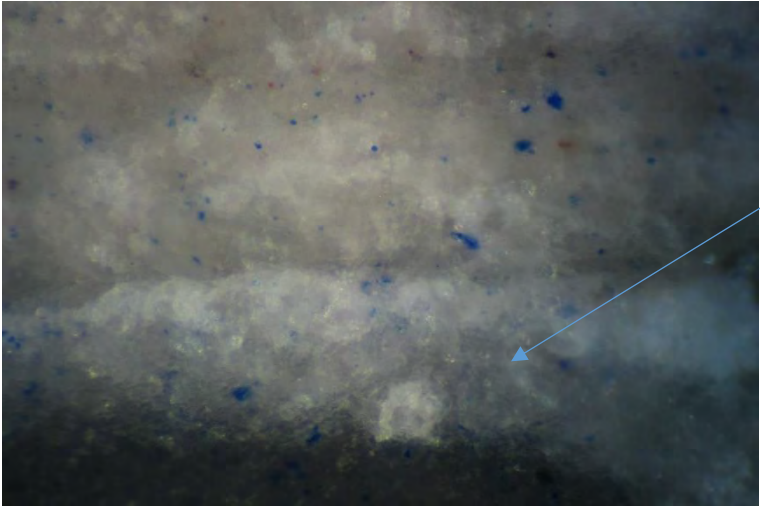
| Sample Ref:PS.35 | Location: 40-46 Princess Street |
|---|---|
| <br> | <p>X50 Magnification -</p> <p>Current green paint scheme.</p> <p>2No earlier red schemes.</p><br><p>10No white and light blue limewash schemes.</p><br><p>X400 -</p> <p>Earliest paint layers.</p><br><p>Earliest paint layer – a white limewash tinted with Prussian Blue pigments.</p> |
| Early schemes tested for lead | Yes – negative. |

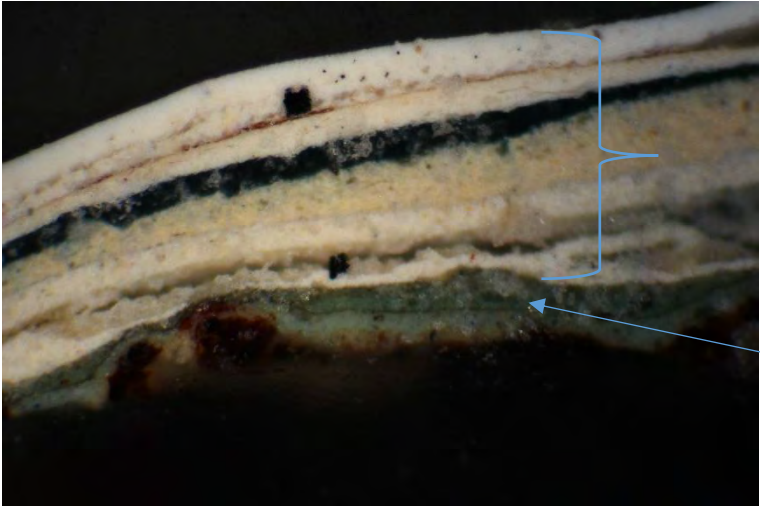
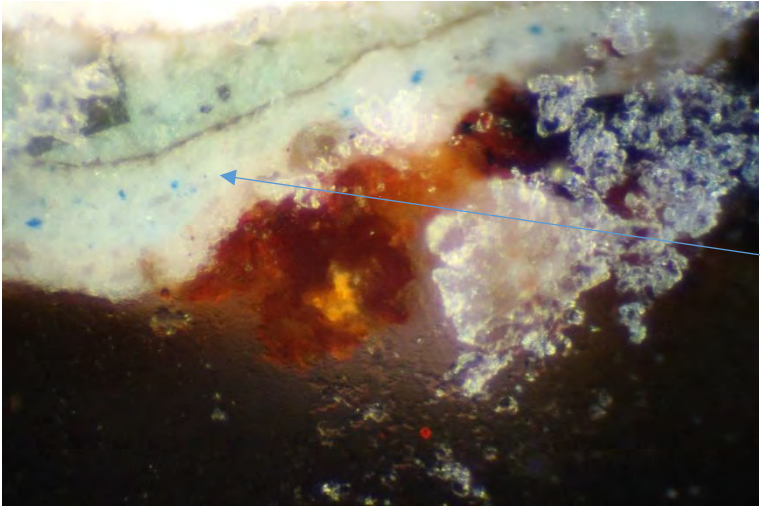
| Sample Ref:PS.36 | Location: 40-46 Princess Street |
|---|---|
| <br> | <p>X100 Magnification –</p> <p>Current off-white paint scheme.</p> <p>6No white / off-white paint schemes with a single black scheme.</p> <p>Earlier 2x green schemes with some evidence of a black/red primer.</p><br><p>X400 -</p> <p>Earliest paint layers.</p> <p>Earliest decorative coating is the light green oil paint scheme. The red/brown primer coating is likely to have been applied at the mill before delivery to site.</p> |
| Early schemes tested for lead | Yes – positive. |

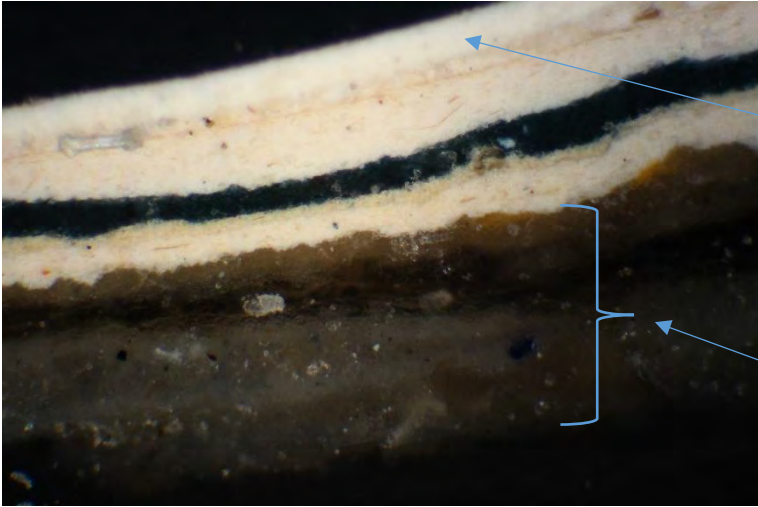
| Sample Ref:PS.37 | Location: 40-46 Princess Street |
|---|---|
| <br> | <p>X100 Magnification –</p> <p>Current off-white decorative scheme.</p> <p>Later white schemes based on zinc oxide with a single black paint layer.</p> <p>Earlier limewash applications.</p><br><p>X400 -</p> <p>Earliest paint layers.</p> <p>Earliest paint layer – a light blue limewash.</p> |
| Early schemes tested for lead | Yes – negative. |

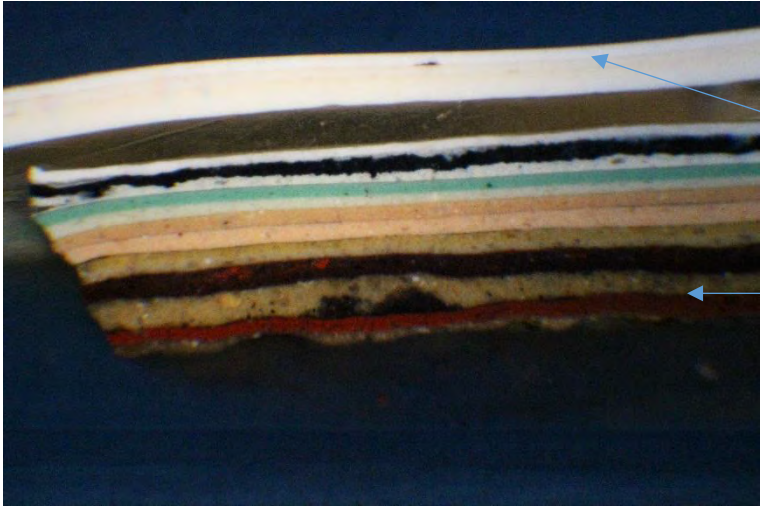
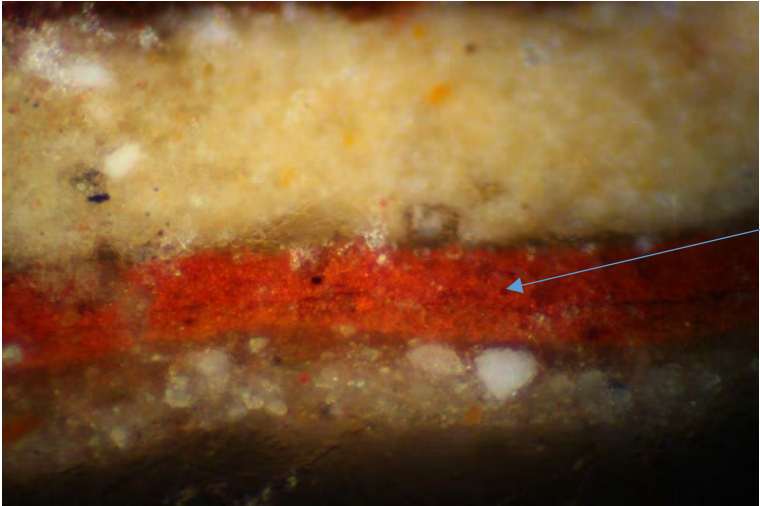
| Sample Ref:PS.38 | Location: 40-46 Princess Street |
|---|---|
| <br> | <p>X50 Magnification –</p> <p>Current white paint scheme.</p> <p>12No layers are visible in the sample.</p> <p>Earliest paint coatings – red iron oxide paint layer.</p><br><p>X400 -</p> <p>Earliest paint layers.</p> <p>Earliest decorative paint layer – a red iron oxide based oil paint over a off-white primer.</p> |
| Early schemes tested for lead | Yes – positive. |
