## Verification Report

GEO101021

007

101 Charles Street

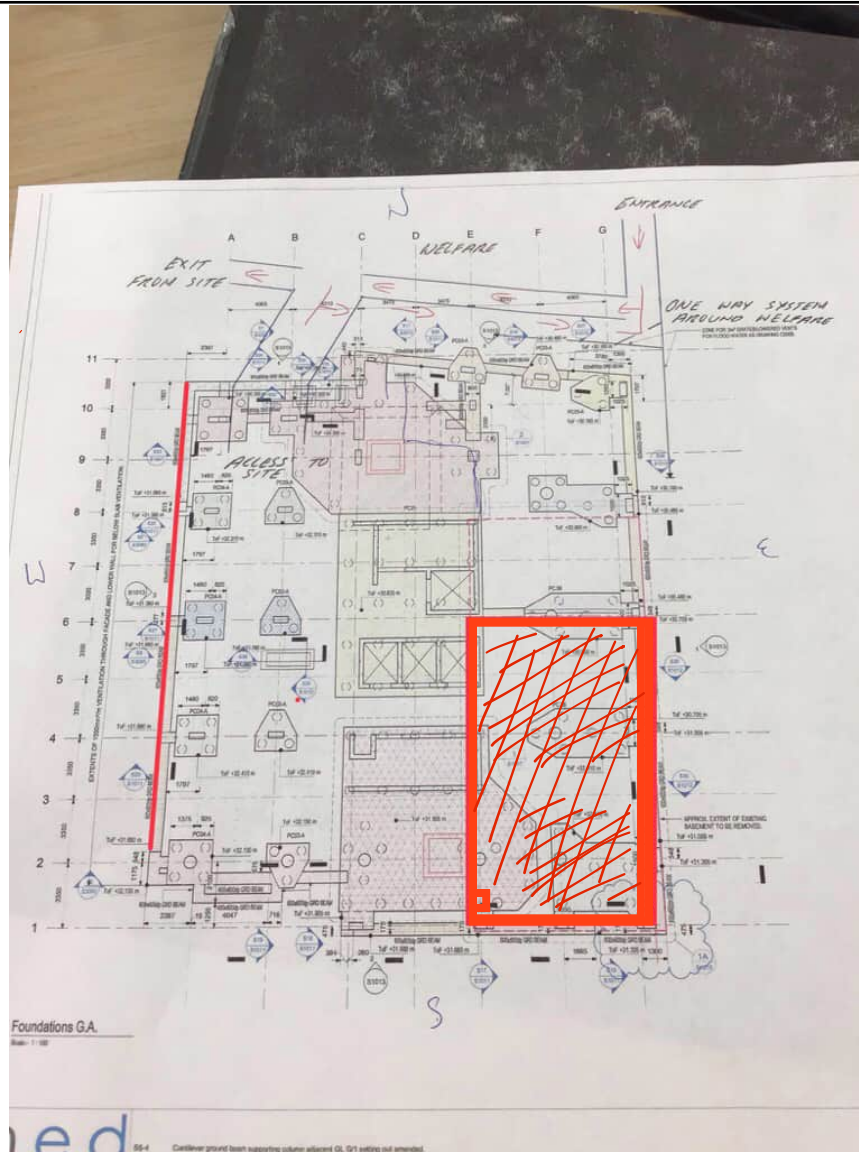
Area highlighted GL 1-6/E-G and West Toe Detail verified on this visit.

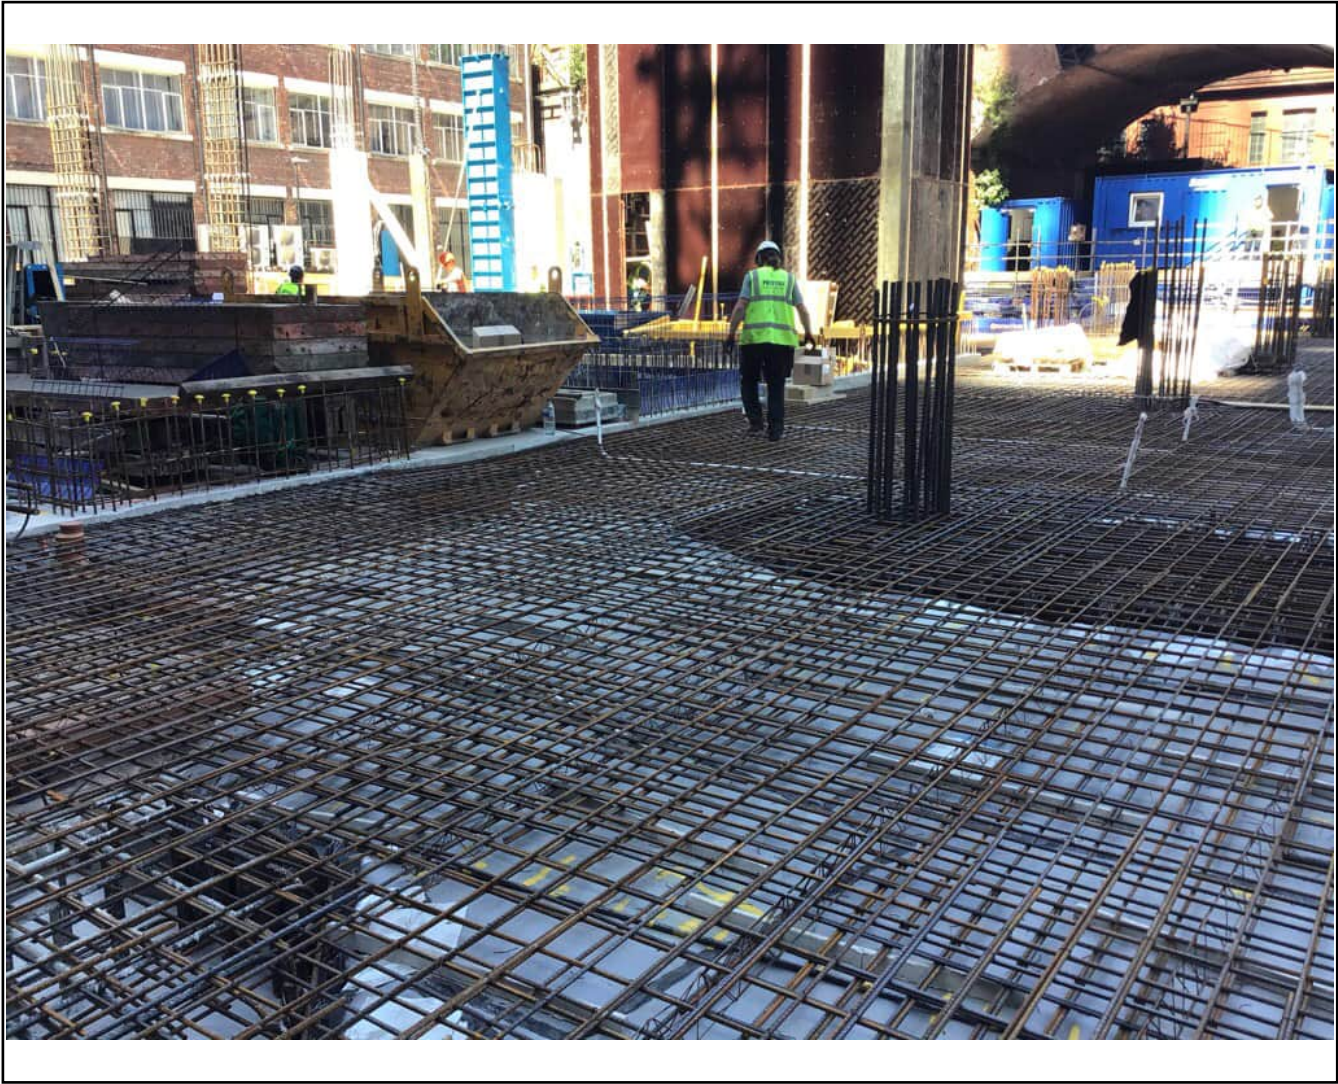
Overview of verified area

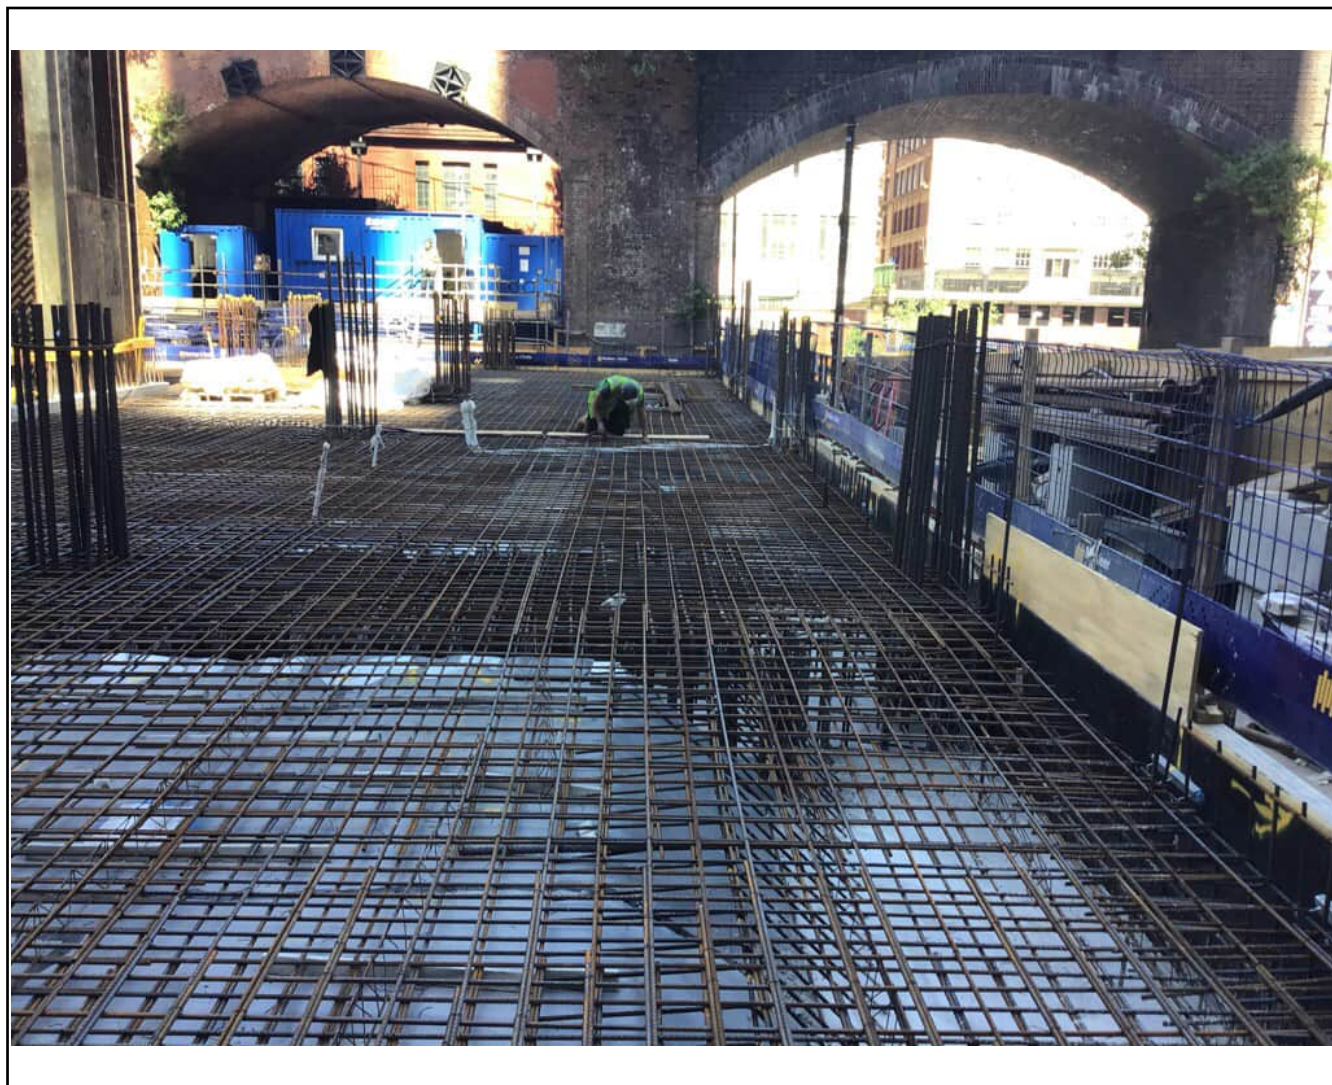
Overview of verified area

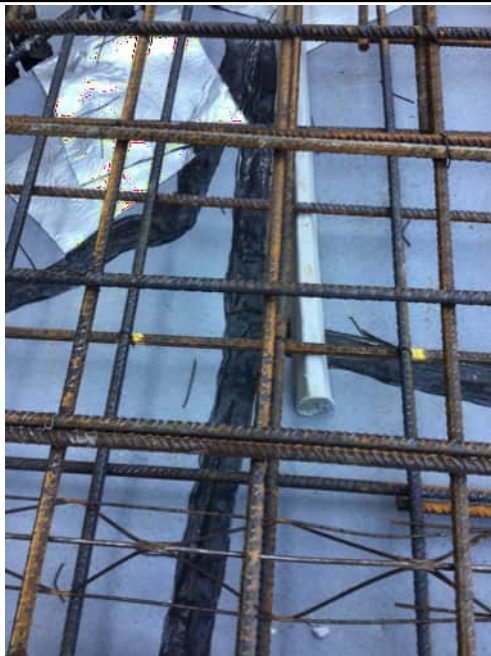
LOCATION/GRID LINE: Gridlines 1-6/E/G

NOTES: Visqueen Ultimate Geoseal has been applied to a large area within the grid lines given above. It has been extrusion welded on every joint to ensure that a good bond has been created. A pick and probe was carried out on welds, however due to limitations it wasn't possible to check all.

Left photo) Visqueen Geoshield Ultimate, with extrusion weld on joint.

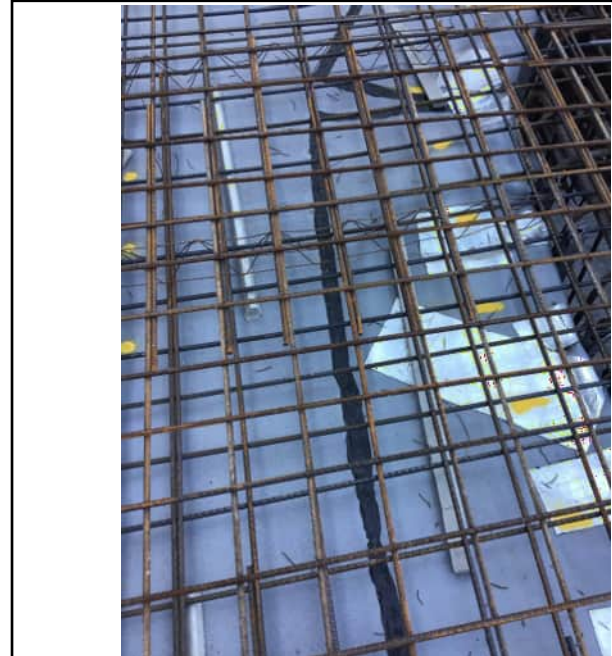
Right photo) Overview of membrane with concrete spacers holding the rebar above it.

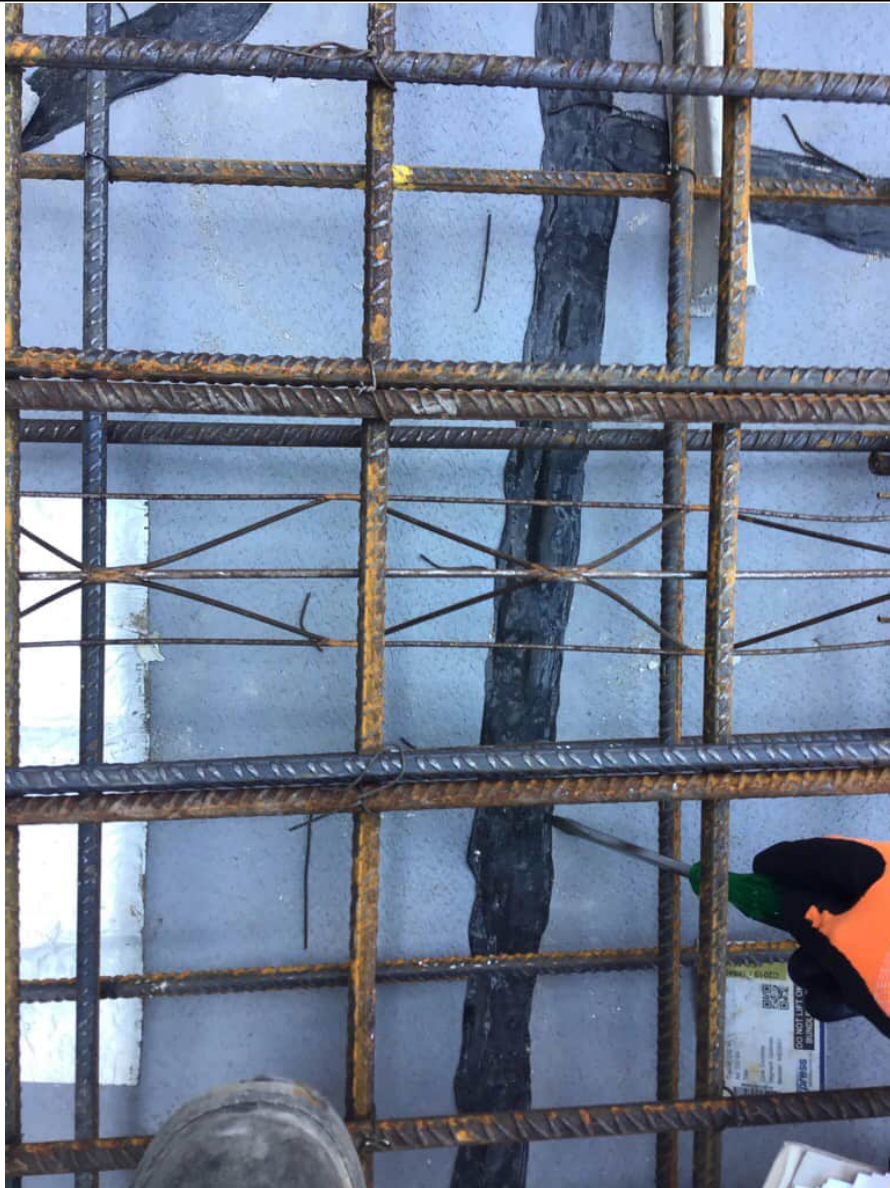
Above photo) this show a pick and probe test being carried out on the extrusion weld, which has been carried out on the overlap of Visqueen Geoshield Ultimate. Due to the rebar already been installed pick and probe tests couldn't be carried out on every weld.

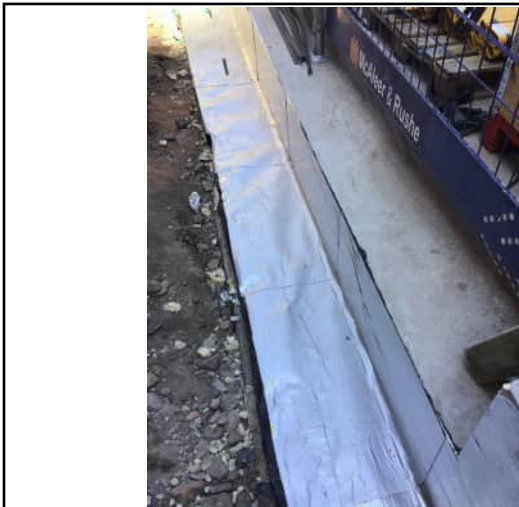
LOCATION/GRID LINE: West Toe Detail

NOTES: Gas Resistant Seal Adhesive Membrane has been

applied to the length of the western toe detail. A pick and probe test was carried out

on the overlaps to ensure that a good seal has been created.

Left photo) overview of Western Toe Detail, which as had GR SAM applied to it by the installers.

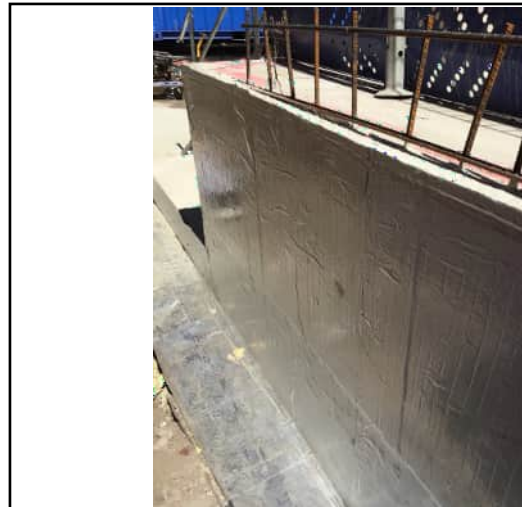
Right photo) GR SAM applied to Western Toe Detail.

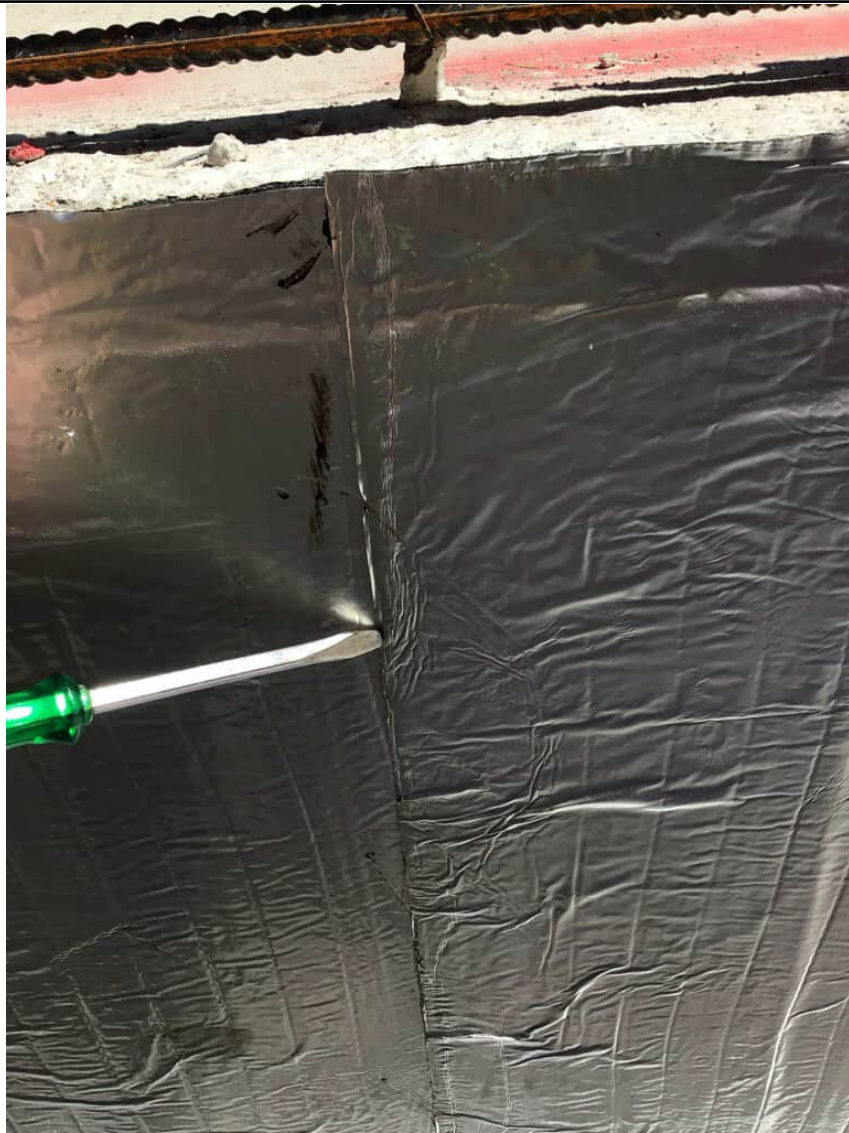
Above photo) a pick and probe test was carried out on the GR SAM that has been

applied to the Western Toe Detail. The length of the toe was firstly coated with

Bitumen primer, a good seal was created across the whole verified item.

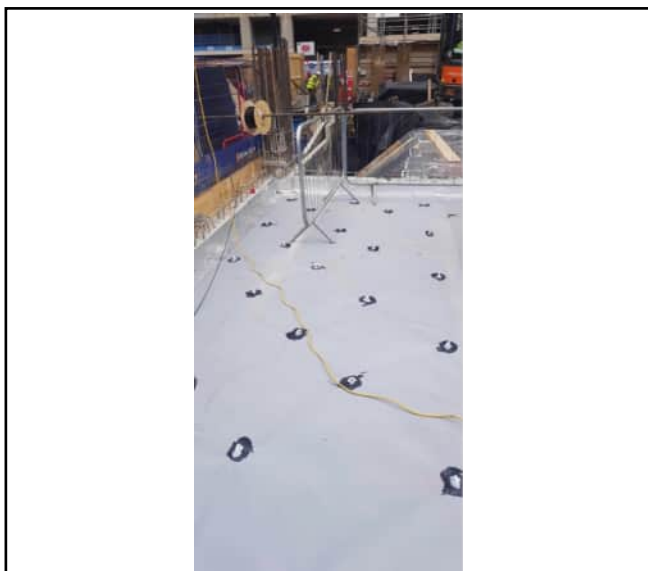
LOCATION/GRID LINE: Membrane Hooks

NOTES: This item is a follow on from the previous visit, hooks have been extrusion welded to the Visqueen Ultimate Geoseal as per manufacturers design. Wire has then been threaded through the loop on the hook and tied to the rebar which has been installed on the insulation covering the membrane.

Left photo) this is an overview of the Visqueen Ultimate Geoseal which has been covered with hooks and the extrusion welded to the membrane.

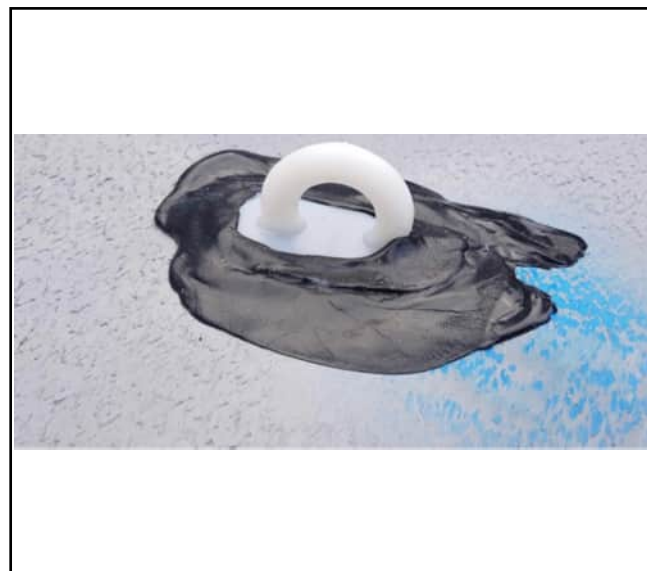
Right photo) close up of a welded hook.

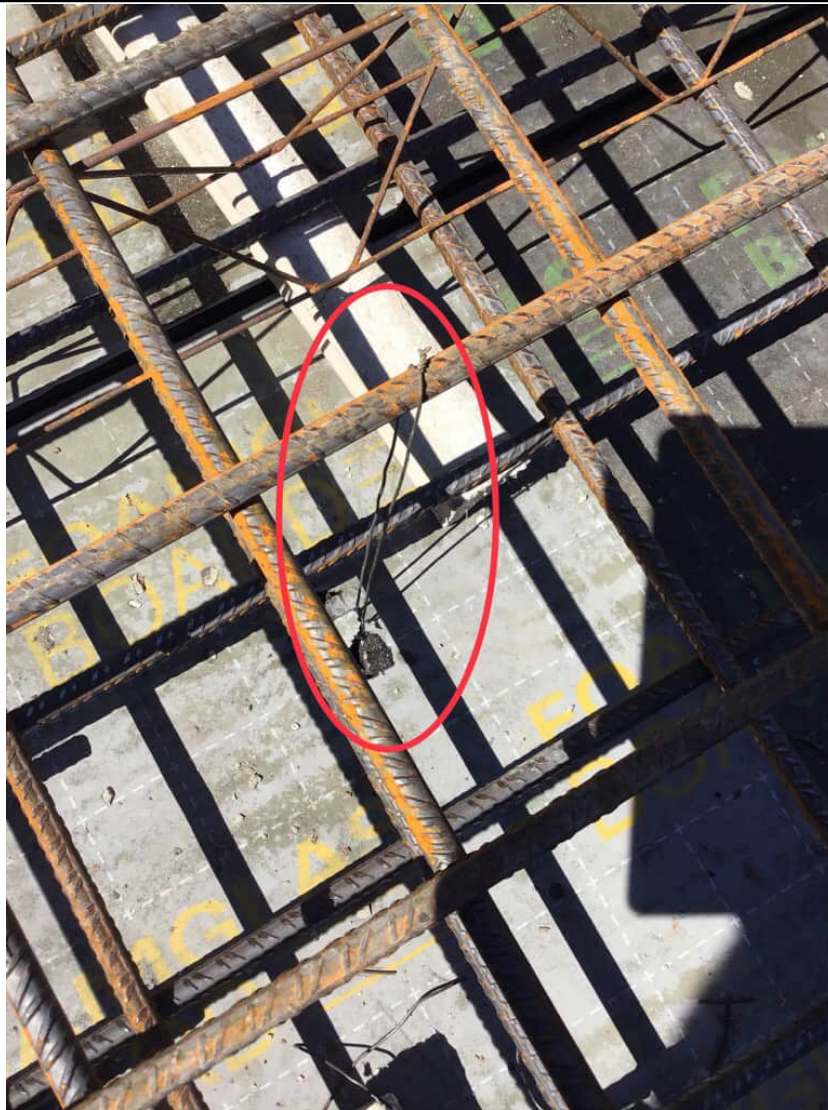
Above photo) this show wire that has been tied to the steel rebar sitting on top of the insulation. The insulation has been laid on top of the membrane. The other end of the wire is tied to the hook attached to the membrane.

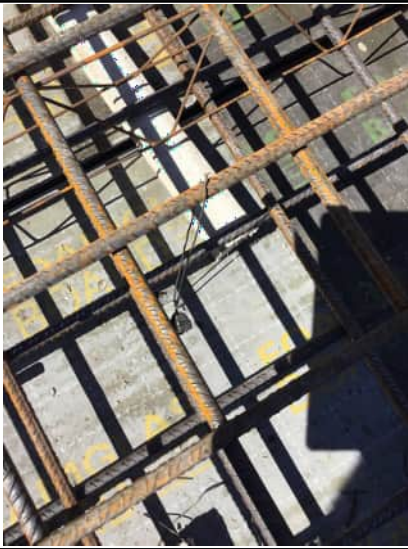
Wire ties holding the membrane  
to the rebar.

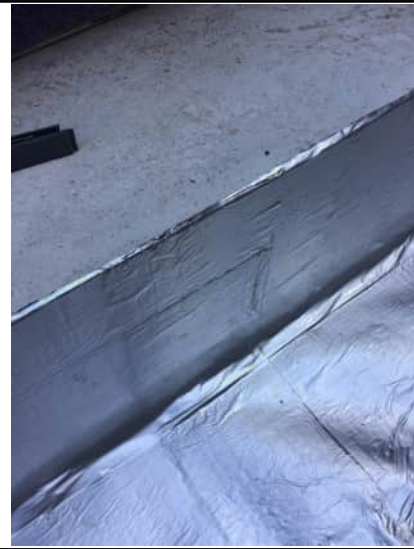
GR SAM applied to Western

Toe Detail

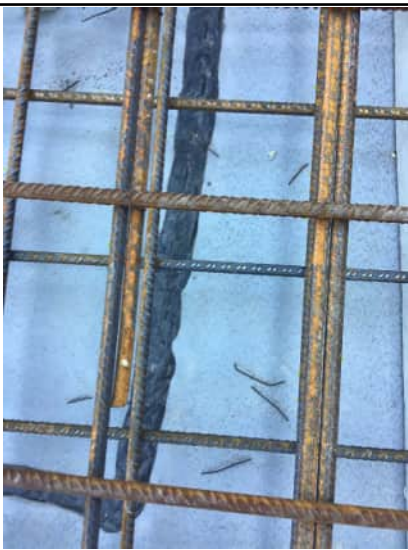
Extrusion weld on Visqueen

Geoshield Ultimate

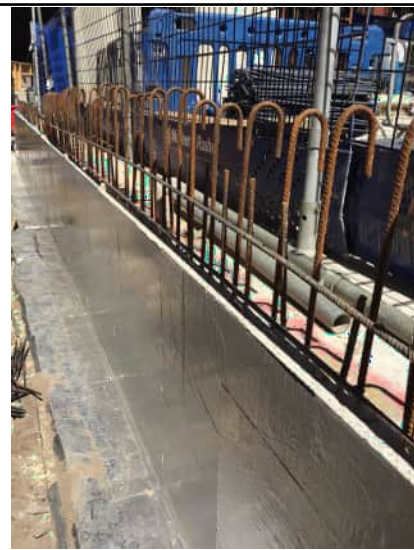
Western Toe Detail.
