Project title Victoria North River Works

281943

8 July 2021

Subject Baseline Fluvial Geomorphology Survey

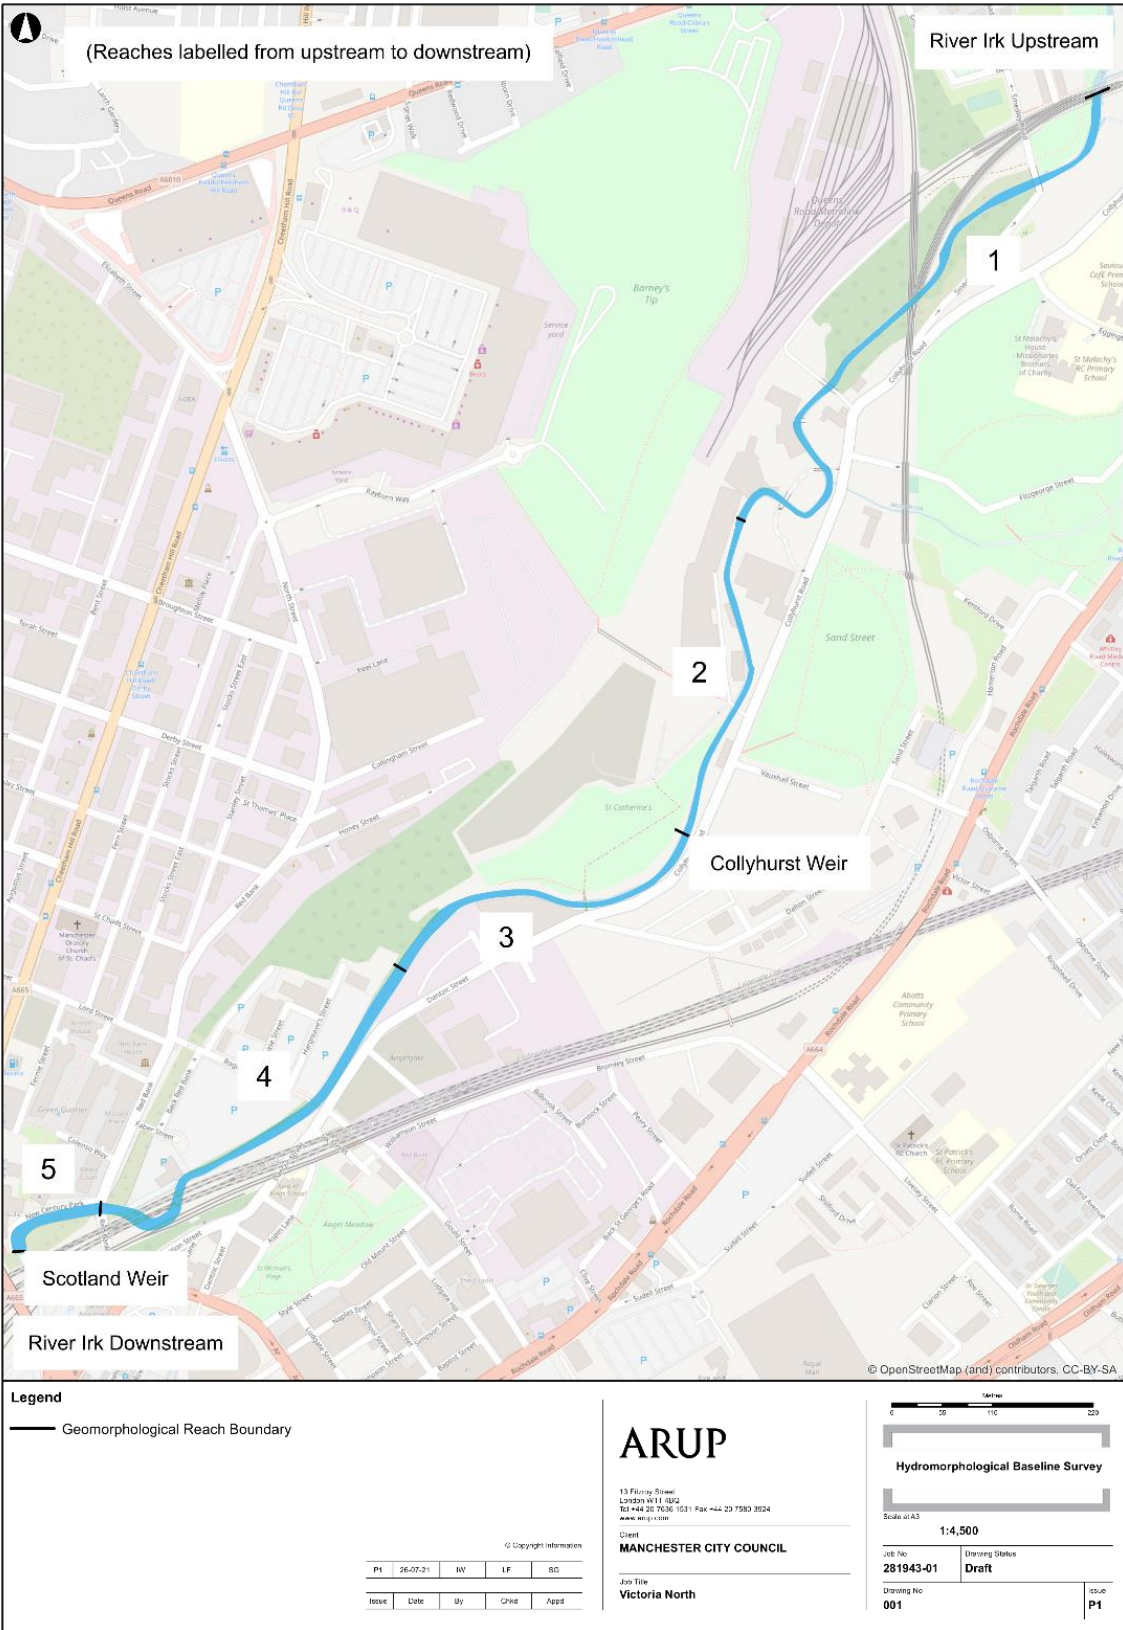
**Figure 1:** Geomorphological reaches, numbered from upstream (1) to downstream (5). Reaches 3, 4 and 5 are located within the proposed scheme boundary. Reaches 1 and 2 are located outside of the proposed scheme boundary.

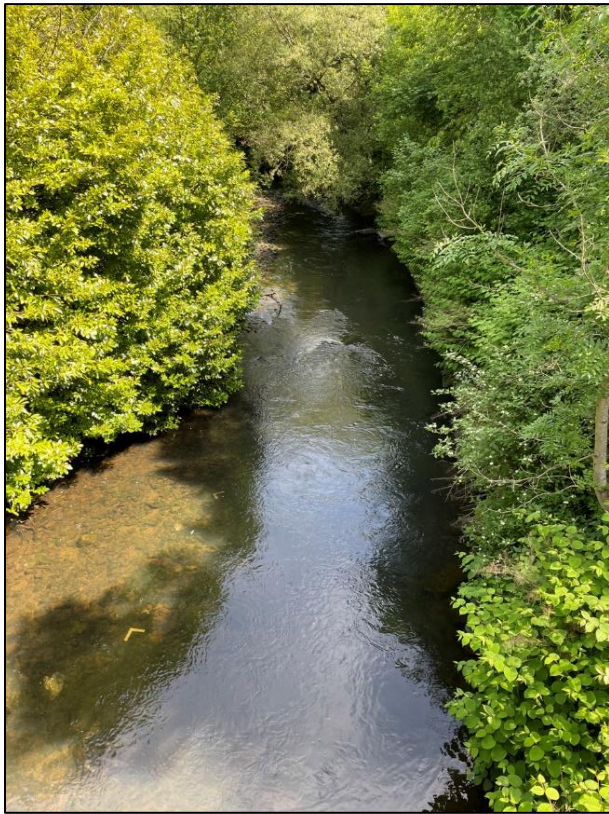
**Figure 2:** Downstream view of Reach 1 from Smedley Road Bridge.

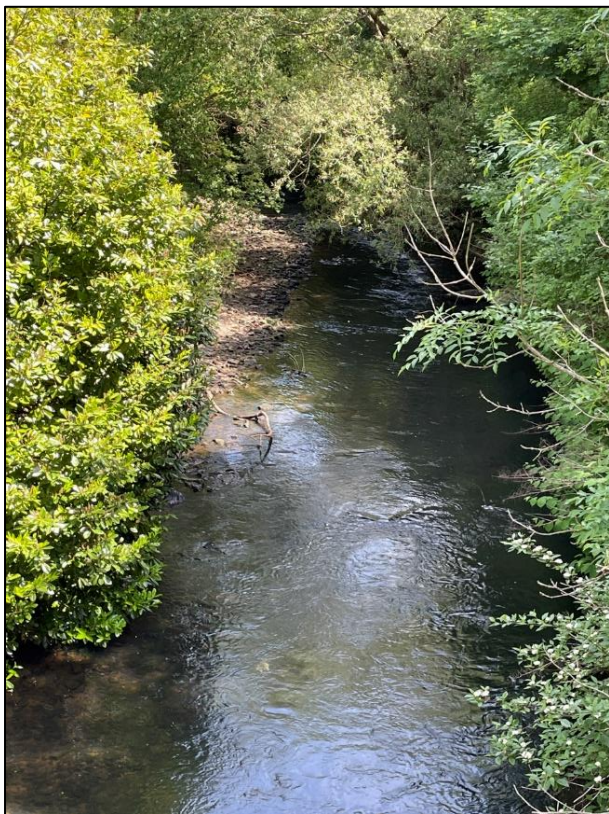
**Figure 3:** Downstream view of Reach 1.

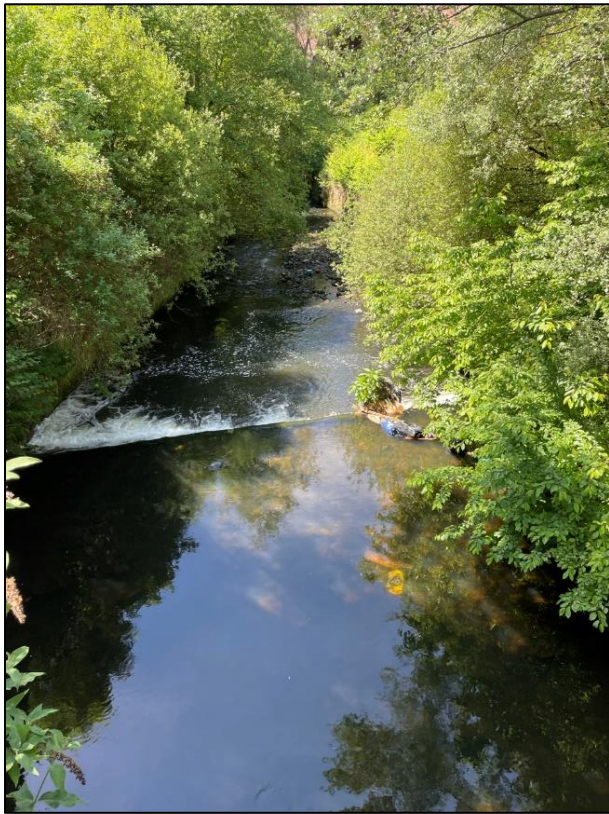
The stone weir located downstream of the Smedley Road bridge is approximately 10 m wide across the channel with no sluice gates present. There is no sign of excessive bed or bank erosion, or excessive aggradation either upstream, downstream or at the structure. However, the weir is affecting channel morphology as well as flow and sediment continuity. There is no reduction in morphological diversity of the banks or bed. No other structures affecting channel morphology or flow and sediment continuity are visible along this reach. A further 4 m long, 1.5 m wide side bar made of fine and coarse gravel was recorded downstream of the weir.

**Figure 4:** Downstream view of Reach 1 showing the 10 m stone weir.

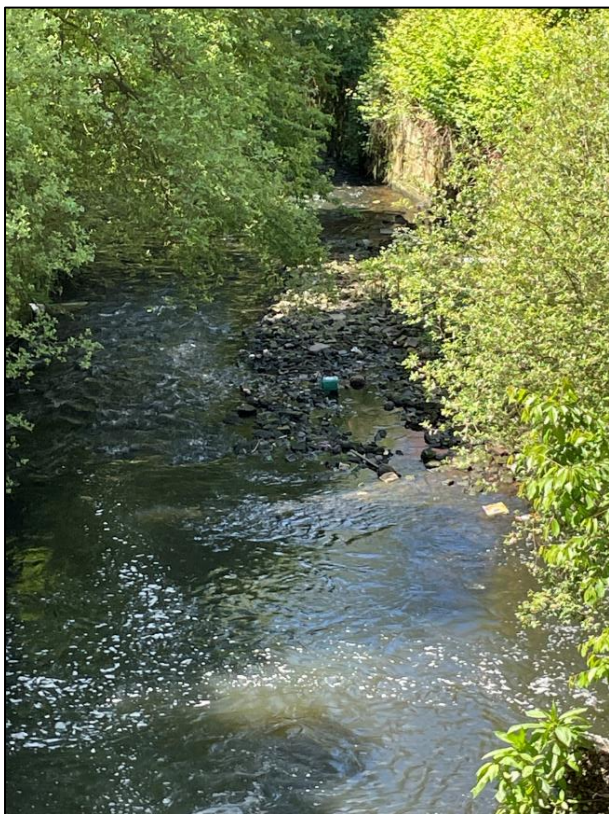
Riffles and glides dominate along this reach, although ponded sections are also present. The dominant substrate is comprised of cobbles, however silts, fine and coarse gravels, and boulders (mostly artificial material: rubbish) are also visible. There are also bars present comprised of cobbles. In particular, an 8 m long, 2.5 m wide point bar made of silt, fine gravel, coarse gravel and cobbles is present on the right bank near to the upstream limit of this reach. There are no sources of fine sediment or silty margins evident and no overhanging vegetation or channel shading throughout the reach.

**Figure 5:** Downstream view of Reach 1 showing the bar and microscale riffle feature.

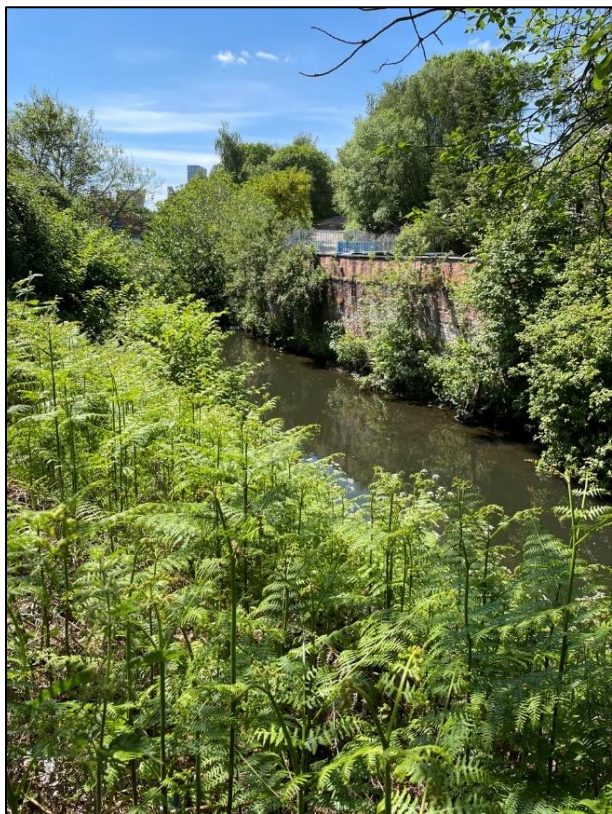
**Figure 6:** Downstream view of Reach 2 showing the brick wall on the right bank of the modified urban reach.

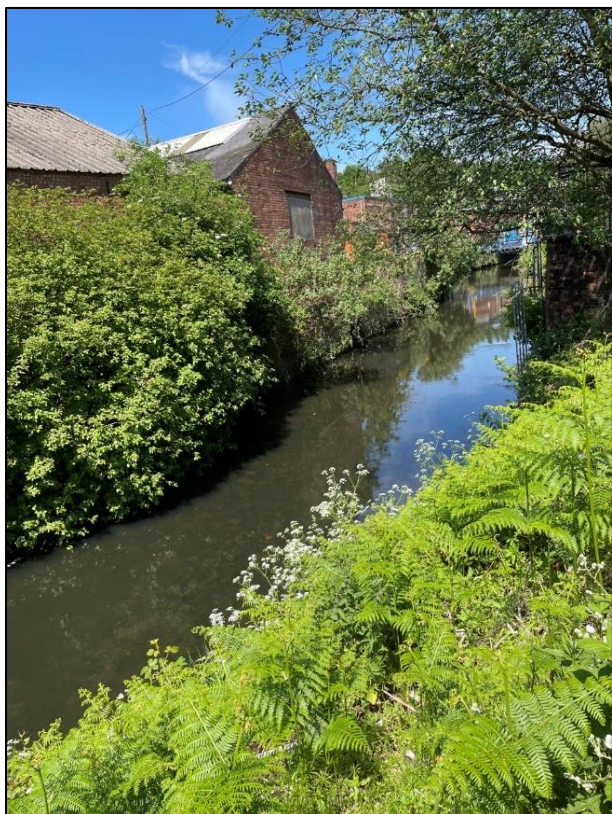
**Figure 7:** Upstream view of Reach 2 showing a road on the left, and the brick wall dominating the right bank.

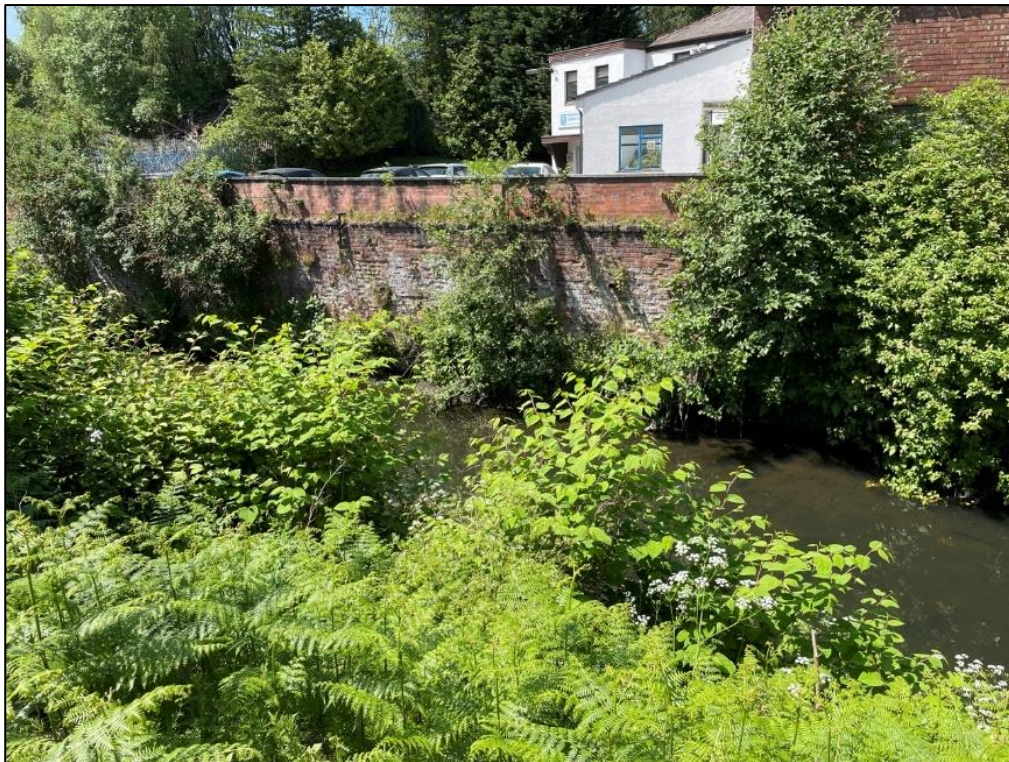
**Figure 8:** Right bank of Reach 2, showing a brick wall.

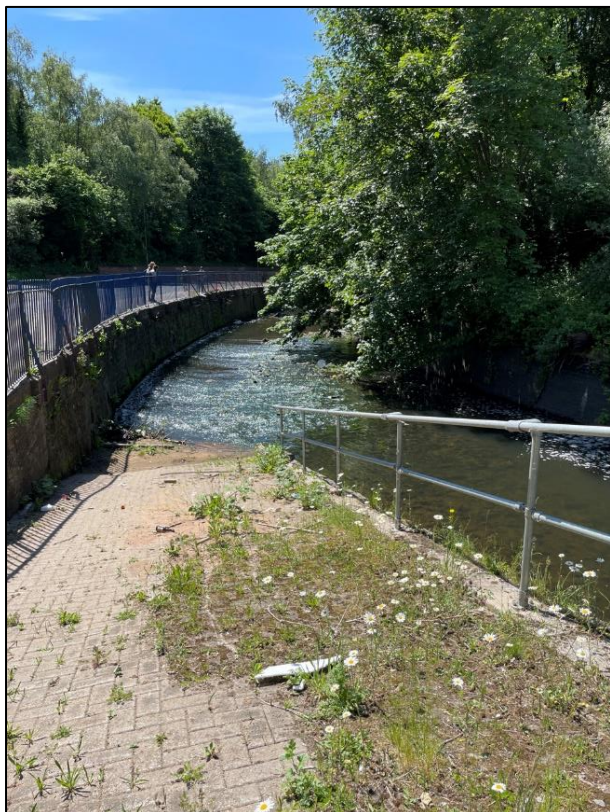
A 1.5 m high, 10 m wide stone weir is present in the channel, marking the end of Reach 2; this is Collyhurst Weir. There is pooling ahead of the weir, and a glide which turns into a riffle/run below the weir near an access ramp as shown in photograph(s) below (this is in the upstream extent of Reach 3). The weir is not causing excessive bed or bank erosion, or aggradation. However, it is affecting channel morphology, as well as flow and sediment continuity. The weir does not have a fish pass.

**Figure 9:** Downstream view of Collyhurst Weir (this is the upstream-most extent of Reach 3), showing flow types behind the weir which are sequences of runs and glides.

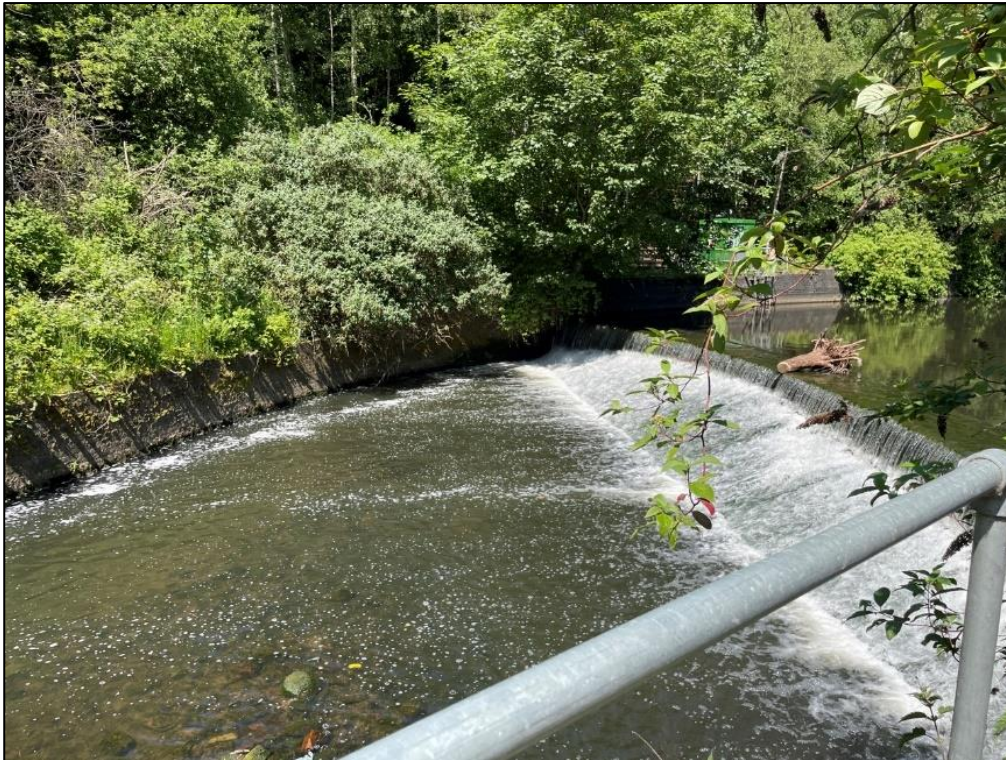
**Figure 10:** Upstream view of Reach 2 showing Collyhurst Weir.

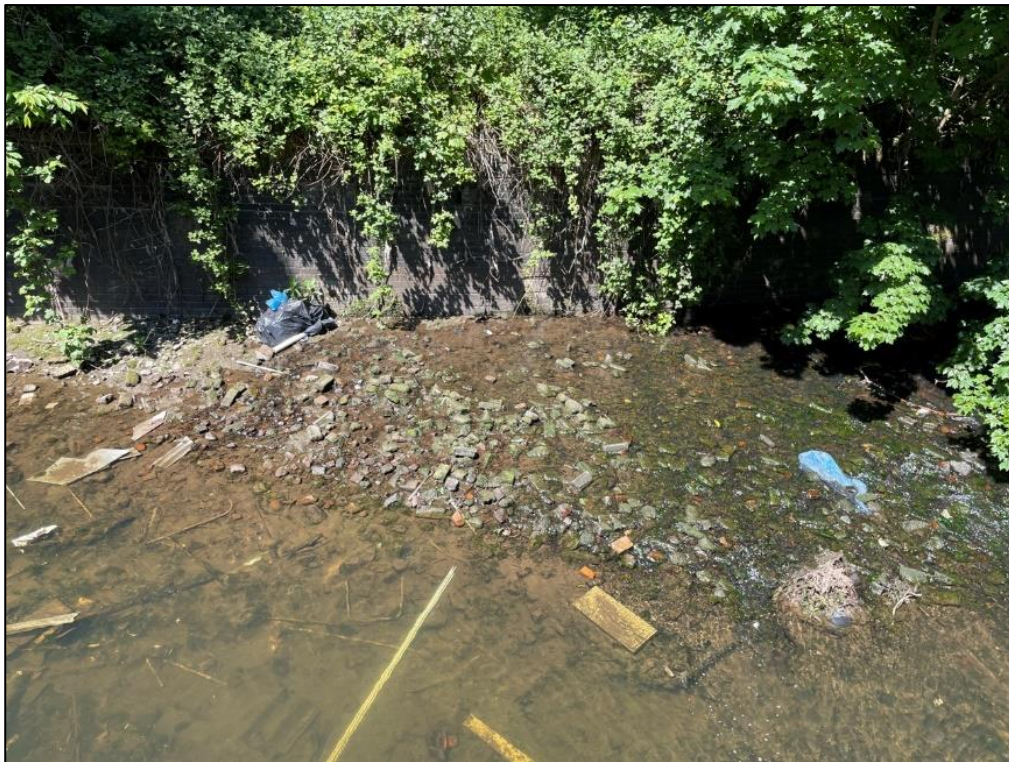
**Figure 11:** View across channel of Reach 3, showing the bar made of cobbles.

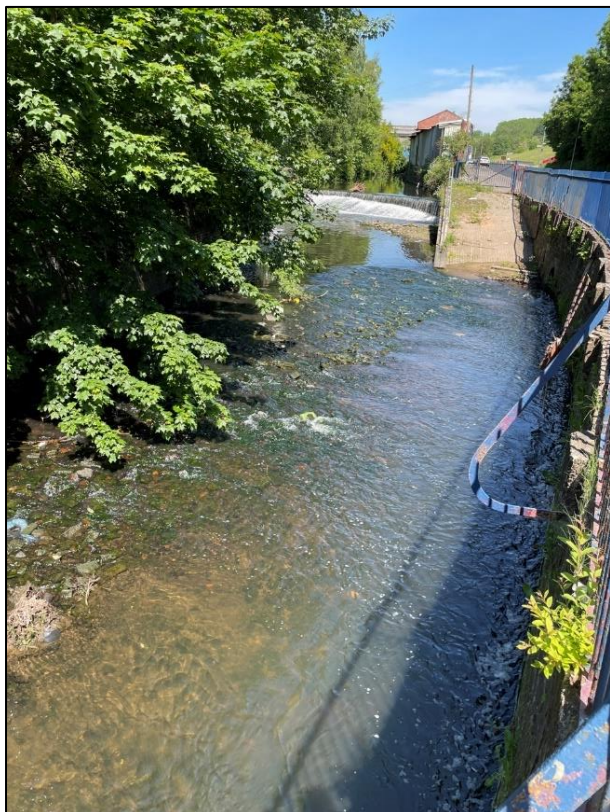
**Figure 12:** Looking upstream from Reach 3 to the boundary near Reach 2 (Collyhurst Weir)

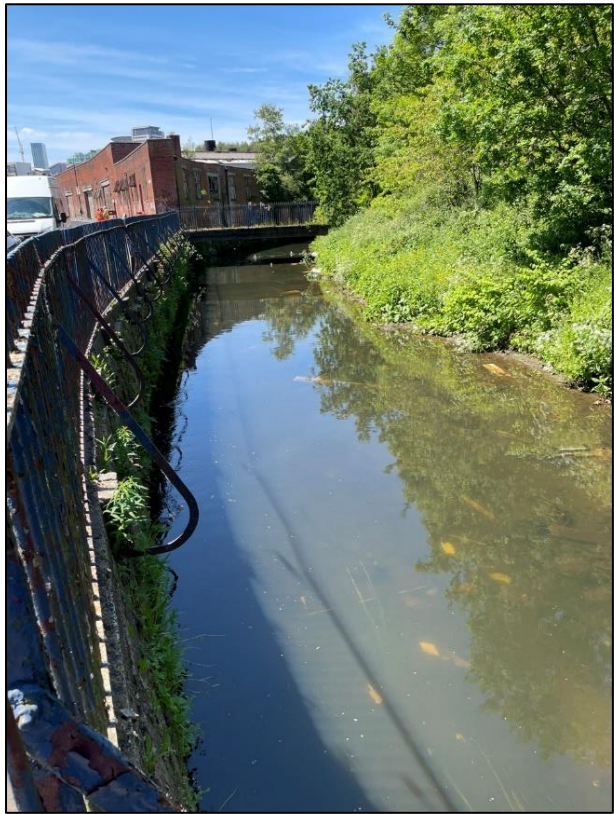
**Figure 13:** Downstream view of Reach 3 showing footbridge across the river.

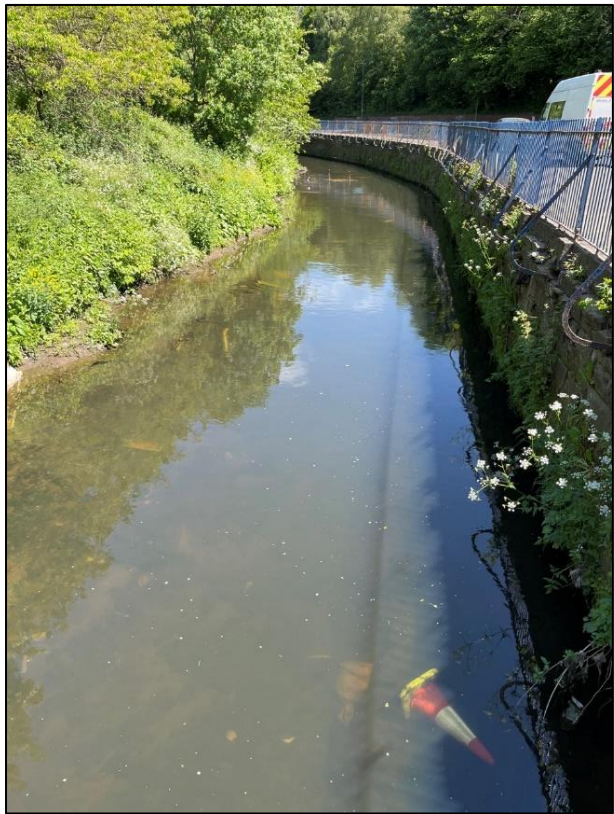
**Figure 14:** Upstream view of Reach 3 from footbridge, showing modified urban reach with boulder size rubbish scattered across substrate.

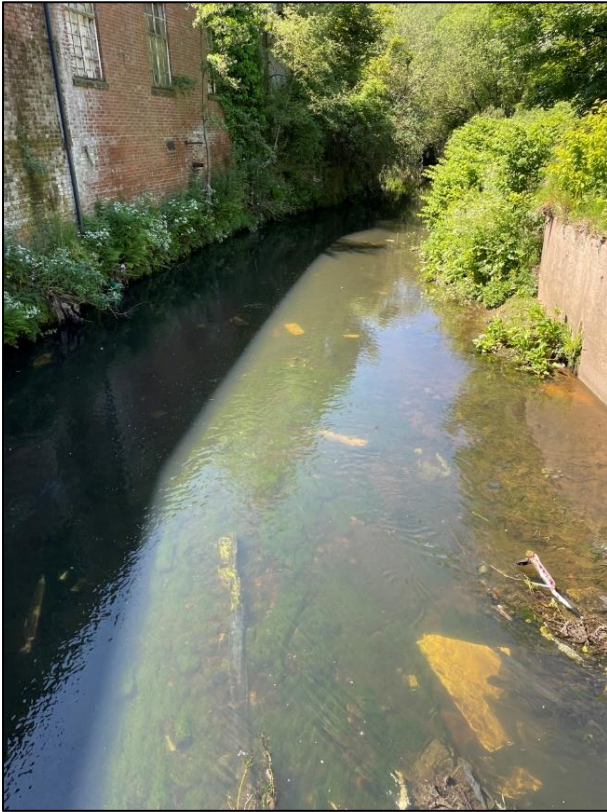
**Figure 15:** Downstream view of Reach 3 from footbridge, showing modified urban reach with boulder size rubbish scattered across substrate.

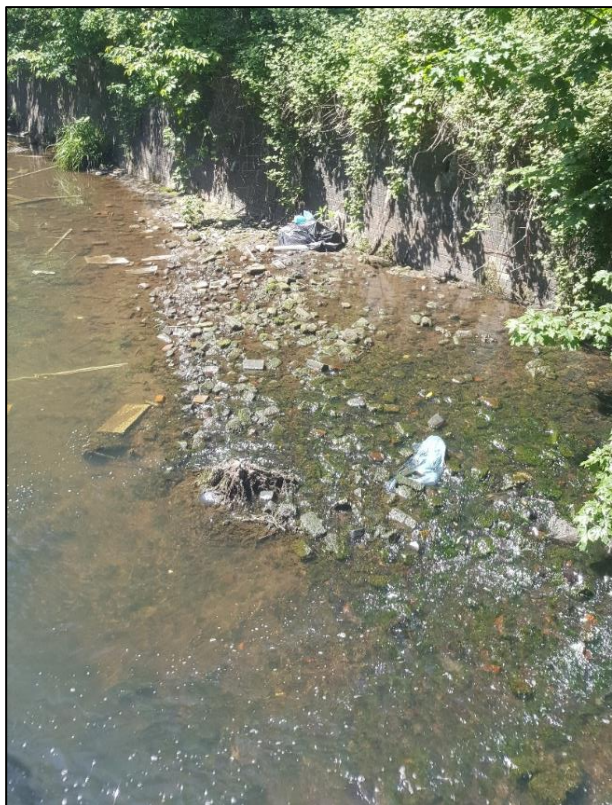
The river bed is comprised predominantly of silt and cobbles, with no bedrock observed. The reach is dominated by depositional features including artificial berms and fine sediment, although scour was also observed along the banks where higher energy flows have undercut deposited sediment.

**Figure 16:** Across-channel view of Reach 4 showing erosion of berm on right bank side.

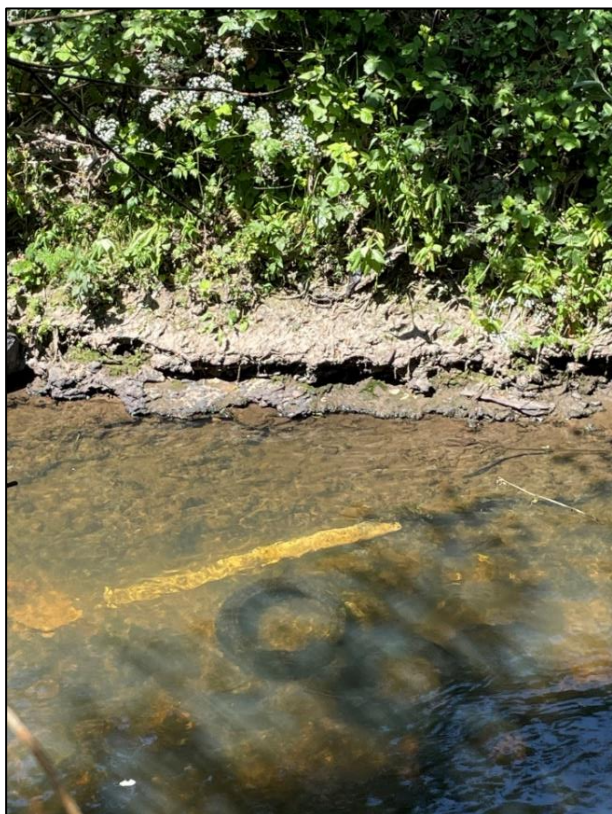
**Figure 17:** Across-channel view of Reach 4 showing erosion of berm on right bank side.

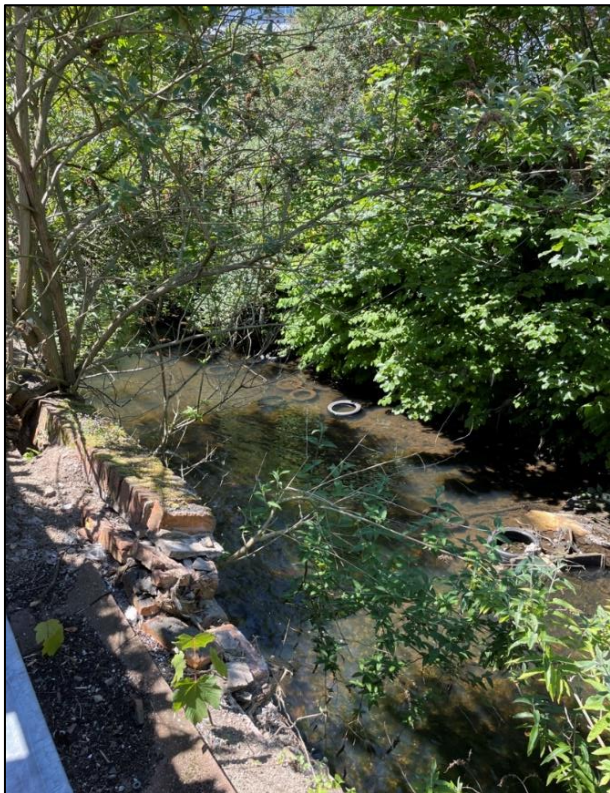
Fly tipping is evidently a serious and prolonged issue at this location, evidenced by a significant amount of large rubble alongside large quantities of tyres and home appliances.

**Figure 18:** Downstream view of Reach 4 showing typical hydromorphology and tyres in channel.

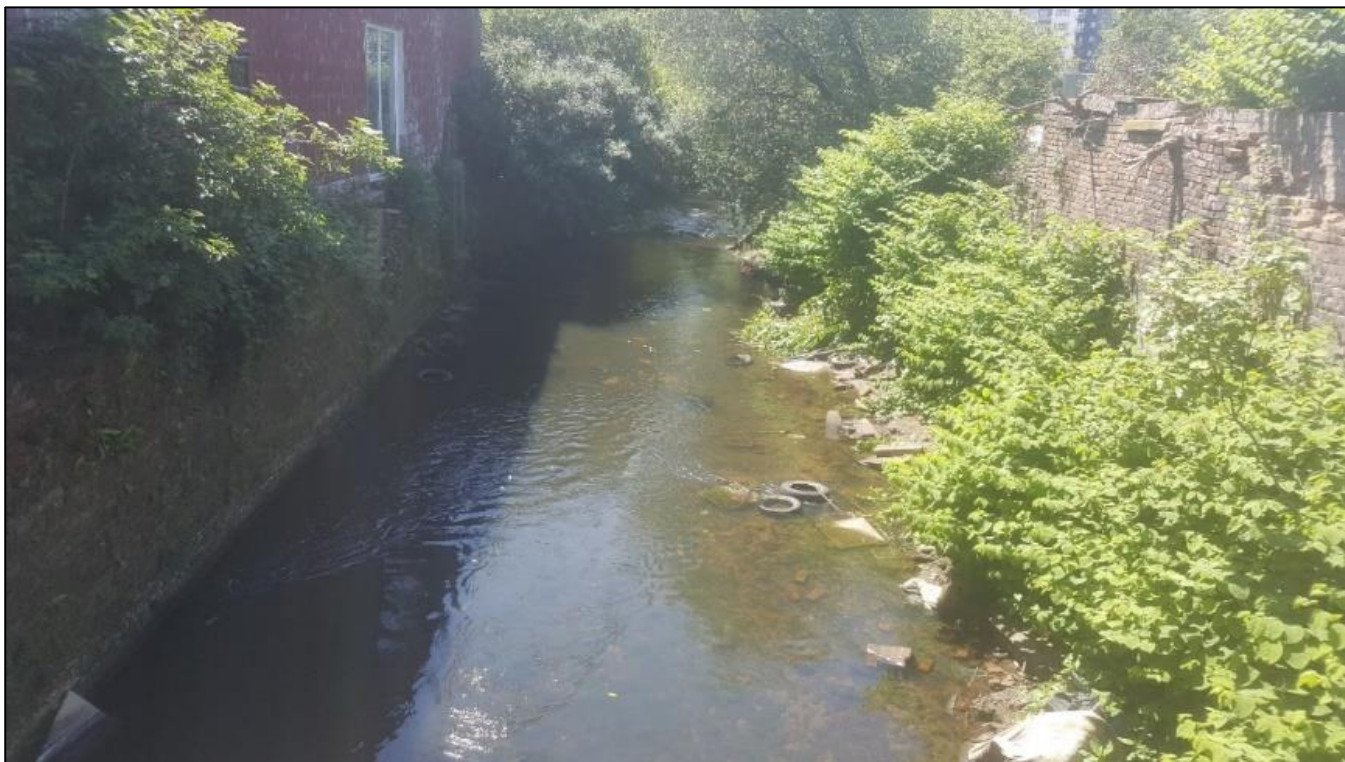
**Figure 19:** Downstream view of Reach 4 from Vauxhall Road

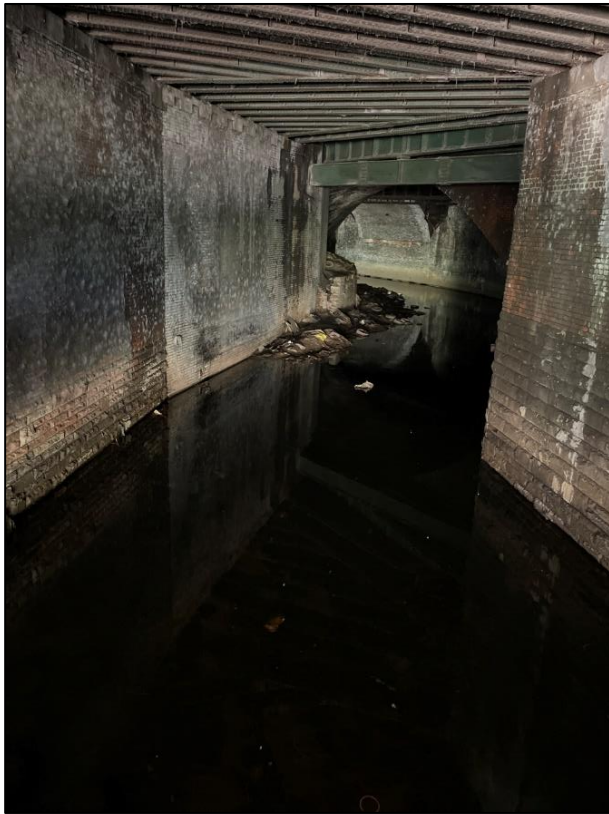
Along this reach, silt and cobbles are the dominant substrates. There is significant deposition of urban material, mainly tyres, home appliances and rubbish, although these are predominantly concentrated within the culvert.

**Figure 20:** Culvert upstream of Scotland Weir

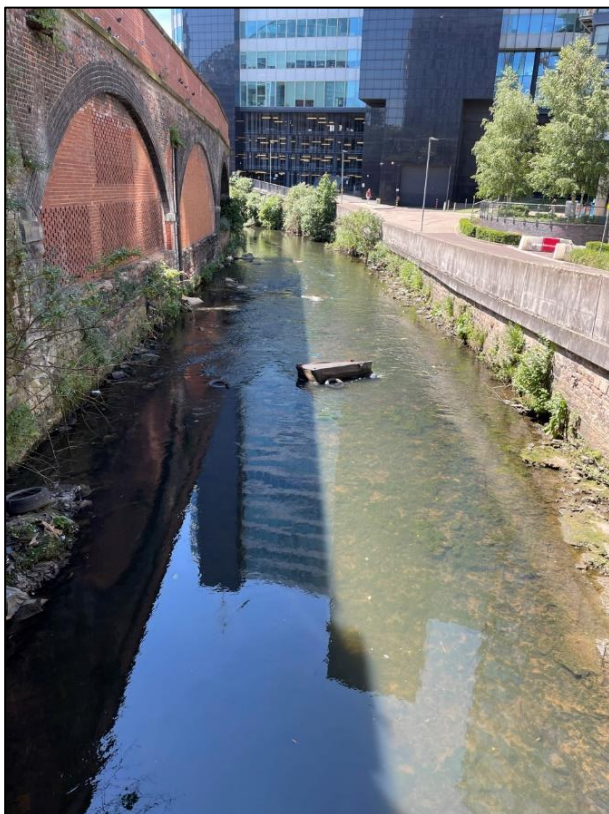
**Figure 21:** Looking downstream of culvert

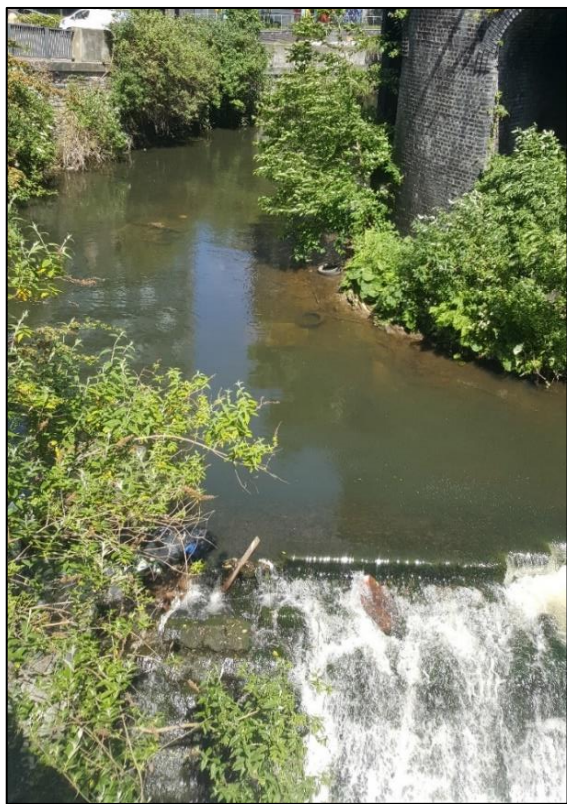
**Figure 22:** Scotland Weir

Scotland Weir is approximately 8 m wide with a 3 m high impoundment. The structure is affecting channel morphology, flow continuity, sediment continuity both upstream and downstream of the structure. A glide is observed around the weir although there are localised areas of ponding observed. There is no bed or bank erosion as a result of the weir, nor excessive aggradation or reduction in morphological diversity of the bed or bank. The gradient is low (near flat) and there is no bed level variation. Along this reach, there are no significant sources of fine sediment input or silty margins observed. Moreover, no channel shading or overhanging bank and low vegetation is present.

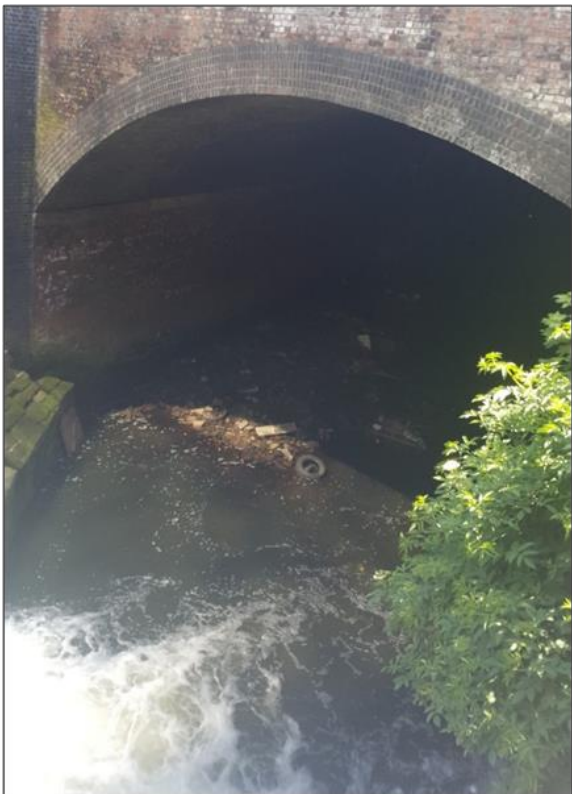
**Figure 23:** Bar under bridge d/s of Scotland Weir

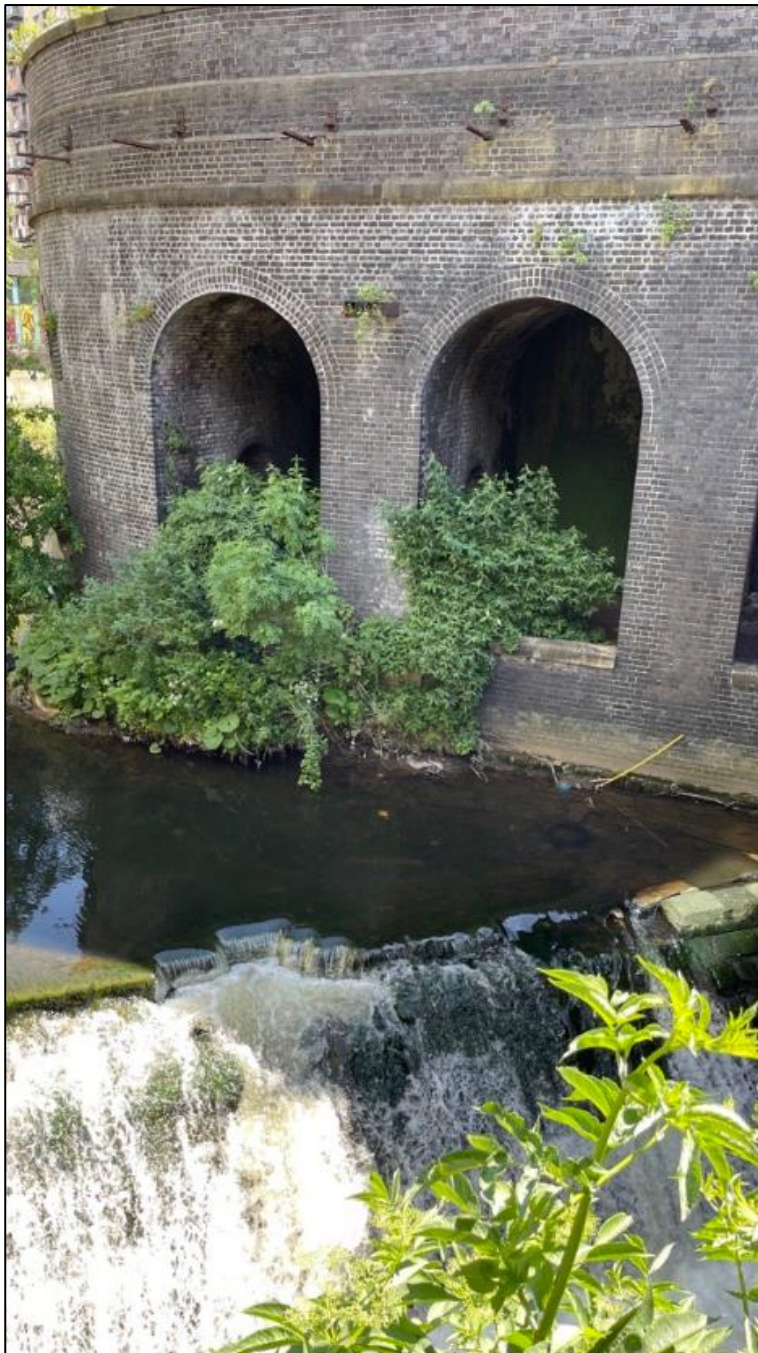
**Figure 24:** Scotland Weir, the downstream end of Reach 5 and the survey area.
