## Verification Report

GEO101021

McAlear & Rushe

101 Charles Street

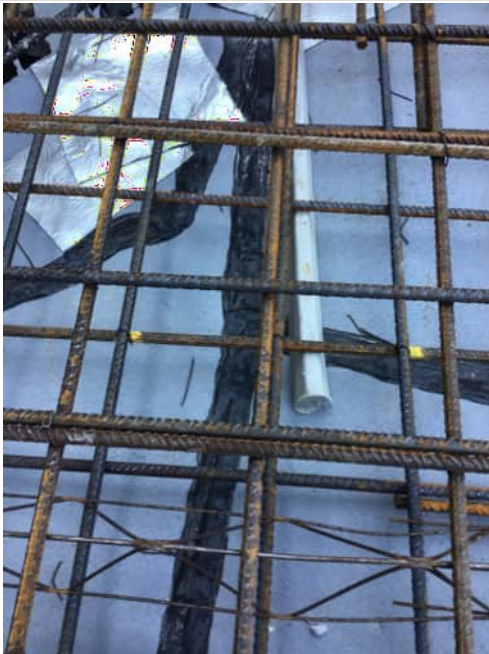
LOCATION/GRID LINE: Gridlines 1-6/E/G

NOTES: Visqueen Ultimate Geoseal has been applied to a large area within the grid lines given above. It has been extrusion welded on every joint to ensure that a good bond has been created. A pick and probe was carried out on welds, however due to limitations it wasn't possible to check all.

Left photo) Visqueen Geoshield Ultimate, with extrusion weld on joint.

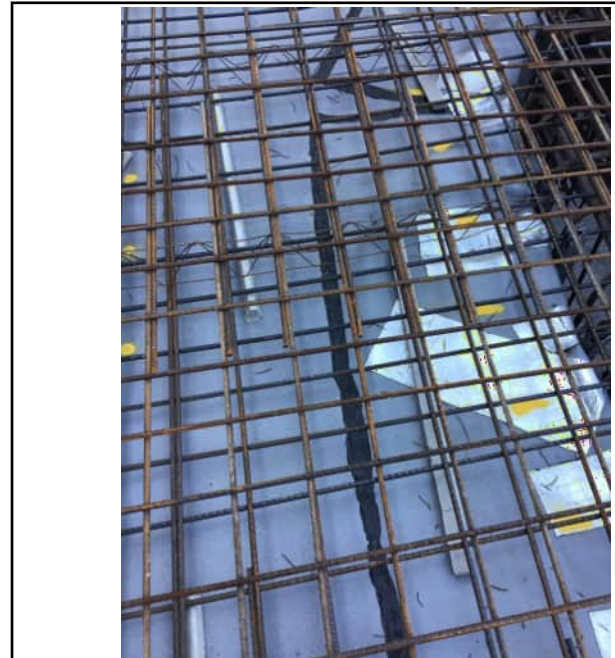
Right photo) Overview of membrane with concrete spacers holding the rebar above it.

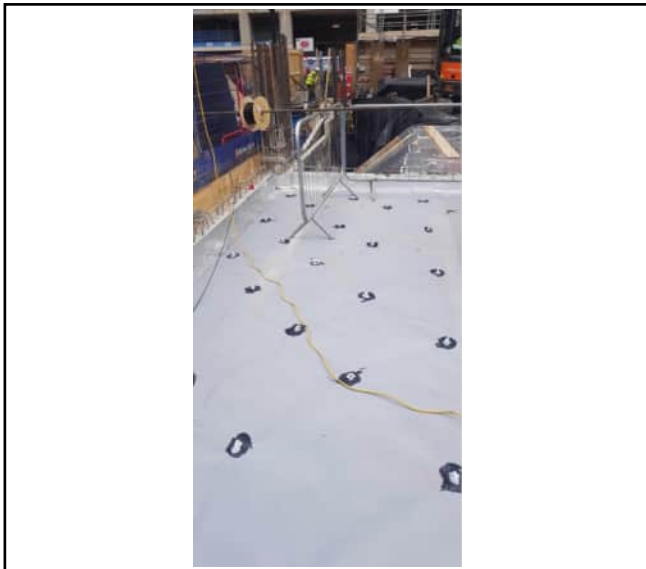
LOCATION/GRID LINE: Membrane Hooks

NOTES: This item is a follow on from the previous visit, hooks have been extrusion welded to the Visqueen Ultimate Geoseal as per manufacturers design. Wire has then been threaded through the loop on the hook and tied to the rebar which has been installed on the insulation covering the membrane.

Left photo) this is an overview of the Visqueen Ultimate Geoseal which has been covered with hooks and the extrusion welded to the membrane.

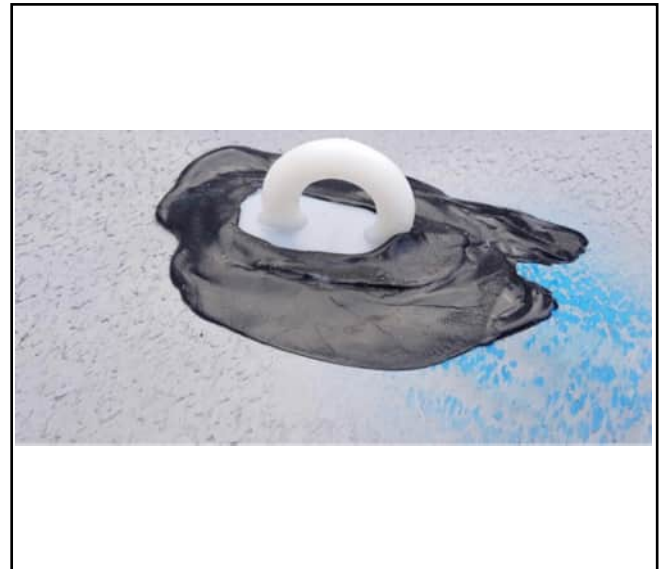
Right photo) close up of a welded hook.
