PLANNING ISSUE

PROJECT  
MEDLOCK  
VICTORIA MILL  
MILES PLATTING

TITLE  
ROOF PLAN PHOTOGRAPHIC RECORD AND REPAIRS

DRAWING No  
AP106

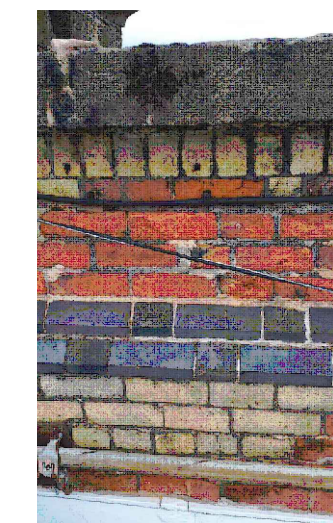
1 General view of front parapet, record photo

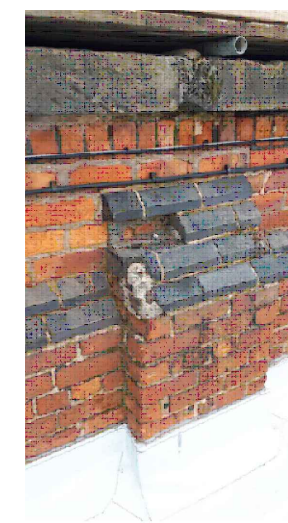
6 Missing cant brick requires replacement

REINSTATE ALL MISSING CANT BRICKS AND PARAPET WALL INNER LEAF BRICKS USING BRICKS AND MORTAR TO MATCH EXISTING.

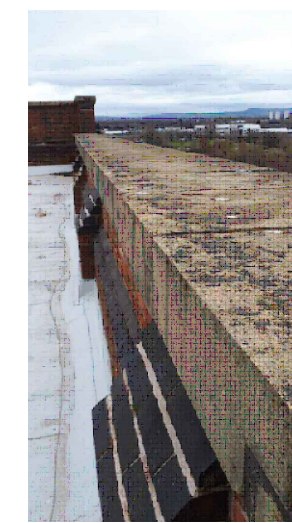
11 Modern concrete copings to rear elevation, record photo

THE EXISTING COPINGS HAVE BEEN ASSESSED BY SUTCLIFFE STRUCTURAL ENGINEERS AND THEY FOUND NO EVIDENCE OF MOVEMENT IN EITHER THE MODERN PRE CAST COPINGS OR THE ORIGINAL STONE COPINGS. PLEASE SEE THEIR REPORT WHICH ACCOMPANIES THIS APPLICATION.

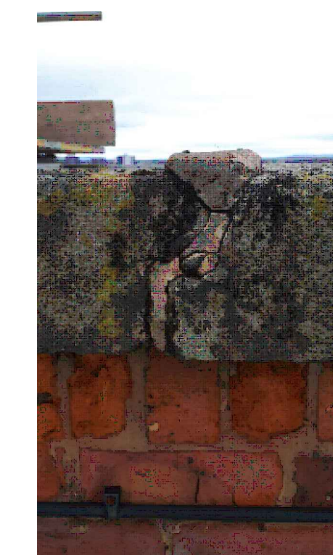
2 Coping stone mortar joint, record photo

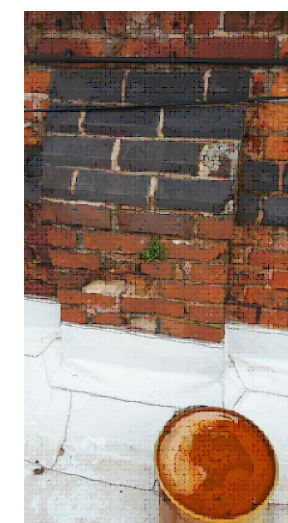
7 Spalling mortar to front parapet requiring repointing and vegetation growth requiring removal

RAKE OUT AND REMOVE ANY CRACKED, SPALLED OR LOOSE MORTAR TO A MINIMUM DEPTH OF TWICE THE HEIGHT OF THE JOINTS AND THOROUGHLY CLEAN OUT JOINTS OF ALL PLANT, SEED GROWTH AND DEBRIS. THOROUGHLY DAMPEN BRICKWORK AND REPOINT AREAS OF BRICKWORK USING GOOD QUALITY MORTAR TO MATCH EXISTING.

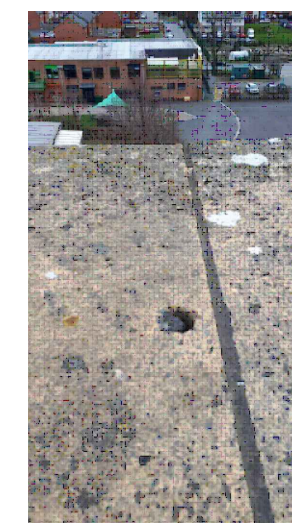
12 Steel dowel bolt through modern concrete coping on rear elevation, record photo.

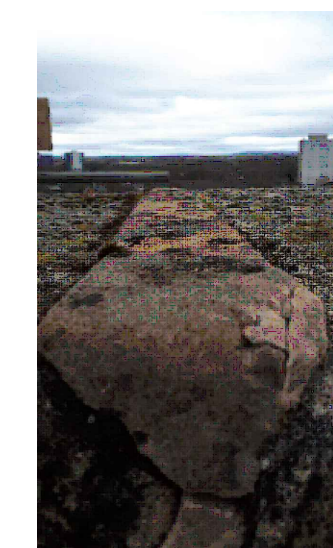
3 100mm x 10mm sand/cement fillet between stone copings, record photo

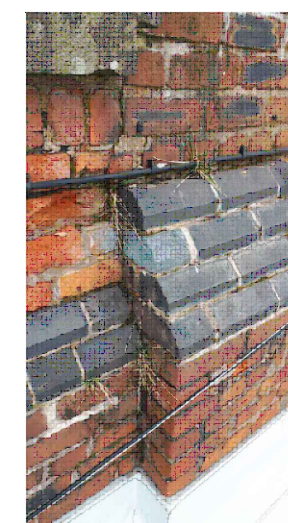
8 Vegetation growth in mortar joints requiring removal

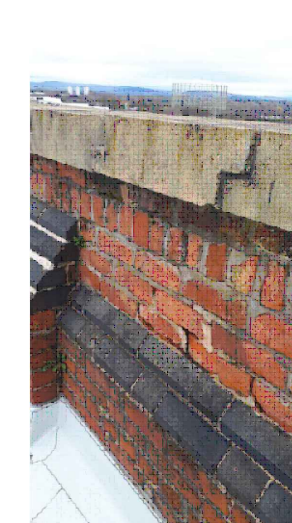
13 Weathered brickwork to rear elevation, record photo

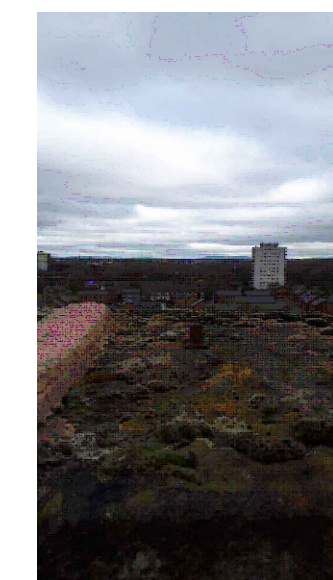
4 Steel dowel through coping stone, record photo

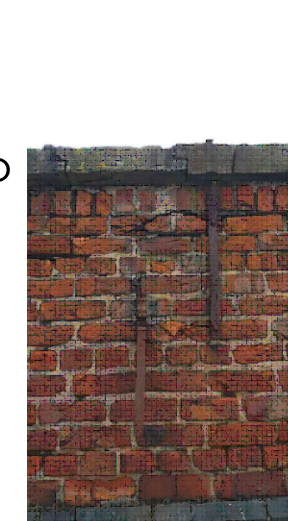
9 Steel restraint straps and cracking brickwork on northern corner requires replacement brickwork and repointing

CUT OUT SPLIT/ CRACKED BRICKS TO THE HIGH LEVEL PARAPET WALLS AND BED NEW BRICKS AND MORTAR TO MATCH EXISTING.

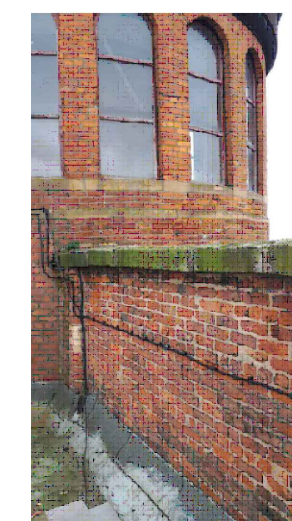
14 Uneven stone copings adjacent to staircase tower, record photo

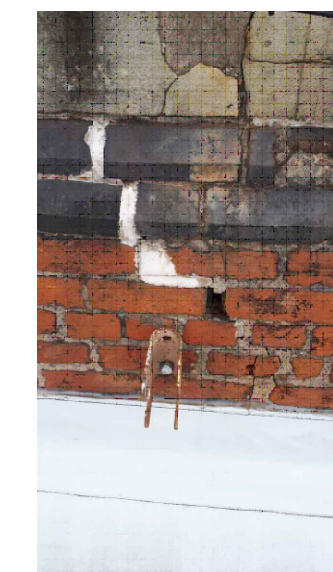
5 Deterioration to front parapet requires repointing

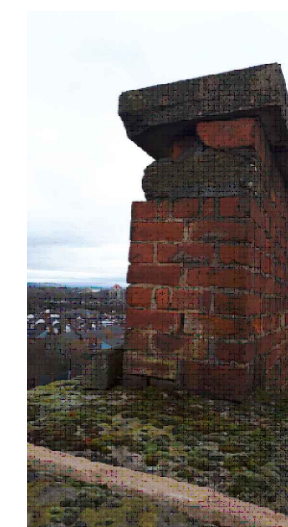
10 Southern corner showing missing brickwork to outer leaf. Missing bricks to be replaced.
