# GEOSHIELD Verification Report

GEO101021

McAlear & Rushe

101 Charles Street

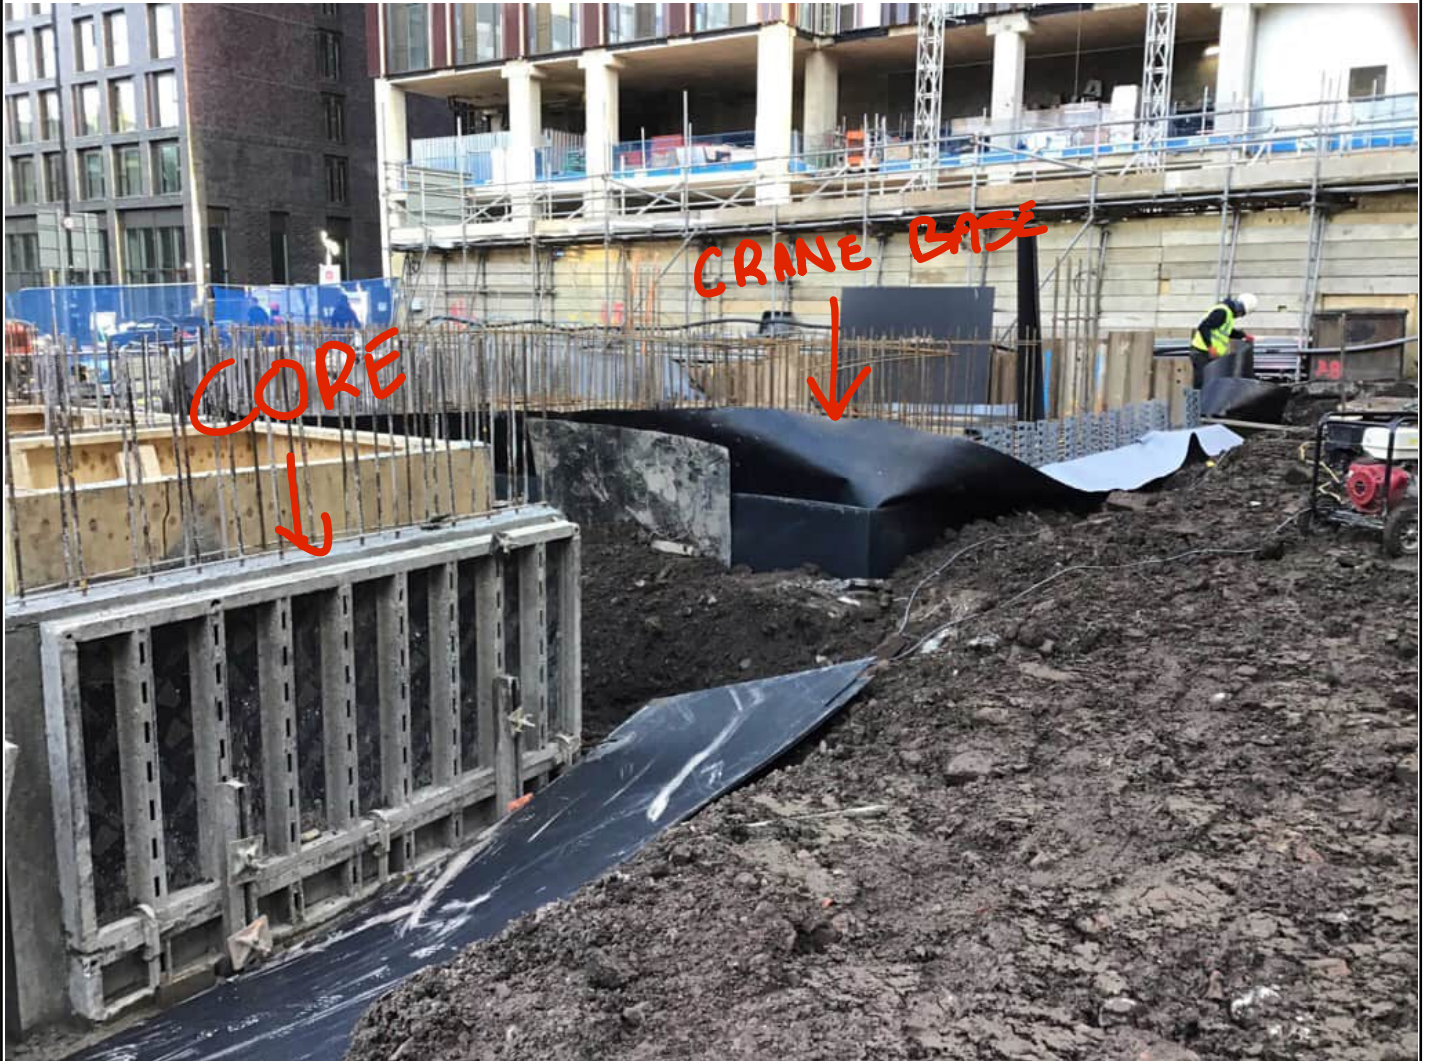
Overview of Core and a Crane Base

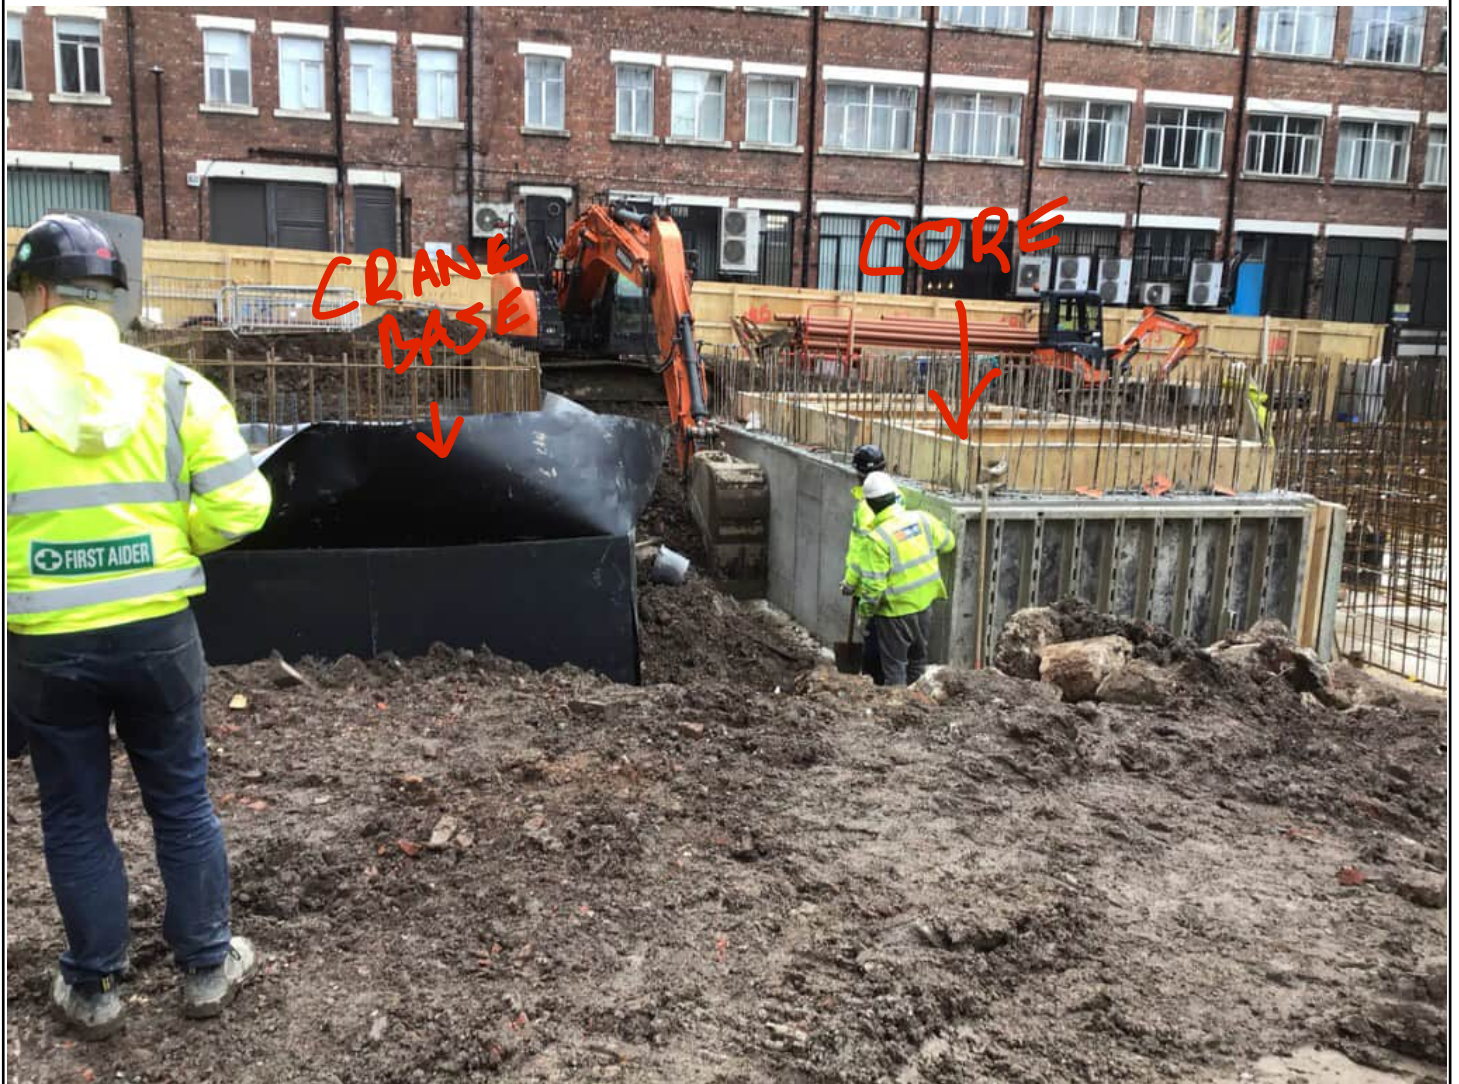
Overview of Core and a Crane Base

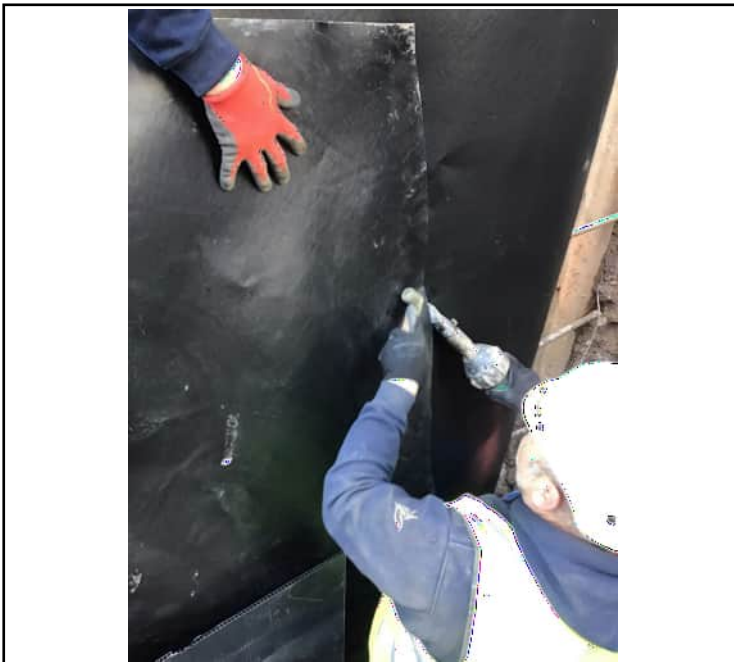
NOTES: Visqueen Geoseal Ultimate installed with minimum 150mm

return beneath the rebar. Long rolls used to minimise the number of joints required.

Joints sealed with hot weld before being extrusion welded. Visual inspection and

pick and probe test carried out.

1. Joints hot welded shut.

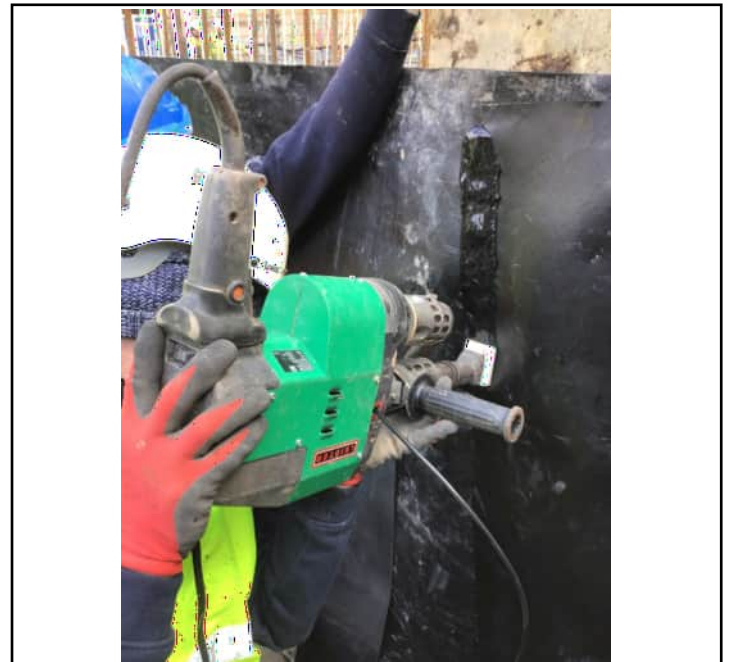
2. Joints reinforced and sealed with extrusion weld.

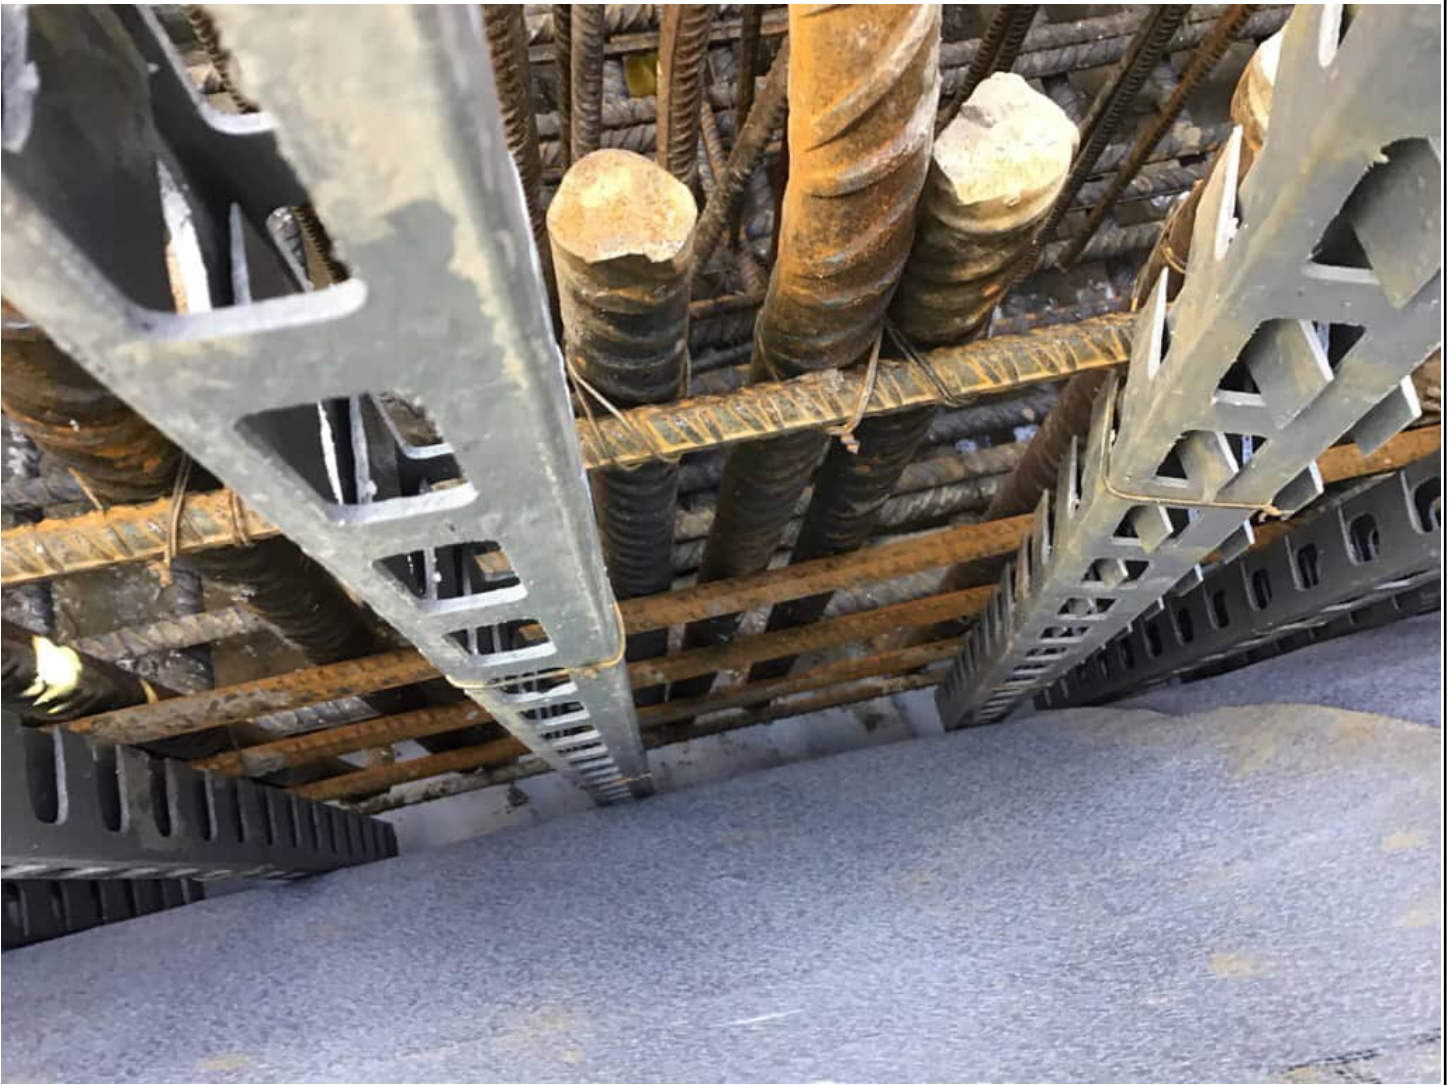
3. Minimum 150mm lap beneath steel rebar.

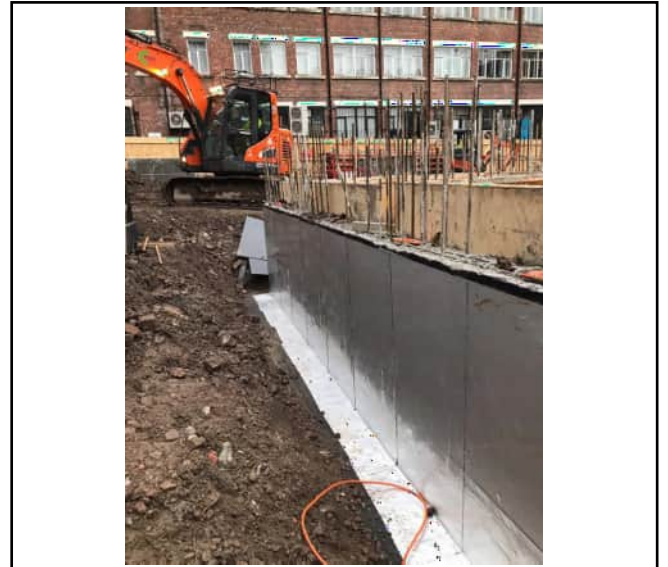
2. GR SAM applied to face of Core

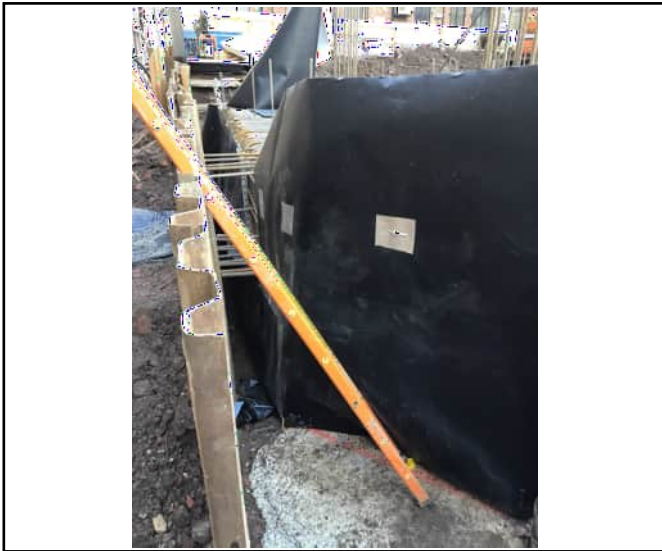
Peg sealed

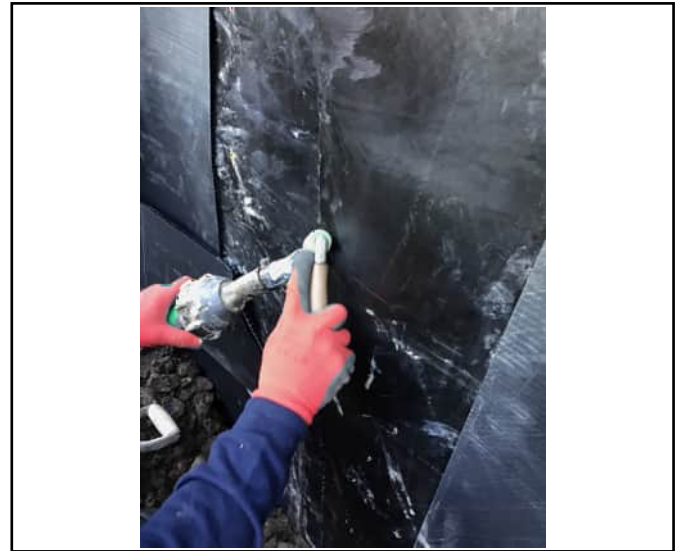
Hot weld in before extrusion

weld witnessed

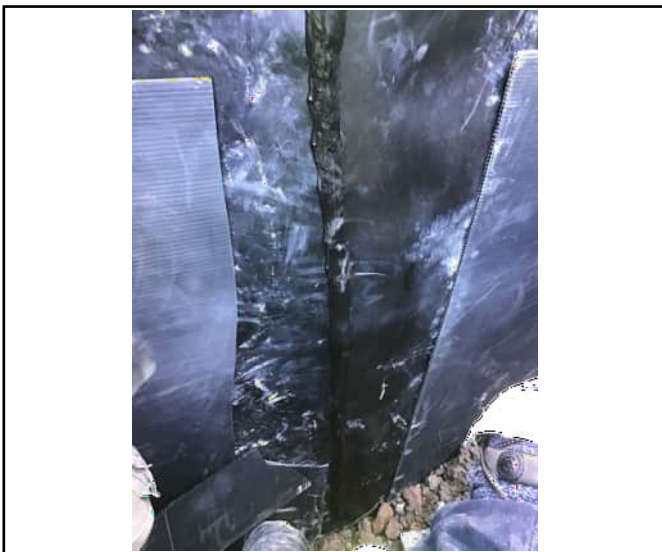
Extrusion weld on complete

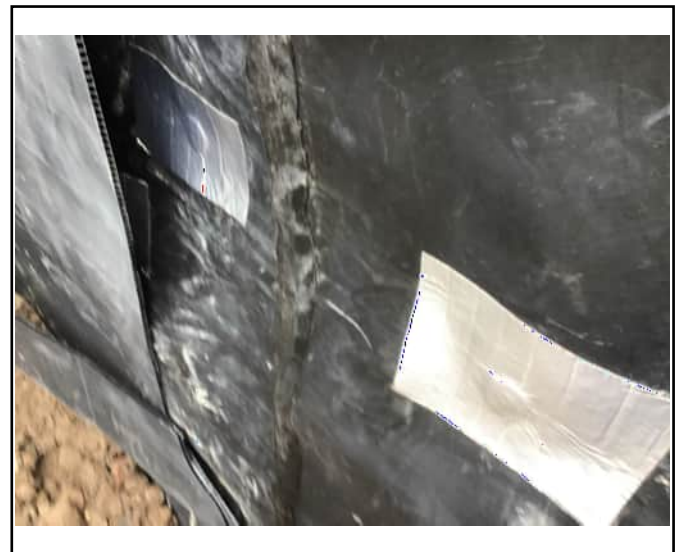
Pegs installed either side of

extrusion weld and sealed

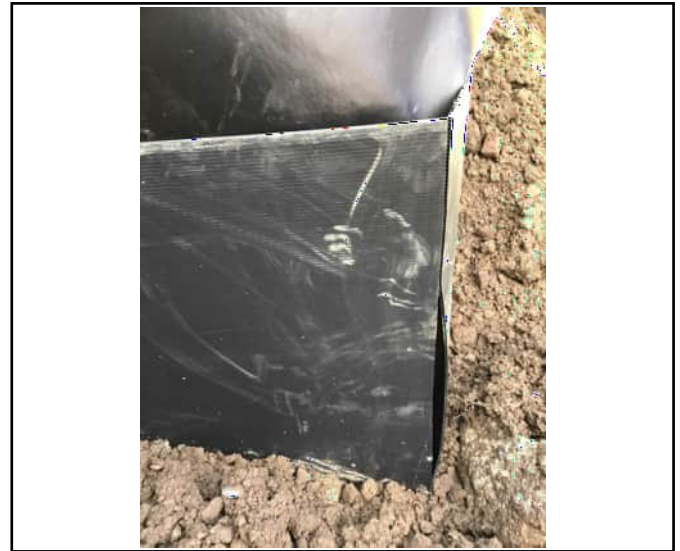
Protection board applied to

base of crane

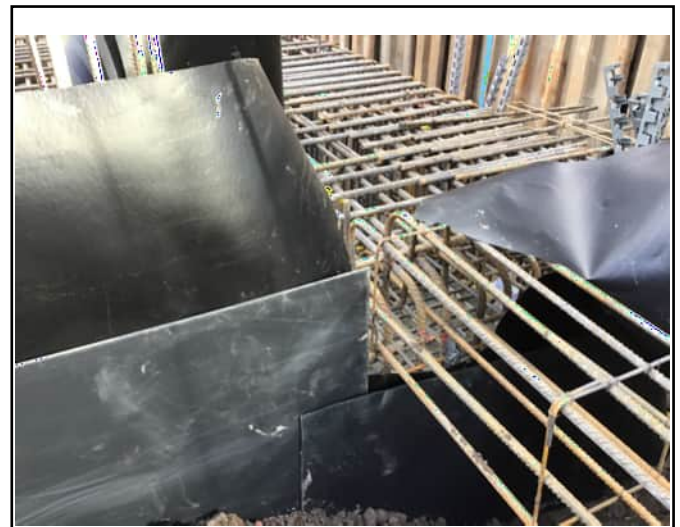
Membrane cut around ring beam

to be connected to base
