## Roof Inspection

New Maldren Hotel Manchester - Level 7 & Level 16

This report is prepared for SPS Flat Roof Systems Ltd, and its purpose is to report on the non-destructive electronic integrity test of the exposed waterproofing membrane of levels 7 & 16 of the New Maldren Hotel, Charles Street, Manchester.

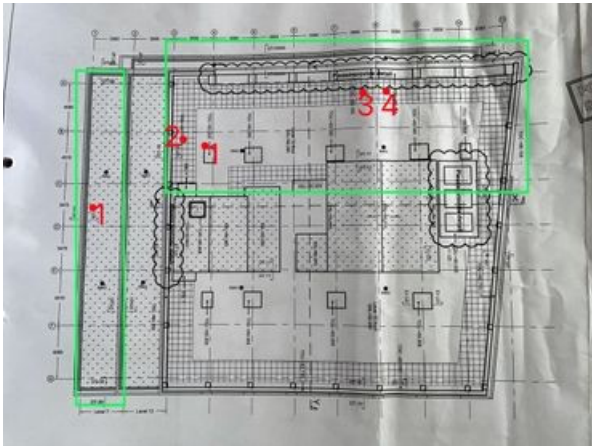
Photo 13

The testing identified five (5) breaches (shown in red on the roof plan sketch) where water may penetrate into the construction.

Level 7: 1 breach caused by mechanical

Level 16: 4 breaches caused by mechanical damage

Five breaches caused by mechanical damage were identified during the testing and inspection; these were repaired by SPS operatives.
