| | MEDLOCK<br>VICTORIA MILL<br>MILES PLATTING | | | | |
| | NORTH EAST ELEVATION<br>RECORD PHOTOGRAPHS AND REPAIRS REQUIRED | | | | |
| MED02 | | AP201 | | C | |

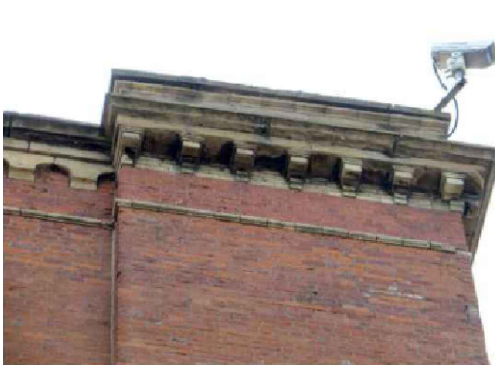
1. Damaged edge to string course. Stone repair required.

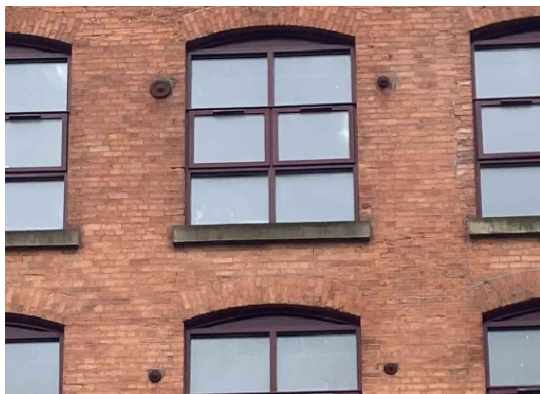
3. Existing metal stabilisation plates to be left in place.

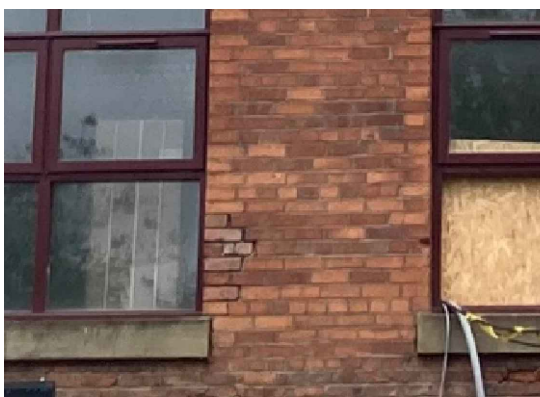
4. Loose brickwork to window reveal. Loose bricks to be rebbed in mortar to match existing.

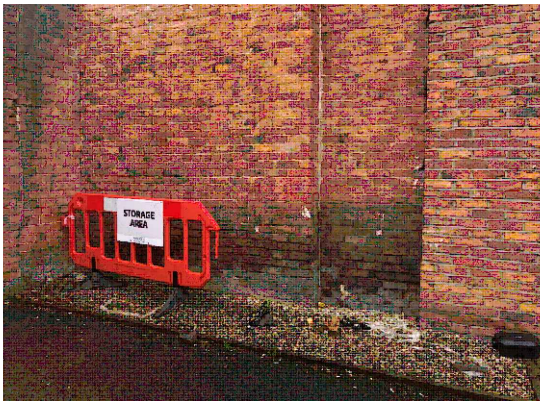
5. Staining to brickwork. Brickwork to be cleaned with a steam cleaner. Brickwork to be repointed if necessary. Mortar to match existing.

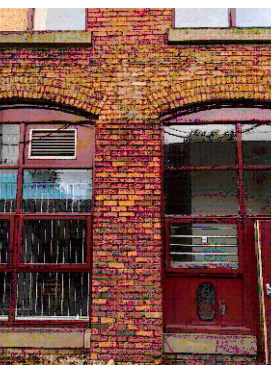
6. Cant bricks to top of brick piers missing. New cant bricks to match the existing cant bricks to the top of adjacent piers, are to be installed.

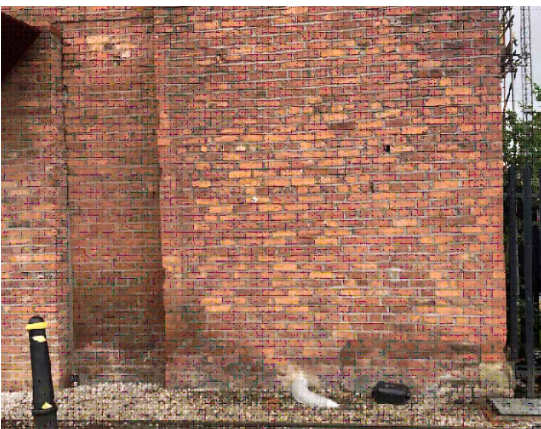
7. Cracking in brickwork. Assess condition of brickwork and mortar. Stabilise if necessary, replace cracked bricks repoint with mortar to match existing.

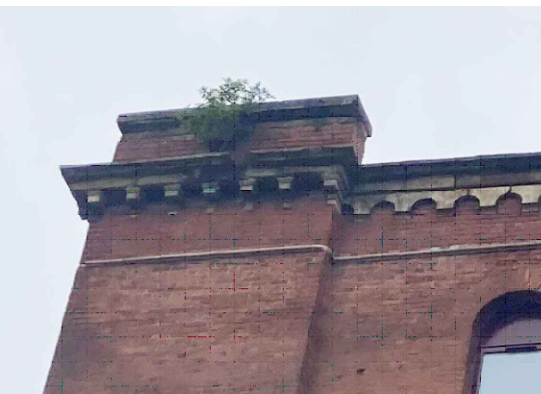
8. Damaged cornice. Stone repair required.

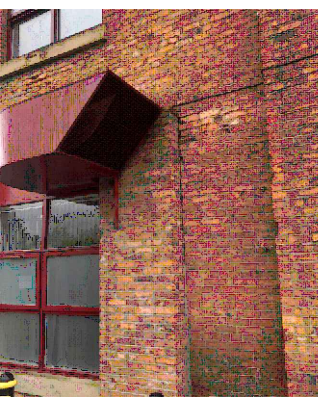
9. Crack between pier and main wall to be repaired with mortar to match existing.
